**FEBRUARY 2021**

**STRUCTURAL REPORT ON  
MORTIMER'S WAREHOUSE,  
RIVER HEAD, DRIFFIELD,  
YO25 6BA**

**PROJECT NO.  
MGC/SJH/HW/45057-Rp001**

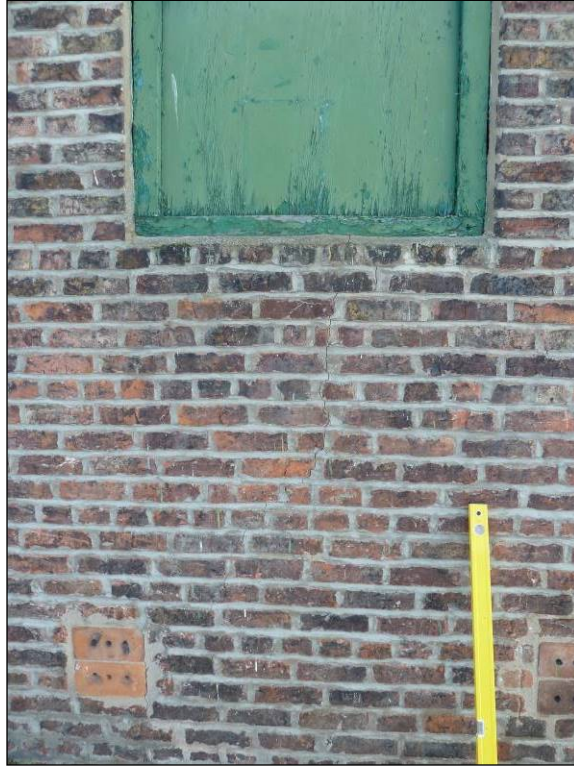
**Photograph No. 1**

- 3.2 Our inspection noted some slight cracking below the right hand ground floor window to the mortar joints and brickwork of approximately 2.5mm at sill to 0mm sixteen courses below, none of which appears to be recent. See Photograph No. 1.

- 5.2 On the above basis, our recommendations are for repairs and maintenance.
- 5.3 Externally and internally as necessary, all cracked and severely weathered mortar joints should be raked out to a minimum depth of 30mm and be repointed with a lime mortar, which will give some degree of flexibility and match the original materials used when constructed. Any cracked, broken or severely weathered bricks should be cut out and new units, of a similar pattern and material, be built in using a mortar similar to that as used in the repointing. When work is carried out adjacent to the damp proof course, great care should be taken to ensure that no damage is done to it or that no mortar bridges across it. All broken or severely weathered bricks below the damp proof course should be cut out and be replaced with a good dense matching brick built in cement mortar and the work is to be carried out in short lengths, so that the stability of the brickwork above is not impaired.

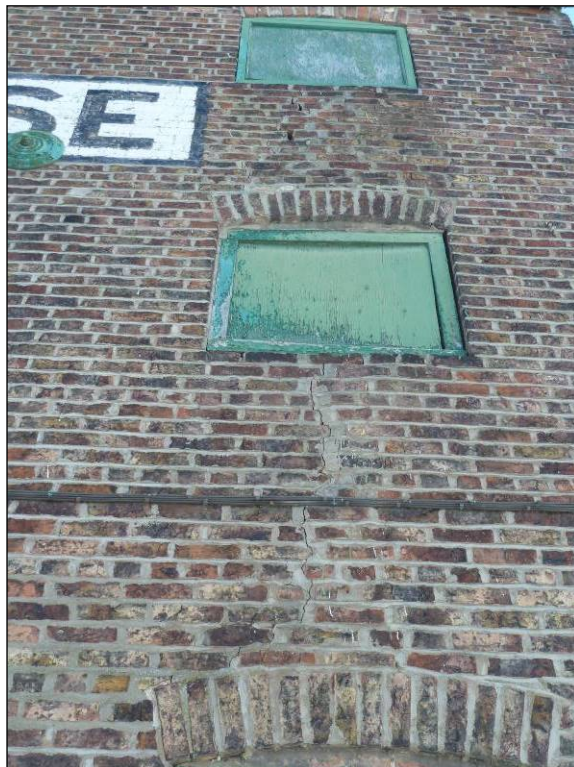
**Photograph No. 2**

- 3.3 Between the arched head of the right hand ground floor window opening and sill of the first floor window we noted some slight generally vertical cracking to the mortar joints of approximately 2.5 – 5mm in width, which does not appear to have occurred recently. See Photograph No. 2.

- 5.4 To the front elevation where the vertical cracking is present install stainless steel helical tie bars within the mortar bed joints bedded in resin and spaced as per the manufacturer's instructions, allowing a minimum length of 500mm each side of the cracking and repoint with lime mortar to match the existing.

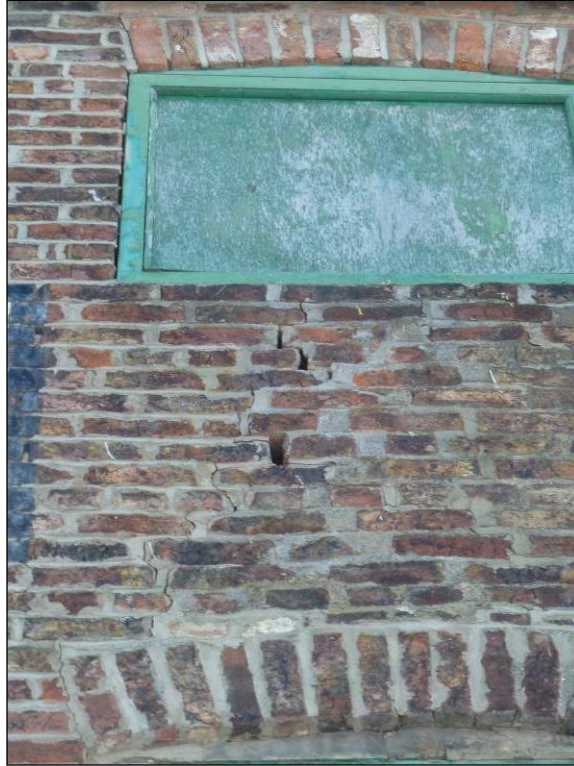
**Photograph No. 3**

- 3.4 Between the arched head of the first floor right hand window and the sill of the second floor window, we noted some slight generally vertical cracking to the mortar joints of approximately 3 – 10mm, which does not seem to be recent, plus some sections of the perpendicular mortar joints have fallen out at some point in the past. See Photograph No. 3.

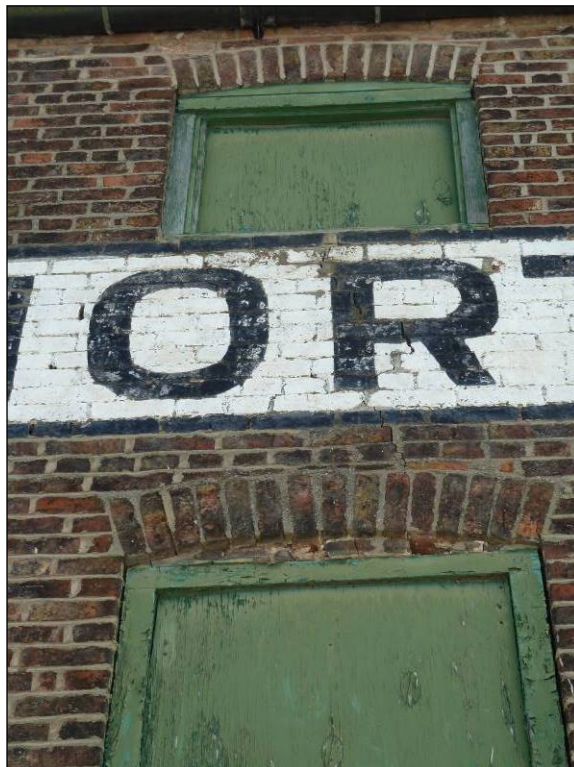
**Photograph No. 4**

- 3.5 We noted some slight generally vertical cracking to the mortar joints between the first floor arched window head, which is second from the left and the window sill above of approximately between 2-6mm, none of which appears to be of recent origin. See Photograph No 4.

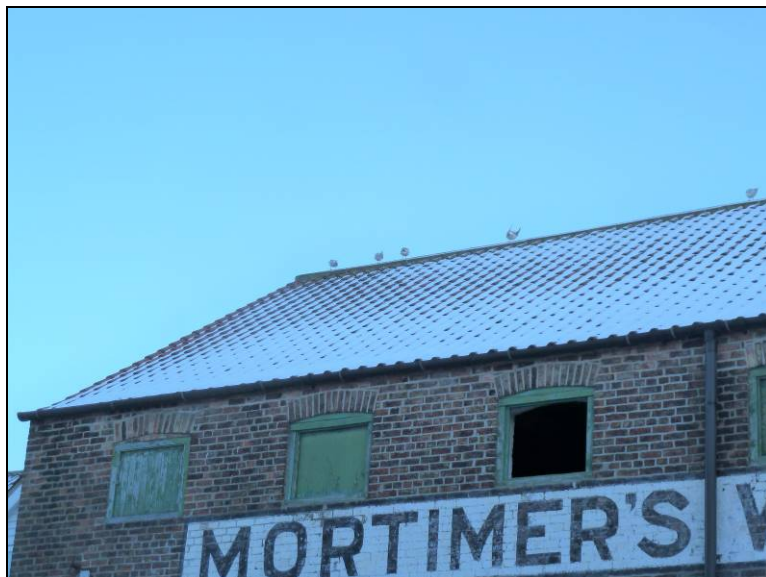
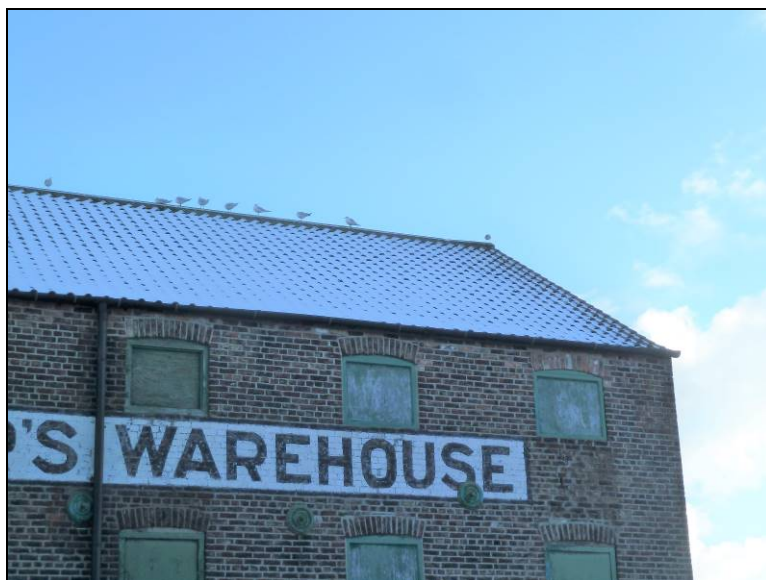
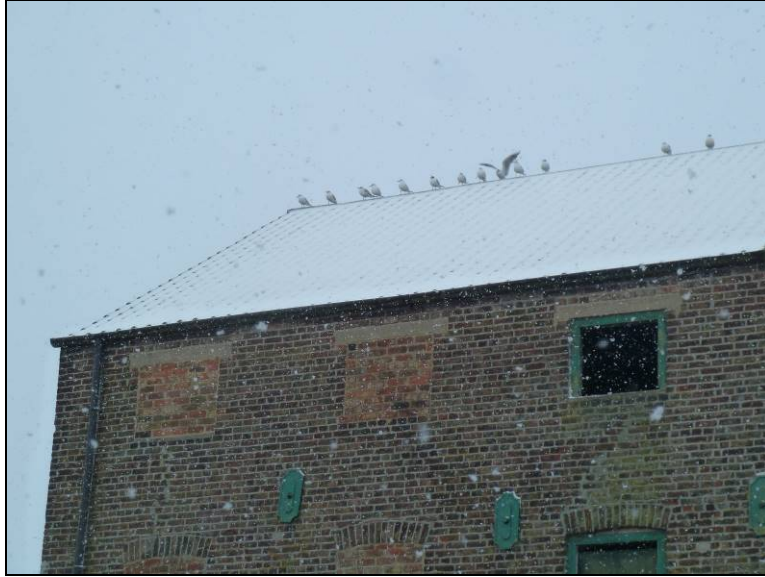
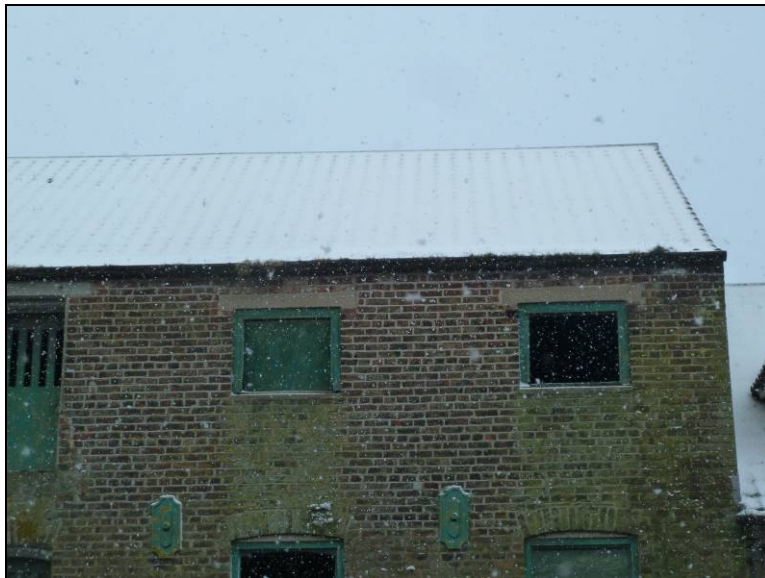
- 3.11 Whilst undertaking the inspection there was a layer of snow fall on the roof which may have impeded our view of any defects that may be present. The ridge line appears to be straight and level. As viewed from a distance no cracked, broken, loose or missing tiles could be detected. The mortar pointing to the verges appears to be in reasonable condition. The gutters and fallpipes appeared to be in reasonable condition, although no specific inspection has been made of these items as they are deemed to be non-structural. We noted that there is a build-up of vegetation in the gutter on the rear elevation. It is understood from the Client's representative that the roof covering was renewed approximately 6-7 years ago. See Photograph No's. 5 – 8.

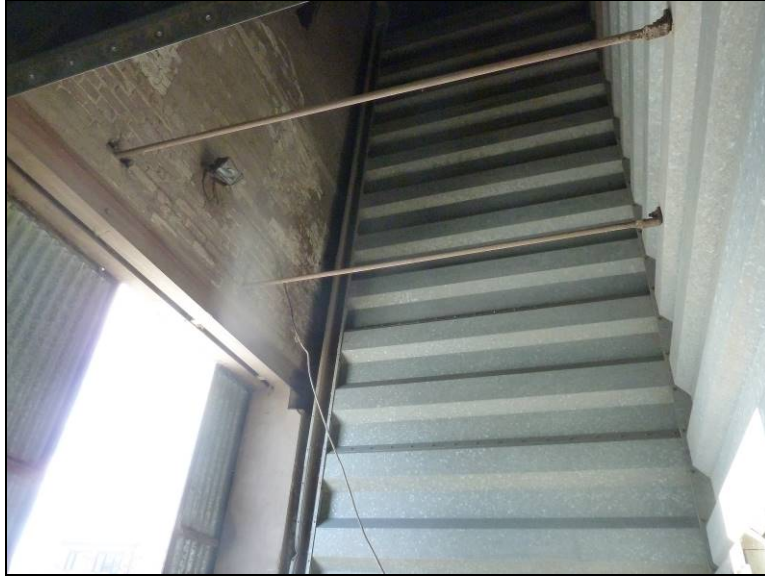
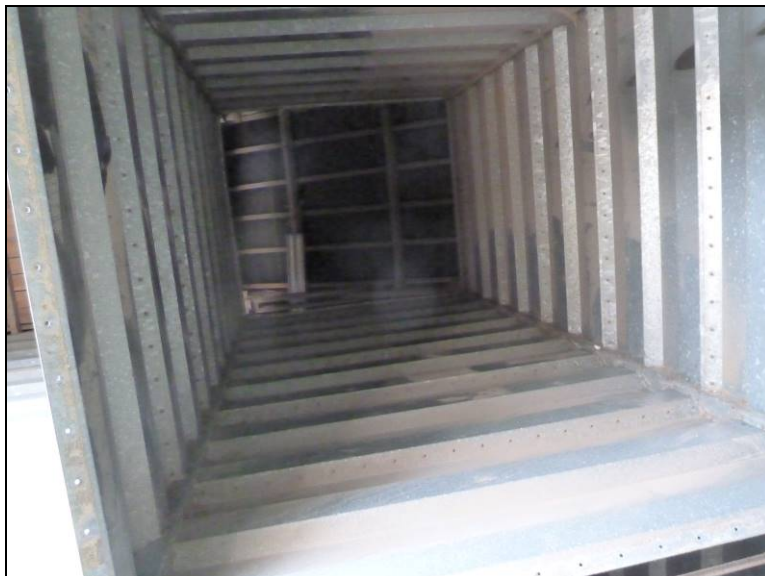
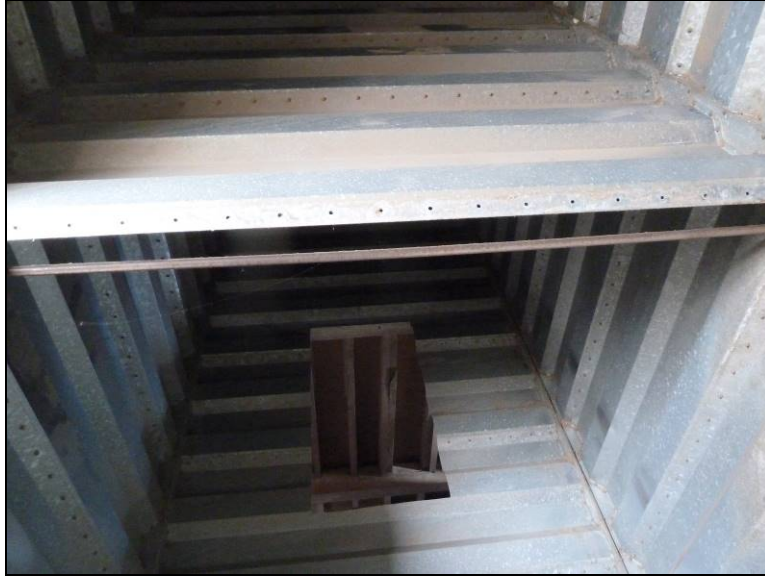
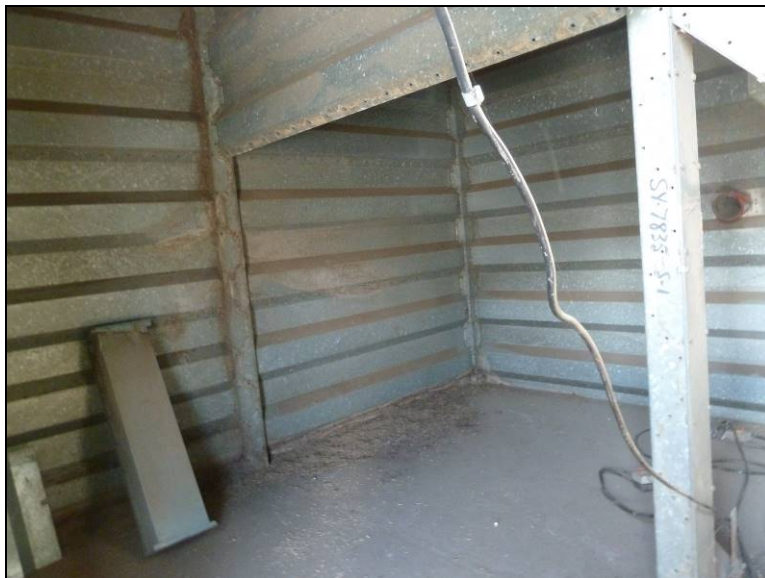
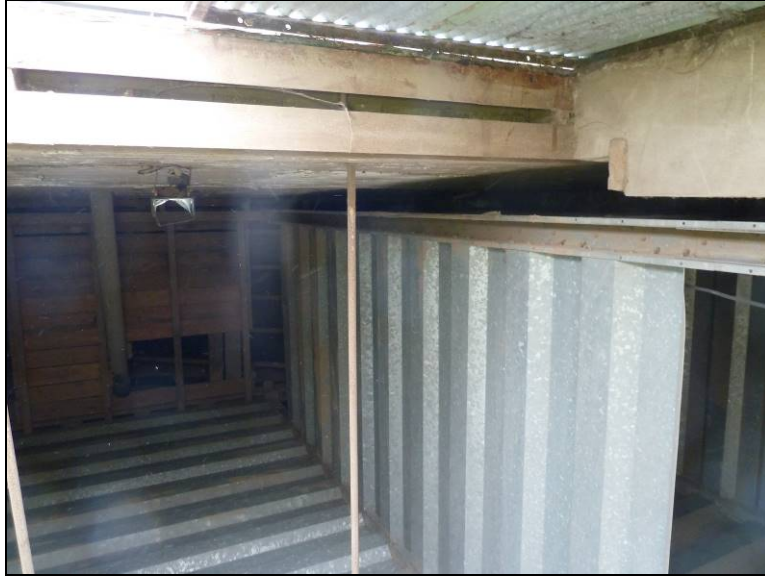
- 3.12 This section of the building comprises ground floor to second floor is filled with galvanised profile metal sheeting and framing and is believed to have formed part of the mill workings. At the time of inspection we did not note any significant defects to the area. See Photograph No's. 9 – 13.
- 3.13 There is a pit in the floor adjacent to the right hand elevation door opening which appears to be in reasonable condition. See Photograph No. 14.

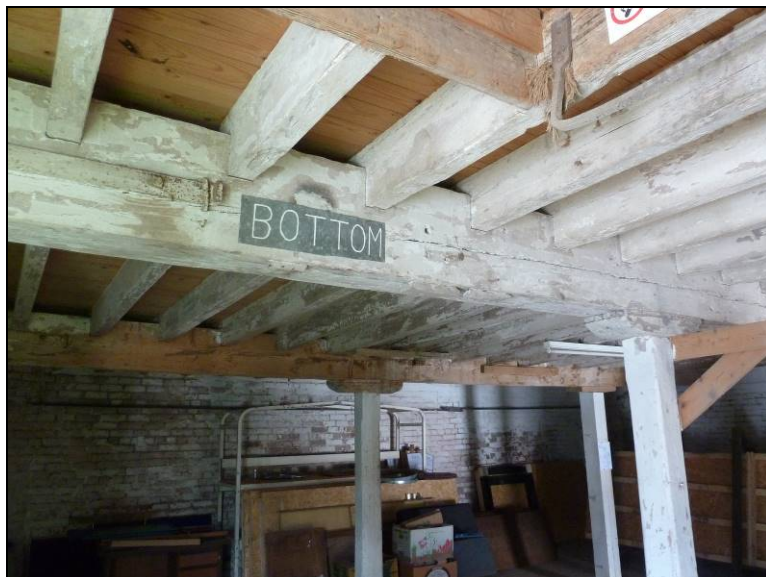
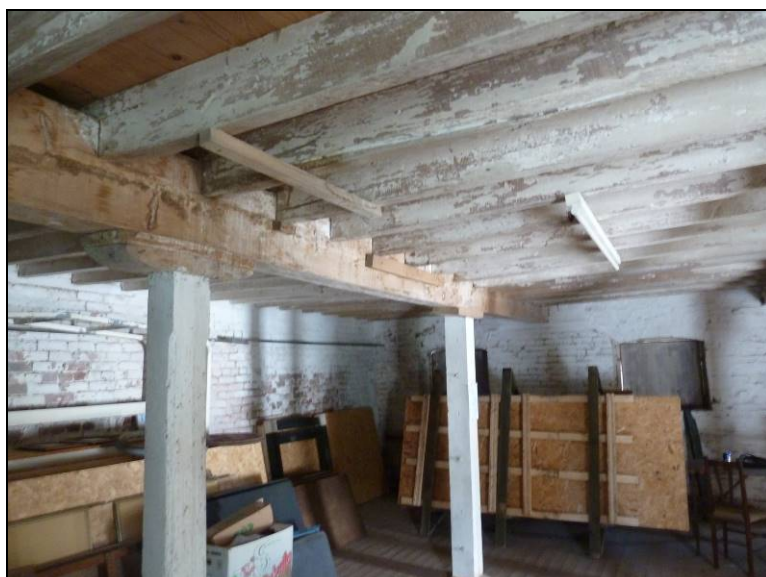
- 3.16 The timber beam which supports the first floor which is adjacent to the north end of the building appears to have been replaced at some time in the past, as the timber does not have a surface coating like the assumed original timbers, and appears in good order. See Photograph No's. 15 & 16.

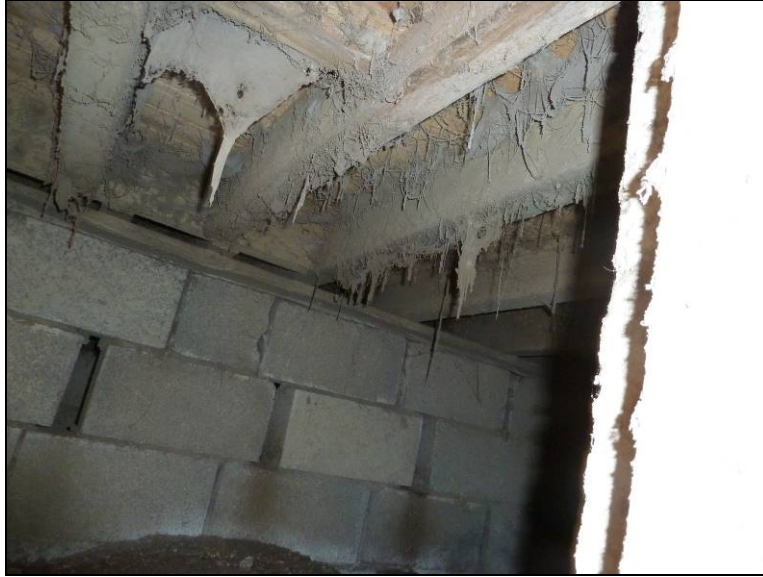
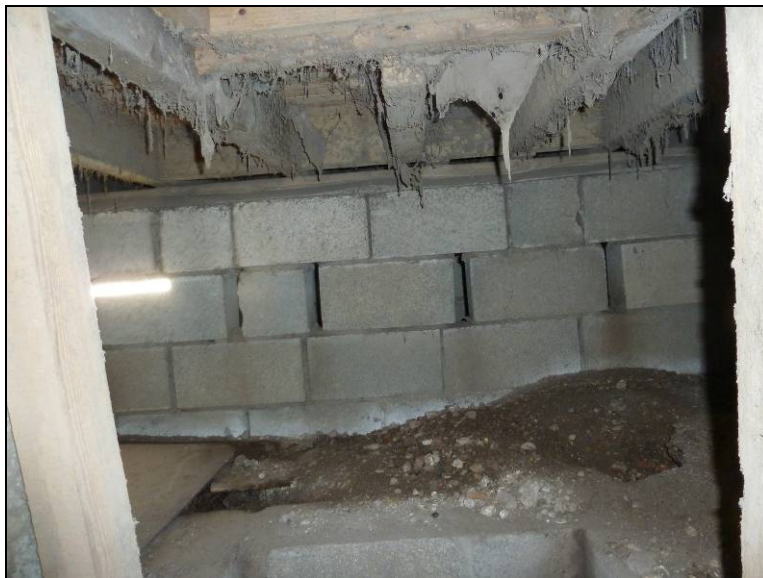
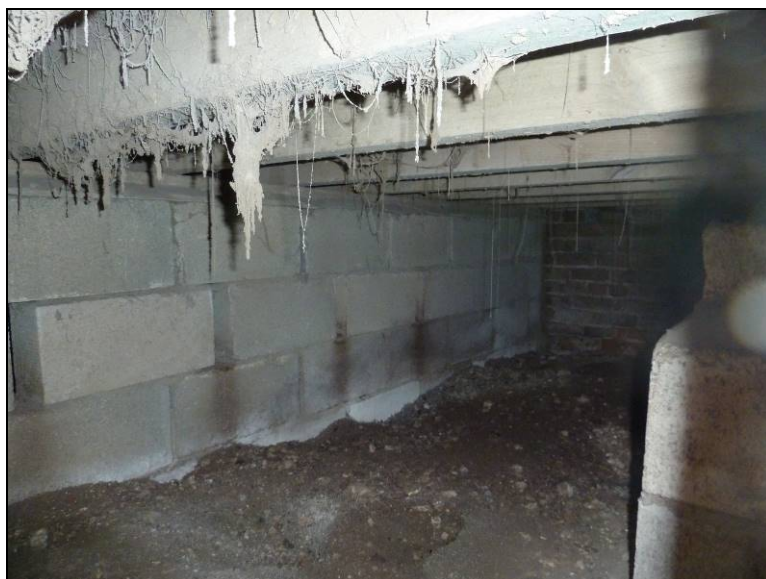
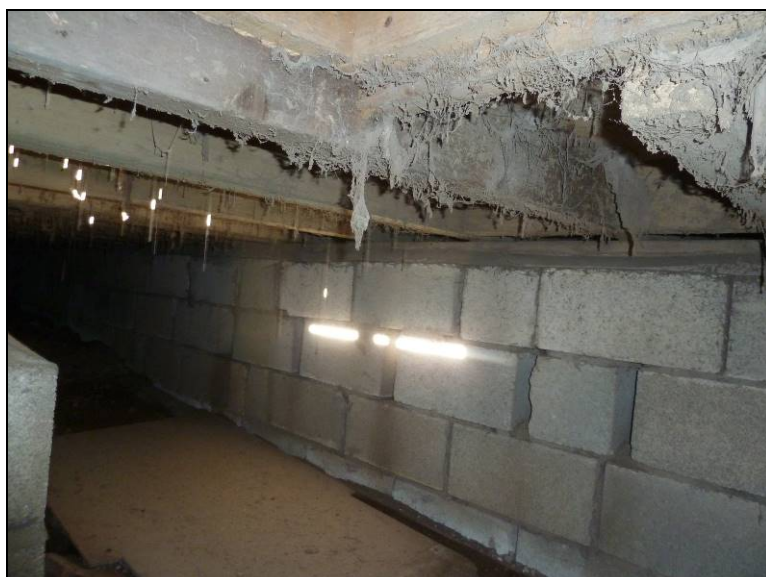
- 3.17 The suspended timber floorboards appear to have been replaced some time in the past. A small section of the under floor void could be seen, which revealed there to be modern blockwork sleeper walls, plus some of the floor joists have been replaced with modern treated timber joints. See Photograph No's. 17 – 20.

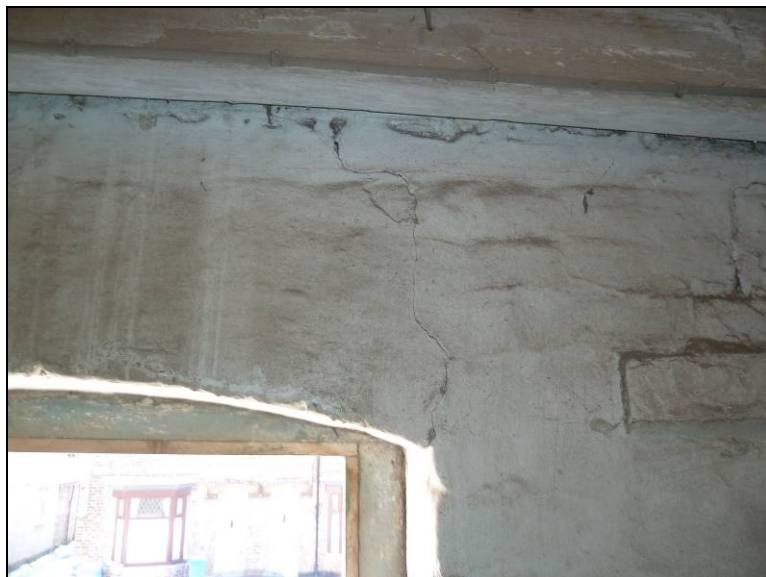
**Photograph No. 21**

- 3.18 Our inspection noted some fine cracking to the right of the window on the front elevation adjacent to the top of the staircase of approximately 2-3mm in width, which does not appear to be recent. See Photograph No. 21.

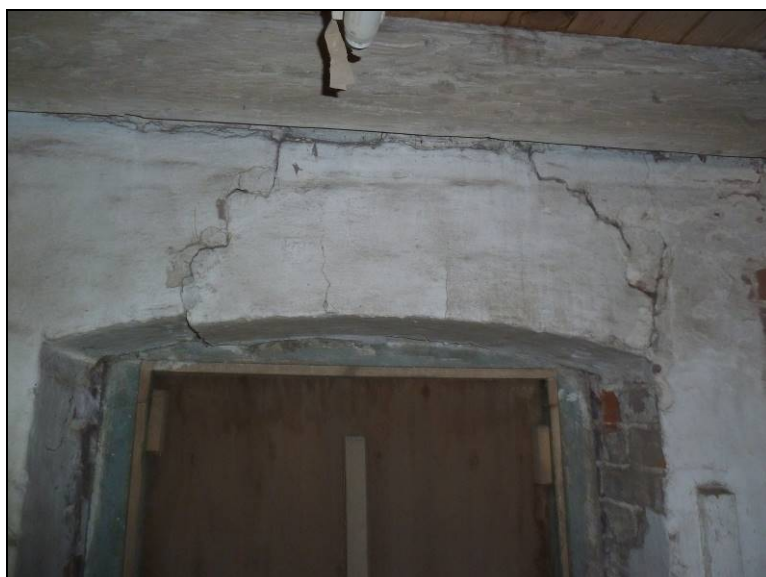
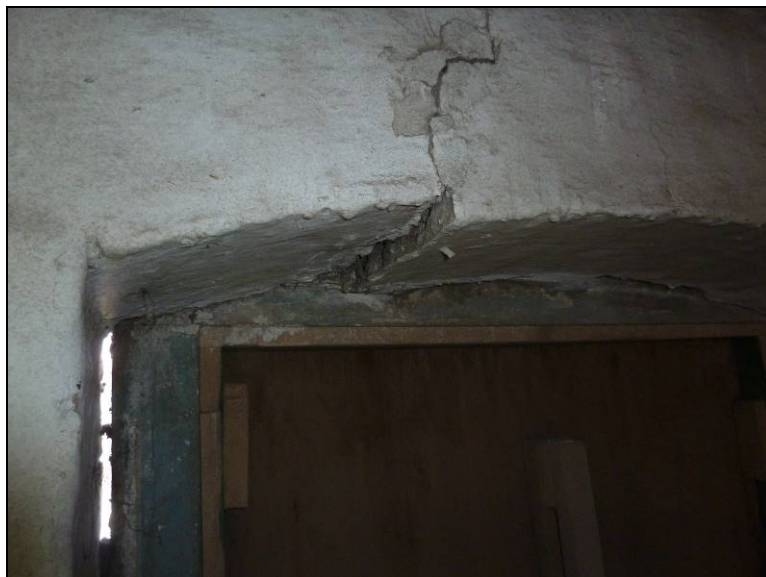
- 3.19 On the front elevation we noted some slight cracking and dropping of the brick arch above the window which is second from the north (left) elevation, the cracking is approximately 2-3mm in width, whilst the arch appears to have dropped around 20mm, none of which appears to be of recent origin. See Photograph No's. 22 & 23.

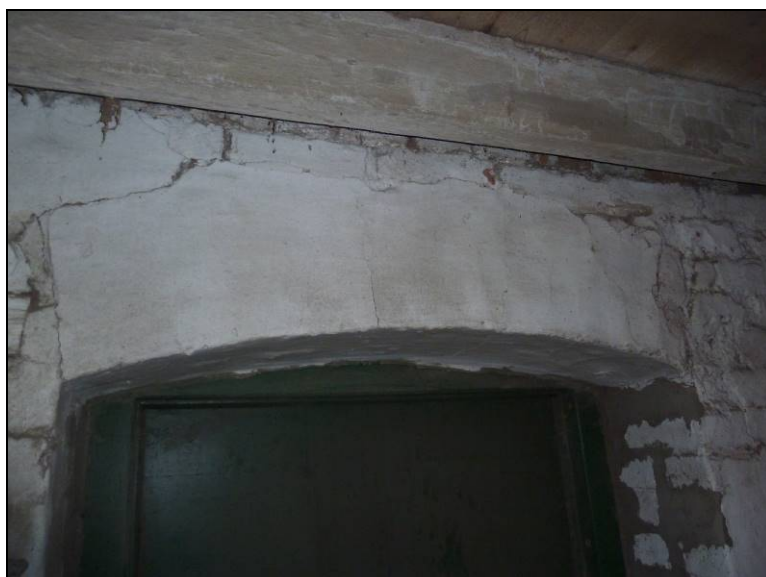
**Photograph No. 24**

- 3.20 Above the window on the front elevation adjacent to the corner with the north elevation we noted some slight cracking to the mortar joints of approximately 3-5mm in width, which does not appear to be of recent origin. See Photograph No. 24.

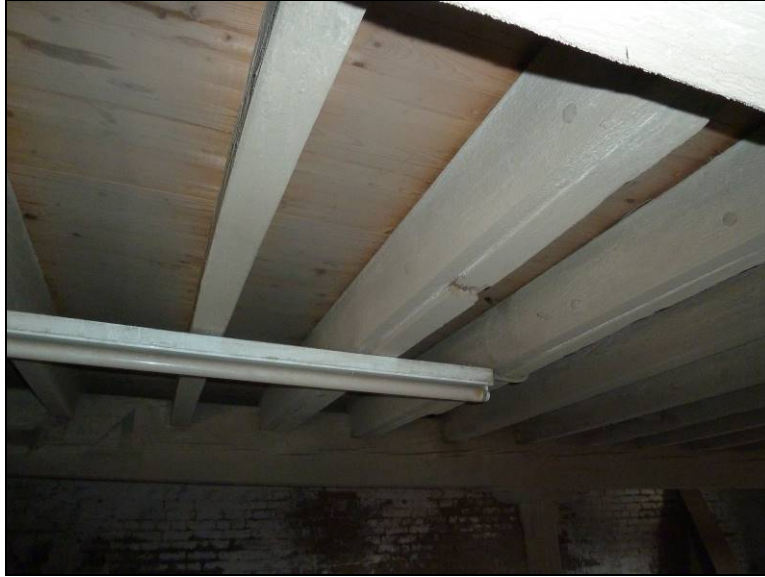
**Photograph No. 25**

- 3.23 Given the apparent slight lean of the wall, we feel that it is stable. As CIRIA Report 111 – Figure 12 (a), a copy of which is in Appendix B, the lean of the wall should not exceed  $0.85 \times$  thickness of the wall, which is approximately 400mm thick. Therefore, the allowable lean before the wall becomes unstable is  $400\text{mm} \times 0.85 = 340\text{mm}$ . As previously measured, the wall is approximately 110mm out of plumb and does not exceed the allowable lean and can be considered to be stable at the time of inspection.
- 3.24 We noted that some of the original second floor joist have cracked, however, additional timbers have been bolted in place to provide support. See Photograph No. 25.

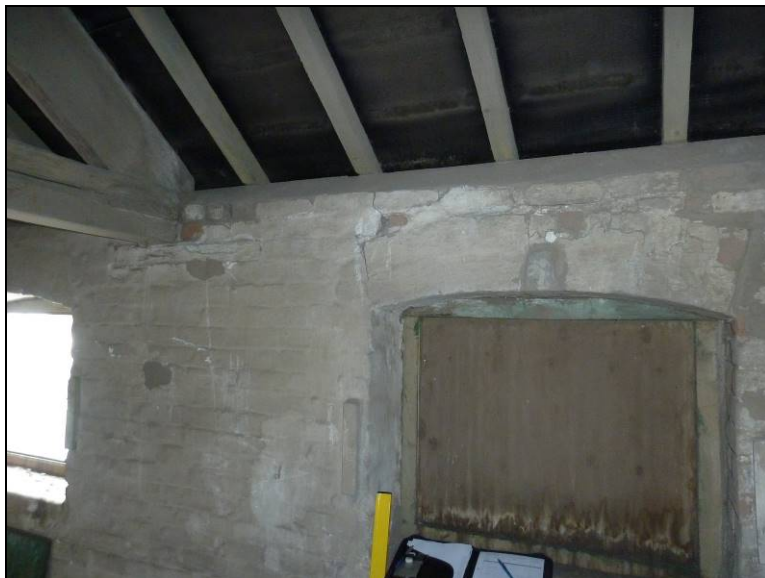
**Photograph No. 26**

- 3.25 When measured with a spirit level, the front external wall appeared to be generally plumb and vertical.
- 3.26 On the front elevation above the left of the second window from the north elevation we noted some slight cracking of approximately 1-5mm in width which does not appear to be recent. See Photograph No. 26.

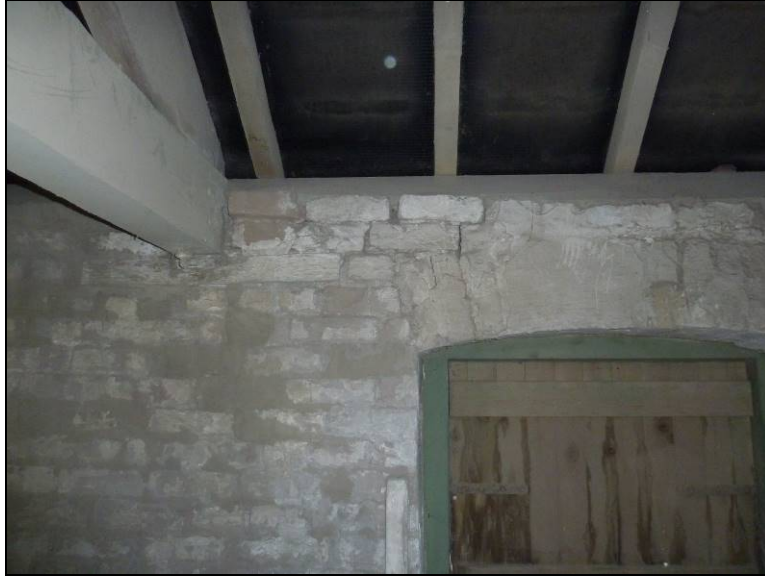
**Photograph No. 27**

- 3.27 Above the left of the window on the front elevation adjacent to the north elevation we noted some slight cracking to the mortar joints of approximately 2-5mm in width, none of which appears to be recent. See Photograph No. 27.

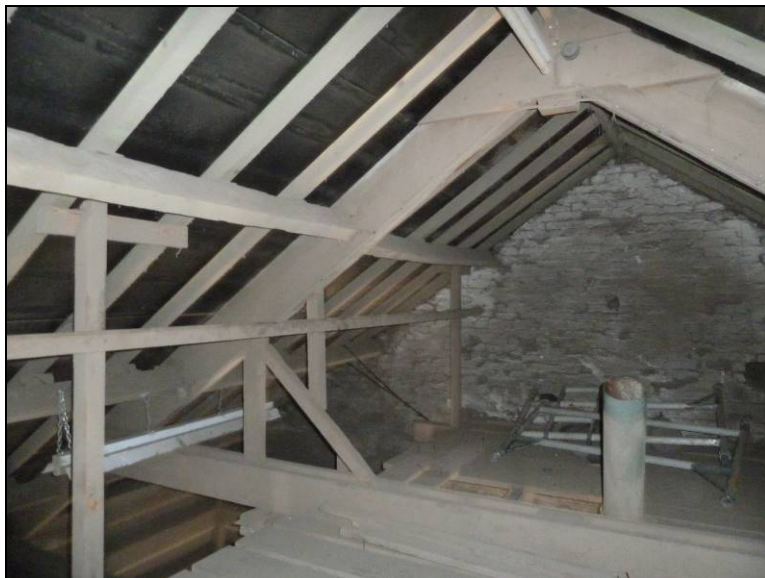
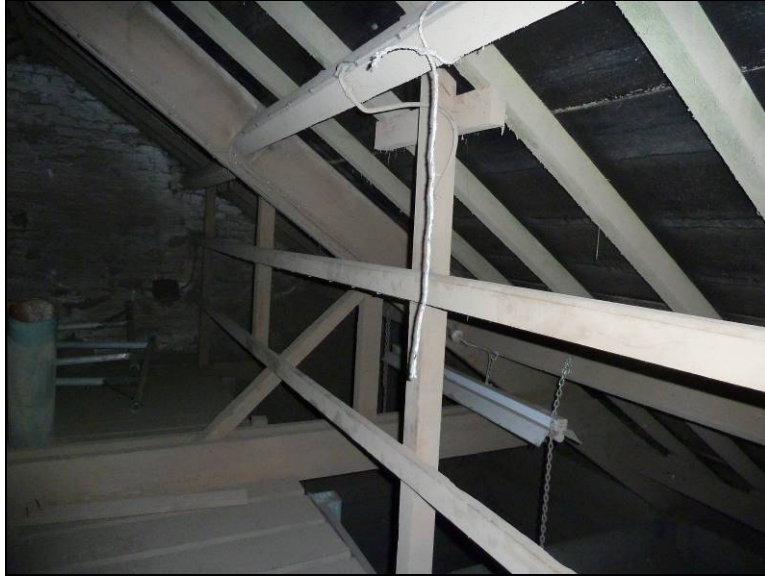
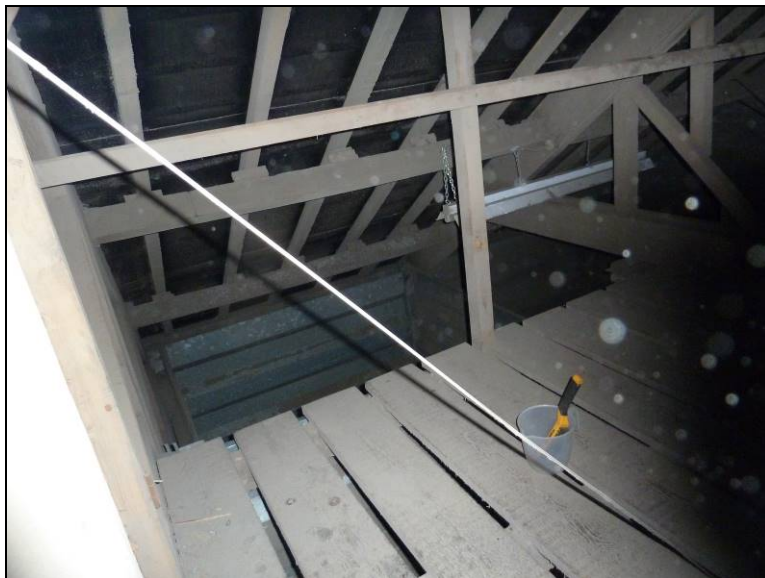
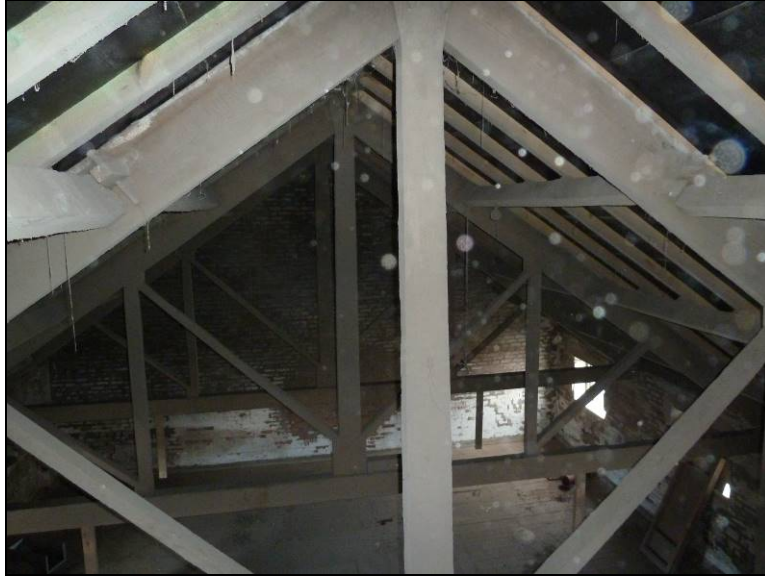
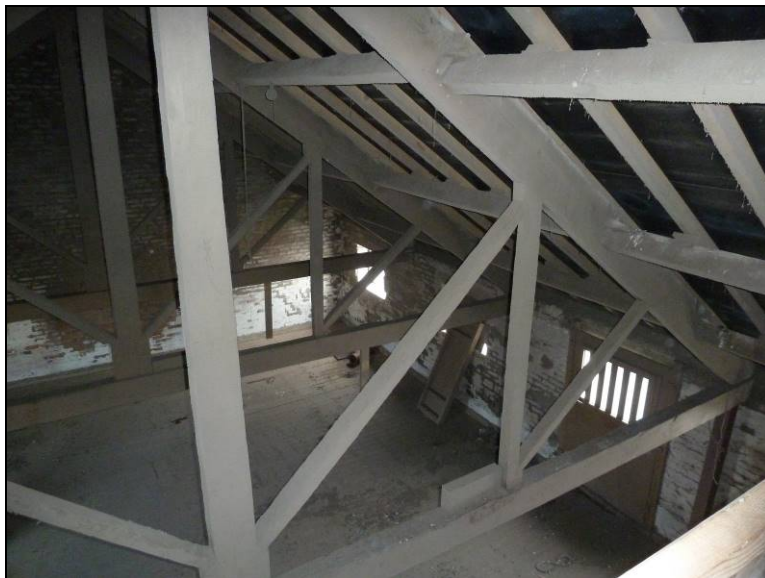
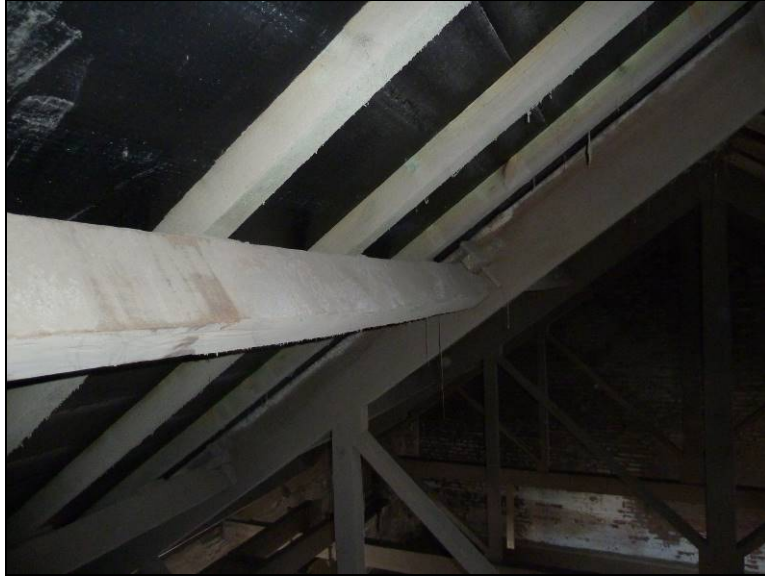
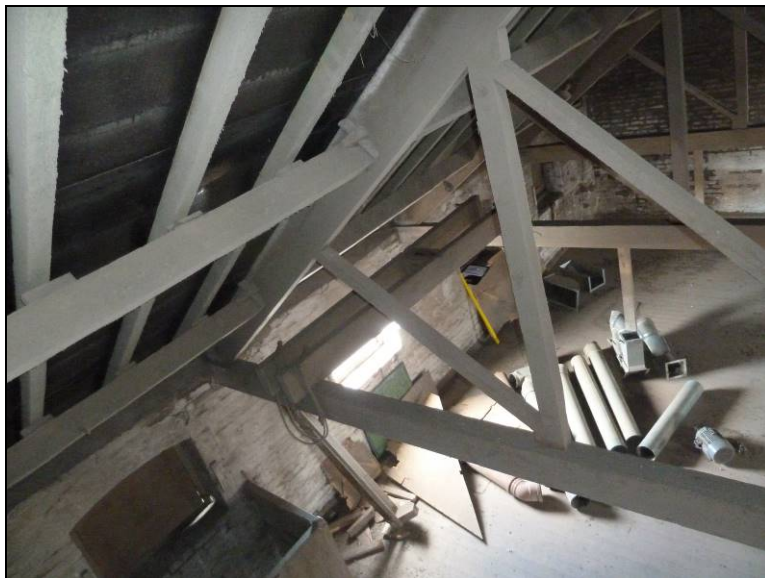
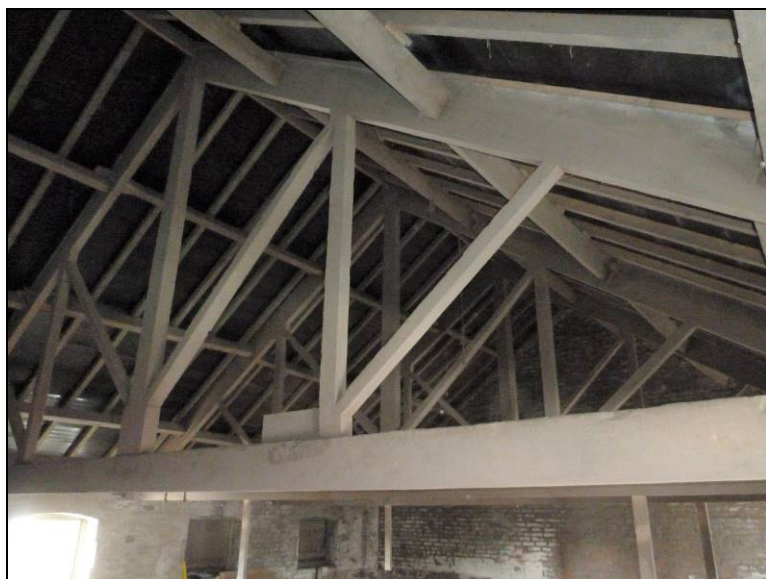
- 3.32 The accessible sections of the roof space was inspected and no signs of serious movement could be detected in the roof timbers, which appeared to be in reasonable condition given their age. It was also noted that it appears the rafters have been renewed in modern saw cut treated timbers and have been packed of the original purlins. See photographs No's. 28 – 35.
