Appendix C

Cornwall Consultants Ltd.,
Regulated Mining Search:
Metalliferous Minerals, 28
October 2019

| Property Address | A-Ddharn Mining Study | |
| Report Reference & Date | JW/CMS/129120 | 28 October 2019 |

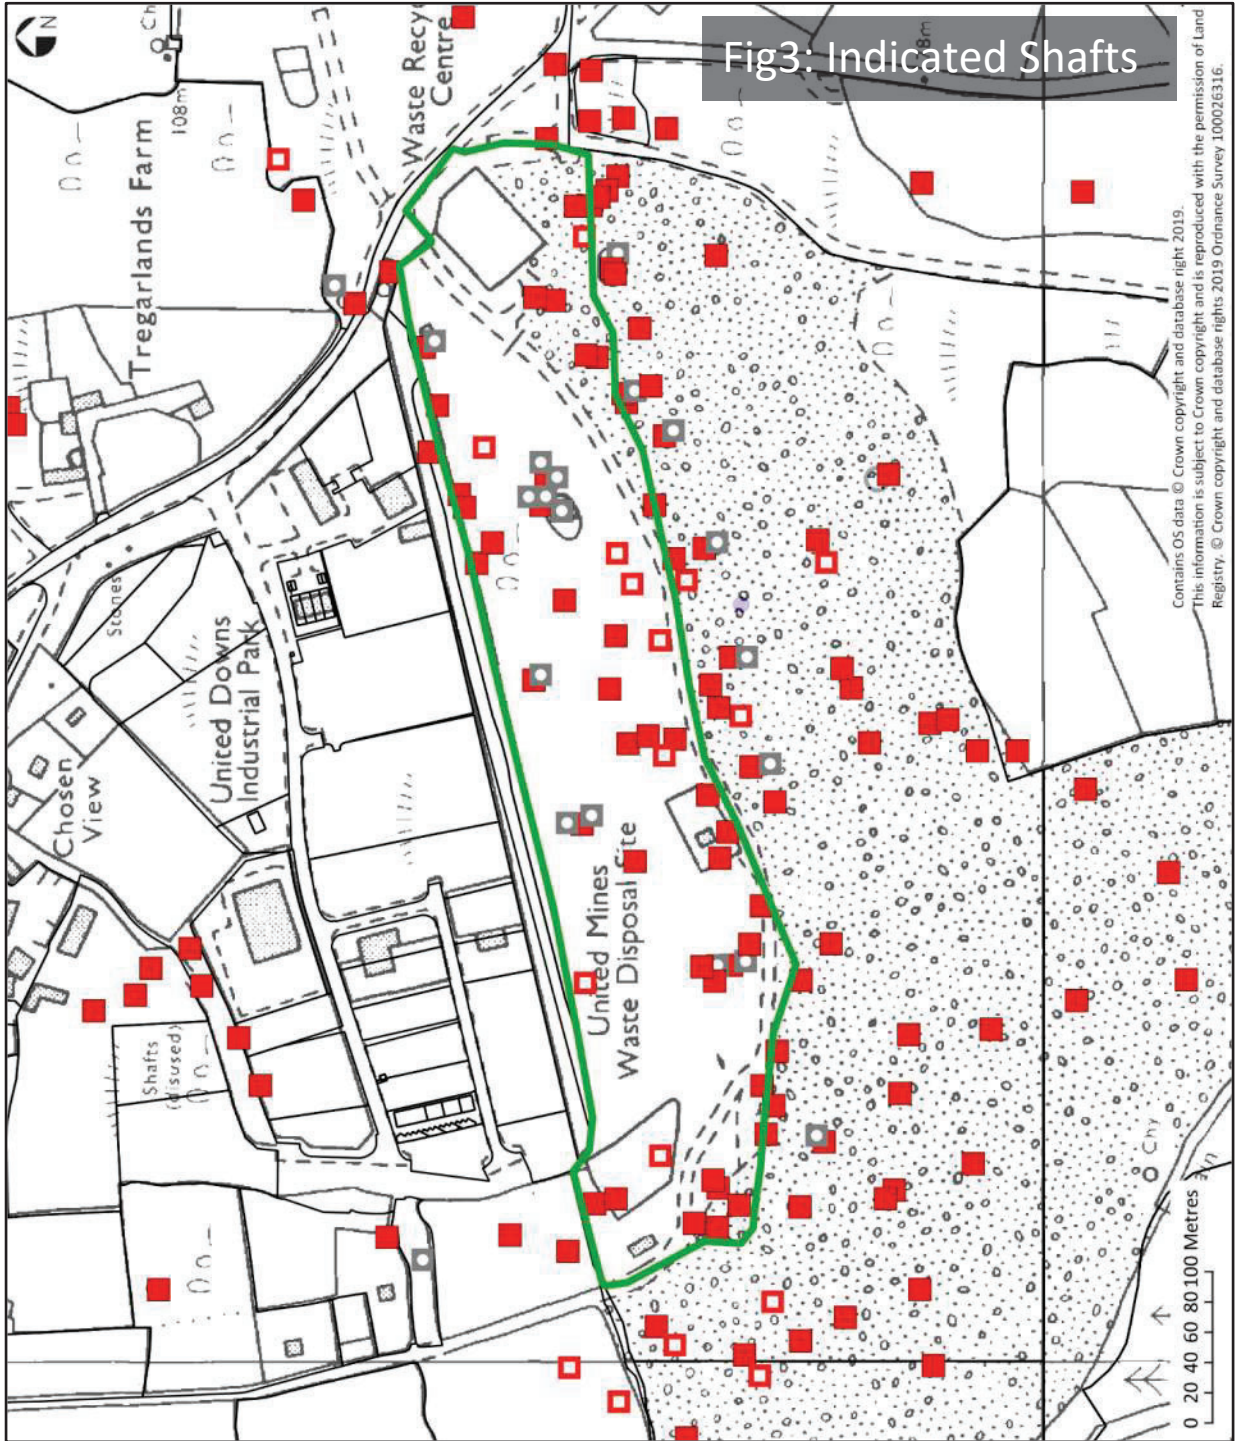
Fig3: Indicated Shafts

Our records indicate that approximately 60 shafts associated with the former United Mines lie within or on the boundary of the property (Figure 3). It appears that a very small number of these (less than 5) were assessed and treated as part of Operation Minecap in the early 1980's, although others may have been subjected to some form of independent treatment since then. We assume that any shafts for which we do not hold records of remediation remain untreated. Most mine shafts in the South West remain unsecured and cannot be considered to be in a stable state.

An intrusive on-site Mining Investigation will be required to fully assess the risks presented by the indicated shafts; mineral lodes and surface workings. It is recommended borehole drilling or slot trenching be constantly supervised by an experienced mining consultant. Geophysical survey may also be applied to appraise these areas between the indicated features and any hotspots should be further investigated.
