# Windows Schedule

**92A Langley Road  
Watford  
WD17 4PJ**

**25/01/21**

**Version 2**

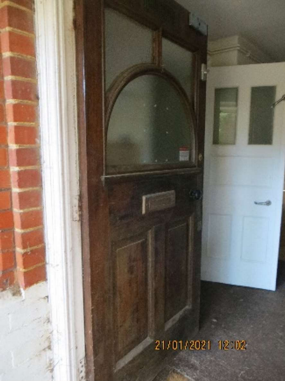
<p><b>D1</b></p>

<p>Hardwood panelled door with single pane glazing at high level. Frosted central panel and stippled glass above with letterbox, brass doorknob, yale lock and high level handle along with magnetic catch.</p>	<p>Refurbish existing door, repair and re-stain.</p>
<p><b>W2</b></p>

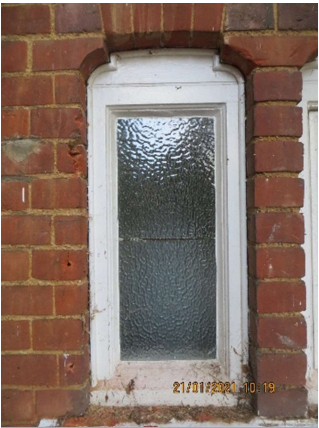
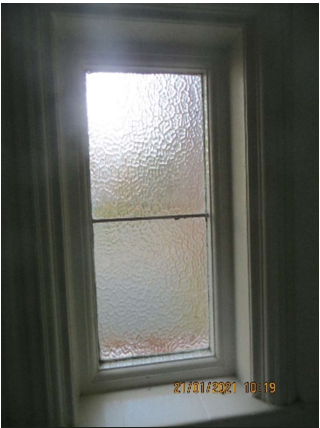
<p>Stippled glass, single glazed metal crittall casement set into a timber frame. Window stay and catch original, unlikely to operate. Single glazed.</p>	<p><u>Crittall casement</u> Replace casement with timber casements to match profile of existing historic timber windows. New toughened glass to be installed. Existing timber frames to be repaired insitu prior to decoration. New heritage style ironmongery to be installed.</p>

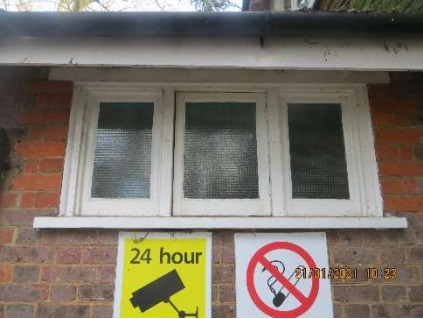
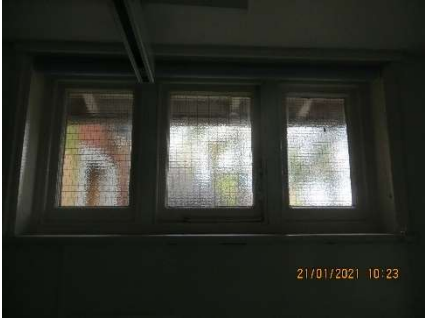
<p><b>W3</b></p>

<p>Single glazed Georgian wired timber casement window with 2nr fixed lights to the left and right and a central opening casement with original ironmongery, stay and catch and locking mechanism. Georgian wired.</p>	<p><u>Timber Casement</u> Carefully remove existing glass. Install new toughened glass (4-6mm thickness). Existing timber casement to be retained, repaired with conservation repairs where possible. If casement rebate is too shallow or casement is unrepairable it will be replaced in timber to match existing profile in size and shape. Repair frame as required. New heritage style ironmongery to be installed.</p>
------------------	---	--	--	--

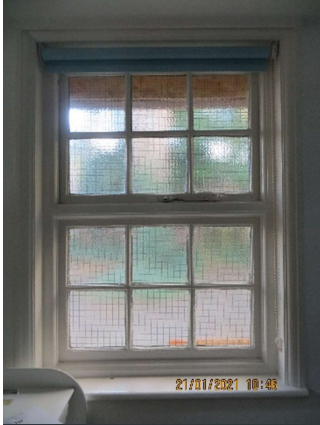
<p><b>W4</b></p>

<p>Timber casement with opening light top hung with a fixed lower casement with integral timber beading and Georgian wired glass. Original stay for top hung casement. Concrete windowsill. Georgian wired.</p>	<p><u>Timber Casement</u> Carefully remove existing glass. Install new toughened glass (4-6mm thickness). Existing timber casement to be retained, repaired with conservation repairs where possible. If casement rebate is too shallow or casement is unrepairable it will be replaced in timber to match existing profile in size and shape. Repair frame as required. New heritage style ironmongery to be installed.</p>
------------------	---	--	---	--

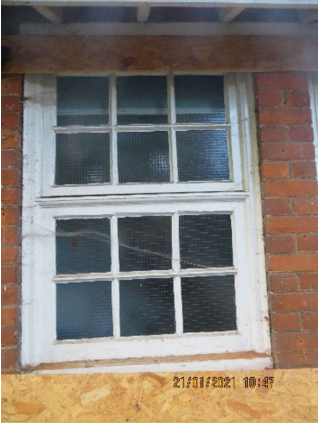
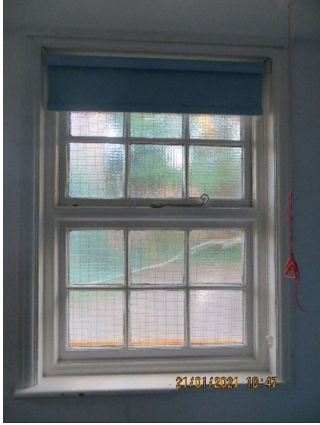
<p><b>W5</b></p>

<p>Timber casement with opening light top hung with a fixed lower casement with timber beading and Georgian wired glass. Original stay for top hung casement. Concrete windowsill.</p>	<p><u>Timber Casement</u> Carefully remove existing glass. Install new toughened glass (4-6mm thickness). Existing timber casement to be retained, repaired with conservation repairs where possible. If casement rebate is too shallow or casement is unrepairable it will be replaced in timber to match existing profile in size and shape. Repair frame as required. New heritage style ironmongery to be installed.</p>
------------------	---	--	--	--

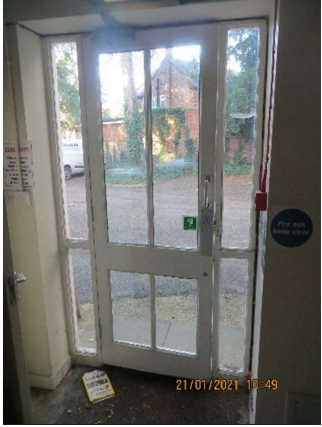
<p><b>D5</b></p>

<p>Timber door with toughened upper and lower glazed panels.</p> <p>Timber side lights with toughened glazing. Complies with BS6206. Some decay noted in the middle transom.</p>	<p>Repair and redecorate</p>
<p><b>D13</b></p>

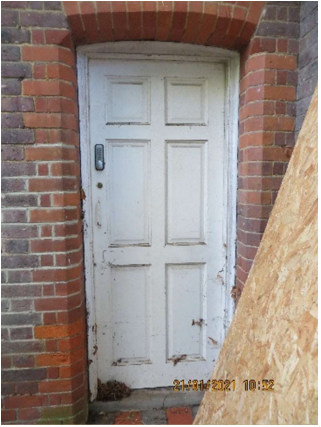
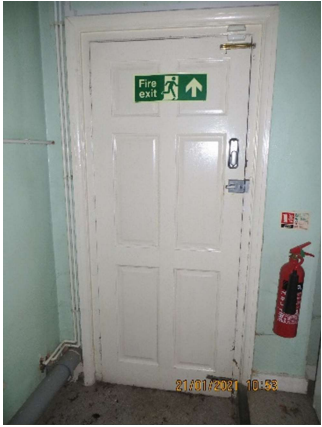
<p>Solid timber six panel door with keypad entry and yale lock and original handle. Generally good condition.</p>	<p>Repair and redecorate</p>

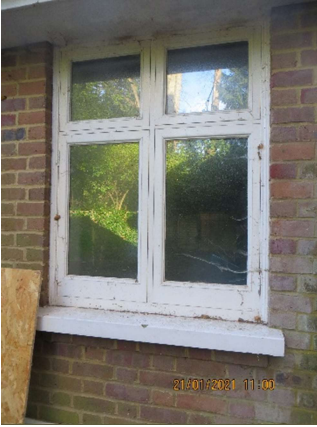
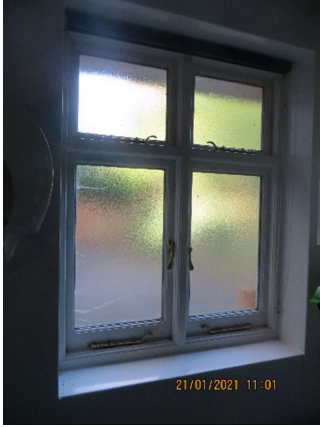
<p><b>W9</b></p>

<p>Timber casement window with opening top and bottom casements. Toughened glazed units with a frosted glass and a concrete sill. Frosted assumed toughened.</p>	<p>Decorate only</p>
<p><b>W10</b></p>

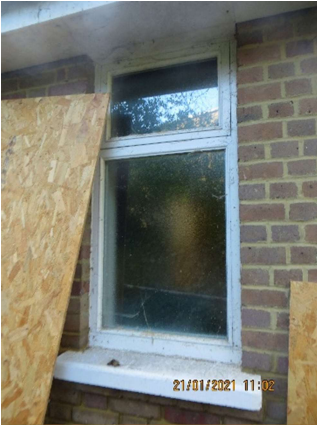
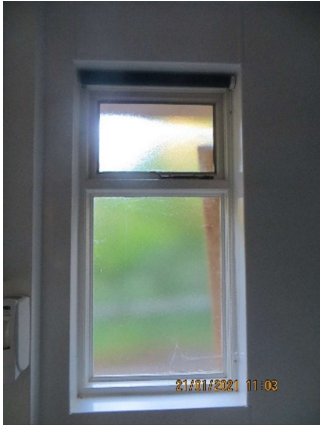
<p>Timber glazed casement window with opening top light fixed to bottom light. Toughened glazed unit and a concrete sill. Frosted assumed toughened.</p>	<p>Decorate only</p>

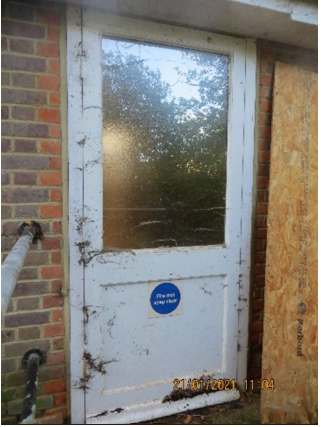
<p><b>D18</b></p>

<p>Timber door with glazed top light and fixed panel at low level. Toughened glazed unit with timber frame and push bar on the inside. Frosted assumed toughened.</p>	<p>Repair and redecorate. Fire ironmongery to be checked for compliance.</p>
<p><b>W11</b></p>

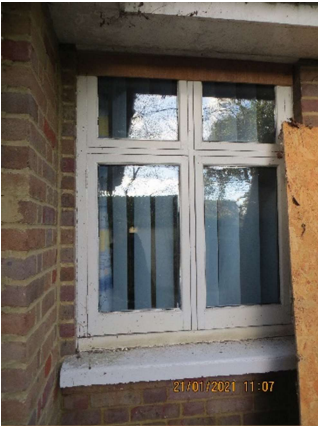
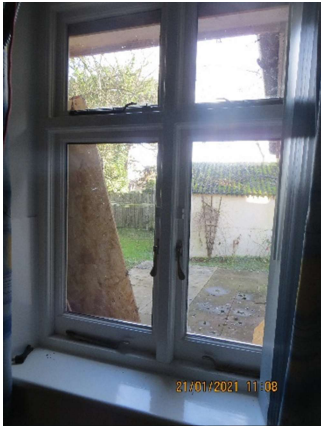
<p>Timber casement window with opening top and bottom casements. Toughened glazed units with a frosted glass and a concrete sill.</p>	<p>Decorate only</p>

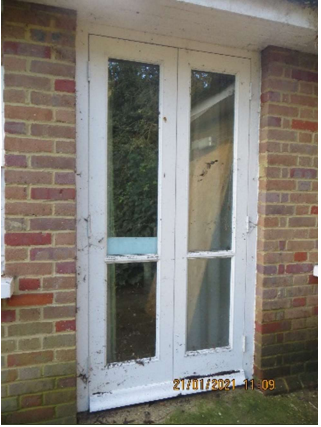
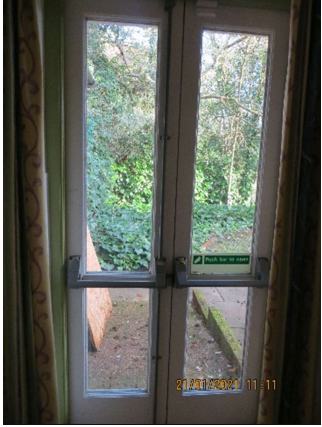
<p><b>D21</b></p>

<p>Double door set with glazed top and bottom lights and drip bar at low level along with fire escape ironmongery internally and toughened slimline glazed unit.</p>	<p>Repair and redecorate. Fire ironmongery to be checked for compliance.</p>
<p><b>W12</b></p>

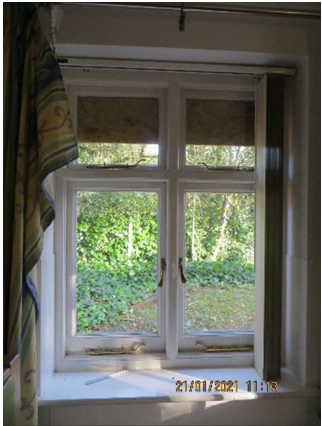
<p>Timber casement window with opening top and bottom casements. Toughened glazed units with a frosted glass and a concrete sill.</p>	<p>Decorate only</p>

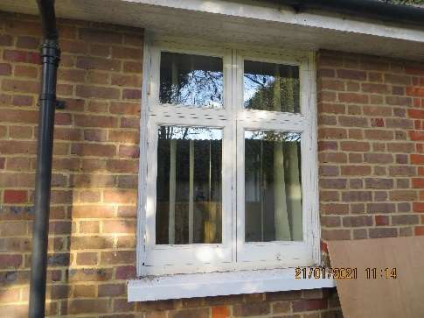
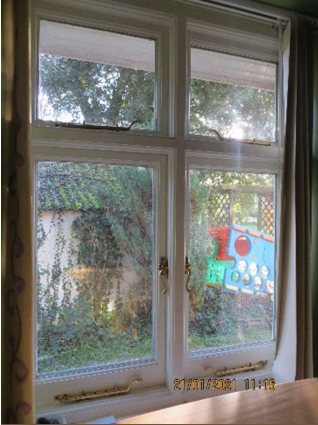
<p><b>W13</b></p>

<p>Timber casement window with opening top and bottom casements. Toughened glazed units with a frosted glass and a concrete sill.</p>	<p>Decorate only</p>
<p><b>W14</b></p>

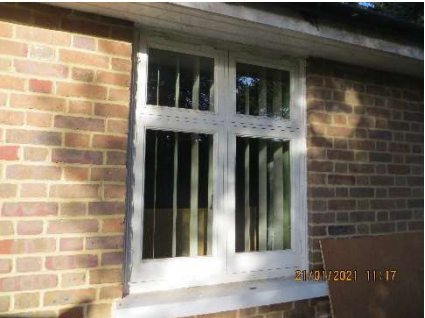
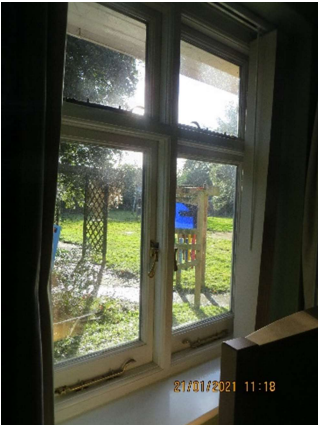
<p>Timber casement window with opening top and bottom casements. Toughened glazed units with a frosted glass and a concrete sill.</p>	<p>Decorate only</p>

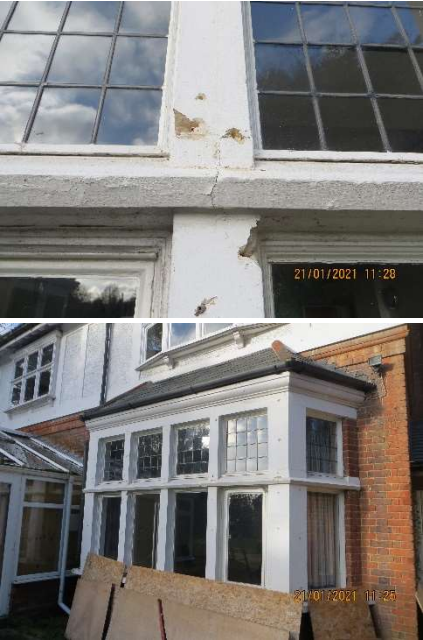
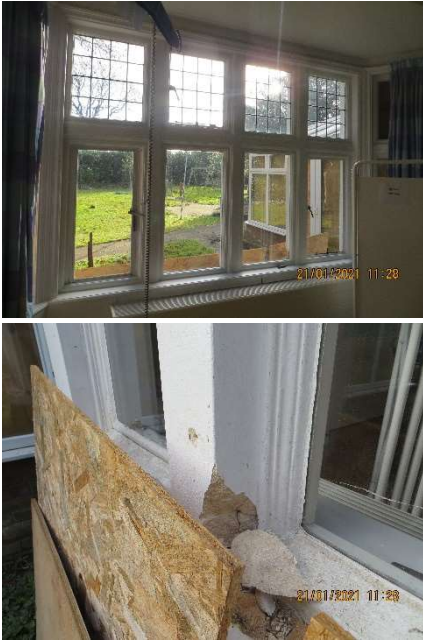
<p><b>W18, W19, W20</b></p>

<p>Large ground floor bay to the rear of the property. Metal crittall casement windows at low level. Opening low level casements to the right and left of the bay with 2nr fixed casements centrally and to the angled sections. Leaded metal crittall casements at high level with a single opening casement centrally. All with original ironmongery. Casements set within a concrete frame which requires repair following fixing of hoarding along with a concrete sill. Timber frame internally. Single glazed.</p>	<p><u>Crittall casement</u></p> <p>Replace casements with timber casements to match profile of existing historic timber windows. New toughened glass to be installed. Existing timber and concrete frames to be repaired insitu prior to decoration. New heritage style ironmongery to be installed.</p> <p>Top casements to have leaded toughened glazed lights to match existing.</p>

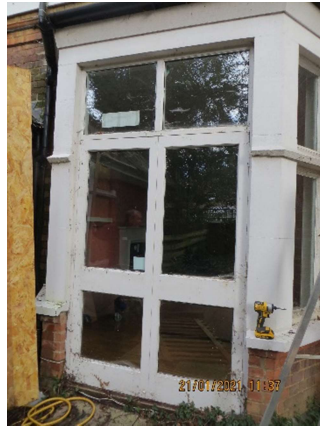
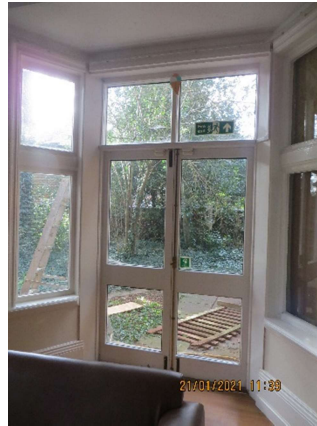
**W32, W33  
& D34**

Timber glazed windows with Georgian wired glazing on the side lights which is window 32 and window 33. All set within a concrete bay frame. Twist handle to open internally with locking catches at low and high level along with magnetic catch strips. No opening lights. Window 32 & 33 is Georgian Wired. Door 34 is toughened.

Timber Casement  
Carefully remove existing Georgian wired side casement glass. Install new toughened glass (4-6mm thickness). Existing timber casement to be retained, repaired with conservation repairs where possible. If casement rebate is too shallow or casement is unrepairable it will be replaced in timber to match existing profile in size and shape. Repair frame as required. New heritage style ironmongery to be installed. Fire escape ironmongery to be checked.

Toughened door glass to be retained.

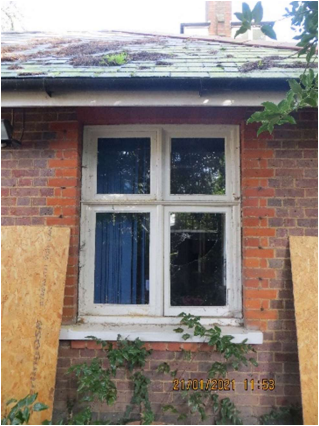
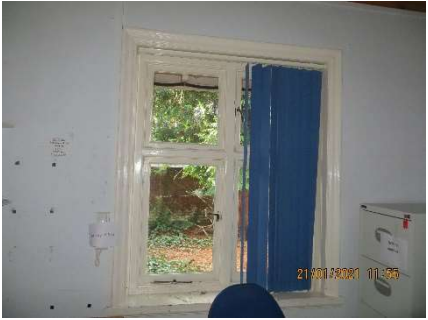
<p><b>W35</b></p>

<p>21/01/2021 11:55</p>	<p>Timber casement windows with opening right casement and fixed casements to the left at low level. 1nr openable casement at high level. Single glazed with a concrete sill. Original ironmongery. Single pane of glass broken. Single glazed.</p>	<p><u>Timber Casement</u> Carefully remove existing glass. Install new toughened glass (4-6mm thickness). Existing timber casement to be retained, repaired with conservation repairs where possible. If casement rebate is too shallow or casement is unrepairable it will be replaced in timber to match existing profile in size and shape. Repair frame as required. New heritage style ironmongery to be installed.</p>
-------------------	---	--	---	--

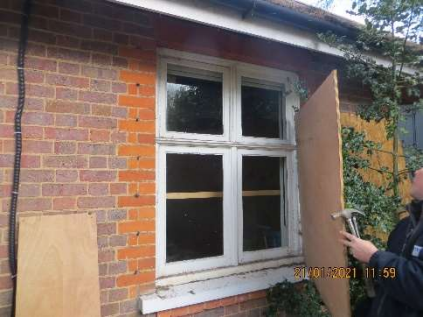
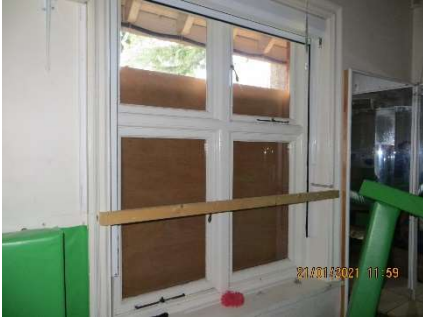
<p><b>W36</b></p>

<p>Timber casement windows with opening right casement and fixed casements to the left at low level. 1nr openable casement at high level. Single glazed with a concrete sill. Original ironmongery. Single glazed.</p>	<p><u>Timber Casement</u> Carefully remove existing glass. Install new toughened glass (4-6mm thickness). Existing timber casement to be retained, repaired with conservation repairs where possible. If casement rebate is too shallow or casement is unrepairable it will be replaced in timber to match existing profile in size and shape. Repair frame as required. New heritage style ironmongery to be installed.</p>
-------------------	---	--	--	--

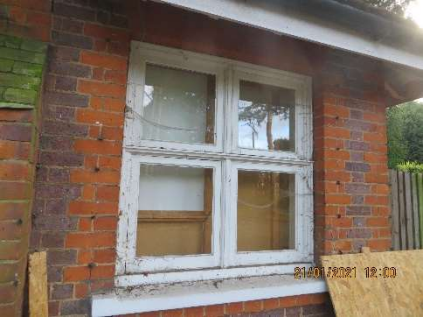
<p><b>W37</b></p>

<p><b>No internal photo</b></p>	<p>Single glazed.</p>	<p><u>Timber Casement</u> Carefully remove existing glass. Install new toughened glass (4-6mm thickness). Existing timber casement to be retained, repaired with conservation repairs where possible. If casement rebate is too shallow or casement is unrepairable it will be replaced in timber to match existing profile in size and shape. Repair frame as required. New heritage style ironmongery to be installed.</p>
-------------------	---	---------------------------------	-----------------------	--

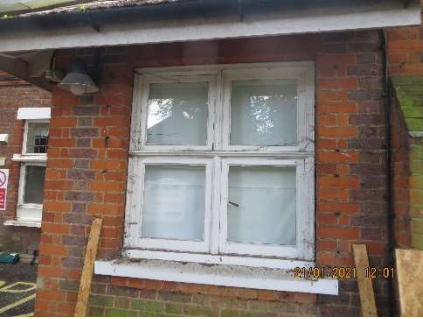
<p><b>W38</b></p>

<p><b>No internal photo</b></p>	<p>Timber casement windows with opening right casement and fixed casements to the left at low level. 1nr openable casement at high level. Single glazed with a concrete sill. Original ironmongery. Single glazed.</p>	<p><u>Timber Casement</u> Carefully remove existing glass. Install new toughened glass (4-6mm thickness). Existing timber casement to be retained, repaired with conservation repairs where possible. If casement rebate is too shallow or casement is unrepairable it will be replaced in timber to match existing profile in size and shape. Repair frame as required. New heritage style ironmongery to be installed.</p>
-------------------	---	---------------------------------	--	--

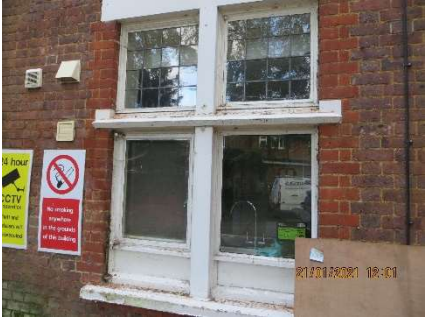
<p><b>W39</b></p>

<p>Metal crittall casement window set into a timber frame with 1nr opening light at low level and metal crittall casements at high level with leaded lights. All original ironmongery. 1nr casement has secondary glazing internally at low level. 1nr glazed unit has been replaced with toughened glass, the other is single glazed.</p>	<p><u>Crittall casement</u></p> <p>Replace casements with timber casements to match profile of existing historic timber windows. New toughened glass to be installed. Existing timber and concrete frames to be repaired insitu prior to decoration. New heritage style ironmongery to be installed.</p> <p>Top casements to have leaded toughened glazed lights to match existing.</p>
-------------------	---	--	--	---

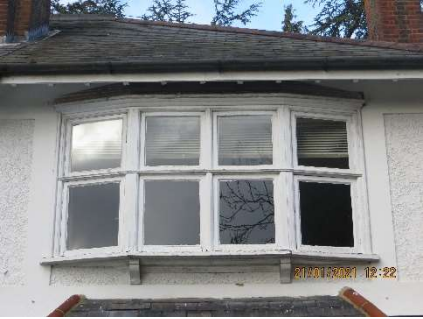
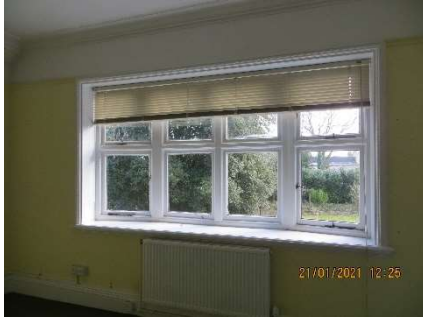
<p><b>W10</b></p>

<p>Large bay window at the rear which is a timber casement single glazed window with opening lights at the side and fixed casements. Windowsill is decayed along with casements where repairs are required.</p>	<p>As above</p>
<p><b>W11</b></p>

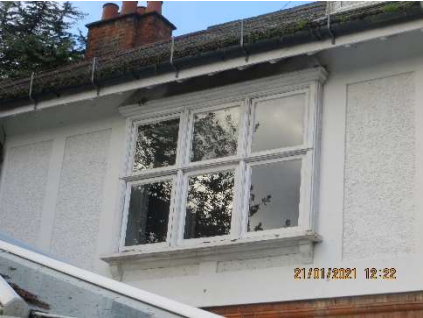
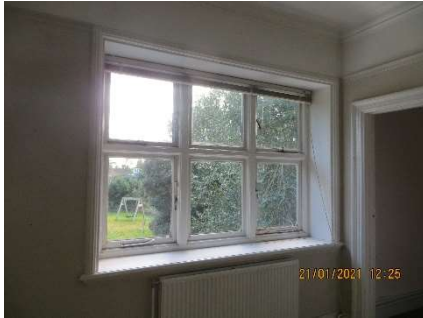
<p>Window above the conservatory. Again, single glazed window with opening lights on the side and fixed casements. Appears that a film may have been applied to this window, but this cannot be confirmed. Sill again looks decayed.</p>	<p>As above</p>

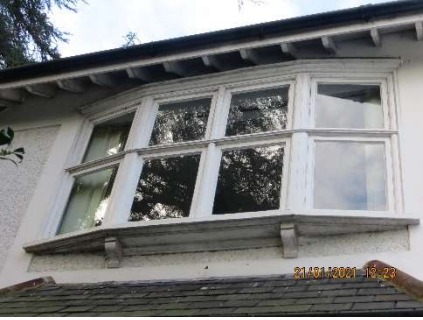
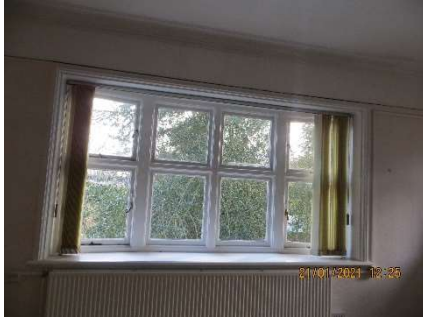
<p><b>W12</b></p>

<p>Above the next bay at the rear. Timber casement window single glazed with opening lights at either side and fixed casements in between.</p>	<p>As above</p>
<p><b>W13</b></p>

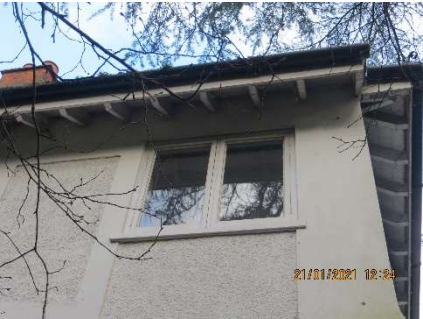
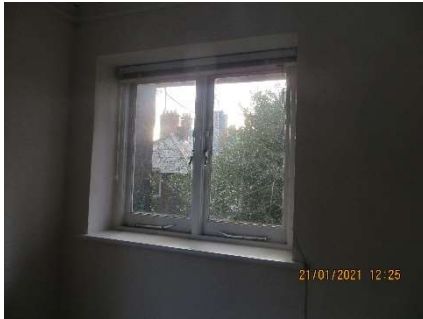
<p>Single glazed timber casement window with Georgian wired glass.</p>	<p>As above</p>
<p><b>W14</b></p>

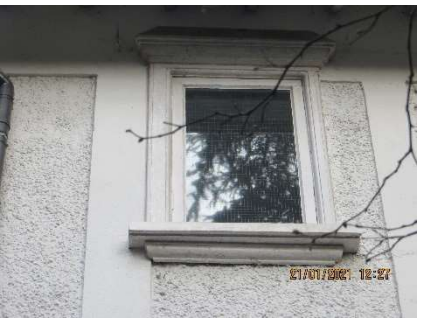
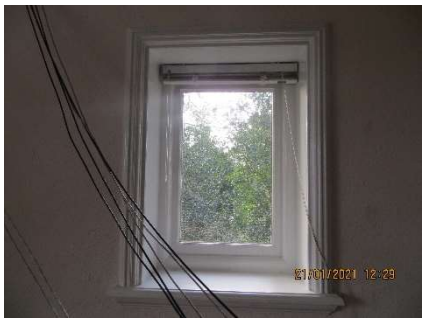
<p>Single glazed casement window.</p>	<p>As above</p>

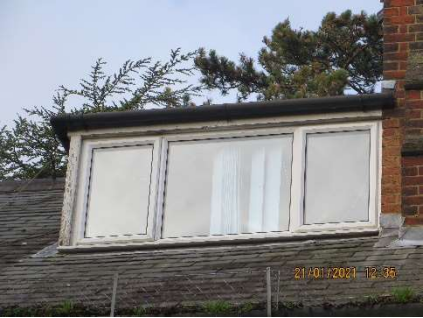
<p>Rear dormer window which is a double glazed UPVC window.</p>	<p><b>Retain as existing</b></p>
<p><b>W2</b></p>	 	 	<p>Double glazed UPVC window to the right-side elevation as looking from the front.</p>	<p><b>Retain as existing</b></p>
