Tree condition assessment

23 Lenten Street, Alton

A H Buckham Limited

Reference: J701.04
February 2021

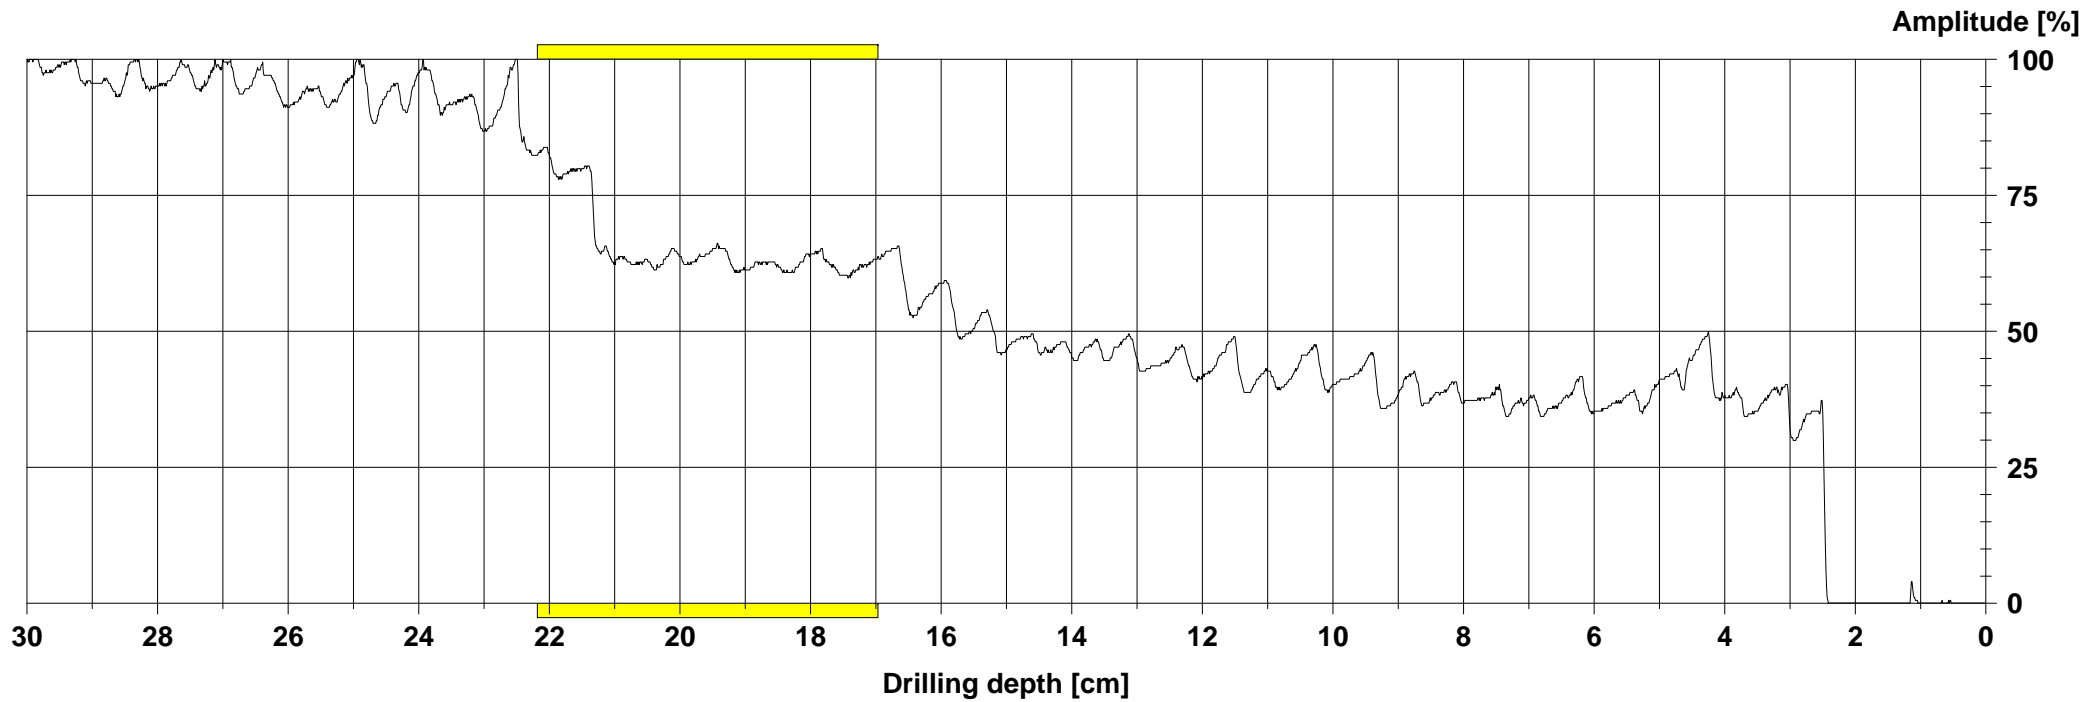
From 17.0 cm	to 22.2 cm	: Partially degraded
	From 0.0 cm	to 0.0 cm	:
	From 0.0 cm	to 0.0 cm	:
	From 0.0 cm	to 0.0 cm	:
	From 0.0 cm	to 0.0 cm	:
	From 0.0 cm	to 0.0 cm	:

Into buttress. Fungal material adjacent to the buttress.

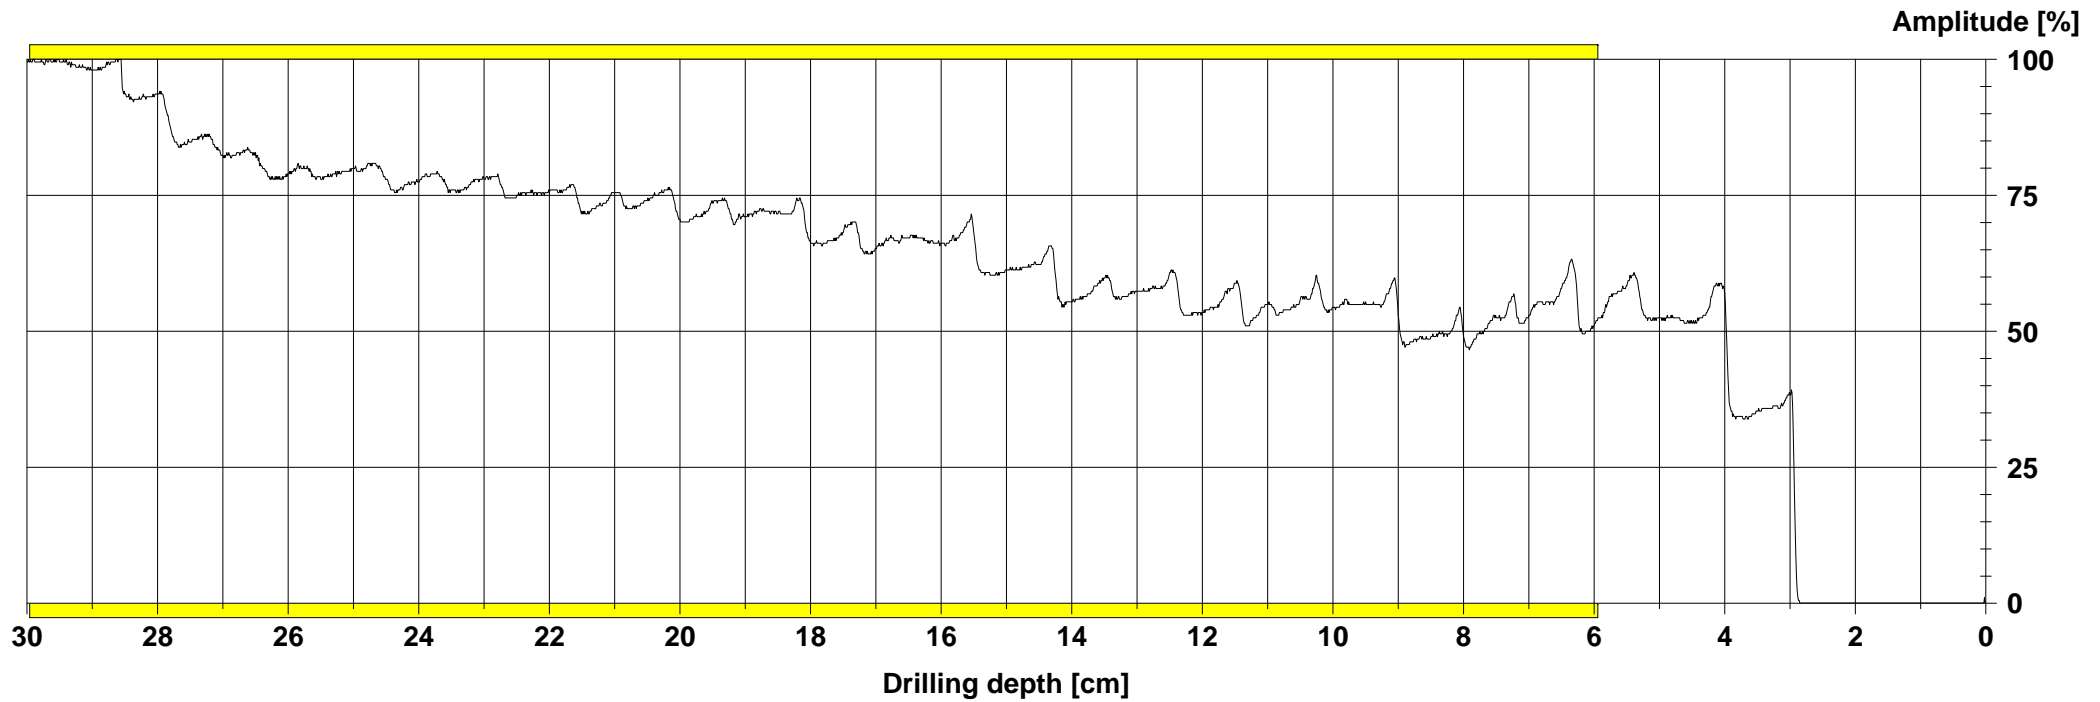
From 5.9 cm to 30.0 cm : Partially degraded
	From 0.0 cm to 0.0 cm :
	From 0.0 cm to 0.0 cm :
	From 0.0 cm to 0.0 cm :
	From 0.0 cm to 0.0 cm :
	From 0.0 cm to 0.0 cm :

Into buttress. Fungal material either side of the buttress.

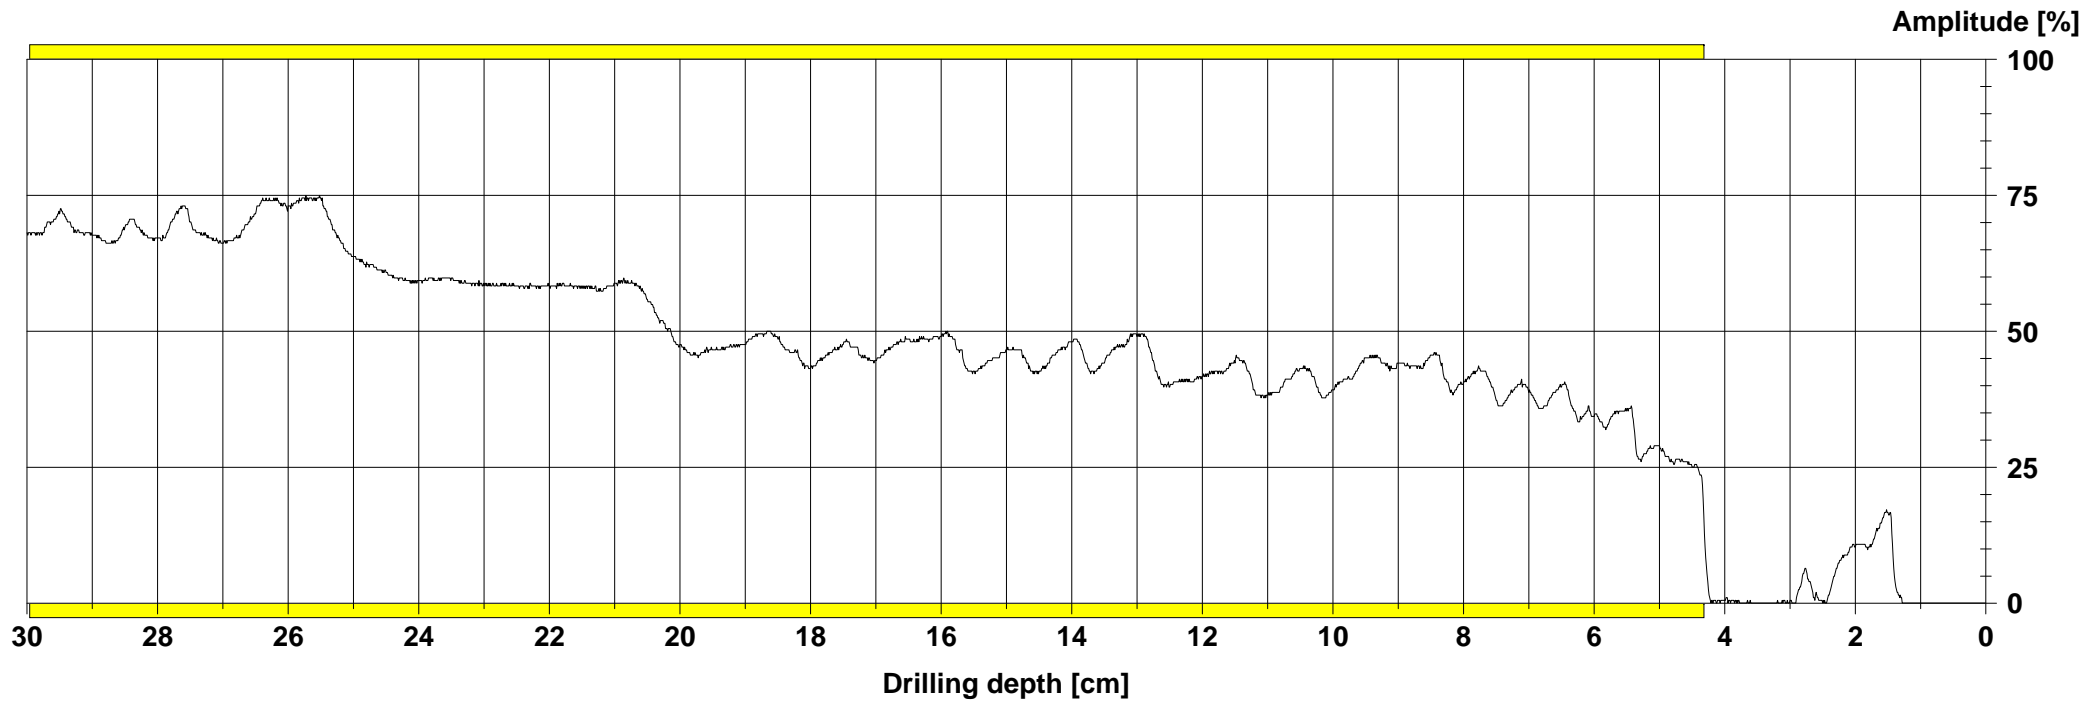
From 4.3 cm to 30.0 cm : Partially degraded
	From 0.0 cm to 0.0 cm :
	From 0.0 cm to 0.0 cm :
	From 0.0 cm to 0.0 cm :
	From 0.0 cm to 0.0 cm :
	From 0.0 cm to 0.0 cm :

Into buttress. Fungal material adjacent to the buttress.

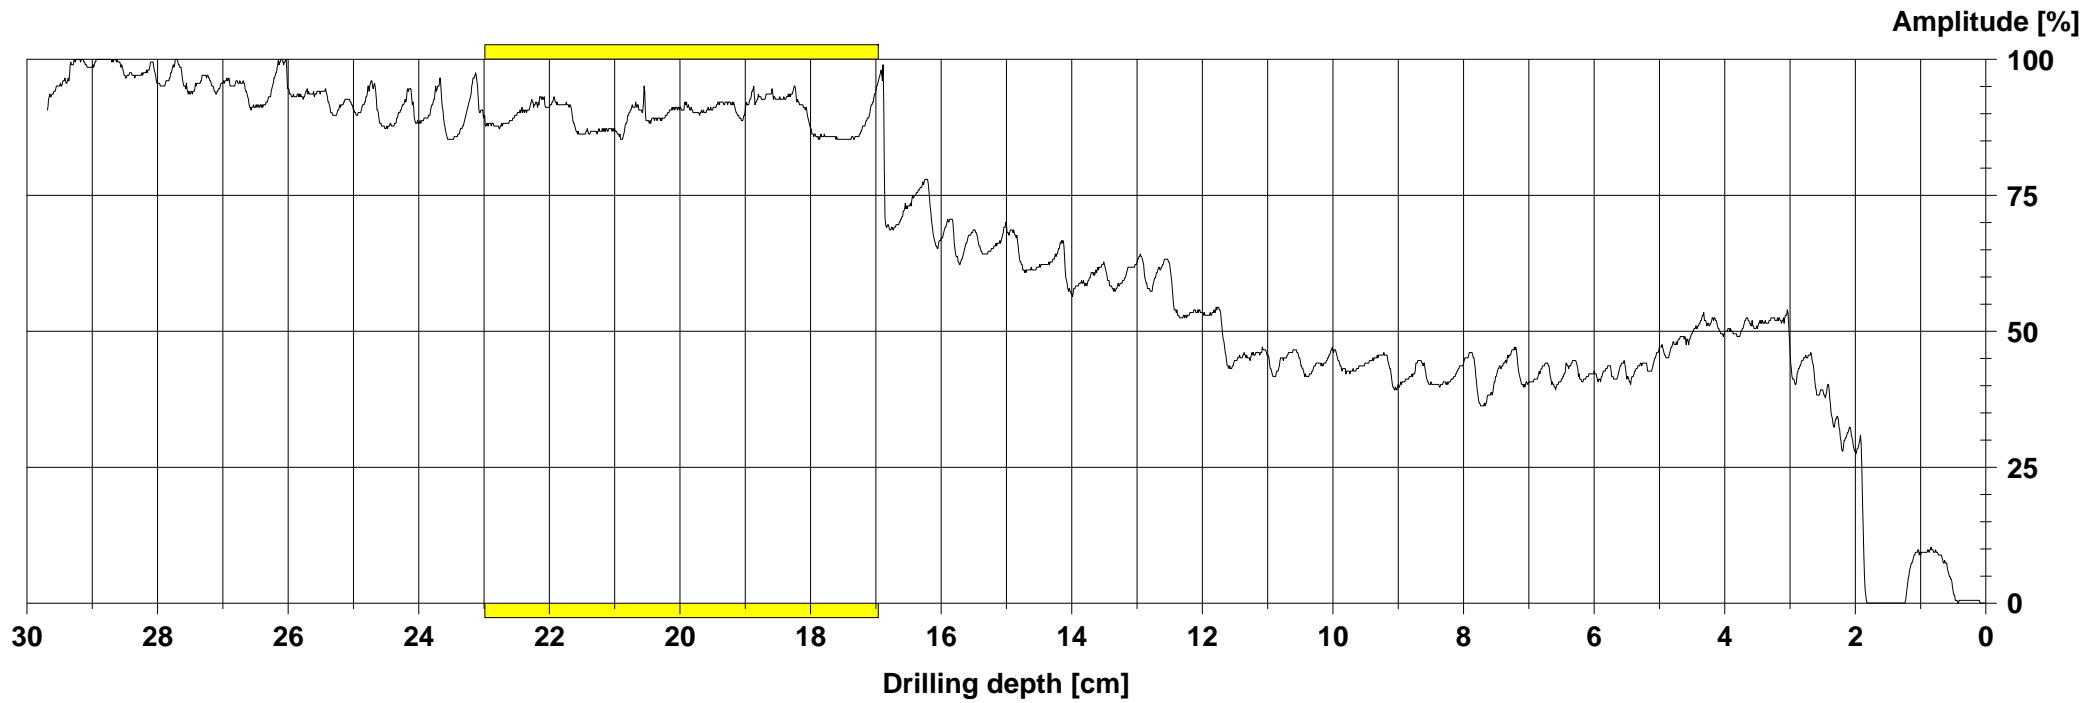
From 17.0 cm	to 23.0 cm	: Partially degraded
	From 0.0 cm	to 0.0 cm	:
	From 0.0 cm	to 0.0 cm	:
	From 0.0 cm	to 0.0 cm	:
	From 0.0 cm	to 0.0 cm	:
	From 0.0 cm	to 0.0 cm	:

Into buttress.

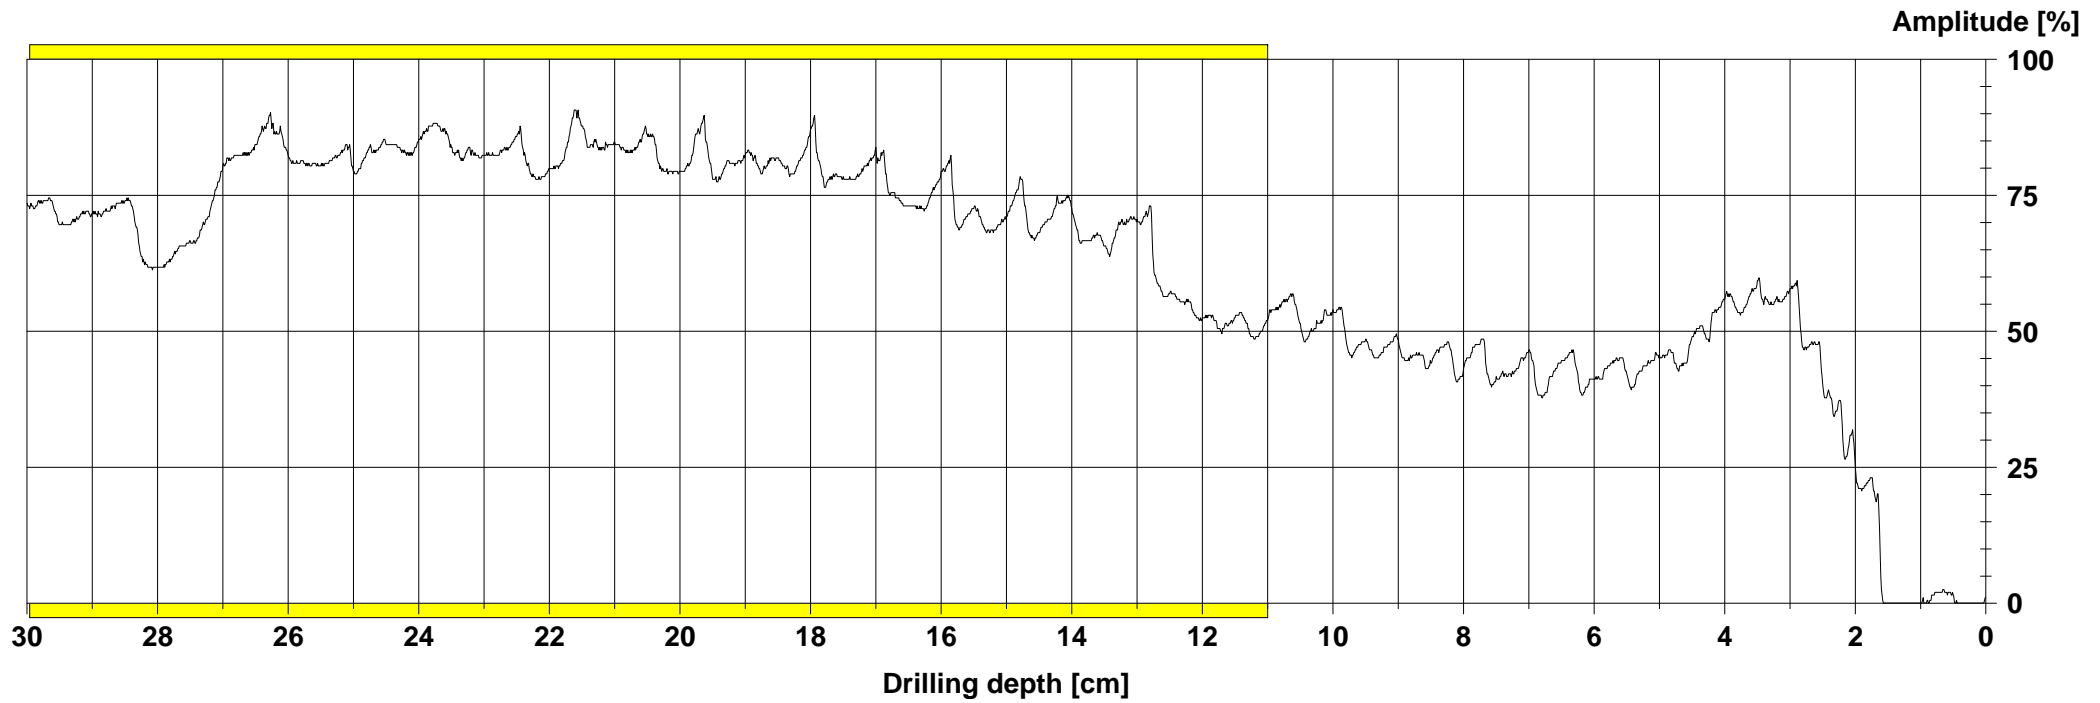
From 11.0 cm	to 30.0 cm	: Partially degraded
	From 0.0 cm	to 0.0 cm	:
	From 0.0 cm	to 0.0 cm	:
	From 0.0 cm	to 0.0 cm	:
	From 0.0 cm	to 0.0 cm	:
	From 0.0 cm	to 0.0 cm	:

Into buttress.

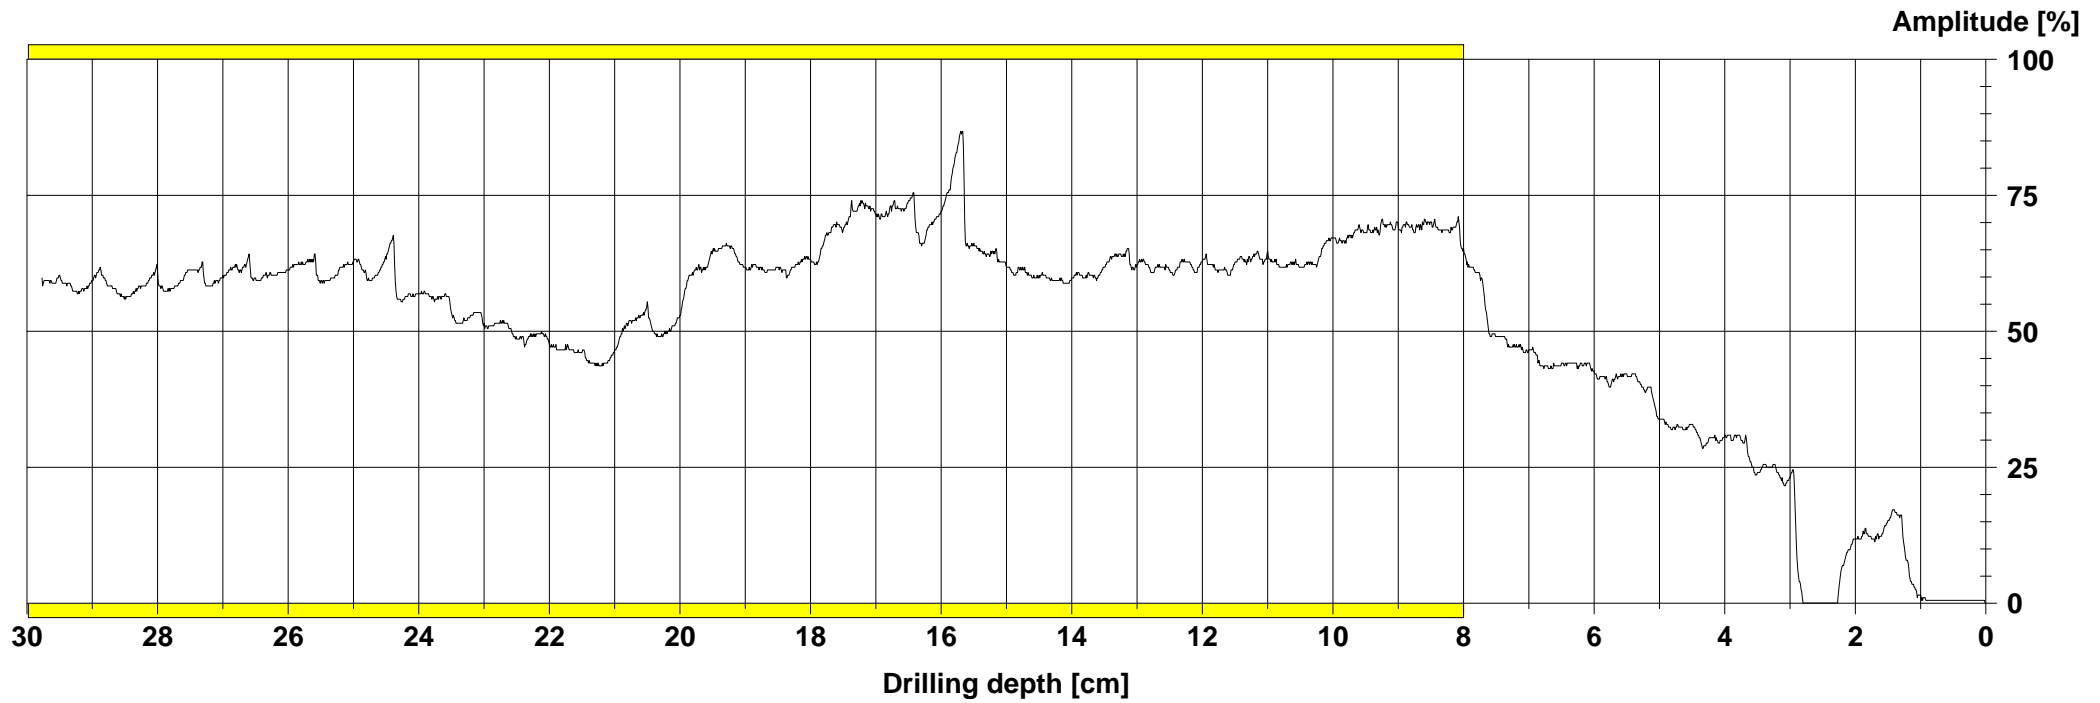
From 8.0 cm to 30.0 cm : Partially degraded
	From 0.0 cm to 0.0 cm :
	From 0.0 cm to 0.0 cm :
	From 0.0 cm to 0.0 cm :
	From 0.0 cm to 0.0 cm :
	From 0.0 cm to 0.0 cm :

Into area between buttresses and immediately adjacent to the fungal material.

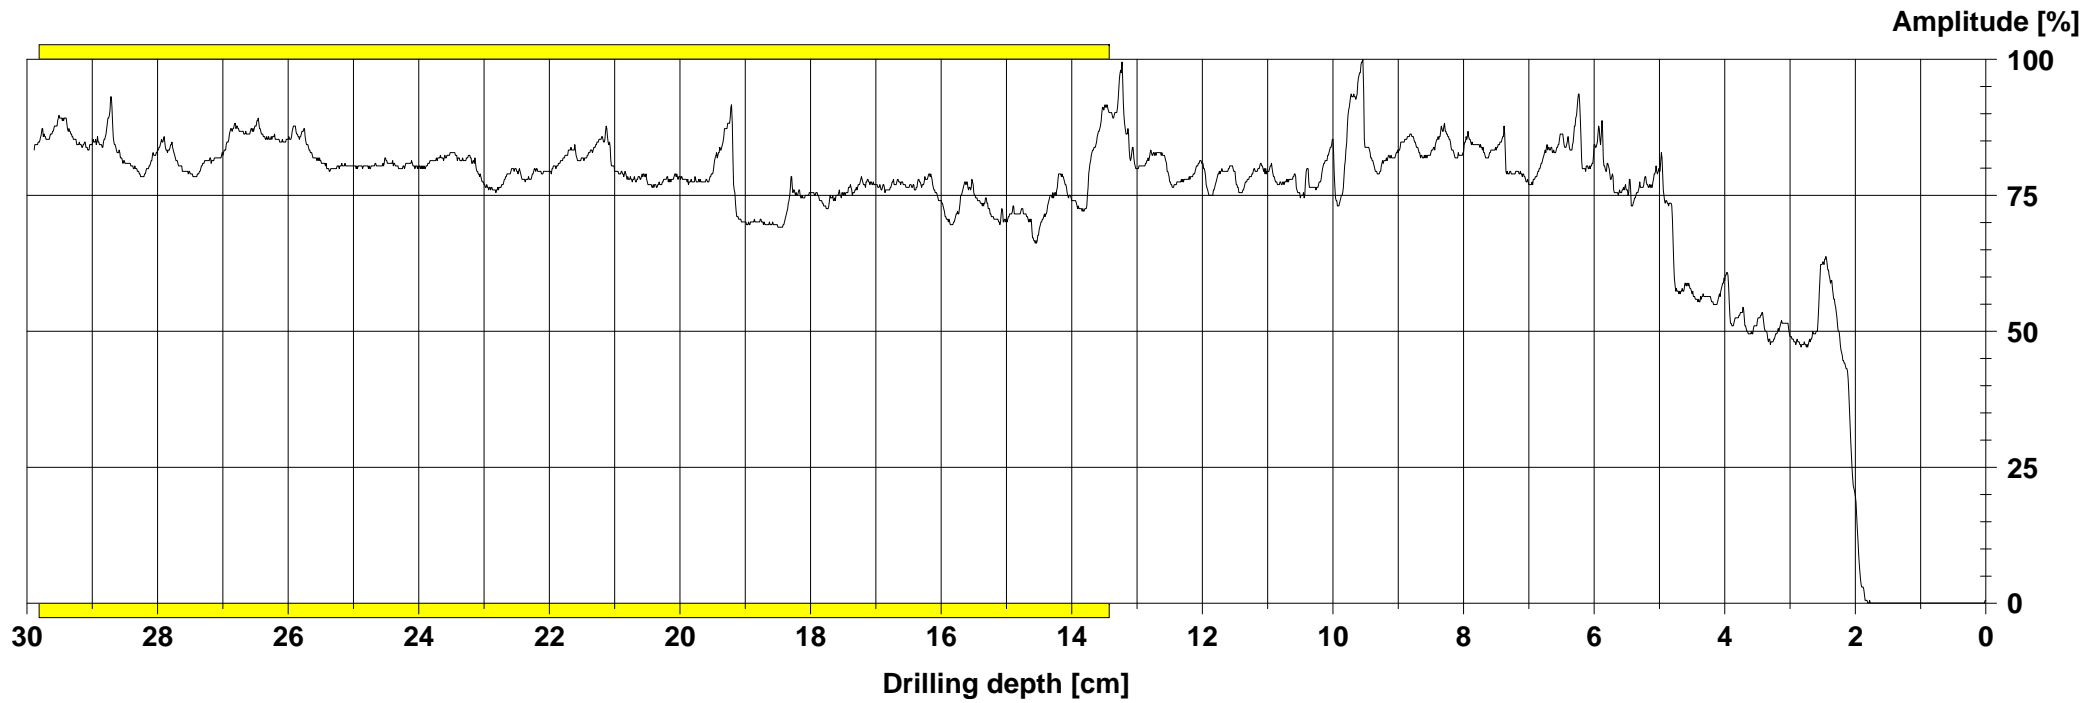
From 13.4 cm	to 29.8 cm	: Partially degraded
	From 0.0 cm	to 0.0 cm	:
	From 0.0 cm	to 0.0 cm	:
	From 0.0 cm	to 0.0 cm	:
	From 0.0 cm	to 0.0 cm	:
	From 0.0 cm	to 0.0 cm	:

Into area between buttresses and immediately adjacent to the fungal material.

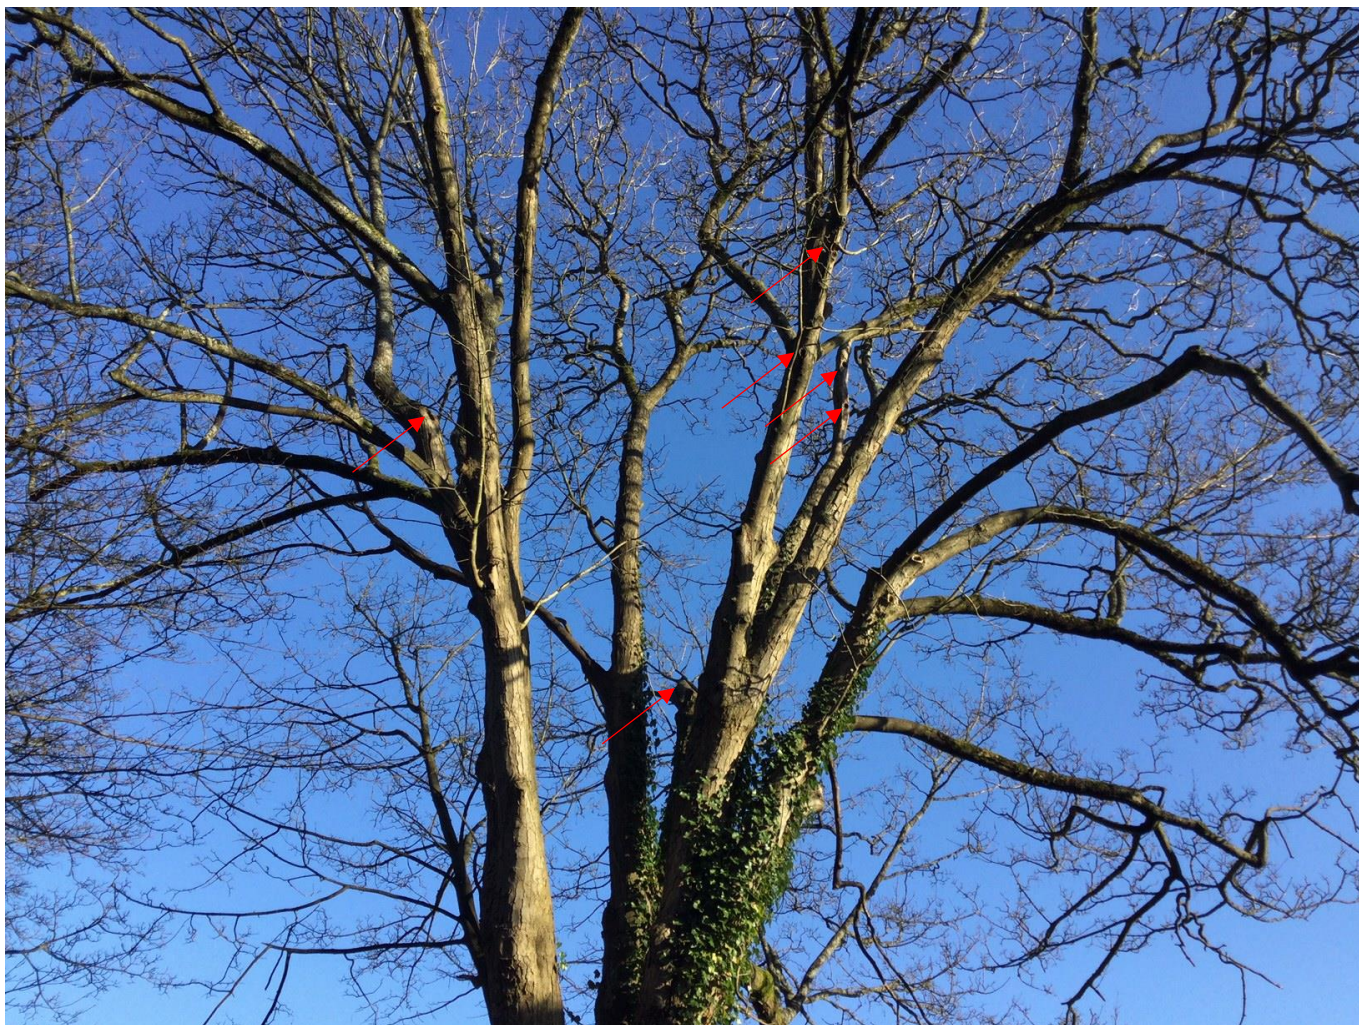
T	2	Sycamore <i>Acer pseudoplatanus</i>	21	Mature	Fair	Poor	Slightly sparse canopy particularly with decline in the lower canopy on the east side. Frequent woodpecker holes in the upper canopy - high potential for structural failure. Two branch failures from the mid canopy. Prior reduction or failures with mature regrowth and subsequent decay in the mid canopy.	Remove. Treat stump (suitable for adjacent to watercourse) to prevent regrowth. Plant replacement lime <i>Tilia x europaea</i> containerised 10 to 12cm girth at 1m in proximity to tree removal, but more than 5m from the boundary and watercourse.	Moderate
T	3	Sycamore <i>Acer pseudoplatanus</i>	19	Mature	Good	Fair	Asymmetrical canopy towards the north west and adjacent stream and towards adjacent dwellings. Asymmetrical canopy due to growth from beneath tree 2. High water table leading to lower soil cohesion and reduced tree stability. Anticipated altered exposure due to loss of tree 2.	Remove. Treat stump (suitable for adjacent to watercourse) to prevent regrowth. Plant replacement alder <i>Alnus glutinosa</i> containerised 10 to 12cm girth at 1m in proximity to tree removal, but more than 5m from the water course.	Moderate

SAL1 T2 sycamore with woodpecker holes, decay and failed branches evident (shown by red arrows).

The sycamore T2 is likely to suffer further primary branch failures. Due to the number of failures, position over the boundary to the site, and the use within the site, the retention of the tree in its current form is inappropriate. Tree works to reduce the tree to a format more suitable for its circumstances is likely to predispose the tree to physiological failure, particularly as the canopy is showing indications of a stressed physiology. Therefore, the recommended management for this tree is removal and replacement.

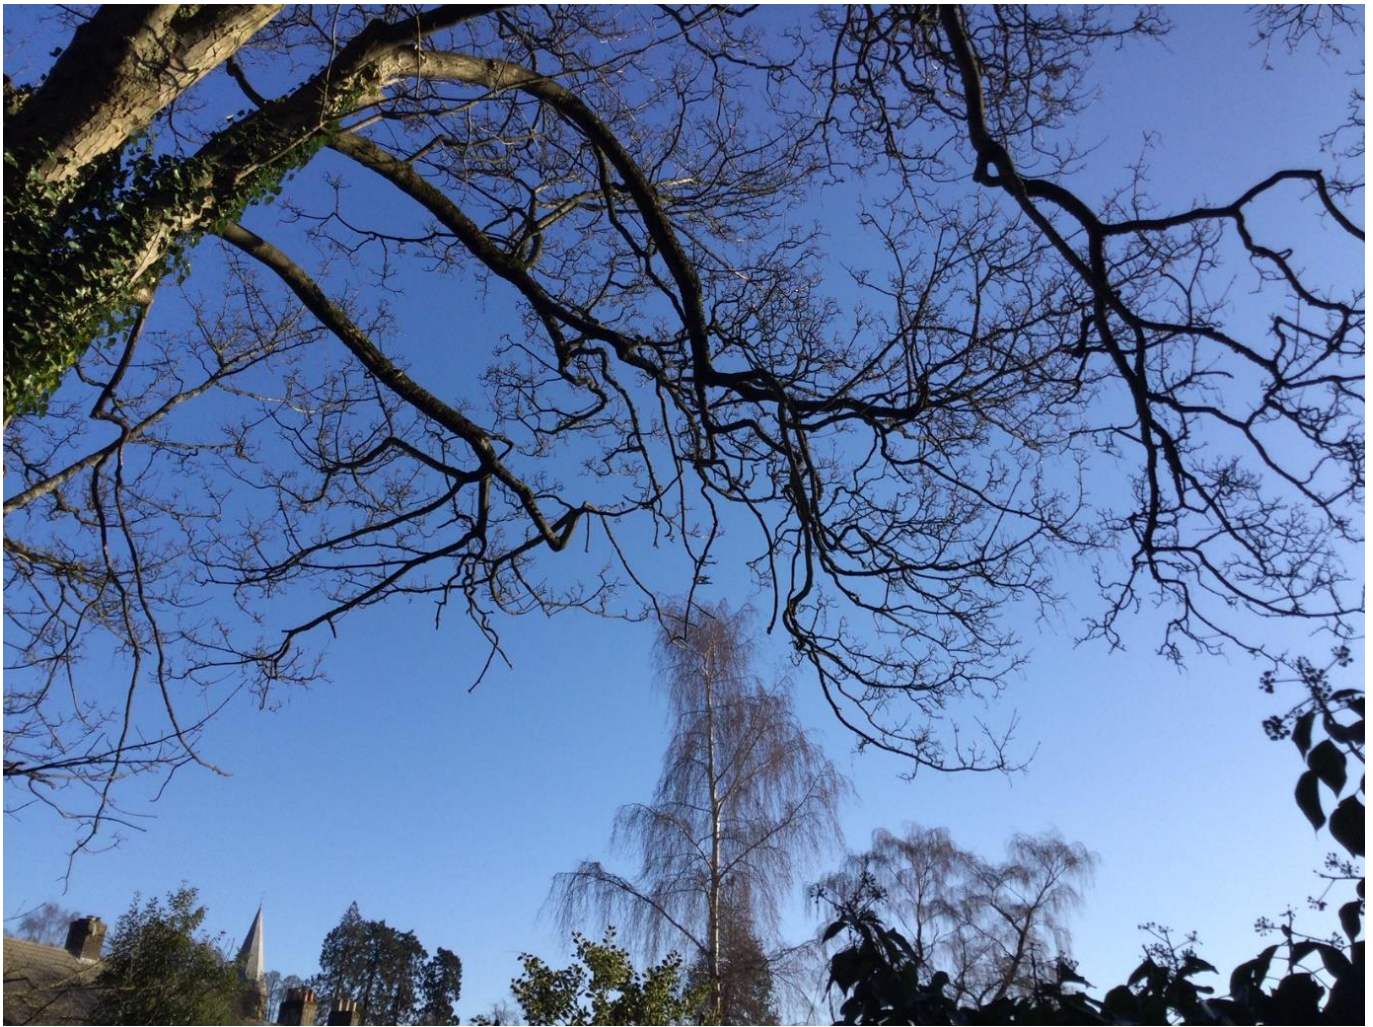
SAL2 T2 sycamore with declining canopy over the adjacent property.

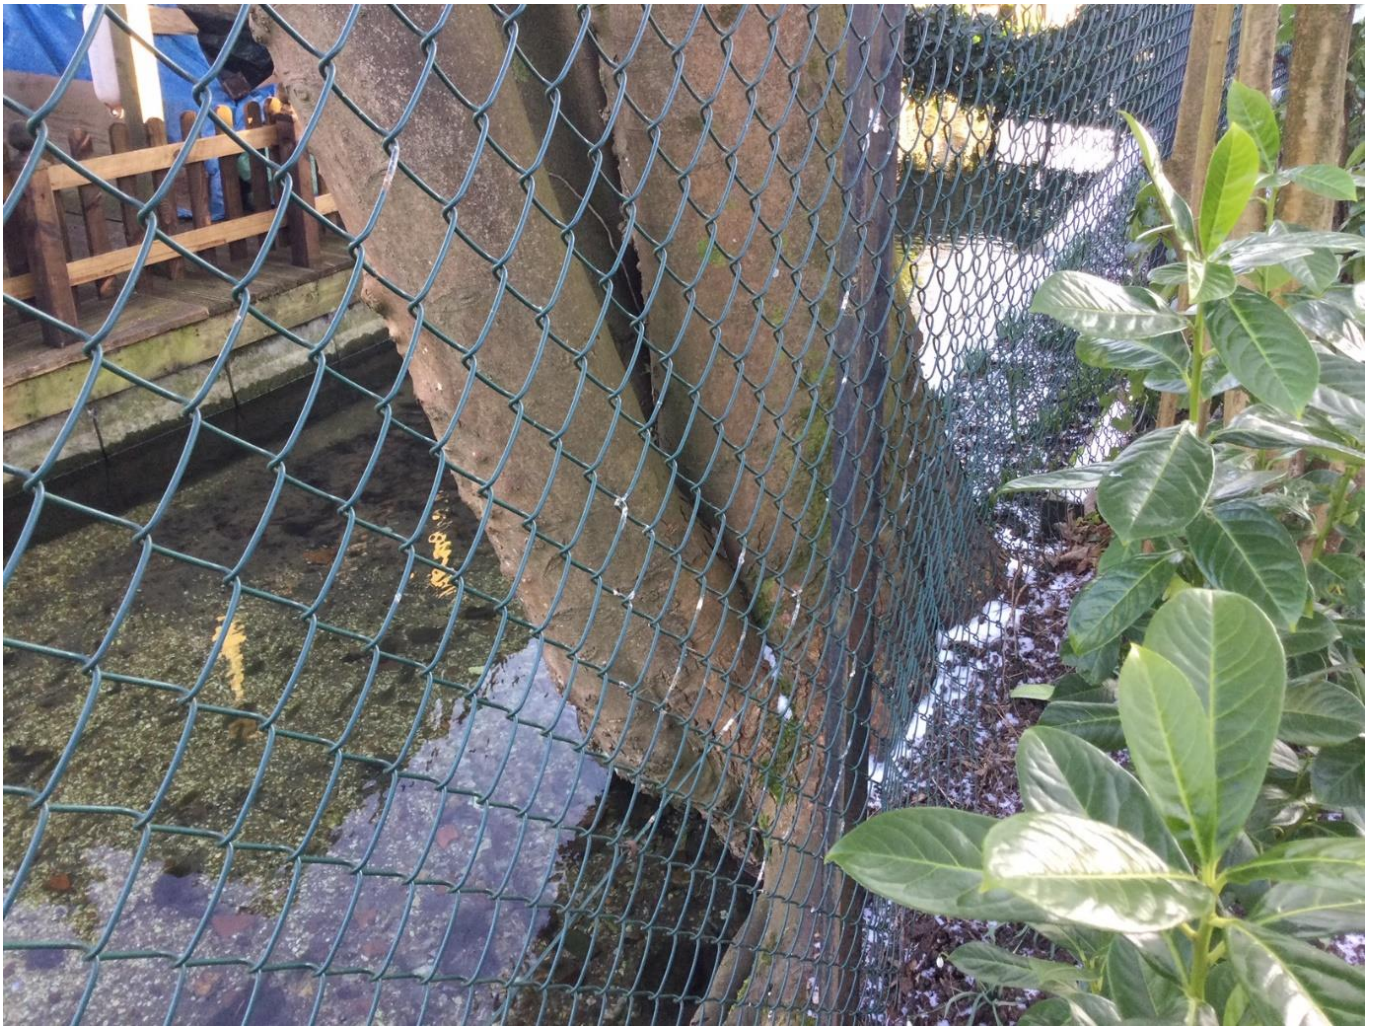
SAL3 T3 sycamore adjacent to the watercourse with lean to the north.

With the anticipated loss of T2, the likelihood of T3 sycamore to fail towards the adjacent dwellings to the north significantly increases. This is due to the altered exposure, asymmetrical canopy, lean and low soil strength caused by the high-water table. Therefore, the recommended management for this tree is removal and replacement.

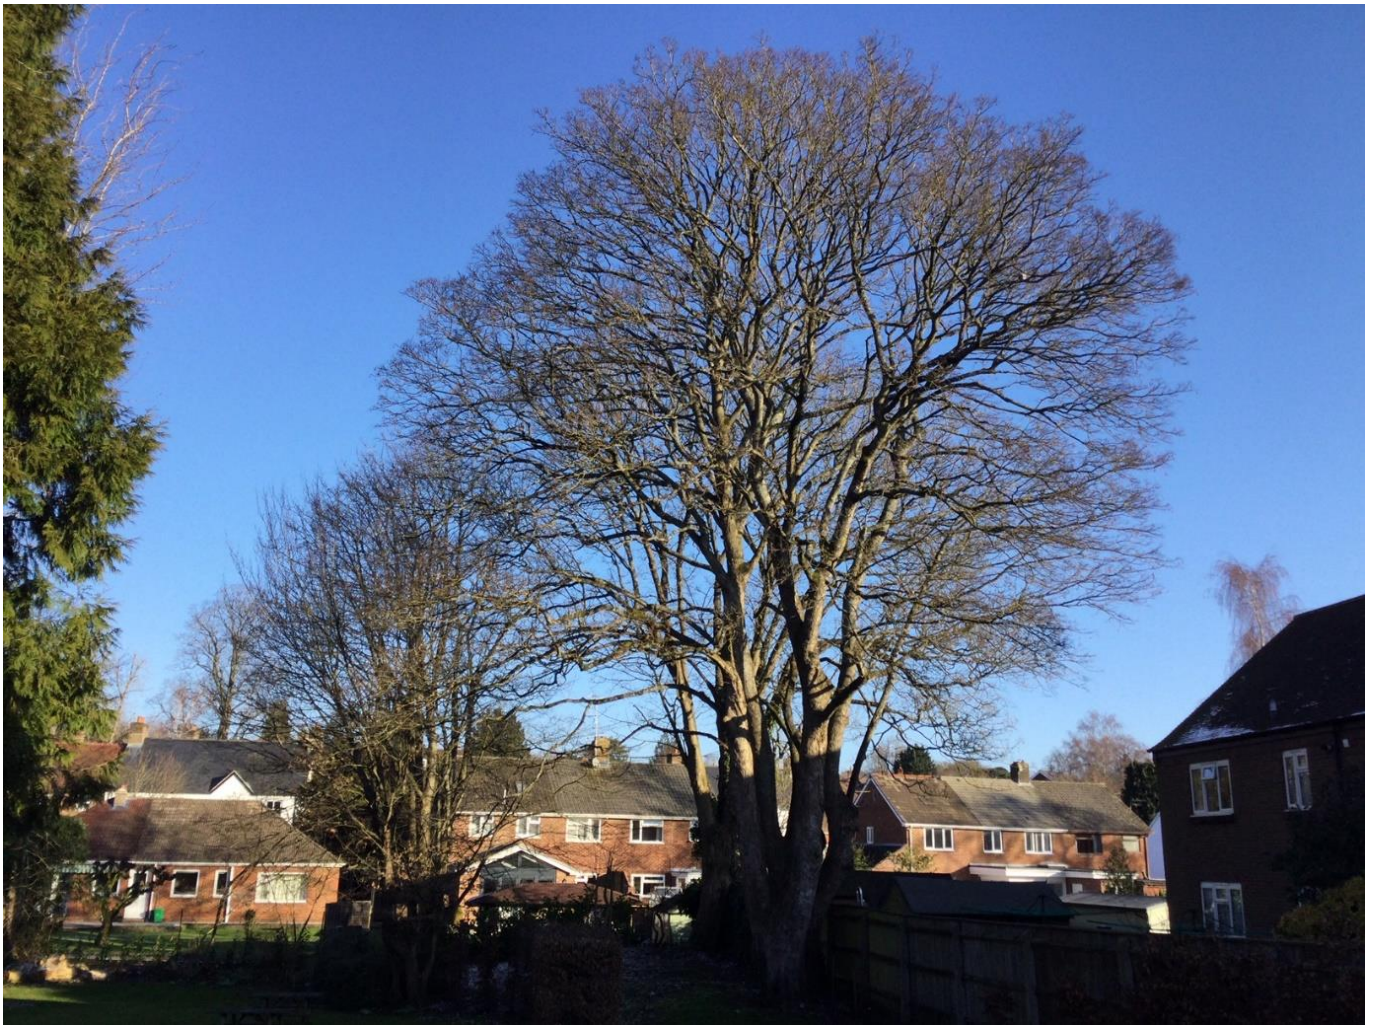
SAL4 T1 sycamore in the foreground, T2 sycamore immediately behind and T3 sycamore to the left.

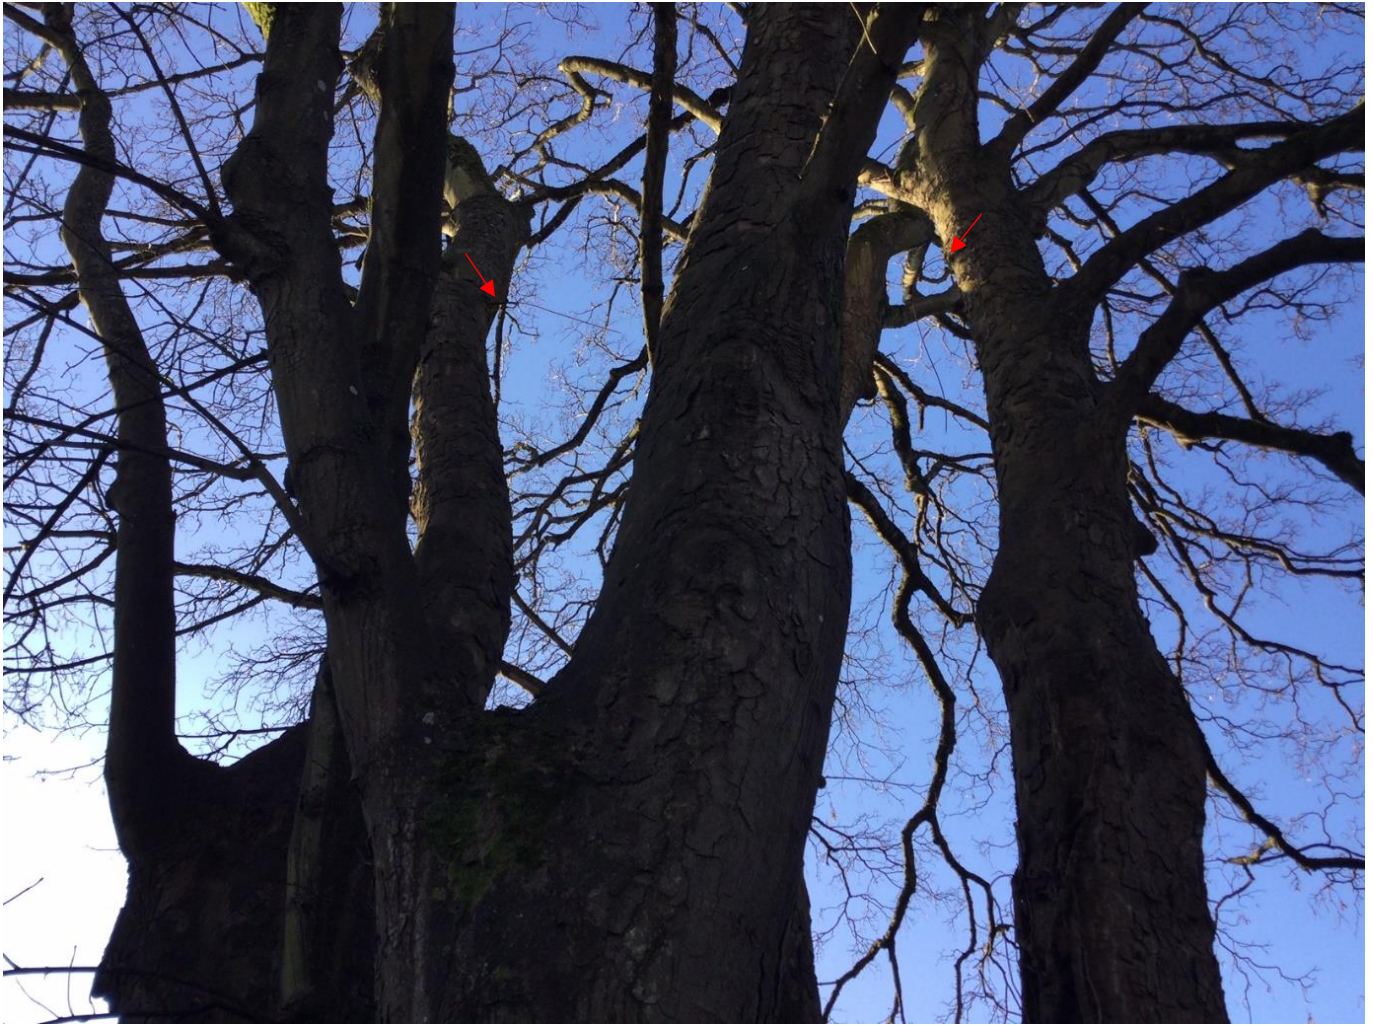
Designation	Reference number	Species	Height (m)	Age class	Physiological condition	Structural condition	Condition notes	Condition related tree works	Priority
T	1	Sycamore <i>Acer pseudoplatanus</i>	22	Mature	Good	Fair	Canopy spread to the north 6m, east 11m, south 8m, west 10m. Overlong branches to the east over adjacent garden and structures. Frequent moderate (25 to 100mm diameter) deadwood. Failed metal cable bracing at c6m. Two stems from the base (north east to south west). Anticipated altered exposure due to loss of tree 2.	Selective tip reduction of lateral radial branches to create a horizontal radial branch length of 8m (this is a reduction of 3m on the east side, and 2m on the west side) and reshape the canopy to form a natural domed canopy form. Install cable bracing to reduce potential for separation of the two stems at the base. Remove deadwood more than 25mm diameter.	Moderate

SAL5 T1 sycamore with failed metal cable bracing identified by red arrows.

With the anticipated loss of T2, sycamore T1 will also have an altered exposure. However, the structure and form of this tree is more likely to withstand its change in circumstances with appropriate remedial tree works. Cable bracing is recommended to be installed to reduce the potential for separation of the stems at the base. This cable bracing will need to be assessed annually by the contractor to ensure that it remains suitable for its purpose and replaced at the end of its safe useful life expectancy. This should be in accordance with the cable bracing providers product details or every 5 years, whichever is the sooner.

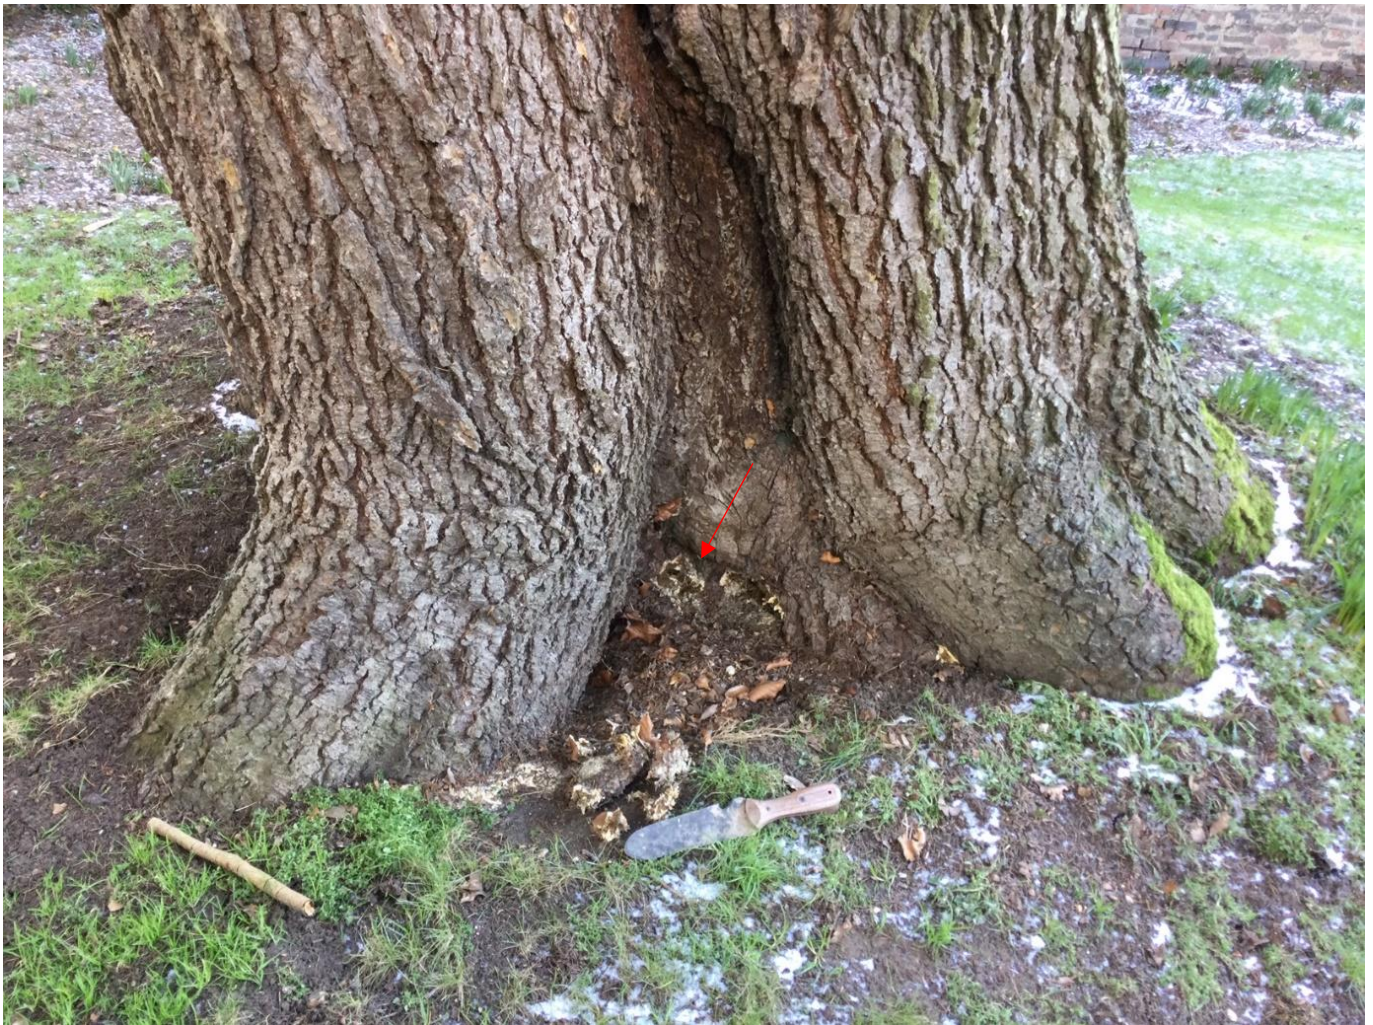
T	4	Cedar <i>Cedrus libani</i>	19	Mature	Good	Poor	Typical historic branch and stem failures in the upper canopy with good wound wood response. Branches close to structures. 16 degrees lean from vertical to south east towards office buildings. Good buttress root development with fungal fruiting body material between buttresses to the east and south. Bark loss and exposed wood to the north. Resi F300 data informs works recommendations.	Remove. Grind stump and structural roots within 4m of the tree to 200mm depth and remove arisings. Import weed free, aerobic, natural top soil to fill the hole left by the removal of the arisings and to allow replacement tree planting. Plant replacement evergreen, tall growing tree species to recreate the courtyard environment.	Moderate

The cedar, T4, has decay at the base of the tree evidenced by the unidentified fungal fruiting body material between the buttresses to the east and the south. To assist the consideration of the decay a Resi F300 was used. The Resi F300 is a mechanical drill which has a 3mm wide needle that measures the resistance as it progresses into the tree. The data is recorded on a paper strip and electronically. This data is measured at a 1:1 scale and are metric units. The Resi data output is per drill and in the top left details measurement / object data including measurement number, drilling depth, wood species (drill set to either hard or soft), identification number, date, time, rate of advance of the drill, diameter of the tree at the point of drilling, level (height above ground level), direction from which the drill progresses in relation to the centre of the tree stem, specific species of the tree and site location. The central section is a graph to be read from right to left. The graph shows the drilling depth (in cm) and the resistance Amplitude. If desired, this graph can have annotation added with specific colouring shown above and below the graph. This interpretation colouring then also relates to a box in the bottom left which details the colour coding of the annotation and provides specific measurements. In the bottom right there is a comments box to aid understanding of the data recorded and additional field notes where applicable. This device is used to help provide additional data on the potential decay within a tree.

In this instance, readings from the Resi F300 identify that the decay is present and partial at the point of assessment.

SAL 6 T4 cedar with unidentified fungal fruiting body between the buttresses on the east side identified by a red arrow.

It is not known which decay fungus is colonising the tree, the fungal material is too deteriorated for field identification. Three typical fungi that frequently colonise cedar include *Phaeolus schweinitzii*, *Sparassis crispa* and *Heterobasidion annosum*. All three fungi cause decay of the roots. As partial decay is shown at 0.3m, the likelihood of decay of the base and structural roots is increased. The decay is exacerbated by the lean of the tree. Tree works to reduce the tree to a format more suitable for the use of the site is likely to diminish the aesthetic value of the tree. Therefore, the recommended management for this tree is removal and replacement.

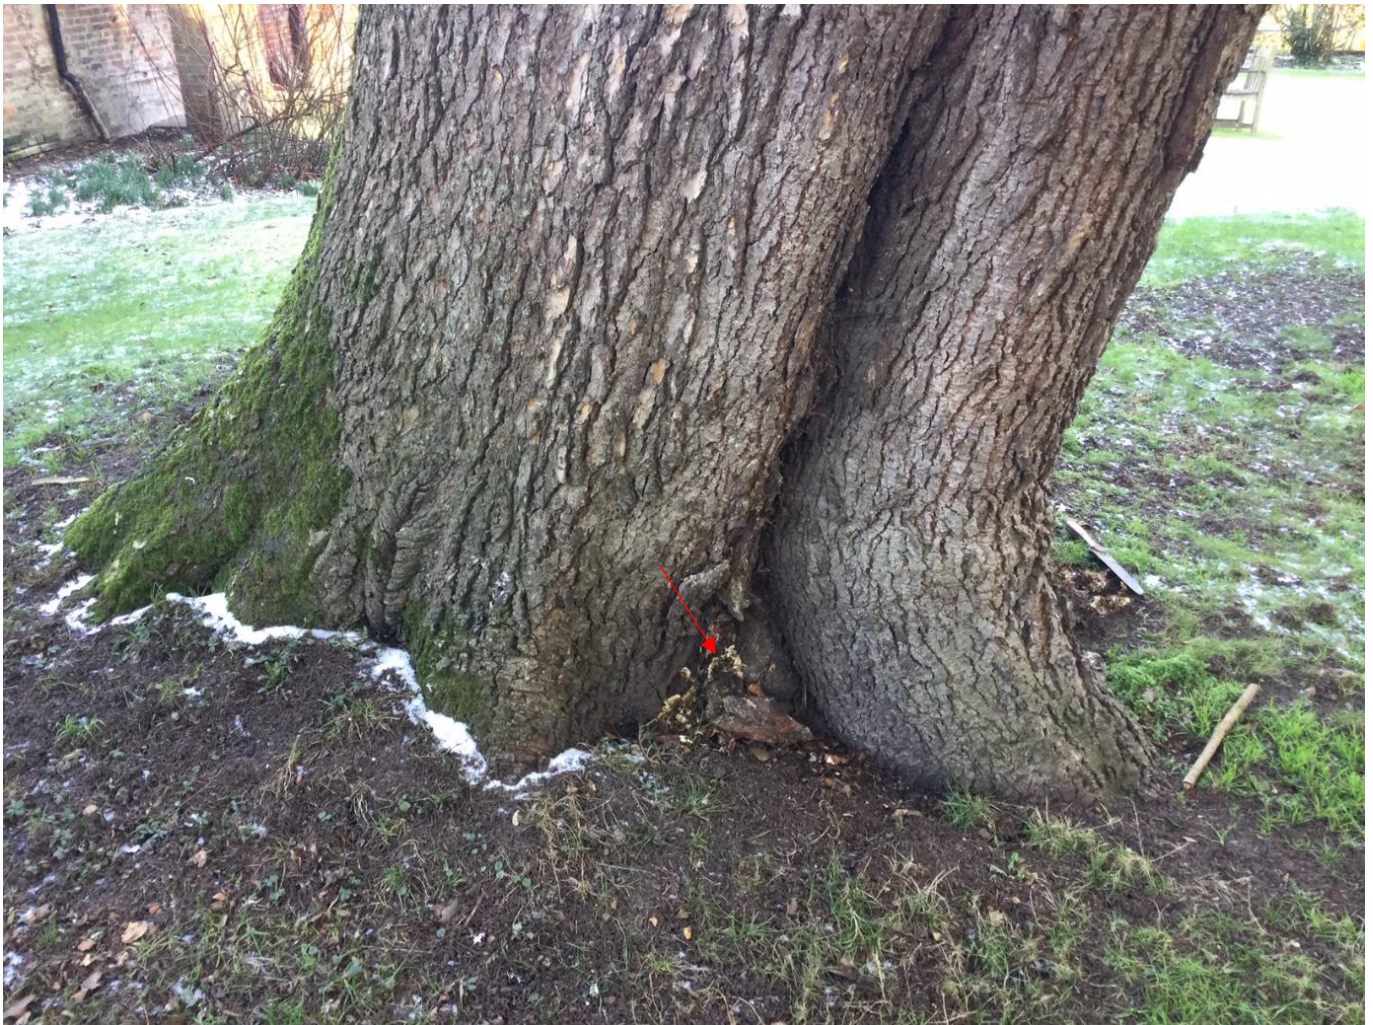
SAL 7 T4 cedar with unidentified fungal fruiting body between the buttresses on the south side identified by a red arrow.
