Outline Specification

Conservation Outline Specification (COS) - February 2021

Photographs

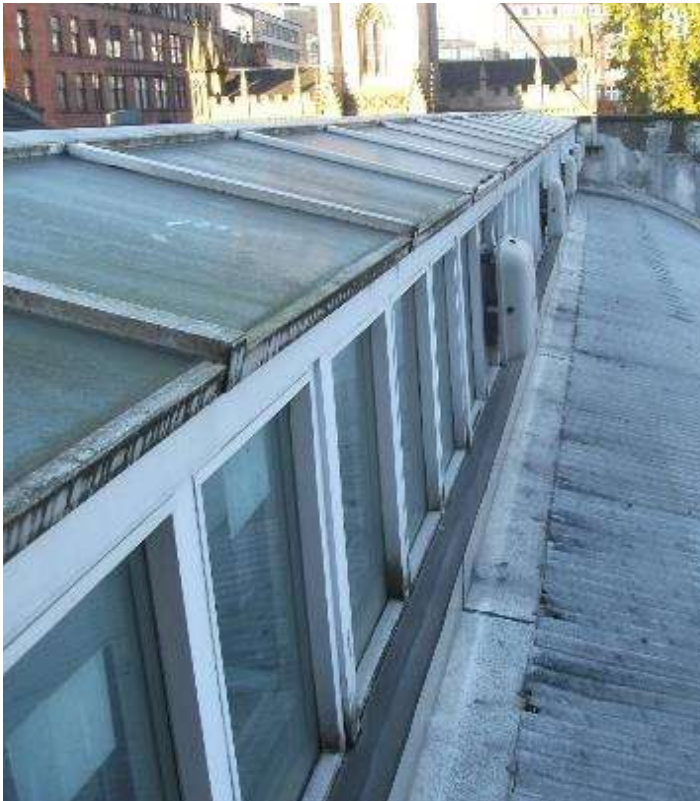
Clerestorey glazing above bar
Refer to item 2 in Scope of Works CHF-1A

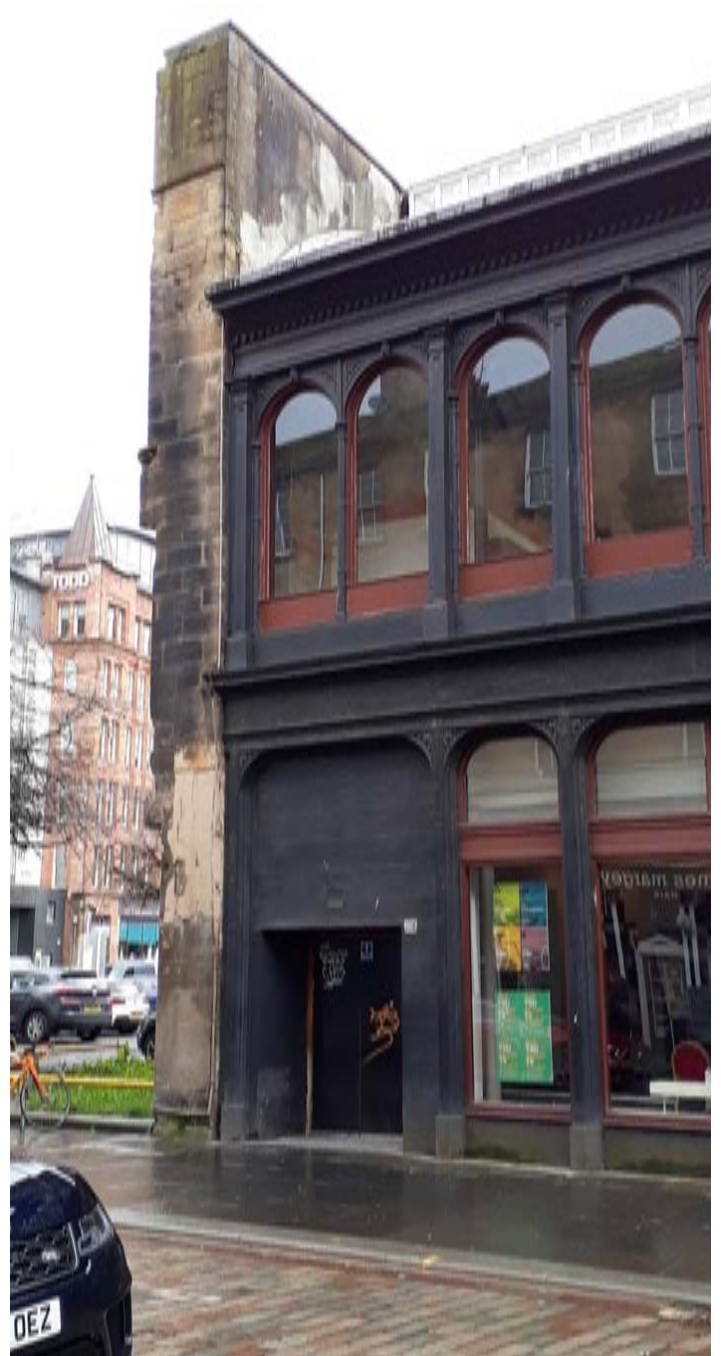
North-west corner of bar
Refer to items 3 & 4 in Scope of Works CHF-1A

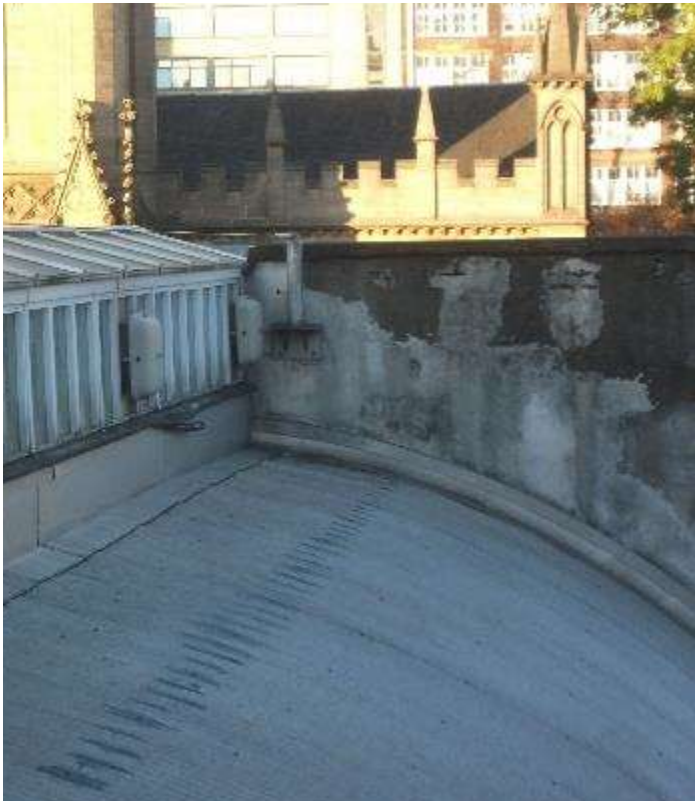
North wall above bar

Refer to items 4 & 6 in Scope of Works CHF-1A

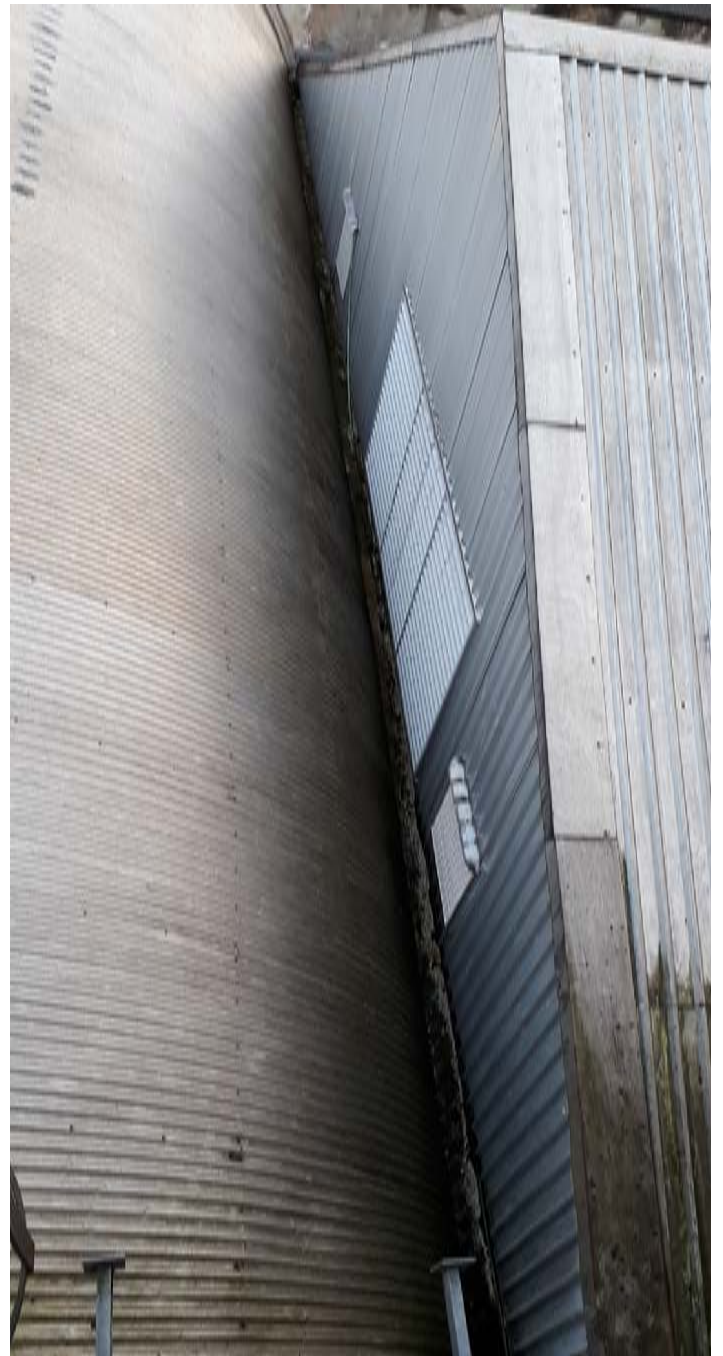
Gutter 'A' between Roofs 1A & 2

Refer to item 5 in Scope of Works CHF-1A

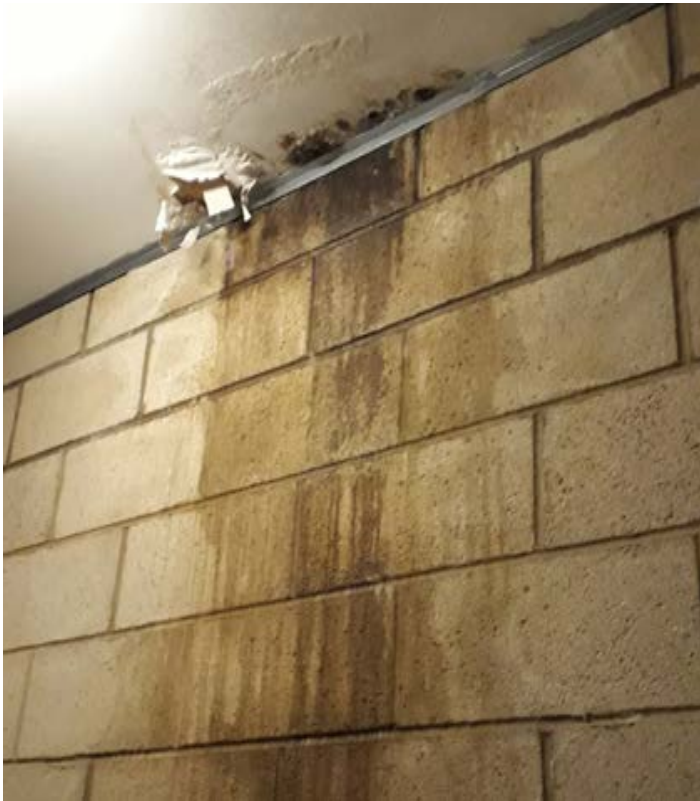
Ceiling of north fire escape
Refer to item 11 in Scope of Work CHF-1A

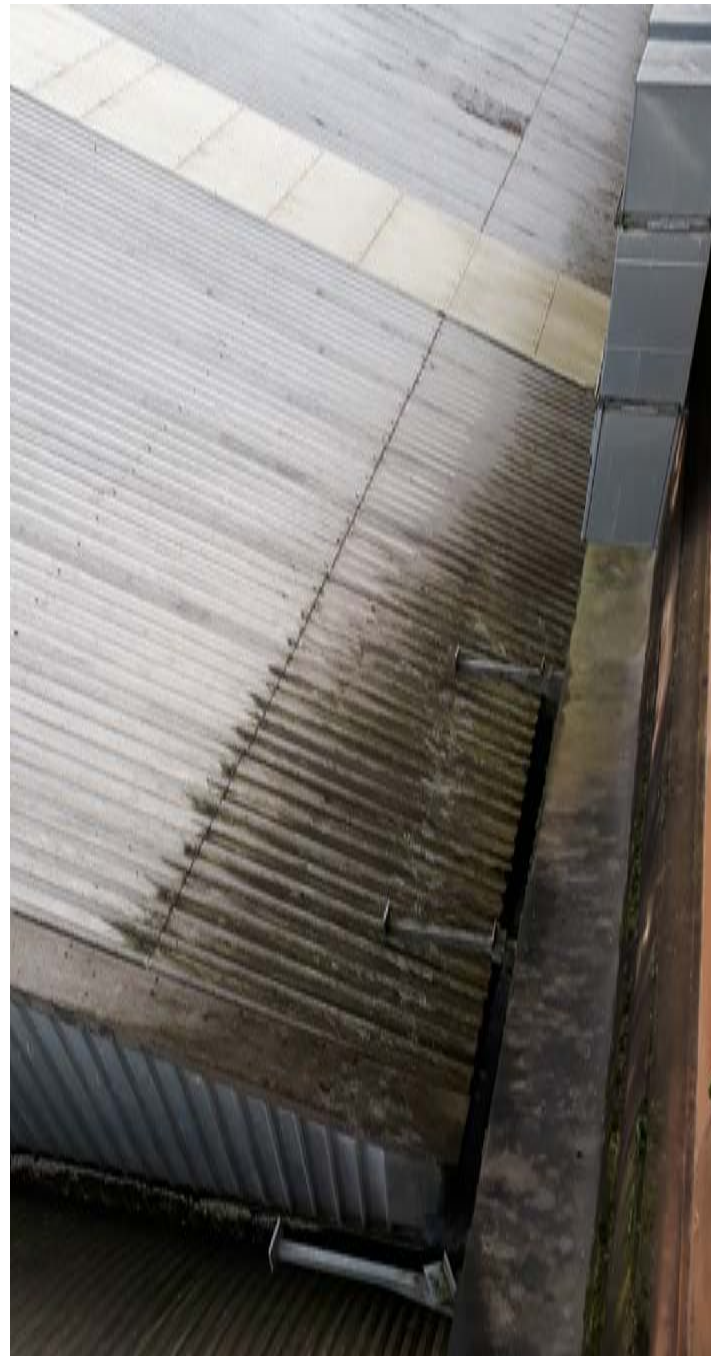
SE corner of roof 1A
A permanent safe access system is required here.
Brackets from earlier system can still be seen.
Refer to item 7 in Scope of Work CHF-1A

2.6 New proprietary Safety Line system to be fitted to top of barrel vault roof of Roof 1A (on both sides of clerestorey glazing). Wires to be fixed to adjacent walls at each end of roof. System re-certified for use.

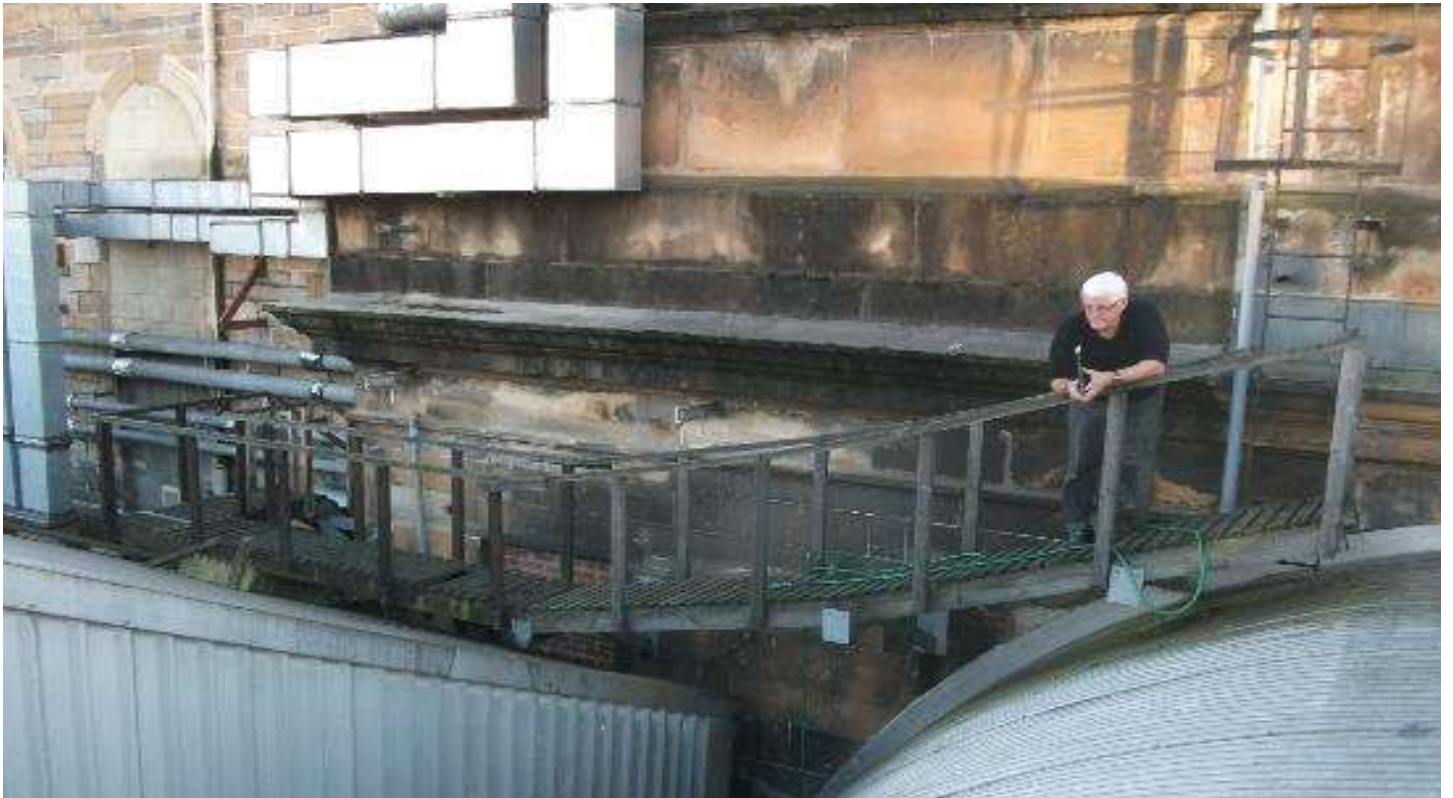
SE corner of roof 1A

The walkway shown has since been removed. The proposed walkway is to follow this route. A caged ladder will provide access from the walkway down to the gutter between roofs 1A & 2 - 'GUTTER A'.

2.9b New 'Fixed Ladder with Safety Cage' to be installed in locations shown on drawing 4687-XX-RF-DR-A-12108. There are to be 4 no. such ladders - to access Roof 1C from 1B; to access Roof 4 plant; to access 'GUTTER A' from walkway and to access Roof 3C from 3B.

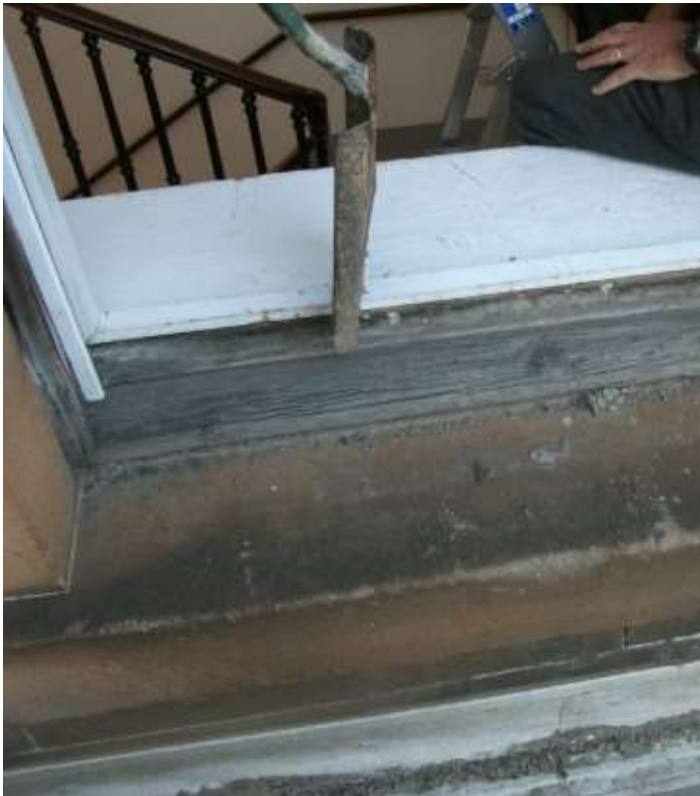
Timber cill in poor condition
Refer to item 1 in Scope of Work CHF-1B

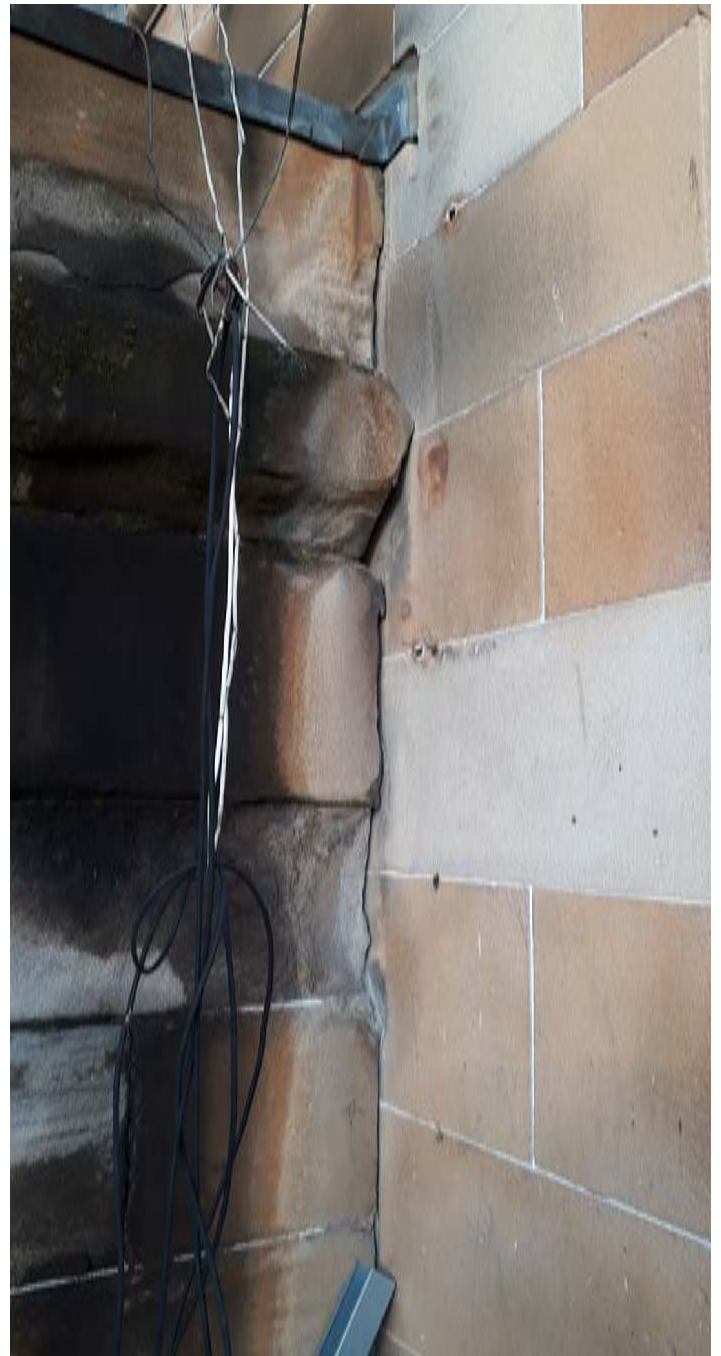
Gap at corner between buildings
Refer to item 2 in Scope of Work CHF-1B

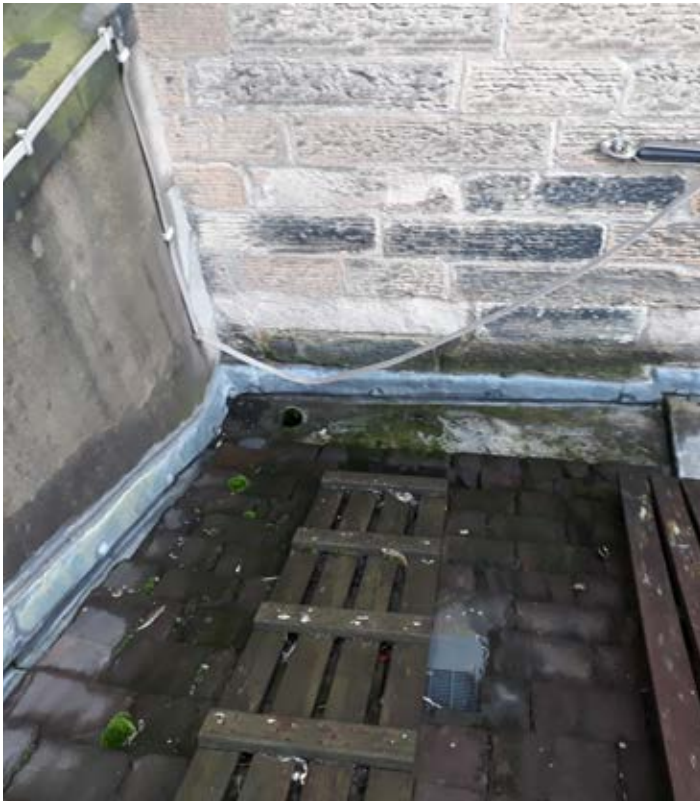
Outlet in poor condition - water ingress below.
Refer to item 3a in Scope of Work CHF-1B

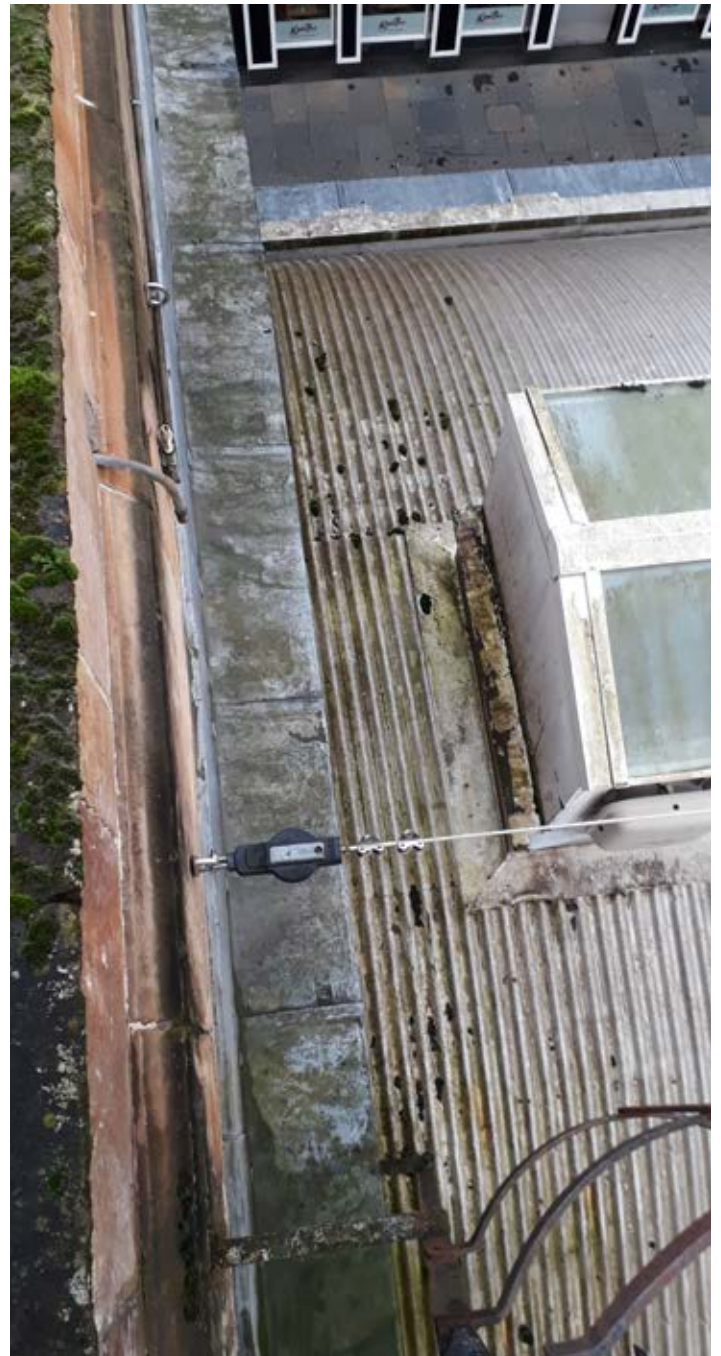
Lead cornice below north parapet
Refer to item 18 in Scope of Work CHF-1B

2.5d Full length of stone cornice below north gable of Roof 1B to be cleaned. Code 7 lead sheet to be laid on top of cornice and formed over edge. Edge of lead to be wrapped around a continuous stainless steel cleat which will form a rigid drip. Lead to wrap up wall by 75mm. Code 6 apron flashing to be lapped over main cornice flashing and ragged into the masonry wall, secured by lead wedges. Raggle to be 25mm wide and infilled with 2-part polysulphide mastic coated with stone dust.

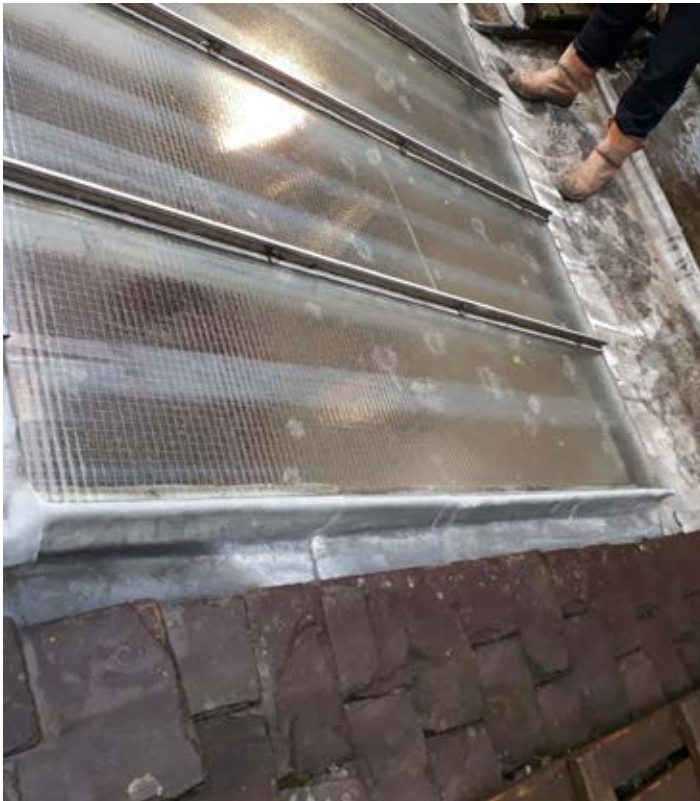
Northern end of skylight above grand staircase
Refer to item 6 in Scope of Work CHF-1B

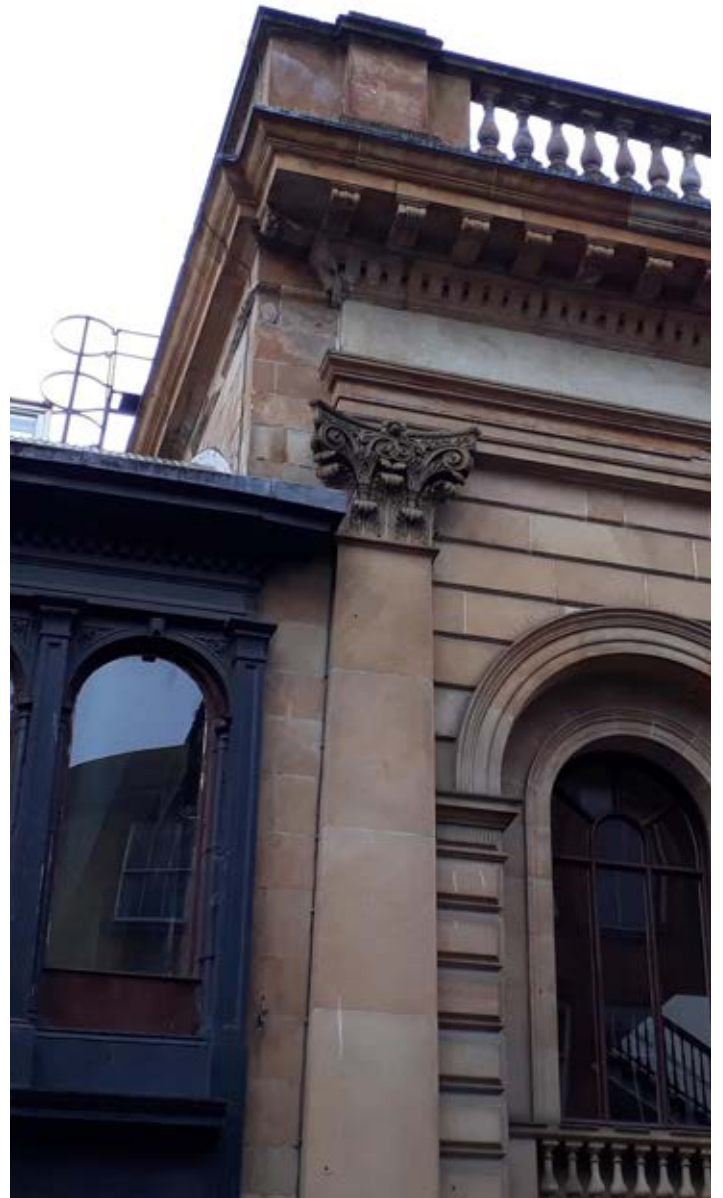
Poor stonework at top
Refer to item 8 in Scope of Work CHF-1B

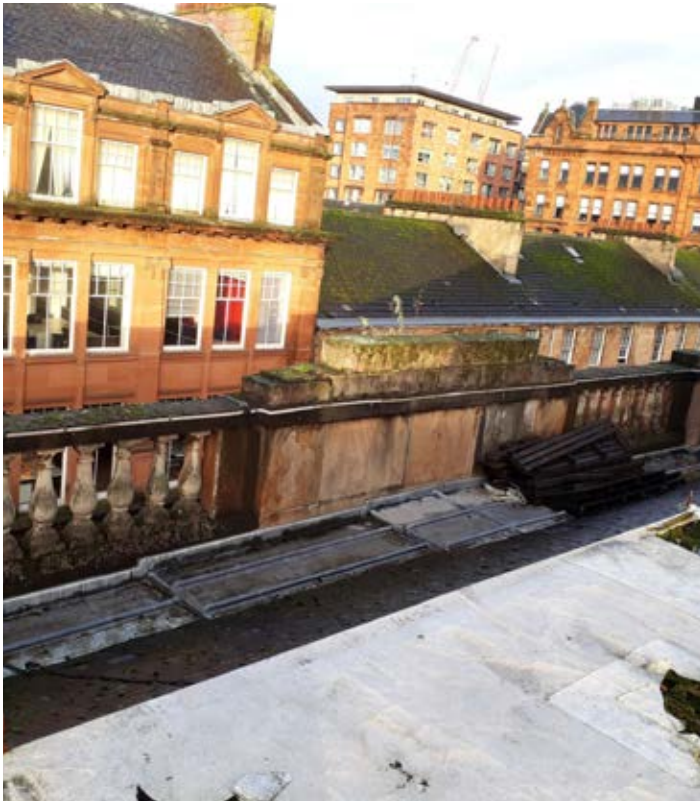
Vegetation at parapet level

Refer to item 7 in Scope of Work CHF-1B

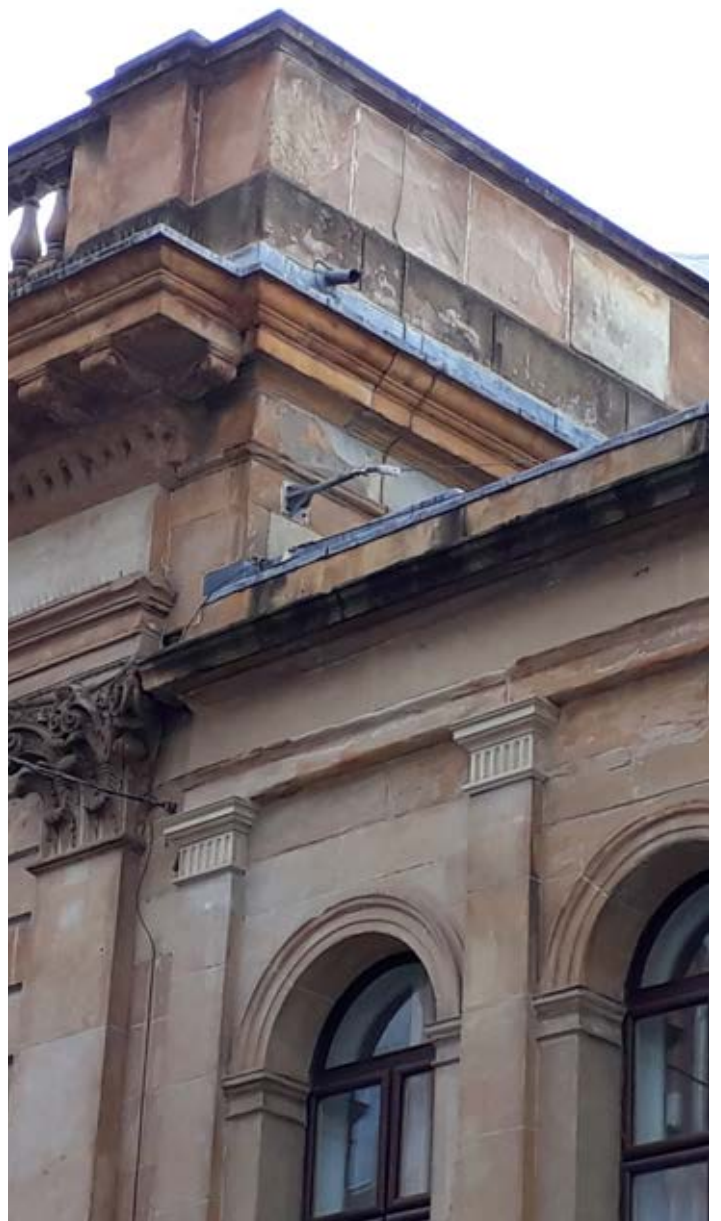
Linostone to south elevation at high level

Refer to item 10 in Scope of Work CHF-1B

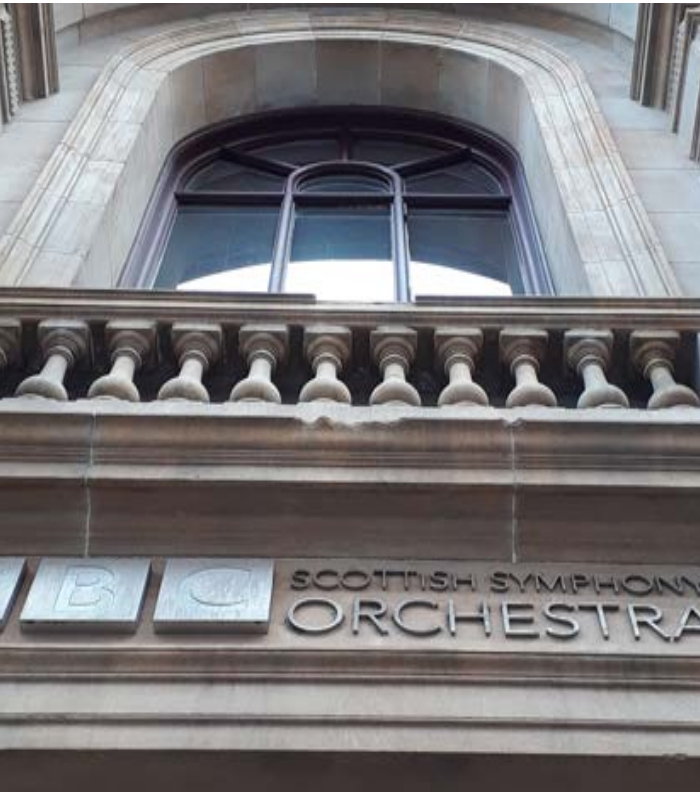
Damaged stone to central parapet
Refer to item 8 in Scope of Work CHF-1B

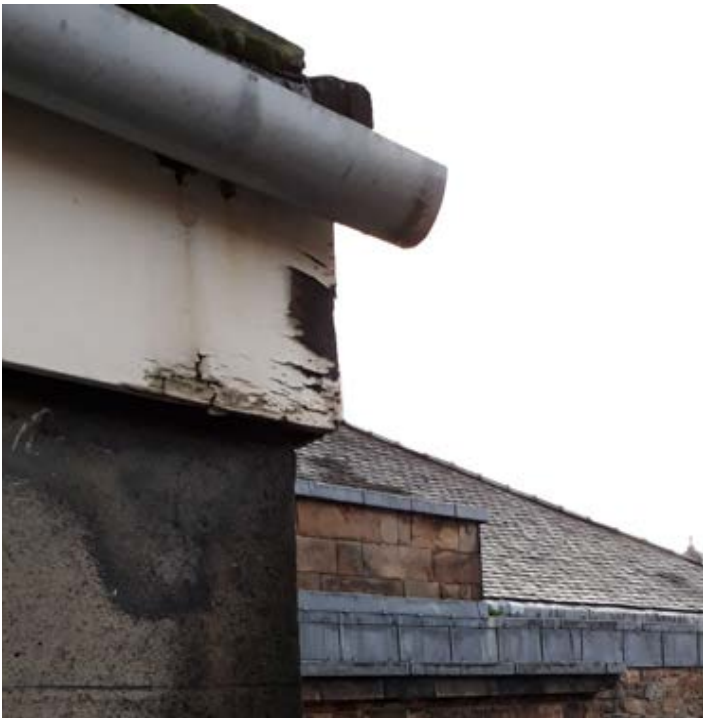
Poor fascia to plant room
Refer to item 11 in Scope of Work CHF-1B

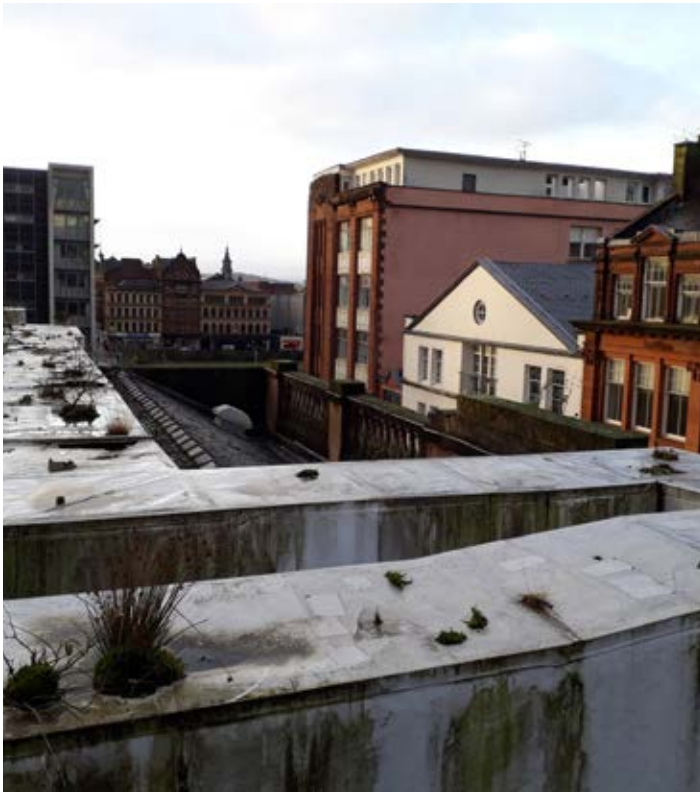
Vegetation and poor lagging to all external pipes and ducts - top 2 photos

Refer to items 13 & 22 in Scope of Work CHF-1B

2.1 Remove all lagging from external pipes and insulation from external ducts. Proprietary external quality mineral wool lagging and insulation to be secured around all pipes and ducting. Insulation and lagging to have waterproof and UV resistant outer cover.

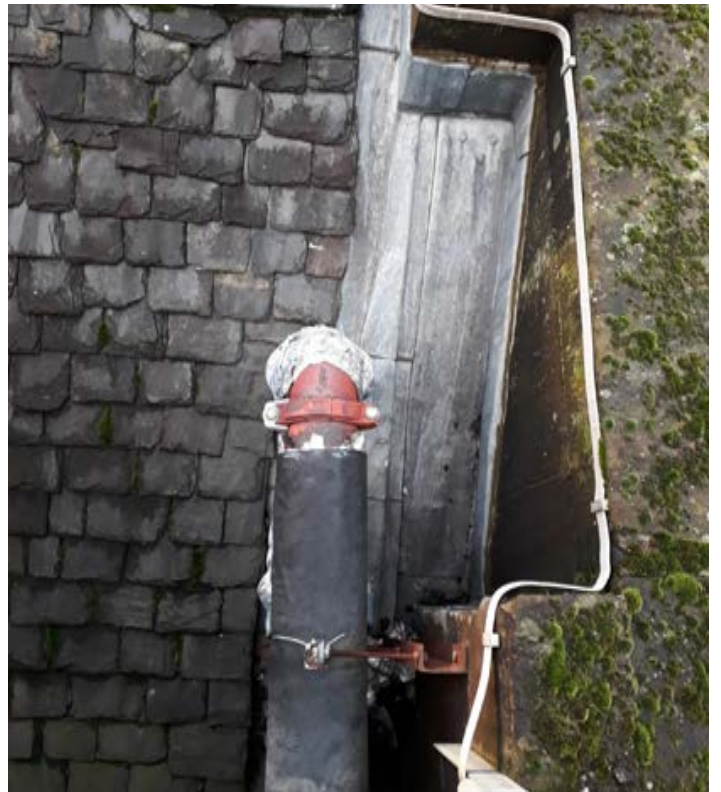
Poor flashing to skylight

Refer to item 14 in Scope of Work CHF-1B

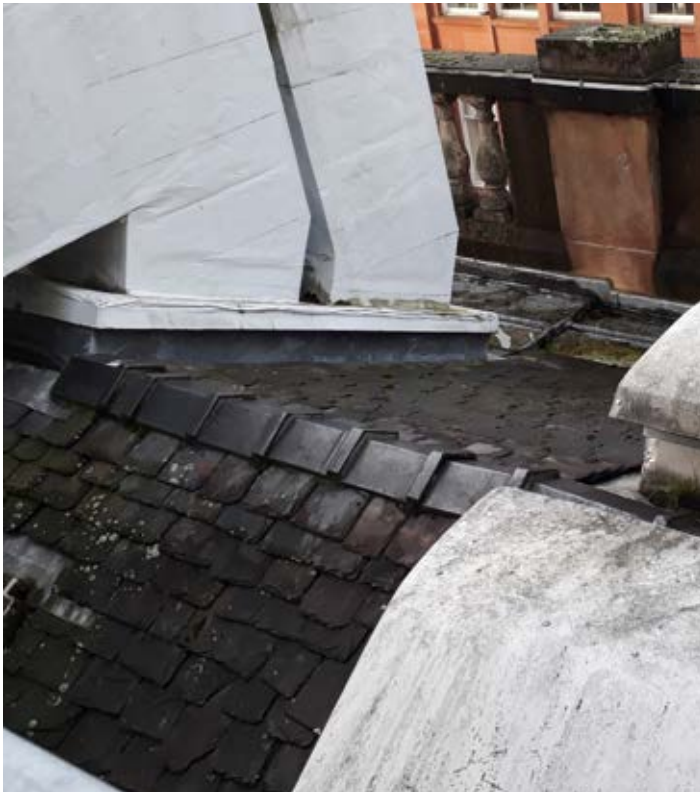
Ridge tiles to be replaced with lead ridge
Refer to item 15 in Scope of Work CHF-1B

2.3a New lead valley and hip flashings to be in code 7 lead. Existing ridge tiles to be removed and replaced with code 8 lead flashings and to be secured with terne-coated stainless steel clips. Any abutment and cover flashings to be in code 6 lead.

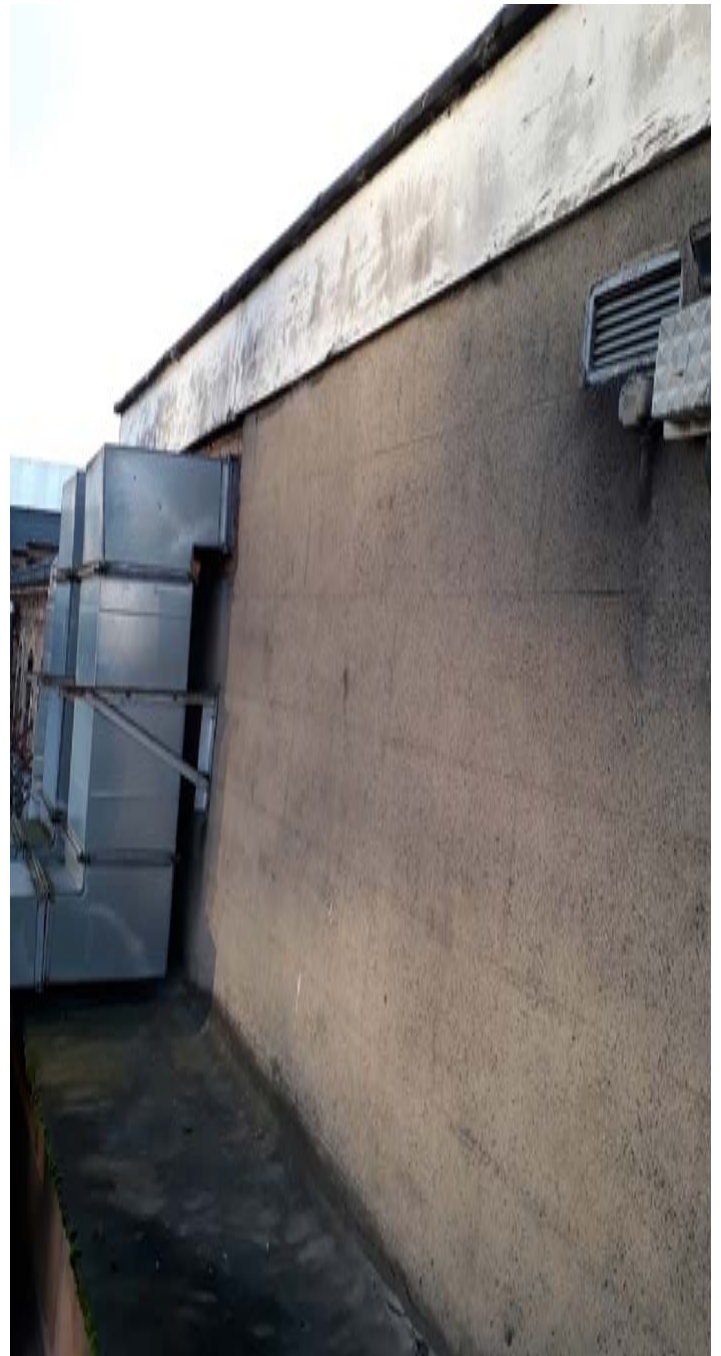
Spalling render and poor asphalt on cornice
Refer to items 17 & 19 in Scope of Work
CHF-1B

2.5e Existing asphalt coating to cornice to be removed. Cornice to be cleaned of all debris and new asphalt applied. Proprietary metal edge trim flashing to be ragged into wall above cornice.

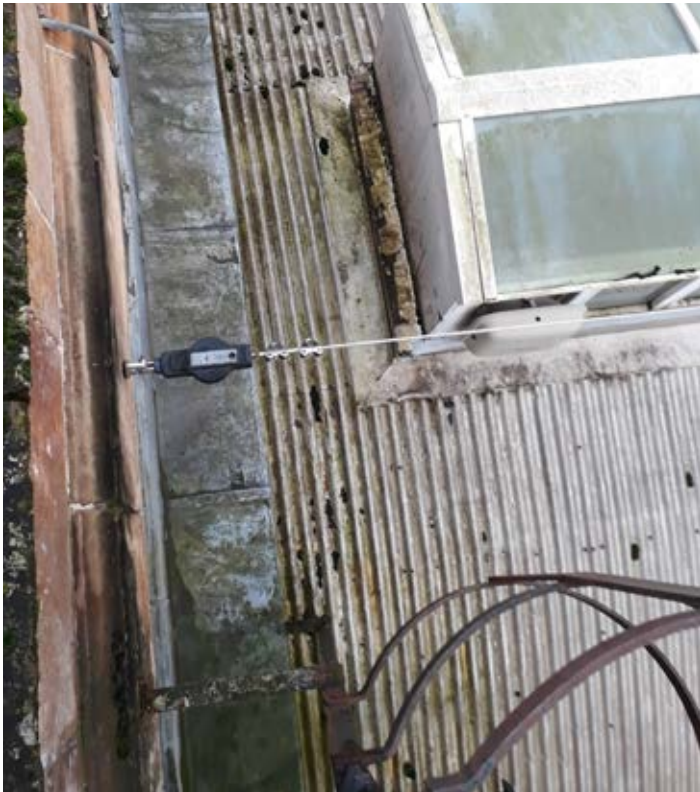
Existing roof ladder to be assessed
Refer to item 4 in Scope of Work CHF-1B

2.9a Existing access ladder and cage to be assessed. If it doesn't pass certification, it is to be replaced with a matching item, secured into the wall using resin anchors. The exact type and number of fixings to be specified by a structural engineer.

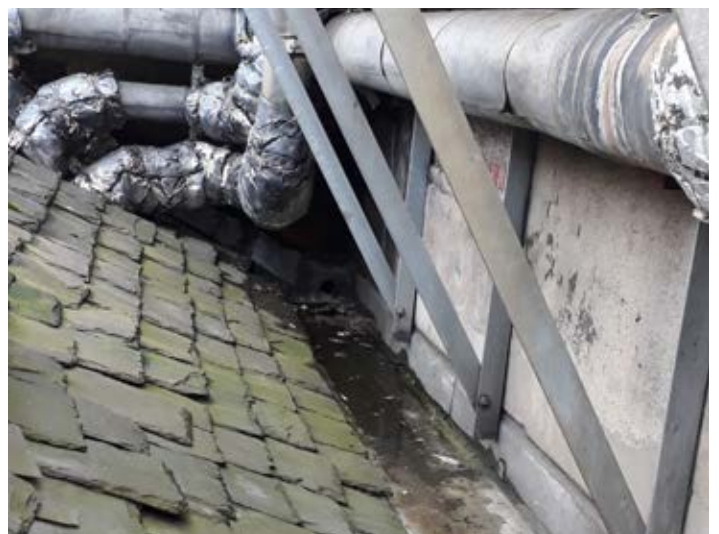
Grating missing from outlet
Refer to item 20 in Scope of Work CHF-1B

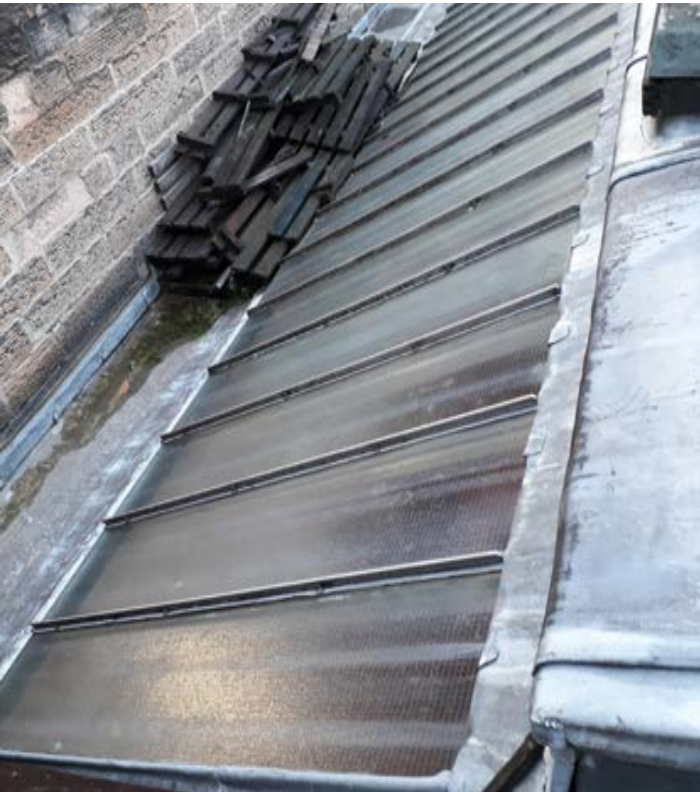
Duckboards stored on lead gutters
Refer to items 23 in Scope of Work CHF-1B

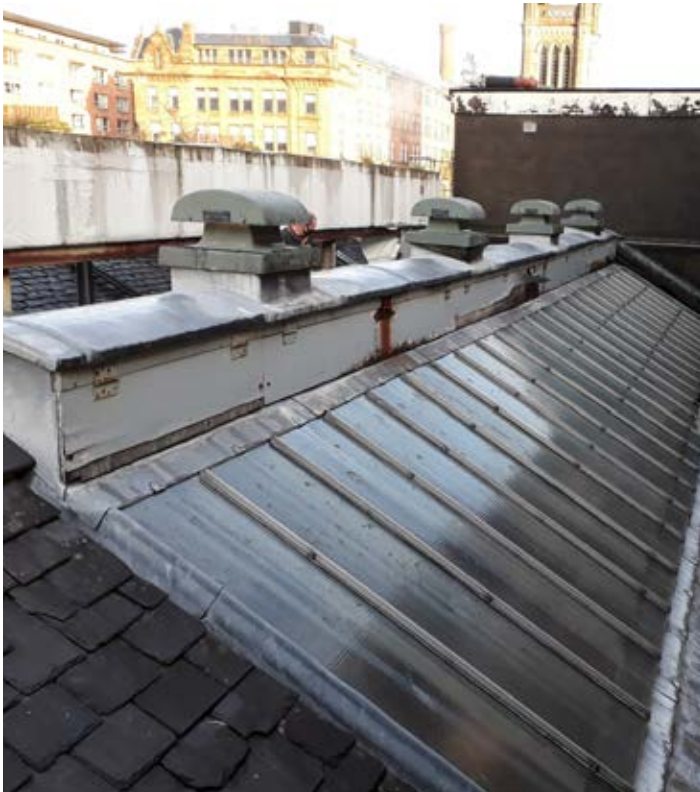
Upstands to main rooflights in poor condition
Refer to items 25 in Scope of Work CHF-1B

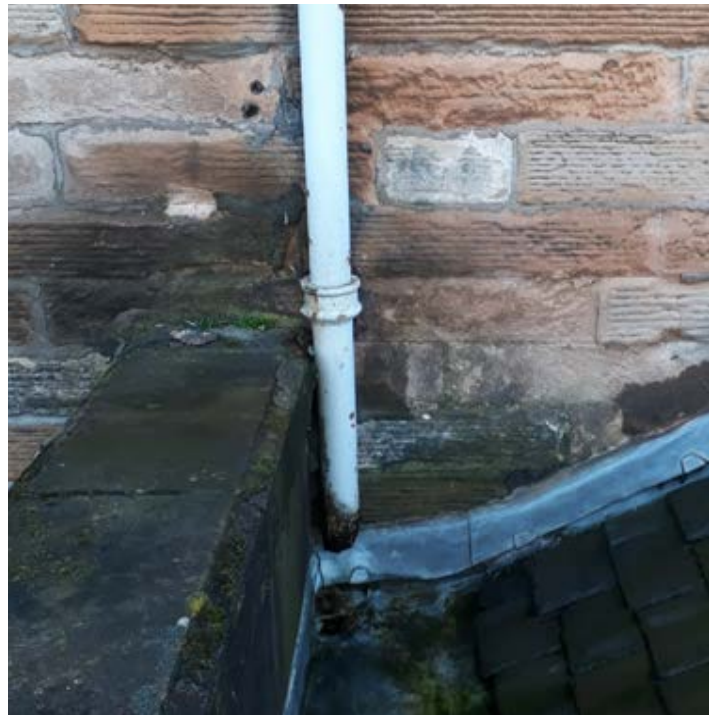
Rusting base of rwp
Refer to items 26 in Scope of Work CHF-1B

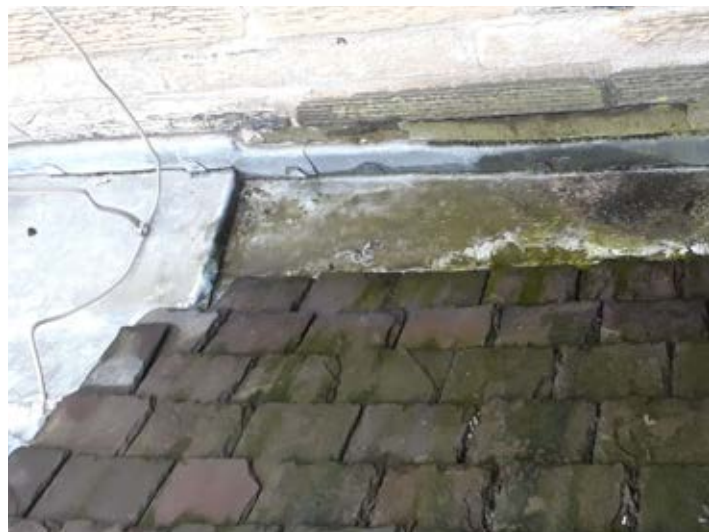
Gutter drip not 50mm
Refer to items 27 in Scope of Work CHF-1B

2.5f Existing lead to be uplifted at area of lead gutter which doesn't have an adequate drip (lowest 2 levels of gutter). Existing (assumed) ply substrate to be replaced if damaged and either replaced with a thinner sheet of ply or have an additional sheet laid on top - in order to attain a drip height of at least 50mm. Once drip is formed, New code 7 lead to be formed around new gutter and formed into outlet. Ensure lead is fitted under existing apron flashings.

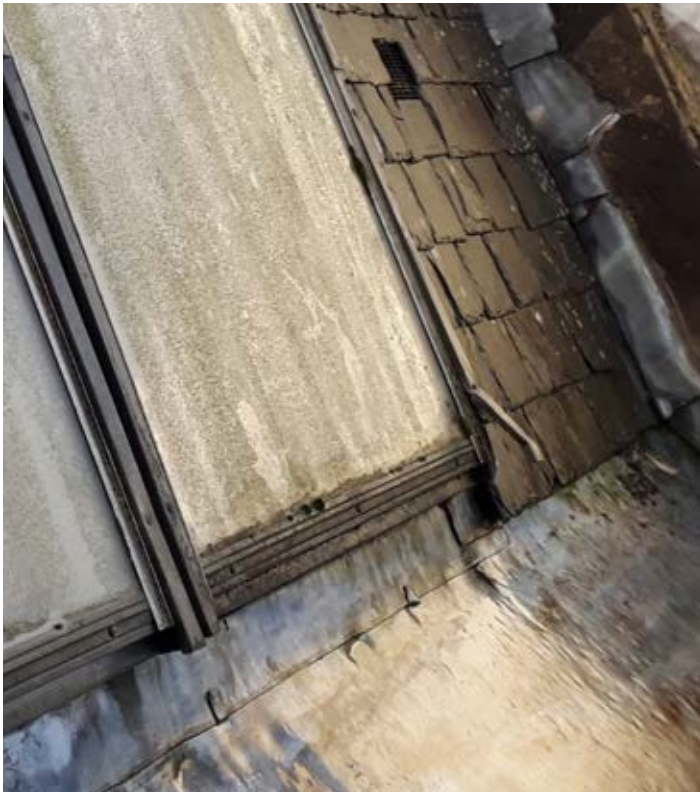
Bent flashing to rooflight
Refer to items 28 in Scope of Work CHF-1B

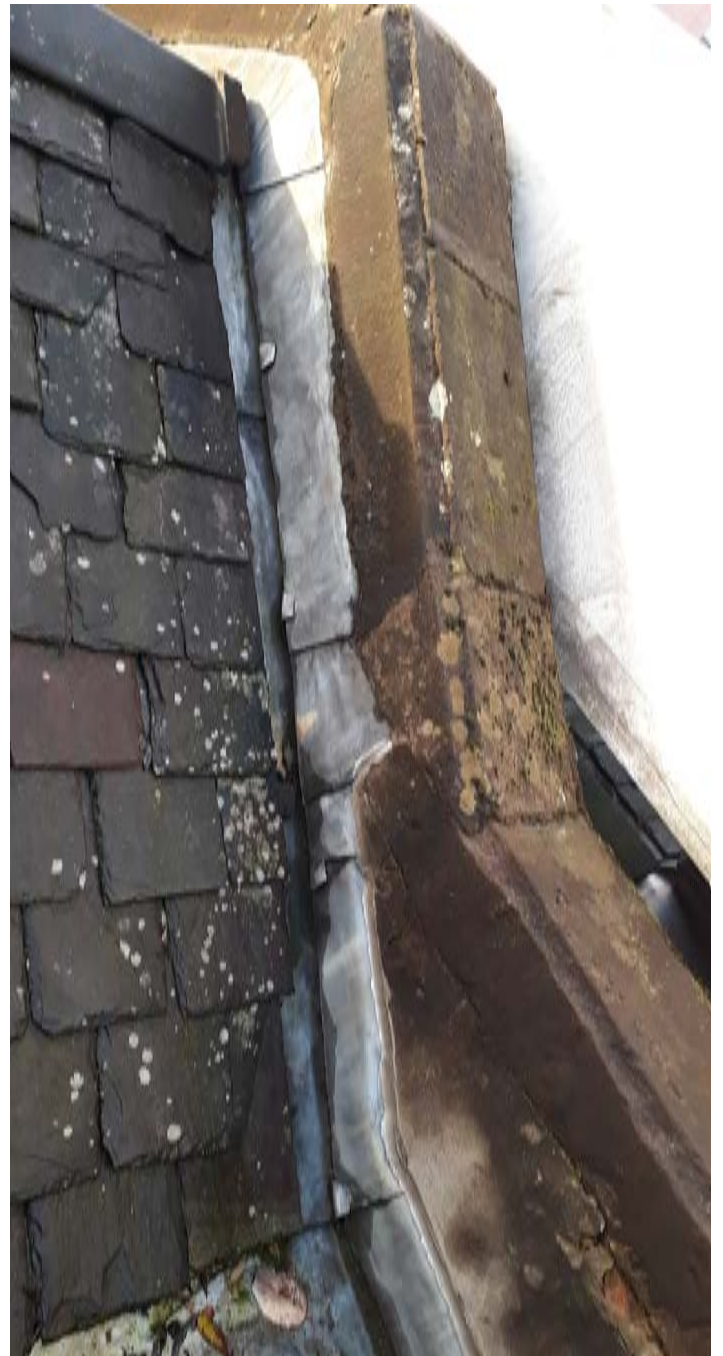
Poor pointing to skew leadwork
Refer to items 29 in Scope of Work CHF-1B

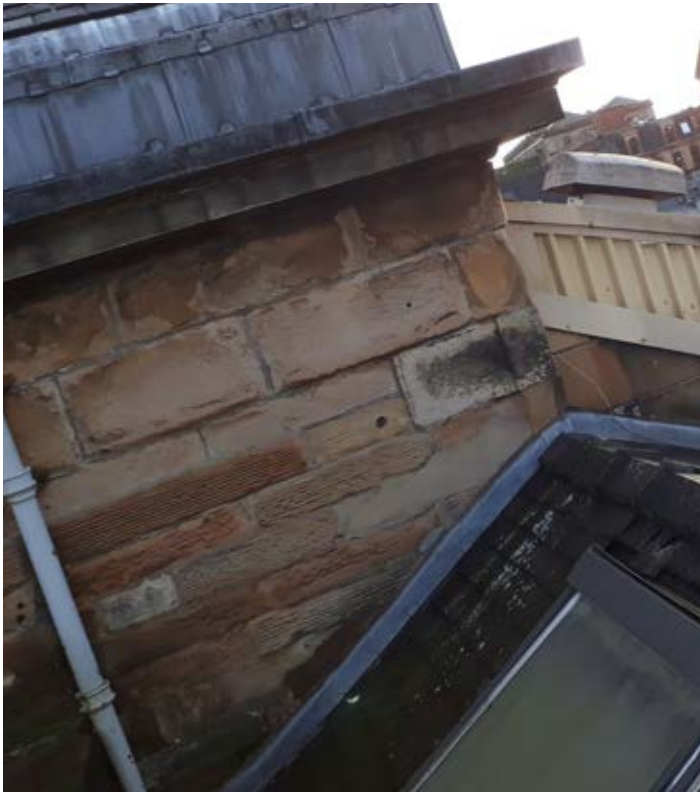
Suspect linostone repair
Refer to items 30 in Scope of Work CHF-1B

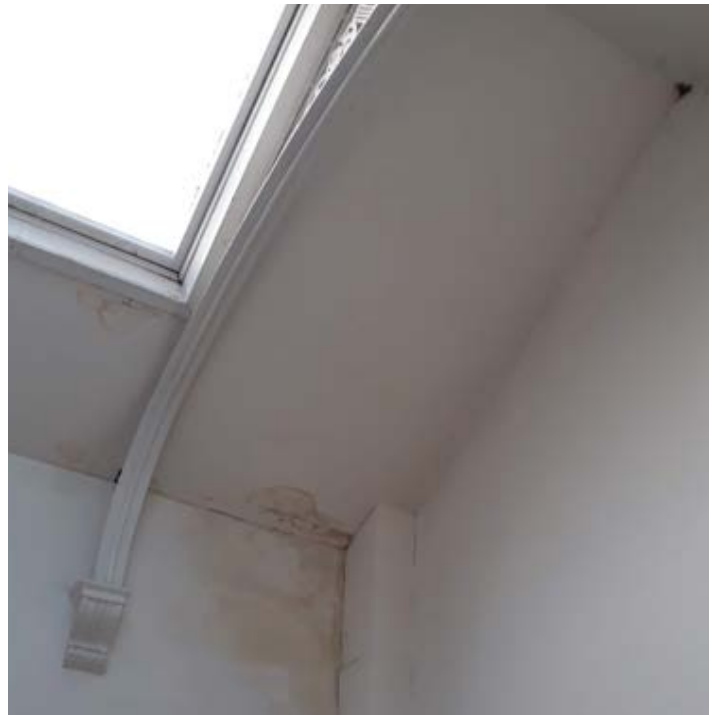
Staining to stairwell below gutter in southern roof
Refer to items 32 in Scope of Work CHF-1B

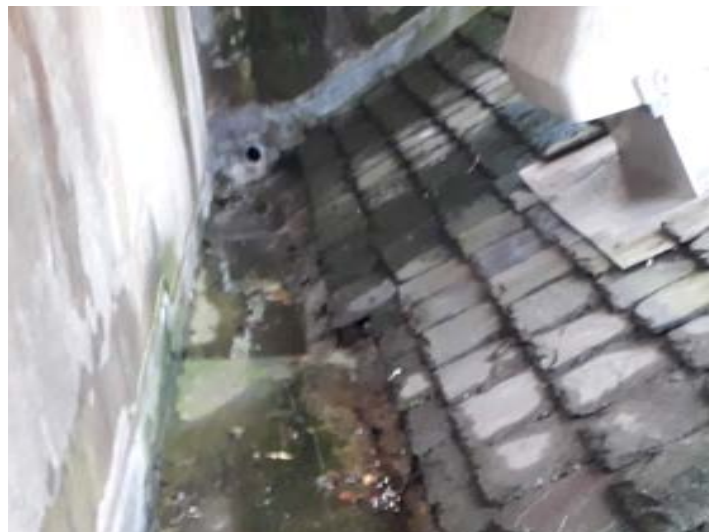
Outlet at end og gutter is too high
Refer to items 31 in Scope of Work CHF-1B

3.7 Drainage pipe removed from southern end of Roof 1B and hole infilled using clay or brick pinnings secured with lime-based mortar. A new proprietary 'Parapet Outlet' to be inseted at base of parapet wall. Existing lead gutter at end of gutter to be replaced with code 7 sheet and formed into outlet.
