Outline Specification

Conservation Outline Specification (COS) - February 2021

Photographs

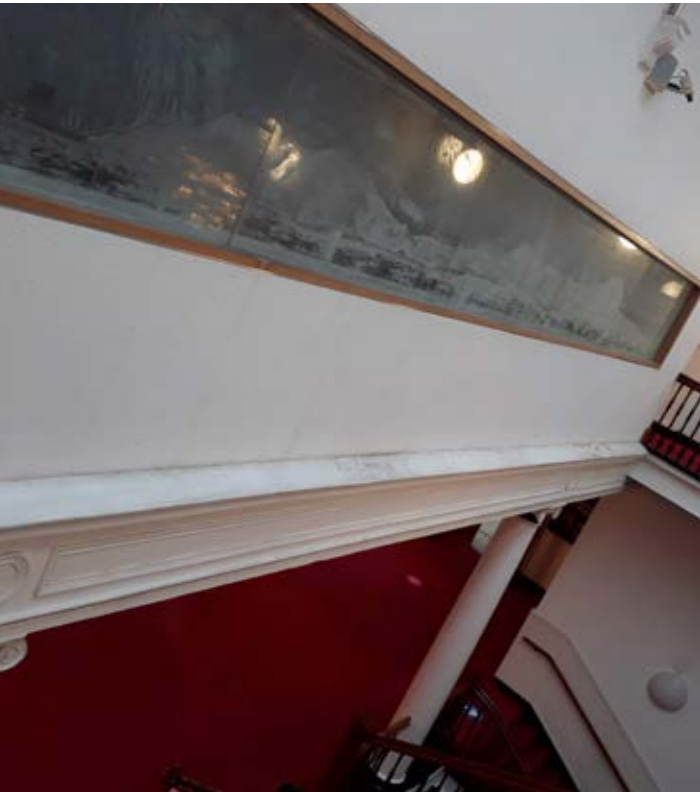
Poor paintwork on ledge below skylight
Refer to item 33 in Scope of Work CHF-1B

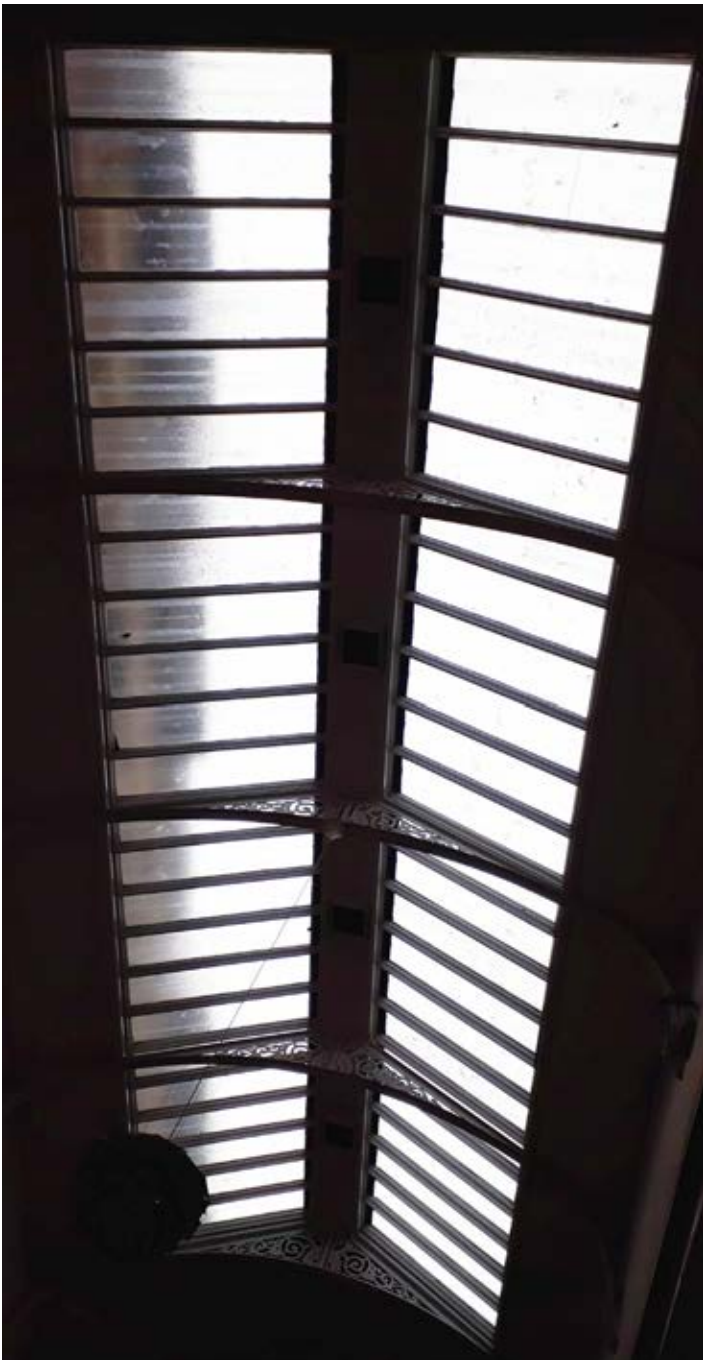
Underside of Rooflight above Main Staircase
Refer to item 33 in Scope of Work CHF-1B

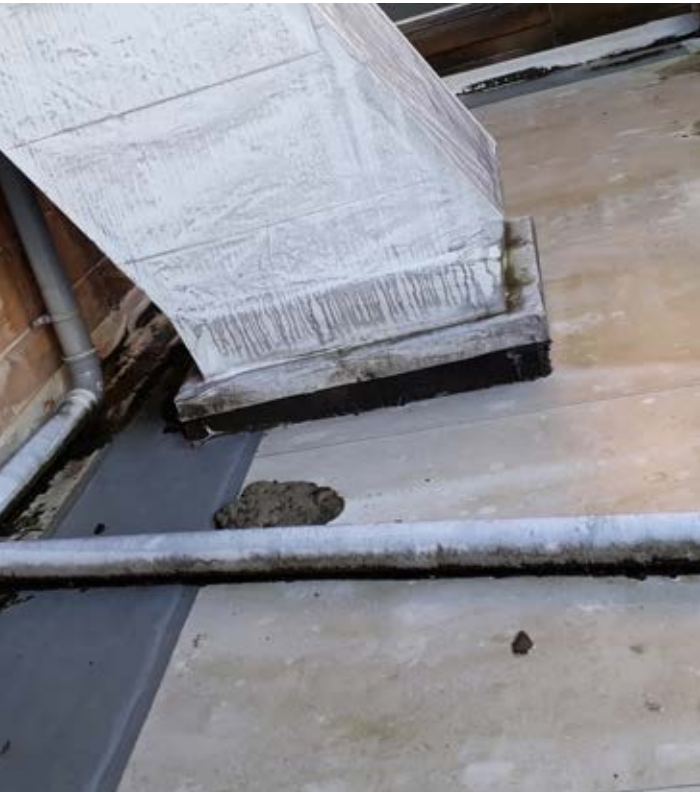
Poor upstand to duct penetration thro' flat roof
Refer to item 1 in Scope of Work CHF-1C

2.4b Remove existing damaged exposed timber kerb and replace with 18mm WBP ply upstand (nominal 150mm high above top of roof). Investigate thickness of existing roof insulation - height from roof substrate to top of upstand to be 300mm. Install new single ply membrane upstand and 25mm thick insulation (as recommended by single ply manufacturer), around new kerb upstand. Single ply upstand to be welded to existing single ply roof. Proprietary metal flashing to be secured to duct - to seal any gaps between the single ply upstand and the duct.

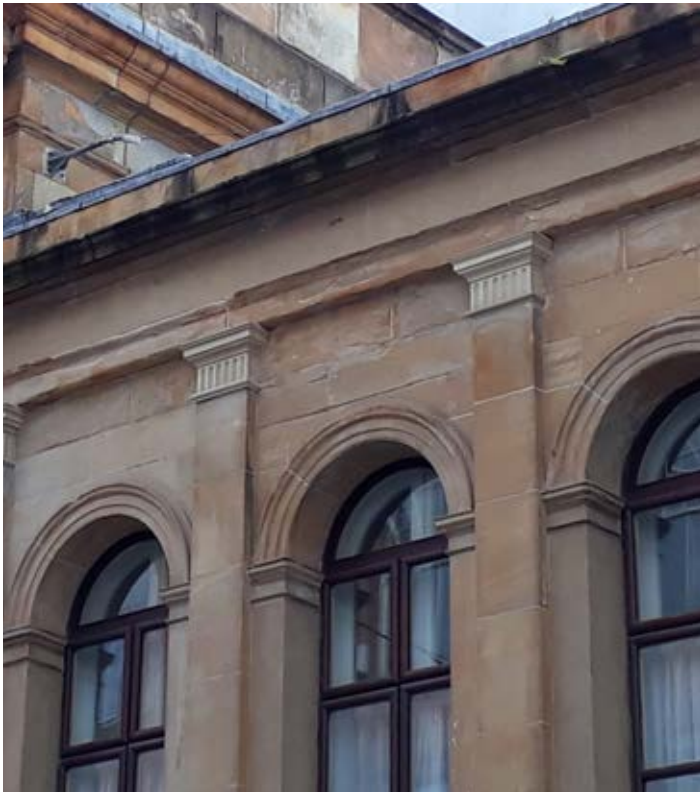
Washed out pointing above central window
Refer to item 3 in Scope of Work CHF-1C

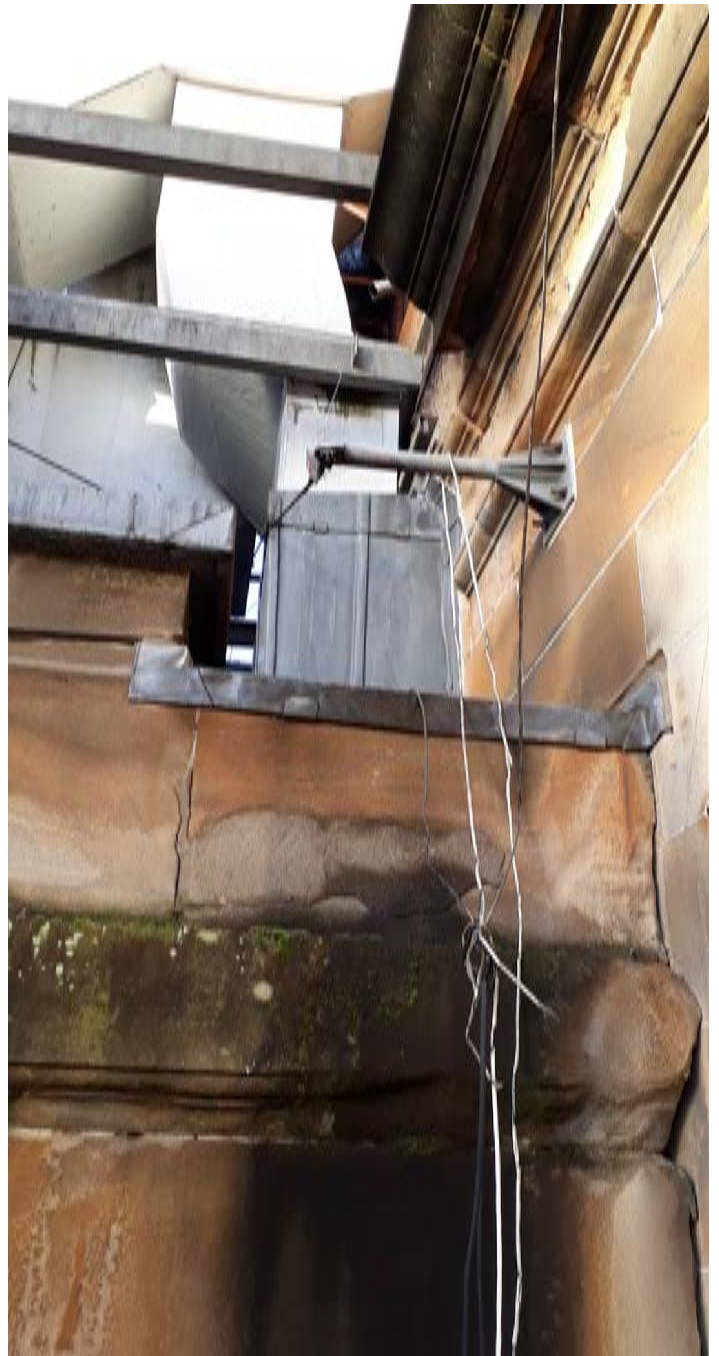
Poor stonework and mass of cables to East elevation. Failed safety line still in place
Refer to items 5, 6 & 18 in Scope of Work CHF-1C

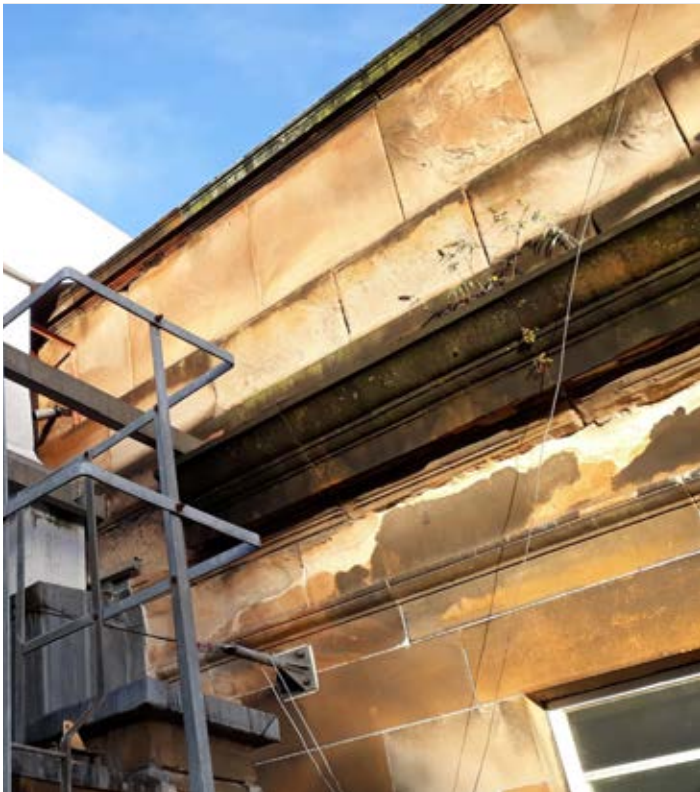
Poor pointing and damaged stone above window
Refer to items 8&11 in Scope of Work CHF-1C

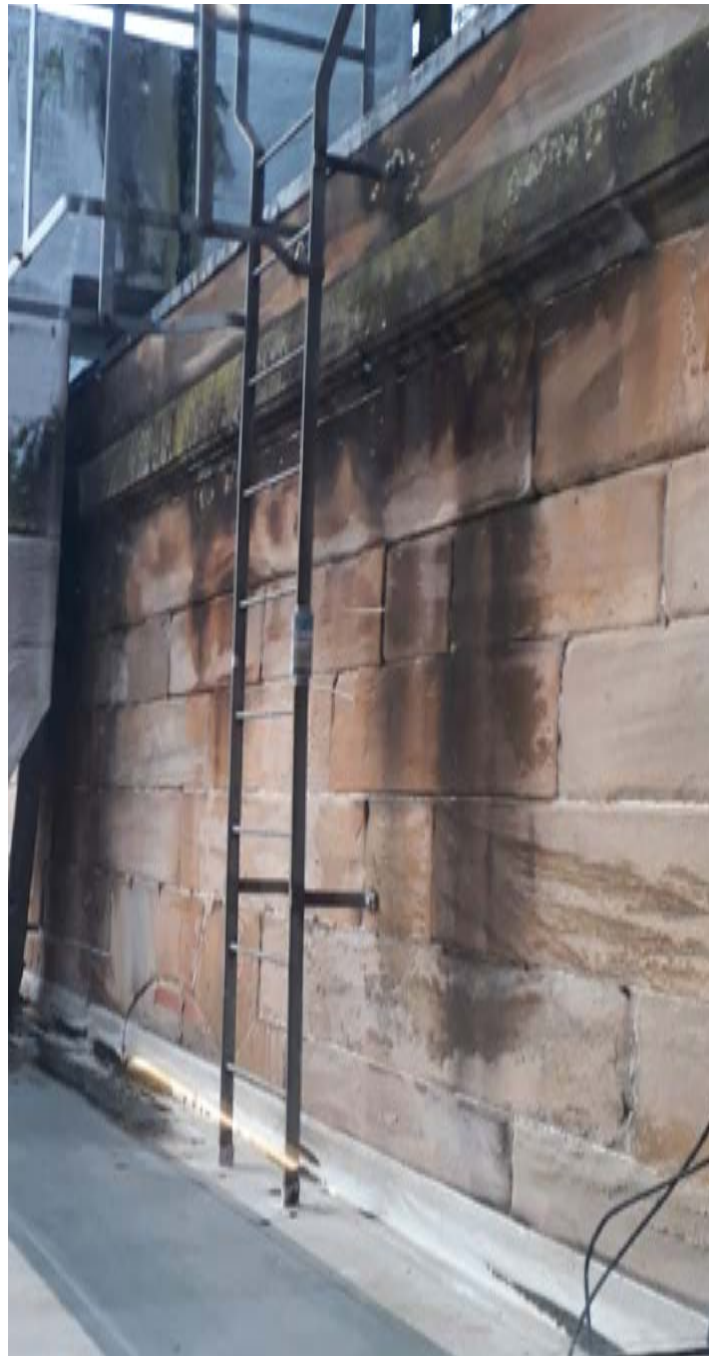
Poor pointing to East elevation
Refer to item 4 in Scope of Work CHF-1C

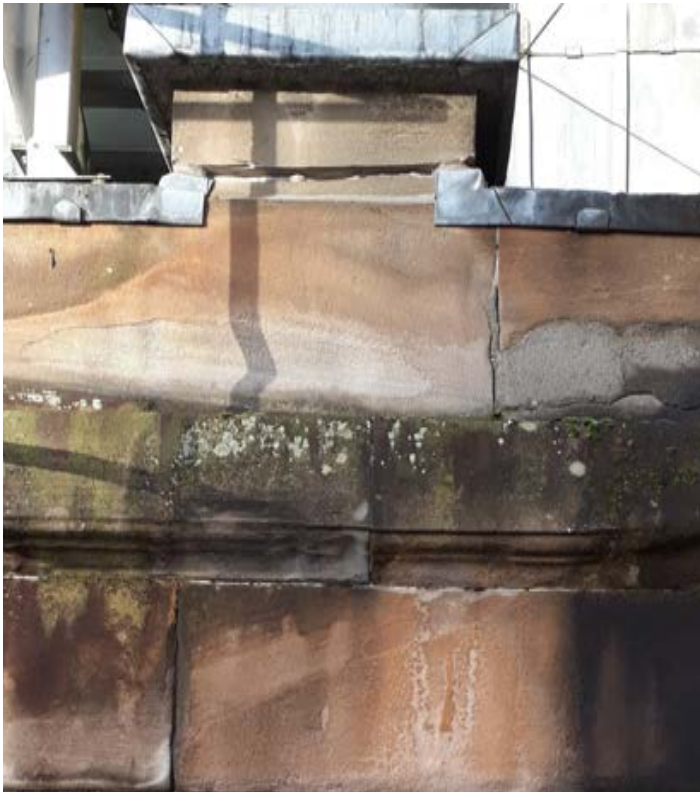
Suspect cement repair and open joint below cap
Refer to items 9 & 12 in Scope of Work CHF-1C

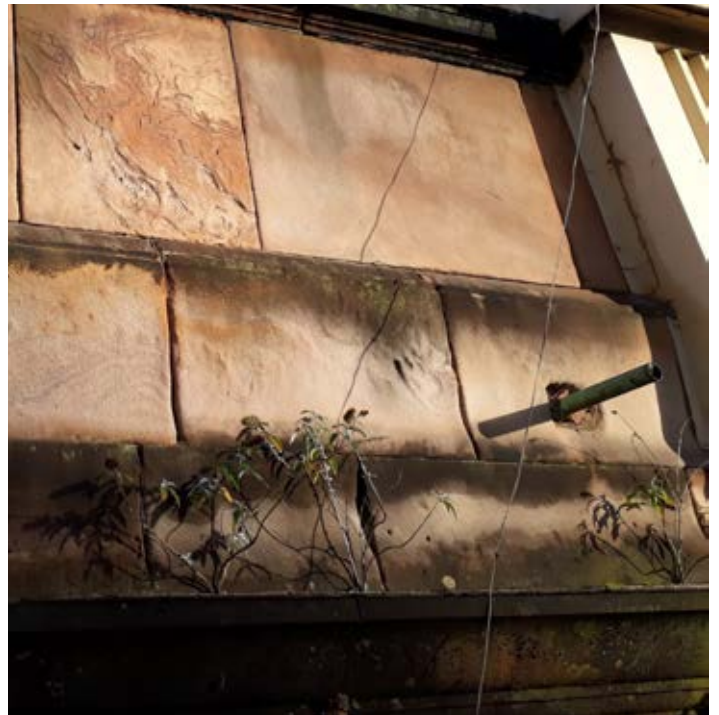
Poor stonework around pipe - and vegetation
Refer to items 7 & 10 in Scope of Work CHF-1C

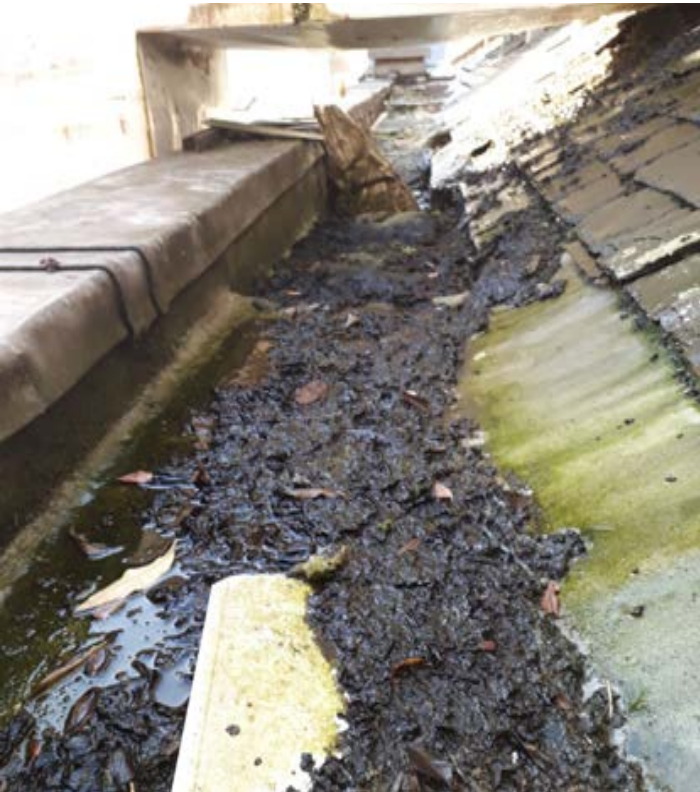
Gutter full of debris - to be cleaned
Refer to item 13 in Scope of Work CHF-1C

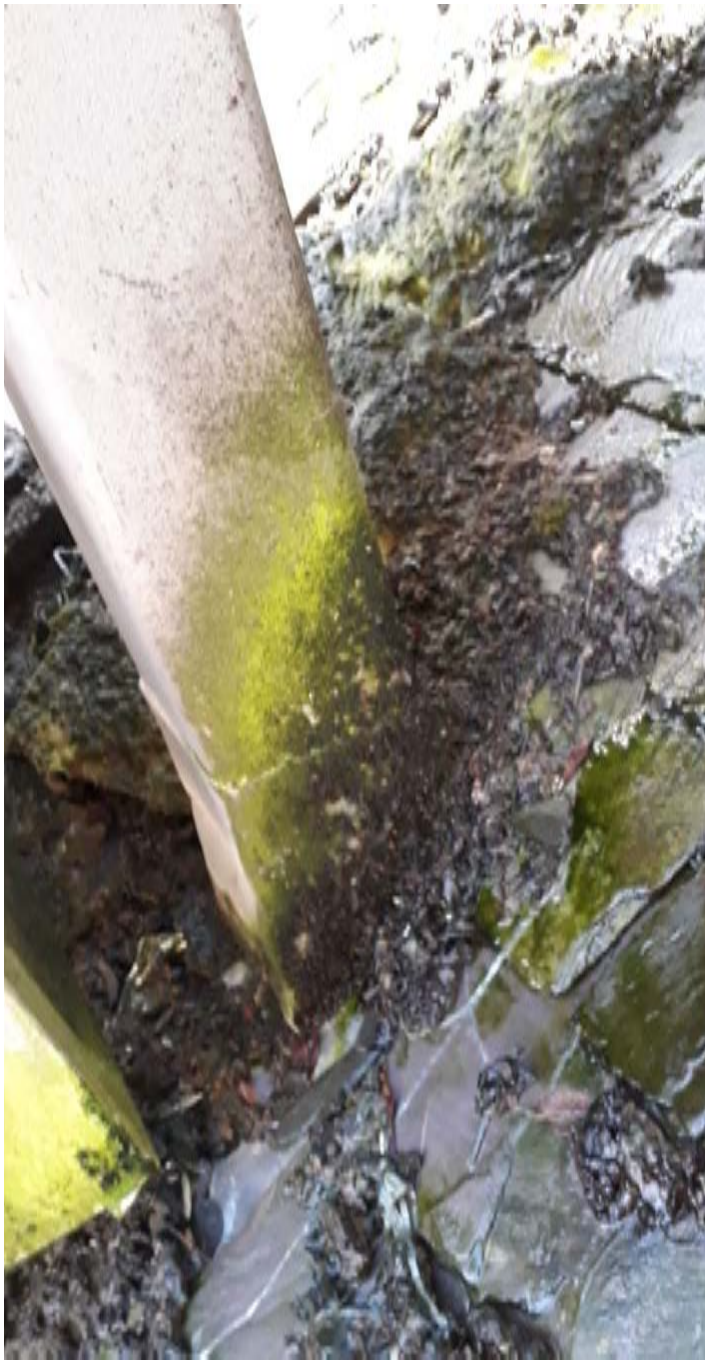
Projections thro' roof have debris collecting
on upper side
Refer to item 16 in Scope of Work CHF-1C

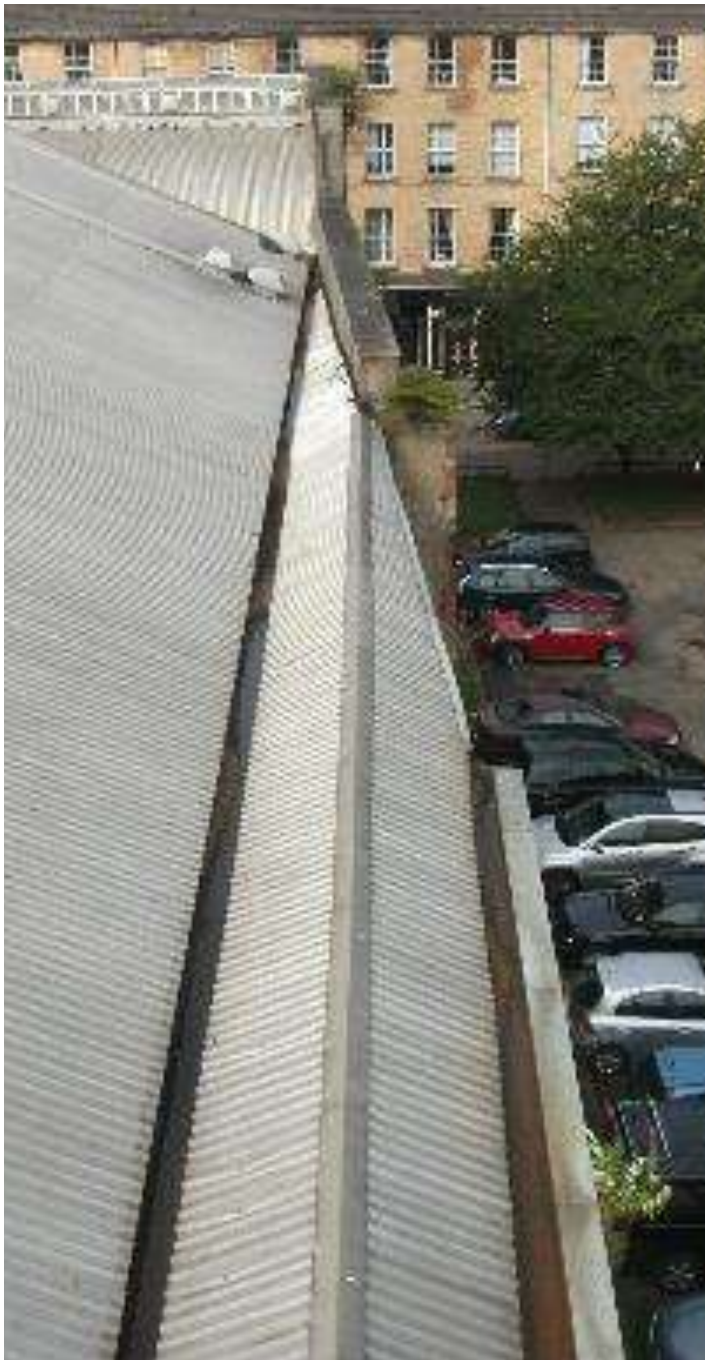
Small pitched roof at north to have Safety Line and gutter to be re-lined
Refer to items 4 & 5 in Scope of Work CHF-2

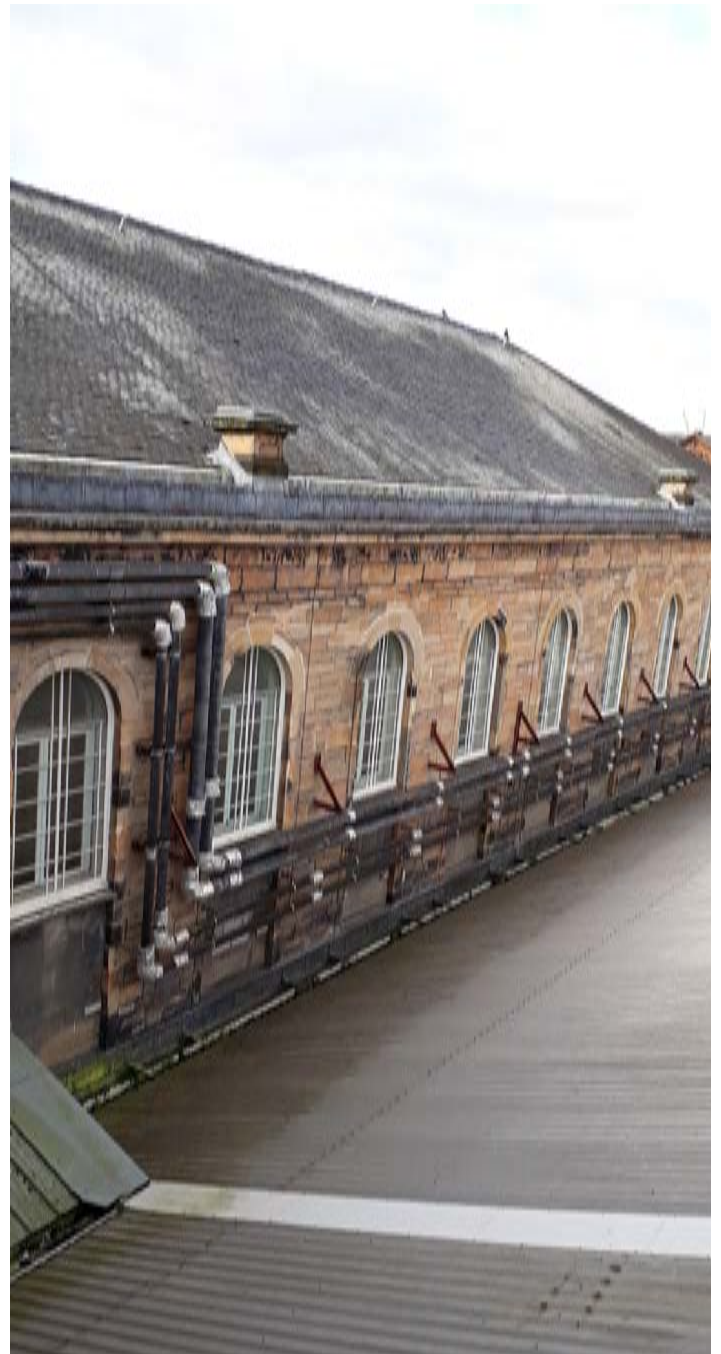
Gutter to be re-lined and new access walkway to be provided

Refer to items 2 & 15 in Scope of Work CHF-2

3.5 Gutters in metal roof 2 (Fruitmarket) to be re-lined. Thoroughly clean out gutter and install new proprietary EPDM bonded steel gutter lining - Unifold Gutter System. Lining to have expansion joints as per manufacturer's recommendations. Provide new 25mm Ø overflow pipe with insect mesh, located halfway up gutter depth. Overflow pipe to connect to new wall mounted identifiable tundish at visible location indicated on plans. Tundish to connect to existing drainage system via trap.

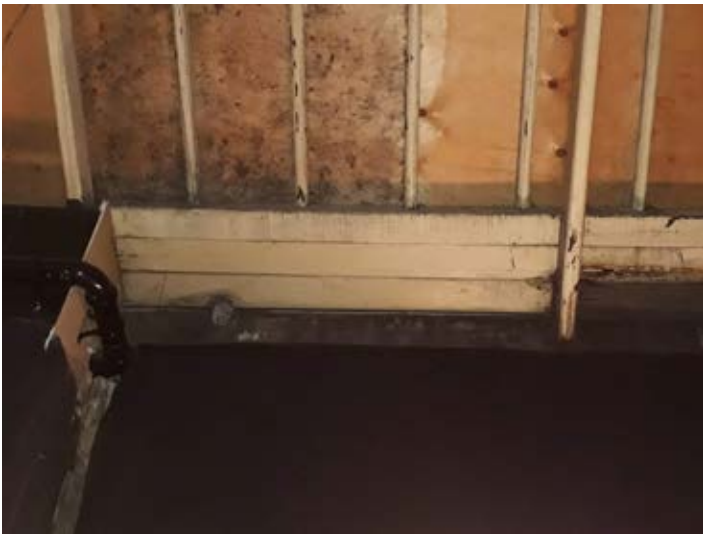
Damage and poor paintwork to ceiling boards
Refer to items 11 & 12 in Scope of Work CHF-2

5.2 Some ceiling lining boards in the Fruitmarket are missing or suffering from rot. New t+g timber boards to match profile and cross section of existing boards to be installed in place of the damaged or missing ones. Boards to be screwed in place through the tongue using stainless steel screws through pre-drilled holes. Paint fully on completion as per item 5.3.

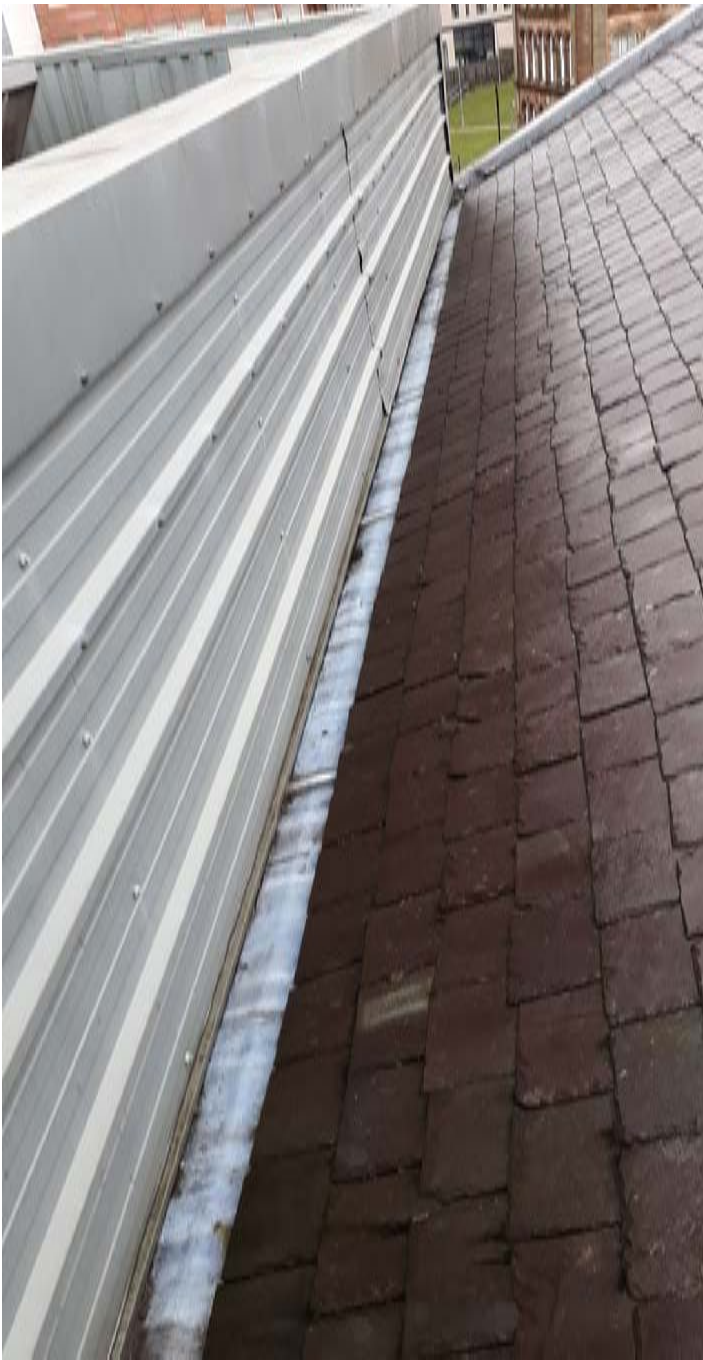
Poor flashing at base of slate pitch
Refer to item 1 in Scope of Work CHF-3A

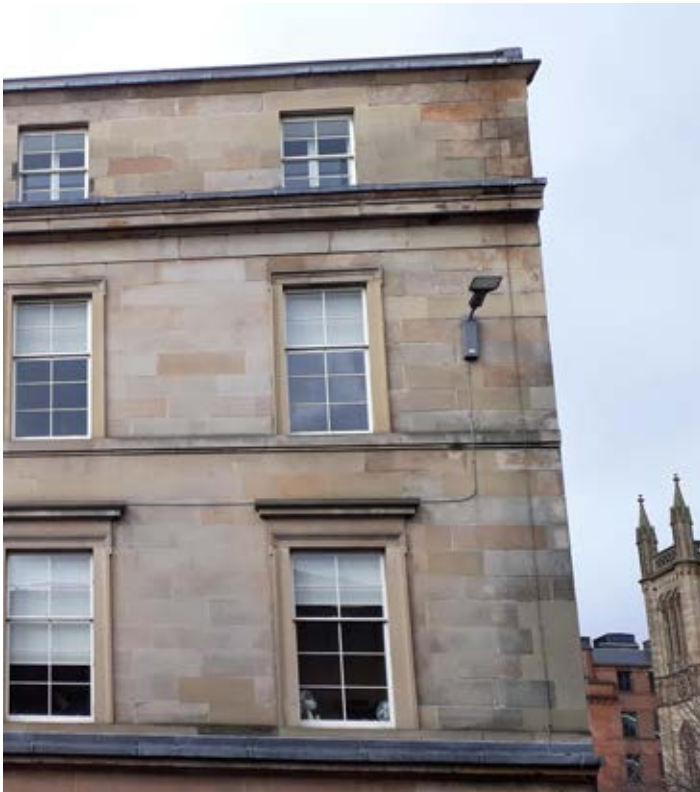
Suspect linostone repair and poor pointing
Refer to items 4 & 5 in Scope of Work
CHF-3A

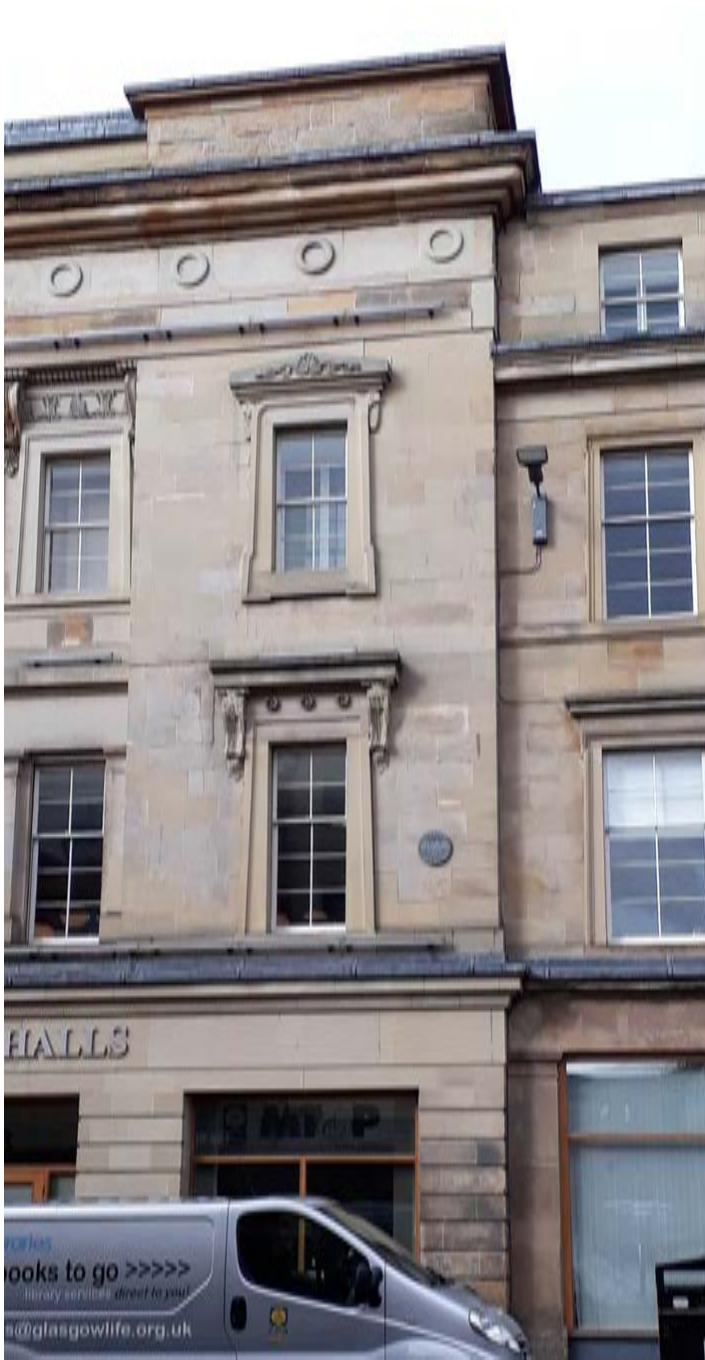
Poor pointing
Refer to items 4 & 5 in Scope of Work
CHF-3B

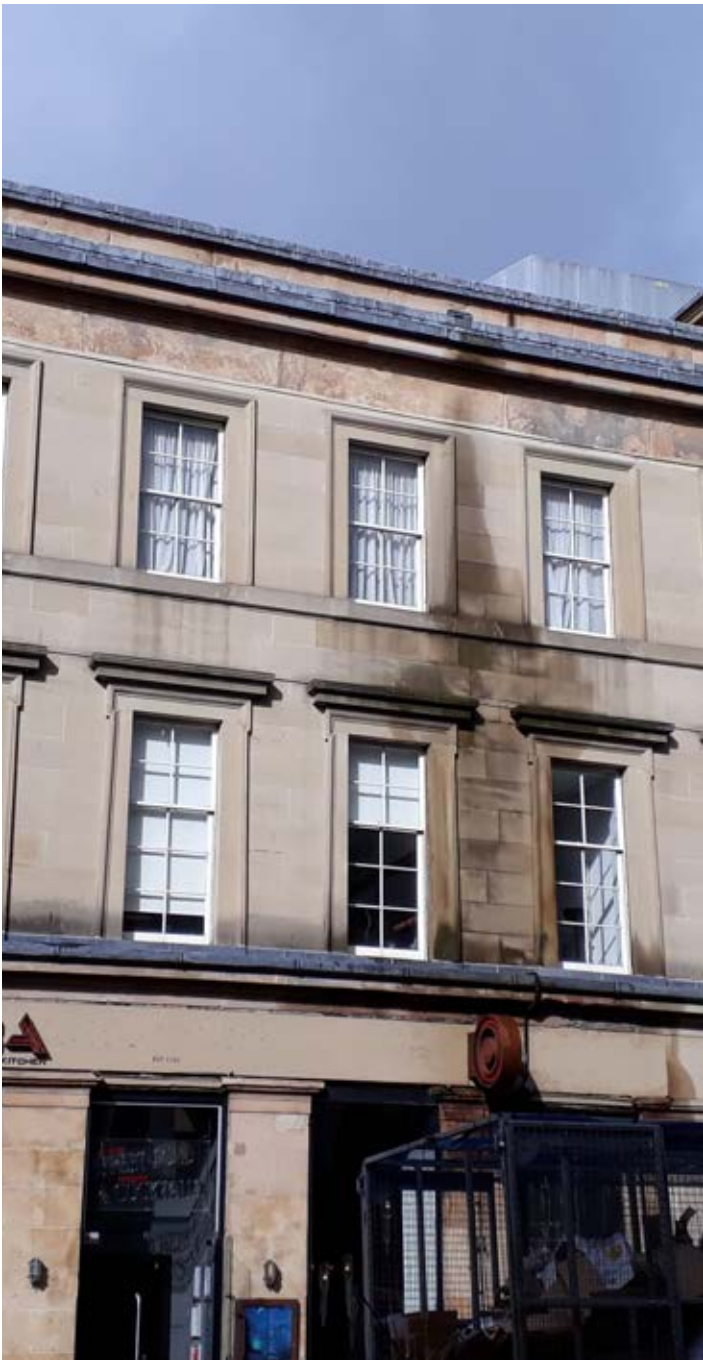
Damp stone - constantly flowing overflow from above
Refer to item 2 in Scope of Work CHF-3C

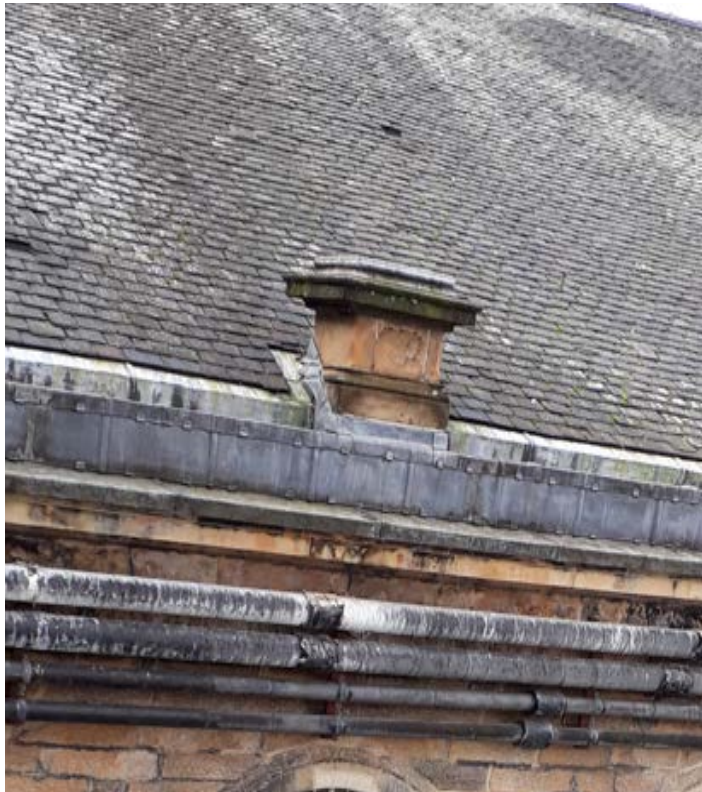
View of Parapet Stone on eaves
Refer to items 1, 2 & 3 in Scope of Work
CHF-4

2.5i Lead caps and skirts to the raised parapet stones on Roof 4 to be carefully removed. New code 7 cap to be installed over top of cap with a central 50mm high timber roll centred on cap. Lead to be laid on top of 18mm WBP ply substrate which is drilled into stone. Edges of cap to be dressed into the moulding of the stonework.

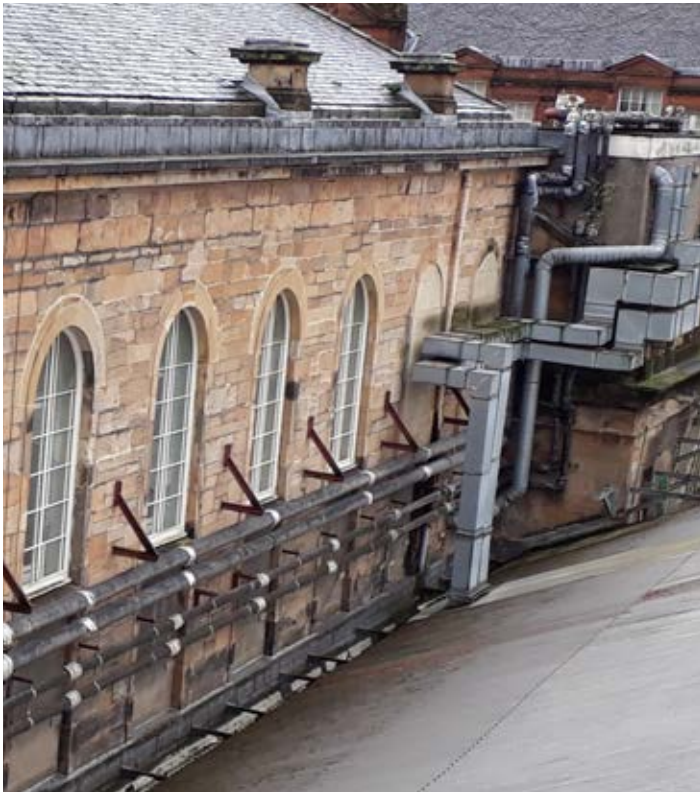
Poor pointing and some damaged rybat stones
Refer to items 6-10 in Scope of Work CHF-4

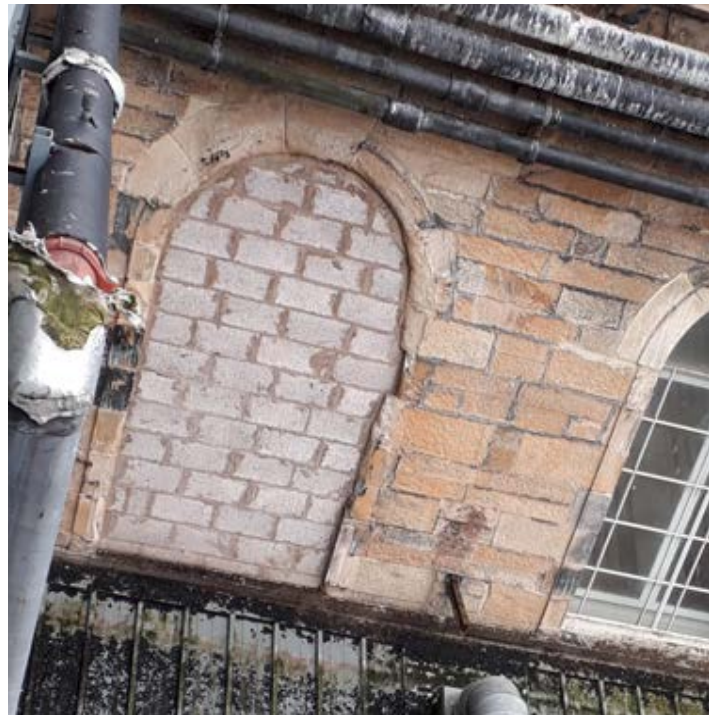
Window blocked up
Refer to item 7 in Scope of Work CHF-4

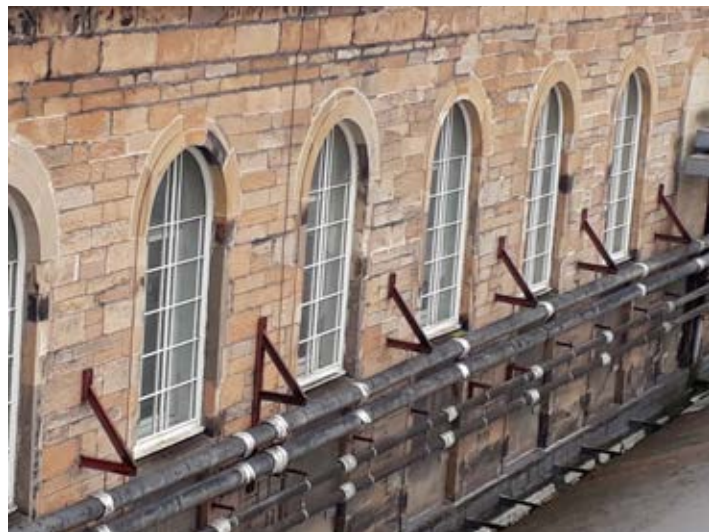
Poor pointing and some damaged rybat stones
Refer to items 6-10 in Scope of Work CHF-4

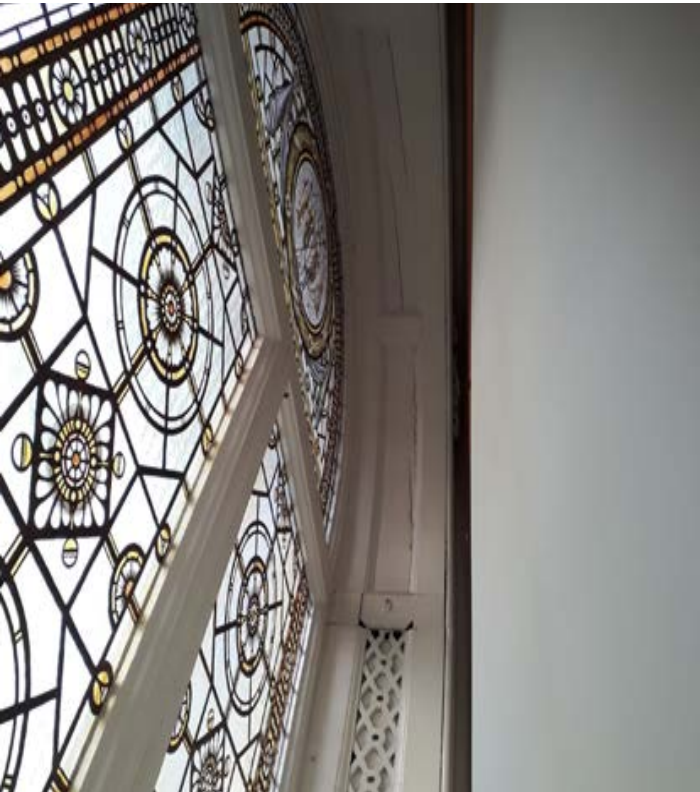
Repairs to windows
Refer to items 11 & 14 in Scope of Work
CHF-4

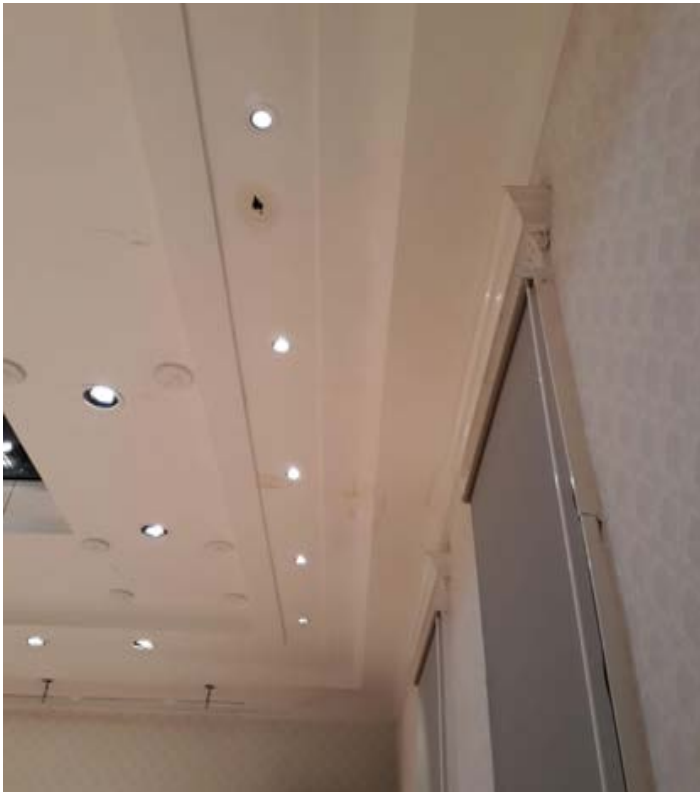
Water damage to ceiling
Refer to item 14 in Scope of Work CHF-4

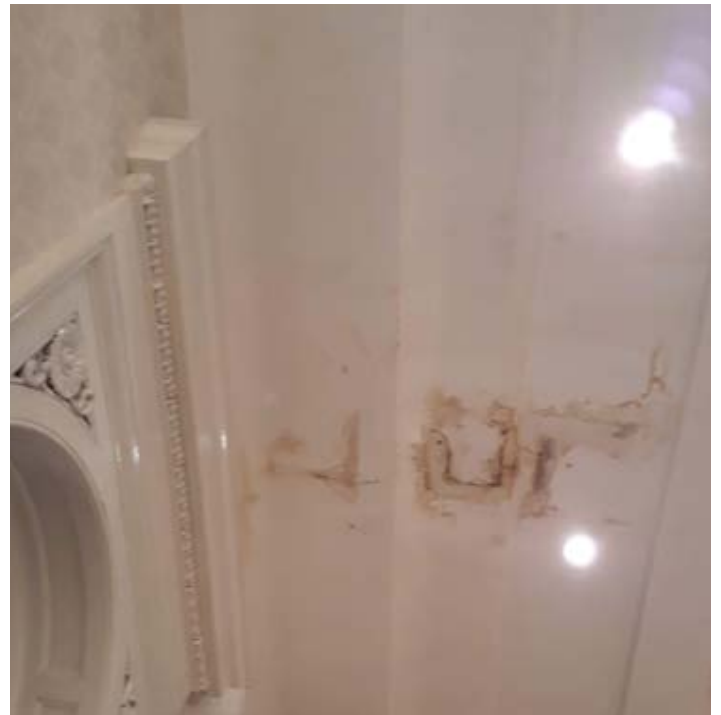
Water damage to ceiling
Refer to item 14 in Scope of Work CHF-4

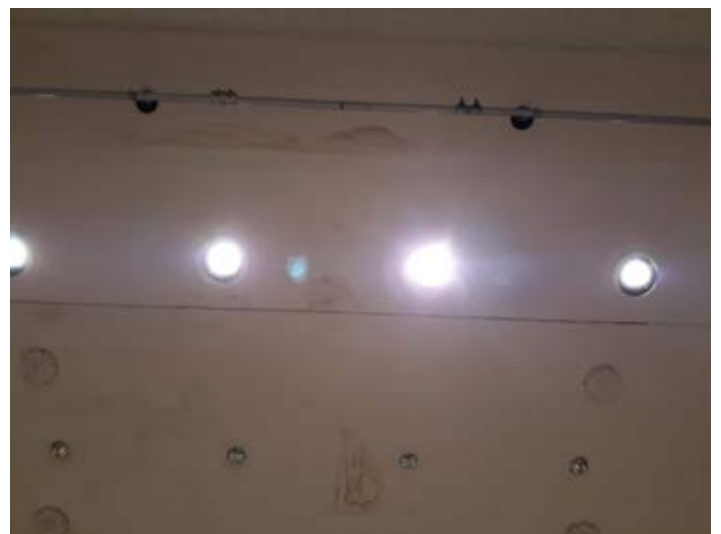
Water damage to ceiling
Refer to item 14 in Scope of Work CHF-4
