City Halls & Old Fruitmarket
Roofworks
City Building

Drawing Name
Zone 3 - East Elevation
Northern Half

Drawing Number
CHF-HML-03-XX-DR-A-12114

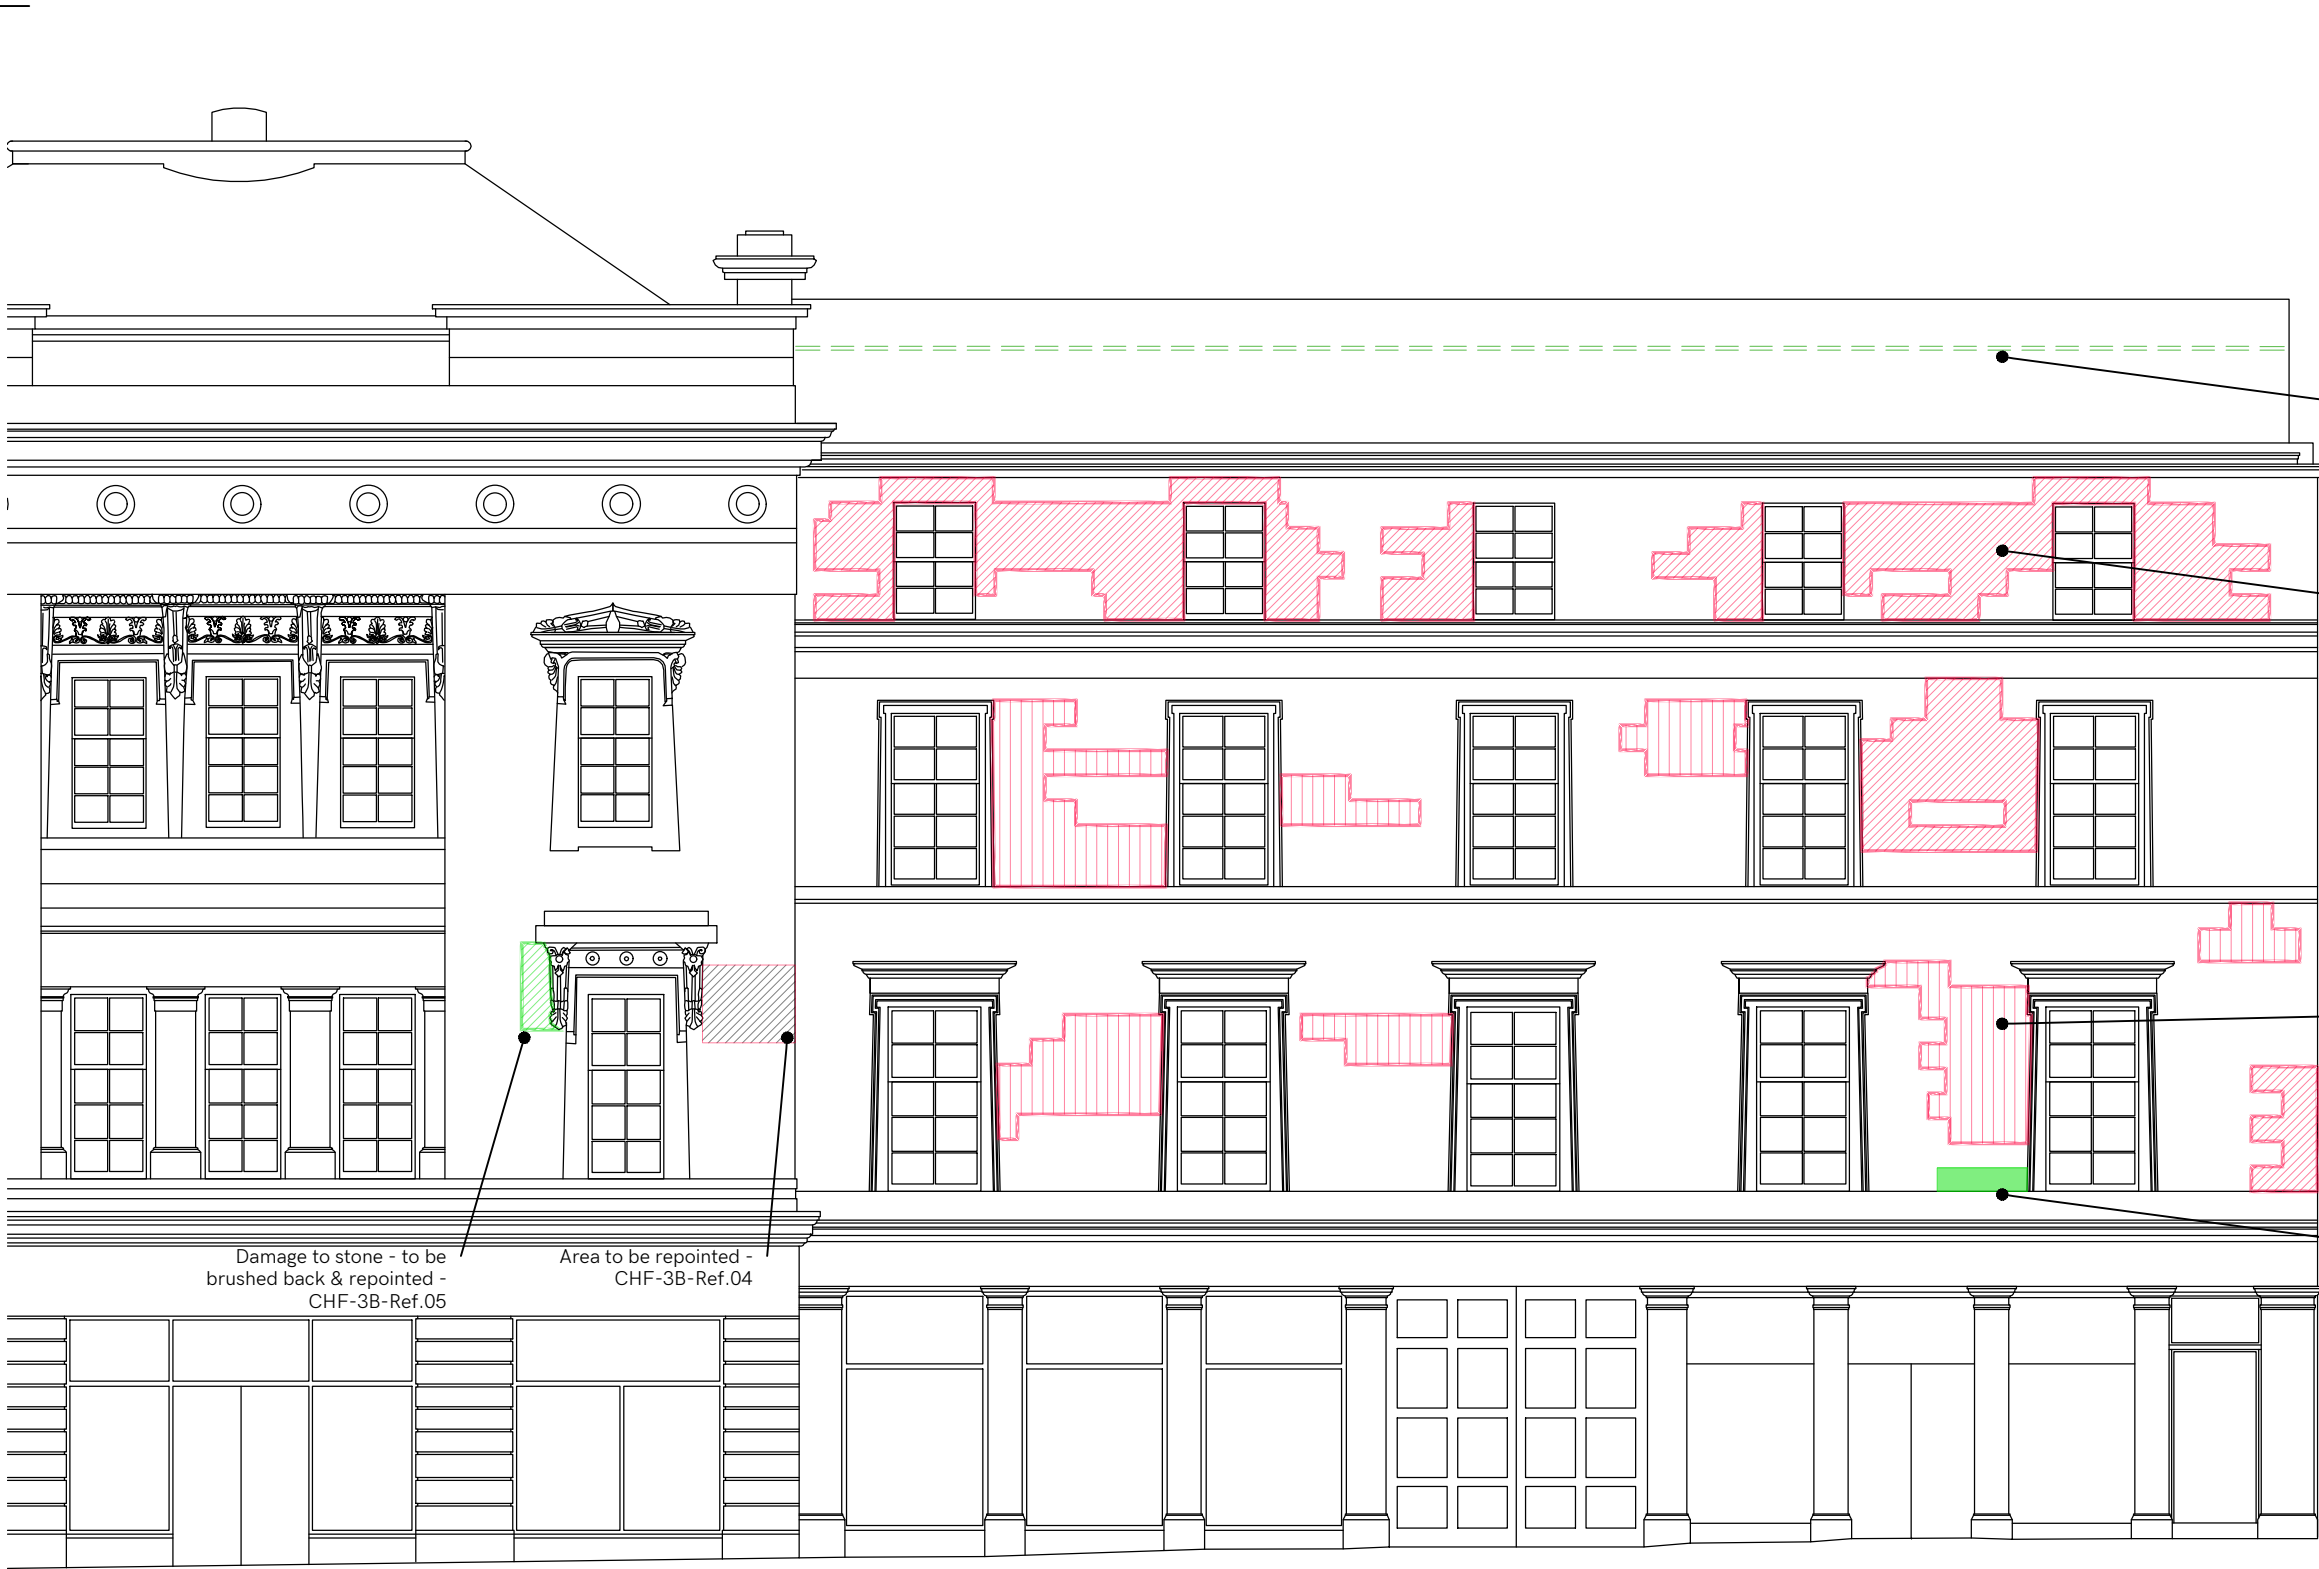
- Stone with poor pointing (appears to have had linostone applied over face and joints are not defined)
- Linostone or cement to be carefully removed. Assume 30% indentation, 50% application of ST.one mortar repair and 20% brushing back required to substrate.
- Indents required
- Joints to be raked out and repointed in lime-based mortar
- Discoloured stone to be cleaned using DOFF system
- Area of stone to be raked out and repointed in lime-based mortar
- Damp stone - source to be stopped and stone allowed to dry out prior to treating with DOFF system
