City Halls & Old Fruitmarket Roofworks City Building

Zone 1 - West Elevation Southern Half

CHF-HML-01-XX-DR-A-12112

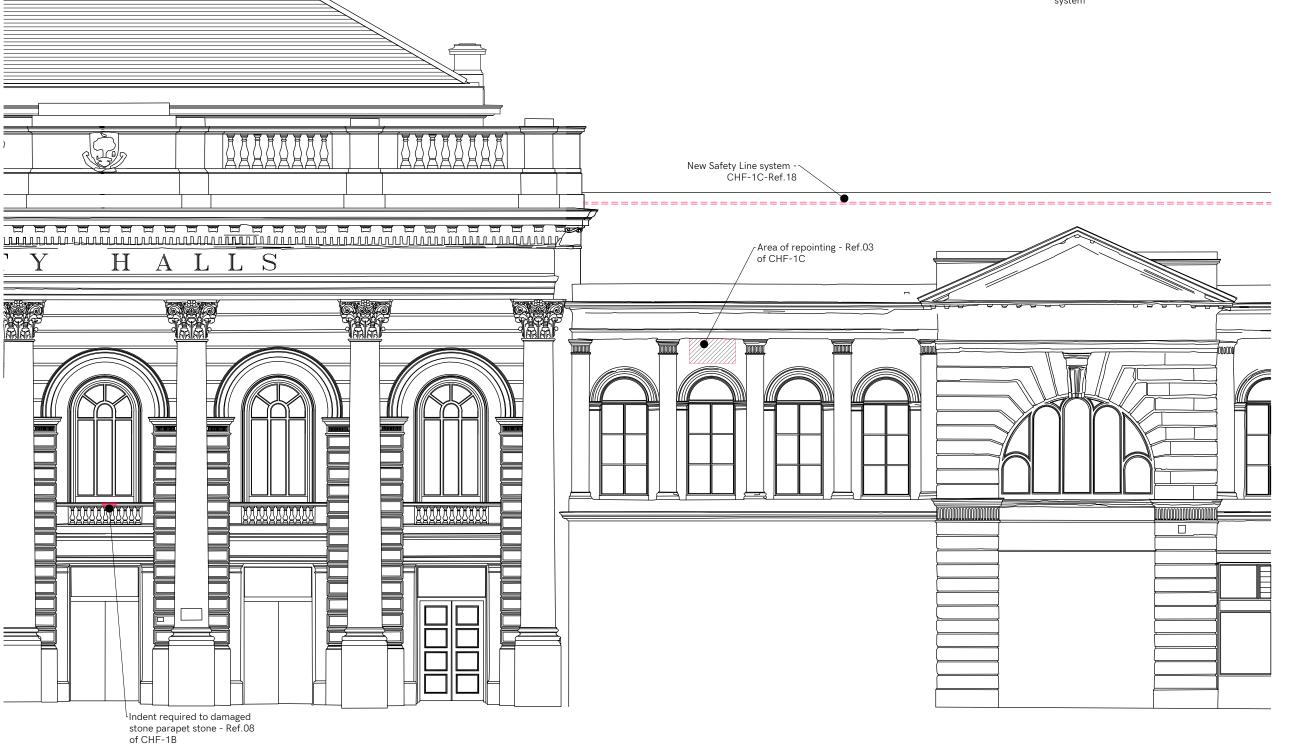
Stone with poor pointing (appears to have had linostone applied over face and joints are not

Damp stone - source to be stopped and stone allowed to dry out prior to treating with DOFF

Linostone or cement to be carefully removed. Assume 30% indentation, 50% application of ST.one mortar repair and 20% brushing back required to

Indents required

Joints to be raked out and repointed in lime-based

Area of stone to be raked out and repointed in
