Project 4687

City Halls & Old Fruitmarket
Roofworks
City Building

Drawing Name
Zone 3 - East Elevation
Southern Half

Drawing Number
CHF-HML-03-XX-DR-A-12116

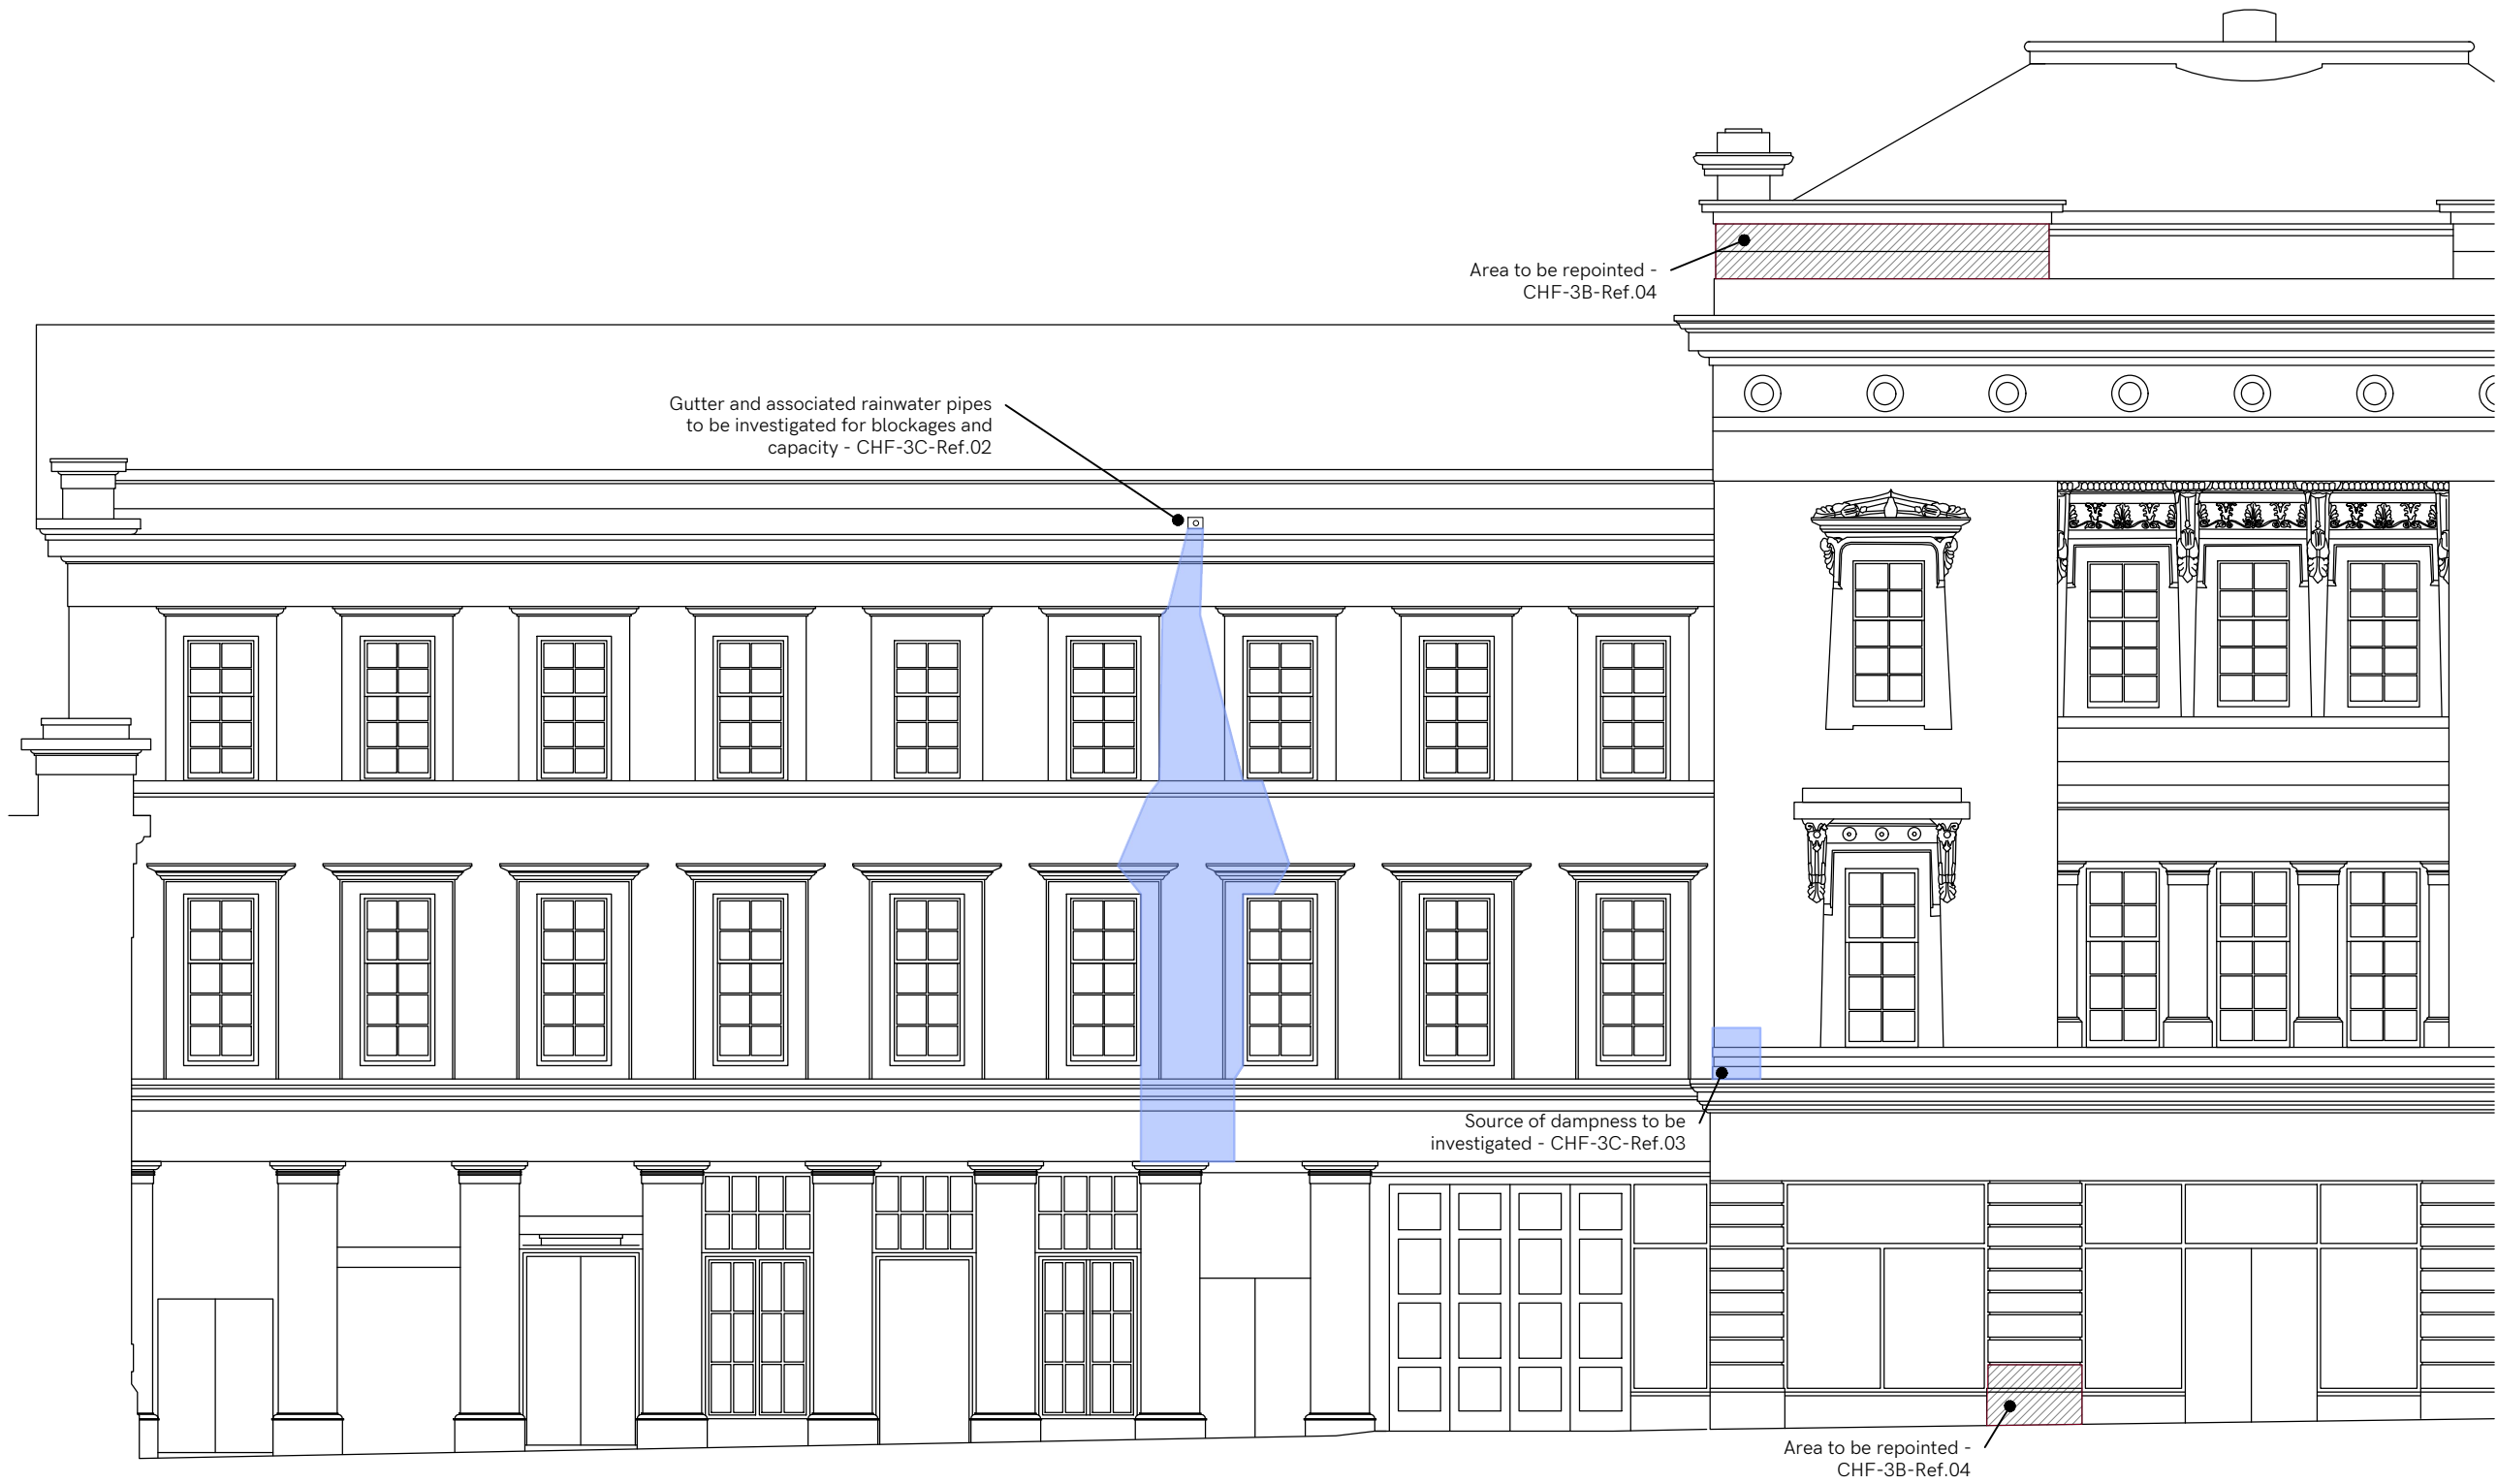
Stone with poor pointing (appears to have had linostone applied over face and joints are not defined)
-

Indents required
-

Discoloured stone to be cleaned using DOFF system
-

Damp stone - source to be stopped and stone allowed to dry out prior to treating with DOFF system

Linostone or cement to be carefully removed. Assume 30% indentation, 50% application of ST.one mortar repair and 20% brushing back required to substrate.
-

Joints to be raked out and repointed in lime-based mortar
-

Area of stone to be raked out and repointed in lime-based mortar
-
