Project 4687
City Halls & Old Fruitmarket
Roofworks
City Building

Drawing Name
Zone 4 - City Halls
North Elevation

Drawing Number
CHF-HML-04-XX-DR-A-12127

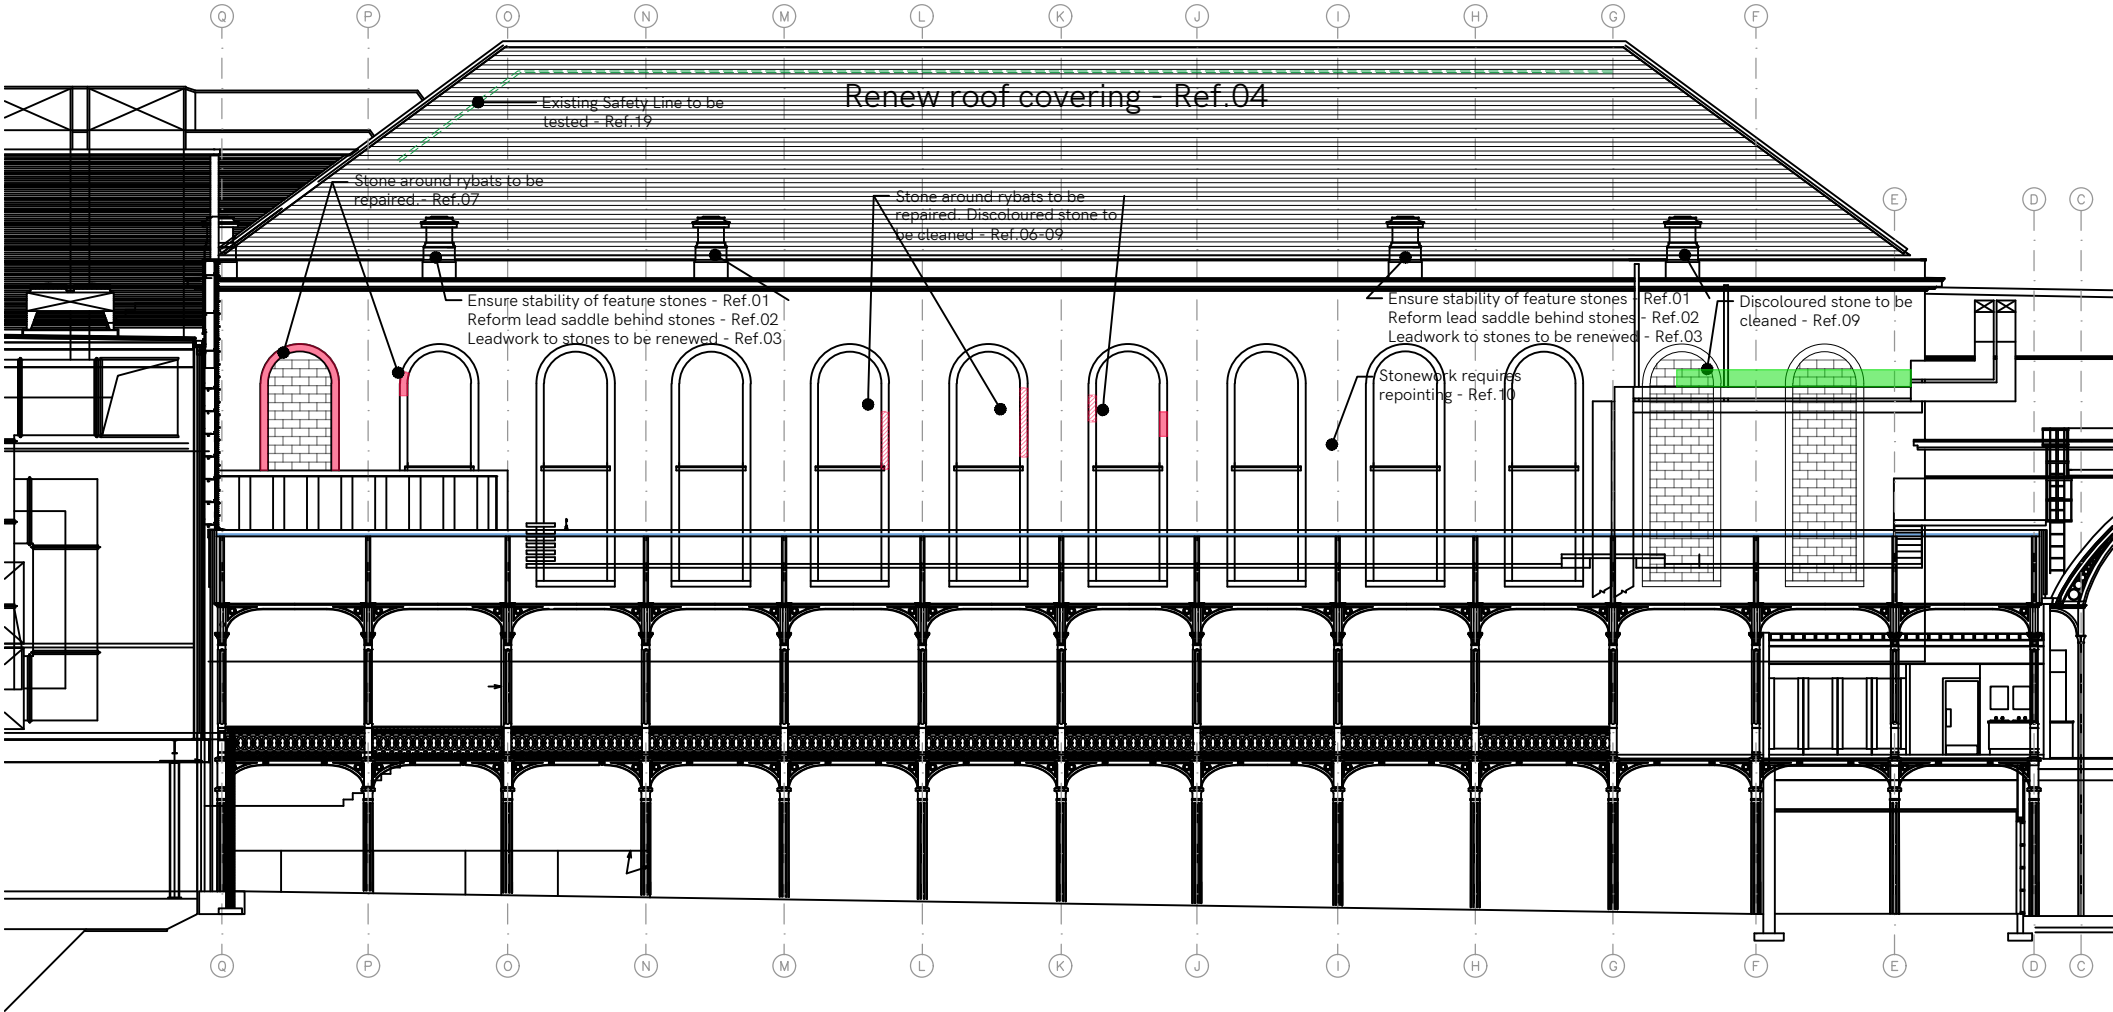
- Stone with poor pointing (appears to have had linostone applied over face and joints are not defined)
- Linostone or cement to be carefully removed. Assume 30% indentation, 50% application of ST.one mortar repair and 20% brushing back required to substrate.
- Indents required
- Joints to be raked out and repointed in lime-based mortar
- Discoloured stone to be cleaned using DOFF system
- Area of stone to be raked out and repointed in lime-based mortar
- Damp stone - source to be stopped and stone allowed to dry out prior to treating with DOFF system

Ref.11 - All windows to be painted inside and out. External burnt sand/linseed oil mastic to be replaced.
Ref.14 - Complete redecoration to Grand Hall to include all ceilings, walls and existing painted timber.
Ref.16 - Specialist to be commissioned to test the lightning conductor system and refix tape as necessary
