**Project** 4687  
City Halls & Old Fruitmarket  
Roofworks  
City Building

**Drawing Name**  
Zone 1 - West Elevation  
Northern Half

**Drawing Number**  
CHF-HML-01-XX-DR-A-12110

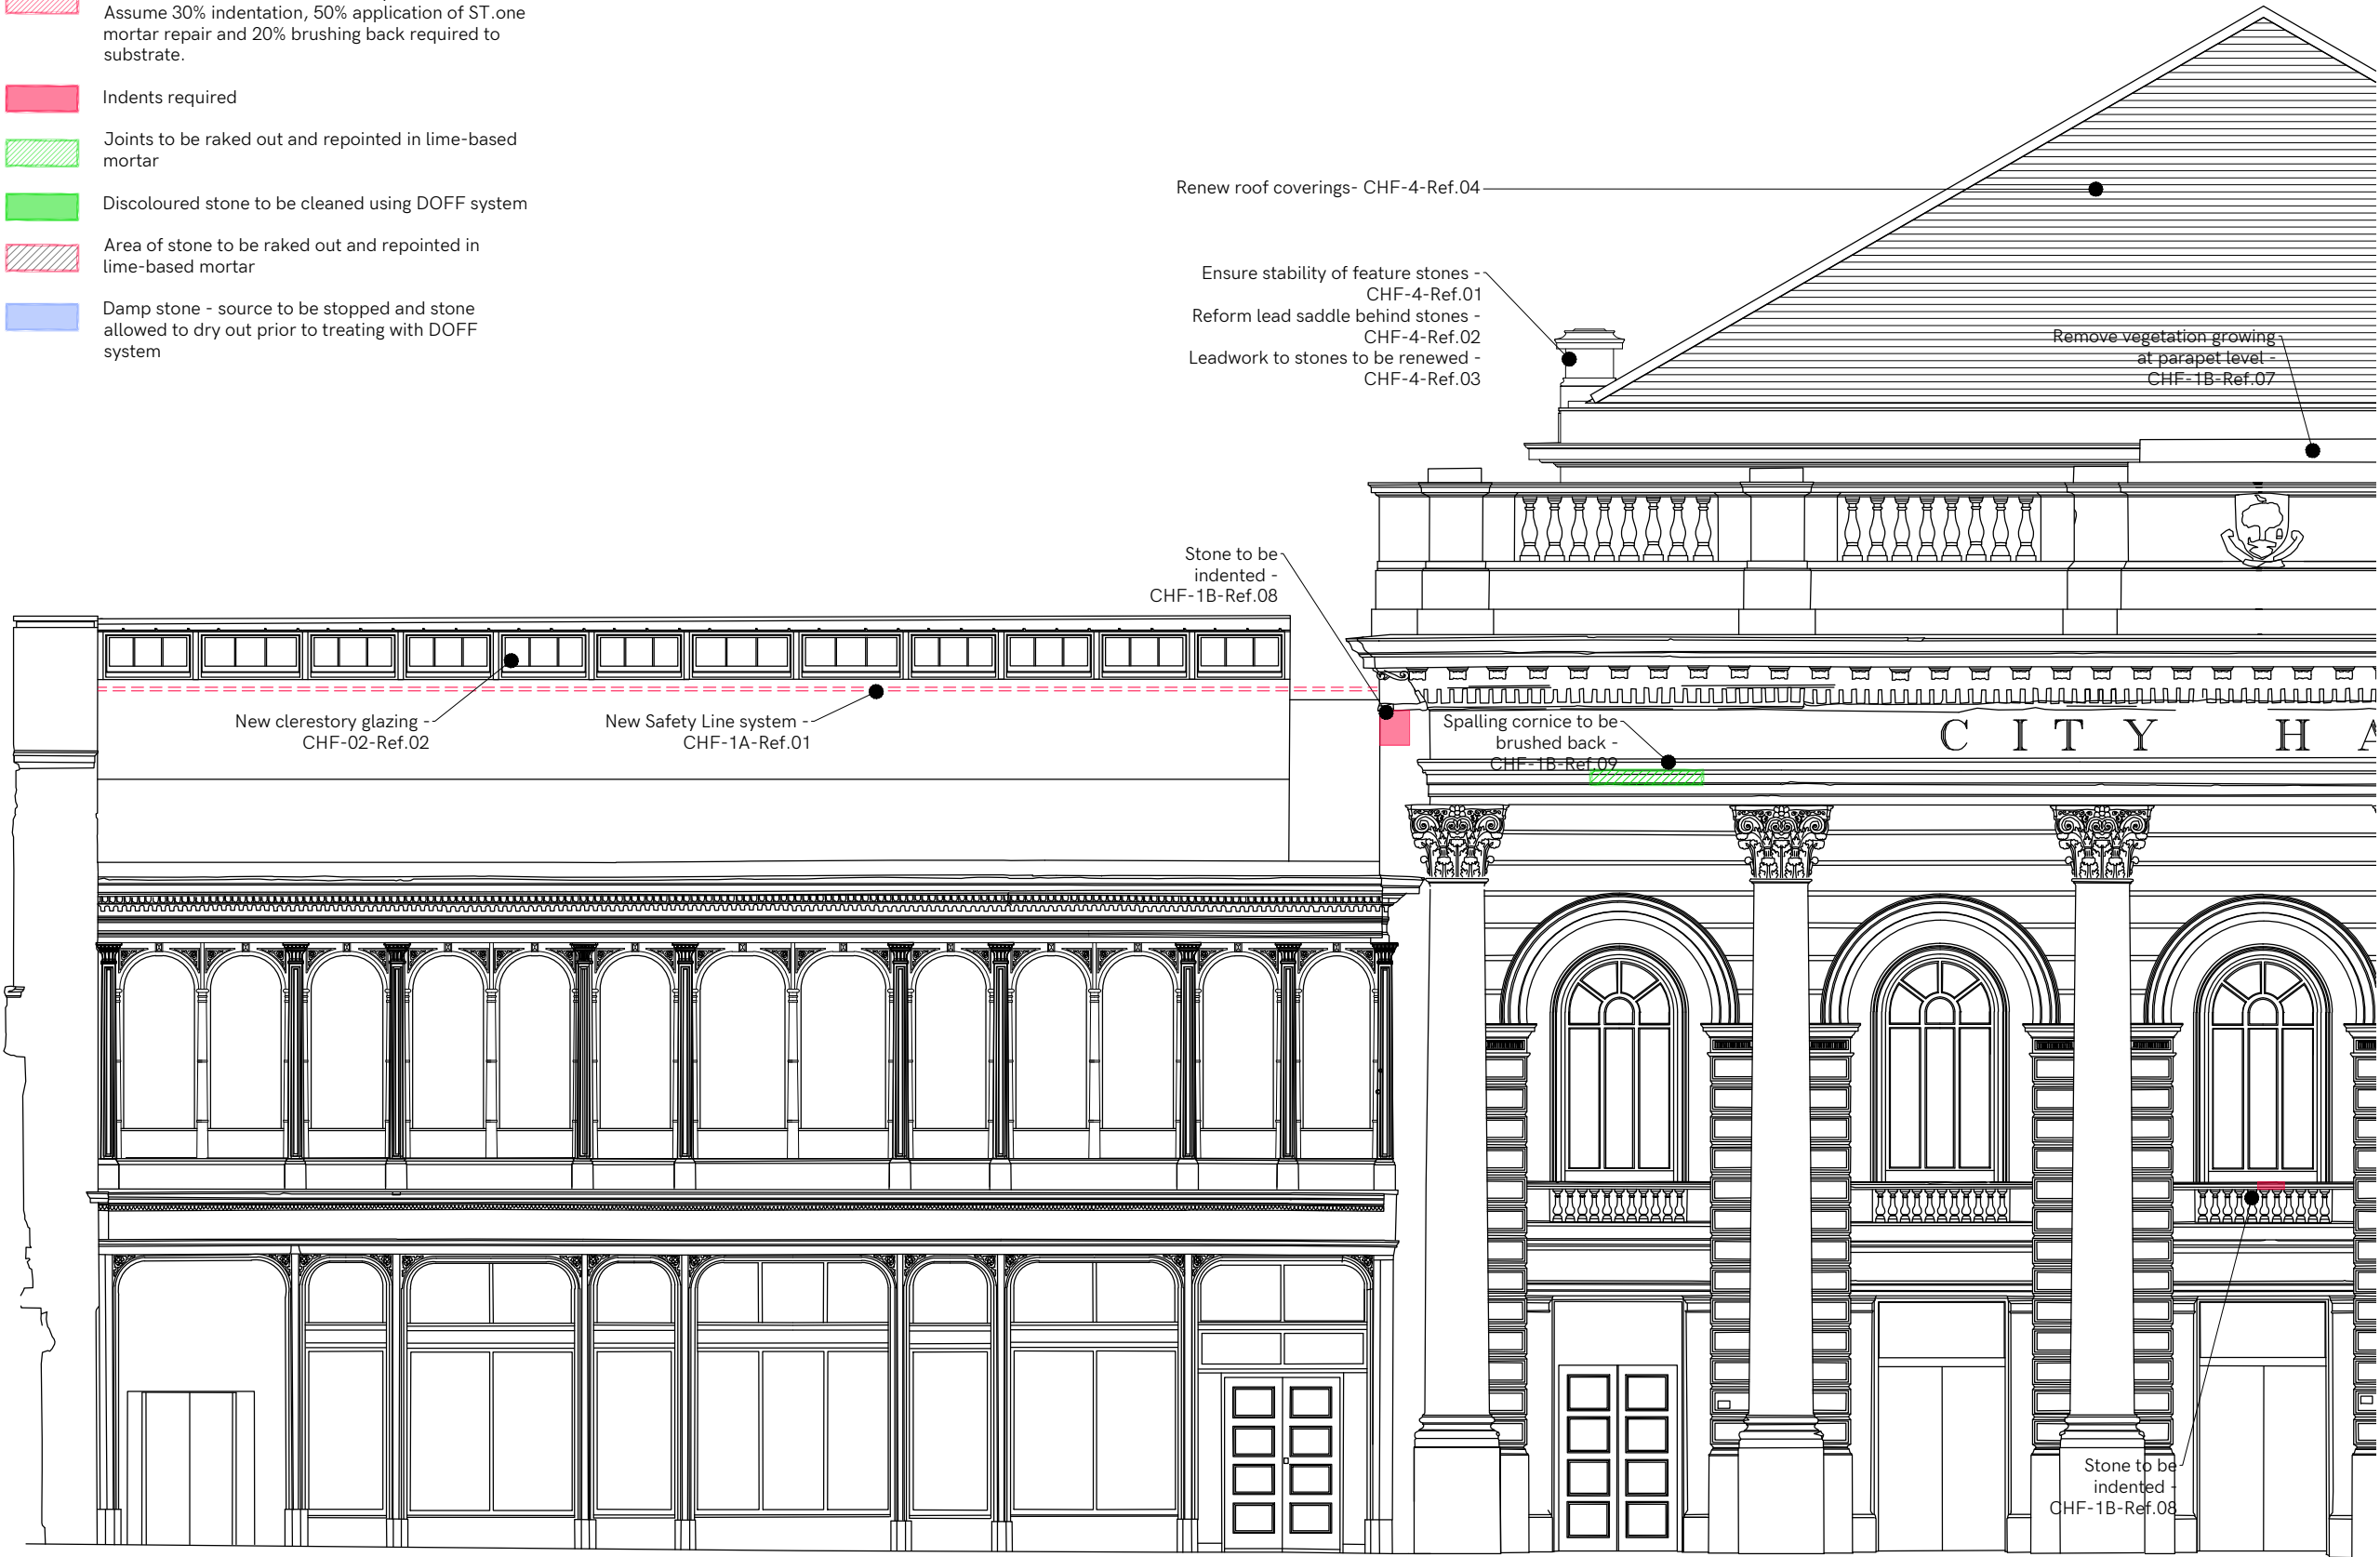
- Stone with poor pointing (appears to have had linostone applied over face and joints are not defined)
- Linostone or cement to be carefully removed. Assume 30% indentation, 50% application of ST.one mortar repair and 20% brushing back required to substrate.
- Indents required
- Joints to be raked out and repointed in lime-based mortar
- Discoloured stone to be cleaned using DOFF system
- Area of stone to be raked out and repointed in lime-based mortar
- Damp stone - source to be stopped and stone allowed to dry out prior to treating with DOFF system
