Arboricultural Report

**Boulders, Higer Penquite,
St Breward, PL30 4NX**

Date: May 2020

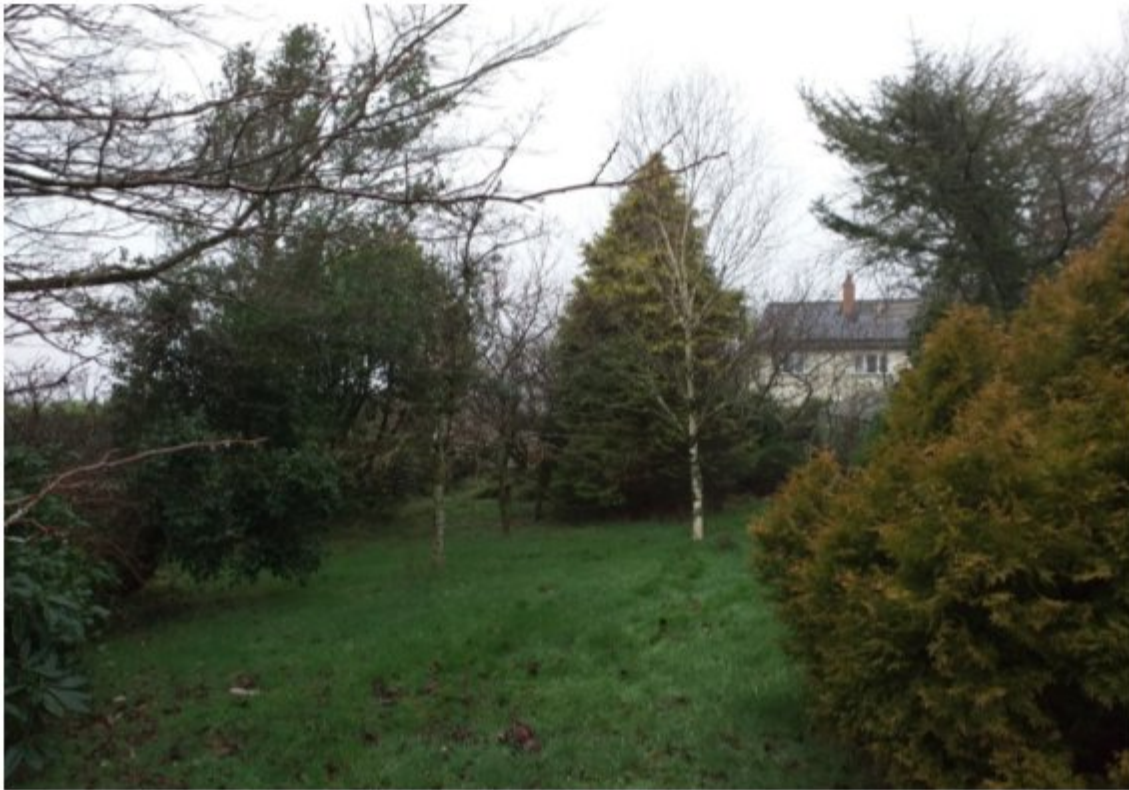
Fig 1: Garden to the west of the bungalow, with ornamental tree planting.

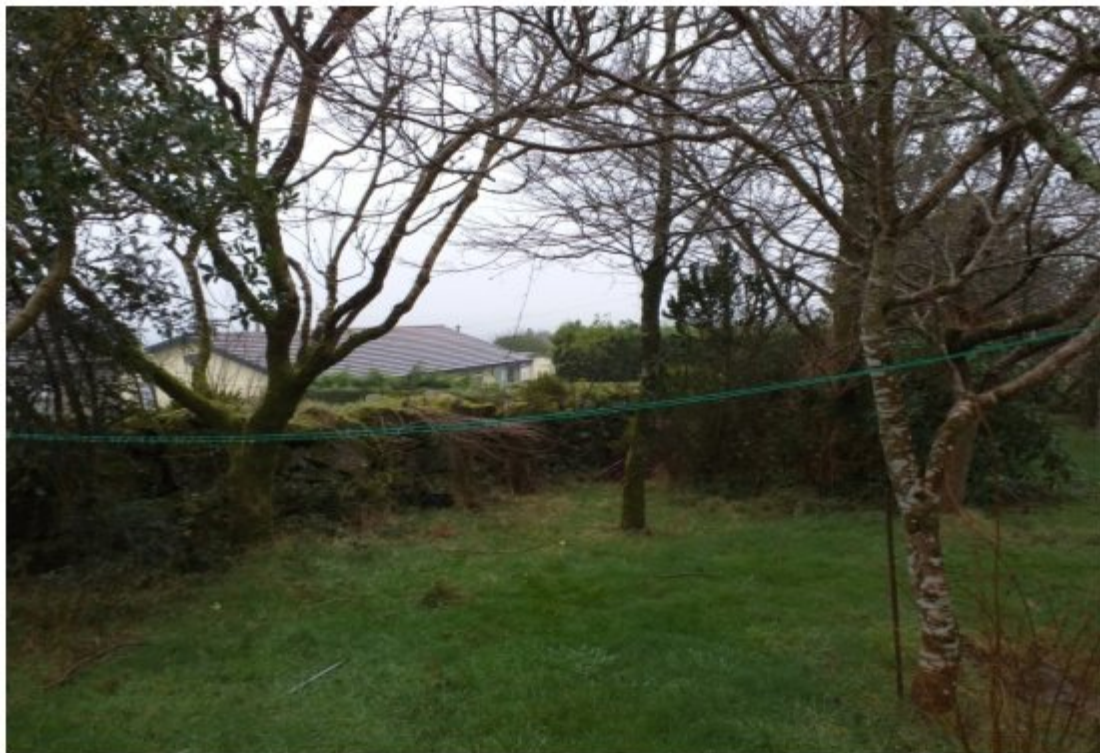
Fig 2: Ash (T18) to the left, Beech (T17) middle, and maple (T19) to the right

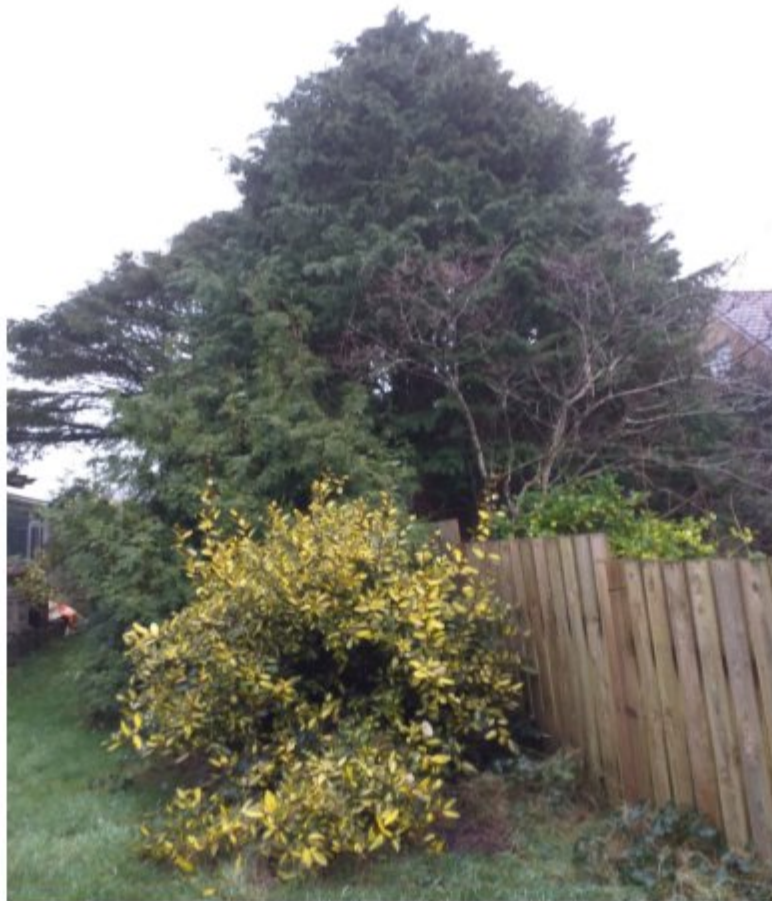
- 5.4 Lime (T24) could be a significant tree, being of good upright form and condition. Yew (T23) is likely to be long lived.
- 5.5 Lawson's cypress (T22) and (T25) are significant trees for this site, since they are located in the neighbouring garden to the south. (T25), with a multi-stemmed diameter of 605mm, giving a Root Protection Area of 7.2m radius, shown on the Constraints Plan.

Fig 3: Lawson's cypress (T22) and (T25), and Yew (T23), on southern boarder and off-site

T20	Flowering cherry (<i>Prunus sp</i>)	4	125	2:2:2:2	1	SM	Good	Good	C	20+
T21	Hiba (<i>Thujopsis sp</i>)	3.5	200	2:2:2:2	0	Y	Good		C	40+
T22	Lawsons Cypress MS (<i>Chamaecyparis sp</i>)	7	280	3:2:3:4	2	SM	Good	Asymmetric crown (Off site)	C	40+
T23	Yew (<i>Taxus baccata</i>)	8	175	4:2:2:2	4	SM	Good	Asymmetric crown	B	40+

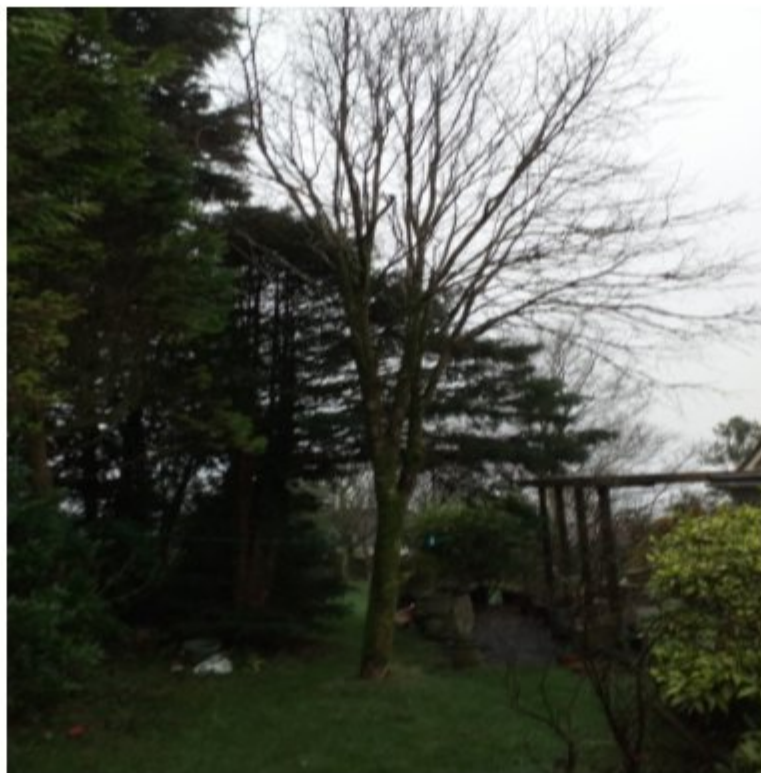
Fig 4: Lime (T24)

Tree ID	Common name Latin name MS=multi-stems	Ht (m)	RPA rad (mm)	Crown spread N:E:S:W	Ht Crown Clear (m)	Maturity	Physiological Condition	Structural Condition	Cat Grade	Estim Rem. Yrs
T24	Small Leaf Lime (<i>Tillia cordata</i>)	9	250	3:2:2:2	5	Y	Good	Part suppressed by (T25)	B	40+
T25	Lawsons Cypress MS (<i>Chamaecyparis</i> sp)	12	605	3:3:3:4	4	M	Fair	(Off-site)	B	0+
T26	Lawsons Cypress (<i>Chamaecyparis</i> sp)	7.5	160	2:2:2:2	2	Y	Good	Good	C	40+

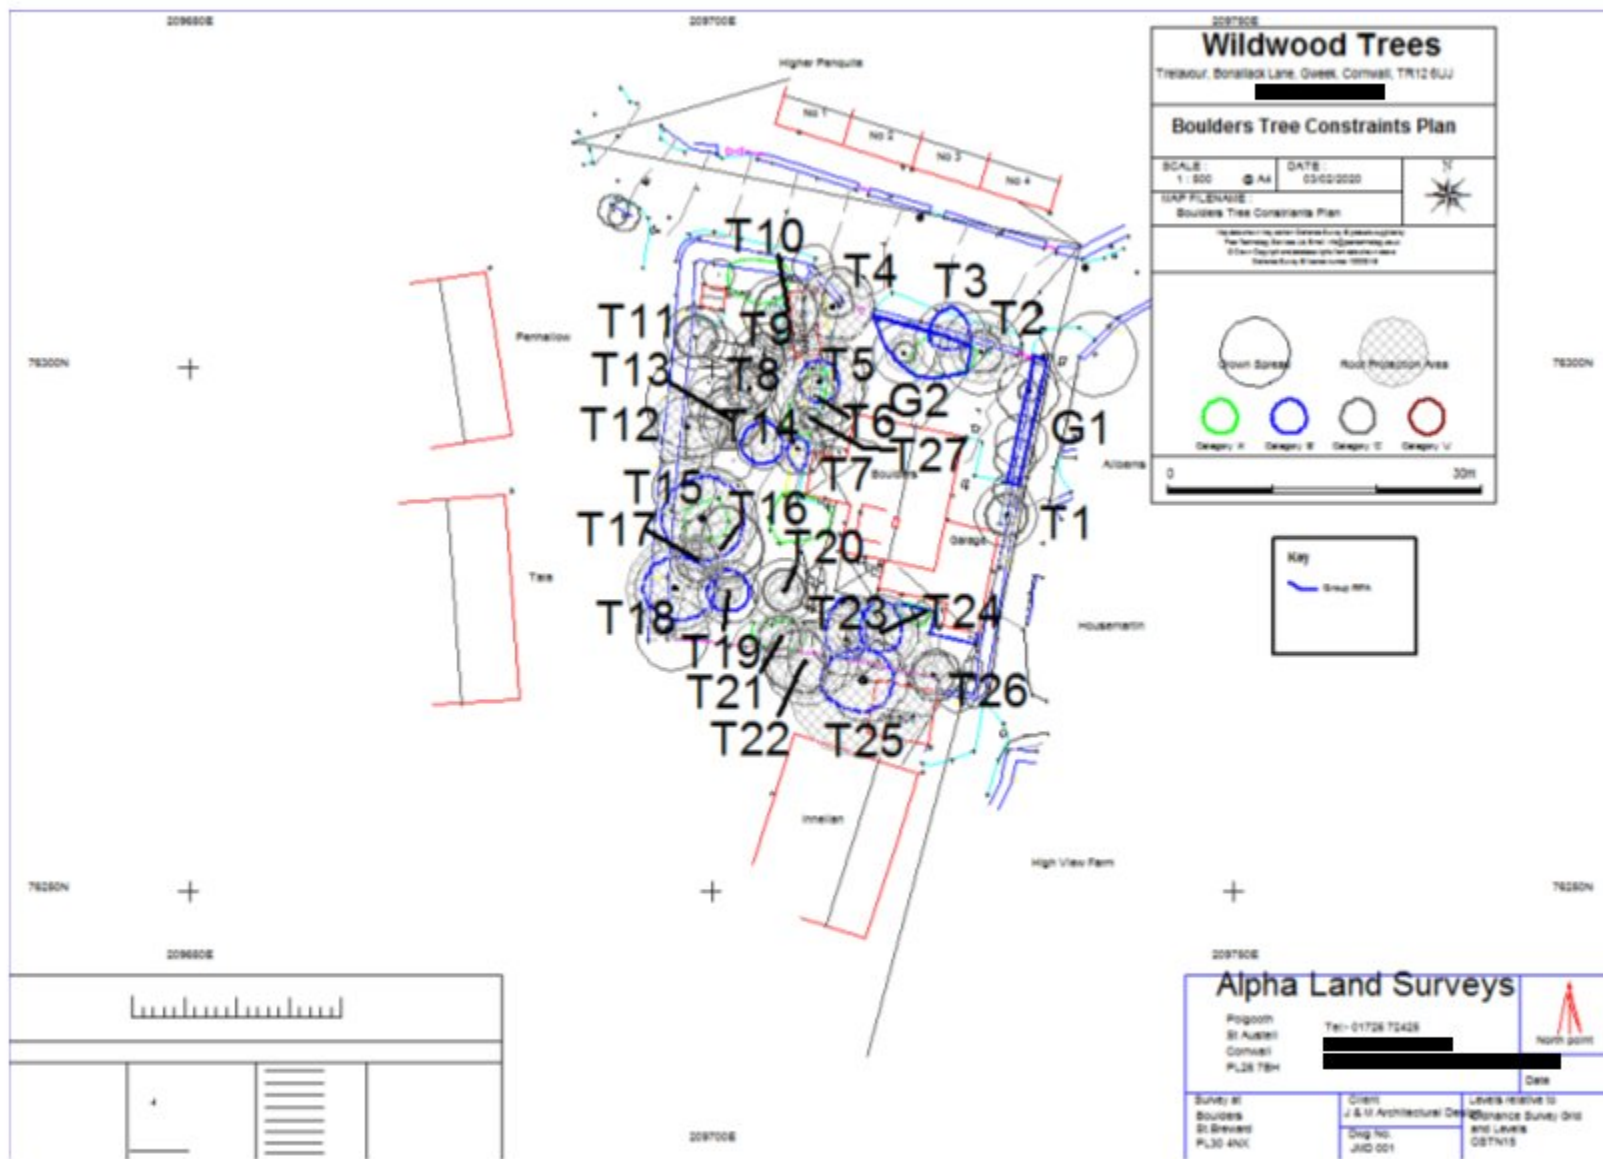
Fig 5: Tree Constraints Plan

- 5.1 The Tree Constraints Plan indicates the extensive ornamental tree planting that has taken place in this garden. Individually, most of the trees are still quite young, (with heights between 4 and 8m and stem diameters around 200mm) and most have been classed as 'C' category for this reason.

- 5.2 Elm (T11), on the western boundary of the plot, is a fair size, (11m height and 8m canopy spread) and is recommended for retention, although it will need monitoring for any signs of Dutch Elm Disease infection.

- 5.3 Unfortunately Oak (T1) is located close to the powerlines, so will continue to be periodically trimmed or topped by the utility company. Again this only attains a 'C' category.
