Arboricultural Report

Tree Condition Assessment

Alderman's Park
Redland Court Road
Bristol

20th January 2020

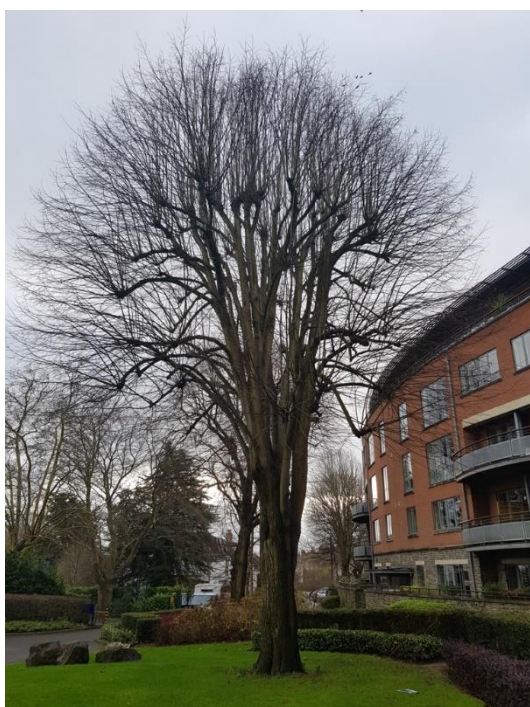
8.1 T4 – Lime – Lapsed pollard with secondary pollard at approximately 9m. The main unions are predominantly bark included and as a result cable braces have been installed. The large upright stem nearest the flats is not braced however and is exhibiting a significant bark inclusion predisposing the stem to failure in adverse weather conditions.

Plate 1: T4 – Lime requiring further reduction

Given the poor branch unions at the bole it is recommended that the tree is reduced beyond the secondary pollard points and new pollard pints established just above the cable brace at a suitable pruning point.

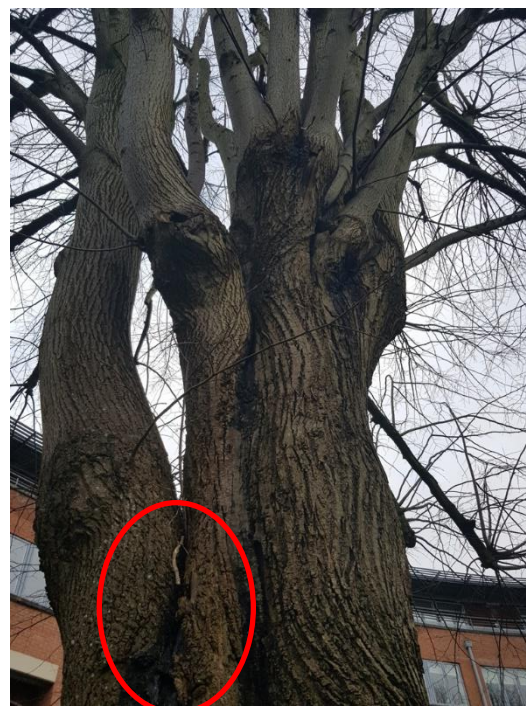
Plate 2: T4 – Major bark included union on building side.

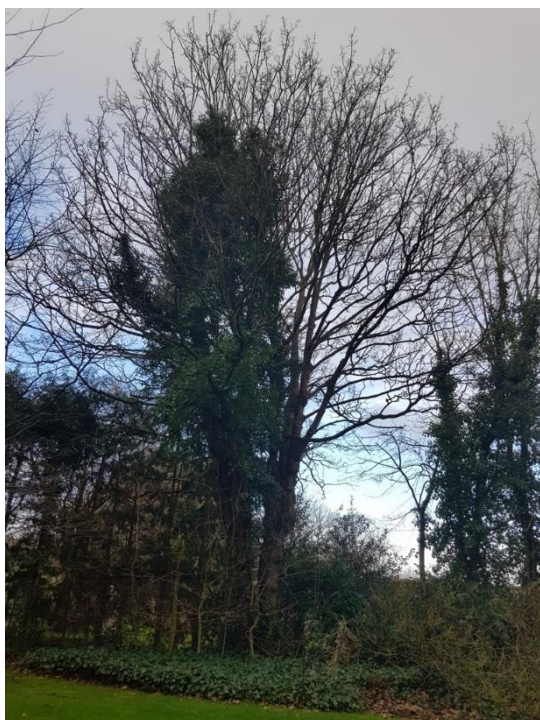
8.2 T19 – Sycamore – This mature tree is covered in cankers and associated necrotic areas which prevail throughout the trunks. This will eventually lead to stem fractures and so it is recommended that the tree is either completely removed or monolithed to 4m, coronet cut and retained for habitat.

Plate 3: T19 – sycamore – Cankers and necrotic bark throughout

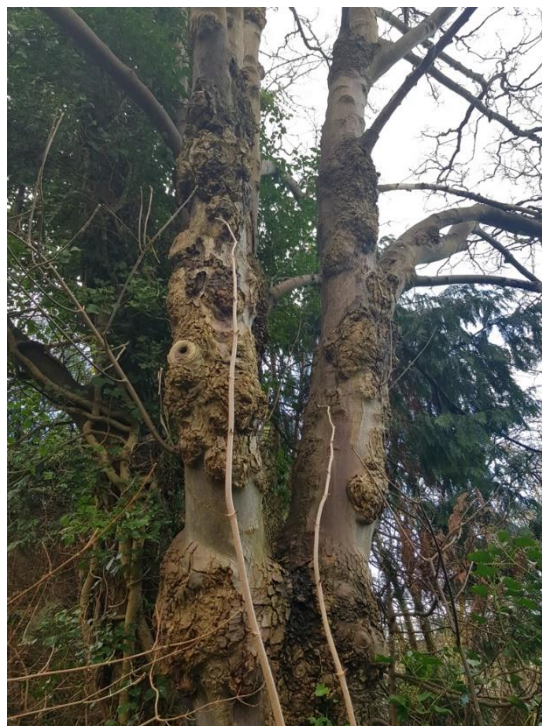
Plate 4: T19 – Cankers and necrosis evident on all stems.

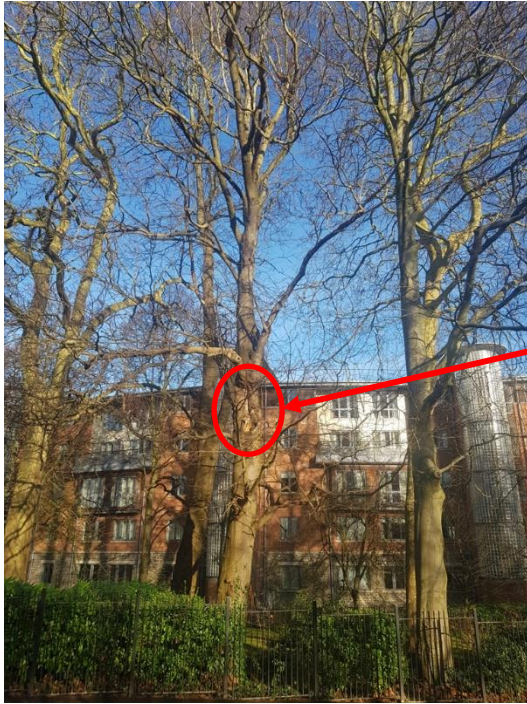
8.3 T44 – Norway maple – Growing on the boundary of the site a decay pocket is evident at 5m on the west side as a result of an historic limb loss. Stem flattening above this point indicates further decay. Bleeding canker is also evident at same side at 2m. Further signs of wood dysfunction can be seen at 3m above the flattened stem. It is recommended tha the tree is monolithed to 6m , coronet cut and retained for habitat.

Plate 5: T44 – Norway maple with decay in stem.

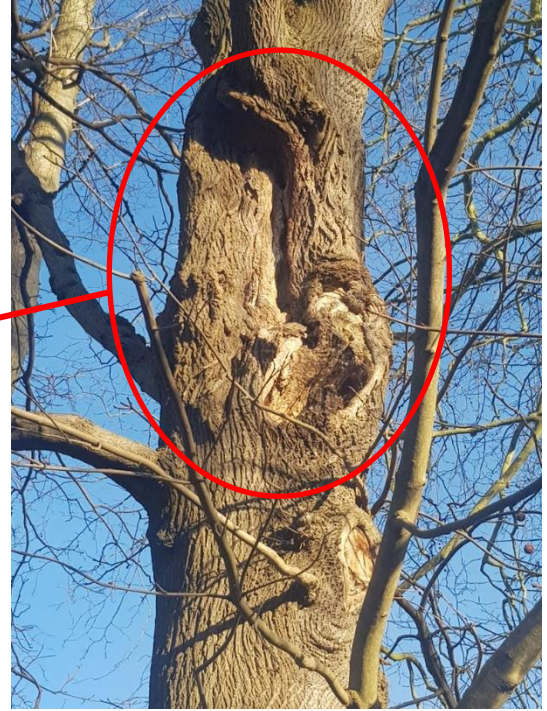
Plate 6: T44 – Close up of area of decay.
