# PHASE 1 SITE INVESTIGATION

Air Balloon Road

Moosehead Ltd

Project No. 001MAHIP1

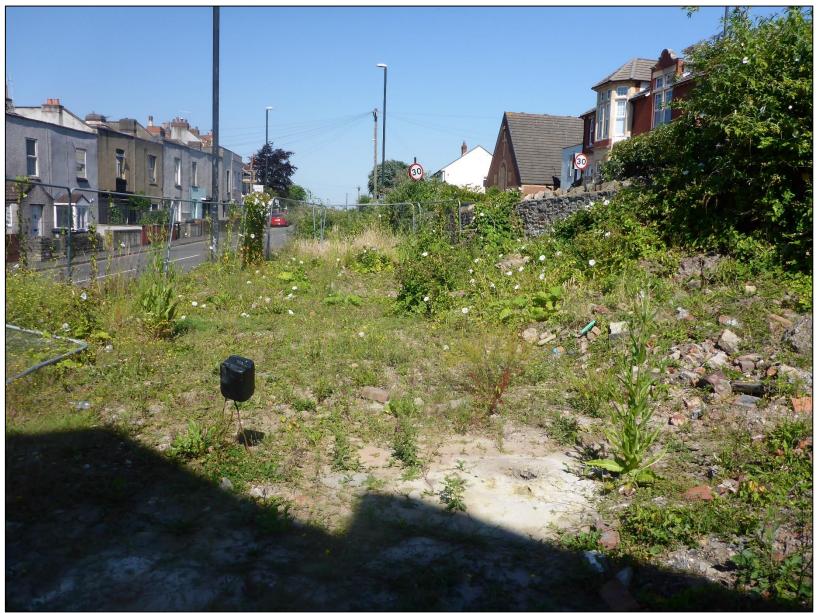
A walkover survey was carried out on 25<sup>th</sup> June 2020. The site was observed to be a cleared area that was largely overgrown with some areas of bare ground. Frequent building rubble was present on the site. The bare soils were observed to have masonry fragments present with some clinker and wood. Evidence of boreholes were observed from a previous investigation. A concrete pad with an electricity cable was present on the western side of the site. No tanks or staining were observed on the site and no evidence of vegetation stress was present.

Figure 1. Looking west showing rubble, with a borehole in the foreground.

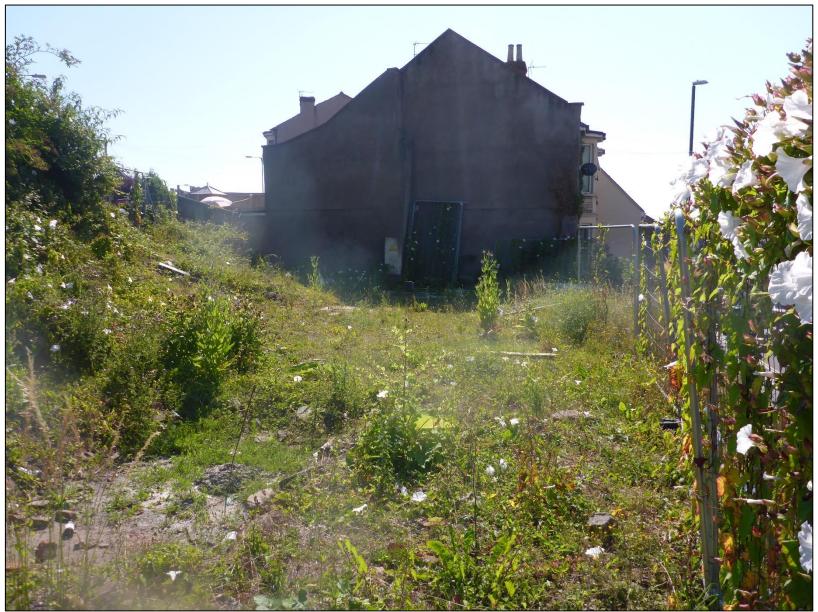
Figure 2. Looking east towards the adjacent housing.

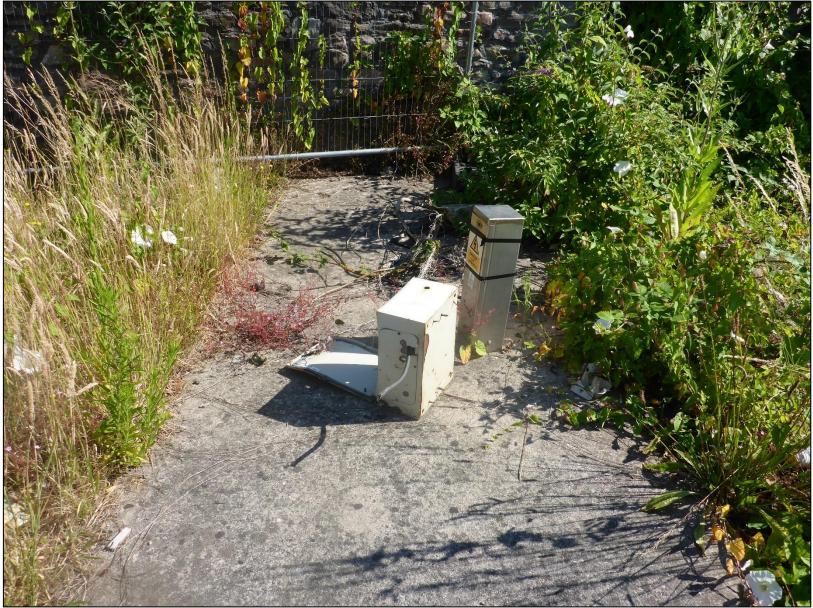
Figure 3. Concrete plinth and electricity cable on west of site.

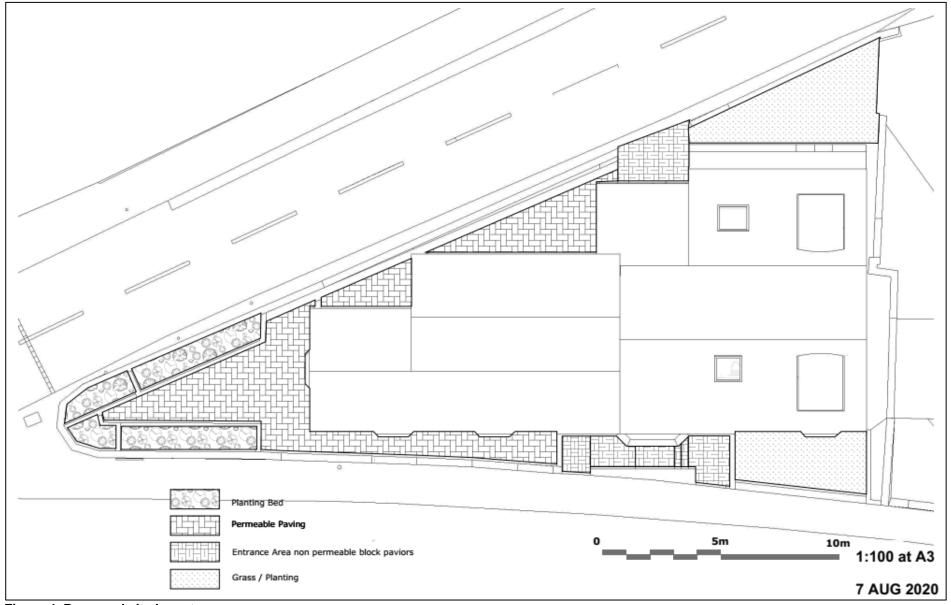
Figure 4. Proposed site layout.

As discussed in section 7.1, the potential for the presence of heavy metals, PAH compounds and asbestos cannot be ruled out. If present pathways will include those involving ingestion, dermal contact and dust inhalation. Vapour intrusion pathways are not expected to be present. However, as shown in figure 4, the proposed site layout includes minimal soft landscaped areas. The area shown as a planting bed on the western part of the site will be a raised area and will therefore mitigate the pathways discussed. There are two grass/planting area on the eastern part of the site. The northern one is to be located in an area that will be excavated for slop stability purposes with clean soil bought in to infill the excavation. The southern of the two areas will be located where a tank is to be located for surface water drainage control. Again, any soils emplaced following the installation of the tank will be imported clean materials. Consequently, the proposed site layout will remove the proposed pathways and there is therefore not considered to be a pollution linkage present.

Where soft landscaping is to be present in the form of planters, turfed areas etc a minimum depth of 600mm of clean imported soil should be emplaced. Depths and chemical analysis of imported soils should be confirmed and where materials are disposed of off-site, waste transfer notes should be retained.
