ARBORICULTURAL REPORT (*Insurance and mortgage appraisal*)

OUR REFERENCE	140573/PRO
CLIENT	Mr Tree
SITE	8 Cudas Close, Epsom, Surrey KT19 0QF
REPORT BY	Mr Paul Roberts
DATE	19 th December 2016
DATE OF INSPECTION	16 th December 2016

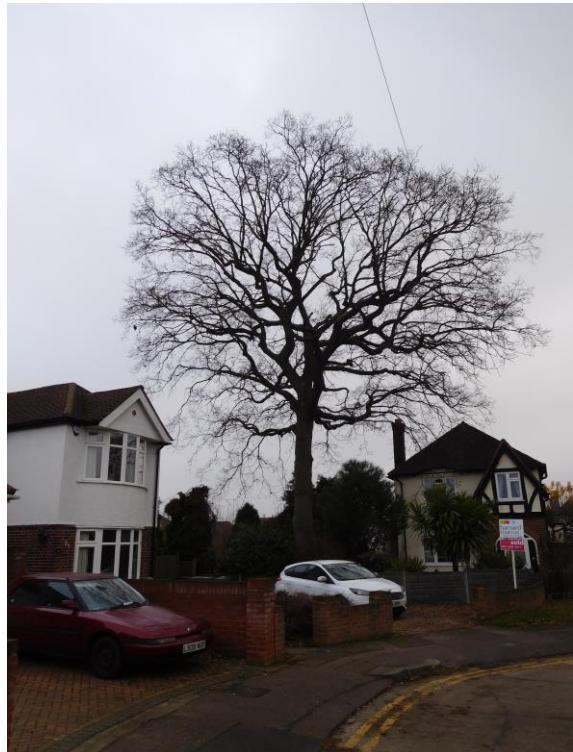
The mature oak tree identified as T1 and located within the front garden of the neighbouring property of number 9 Cudas Close, was noted to have a multiple major dead branches throughout the crown, of which some overhang the subject property of number 8 Cudas Close.

The trees within the site and the school grounds are in a good physiological and structural condition showing no signs of ill health or significant structural defects that may affect the subject property. However, the adjacent Oak tree identified as T1, is in a fair physiological and structural condition with major deadwood present over the subject property. As such there is the potential for personal injury or property damage from falling deadwood. As this tree is located within the property of number 9 Cudas Close the legal obligation to ensure the tree does not pose a hazard would fall upon its own at not that of the subject property.

Although deadwood is present in the crown of T1, in terms of direct damage from full tree failure there is a low risk to the property.

Photograph 1; Showing tree T1

Further to the removal of deadwood in tree T1, works to reduce the extent of its crown has been recommended, this is primarily made due reason so of sound arboricultural management to prevent future failure and it is recommended these are completed within the time frames specified in the tree survey schedule attached as appendix I.

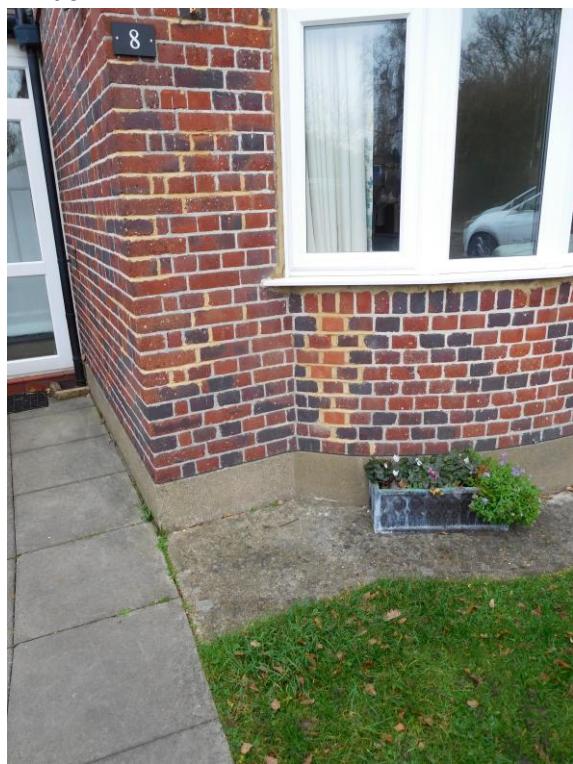
The site is located at 8 Cudas Close, Epsom, Surrey KT19 0QF and comprises of a 4-bedroom two storey detached residential property, with a small garden and driveway to the front and larger garden to the rear. The windows to the front of the property are of a bay type with some recent re-pointing noted within the lower bay windows supporting brick work.

The recent re-pointing to the supporting brickwork below the lower front bay window, may have resulted from numerous factors and without any further investigations its exact cause cannot be determined.

Photograph 3; Showing recent re-pointing in baby window.

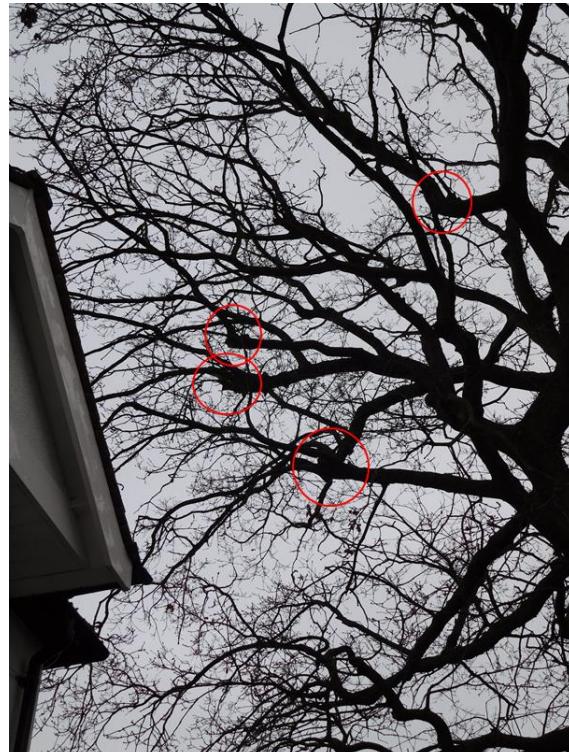
Photograph 12; Identifying some of the historic pruning wounds circled in red, within tree T1.

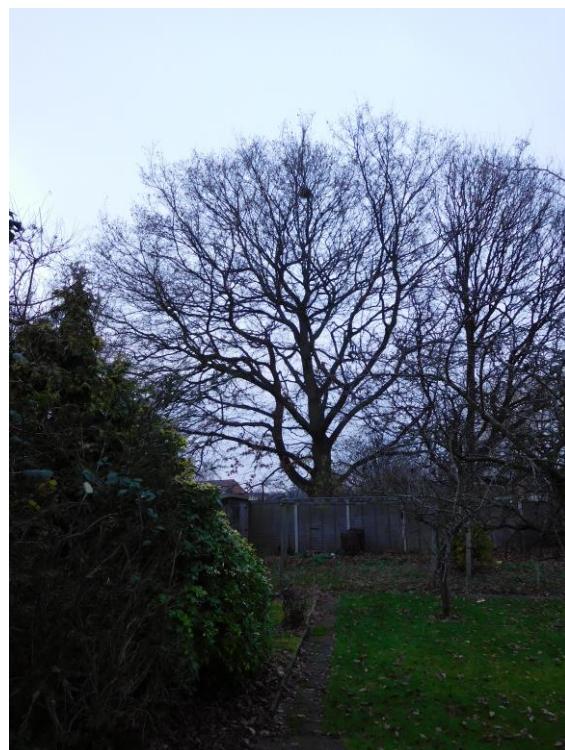
Photograph 4; Showing tree T4 to rear of site.
