Design and Access Statement for works to Summer Fields School Boundary Wall

At:
Summer Fields School
Mayfield Road
Oxford
OX2 7EN

DESIGN AND ACCESS STATEMENT

On behalf of Summer Fields School

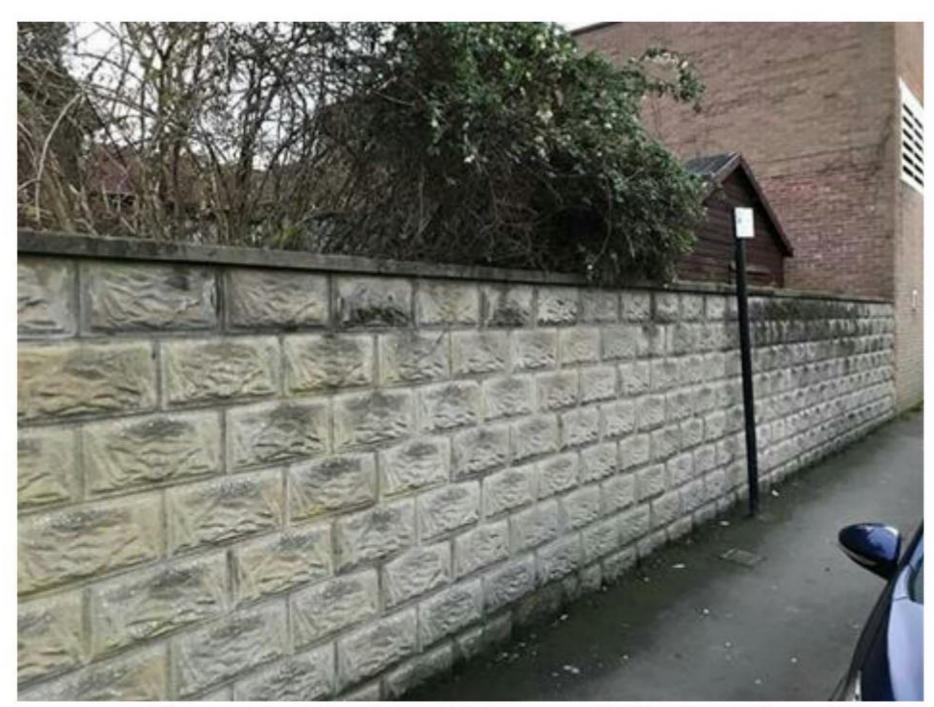
Concrete block section - north facing elevation.

- 4.3 The proposed works comprise the following:
- Removal of ivy and vegetation from the wall prior to bird nesting season.
- Dismantle concrete block section down to existing concrete footings.

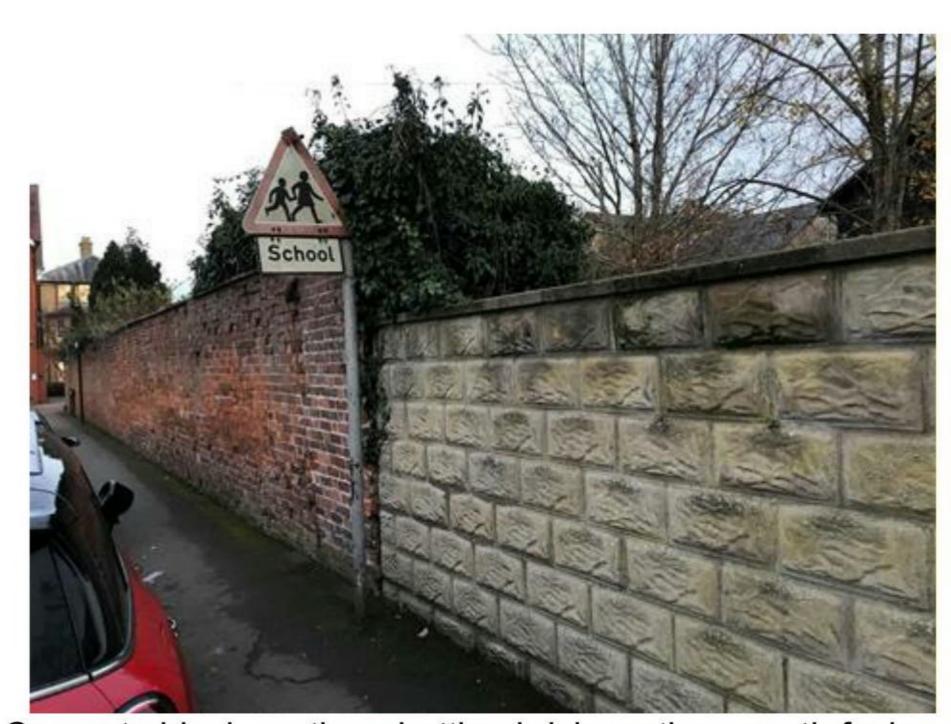
Concrete block section abutting brick section - north facing elevation.

- The proposed brick section will tied in to the existing brick section using movement ties, a 10mm movement joint with mastic sealant finish as recommended by the Structural Engineer.

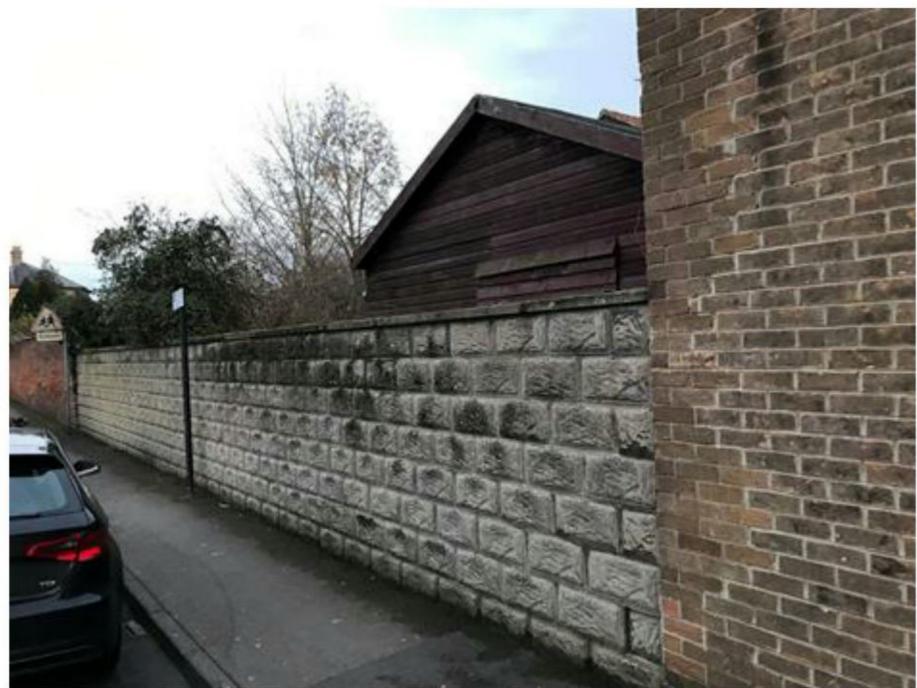
Concrete block section.

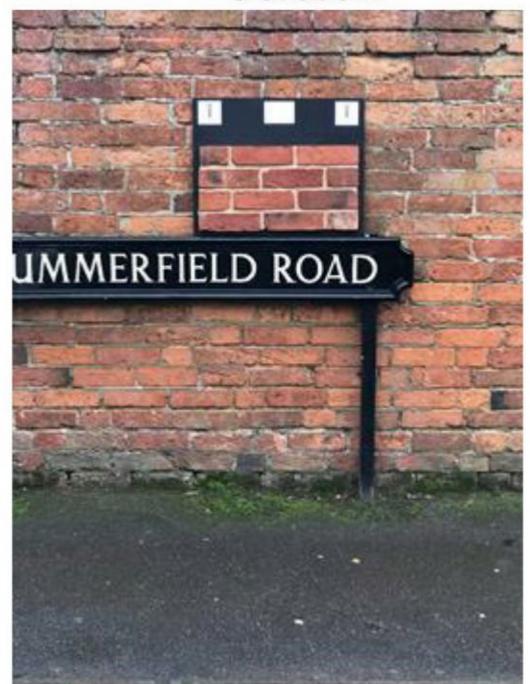
Proposed brick to use for replacing concrete block section.

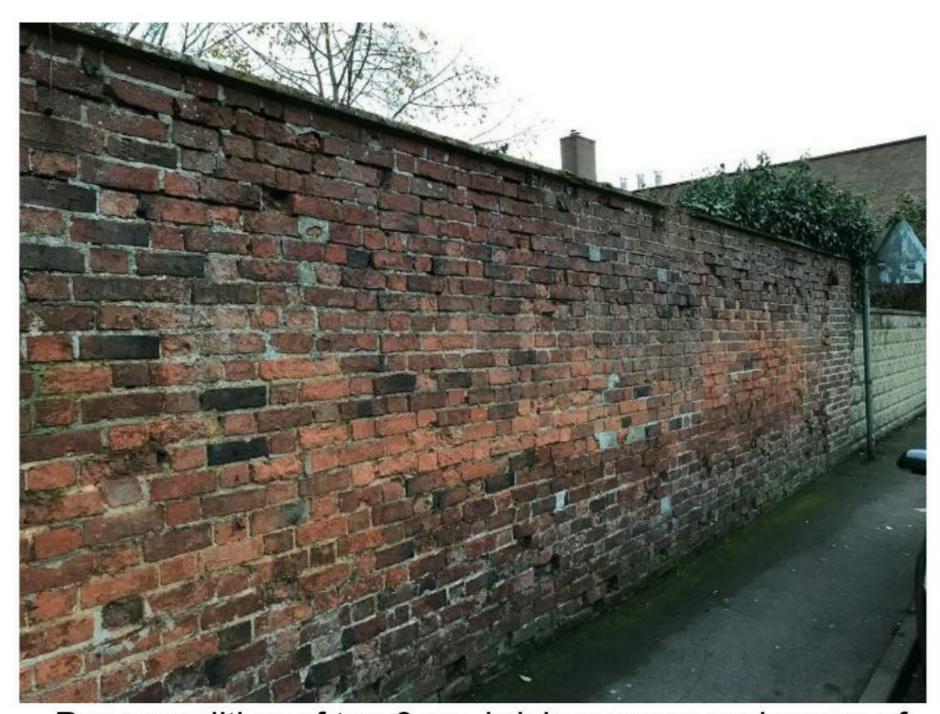
- The top 9 no. brick courses of the wall are in poor condition with many damaged and spalled bricks. It is proposed to carefully dismantle the top 9 no. courses, retain bricks in good condition and rebuild using a mixture of new Imperial Handmade Bricks and salvaged bricks. Sections closer to the new proposed brick wall section will utilise a higher ratio of new bricks while sections further away from this will use a higher ratio of salvaged bricks. We propose that this gradated approach will provide a more sympathetic blend of new and old bricks from the rebuilt section which requires all new bricks to the areas further along the wall which require more minor repairs. New bricks will be required as there will not be enough salvageable bricks that can be reused.

Poor condition of top 9 no. brick courses and areas of repointing required - north facing elevation.

- Loose and friable areas of mortar will be raked out and repointed in an NHL 3.5 lime mortar. This will provide more strength to areas with missing mortar. The use of lime mortar will allow for some movement in the wall, continue to allow the handmade bricks to breathe and release moisture and is more in-keeping with the historic construction of the original wall.

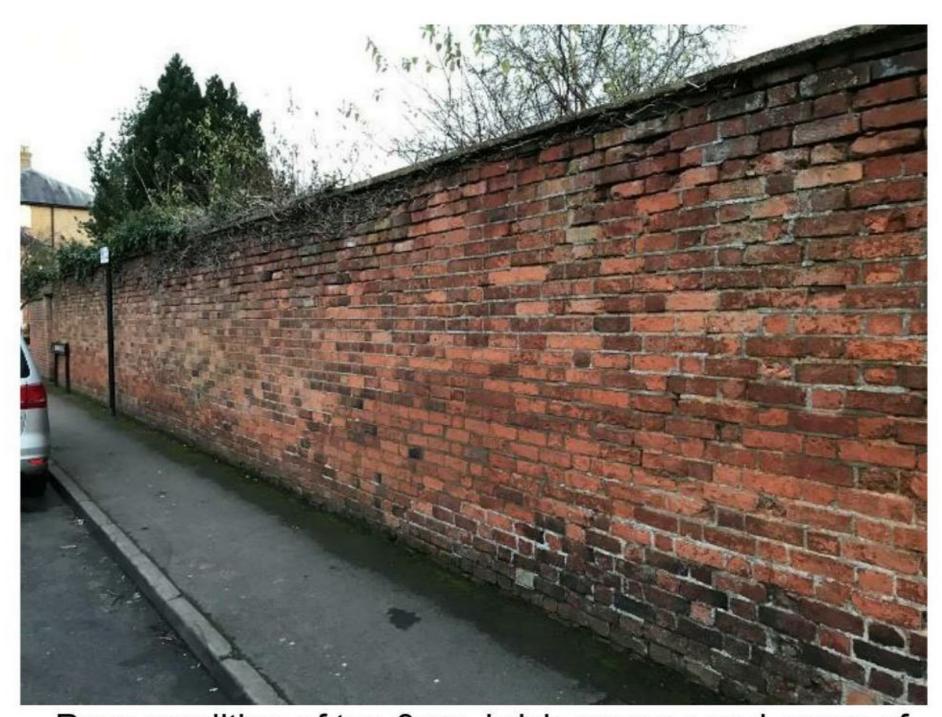
Poor condition of top 9 no. brick courses and areas of repointing required - north facing elevation.

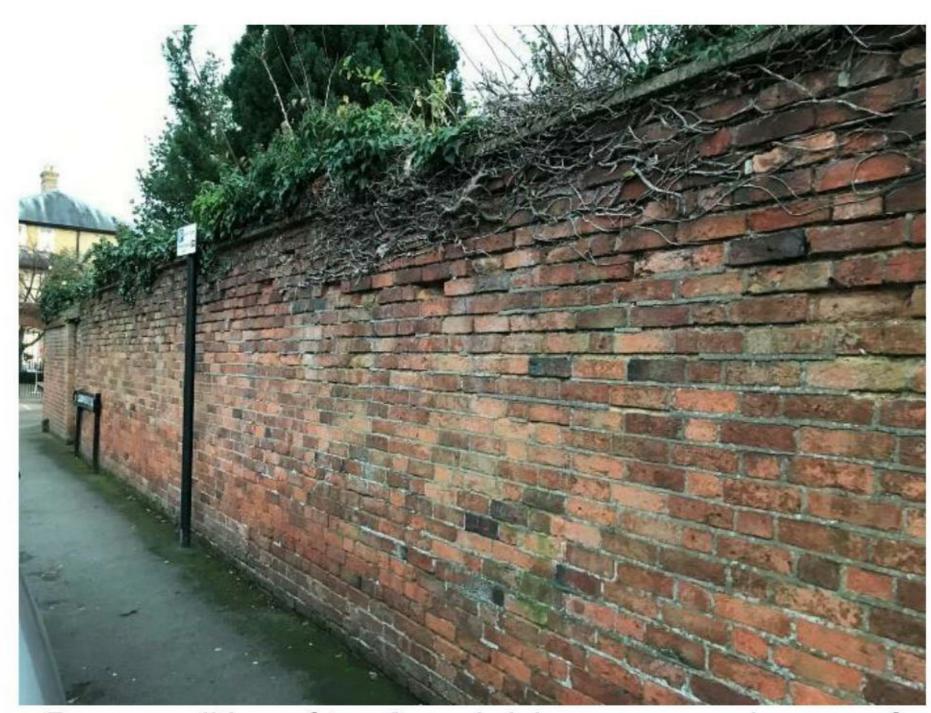
Poor condition of top 9 no. brick courses and areas of repointing required. Vegetation removal required to facilitate work - north facing elevation.

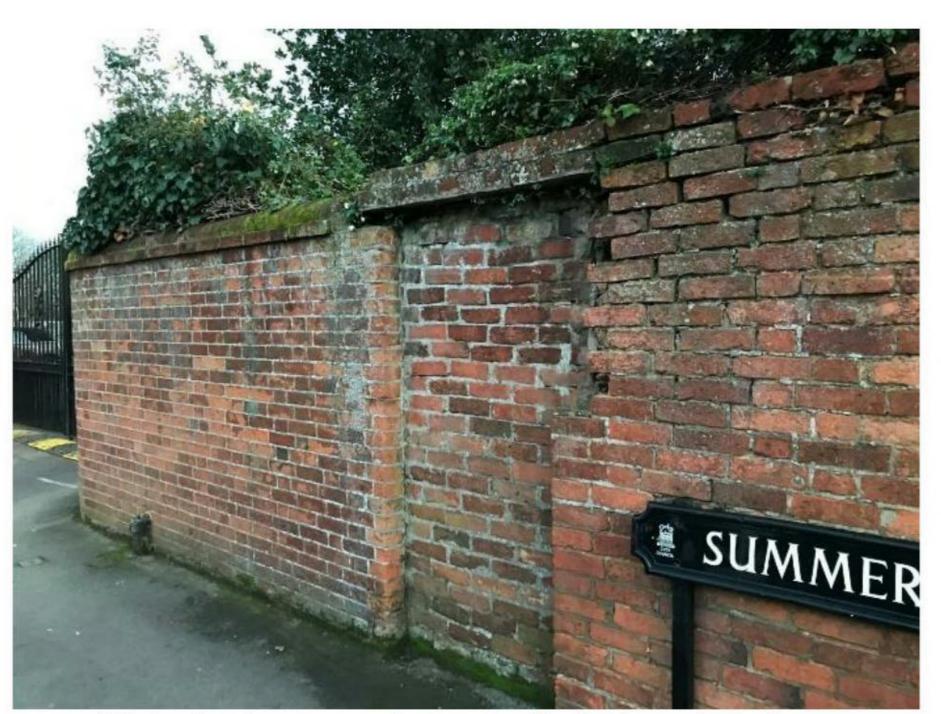
Historic door opening – north facing elevation.

- The uneven brickwork of the infilled historic doorway will be made good using salvaged bricks to create flush reveals. A mild steel plate will be installed into the mortar bed above the doorway to create a lintel and prevent further deterioration.

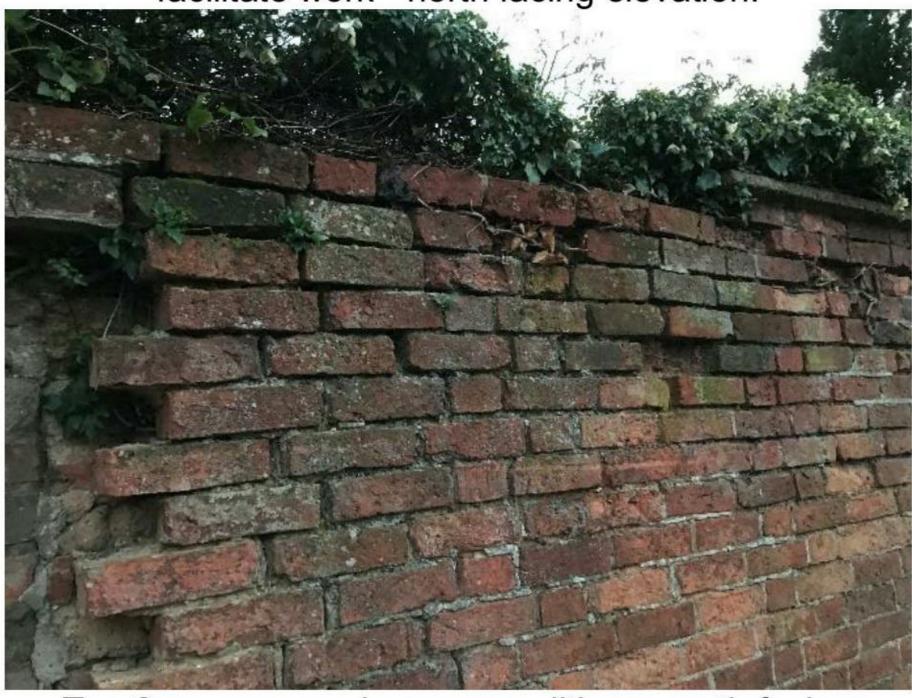
Top 9 no. courses in poor condition – north facing elevation.

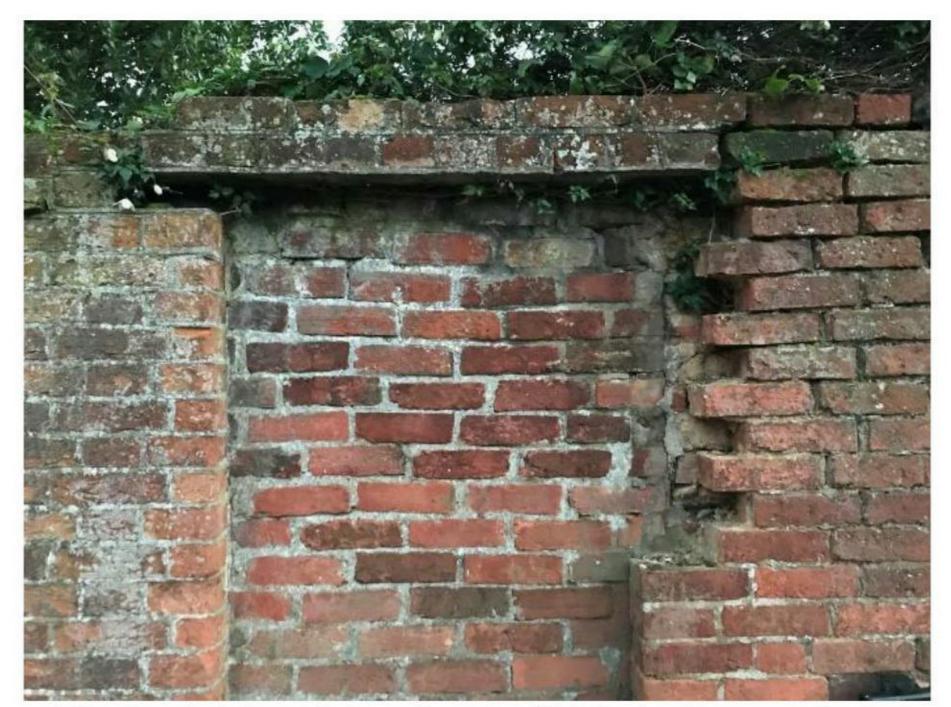
Missing brickwork to returns of historic doorway to be made good and mild steel lintel installed.
