4.2 Repairs and Alterations to Windows: Findings & Recommendations

4.3 Internal Repairs: Findings & Recommendations

4.4 Repairs to Bookcases: Findings & Recommendations

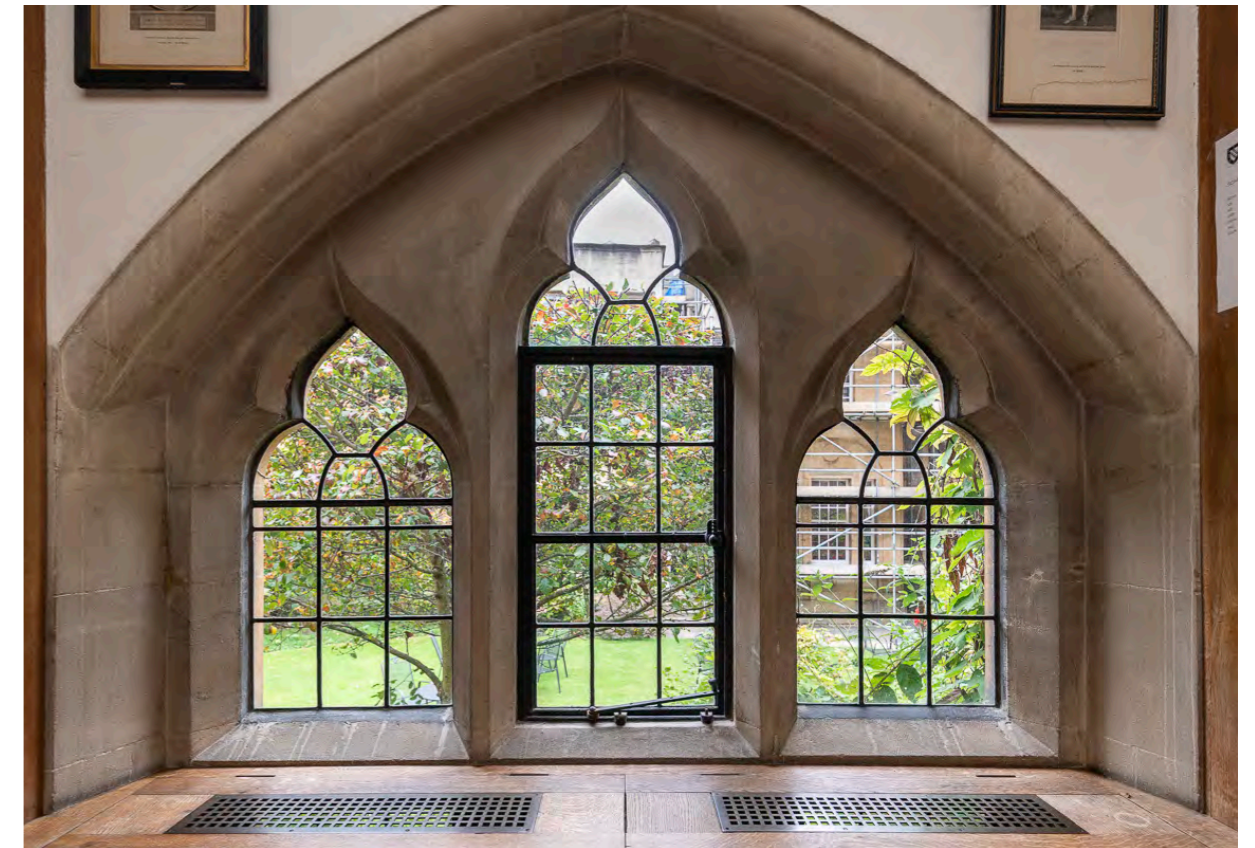
- The windows to the west elevation of the annexe have been altered to incorporate a casement within the upper lights when the mezzanine was installed within the 1950's. These are currently at a level which can be accessed via the mezzanine level. When the mezzanine is removed, these windows will be inaccessible and we are therefore looking to incorporate further opening lights at the lower level. This will be important to achieve adequate ventilation and a comfortable internal environment. We would propose a series of casements, with two out of each of the three lower lights adapted to be opening.

- 01. Upper windows with central casement within the annexe
- 02. Burne-Jones stained glass with casement below
- 03. Sliding light to the north elevation of the main library

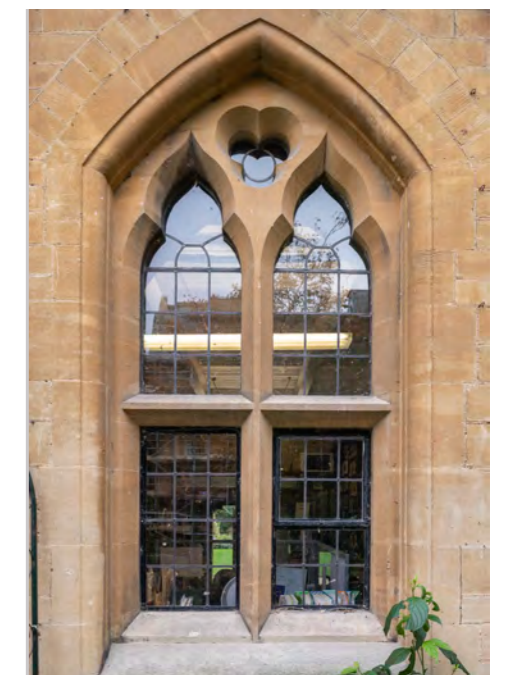
03.

- There are a series of sliding lights to the north elevation of the ground floor and to all first floor windows within the main library. These have failed in all locations at ground floor and are currently not used at first floor level with the pulley systems removed and the sliding units fixed shut. The failure of these windows is likely due to a combination of the original design, a lack of maintenance and inadequate ironmongery. In discussion with Salisbury Cathedral Glass, they believe that the force of the sliders being lowered causes the fixed lights and sliders to be shaken to the point where this causes damage to the glazing and frames. This may be partly due to the windows not being regularly oiled, or could be that the design of the tracks does not promote a smooth and even operation. The simple pulley system also does not allow users to control the

rate at which the light is lowered, often resulting in the lights dropping quickly leading to shaking.

It is the intent to try and replace these with sliding lights to match the existing, but to propose a more robust pulley system and frame to help prevent future failing. If this is not possible, we would look to replace them with casements to match the south elevation. From historic images from the 1930's we believe that sliders may have also been installed on the south elevation, as a horizontal break can be seen. These are now casements, which would suggest that a solution for repairing the sliding units could not be found at this time and were likely replaced in the 1950's when other refurbishment works were carried out. At ground floor level, the new casements would match the north elevation, with a single casement to the east light. At first floor level, the casement would be in the top section of the window only, keeping the horizontal division as currently seen.

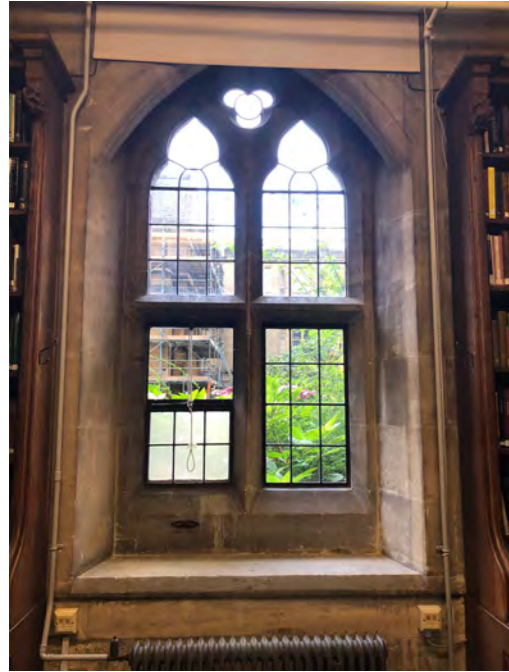
- 01. Sliding light to the ground floor of the main library
- 02. Close up of missing glazing to sliding unit
- 03. Surviving diamond quarries to west gable end
- 04. Burne Jones stained glass with casement below

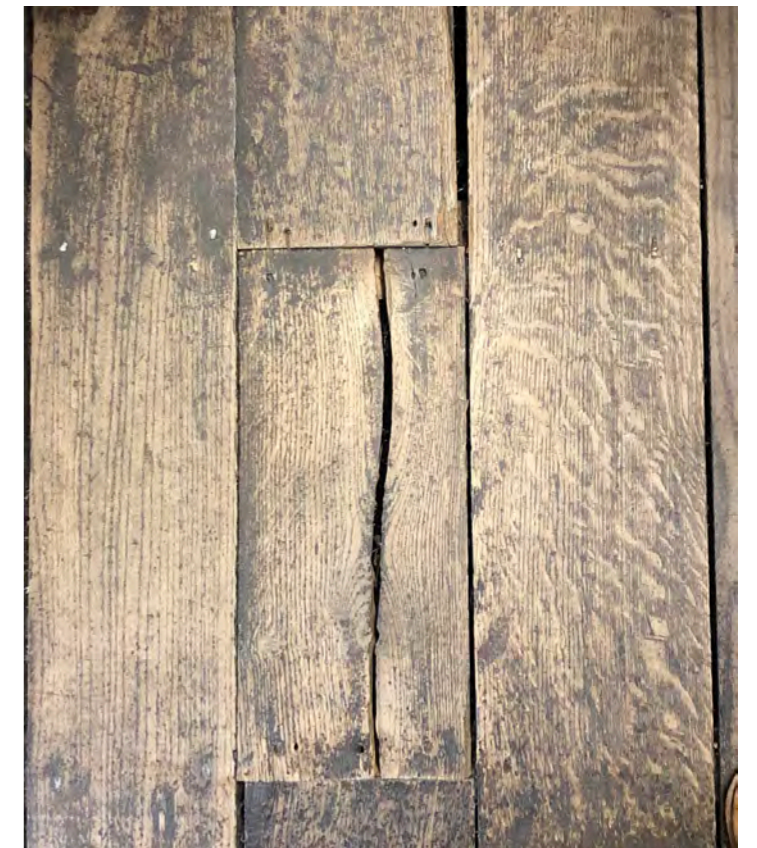
Both the ground and first floor have oak floorboards throughout of varying condition. At ground floor the most eastern bay has been carpeted, and lino has been laid along the central aisle. At first floor level lino has also been laid along the central aisle, as well as throughout the western and eastern bays. The annexe ground floor level has been lowered and consists of a screed with inset rails for the rolling bookstacks. The floorboards which are visible at ground floor have been heavily altered, with a large number of cut or damaged boards and evidence of woodworm activity. The quality and width of the boards also varies widely, ranging from 220mm to the south to 150mm to the north. Over 50% of the floor is also not currently visible due to the presence of the bookcases and lino. This means that we have to make some assumptions on the condition of the floors based on the condition of the boards we can see. The first floor appears to be in a better condition, although there is still evidence of woodworm, cut boards and adaptations due to the installation of contemporary services. The width of the boards is also more consistent being approx 170mm across the whole floor.

01. Damaged oak floorboards at ground floor
02. Floorboards at first floor

The floors will require removal at both levels; at ground floor this is due to the installation of new services and at first floor this is due to the strengthening of the steel beams. This provides us with the opportunity to look at these floors in the context of the project as a whole and ensure that floors of a quality which match that of the library are put back on completion of the repairs works.

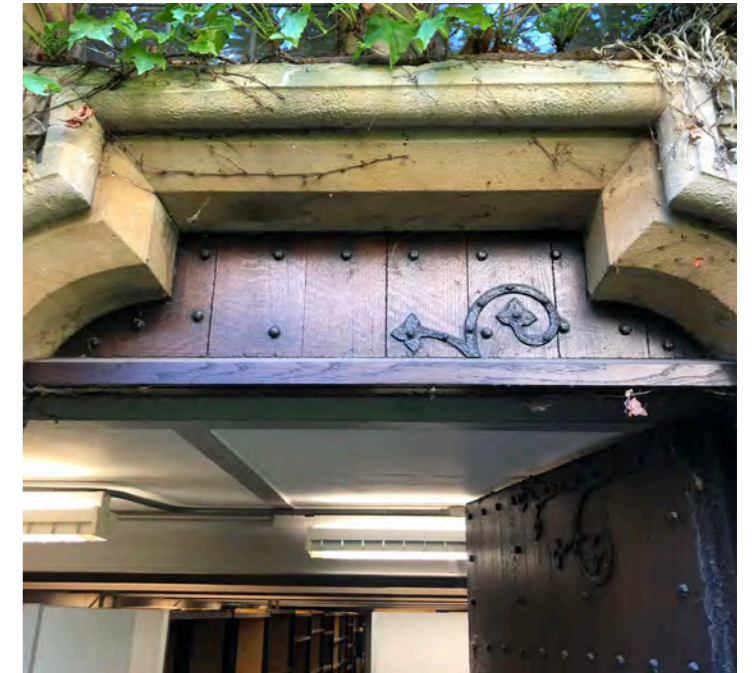
The north door to the Annexe was badly damaged when the mezzanine floor was installed, with the head of the door cut and permanently fixed. With the mezzanine removed, this door will be repaired, with new boards spliced into the head of the door and timber panelling to match the existing moulding created to the inner face. The removal of the existing steps to create a level threshold will also require an additional section to be added to the base of the door.

- 01. Door DG1 - Main entrance door
- 02. Door DG2 - To be removed
- 03. Door DG3 - To be upgraded
- 04. Door DG4 - No door
- 05. Door DG5 - To be removed
- 06. Door DG6 - Interior face
- 07. Door DG6 - Cut head to door
- 08. Door DG7 - To be upgraded

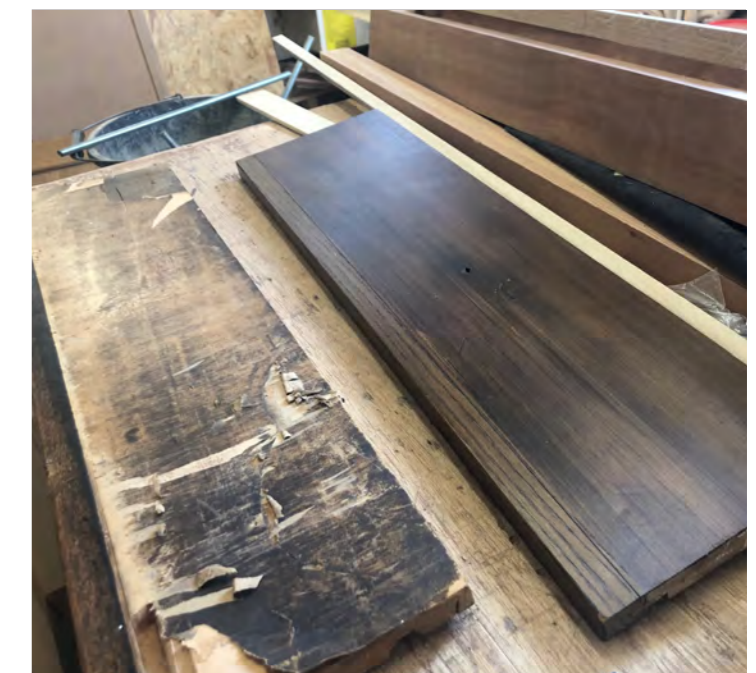
01. Typical bookcase at ground floor
02. Test removal of the leather from the bookcases

Tests have been undertaken to remove the leather and this was possible without causing damage to the timber beneath. Shelves will then be re-stained to match the bookcases.

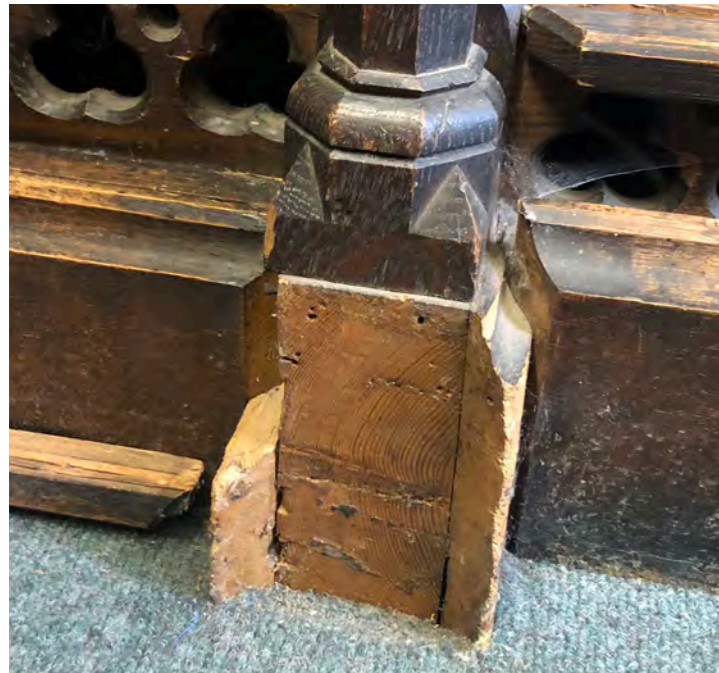
- 01. Repair to lower blocking
- 02. Missing nosing to bottom shelf
- 03. Woodworm to middle blocking
- 04. New shelves

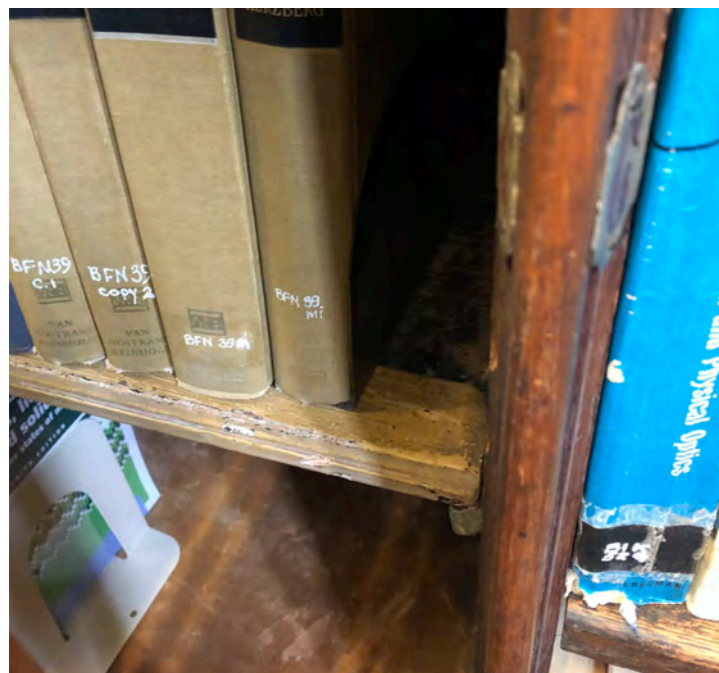
- 05. Removed leather to shelves
- 06. Missing number plate and repairs to skirting and nosing
- 07. Missing end plate
- 08. Contemporary coat hook
