Detailed condition survey of

Rosewarne House, Holman Park, Camborne TR14 8FE

Lesley Anne Price RIBA

3rd January 2018

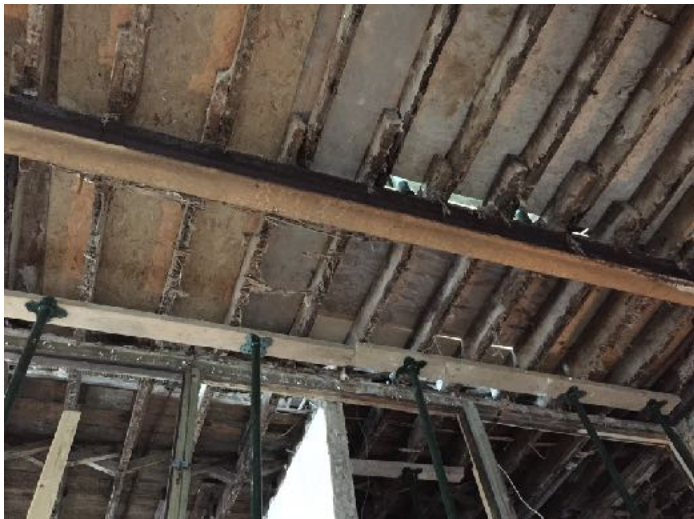
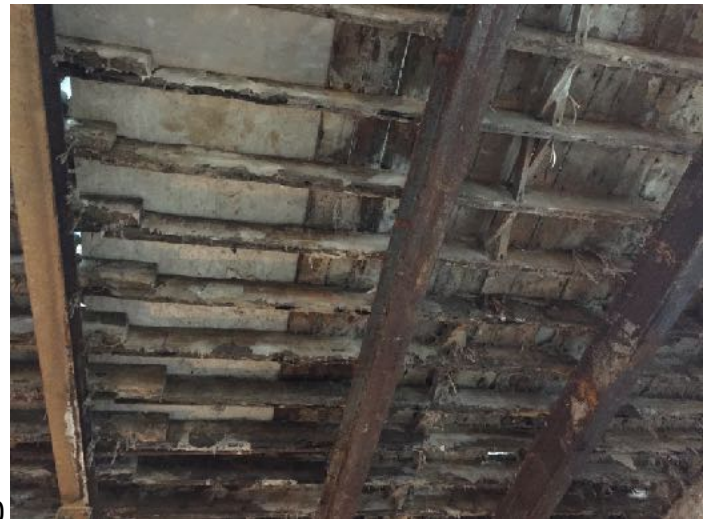
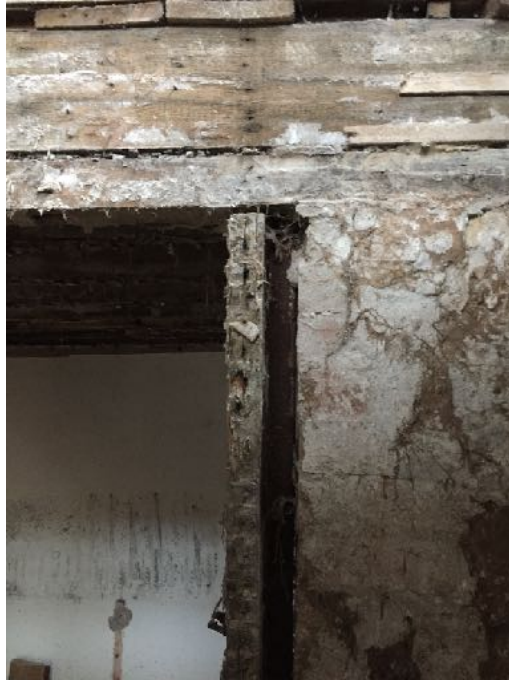
The structure had been built with the use of peculiar half column steel posts and 'I' beams, all of which are now rusting, but which have managed to stabilise the ground floor ceiling structure. However the roof is now in danger of imminent collapse due to the removal of structural partitions and cutting out of new doorways, etc., upstairs. Various walls in this area have been much altered under the ownership of Scope which has means that they can no longer perform the task they originally provided. Fortunately the ground floors are all of concrete, so the rot was confined to the walls and ceilings in these zones. We have provided a temporary support of Acro props - tall props - the ceilings are 4.5m high in this area.

The whole area is completely riddled with dry rot. All first floor joists, floorboards (ceiling) and partitions have in part crumbled to dust, and either have already collapsed or are in danger of doing so. Downstairs the timber framed partitions have gone and dry linings to walls have fallen. It is the finest case of dry rot I have seen; textbook stuff; with remarkable mycelia growths and tendrils running all over the surface and all through the lime mortar in the stone walls.

We shall need to introduce a steel framework to support the roof correctly. This means that we can continue to replace the relatively thin partitions and keep the room proportions.

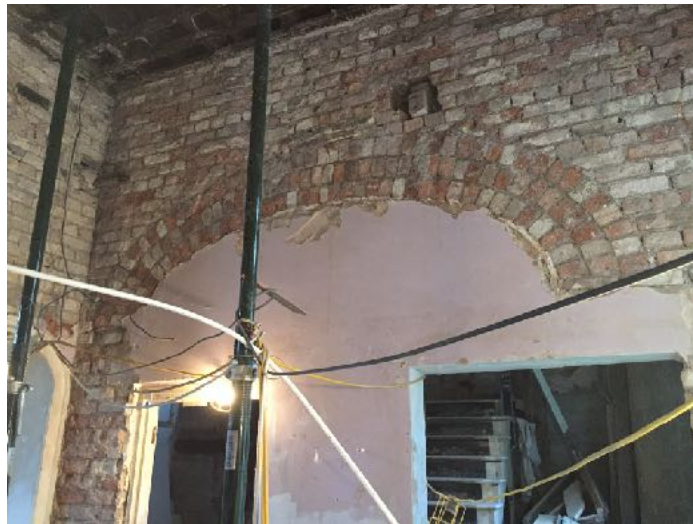
removal of damaged plaster has exposed the archaeology of the walls. Archways and various blocked doorways and interior windows can be seen, together with evidence of old fireplaces and earlier uses. Please see photographs and drawings illustrating this.

Joists in the ceiling have been cut out for services and after the rot have no strength remaining.

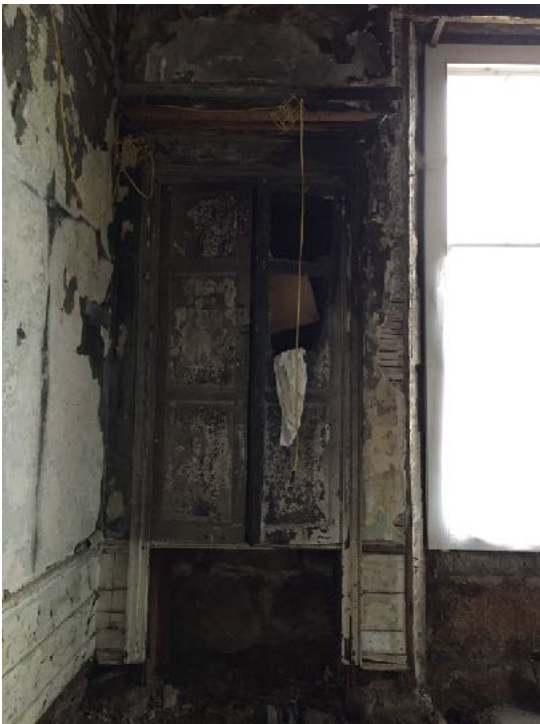
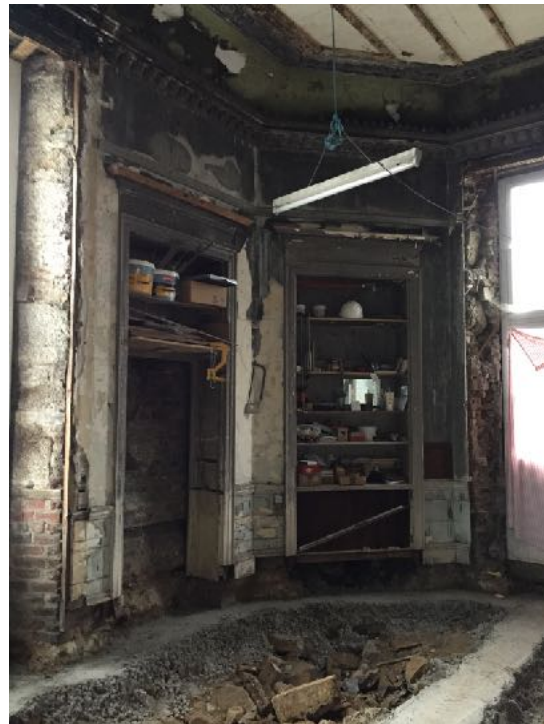
Behind the bookcases, dry rot has been rampant, and on removing the architraves, mycelia can be seen wending their way through the back of the plaster to attack the plaster laths.

The skirtings and floor boards have been damaged beyond repair.

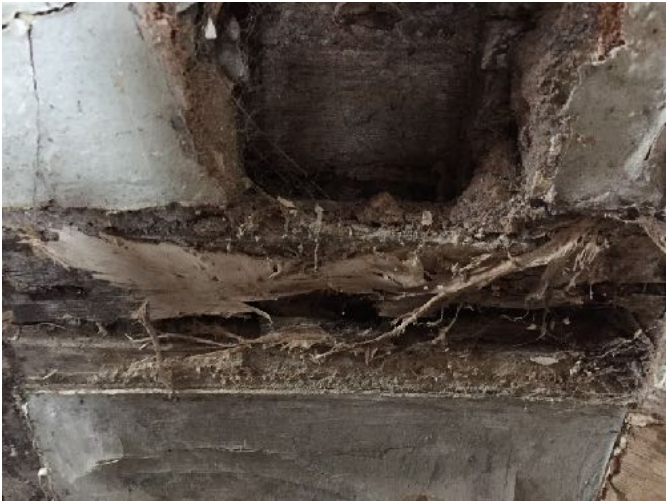
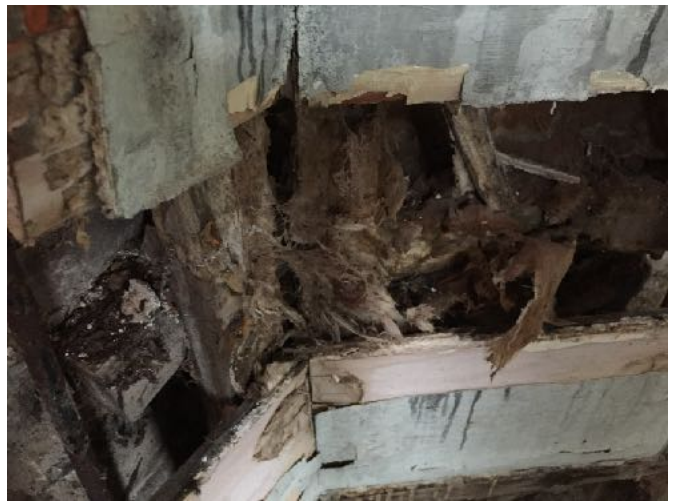
Where the door cases have been removed, the poor construction of the building can be seen. We believe this to be an early C20th change to the room during the Holman ownership.

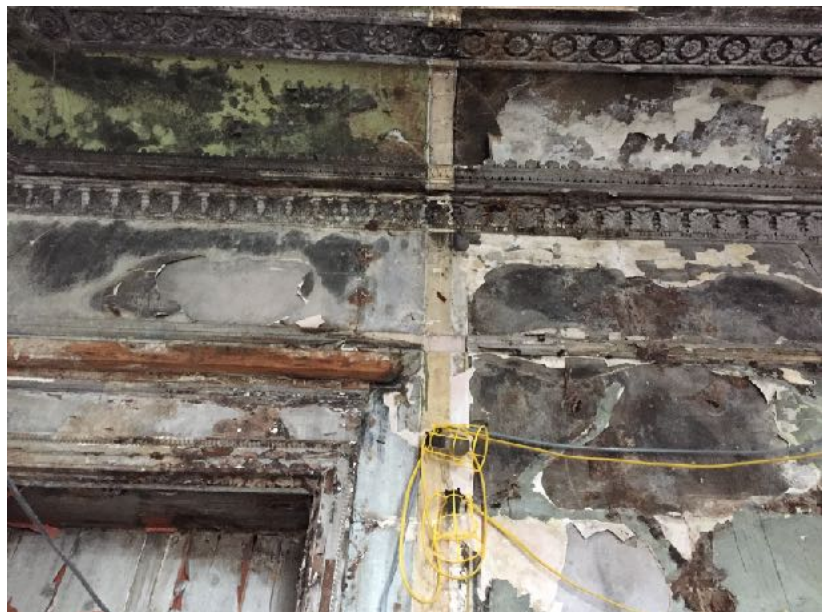
This is the area visibly most badly infested, and from where fruiting bodies were removed on a regular basis. You will see that this is probably the finest cornice in the building, albeit the most damaged.

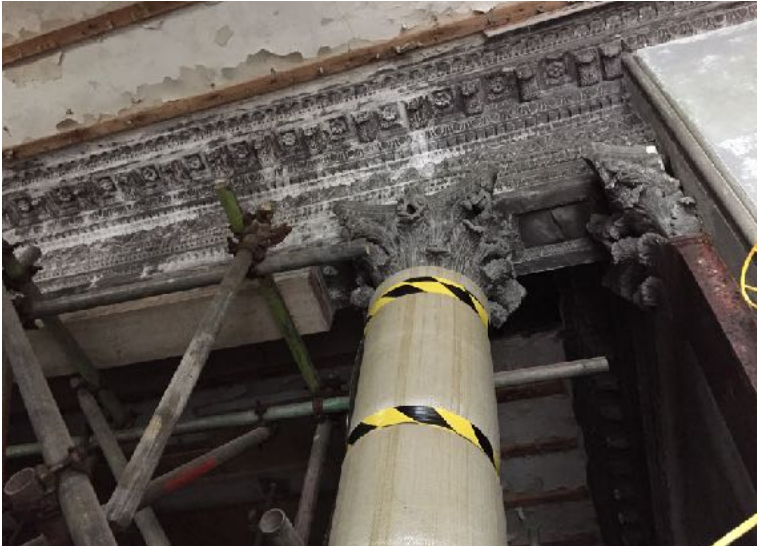
Above: the roof to the rear is collapsing and is now supported on 2-storey scaffolding.

Various sections of ceiling and cornice plaster have fallen as the now dried-out dry rot fungus has led to delamination of layers of plaster.

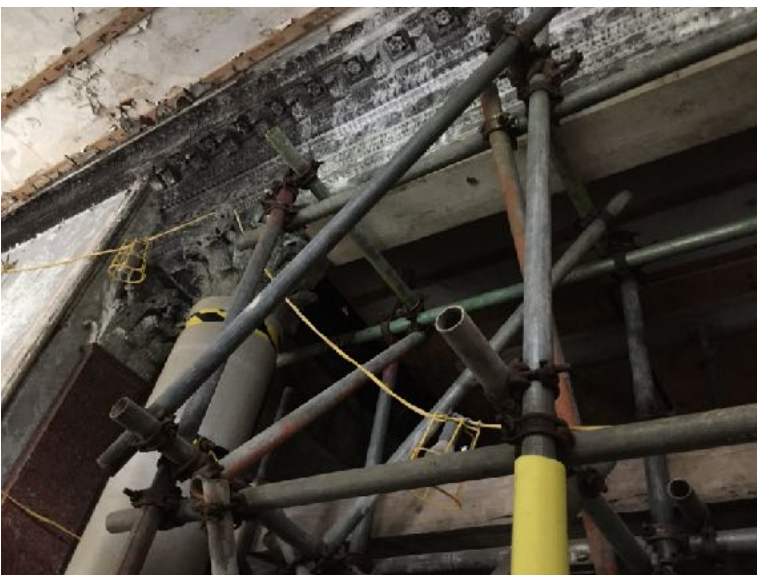
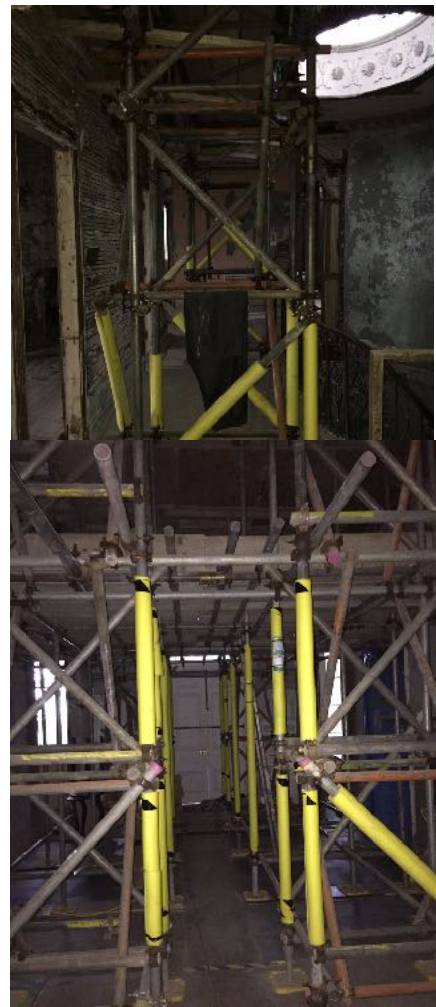
The walls: The scagliola columns have suffered from damp and are spalling in areas while their iron central posts are rusting and causing the plaster to crack.

A fire which was started in the adjoining Library has caused surface smoke damage, which fire led to the swamping of the area with gallons of water from the Fire Service. The south wall (to the right) is of thin timber construction and attempting to hold up the first floor walls and partitions. It requires extra strengthening.

The lintels and door cases in all 4 main doorways have rotted and will require repair or replacement.

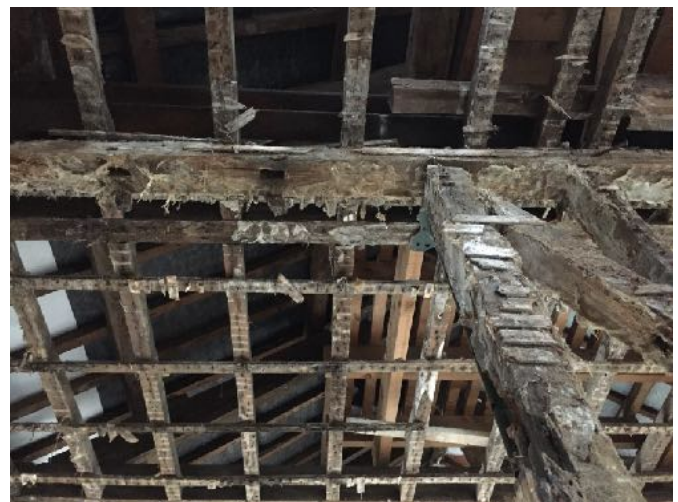
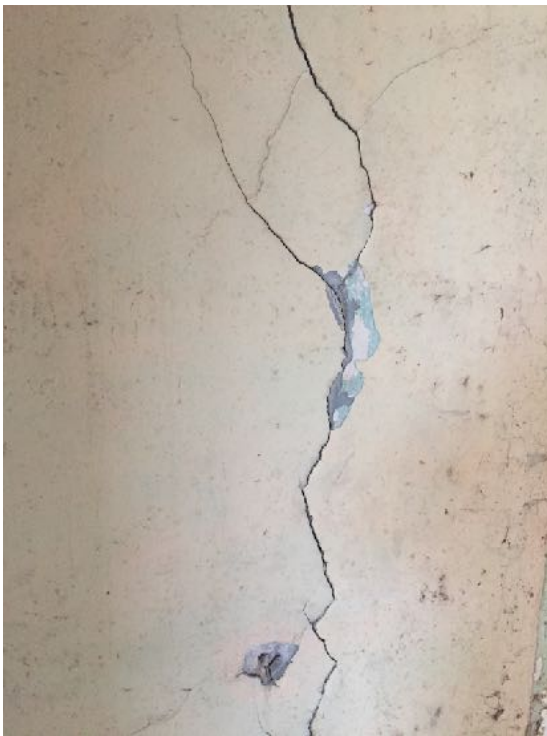
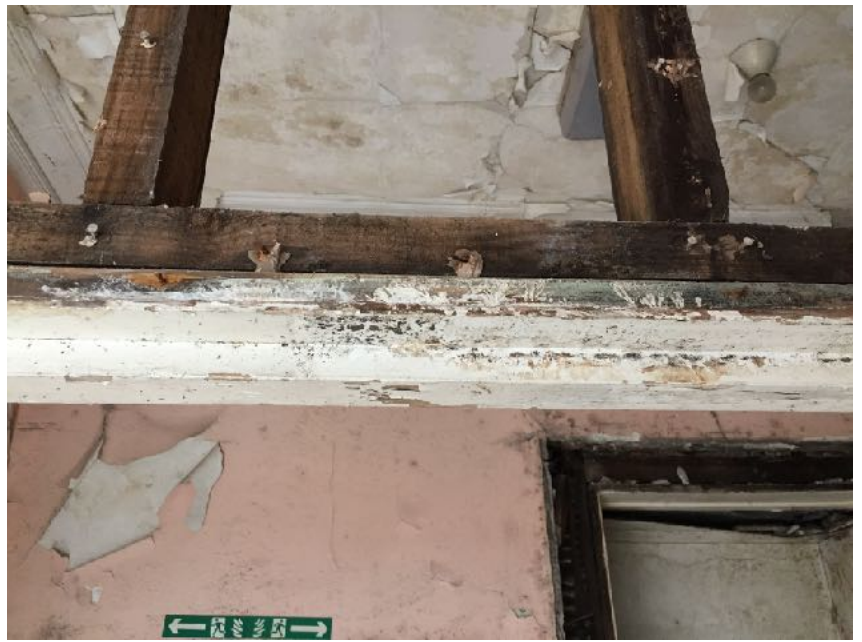
**Above in the upstairs corridor and landing**

All much damaged by water ingress and vandalism

The drum around the staircase is in need of extra support, and the moving of the landing partition 120mm towards the front of the building (west) means that it is no longer supporting the weight of the roof. This area requires steel framing within the depth of the existing partitions and floors to avoid changes to room proportions.

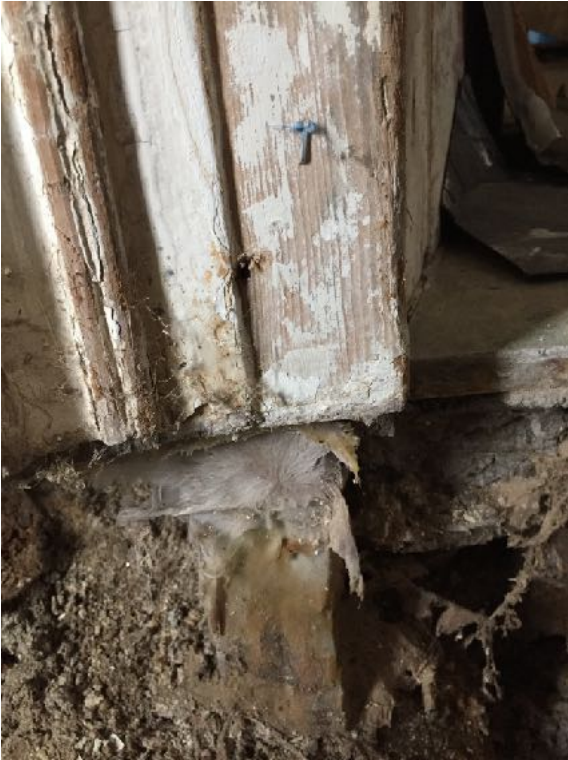
At first glance this appears to be the room in the best condition, however, the area around the doorway in to the Entrance Hall is riddled with dry rot. We have been dismayed to see that there is still a live body to the left of the door.

You can see evidence of the earlier infestation, when we removed large yellow-orange fruiting bodies from the door case. We shall have to remove this to check that there is no damage to structural elements.

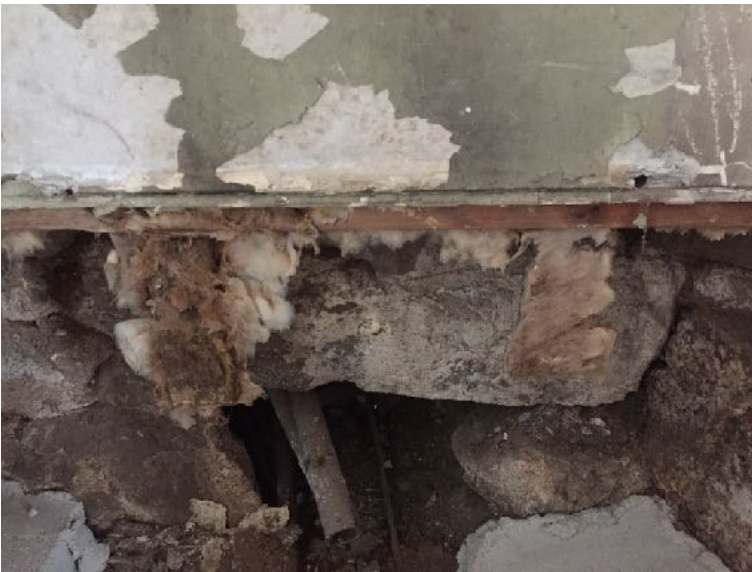
This charming square room is in poor condition. It is one of only two places where the dry rot appears to be still active behind the old dry lined plaster walls - we believe it is being maintained by the wet in the mud-mortared rubble stone wall behind.

We need to remove the lath and plaster to expose the wall to assist its drying out

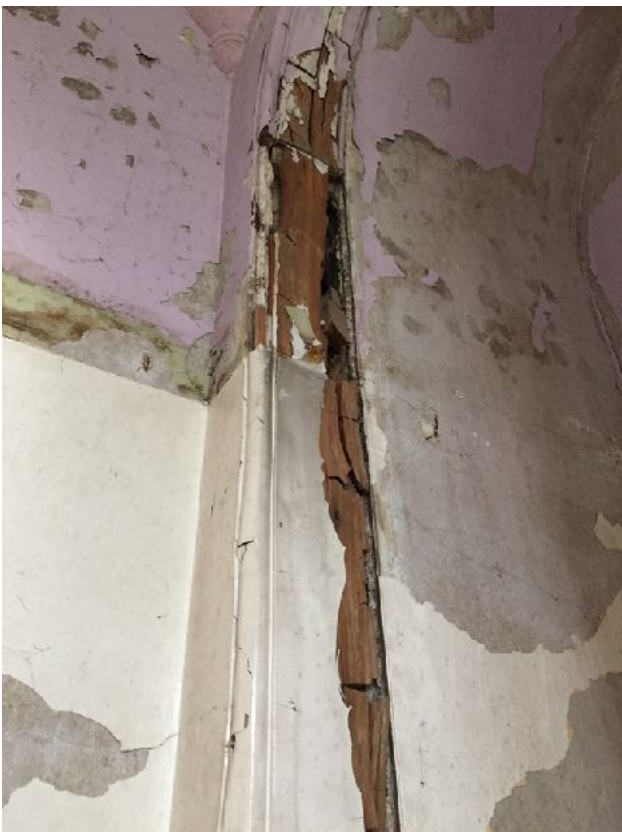
The timber trim to the alcove has been destroyed by rot; we shall reinstate with plaster, keeping the use of timber to a minimum for longevity.

Fungus fibres cover the surfaces of the walls, and even the relatively new timbers from Scope occupation have succumbed to the rot.

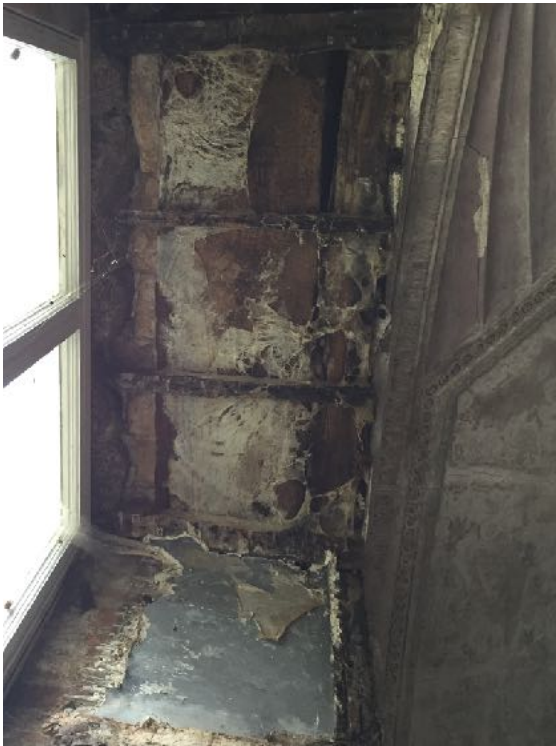
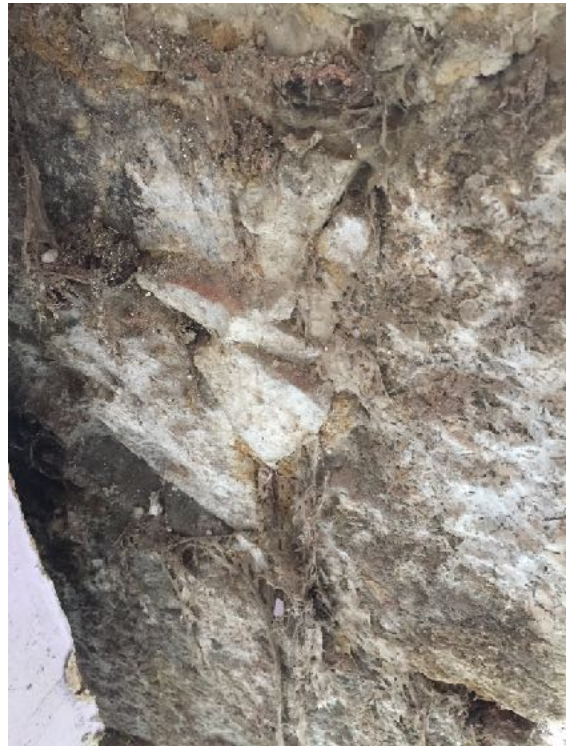
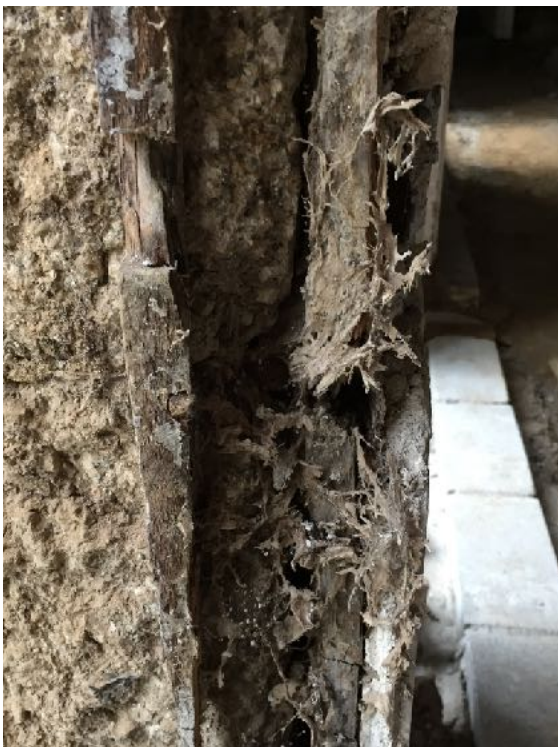
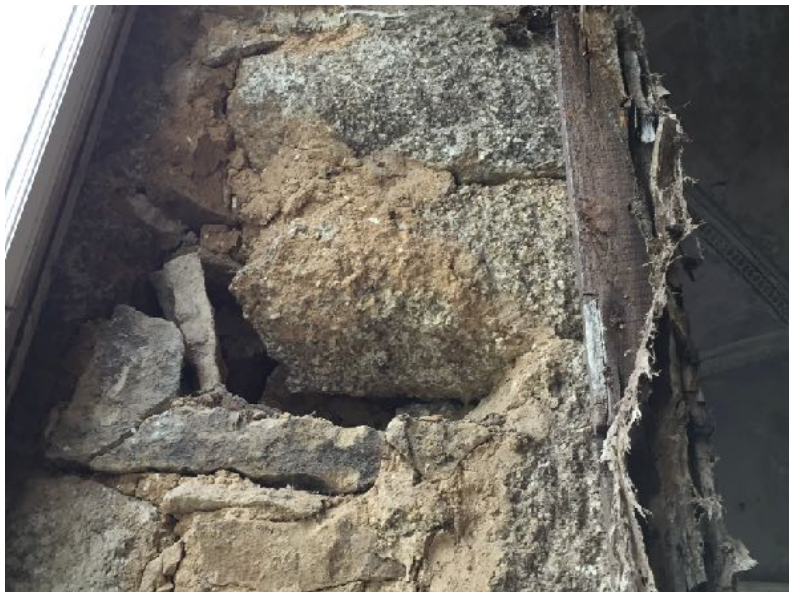
4 photographs illustrating the condition of the window reveals and lintel above. We shall replace the lintel and patch the walls with lime mortar.

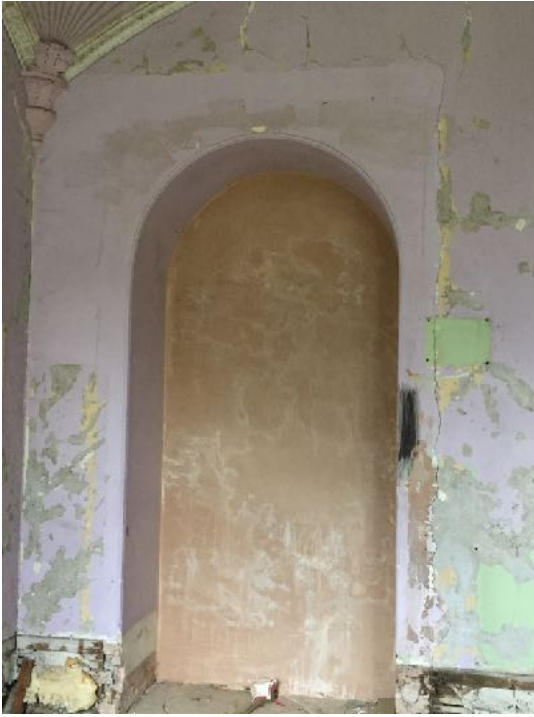
The old doorway to rear corridor: you can see the outline of a rectangular opening, presumably a doorway before the house was remodelled in the late C19th/early C20th.

(The modern plaster is a temporary intervention for privacy in bathroom but will be removed for the insertion of a doorway.)

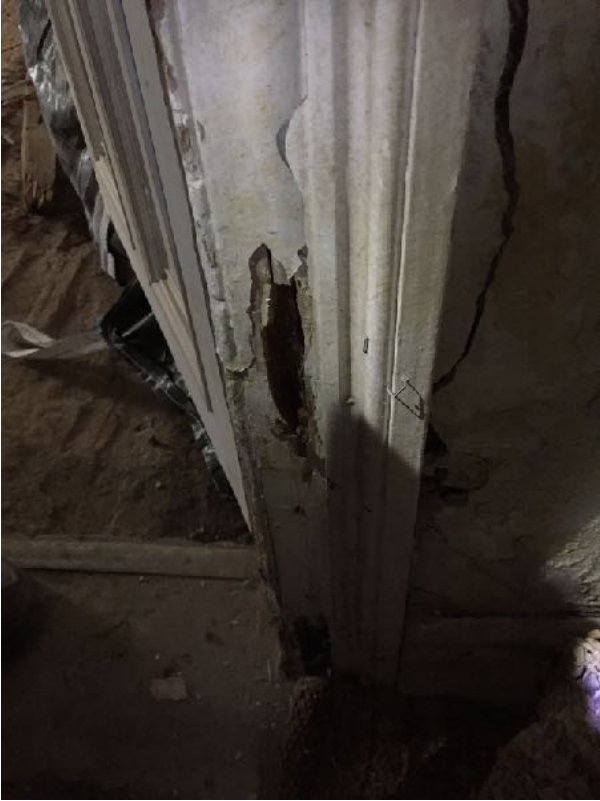
As in every other room, this north facing room has suffered from water ingress from above. The floor surface in the bathroom above is of marble on a lead tray so the water has been cascading down the walls, the weight leading to the failure of the ceiling structure, which has collapsed.

In these photographs you can see the evidence of dry rot mycelia and an earlier higher ceiling height. These traces of earlier walls still have their paint surfaces.

We shall be reinstating the lower ceiling (probably early C20th) as the room will be retained as a bathroom.

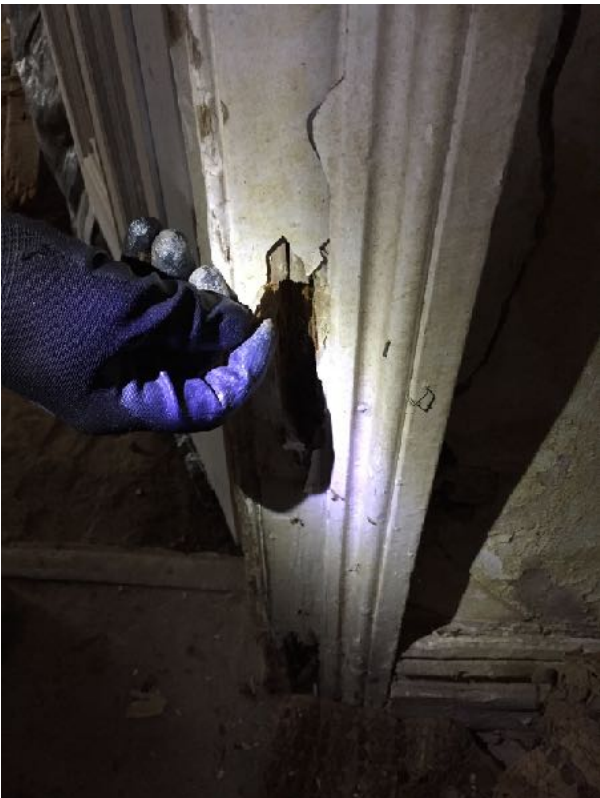
There is a single doorway in this area which opens on to the Drawing Room. Unfortunately its architrave has been damaged by rot, but the door itself and the windows in this area have been repaired and kept safely for reinstatement.

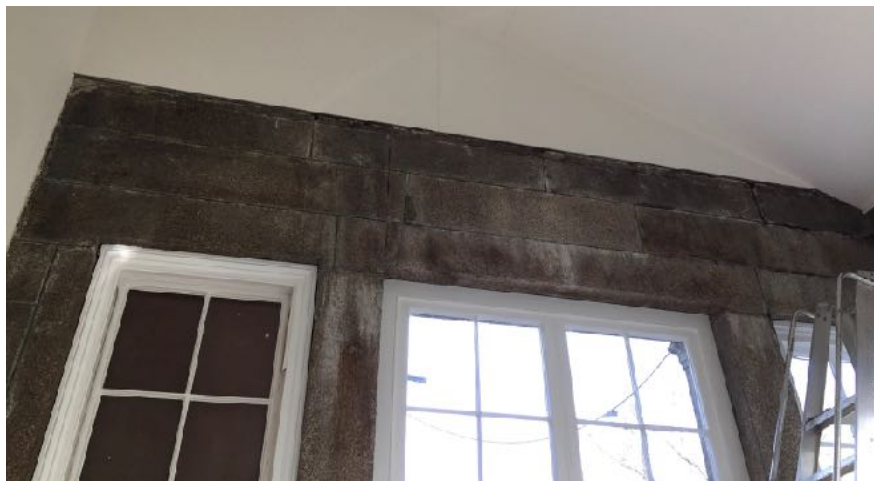
It still requires wiring and heating and we have a horizontal leak through the stones above the double doors which we have to address, probably with prompt cement pointing.

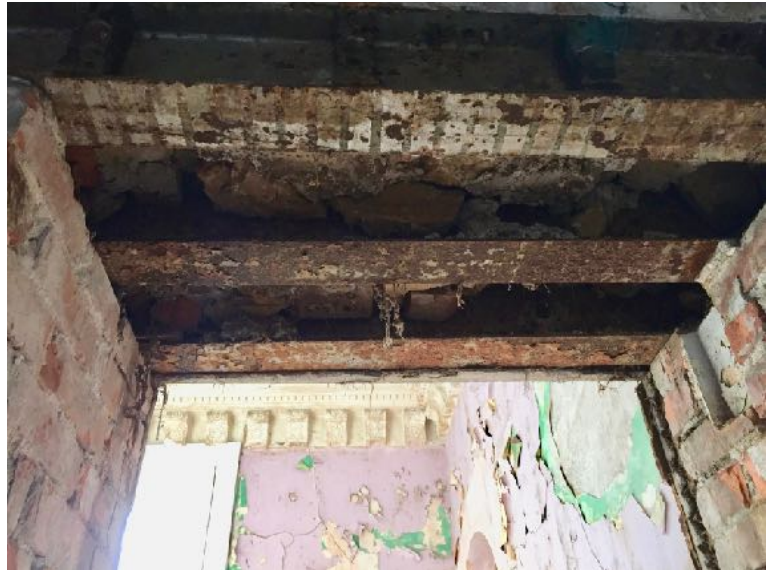
Lintel between Laundry and Anteroom has completely rotted out; fortunately steels have saved it from collapse. Requires smooth finish as part of door lining repairs.

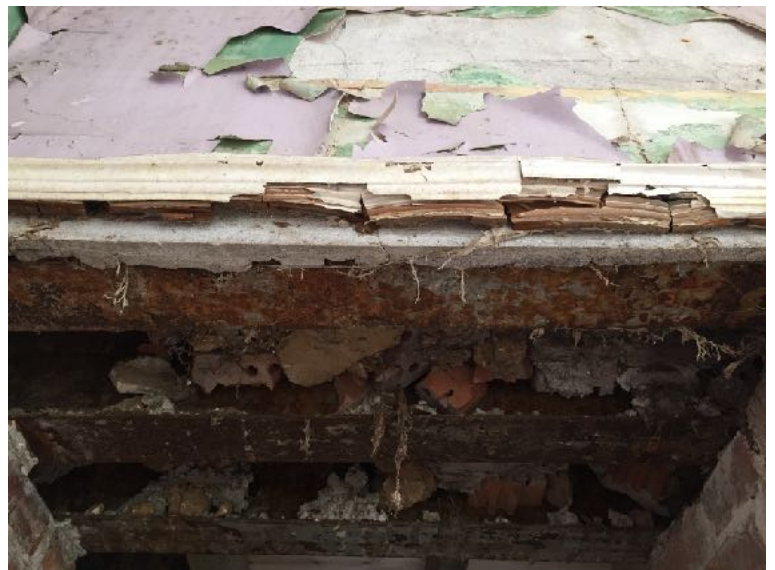
Looking at same lintel between Anteroom and Laundry, the damage to architrave can be seen clearly. The door has been repaired and stored for reinstallation but the door lining and architrave will require replacement.

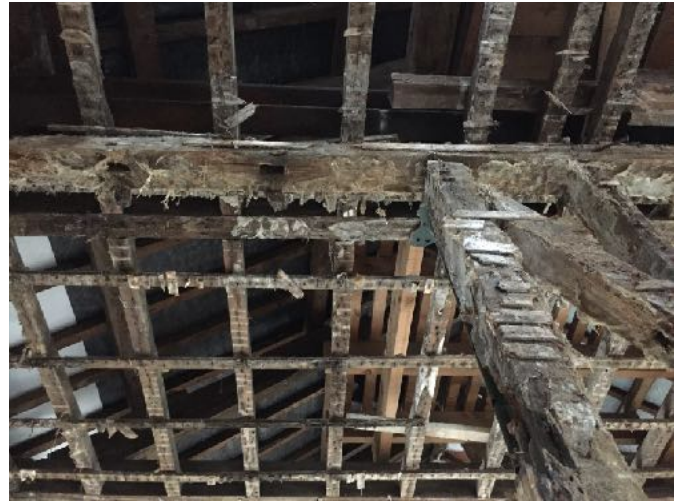
The floor has completely rotted out and the walls are much damaged.

This has reached to the ceiling battens in places, but we intend to retain most of the roof structure. However, the timber partitions, which had already been much damaged by later cut-outs for new doorways, have failed completely. They were of small dimension and had been moved across the room to a position where they have been unable to support the roof above. We shall need to reinstate structural support without altering the dimensions of the rooms.

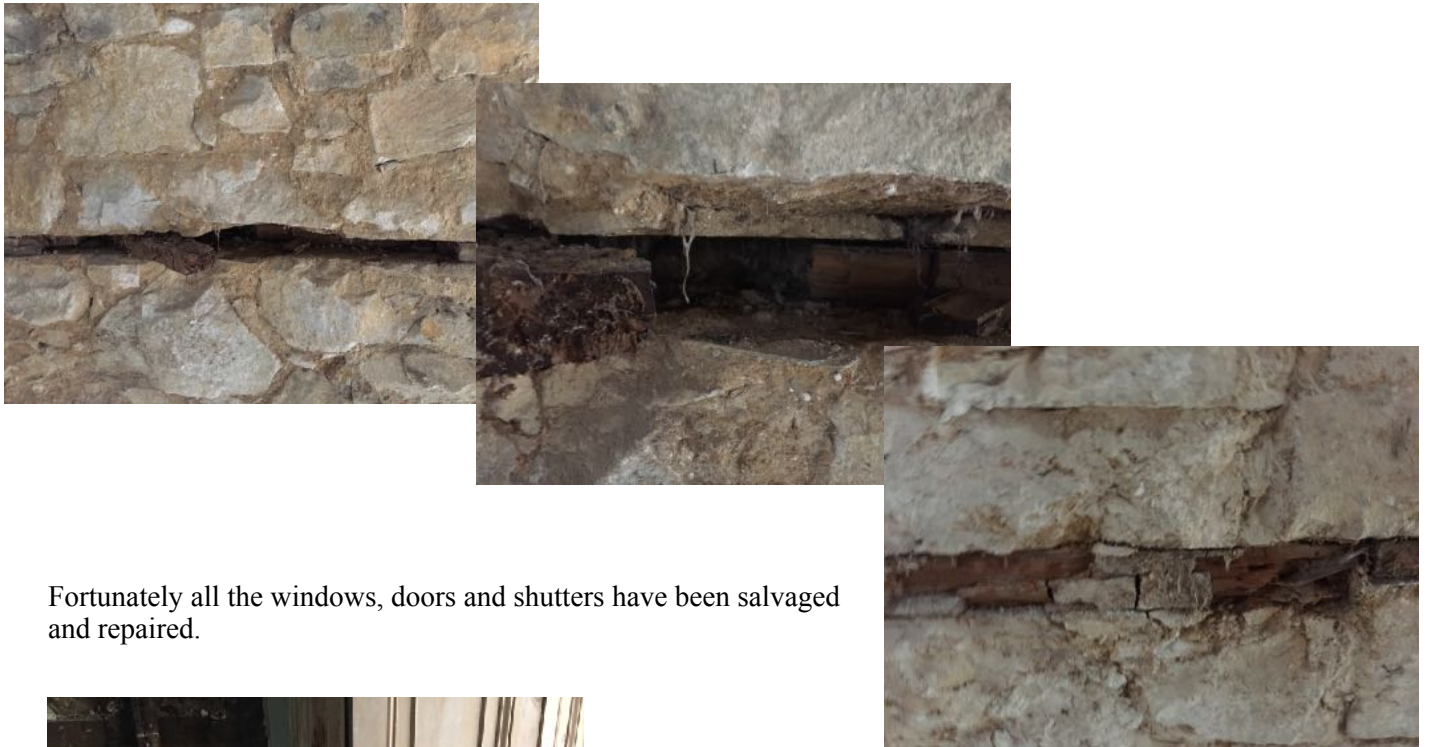
The walls themselves have deep horizontal timber fillets (to which to attach the plaster framework), all of which have rotted, and which we shall replace with brick and slate as a permanent repair.

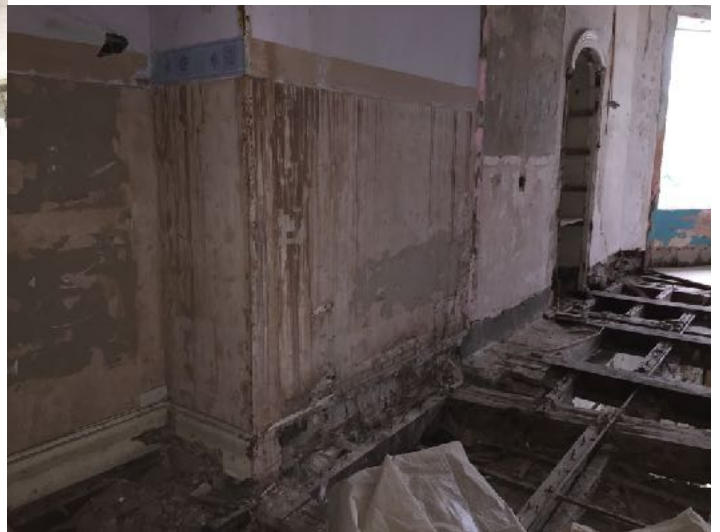
The linking corridor of these two rooms has also suffered. Fortunately none of the ceilings is ornate and the running mould cornices will be easy to repair and replicate.

To left, you can see the pattern of fungus behind the architrave.

Below you can see the deflection from left to right.

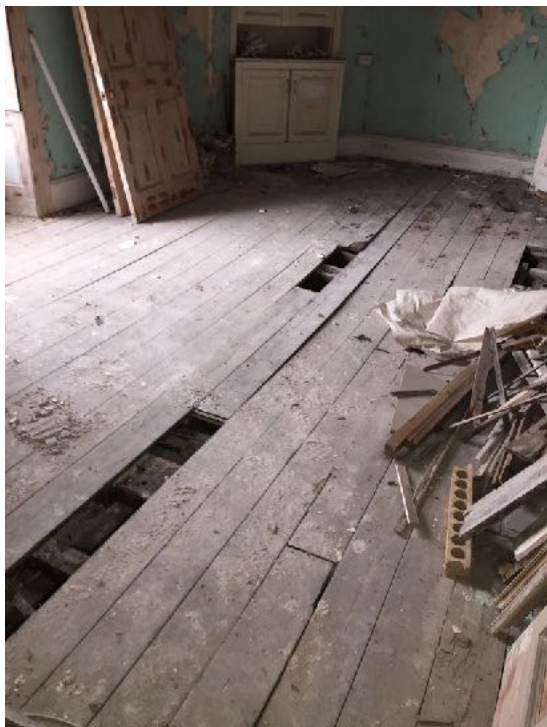
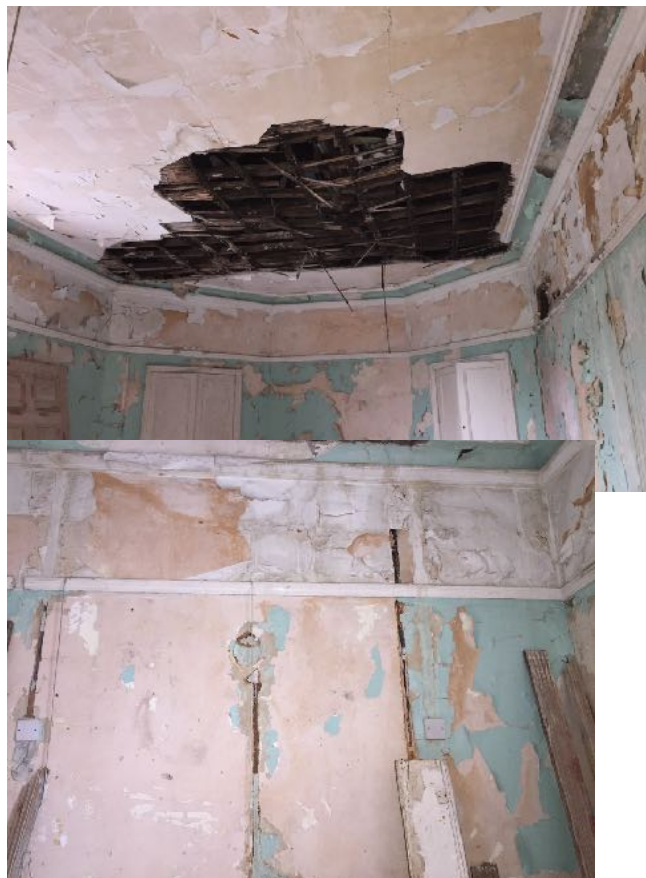
Bedroom 2 is west facing. Unfortunately its ceiling has collapsed, together with its laths, and the floor is deflected by 175mm, so major structural work is required to bring the room back in to use.

Unfortunately dry rot has been active in the whole of this area.

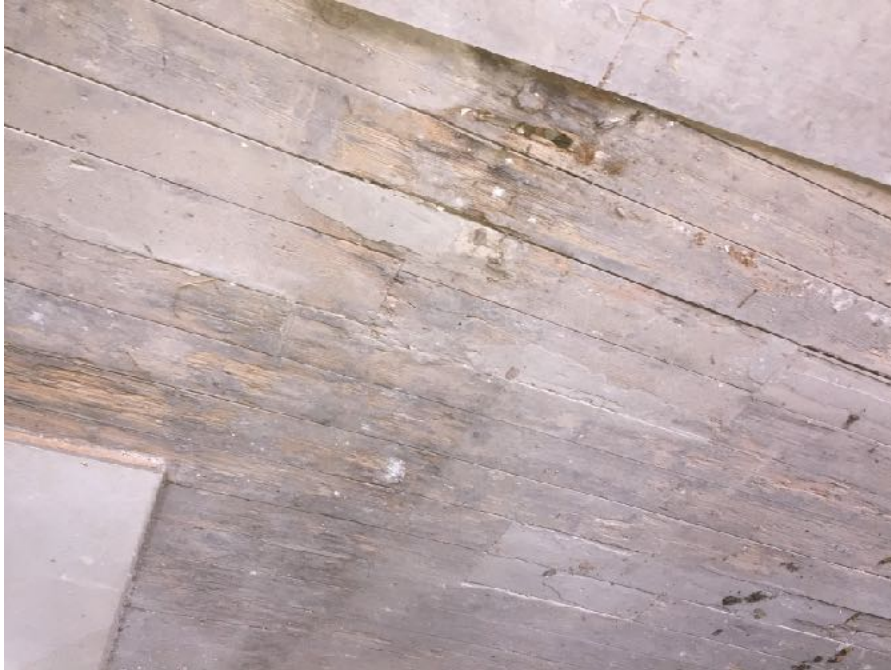
This room has suffered greatly as a result of the missing leadwork and subsequent water ingress..

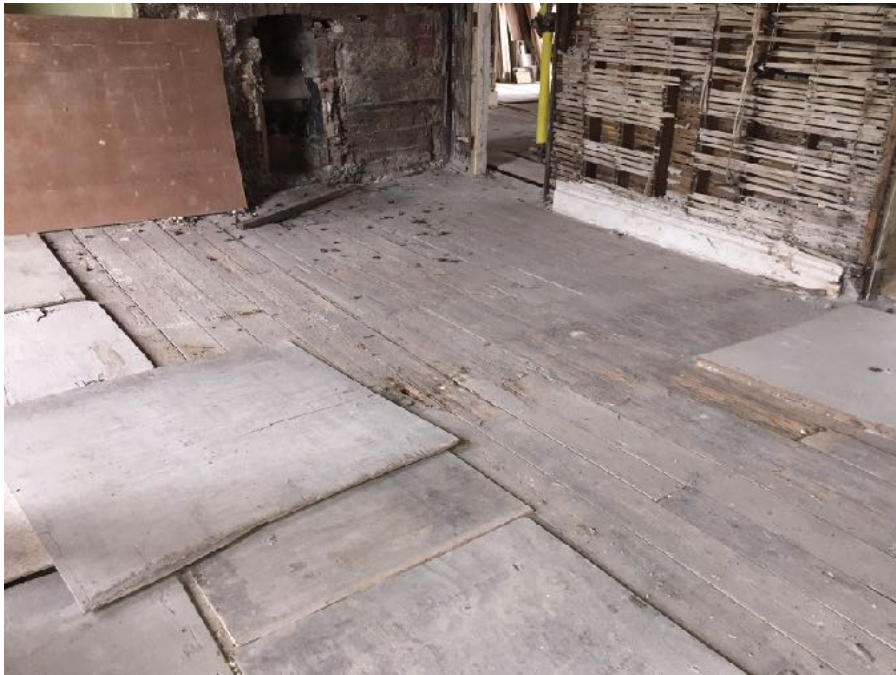
The floor has dissolved in places, and been abraded in others. It is very fragile.

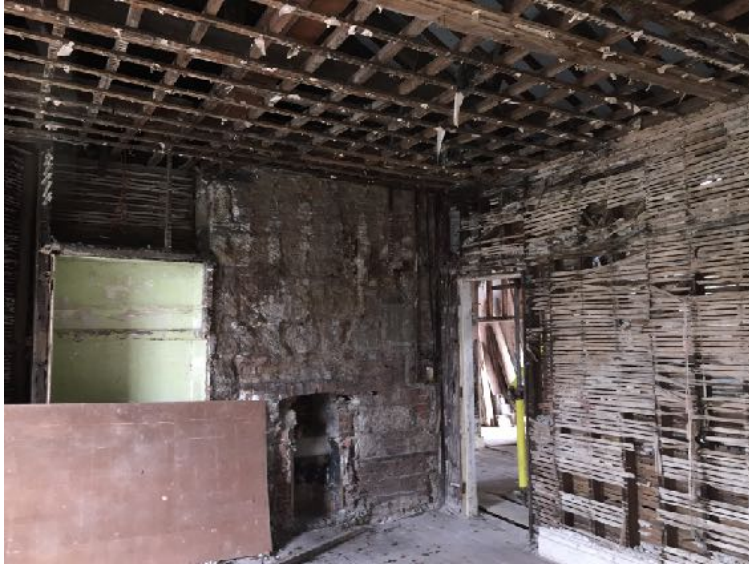
The room has serious structural problems as the flimsy partition has been moved back from its original position (presumably to widen the landing) where it was holding up the roof. Now that it is so badly damaged, it can no longer serve this function and major structural repairs are being designed. At the same time, there is at least one massive original timber in the floor void, and this will be kept as a structural member if at all possible.

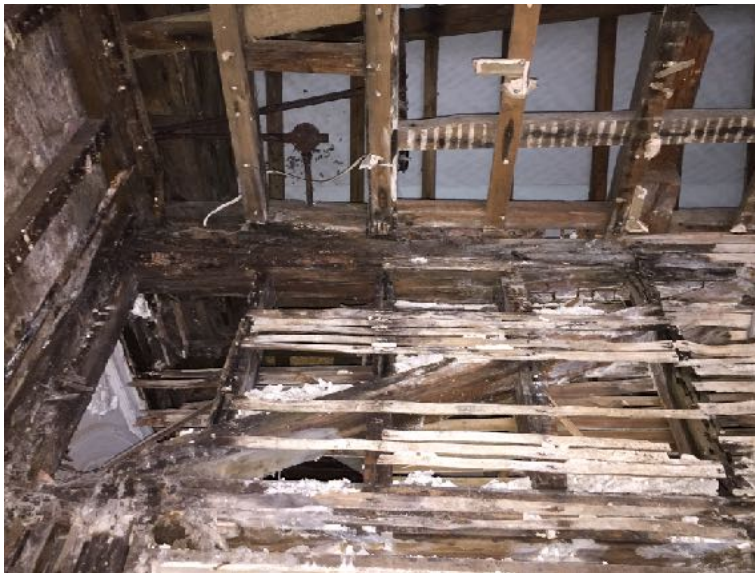
The plaster has already been removed from the partition to lighten its load and to allow the damp within to disperse.

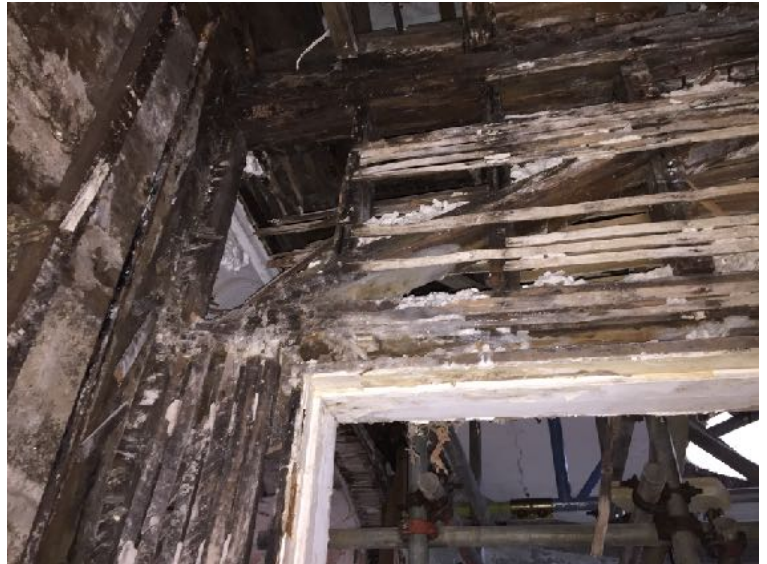
Dry rot has been active here also and the affected timbers will need to be destroyed by incineration.

Even relatively new timbers dating from Scope's ownership have suffered rot at their bases. I don't think we should underestimate the amount of water which flowed through this building for at least 5 years...

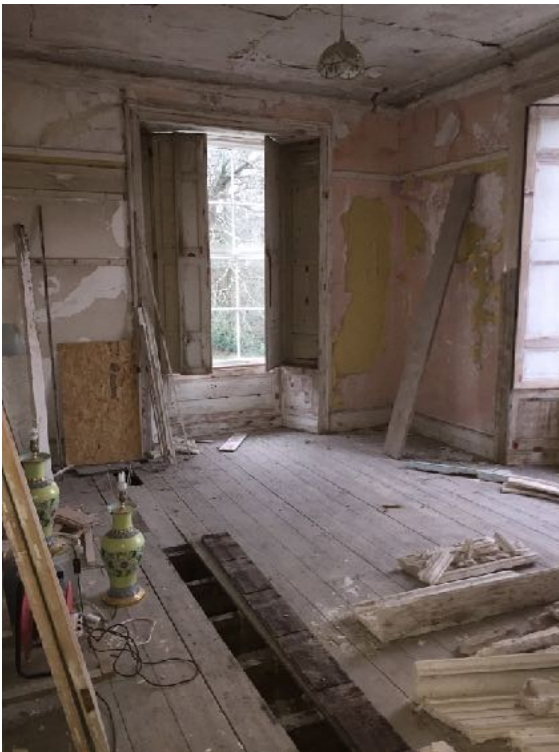
Being on the south side these rooms receive most sun and have, subsequently, dried out more quickly. That said, the damage has already been done in that much of the timber has lost its strength and is no longer useful. Unfortunately, and to our surprise, dry rot is still active behind the plaster in this one corner room.

Obviously it has all been soaking wet as the parapet gutters above had been stripped of their lead over the years prior to our arrival. This has led to cracking of the ceiling plaster, damage to floor boards and the growth of mould.

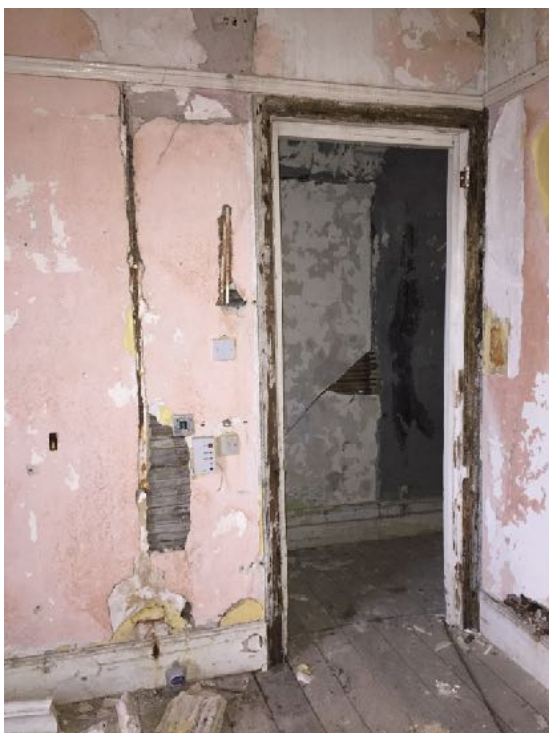
While the doors and windows and shutters have been repaired successfully, the architraves and skirtings are for the most part beyond repair and can be replaced.

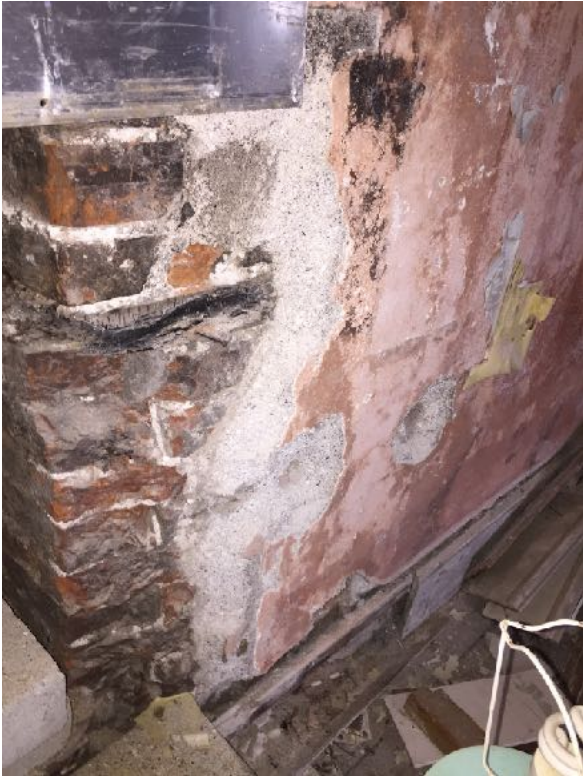
Here you can see the thickness of the plaster around the fireplace.

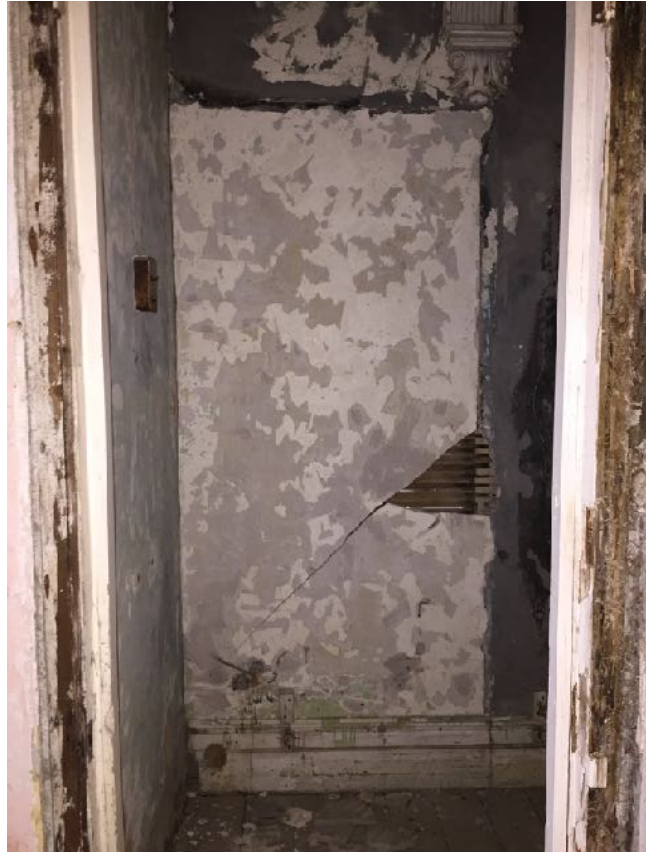
The corridor: Looking through to the corridor beyond, the cracks in the plaster are remarkable.

And just as remarkable, is the dry rot in the door frames. However, we have removed the architraves for repair and treatment. They have been labelled and are being stored in the house.

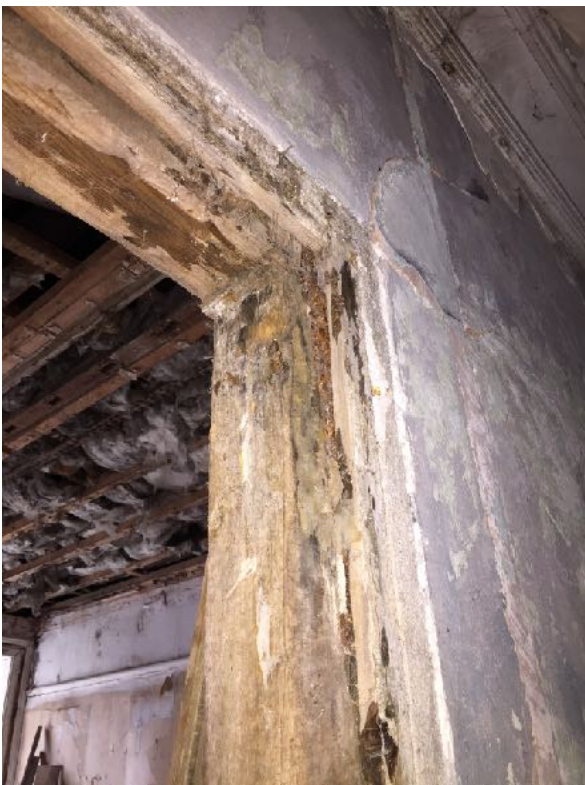
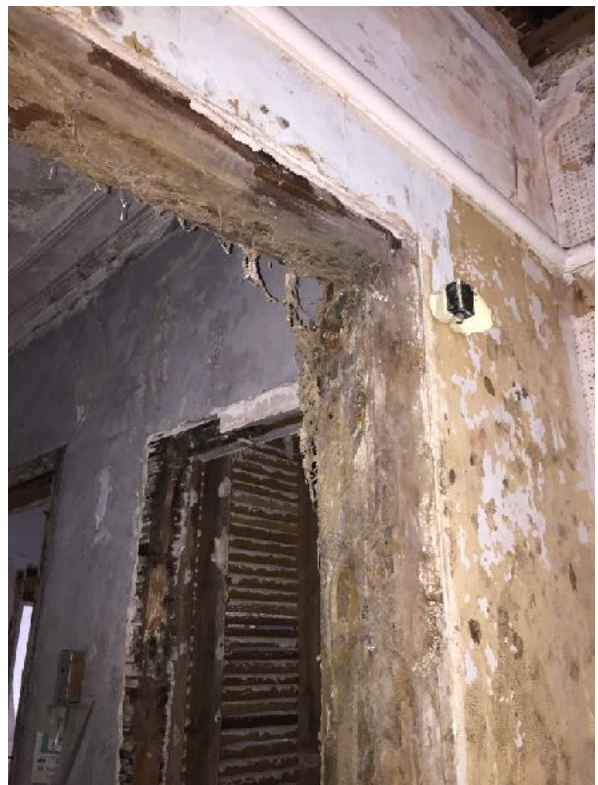
The door frame will need attention.

Some of the floors are abraded; we do not know the cause of this although it may possibly be damage from the use of wheelchairs..

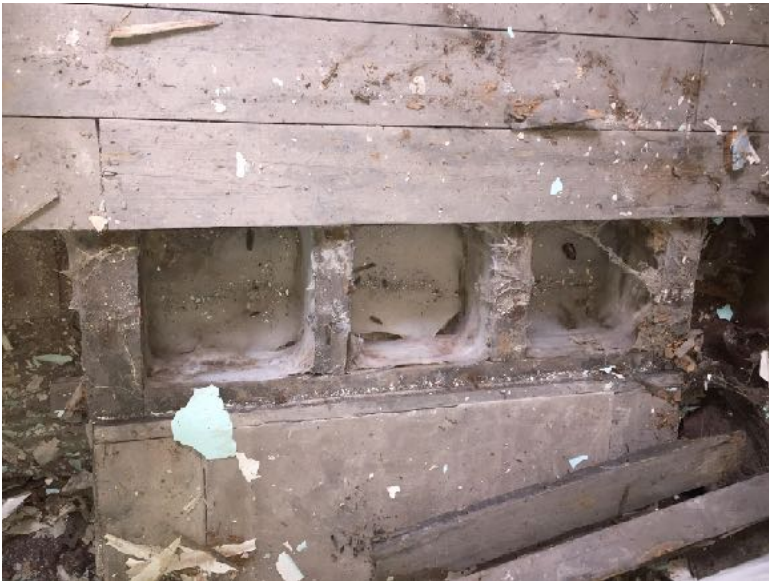
The third bedroom is above the Music Room. It has also suffered as the other rooms in this area. You can see the mycelia between the joists - a cashmere blanket of fungus.
