Detailed condition survey of

Rosewarne House, Holman Park, Camborne TR14 8FE

Lesley Anne Price RIBA

3rd January 2018

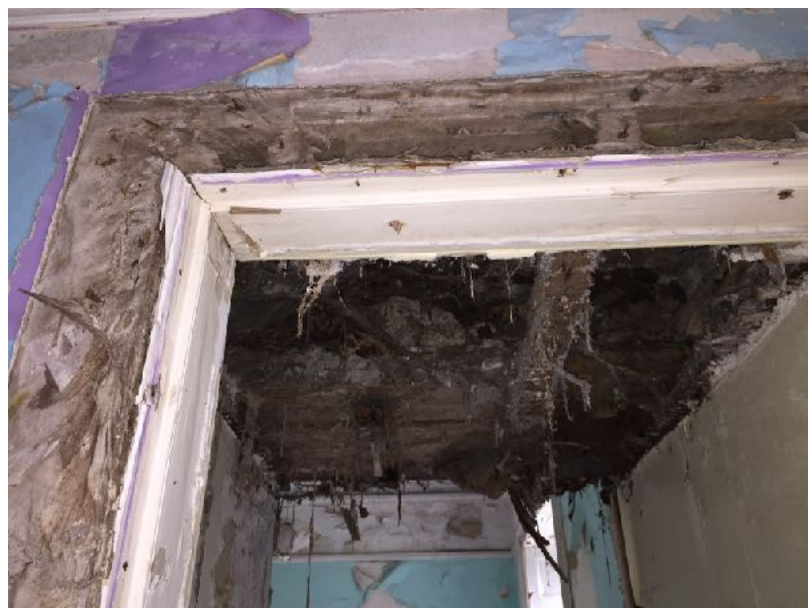
Its doorframe is also particularly affected, although the door has been saved. The windows and shutters are also in useable condition.

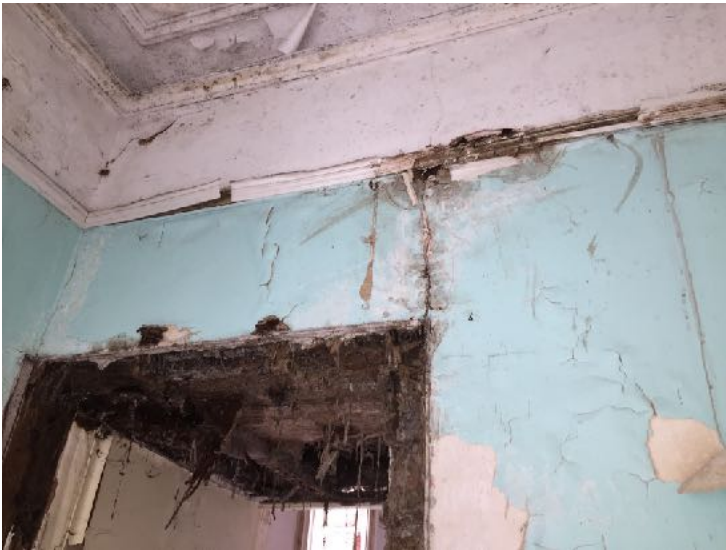
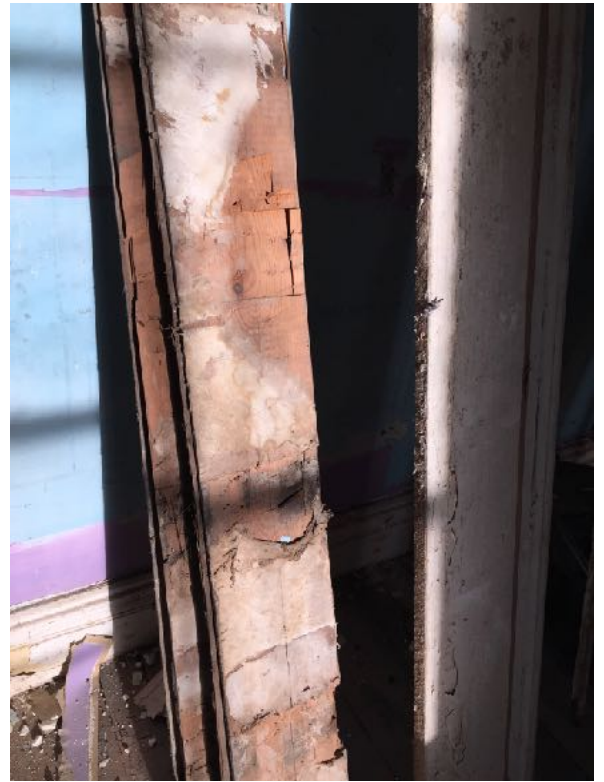
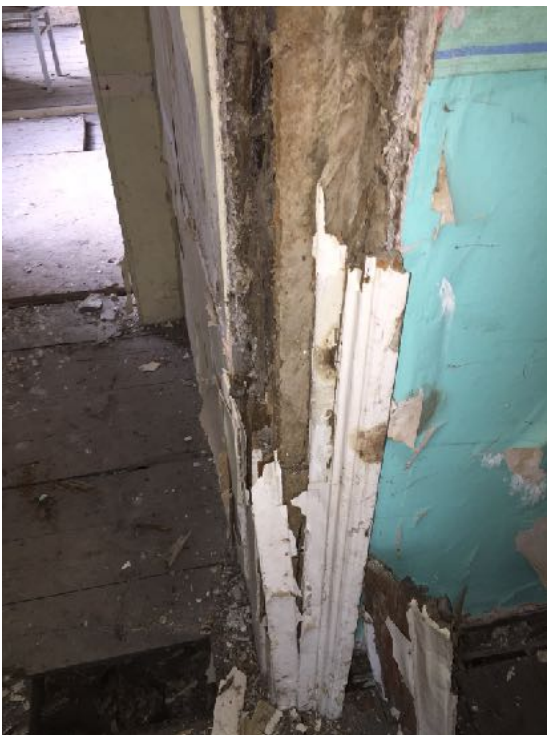
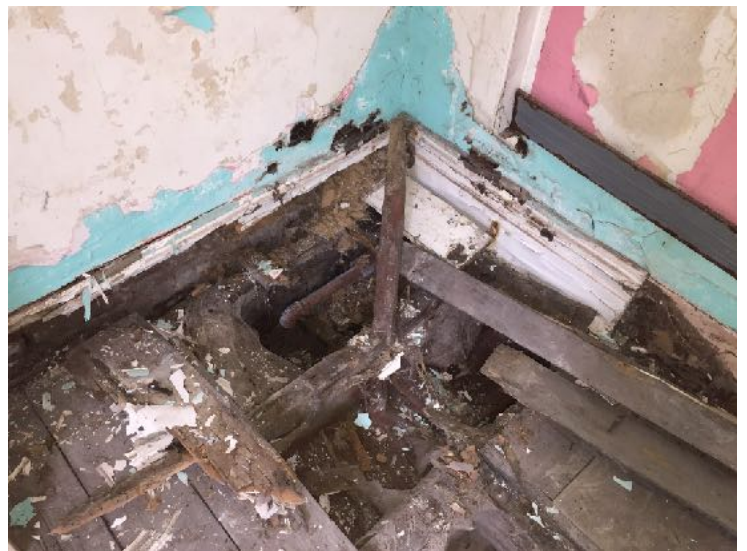
Bedroom 4, however, is the most severely affected by dry rot issues. It is situated below an old rainwater collection tank which had originally and recently been lined with lead until it was stolen along with the roof lead. This meant that most of the water hitting the roof on the whole of this wing was directed through the room (and down to the Anteroom below).

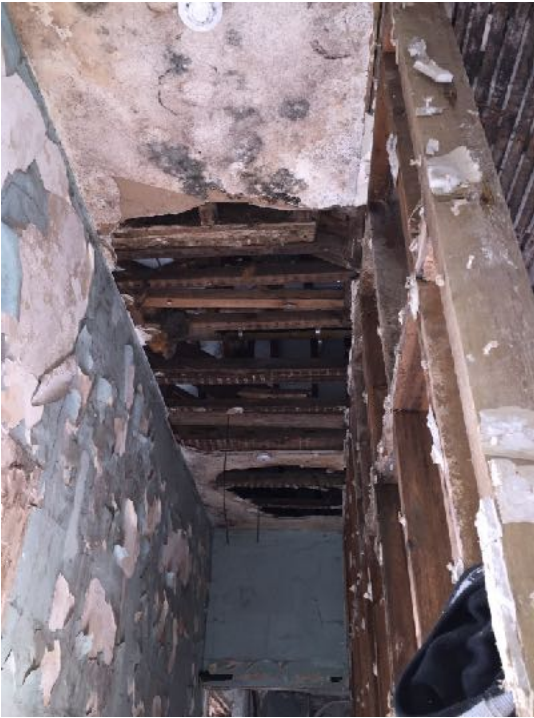
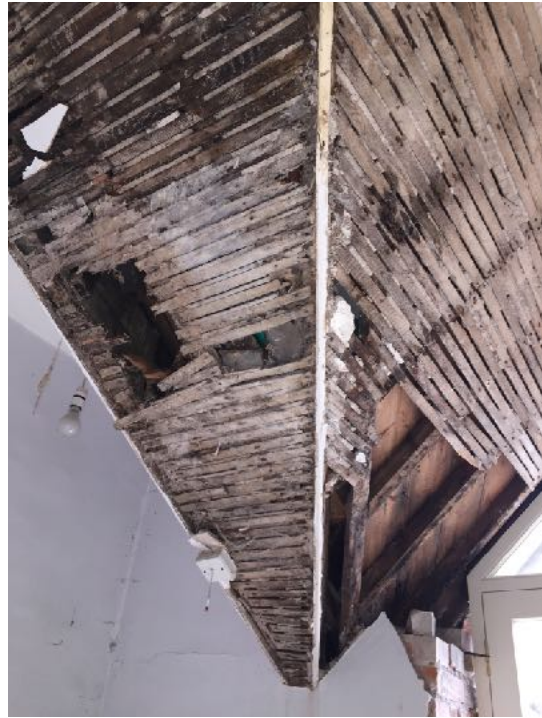
Going back in to the corridor area (previously a bathroom), it has a green and white marble tiled floor sitting in a lead tray. It is much deflected and broken, but we hope to save it to reuse in this area, perhaps by turning it over. We have also managed to retrieve matching marble slabs from this area which were used vertically.. from the courtyard behind where they had been removed and smashed in an attempt to steal them. Some will be reusable and whatever we can use we shall.

There are various areas of plaster fall, and due to removal of supporting walls, there is a major structural issue in this area which we shall resolve by use of cantilevering steels (invisible when in situ).

Dry rot in the door frame (much altered) and dry rot fringes beside some of the marble cladding.
