Tree Hazard Assessment Report

17 February 2021

Devenish Warren
Belle Vue Road
Weymouth
DT4 8SN

TS/64921/AC

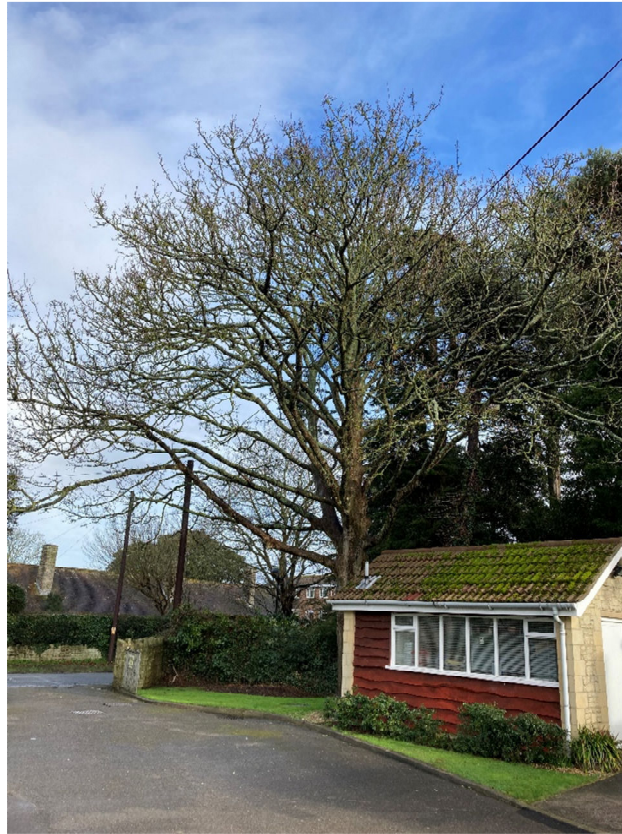
Tree No	Species	Life Stage	Observations	Recommendations	Work priority
1	Sycamore	Early mature	Branches close to overhead cable.	Prune to give 1m clearance from cable.	Moderate 1
15	Birch	Early mature	Branch tips close to gutter.	Prune to give 2m clearance from building.	Moderate 1
17	Cherry	Mature	Decay around attachment point of limb on south side at 2.5m above ground level – compression fork with included bark. No sign of life in limb and high secondary branch has canker.	Remove branch (see pic.3).	Moderate 1
37	Scots pine	Early mature	Two branches on west side of stem have recently failed. Branch directly below appears weak. Pair of branches beneath join stem with a swollen compression fork and small diameter at attachment point. All three remaining branches are exposed.	Remove three branches (see pics. 4 & 5).	Moderate 1

Pic. 1 – Overhead cable at edge of crown of T1

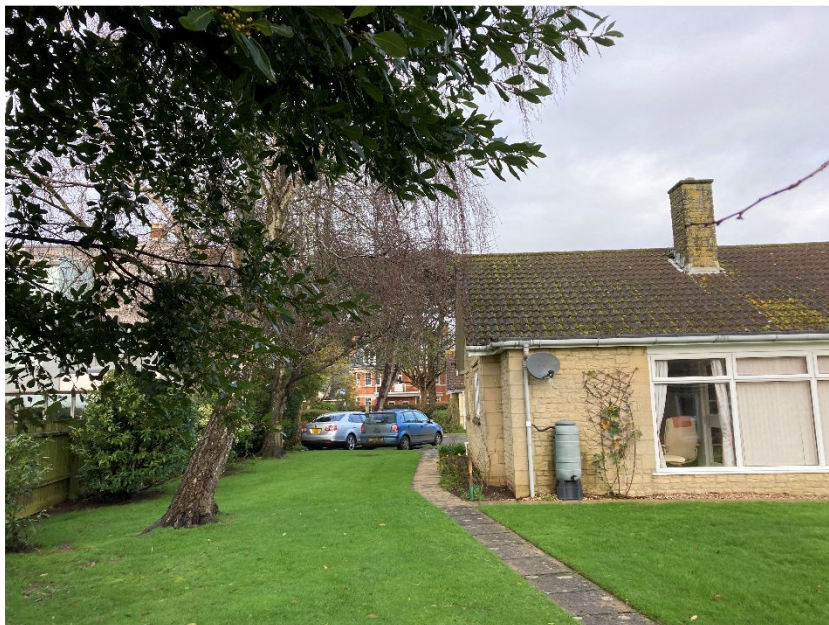
Pic. 2 – Birch, T15

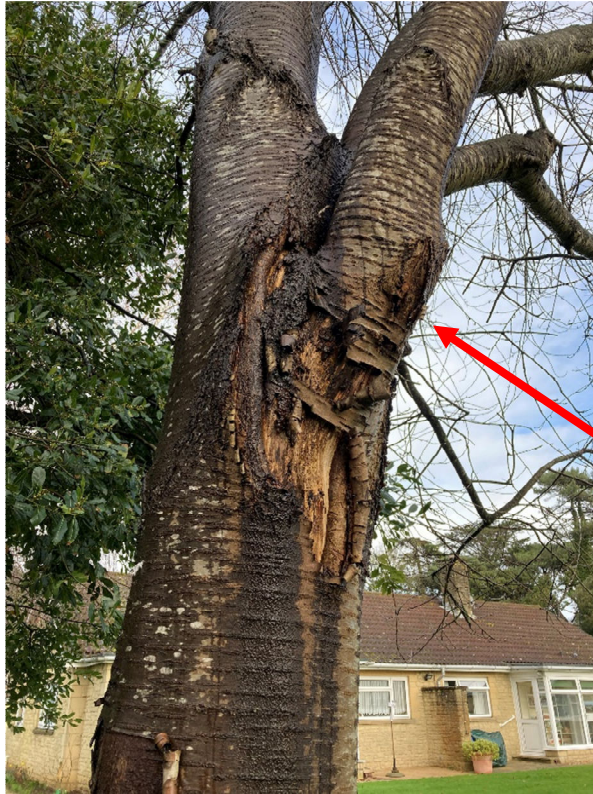
Pic. 3 – Branch to be removed from T17

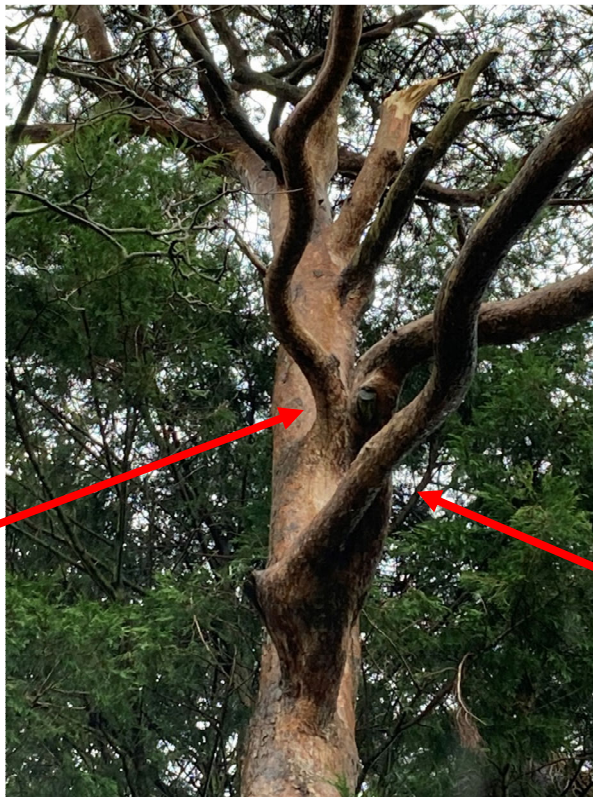
Pic.4 – Branches to be removed from T37

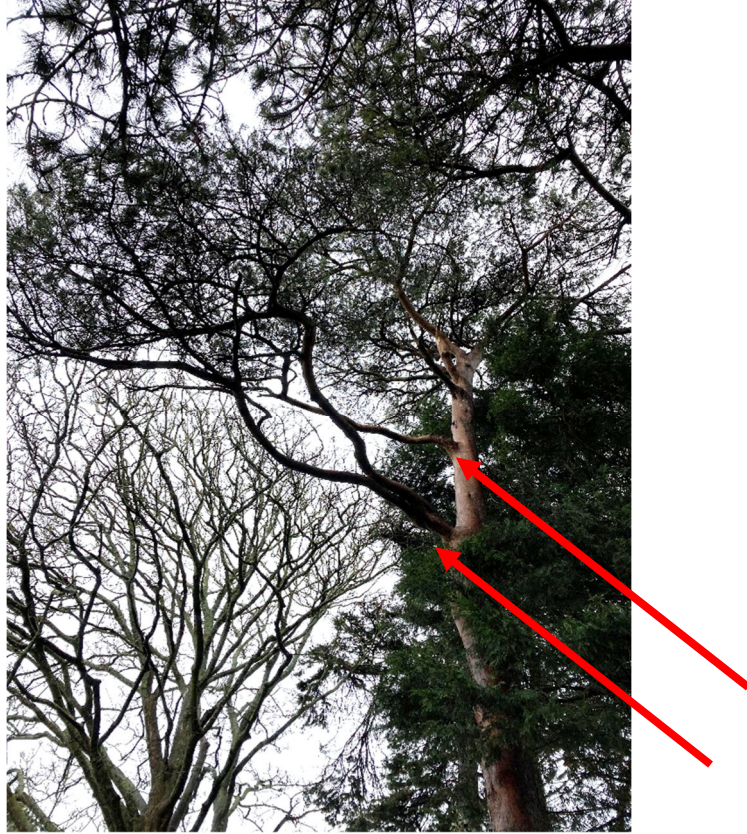
Pic.4 – Branches to be removed from T37
