## 8. Photographs

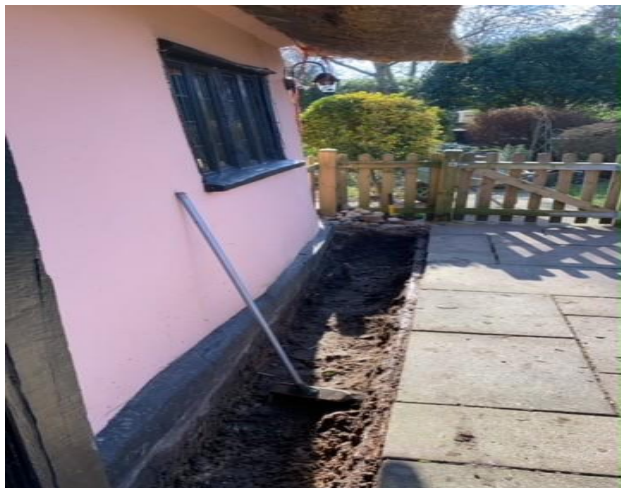
Photo 1

North West elevation

(after removal of the concrete path)

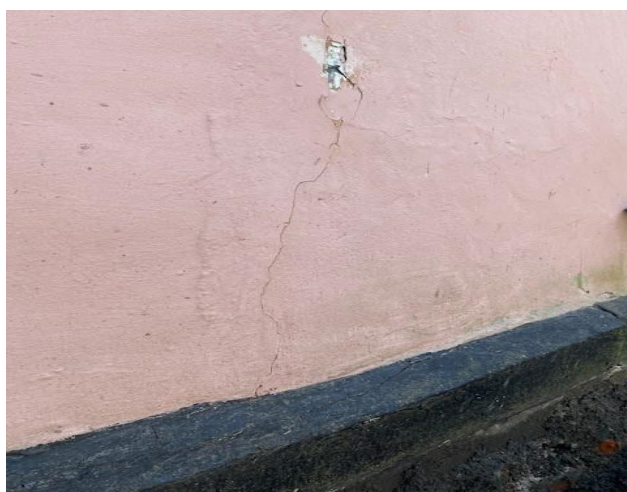
Photo 2

North West elevation

Crack in rendering

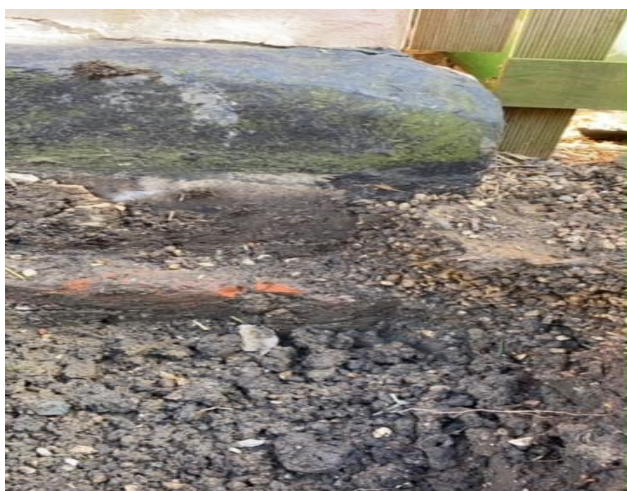
Photo 3

North West Elevation (corner)

(after removal of concrete path)

Showing damp and concrete over bricks

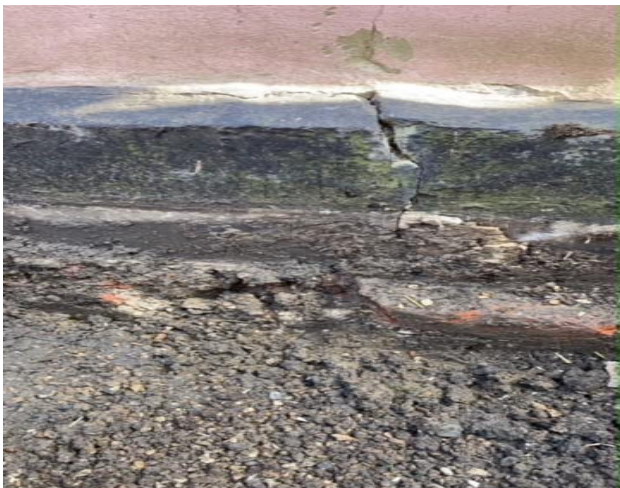
Photo 4

North West Elevation

Evidence of movement in bricks and soleplate, covered in concrete

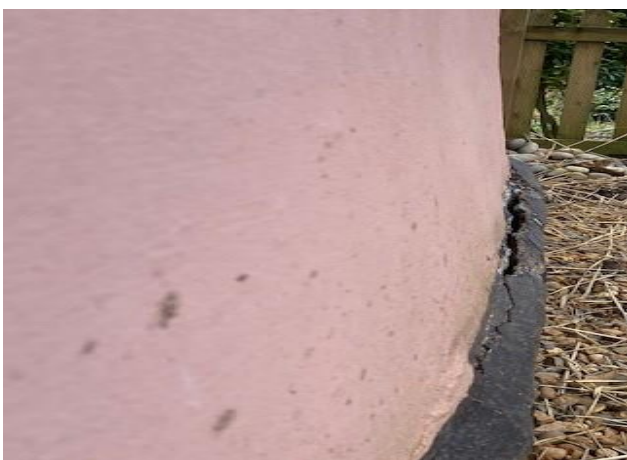
Photo 5

North West Elevation

Evidence of movement in soleplate, cracking of concrete covering and bowing render

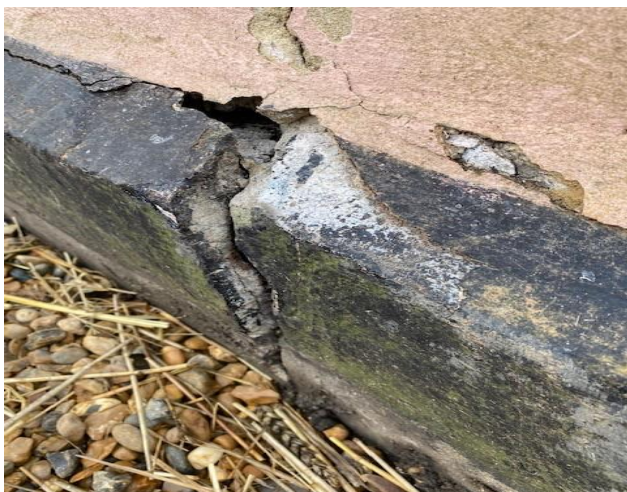
Photo 6

North West Elevation

Evidence of movement in soleplate, cracking of concrete covering

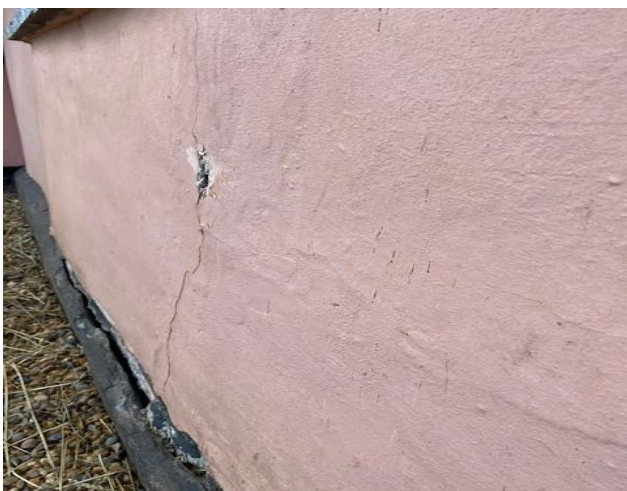
Photo 7

North West Elevation

Crack in concrete render tracking down to soleplate

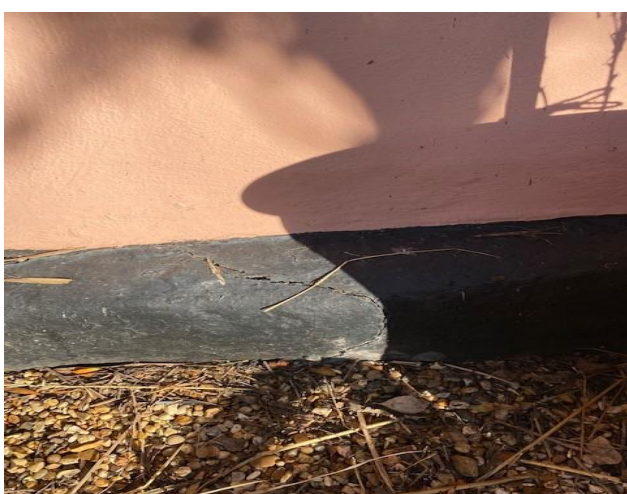
Photo 8

South West Elevation

Evidence of movement/cracking in concrete covering over bricks

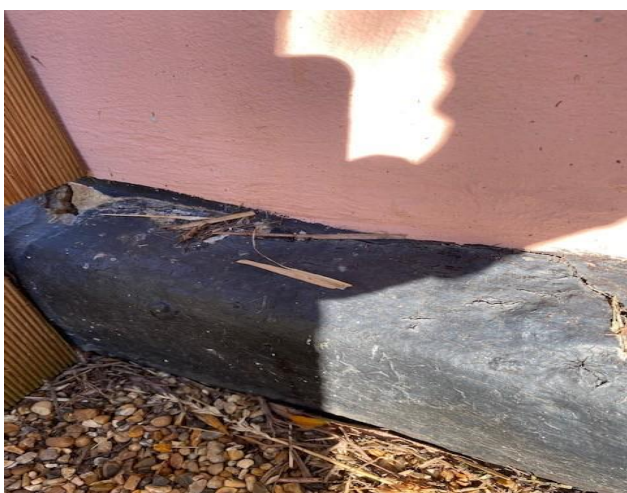
Photo 9

South West Elevation

Evidence of movement/cracking in concrete over bricks

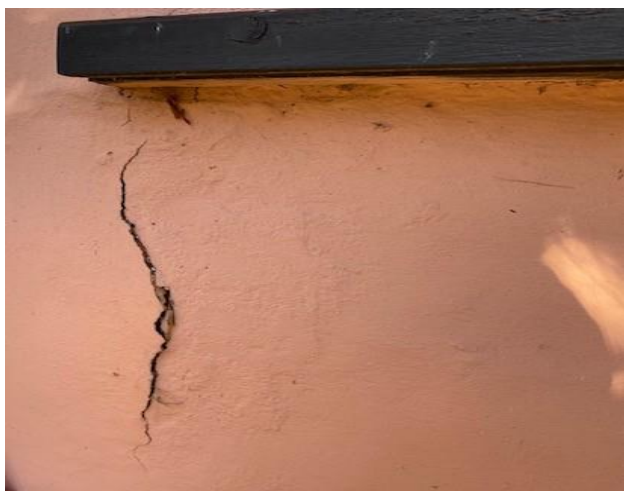
Photo 10

South West Elevation

Cracking in concrete render

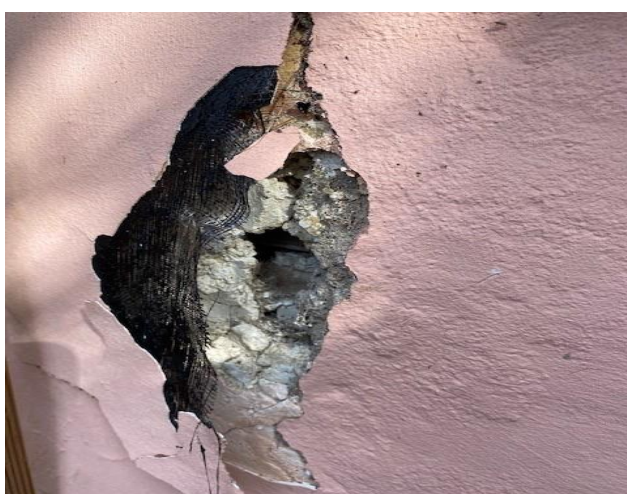
Photo 11

South West Elevation

Cracking in render giving sight to concrete

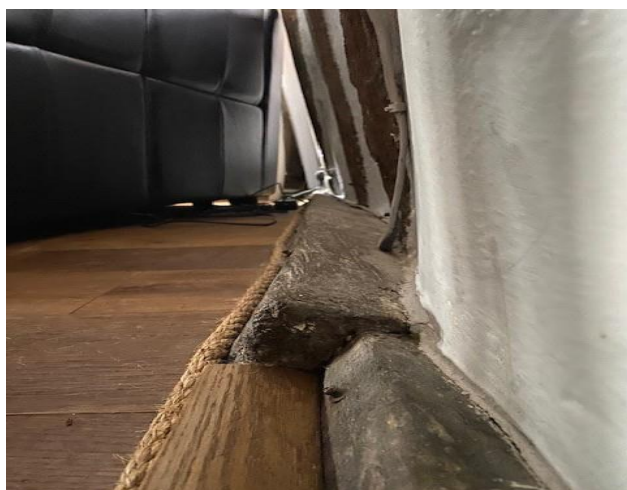
Photo 12

South West Elevation

Internal photograph showing rolled soleplate and vertical timbers not supported
