Tree Survey Report

GARDENERS COTTAGE AND BEECHGROVE
WOODLANDS PARK
DURRIS
ABERDEENSHIRE

August 2020

Struan Dalgleish Arboriculture
The Bothy
Drumoak
Aberdeenshire
AB31 5EP

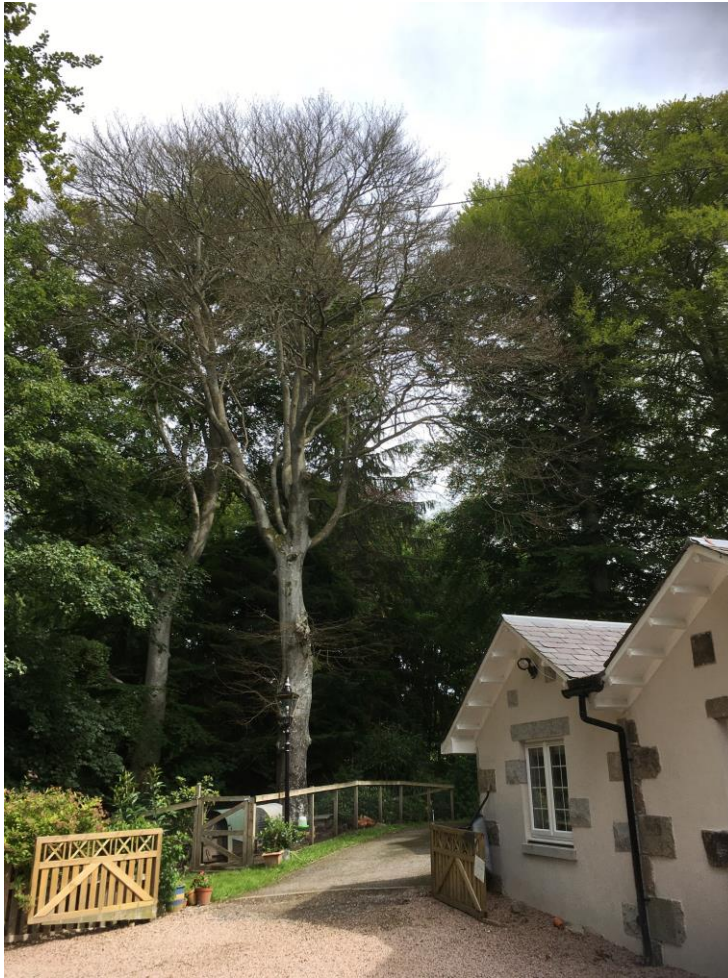
1. Beech 277

This large, recently dead tree overhangs the driveway to Gardeners Cottage and should be removed for reasons of safety.

Photo 1 – Dead beech 277.

This work should be undertaken within 3 months.

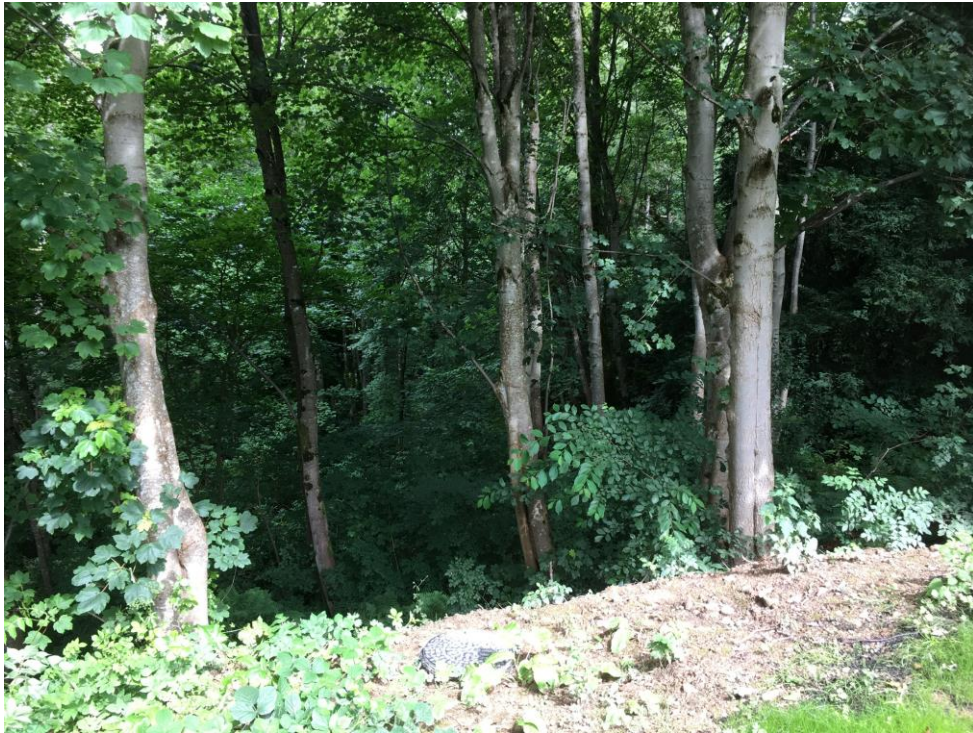
2. Group 282

The trees within this group occur on the steep embankment north west of Gardeners Cottage. Several self-seed, semi-mature sycamore, ash and beech form the dense canopy. Dense regeneration of young trees and rhododendron occurs beneath the canopy.

Photo 2 – Dense embankment of rhododendron and self-seeded trees. Periodic removal of rhododendron and thinning of young self-seeded trees could be undertaken to enhance the quality of individual trees within this group.

The removal of rhododendron and thinning of young trees could be undertaken to encourage the development of better trees and create a diverse woodland area. This work could be carried out within 12 months and at 10 yearly intervals thereafter.

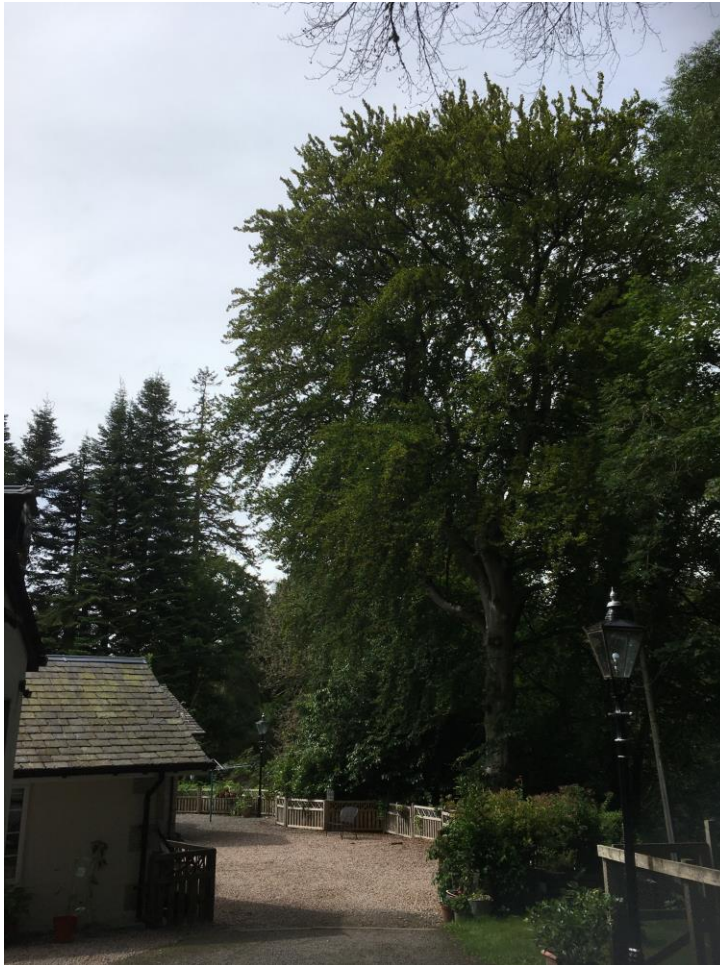
3. Beech 283

This mature beech tree overhangs the car parking area outside Gardeners Cottage. It grows from a low boundary wall which has partially collapsed, possibly at least partially due to the increase in girth of roots.

The crown of the tree appears fairly dense with an amount deadwood within the interior.

Photo 3 – Crown cleaning of beech 283 would reduce the risk of falling branches.

Crown cleaning has been recommended due to the close proximity of the tree to the house and parked cars. This involves the pruning-out larger pieces of deadwood, and poorly formed branches, while retaining the overall shape of the tree.

This work should be undertaken within 6 months.

Any work to repair the wall will require to be carried out carefully to avoid damaging tree roots.

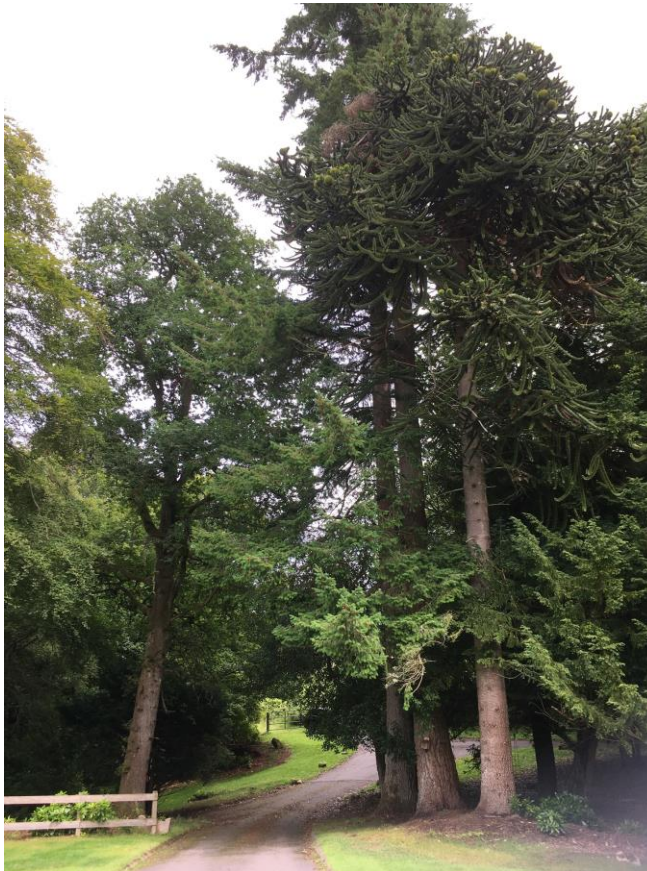
5. Oak 314 and 315

The poor-quality, semi-mature Douglas fir cross's the trunk of 314 and should be removed to maintain the form of the oak.

A broken hanging branch, fallen from oak 315 is suspended above the driveway in the crown of an adjacent holly. This should be removed.

Photo 4 - Deadwooding and removal of a poorly performing semi-mature tree would reduce the risk and improve the appearance of trees on the driveway.

This work should be undertaken within 6 months.

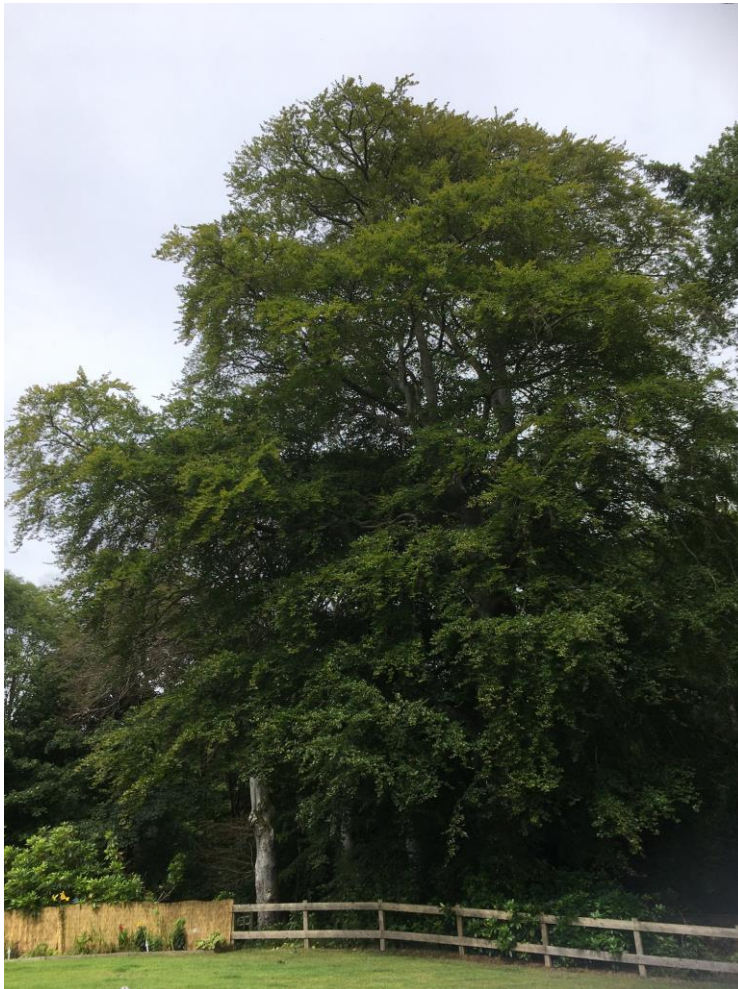
6. Beech 316

This mature tree overhangs the driveway and woodpile at Gardeners Cottage and the garden boundary and lawn of Beechgrove.

The numerous small fungal fruiting bodies on the large wound on the lower trunk could be *Bjerkandera adusta*. The tree is developing new wood around the margins of the old wound.

A significant amount of deadwood is present in the crown and crown cleaning has been recommended as described for 283 above.

Photo 5 - Crown cleaning would reduce the risk from falling branches.

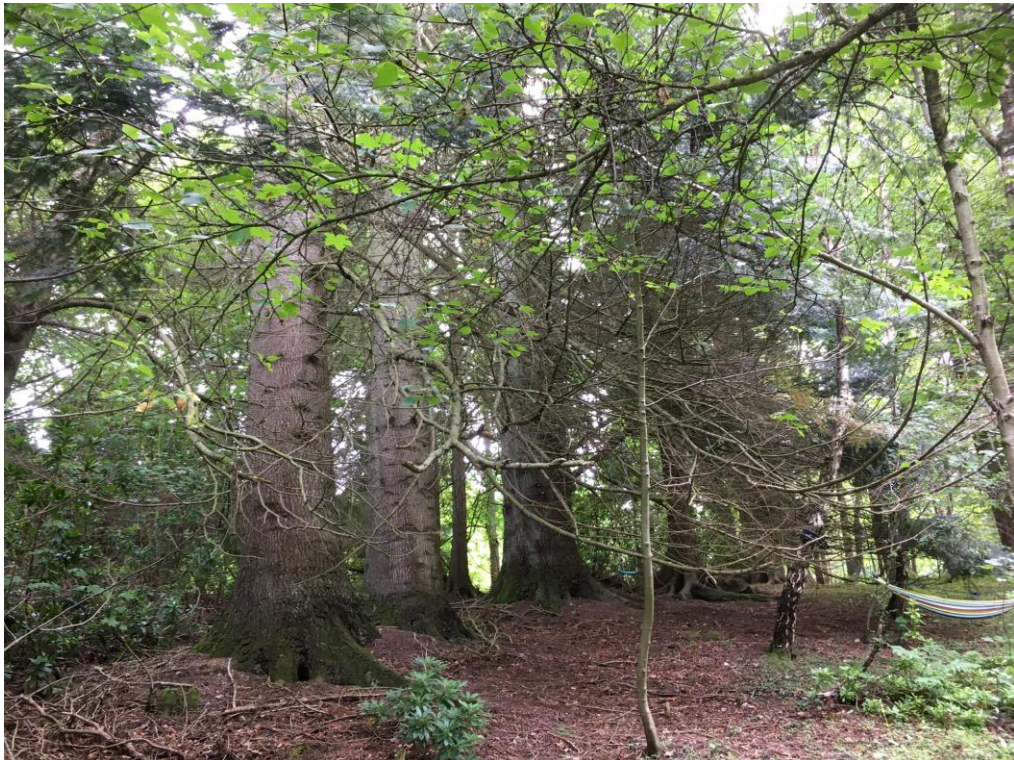
7. Further Inspection of Tall Conifers

The close proximity of neighbouring trees and height of several conifers made visual inspection of the upper parts of these trees difficult, even with binoculars.

Recent failures of Grand firs 290 and 291 were noted to have occurred at poorly formed forks within the upper crown. Nearby similar tree 294 appears to have a poorly formed top and may be prone to failure at the point of defect.

Photo 6 - The use of drone footage would provide a more detailed inspection of the upper parts of tall trees which are difficult to see from ground level.

To obtain a better view and allow more detailed assessment of the upper parts of the tall conifers drone filming can be undertaken.

Aerial inspection of tall conifers 297 and 301 would provide a more detailed inspection of the upper parts of these large trees which occur close to gardens.

This work should be carried out within 6 months.
