Project Name: Jonathan Ungar 15.4.14	Project number:	Date: 29/04/2014	Contact:	
---	-----------------	---------------------	----------	--

Project name :
Jonathan Ungar 15.4.14

Contractor **DrainTechnology (UK) Ltd**
Contact Name: **Paul Ferrito**
Department: **Surveying**
Road: **67 Lashford Lane**
Town: **Dry Sandford**
County: **Oxfordshire, OX13 6DZ**
Telephone:
Fax:
Mobile:
E-mail:

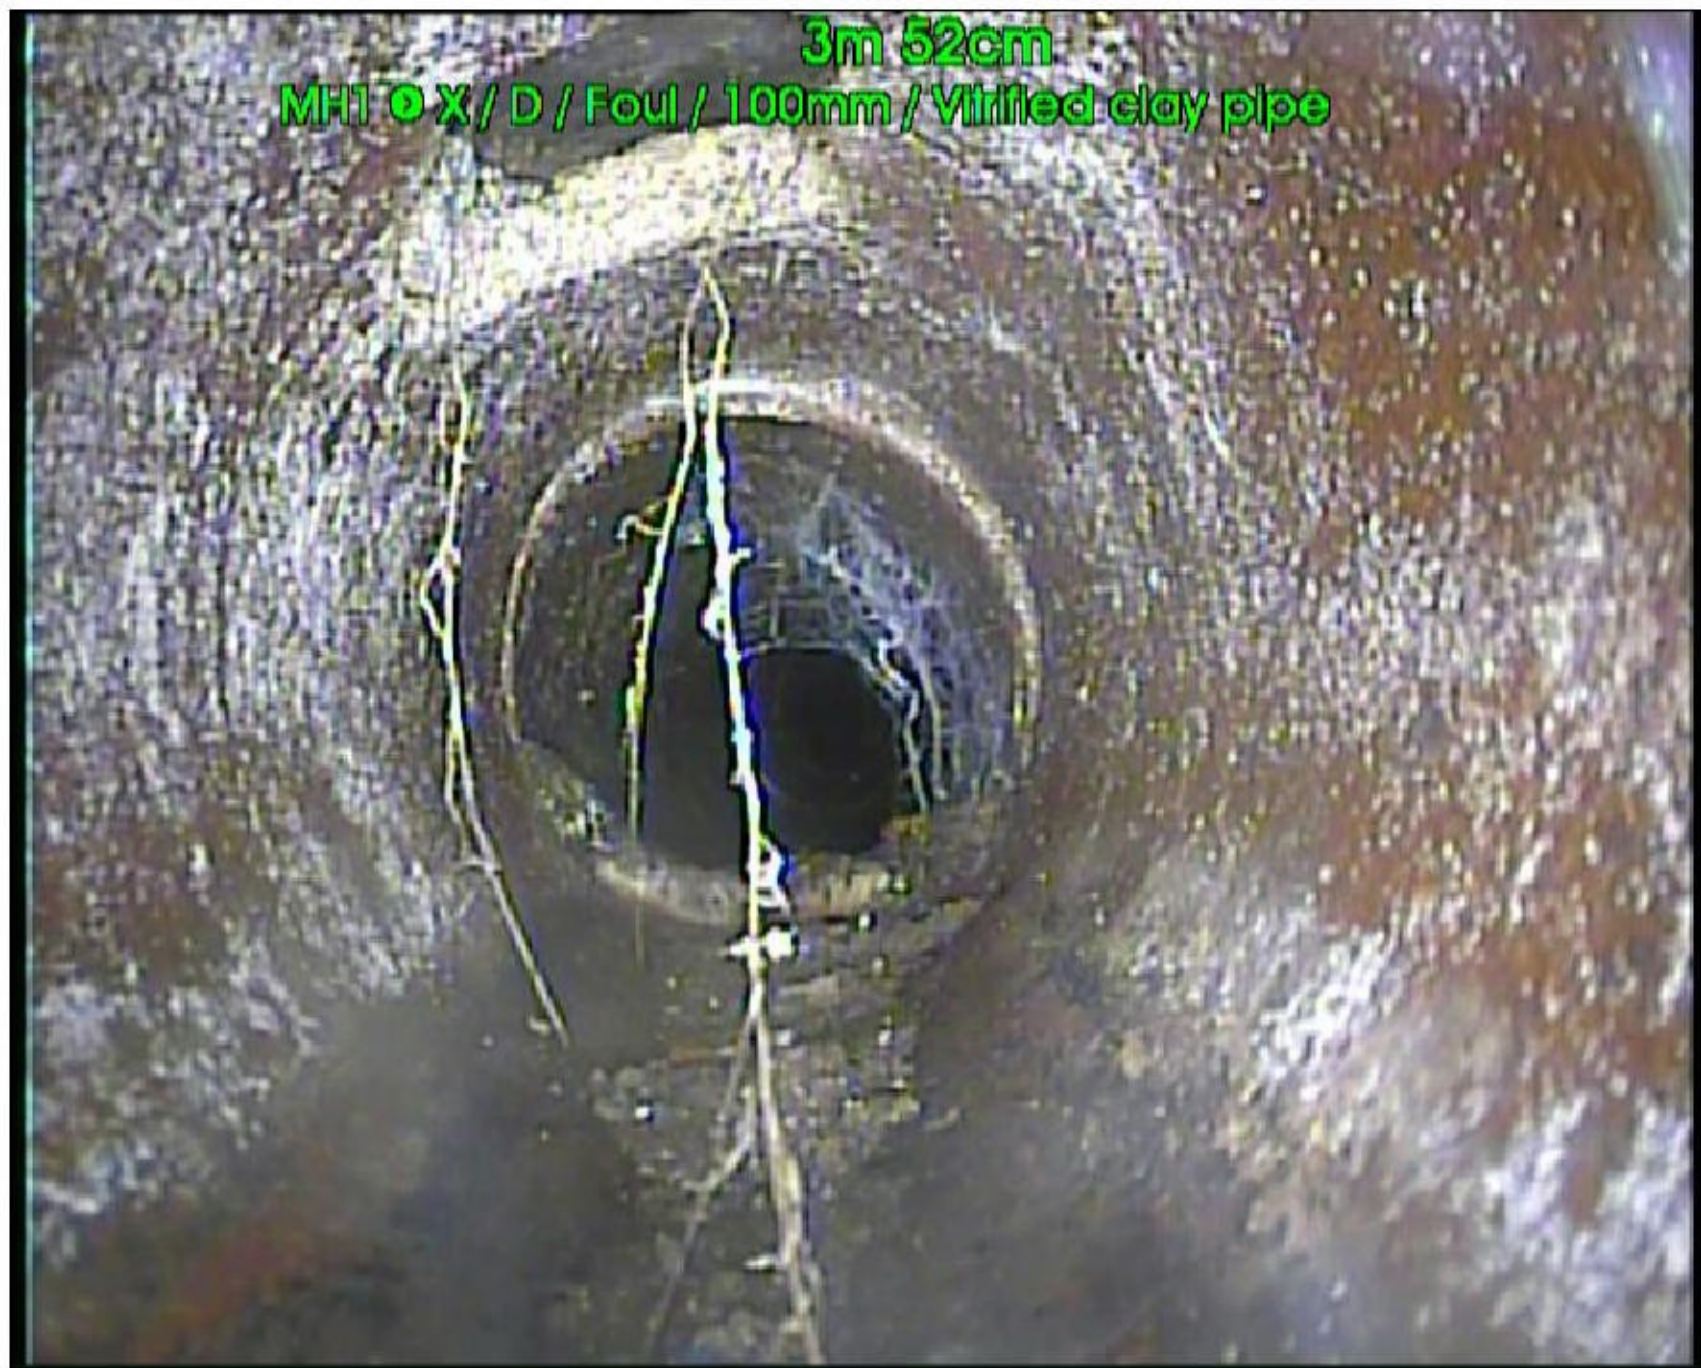
Comment : **The two holes may have had faulty repairs done.**

Photo: 2_2_4_A.jpg
 3.52m, Hole in drain/sewer from 10 O'Clock to 11 O'Clock
 POSS CONNECTION FOR GULLIES

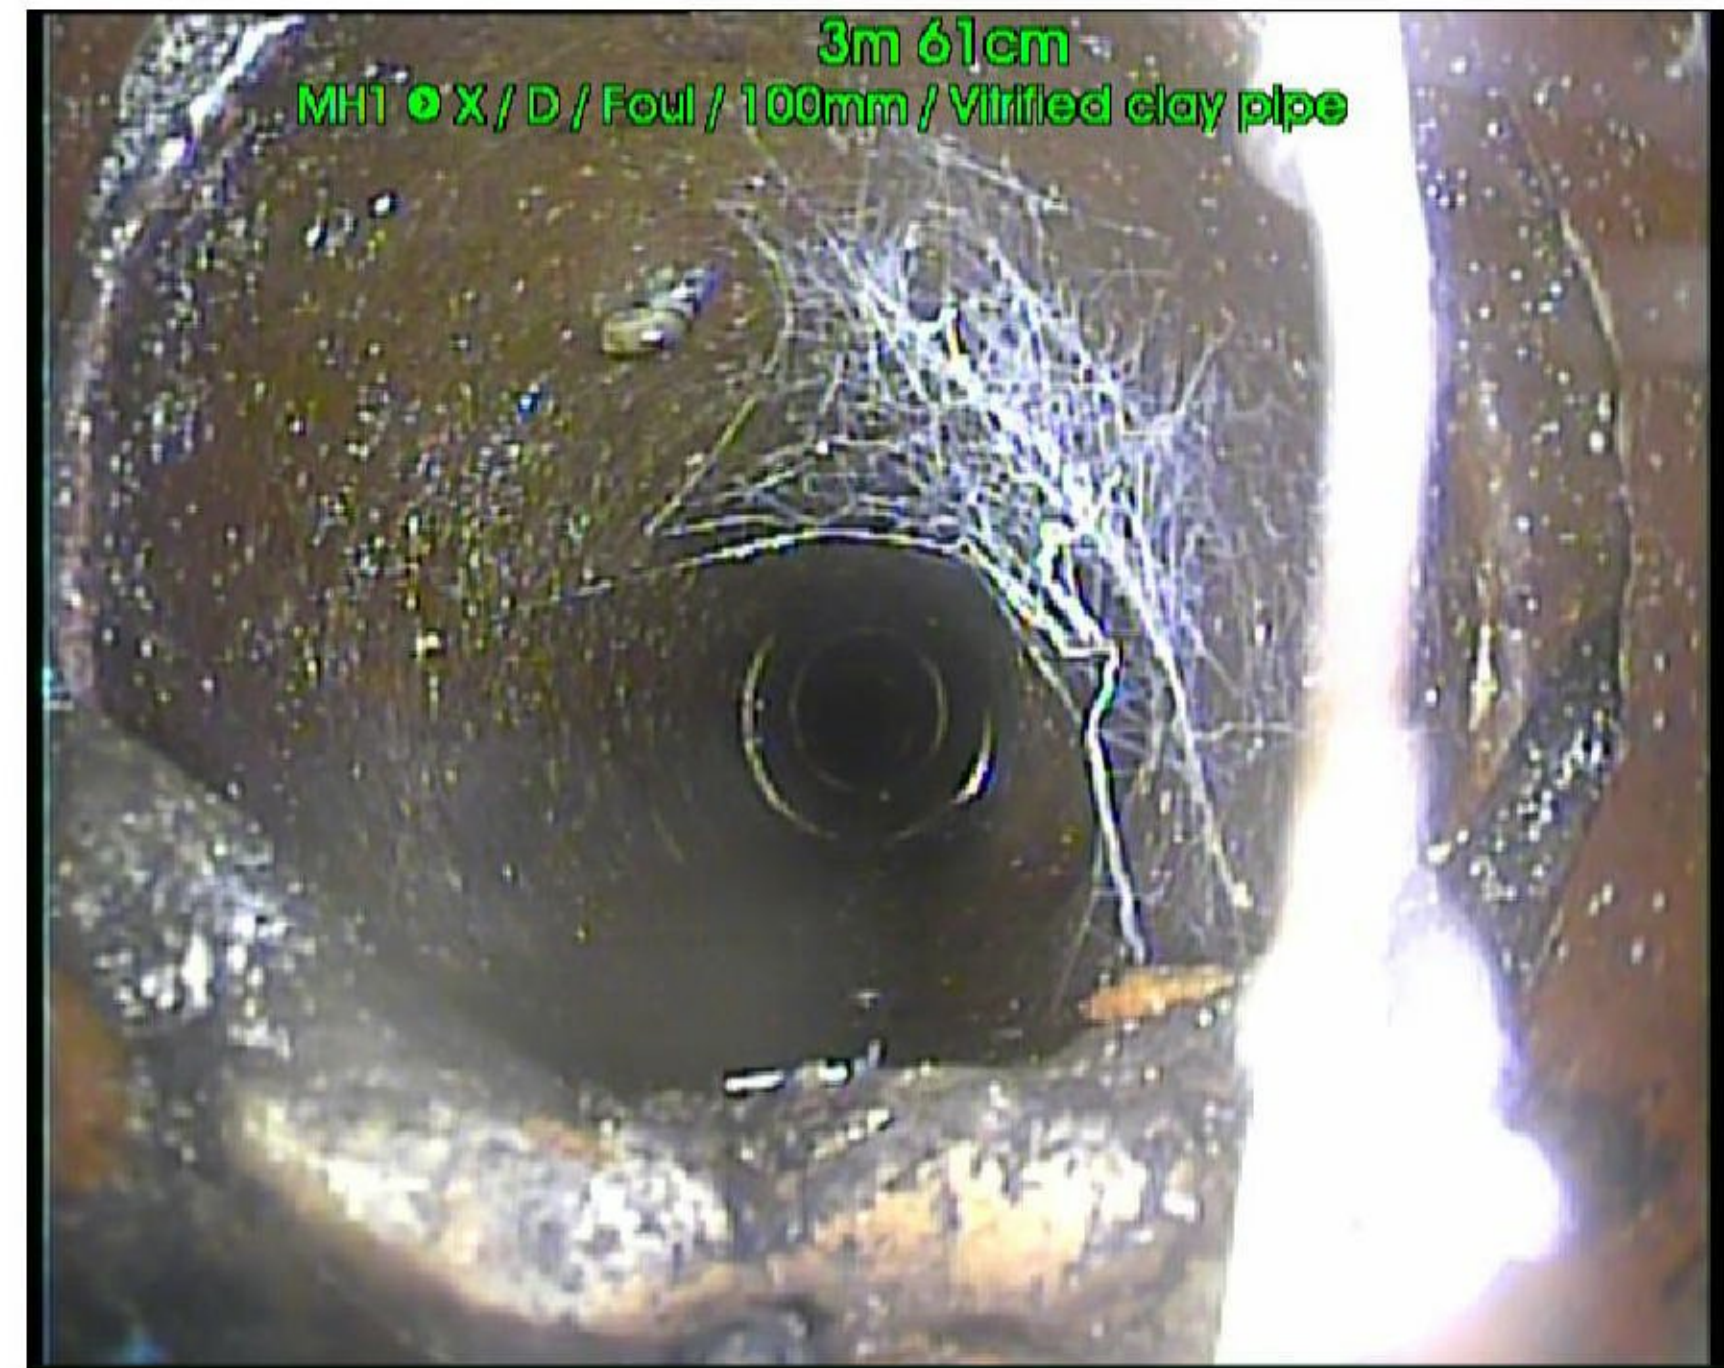
Photo: 2_2_5_A.jpg
 3.61m, Attached deposits, encrustation from 4 O'Clock to 8 O'Clock 15 % cross-sectional area loss SCALE

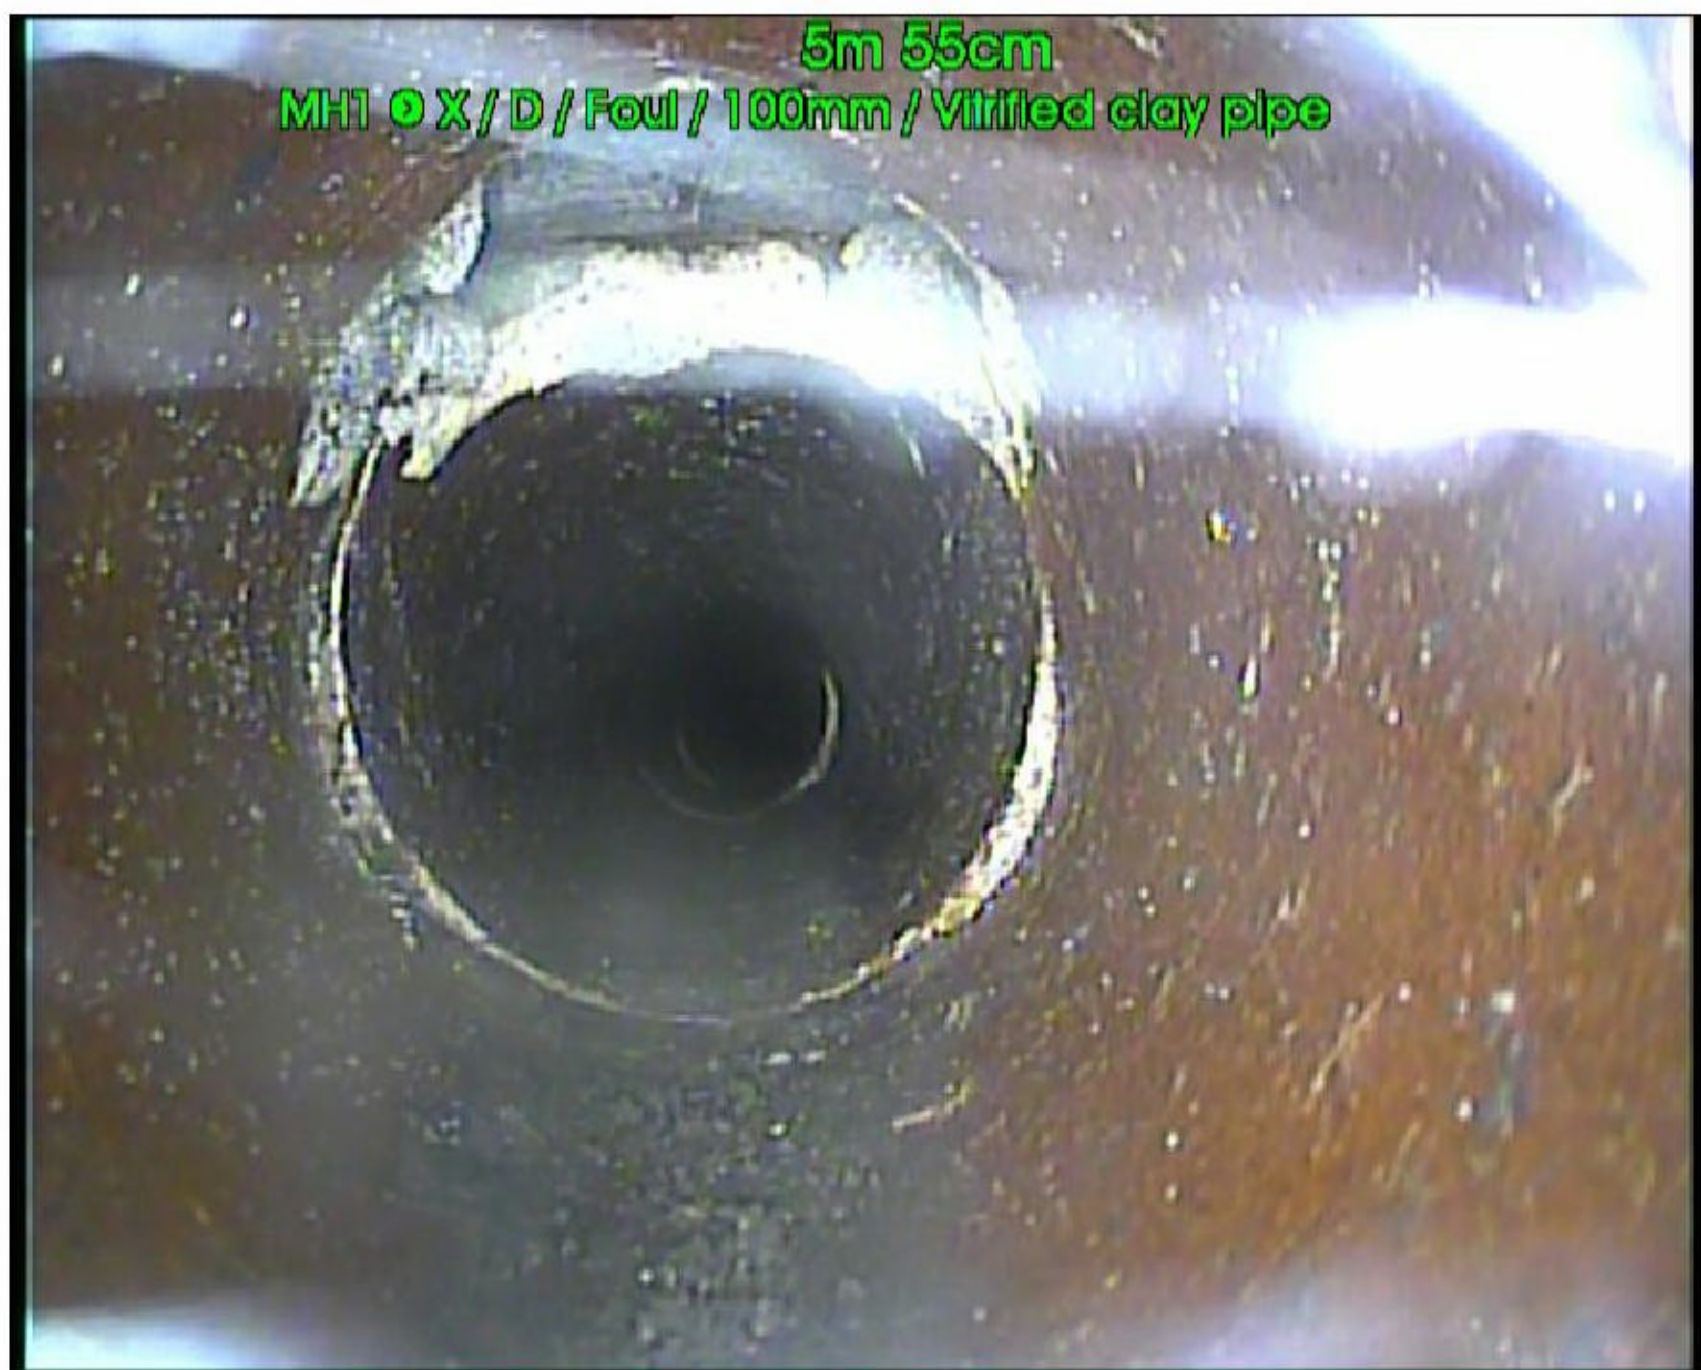
Photo: 2_2_6_A.jpg
 5.55m, Hole in drain/sewer from 10 O'Clock to 2 O'Clock

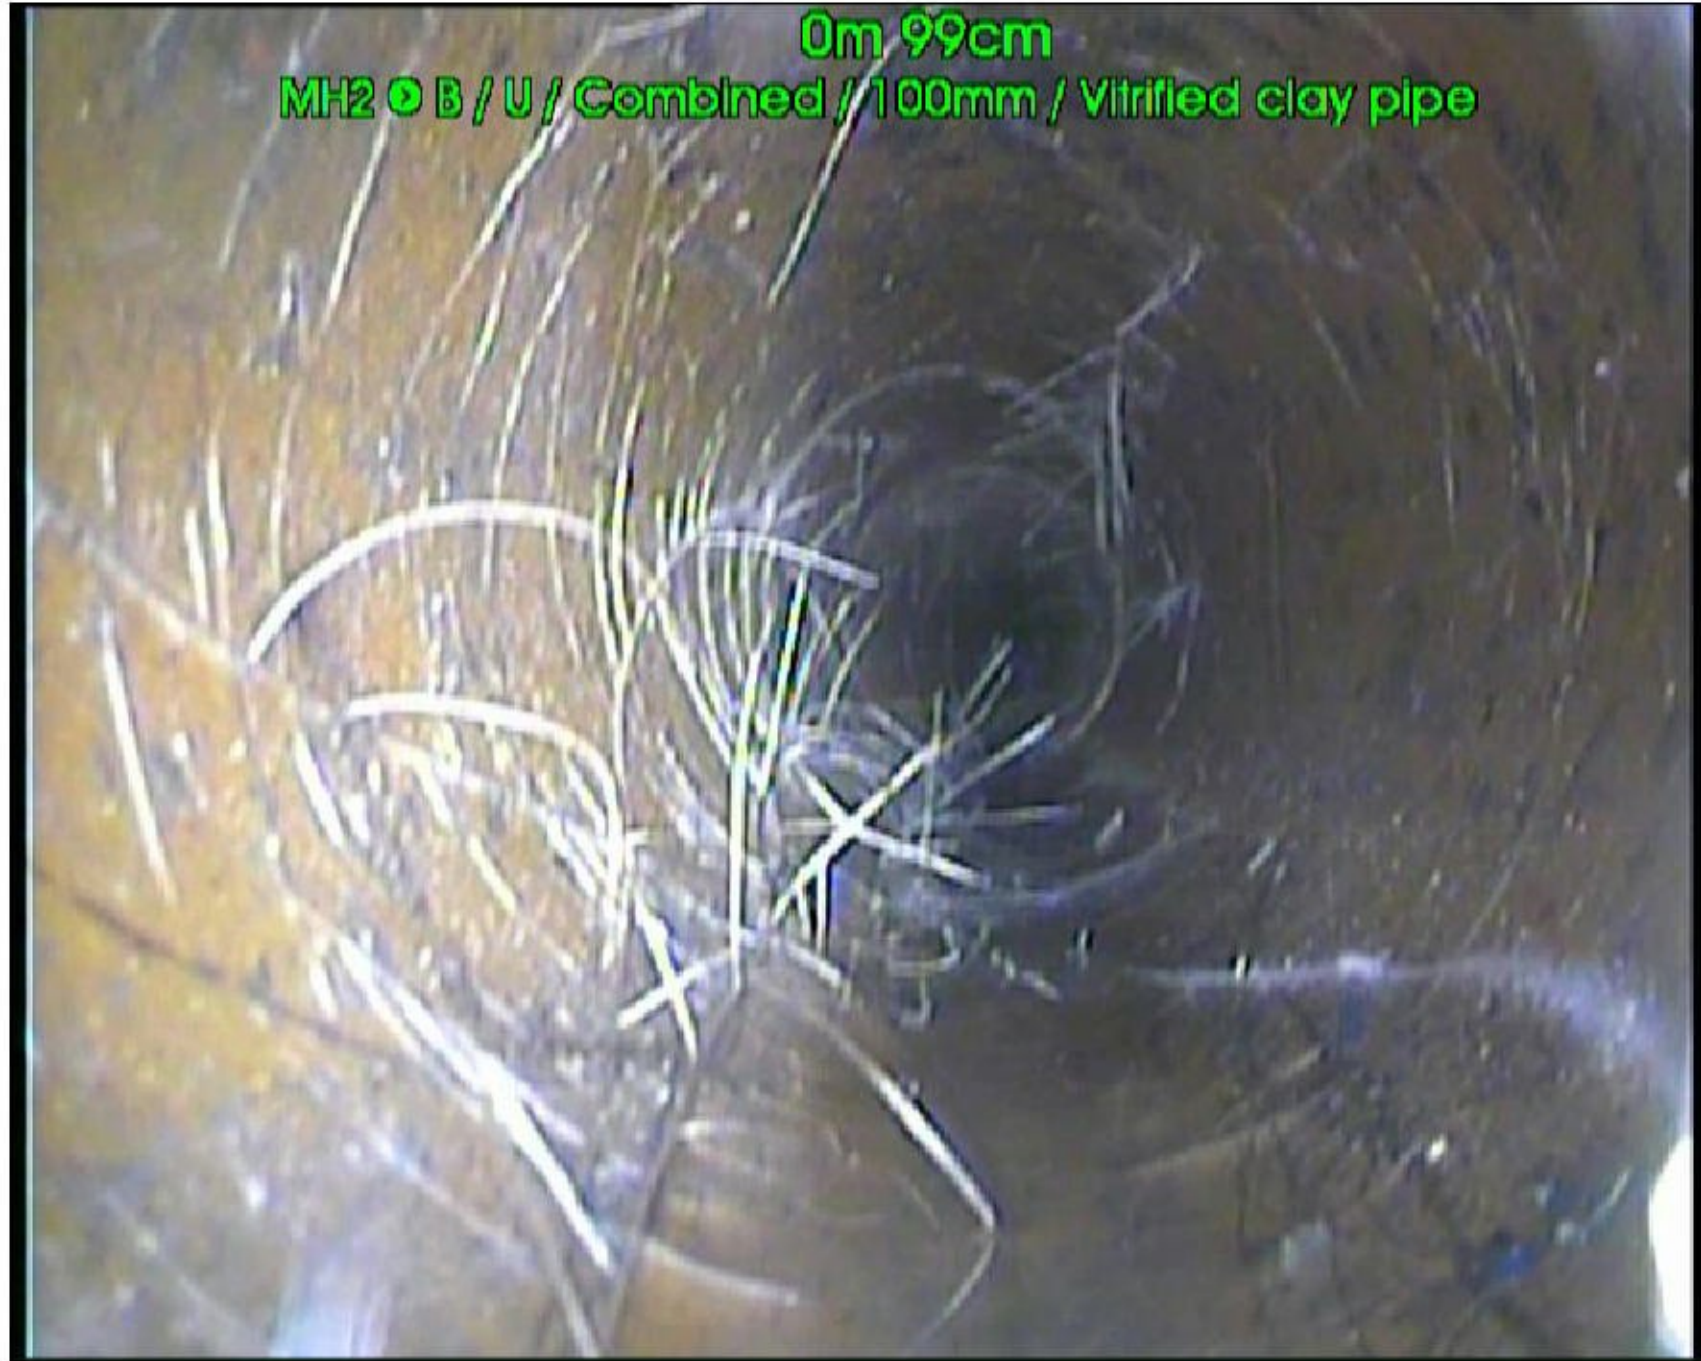
Photo: 5_5_18_A.jpg
0.99m, Roots, fine S1

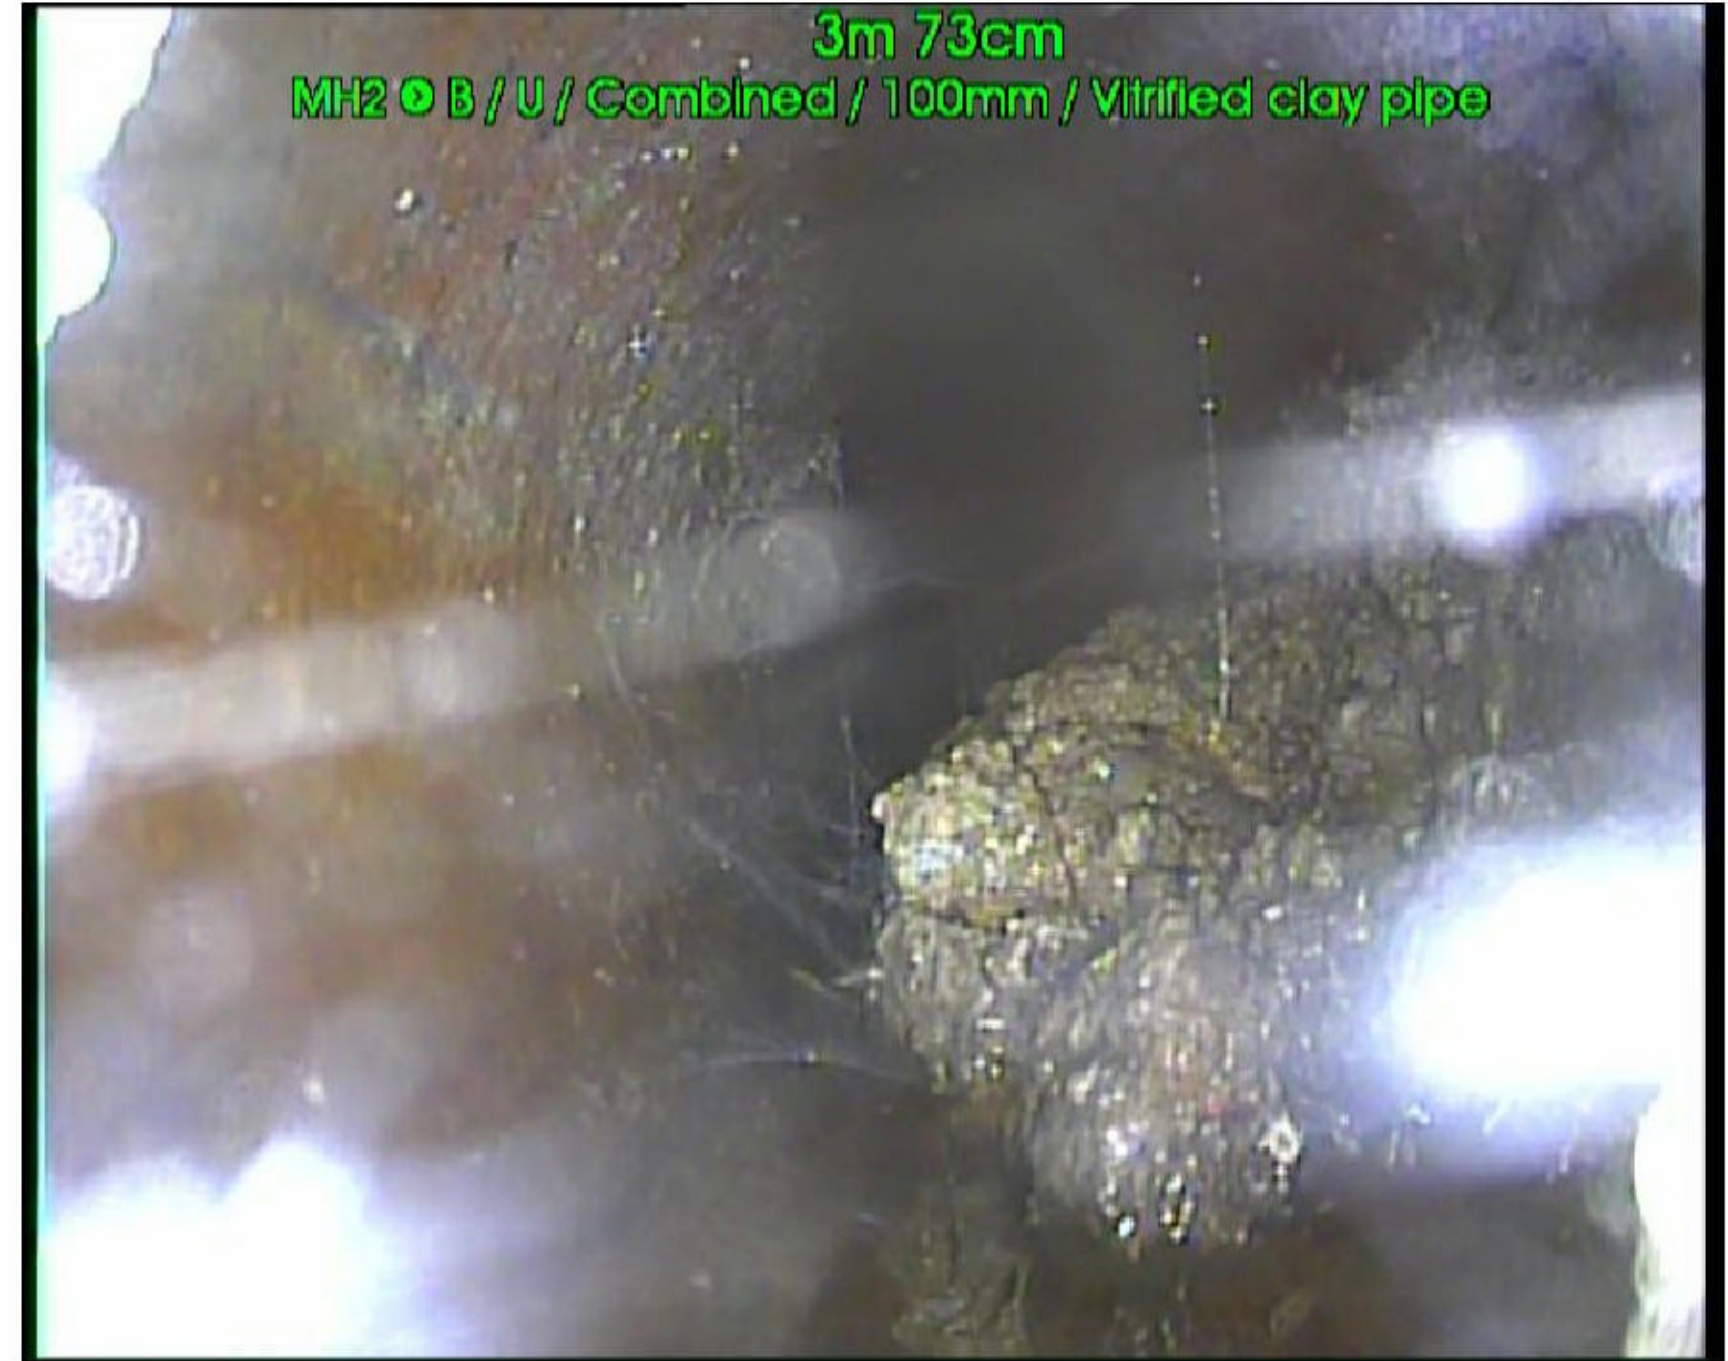
Photo: 5_5_20_A.jpg
3.73m, Roots, fine F1

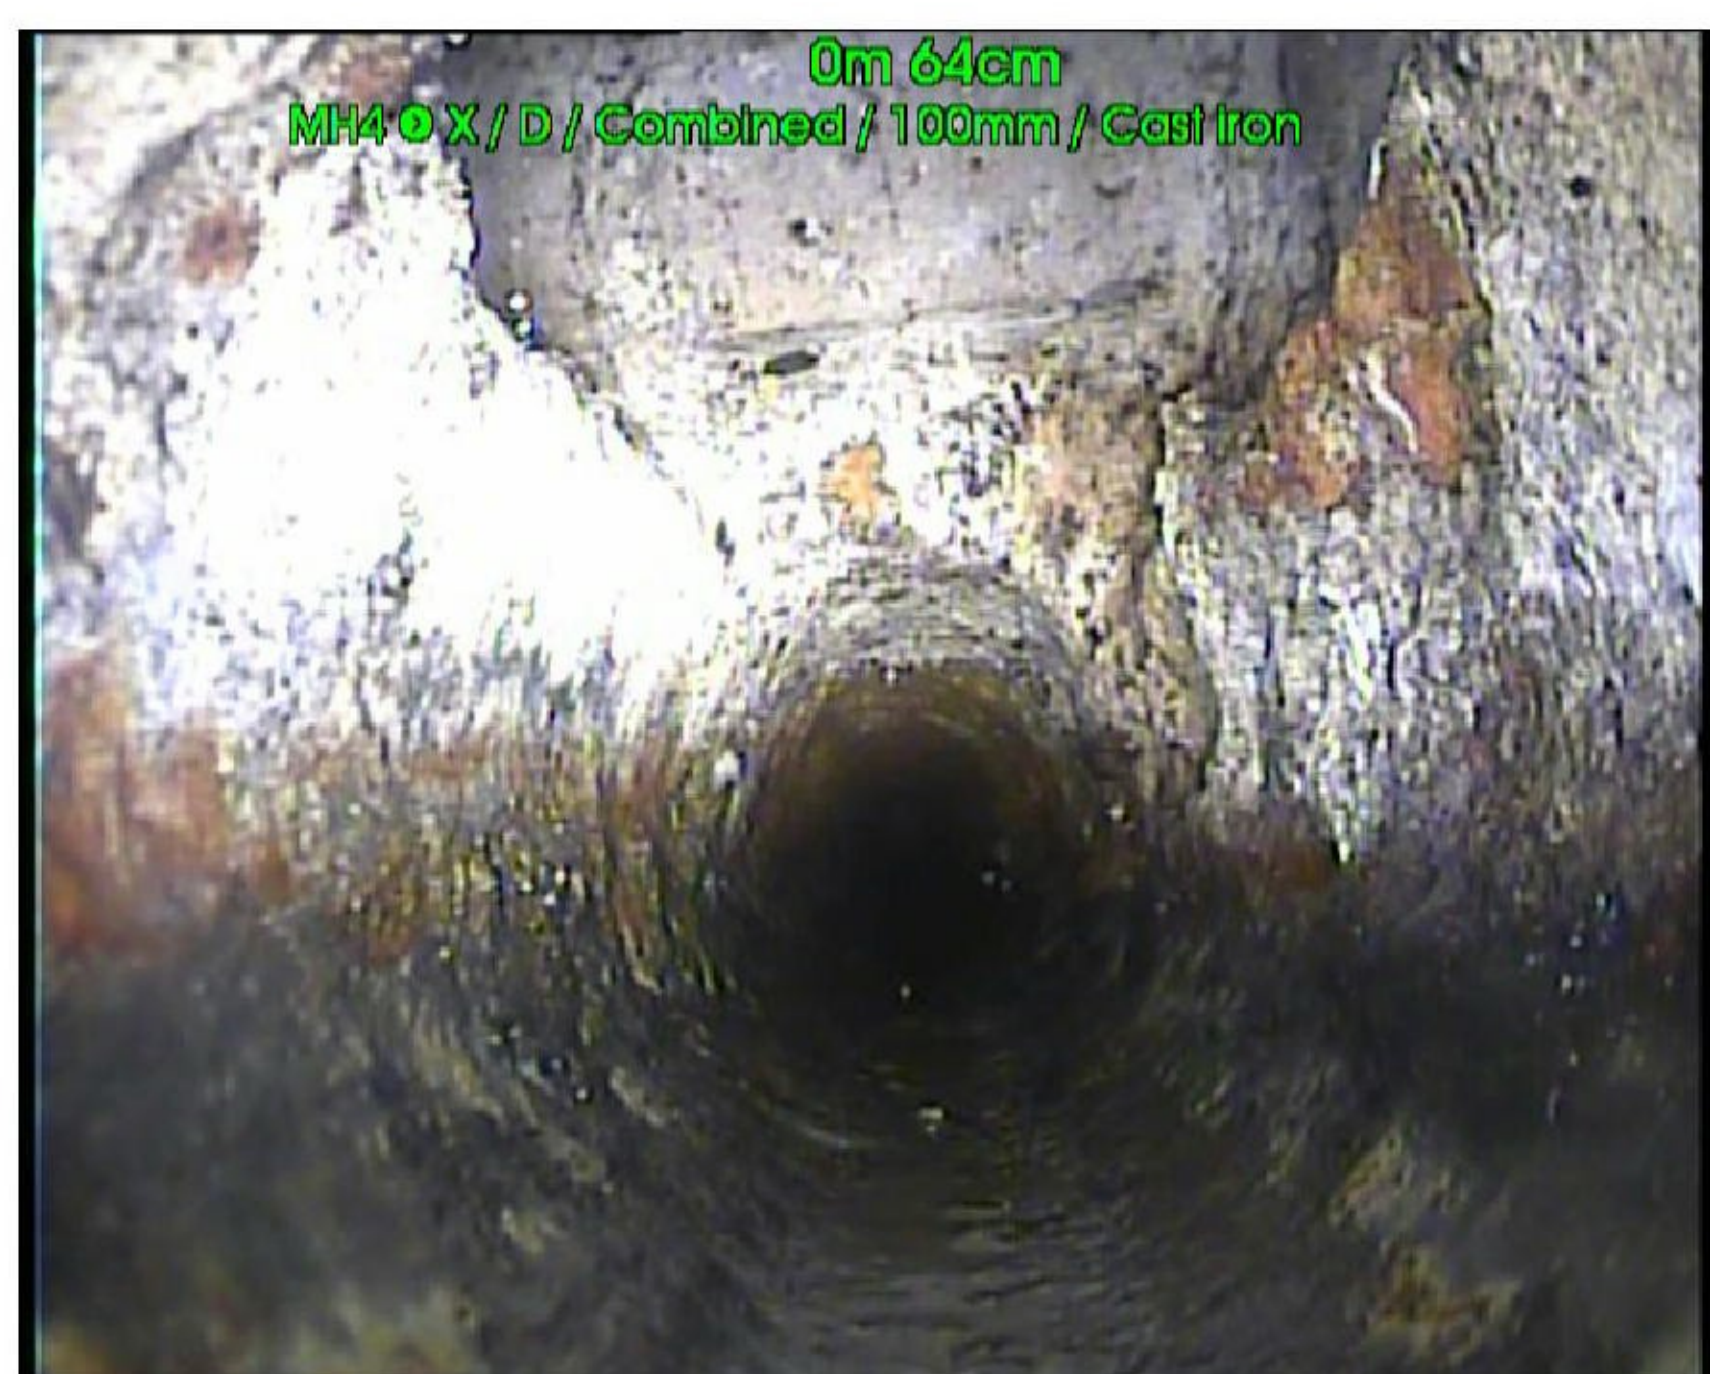
Photo: 9_9_40_A.jpg
0.6m, General remark POSS HOLE OR CONNECTION

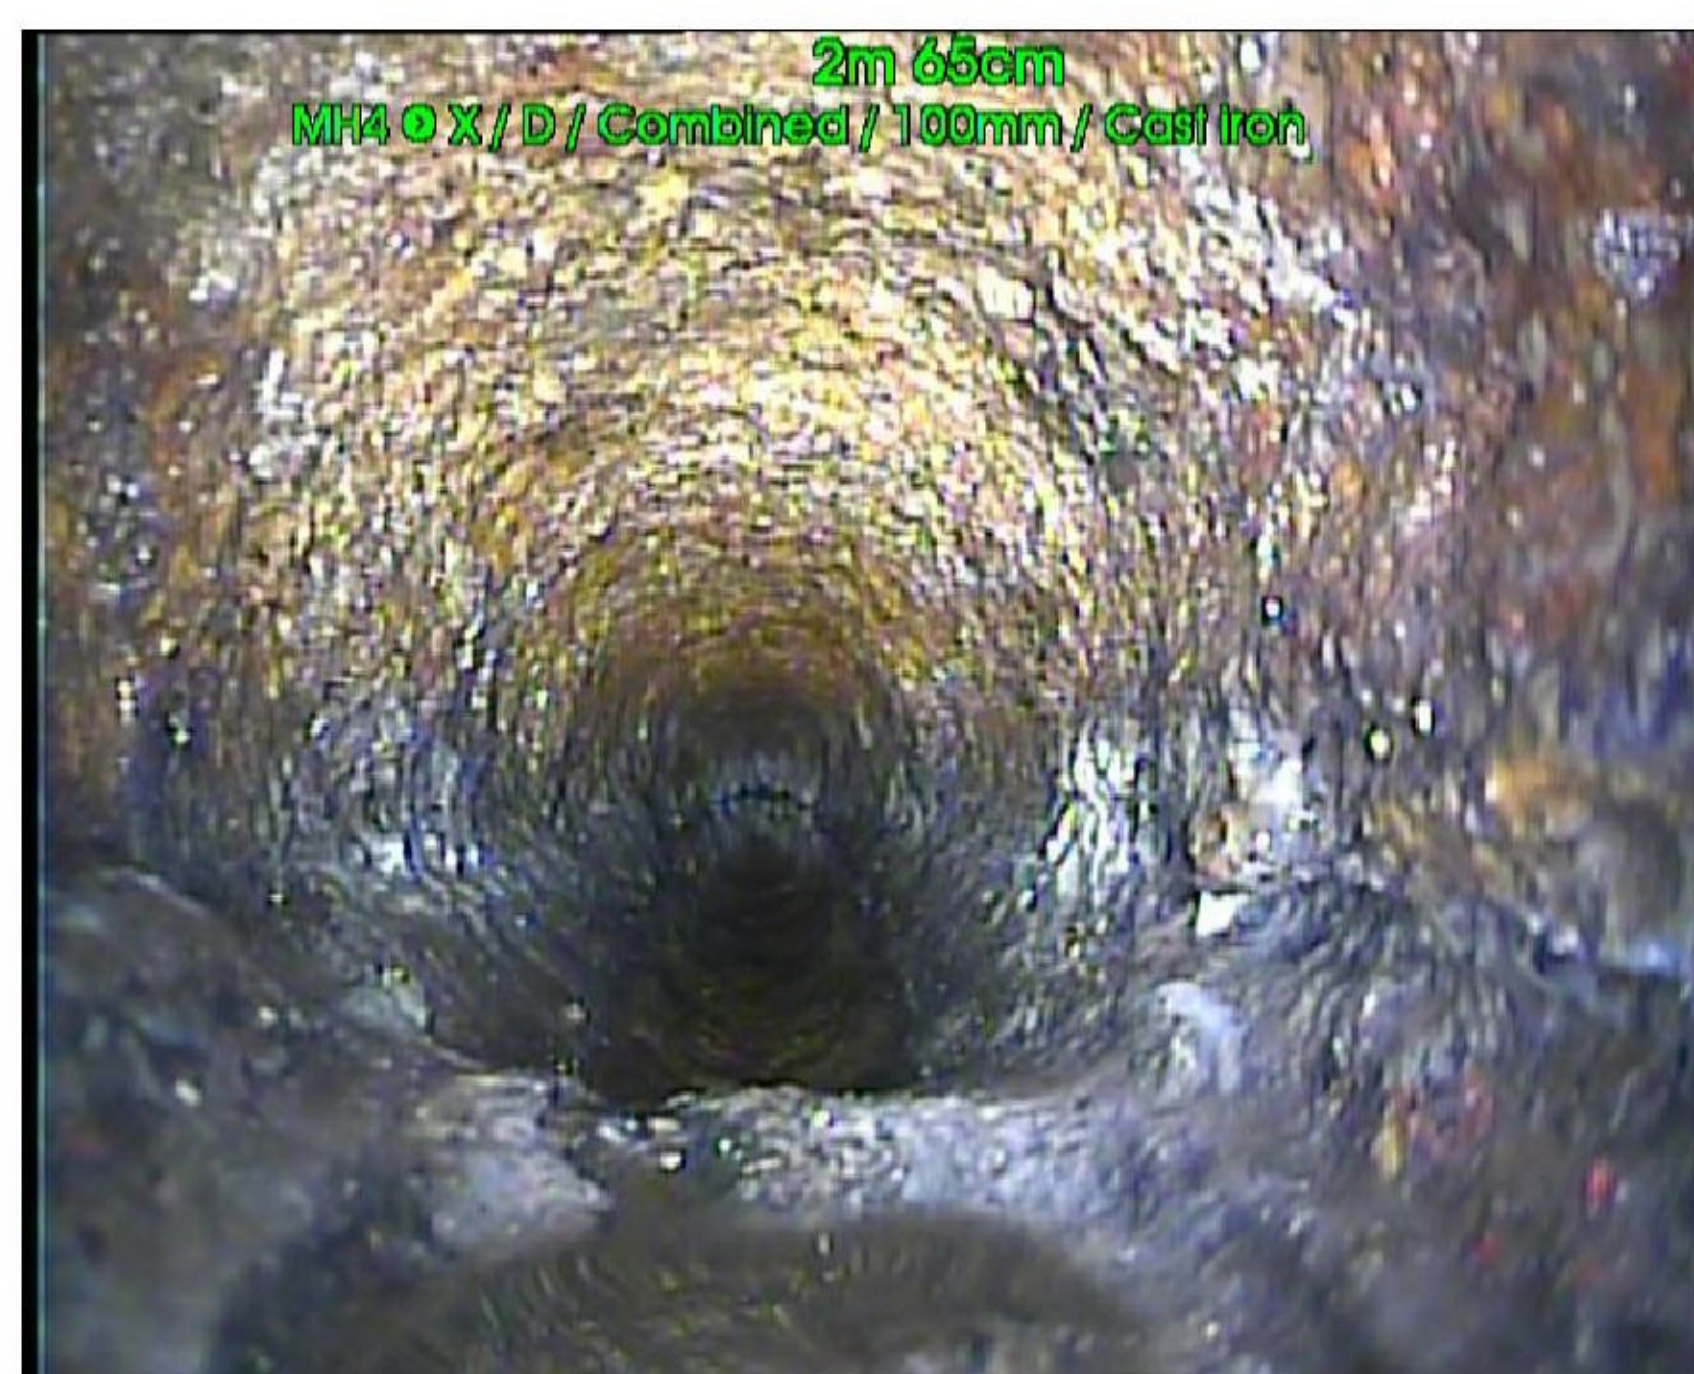
With regard to the internal drainage, manhole 4 downstream X to manhole 5 was in poor state holding water and will require degreasing and HPW jet cleaning to remove the scale and grease build up that has occurred over time.

Photo: 9_9_43_A.jpg
2.6m, Attached deposits, encrustation from 5 O'Clock to 7 O'Clock 20 % cross-sectional area loss

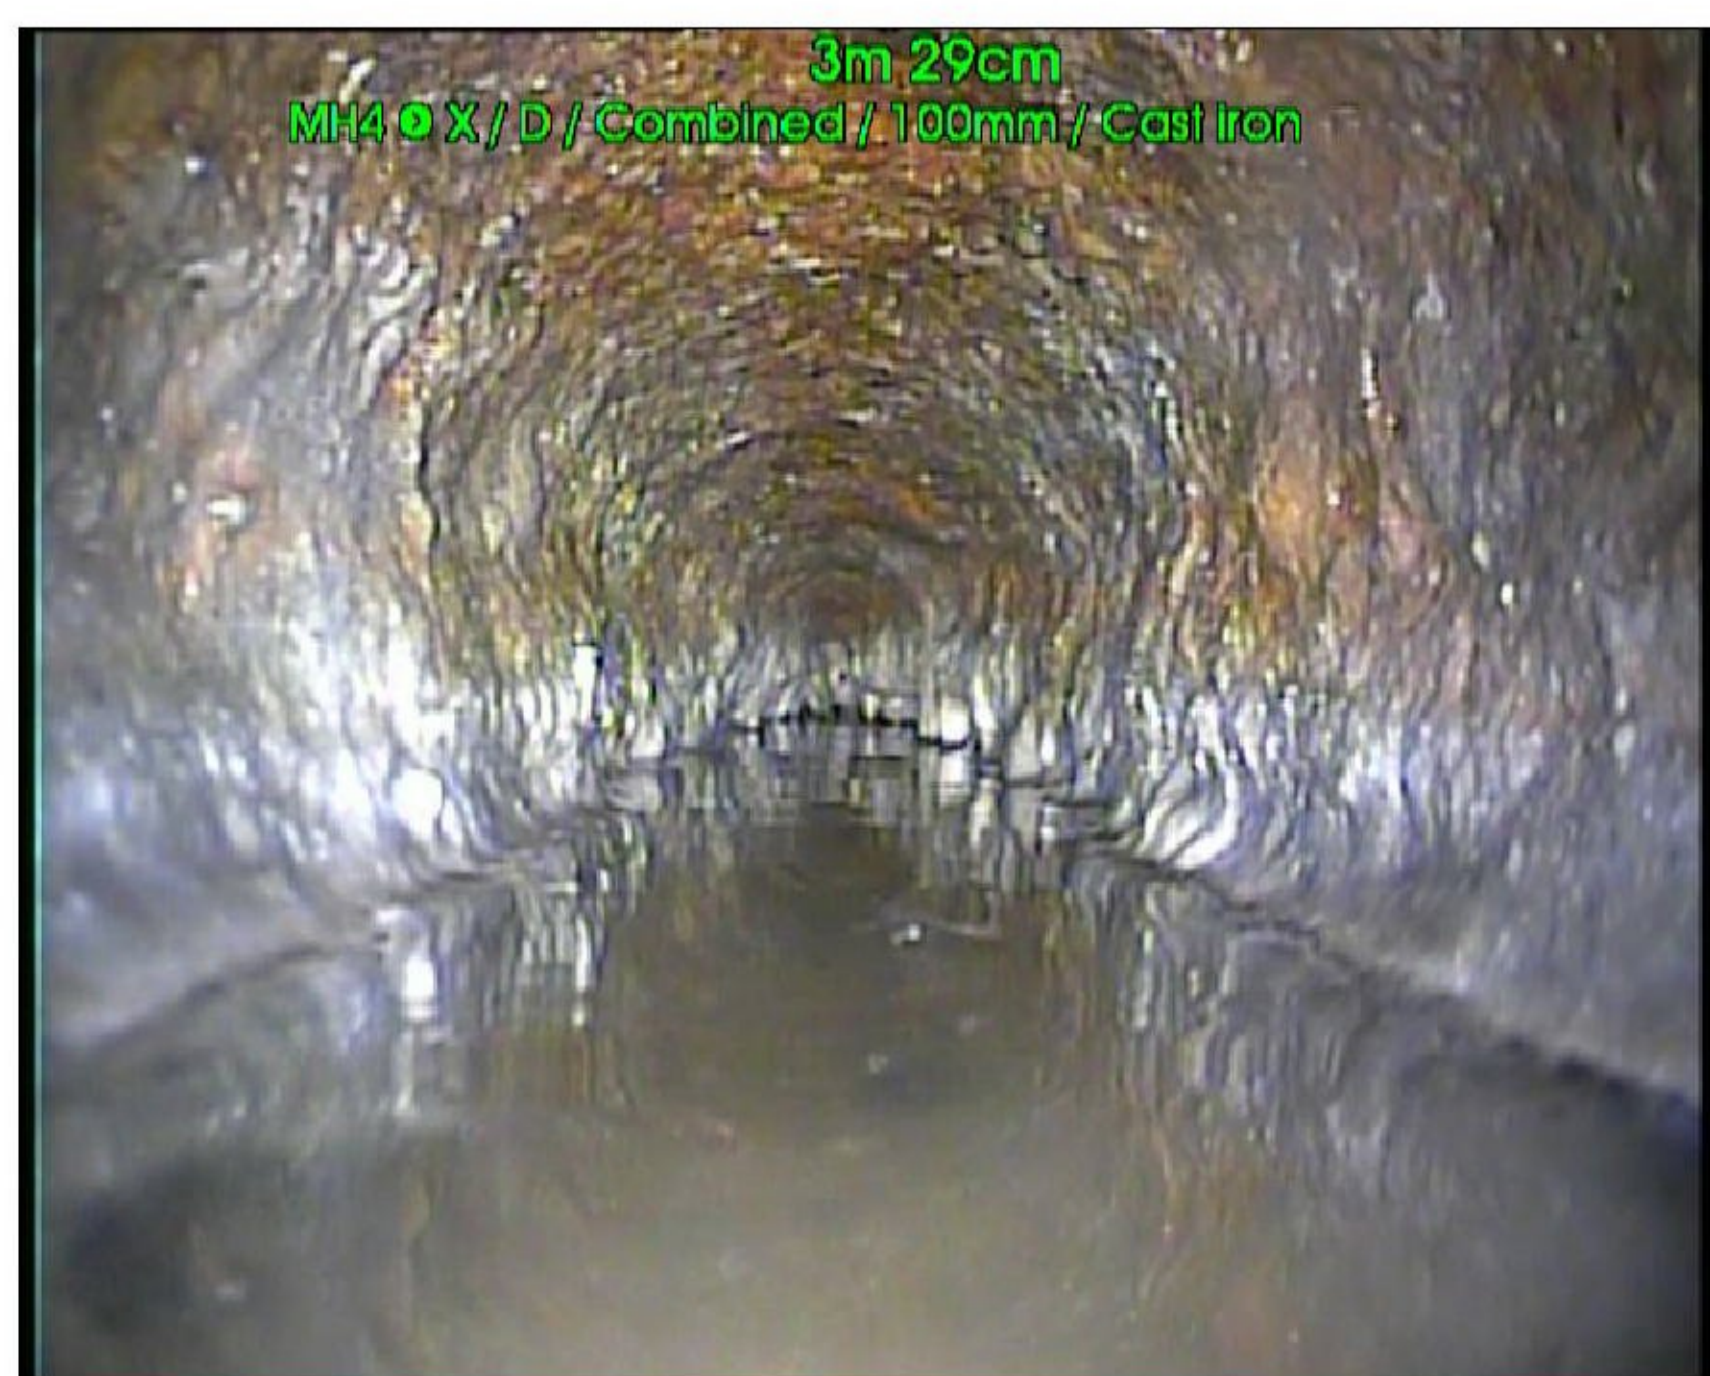
Photo: 9_9_44_A.jpg
3.2m, Water level 10 % of the vertical dimension

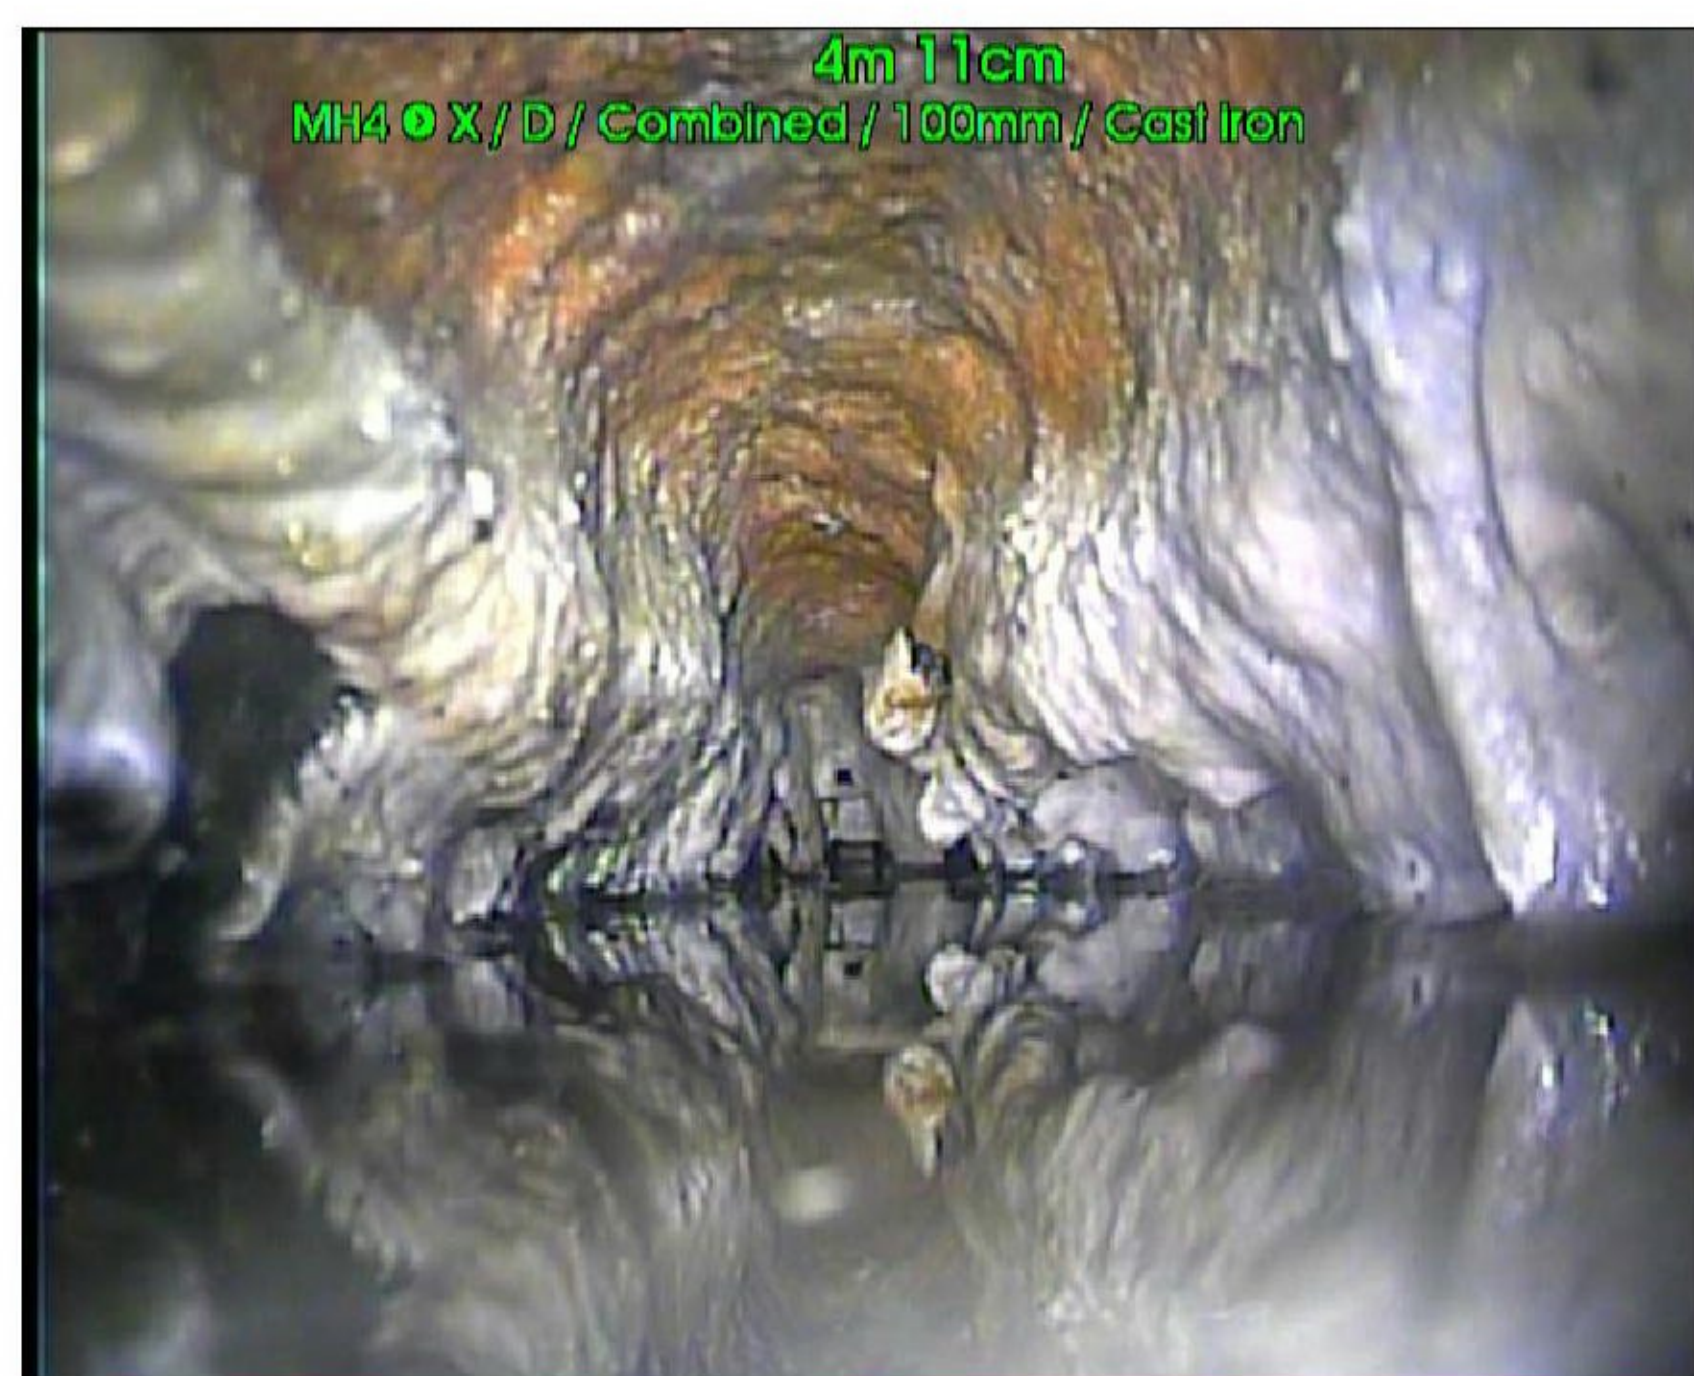
Photo: 9_9_50_A.jpg
4.1m, Attached deposits, grease from 1 O'Clock to 12 O'Clock 50 % cross-sectional area loss F2
