16th July 2020

**CHIMNEY STACK
EAST GABLE SOUTH RANGE
MANOR FARM HOUSE, NETHER WINCHENDON**

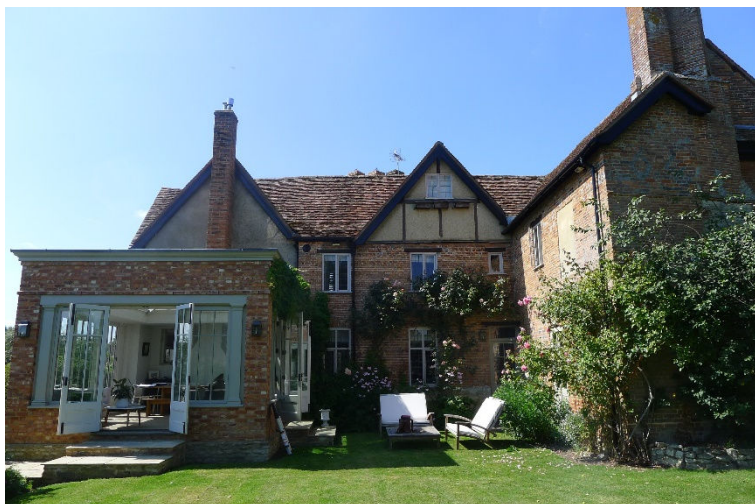
Fig 1 [left]: View of the east elevation

Manor Farm House is a Grade II* listed building of timber-framed origins. It has been much altered over the centuries and subject to extensive modernisation over the last 20 years or so, including a single storey "conservatory" style extension constructed in 2011/2012 to the east of the south range [Figs 1 & 2].

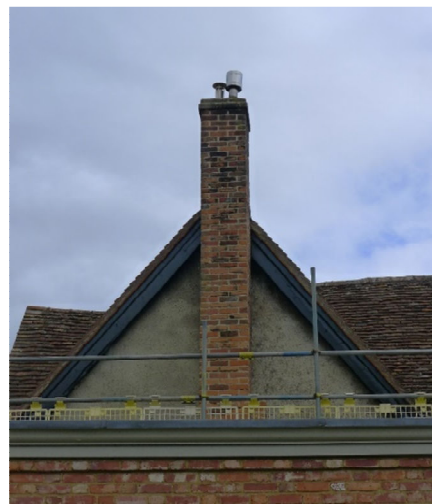
Fig 2 [right]: Detail of the brick stack to the east gable of the south range

1. Cracking is evident to the lining to the base of the chimney within the kitchen and conservatory [Fig 3].
2. The chimney stack projects above the roof of the single storey conservatory extension as a slender brick shaft fitted with two flue cowls, one of which serves the boiler located in the basement [Fig 2].
3. The brick shaft leans slightly to the south, which reflects a combination of prevailing wind and rain, the crystallisation of salts and the lack of restraint and physical connection with the gable [refer to 6 below].
4. There is evidence of historic contaminants of the by-products of combustion leaching through the bricks and mortar that has weakened the mortar].

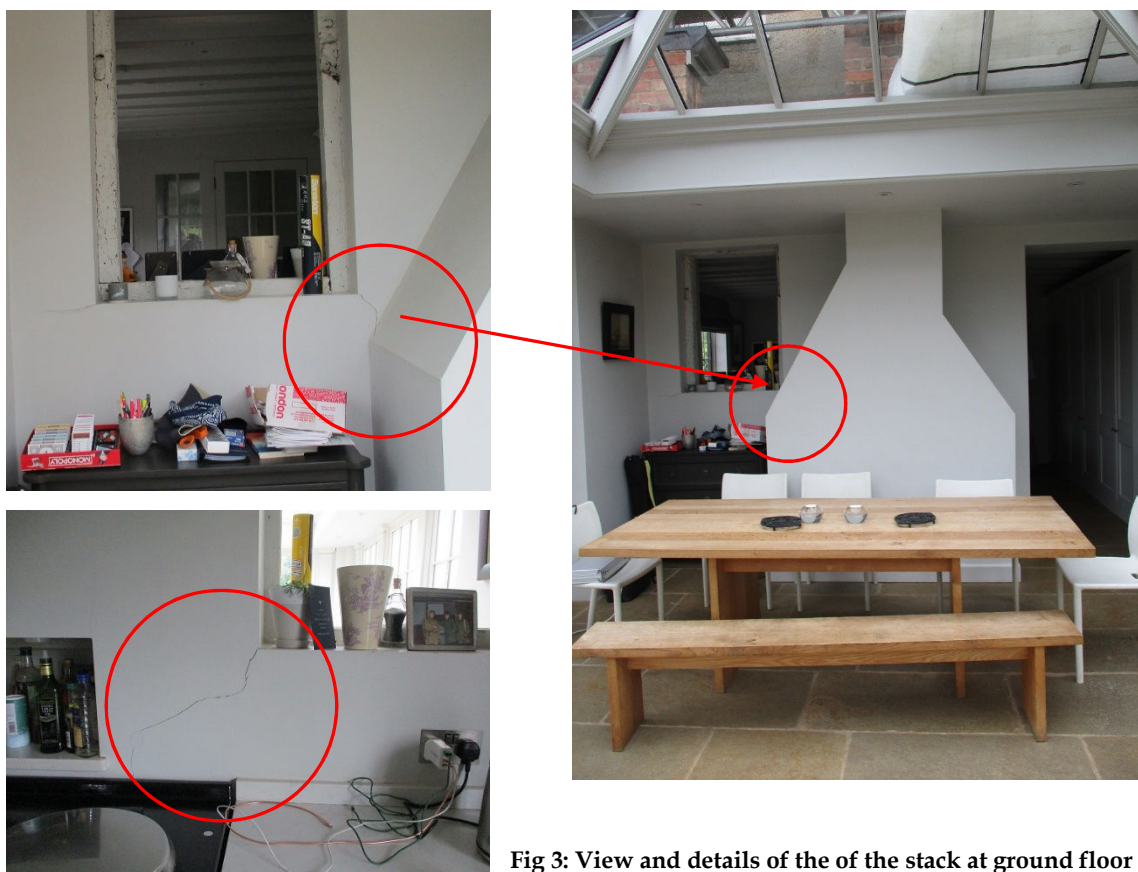
Fig 3: View and details of the of the stack at ground floor level

The stack within in the conservatory extension is fully lined with modern [plasterboard?] boarding.

Top left: Detail of cracking to lining to the east face.

Lower left: Detail of cracking to the west face [the “mirror” image of the location of the cracking to the east face.

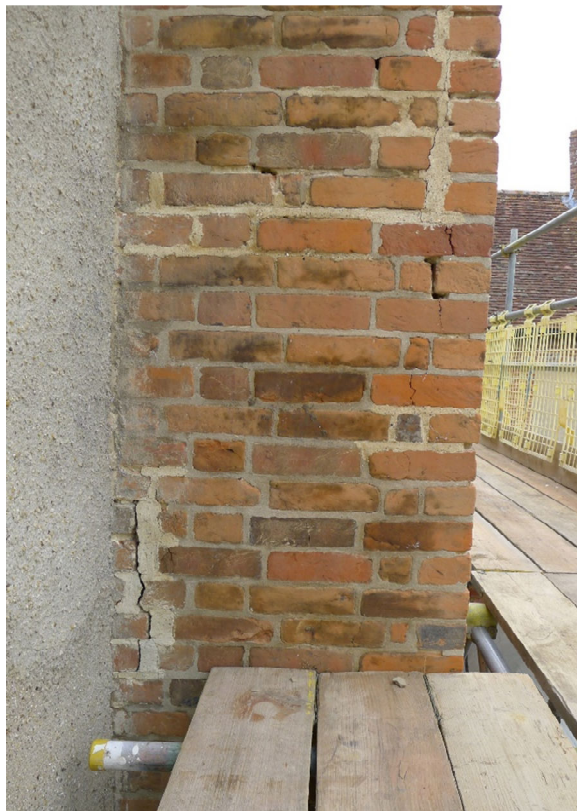
Fig 4: Detail of south elevation of the stack

5. Cracking to the south face of the brick reflects movement and associated stresses that the stack is subjected to [Fig 4].
6. The stack is sparingly toothed into the infill panels of the east gable of the south range [Fig 6]. The movement of the stack has resulted in the rotation of brickwork in the infill panels [Fig 7].

Note the vertical cracking and deterioration of mortar, which is more pronounced at higher level

Consequently, in these particular circumstances, there is validity in the removal of the stack down to ground floor level to eliminate the continued deterioration and risk of damage from seasonal movement.

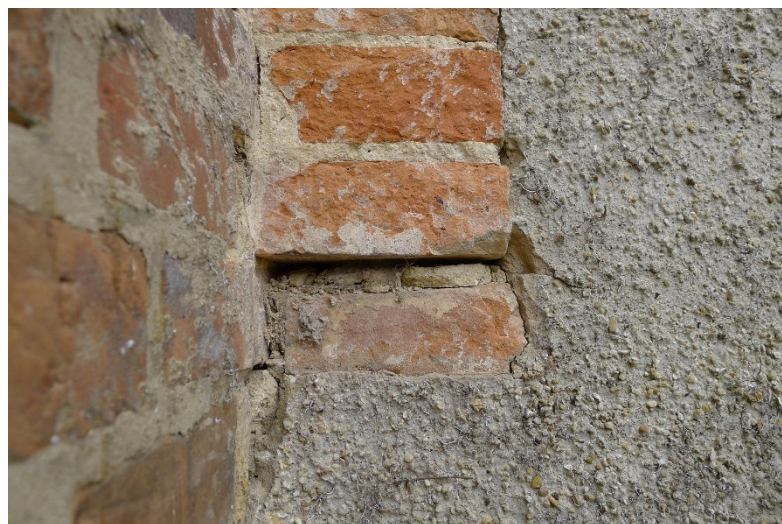
Fig 7: Detail of brick infill panel

Note rotation/lifting of brick
