Our Ref: RS/SD/20055

3rd November 2020

*CHIMNEY STACK, EAST GABLE, SOUTH RANGE
MANOR FARMHOUSE, NETHER WINCHENDON*

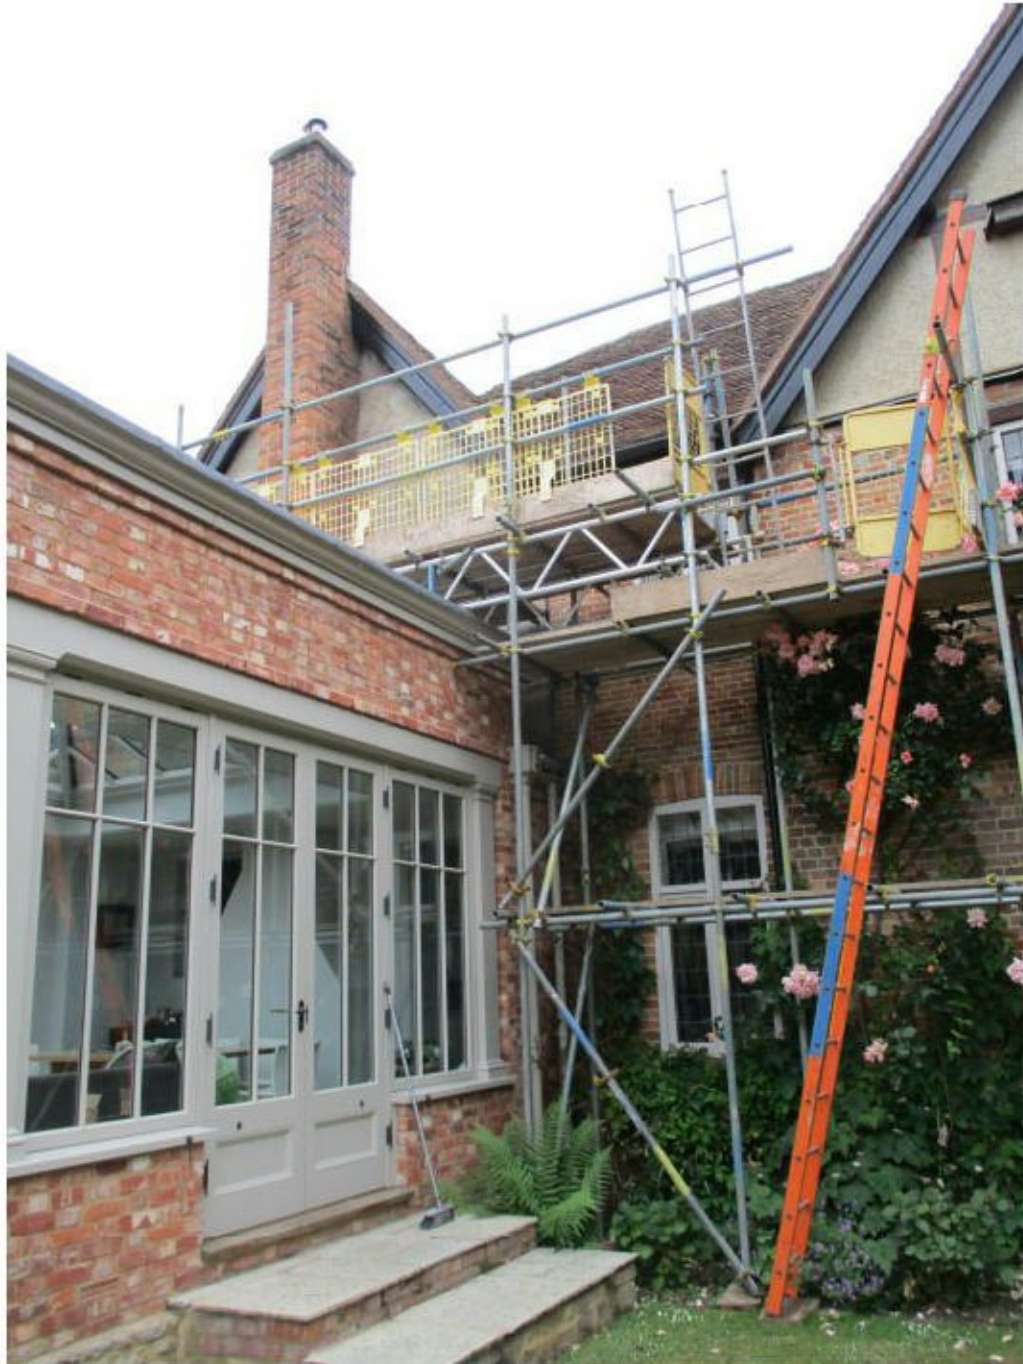
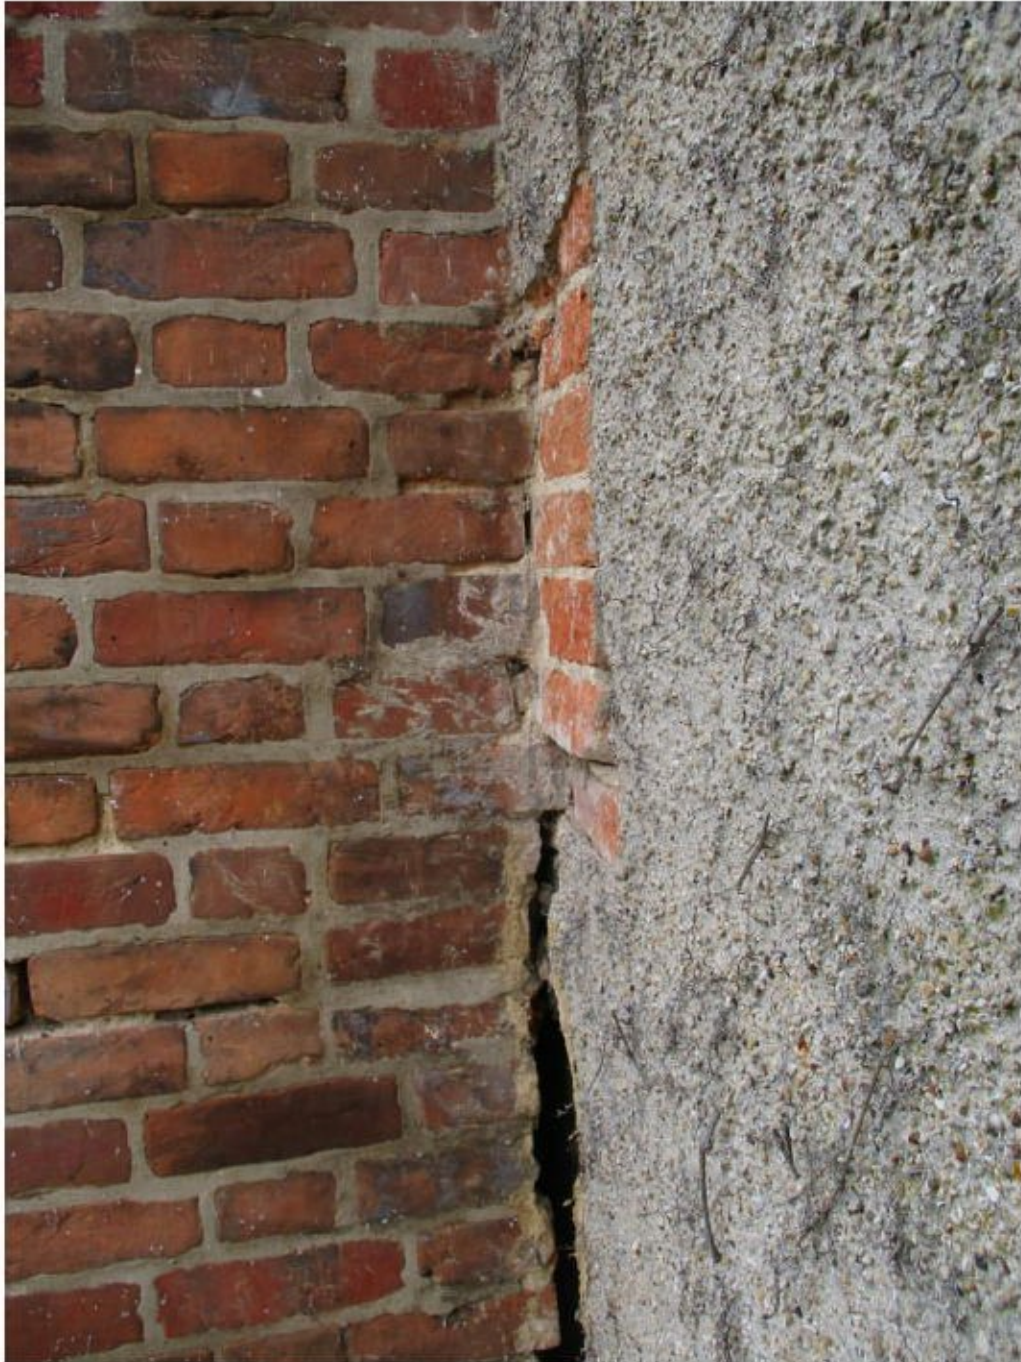
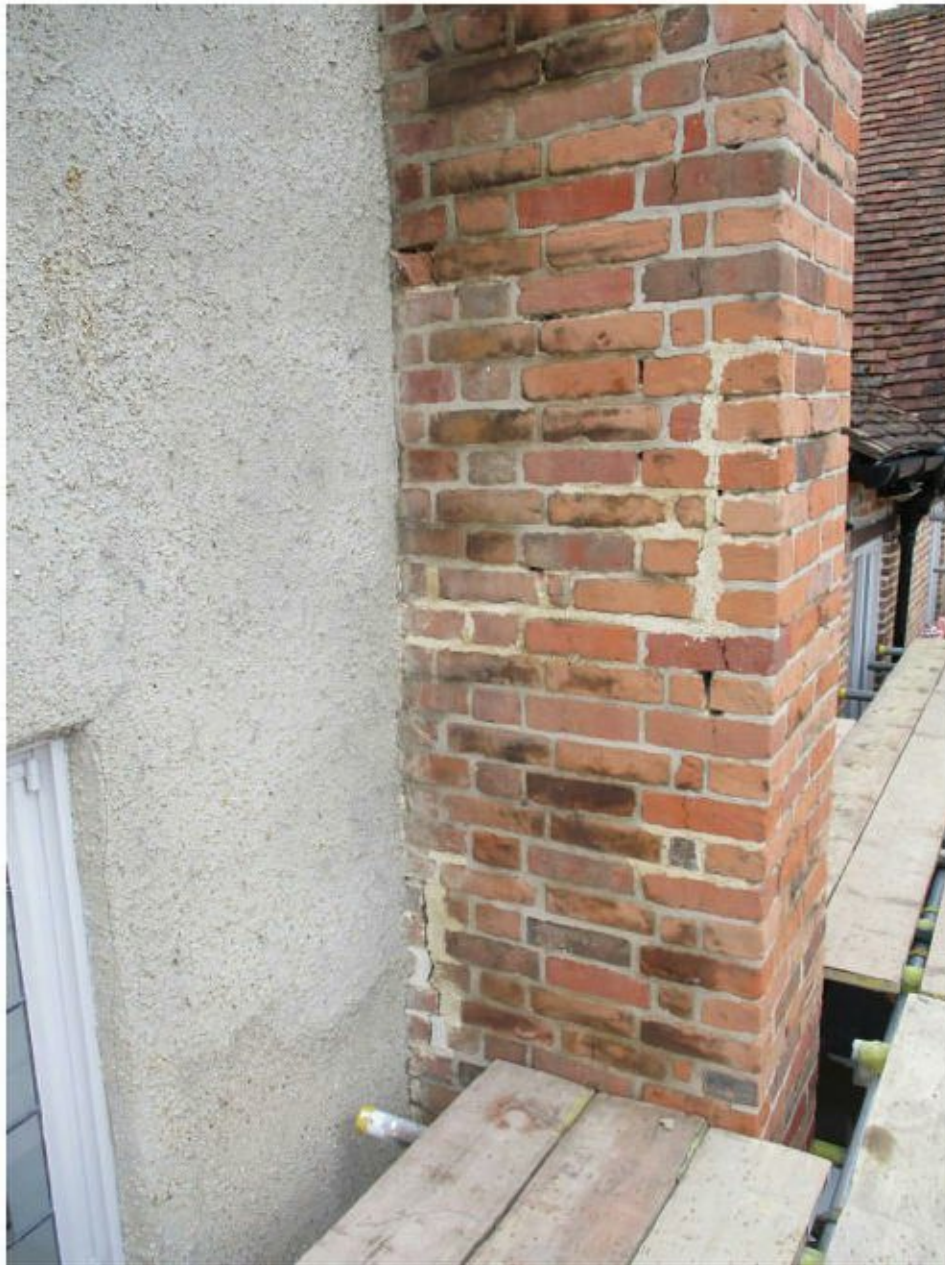
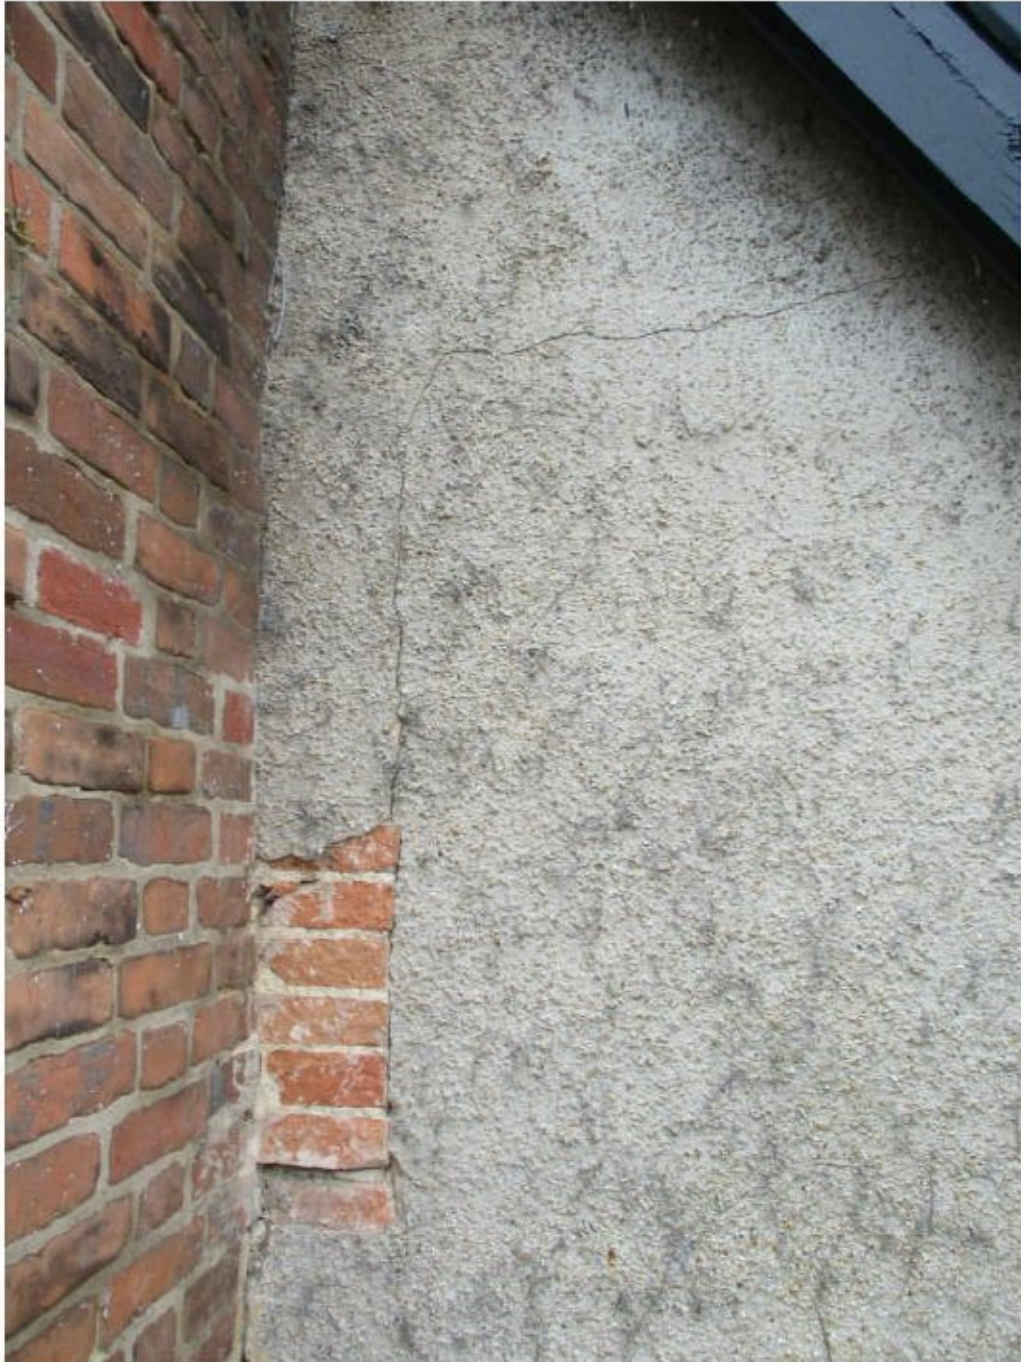
There is evidence that the later brick stack is pulling away from the timber framed gable and damaging it in the process, see photographs P01 to P04. The exposed height of the chimney stack increases the wind load on the gable.

If it is considered that the historic timber frame is the more important part of the structure which must be retained, then the later slender brick stack should be removed in its entirety.

There is therefore, in my opinion, a strong case for removing this later brick chimney stack, in its entirety making good the weatherproofing of the rendered gable frame and securing the lateral connection to the attic floor plate. This action will also remove the risk of leaking flue gases penetrating into the bedroom and also diminish the fire risk.

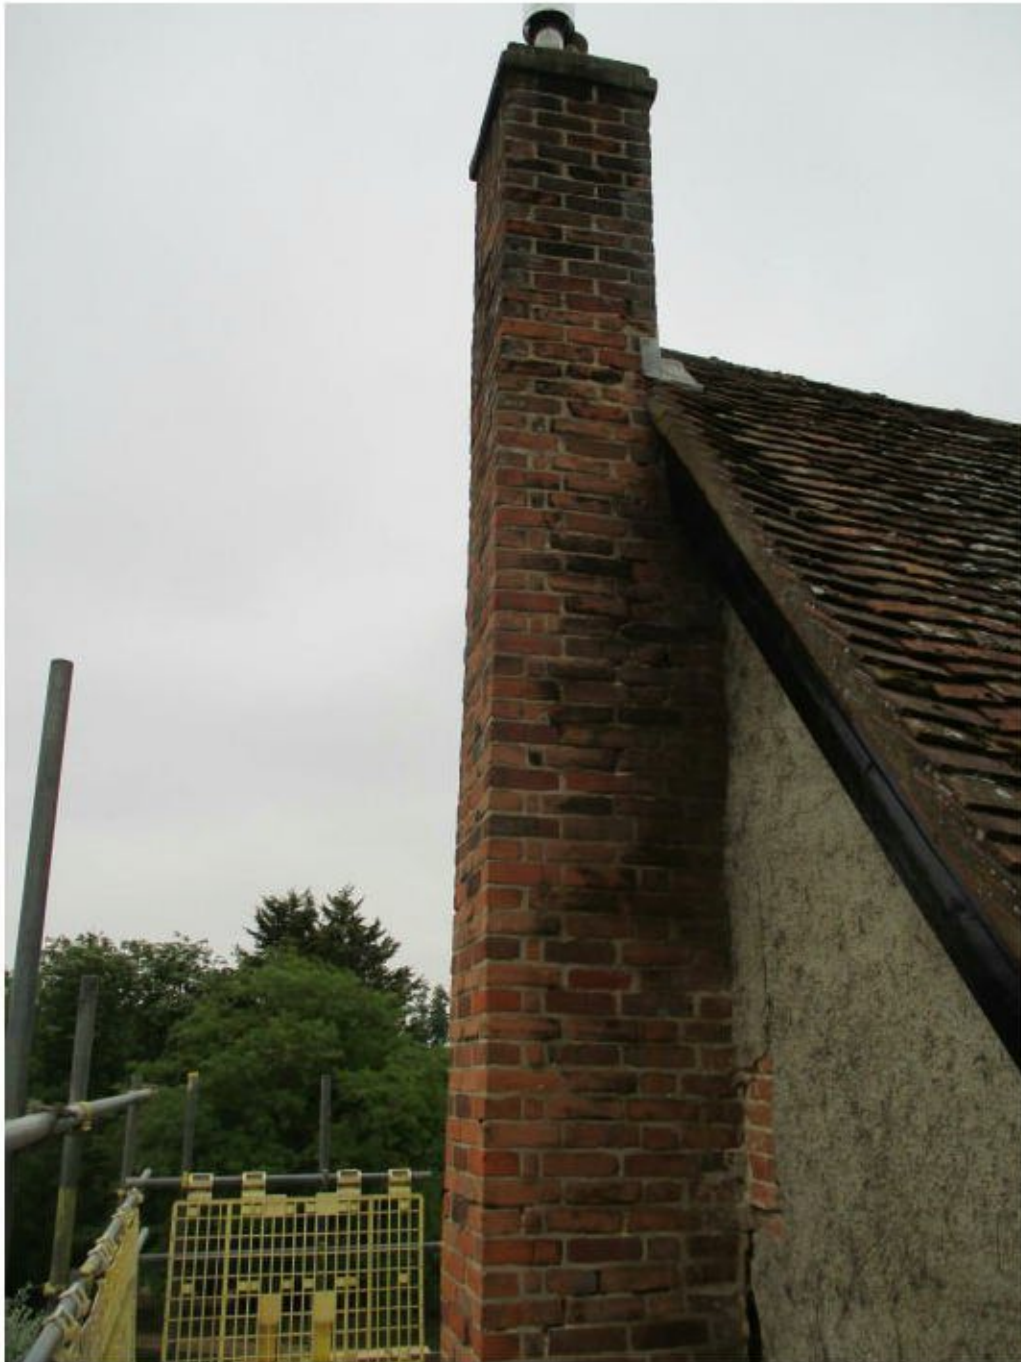
P05

In addition, there are signs of escaping flue gases and consequent black staining of the brickwork, see photograph P05.

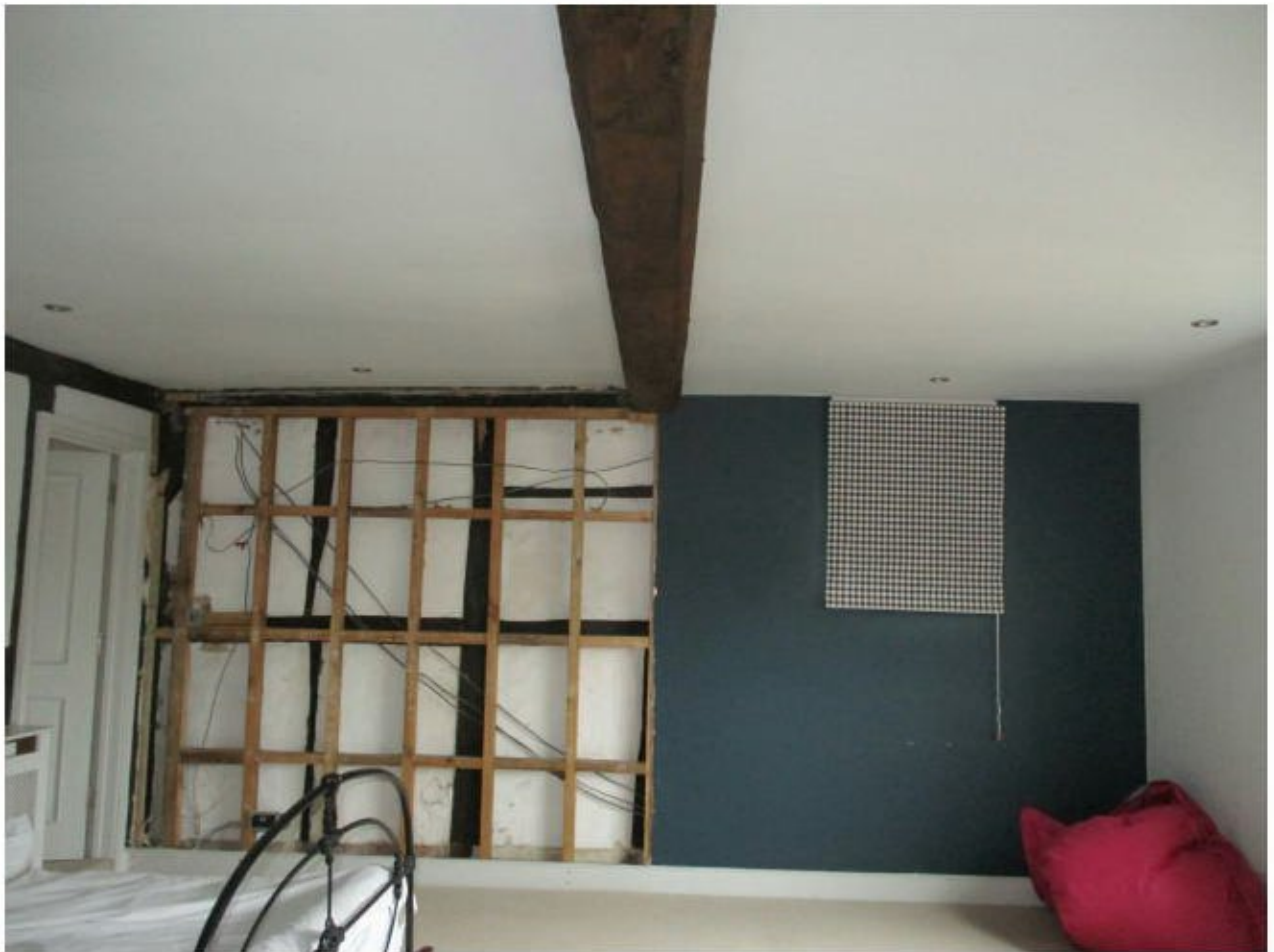
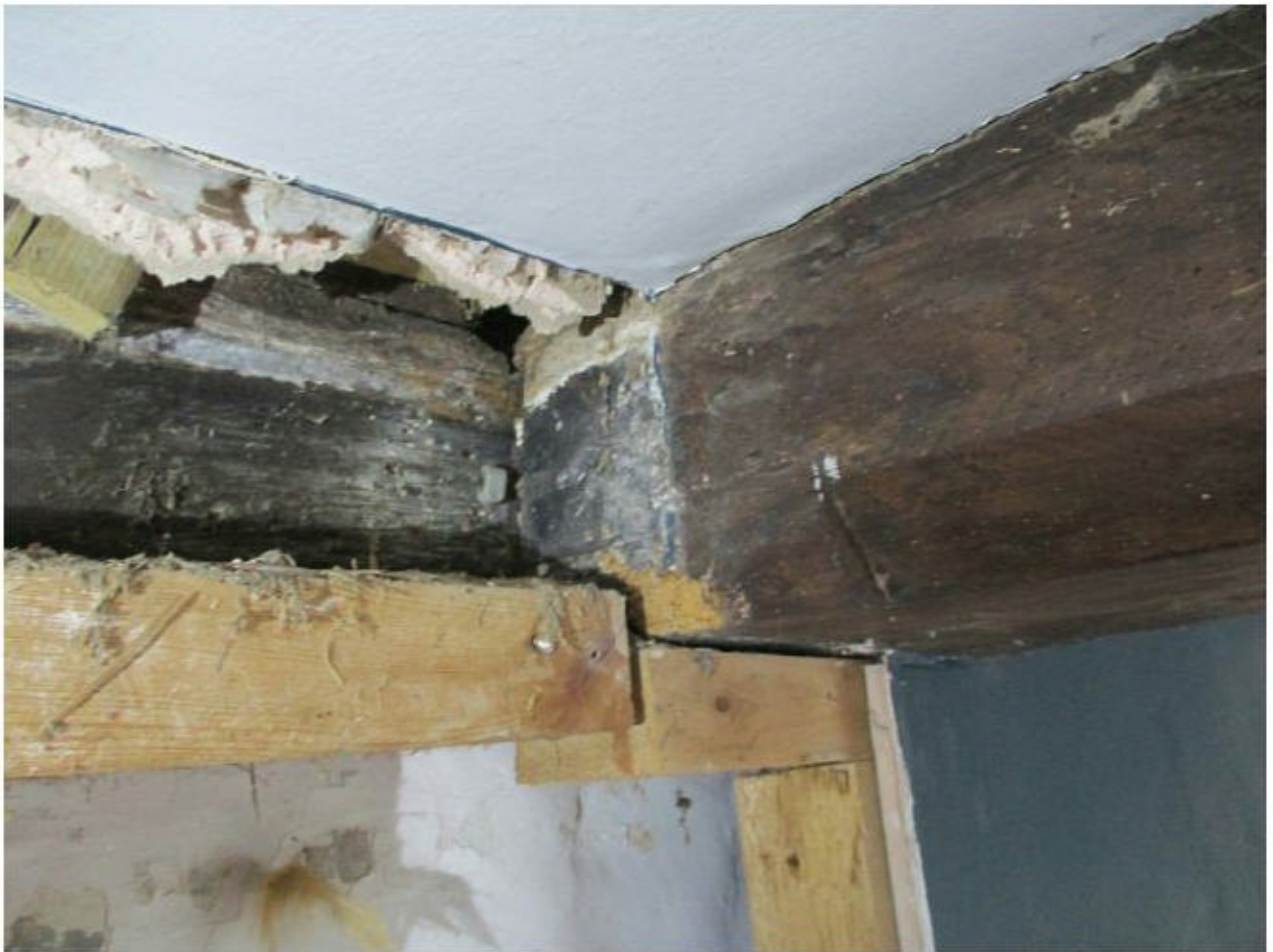
We managed to uncover the modern timber framed panelling on the inside face of the adjacent bedroom to reveal a decaying main beam support into the main horizontal rail of the timber frame at eaves level. This shows considerable decay of the rail and death watch beetle activity. This is almost certainly attributable to leaking surface water behind the brick chimney stack. It also reveals how poorly the gable frame is restrained by the horizontal framing of the attic main floor beam, see photographs P06 and P07.

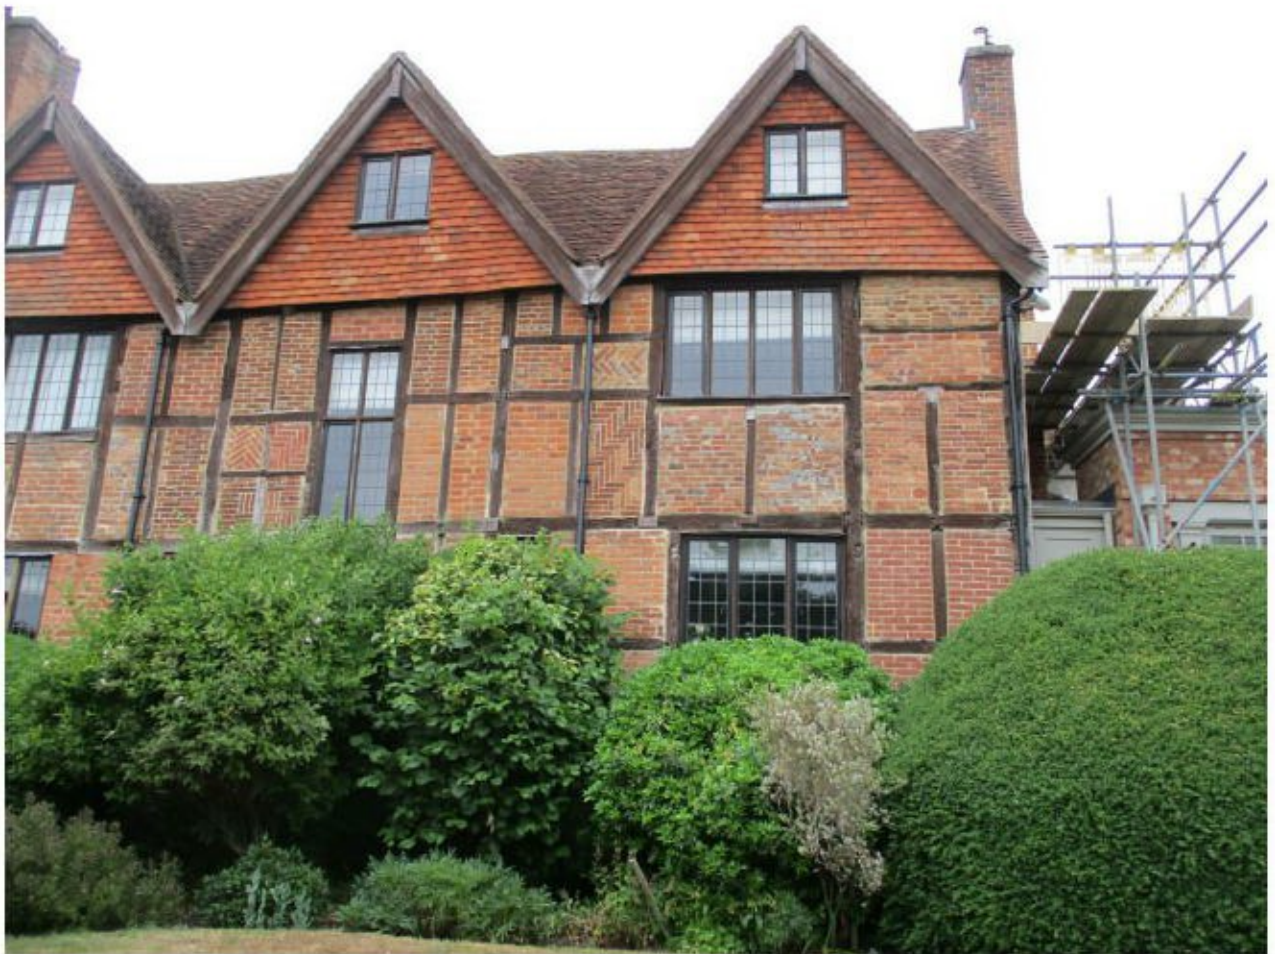
P08

It is also significant that the east gable, under discussion, was designed to be restrained against wind loads by the returning south elevation timber framing. It is clear that all of the joints from the exposed horizontal rails of the historic timber frame on the south elevation to the corner post are severely decayed and require repair to make the junction effective again, see photograph P08.

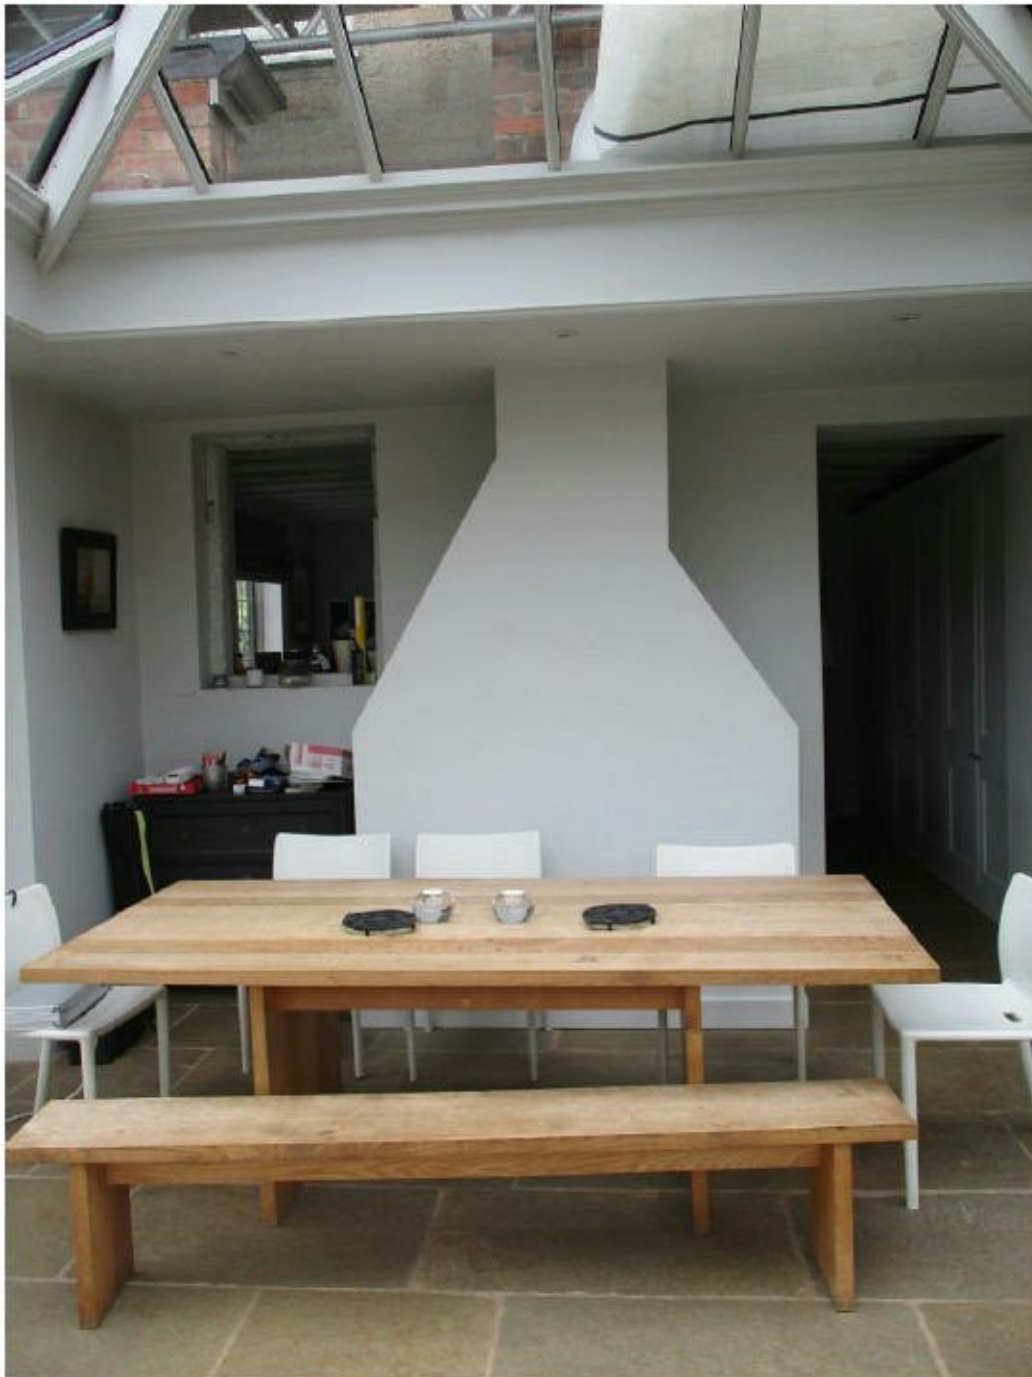
P09

There is also a significant problem with the adequacy of the foundations of the brick stack at ground floor level, see photograph P09.

The evidence would suggest that the historic east wall of the cellar is probably 0.5 – 0.6m thick and founded 1.8 – 2.0m below ground level. The more recent chimney stack would appear to be shallow founded close to ground level and projecting or cantilevering 1.0m so further east. This cantilever action severely distressing the timber framed gable.

Also, the large base of the chimney stack becomes redundant, see photograph P09.

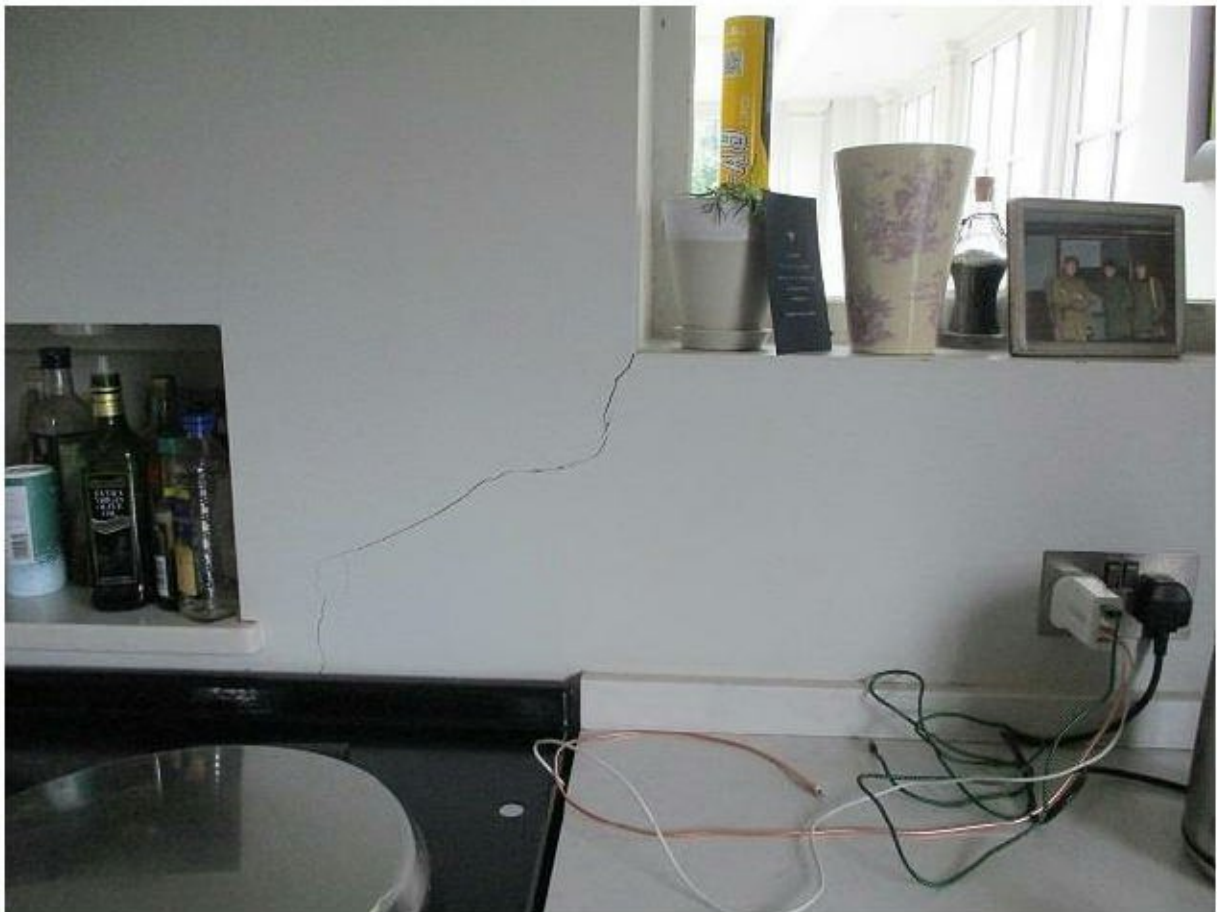
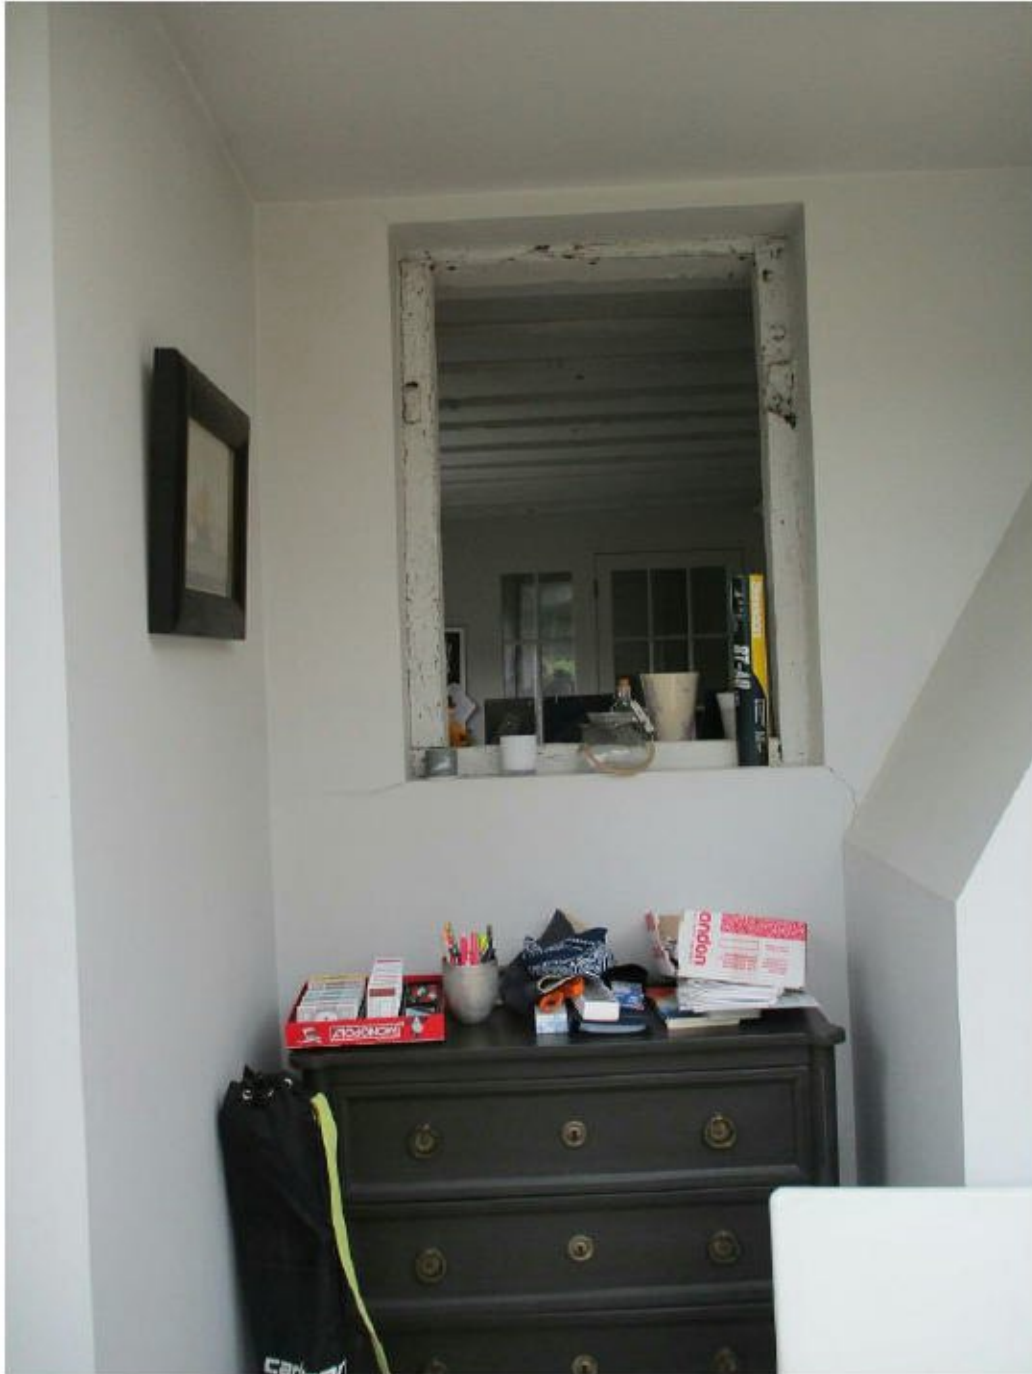
There are cracks in the masonry flanks on each side of the chimney stack at ground floor level suggesting that the bulk of the stack is not adequately supported by the wall of the historic cellar below and is rotating outwards, see photographs P10 and P11.
