REPORT NO. 21-033R_001

**Proposed Conversion of Agricultural Building at Pear
Tree Farm, Hinderclay**

Mr D Thorrold

February 2021

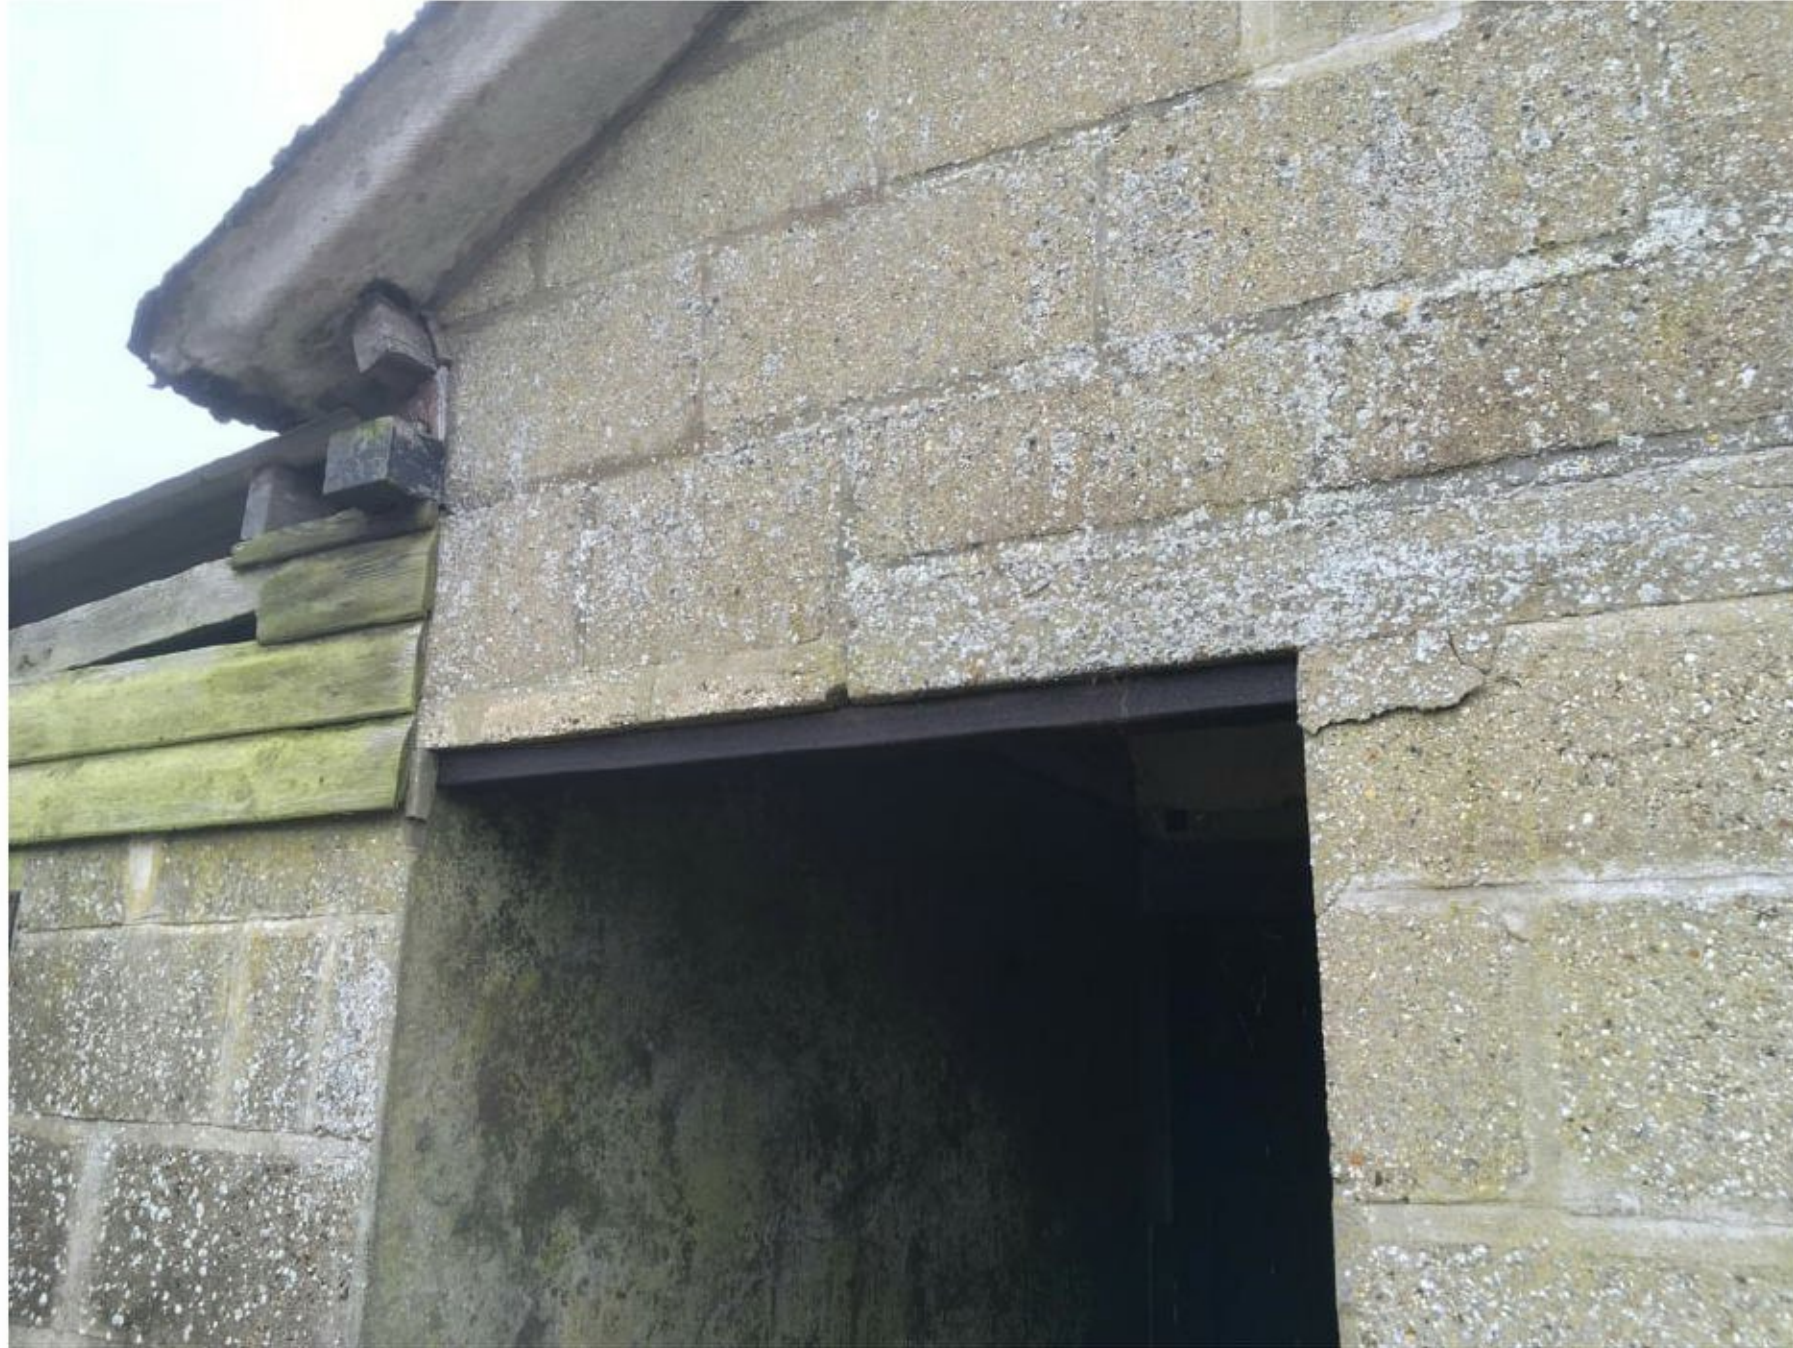
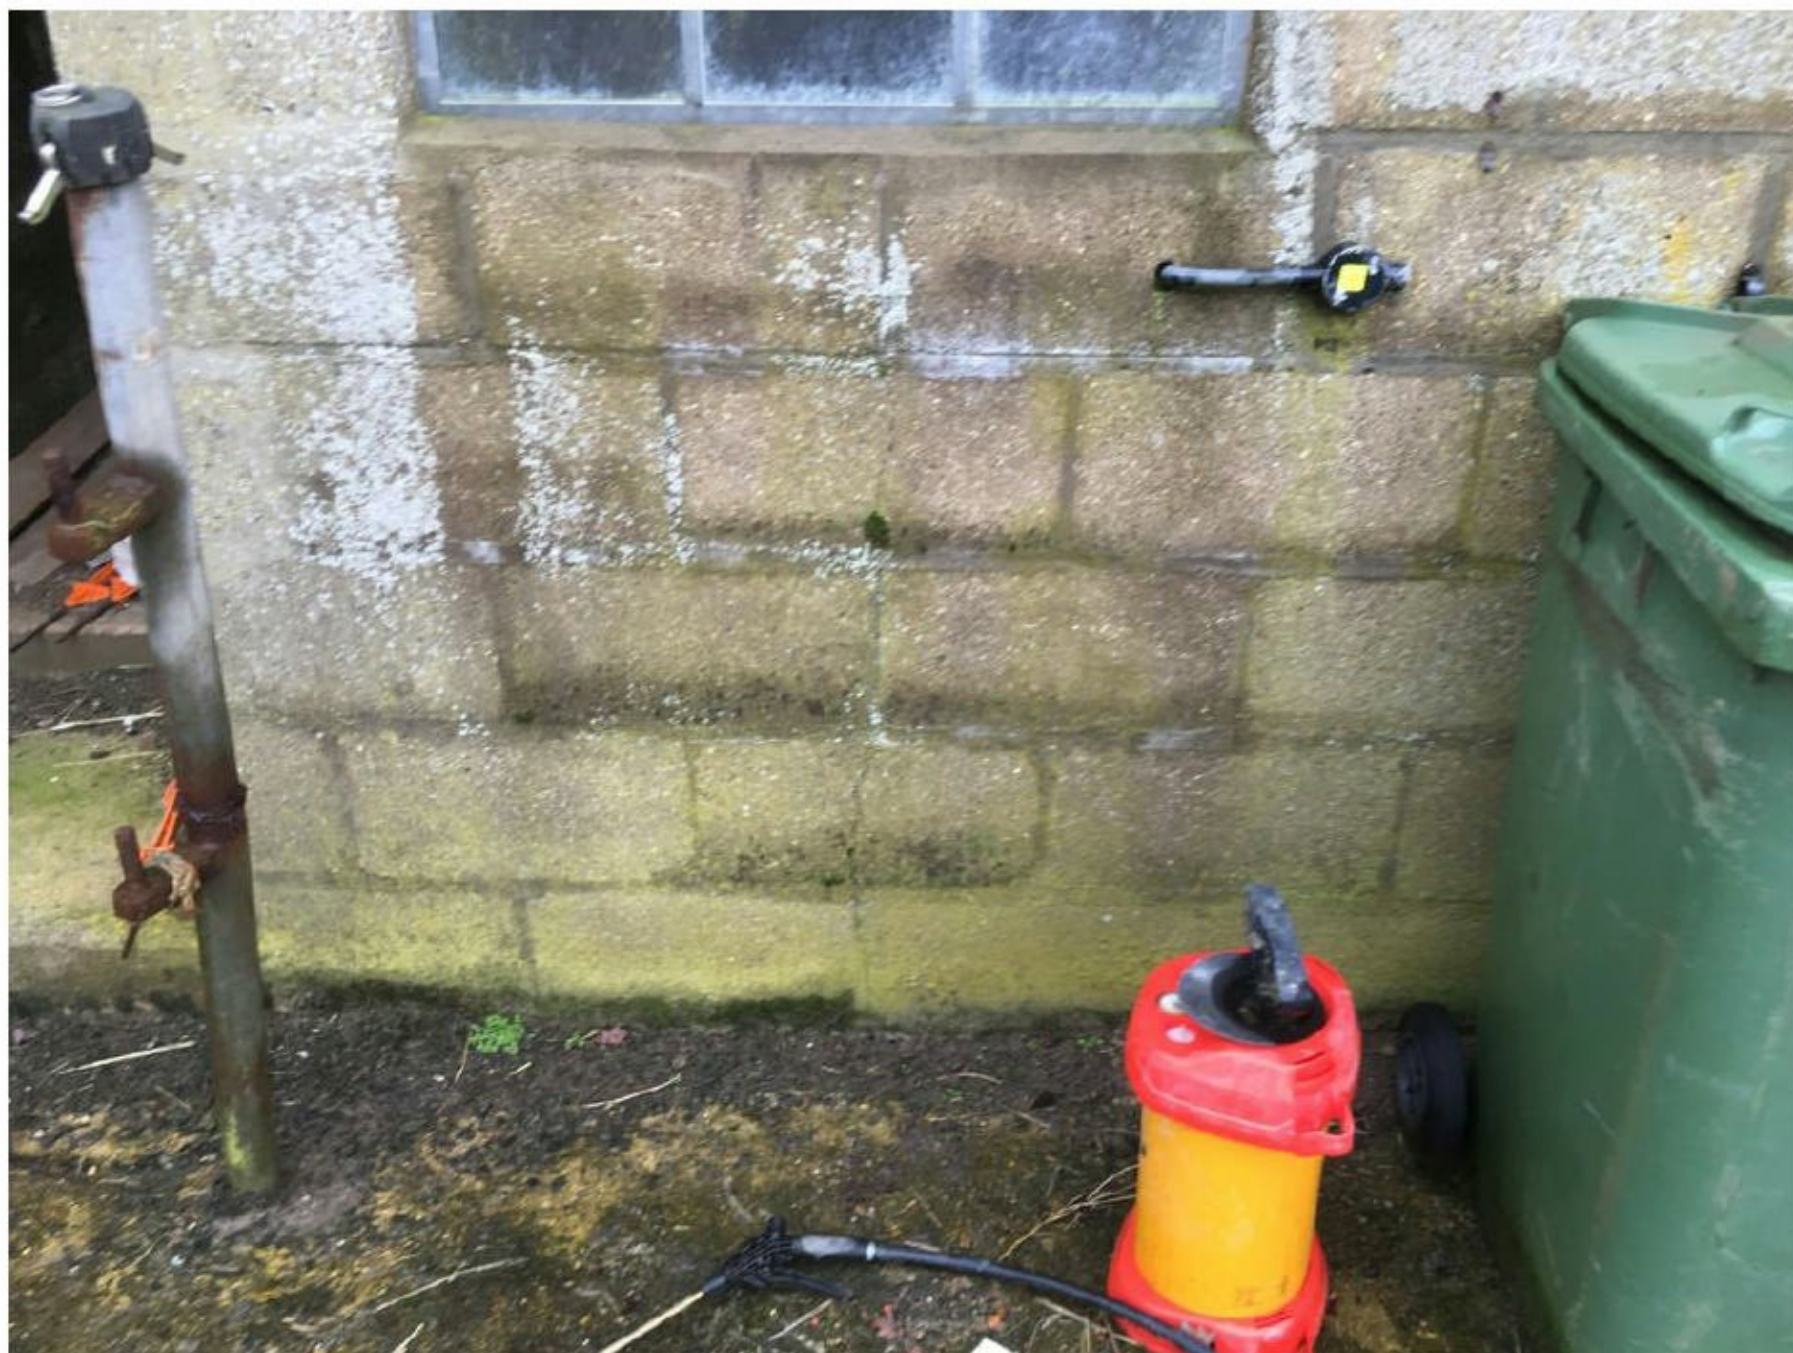
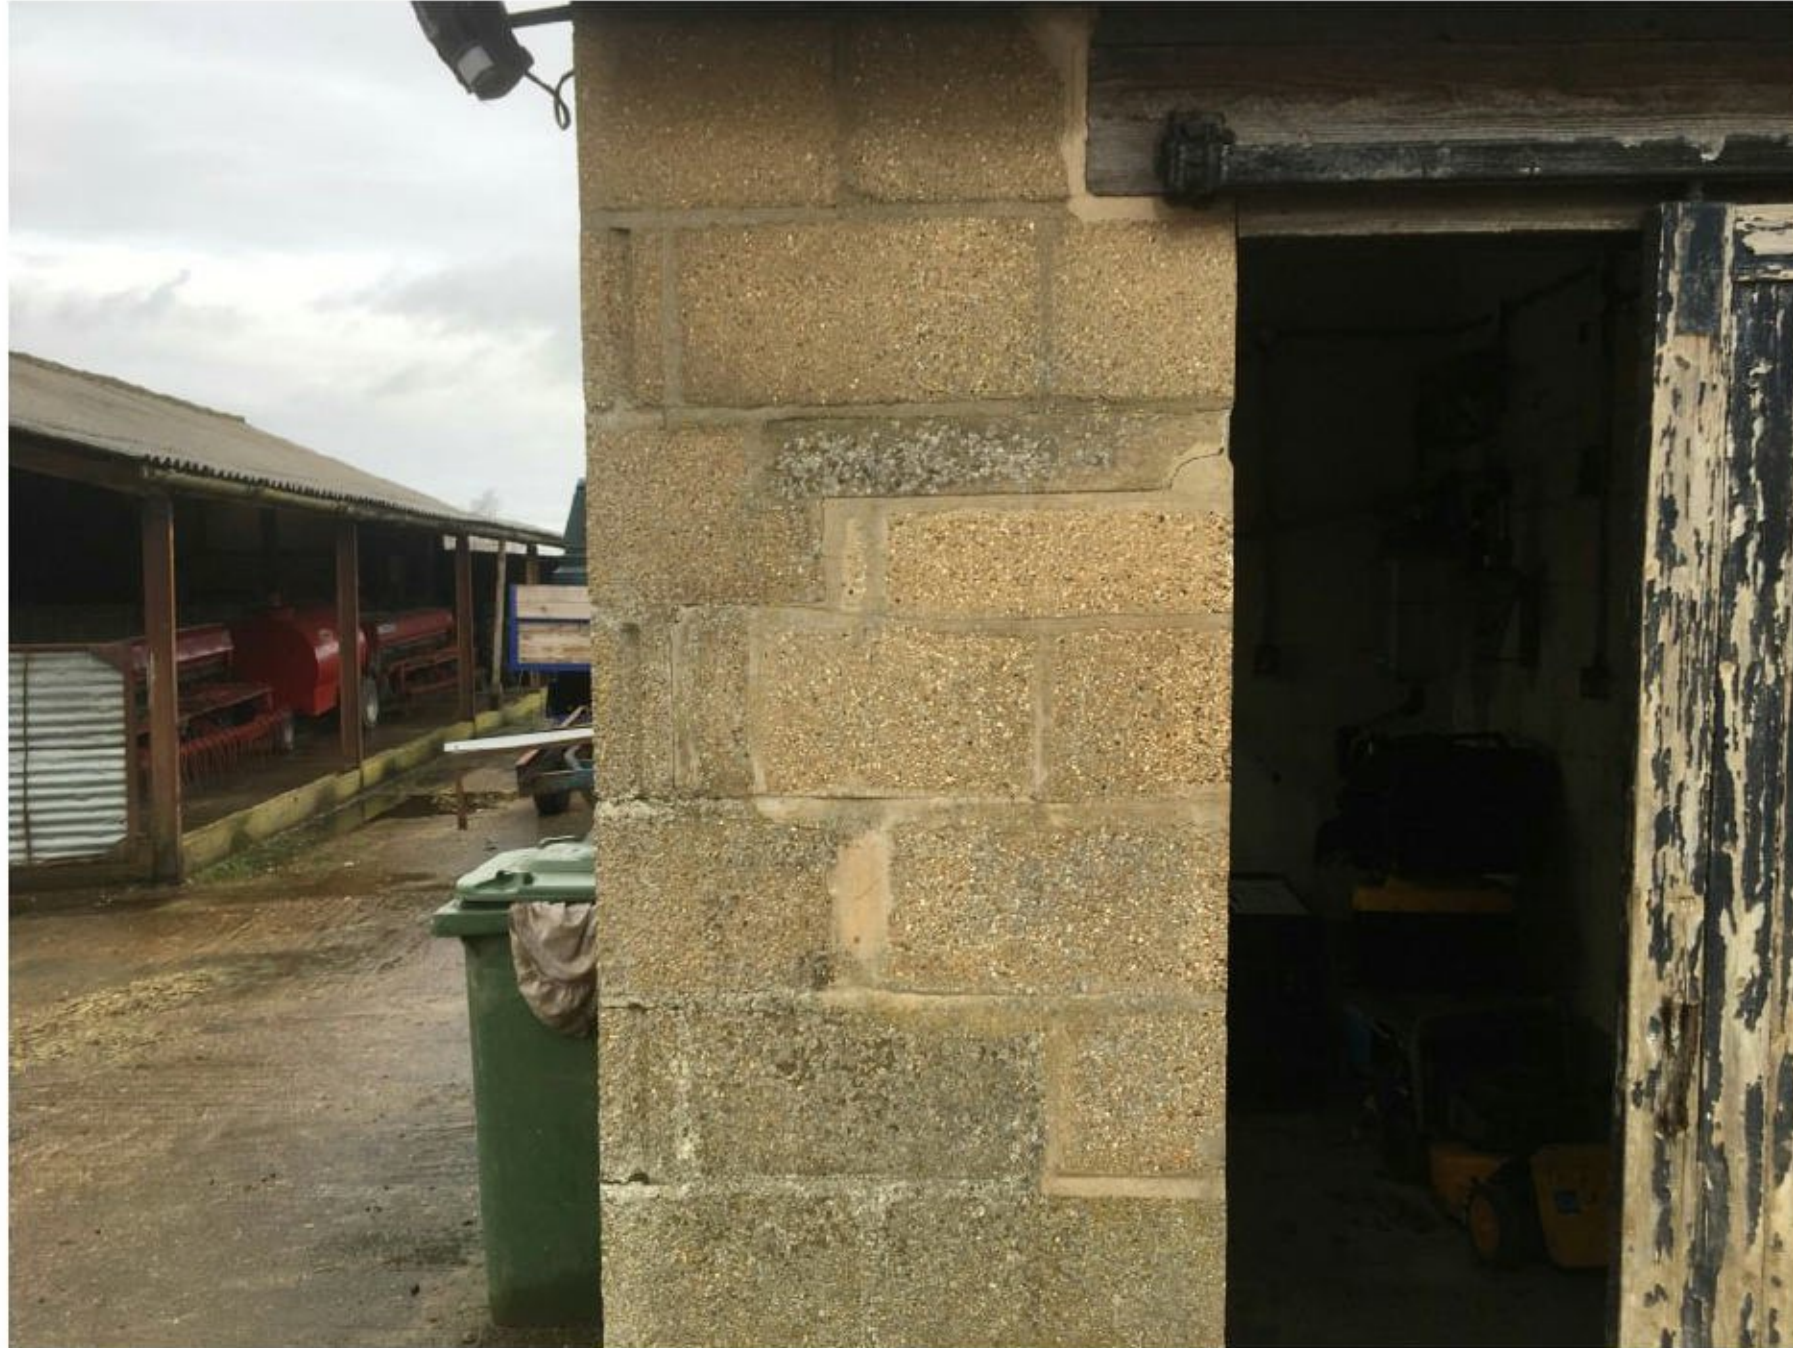
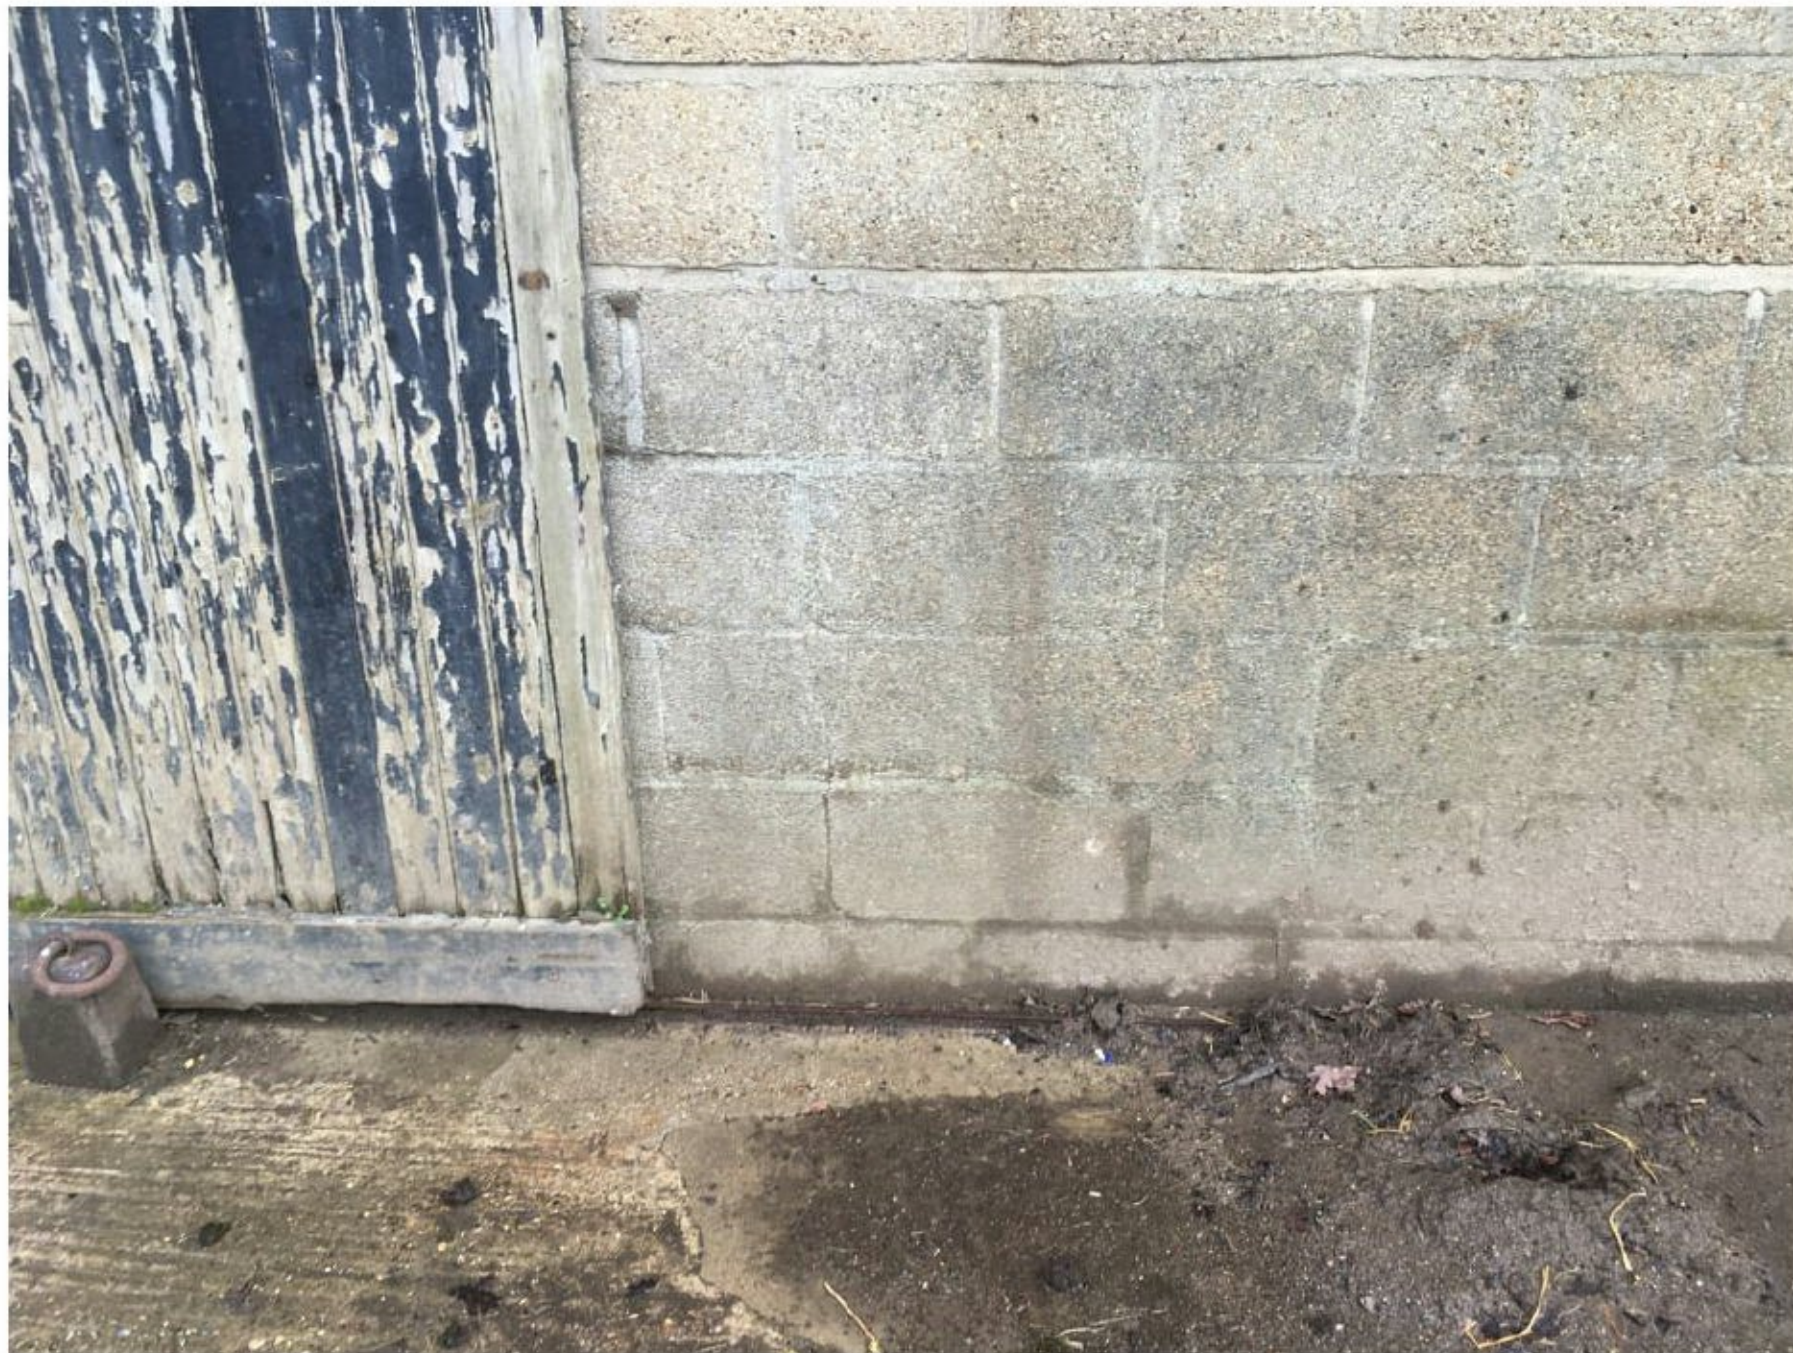
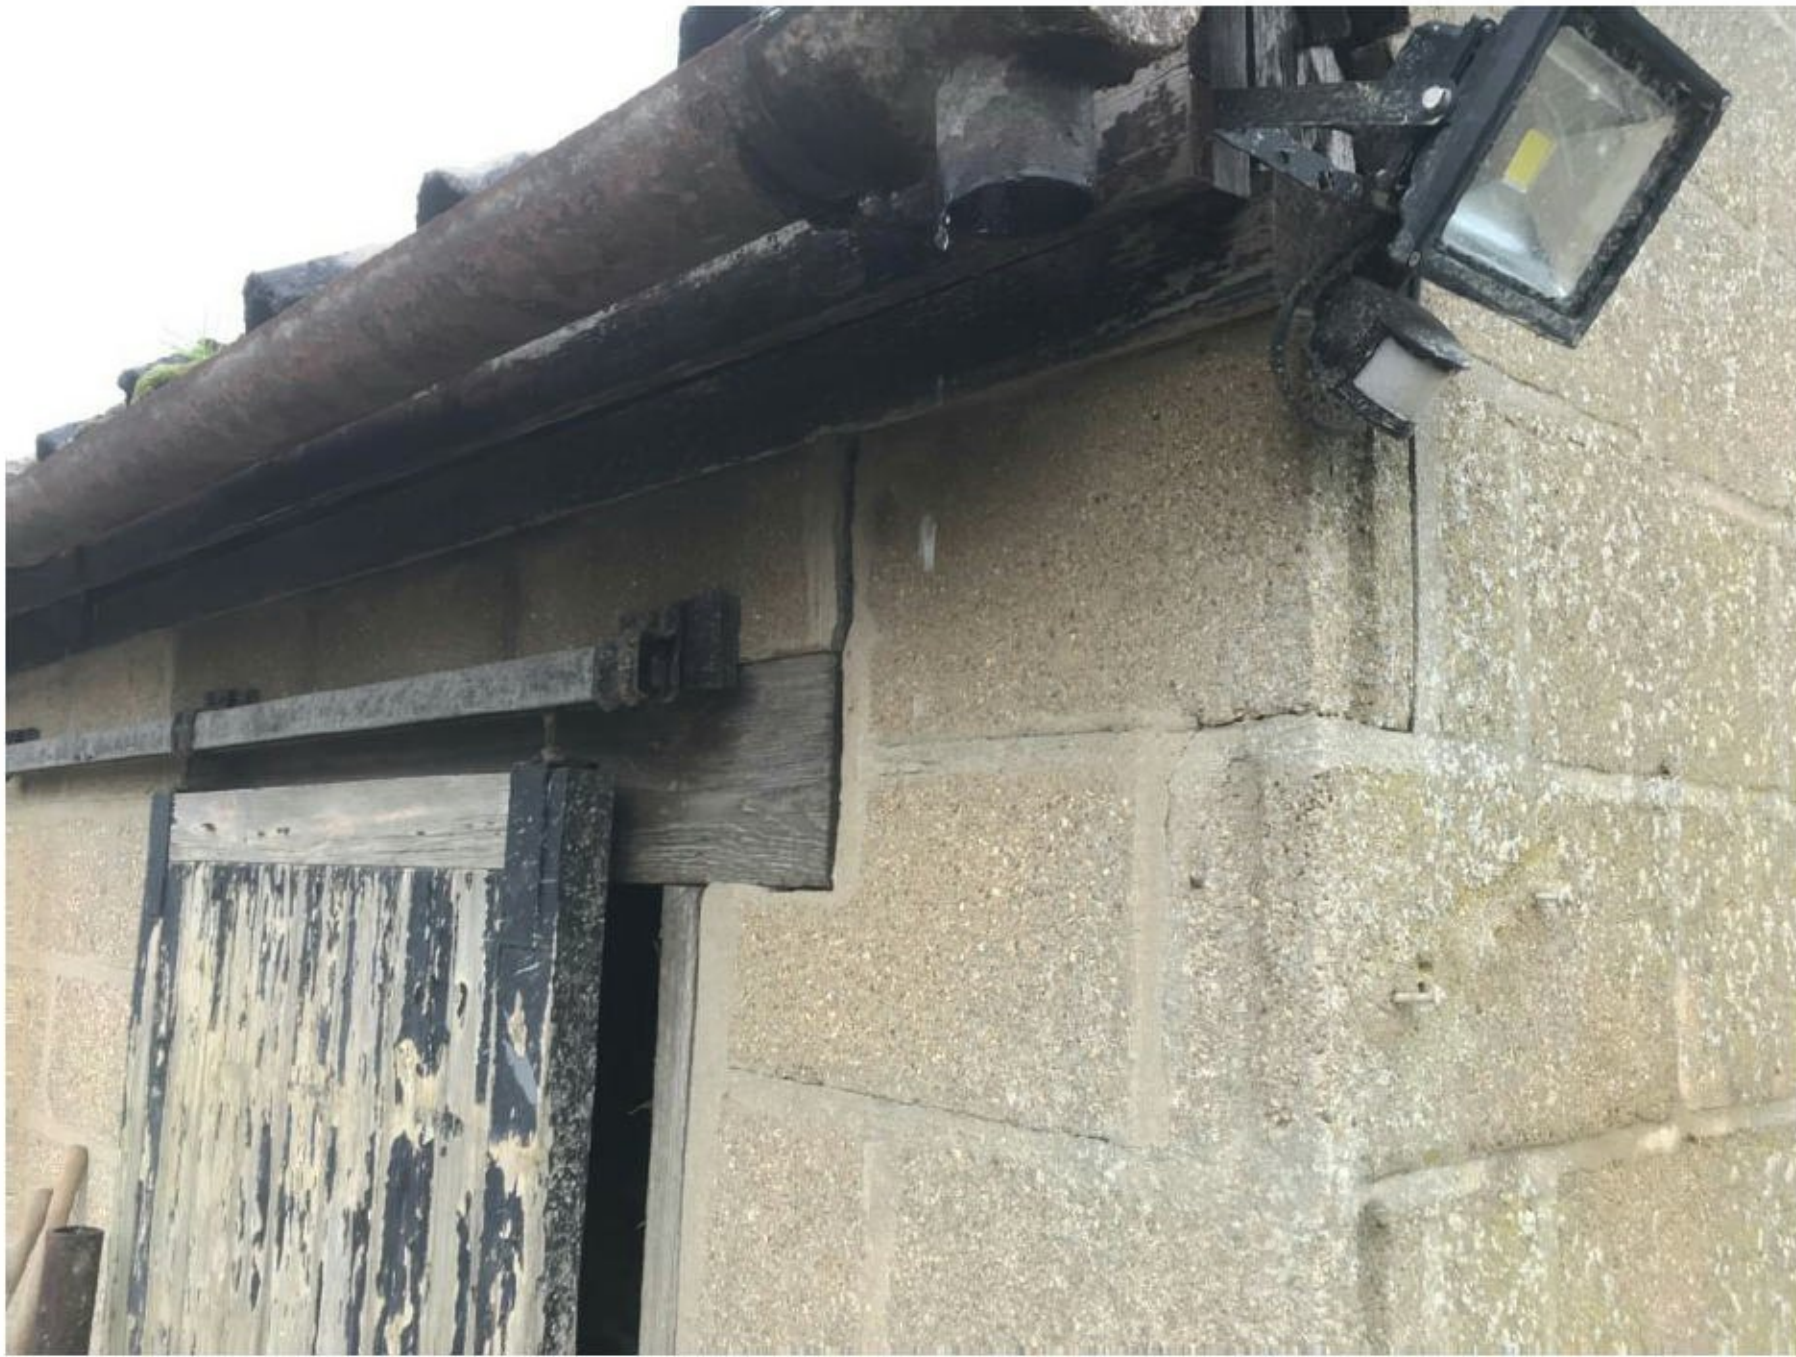
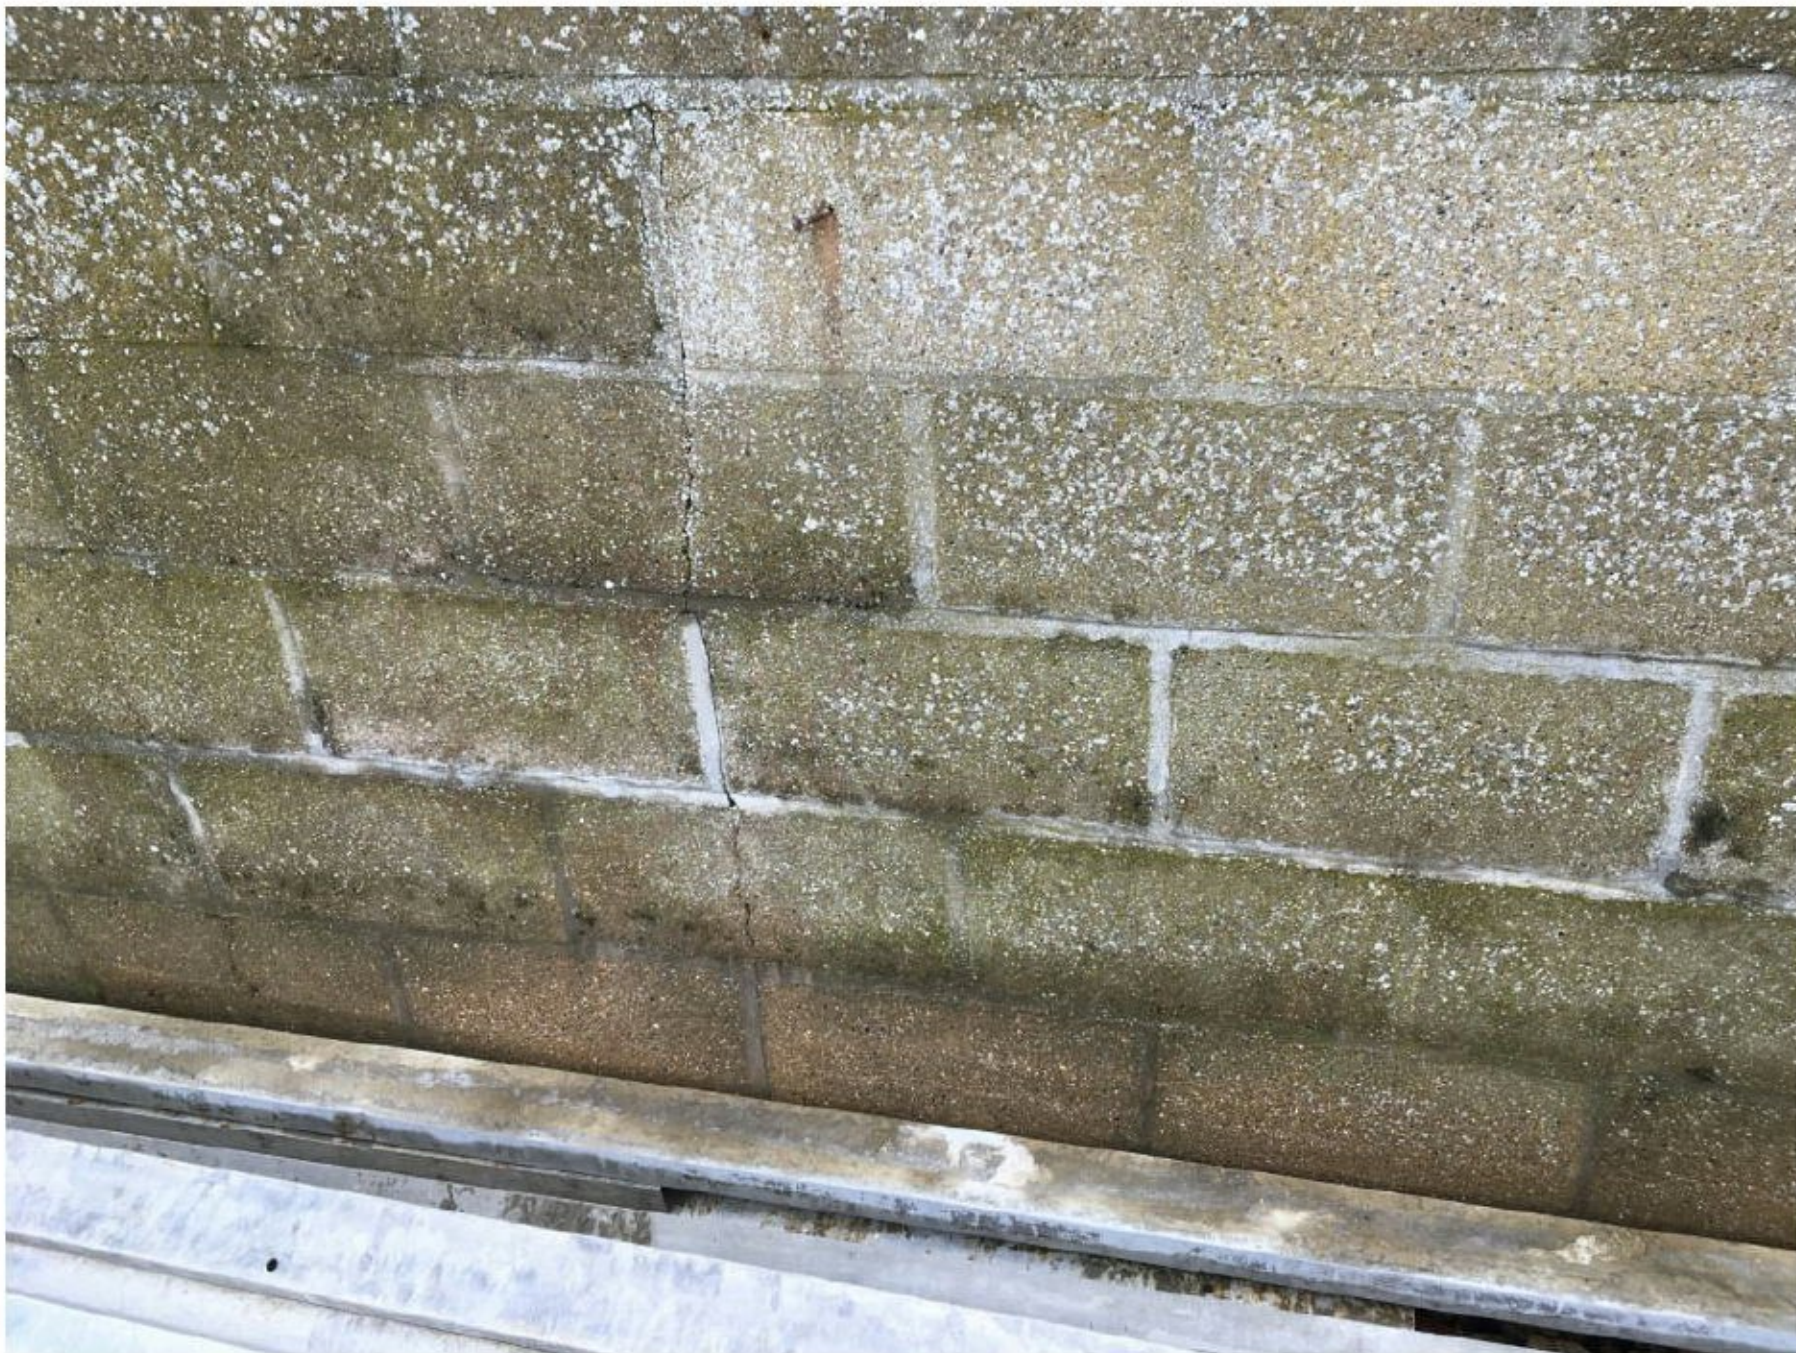
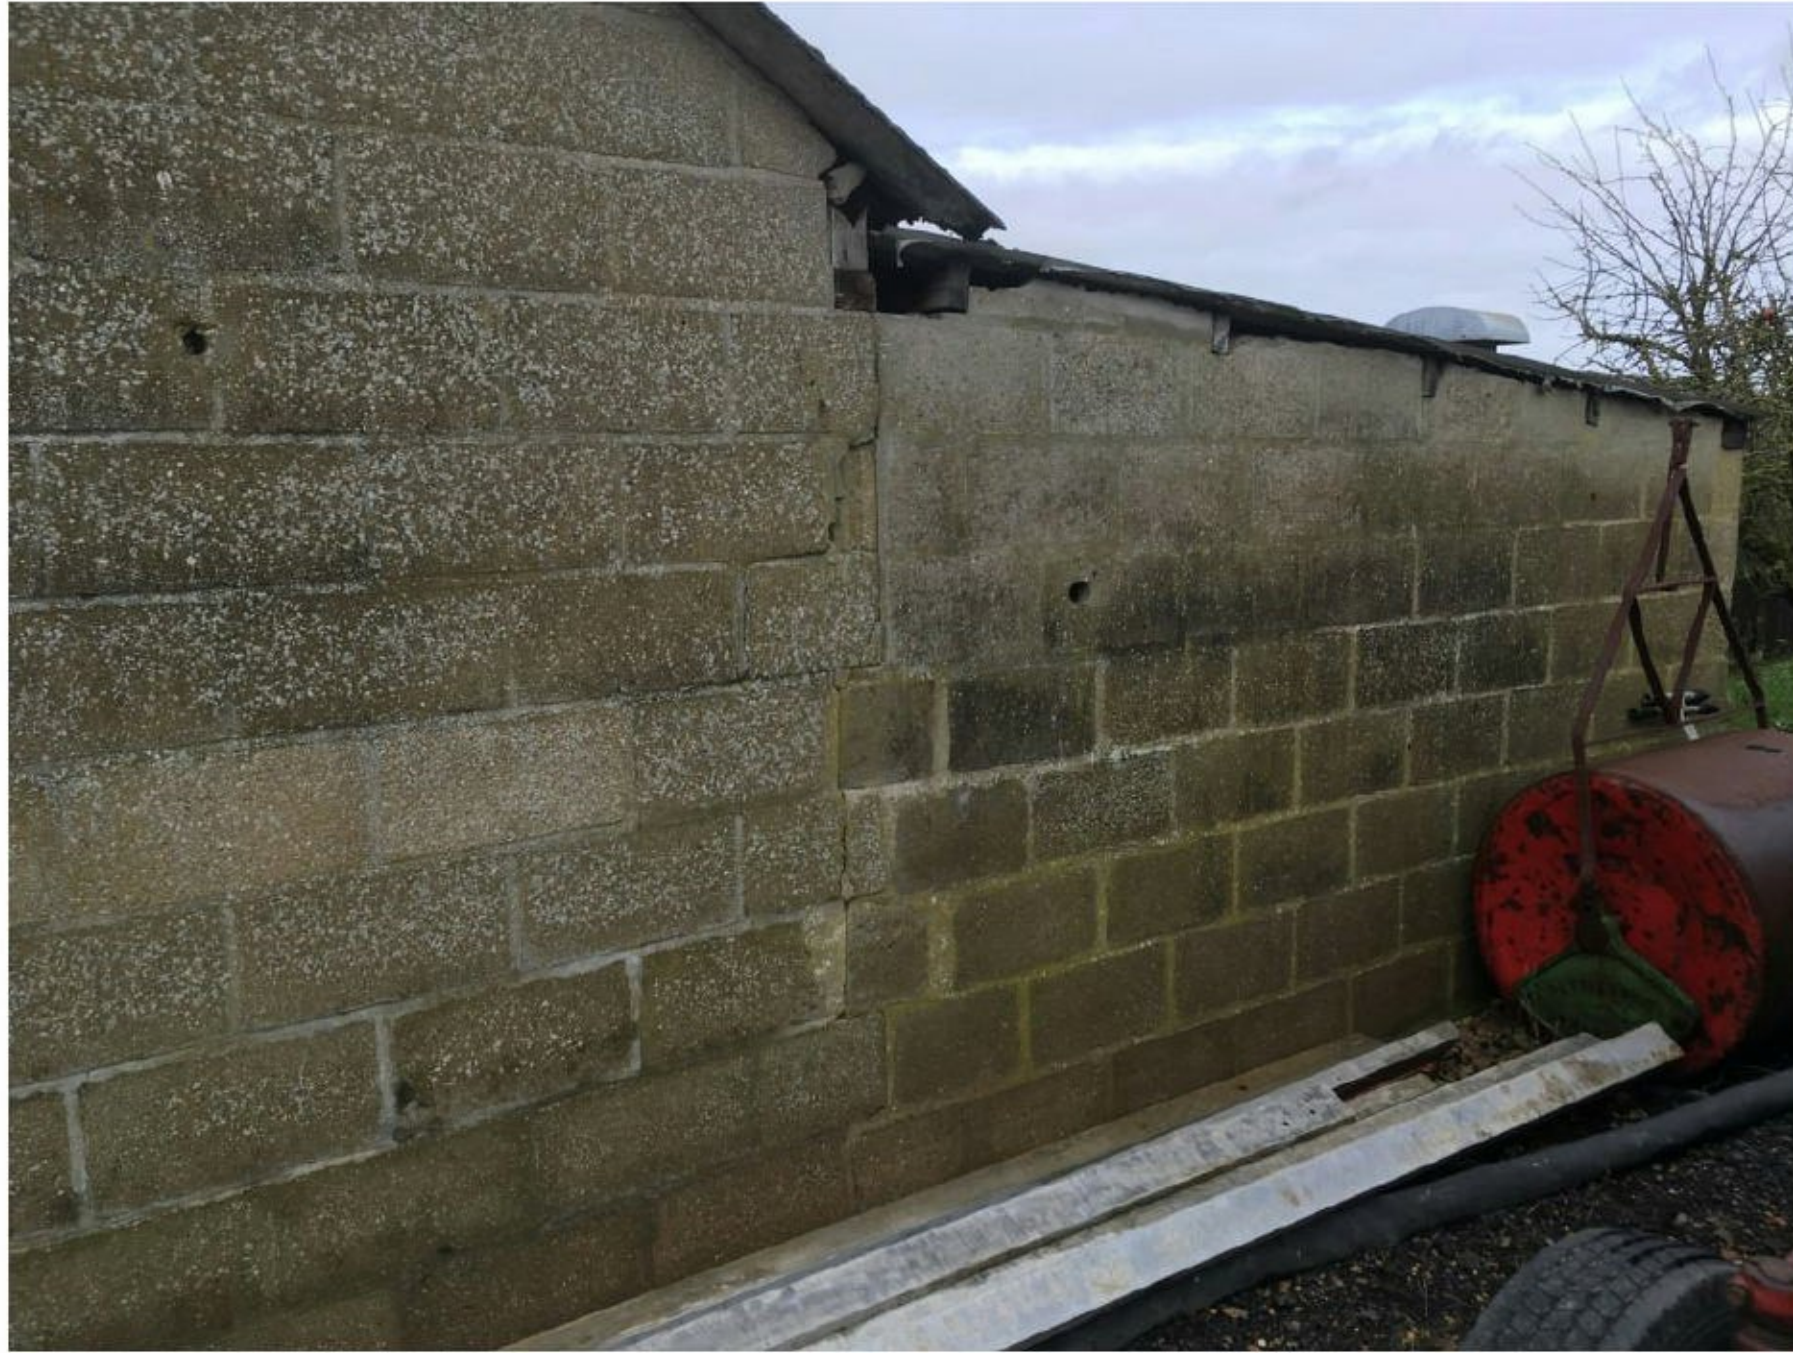
Property Defects

Externally the masonry has a vertical crack on the southern elevation at the duo pitch front section of the barn and the rear mono pitch section. There is a minor vertical crack to the southern elevation a mid point of the duo pitch section wall, propagating from low level.

To the western elevation there is some minor damage that has displaced the masonry around the door openings at lintel level, along with a minor vertical crack central to the masonry elevation.

The northern elevation has a small displaced crack within the masonry adjacent to a door opening. There are no other defects to the remainder of the masonry to the building.

The structure of the building presents in reasonable condition throughout, with no large scale movement or distortion within part of the structure. There has been some minor movement particularly to the southern and western elevations, but this is minor in nature and does appear to be historic.

As with any building of this age, there may be a degree of repair required when converted and of note some stitching of the historic cracking noted to the southern and western elevations should be attended to, however it is considered the structure is adequate to support a conversion of this type.
