REPORT NO. 21-033R_001

**Proposed Conversion of Agricultural Building at Pear
Tree Farm, Hinderclay**

Mr D Thorrold

February 2021

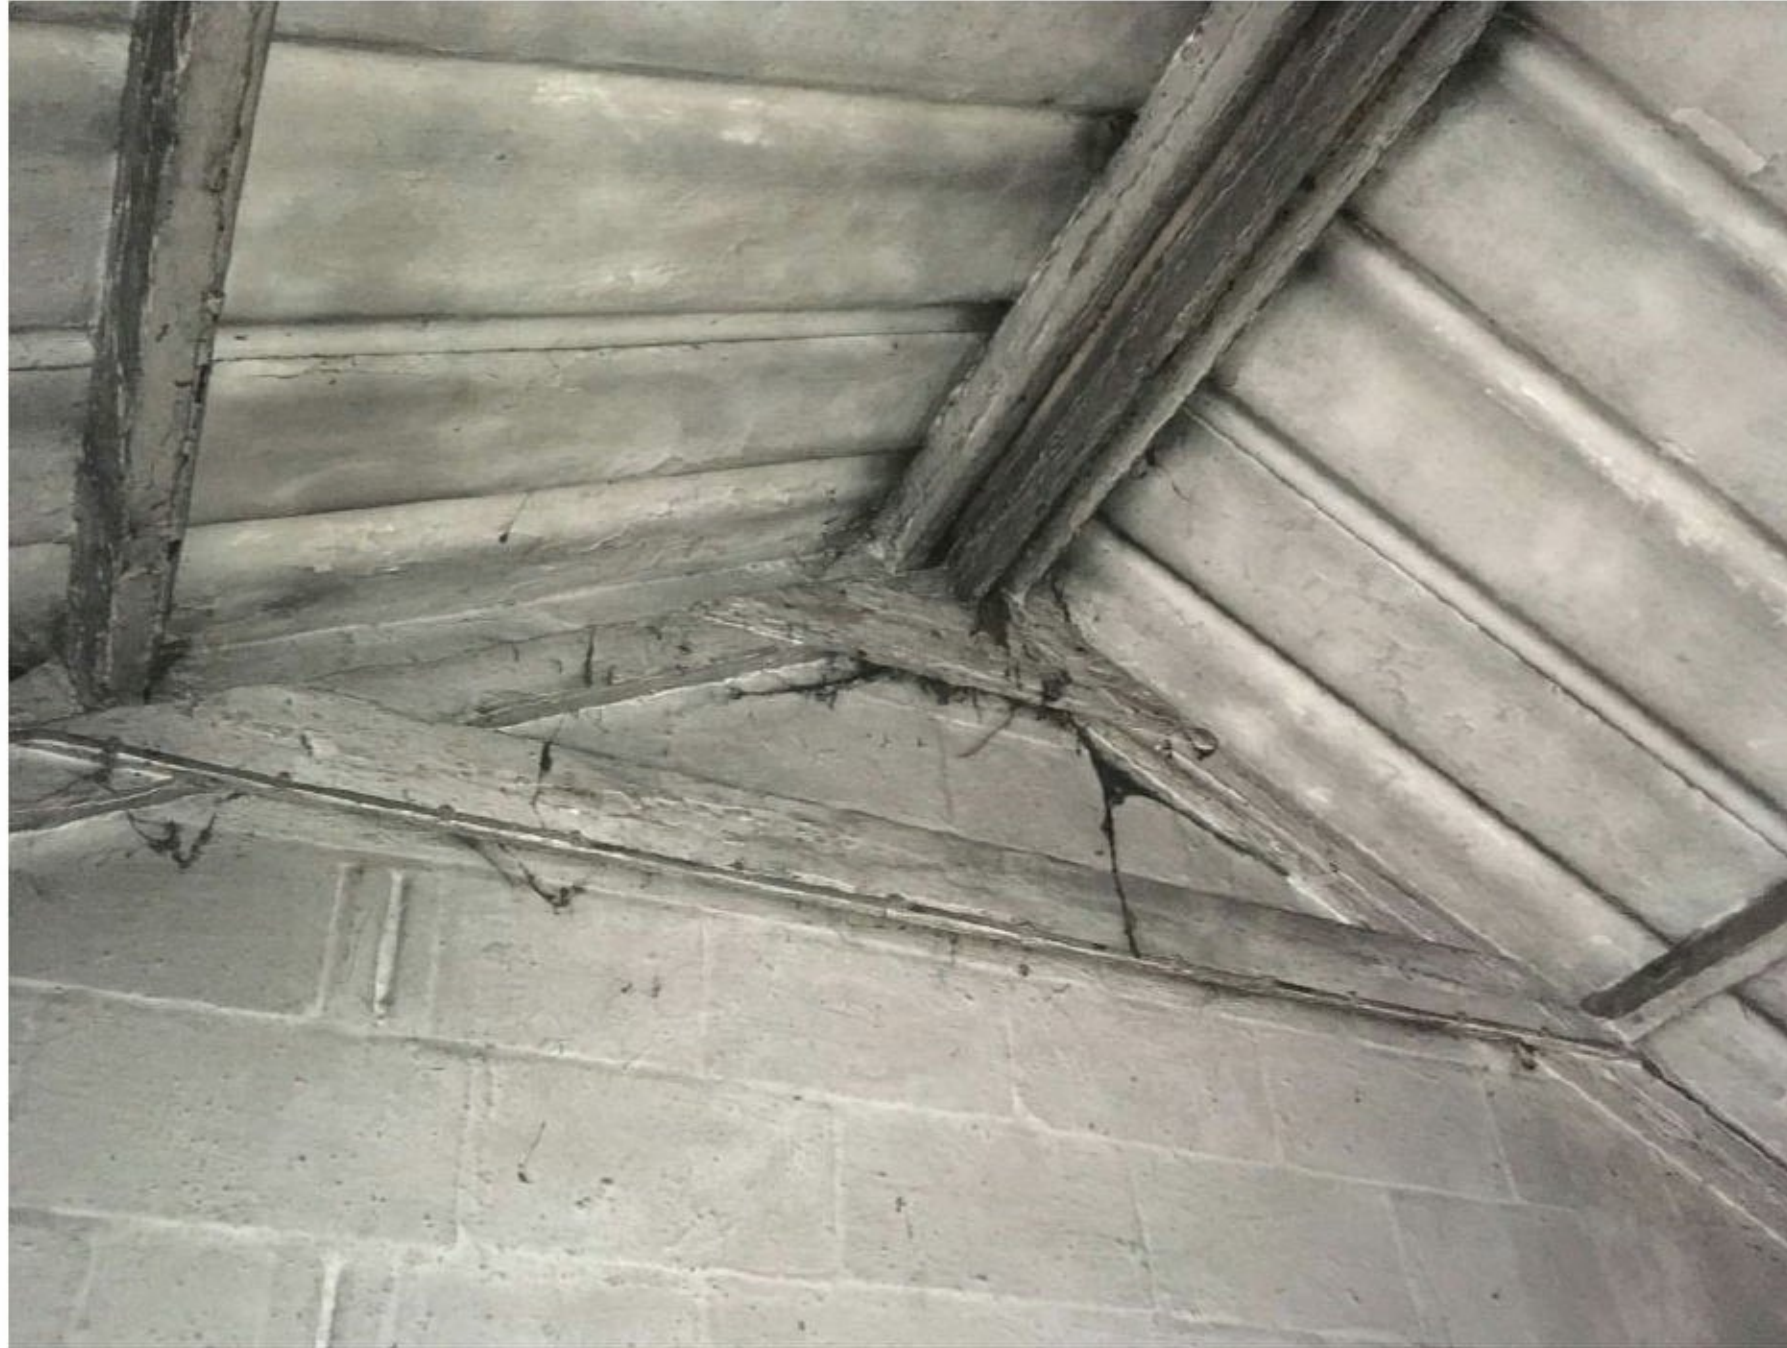
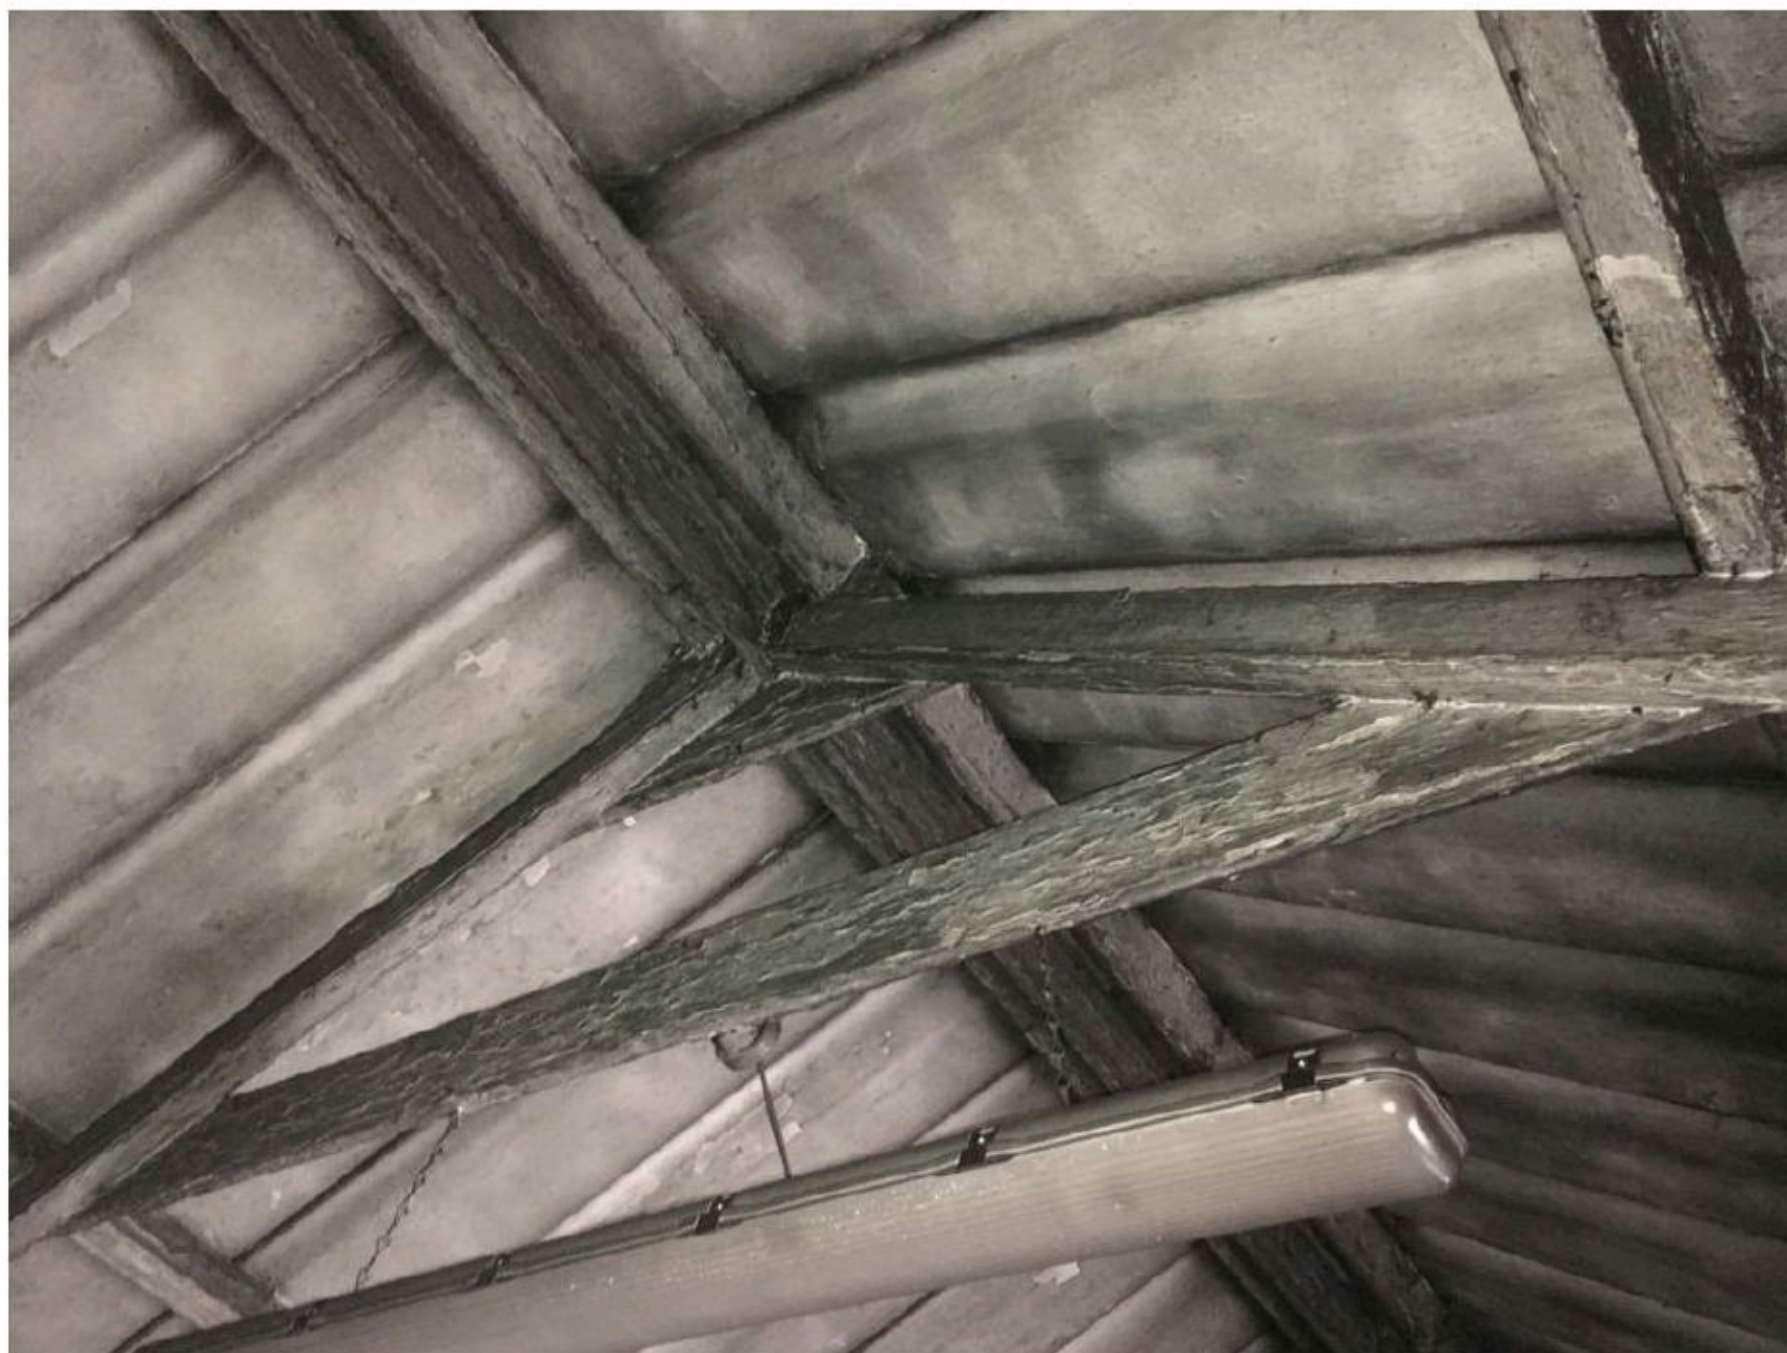
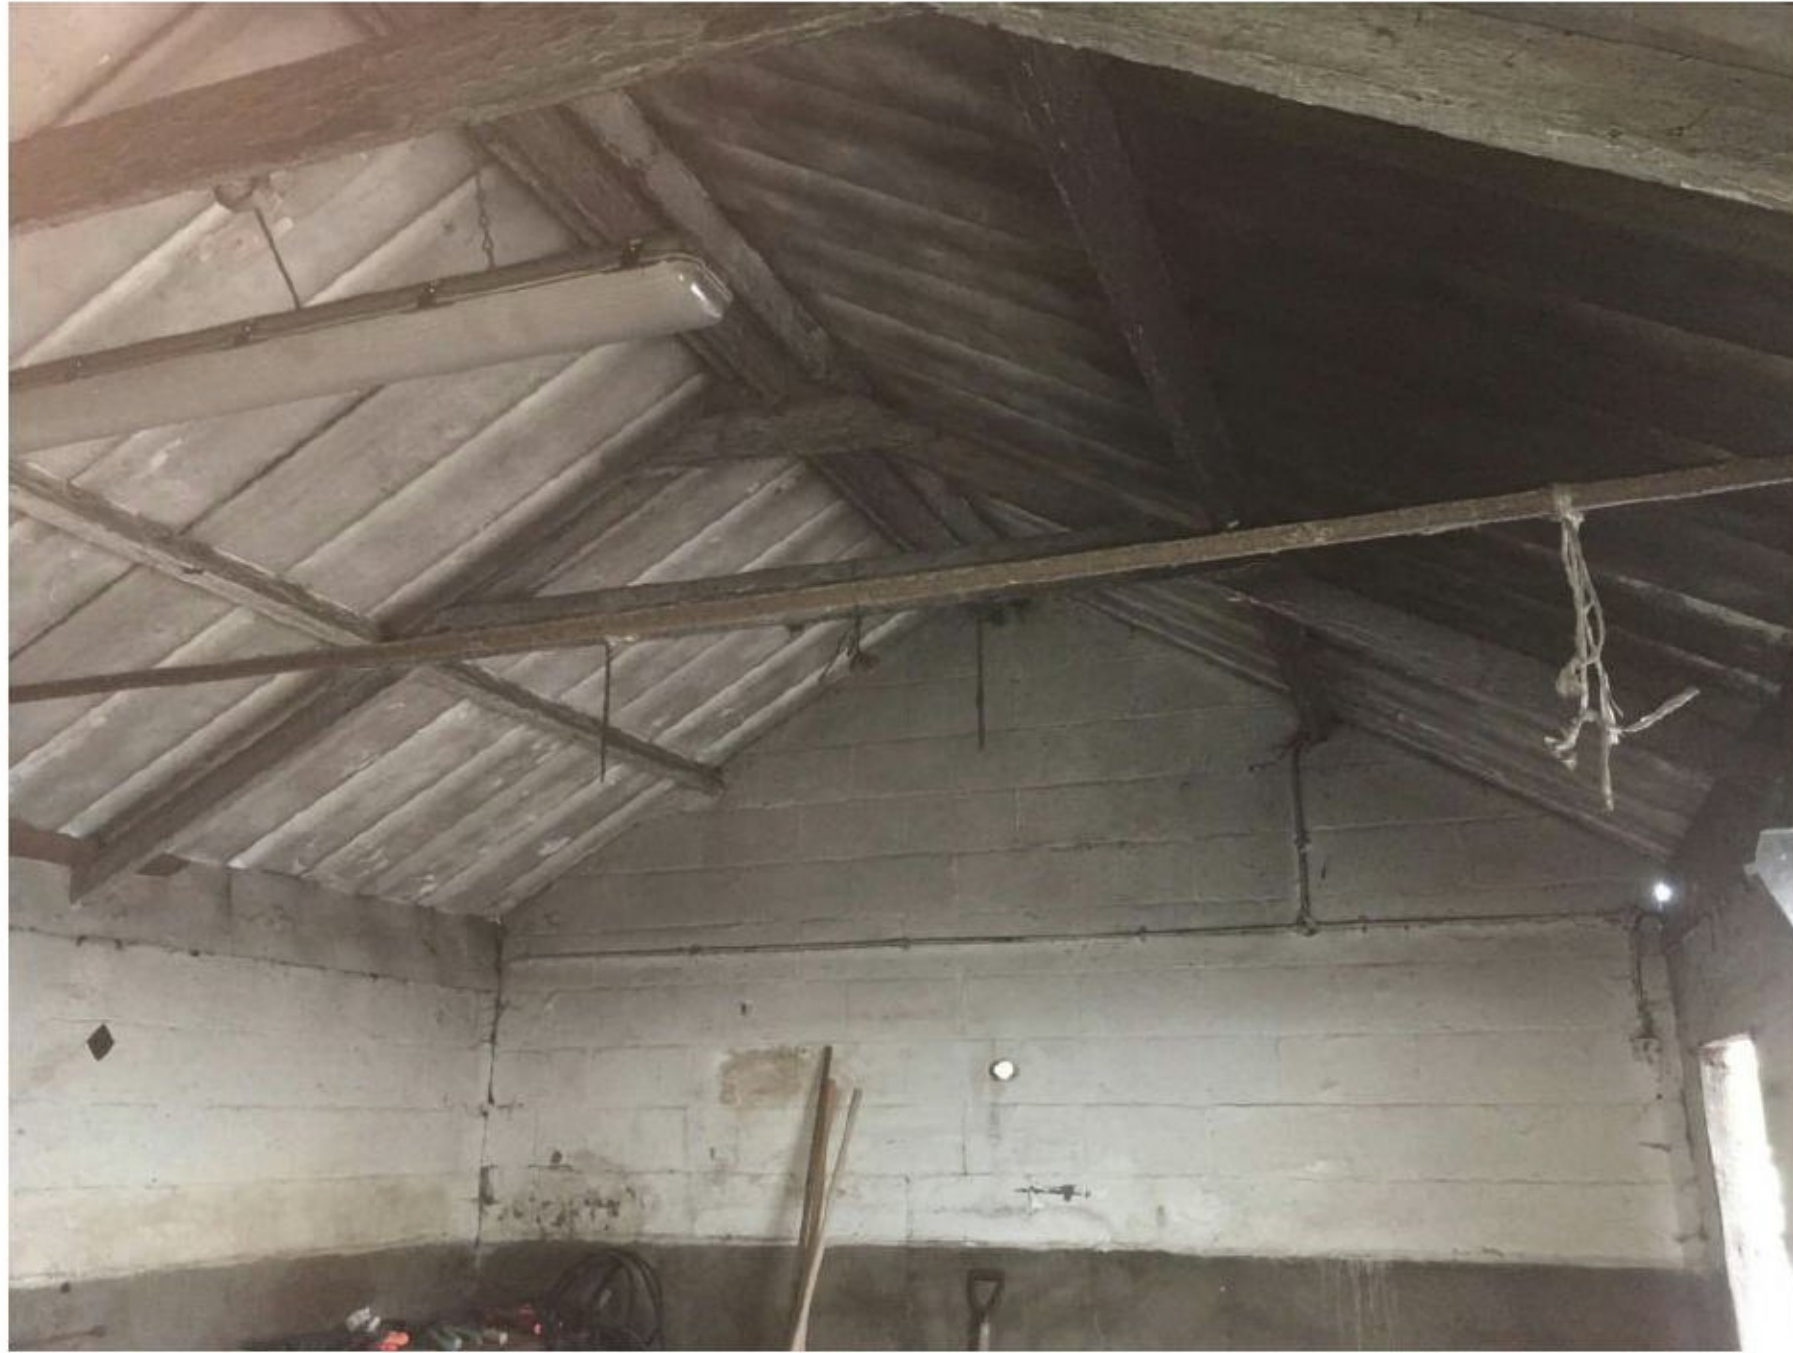
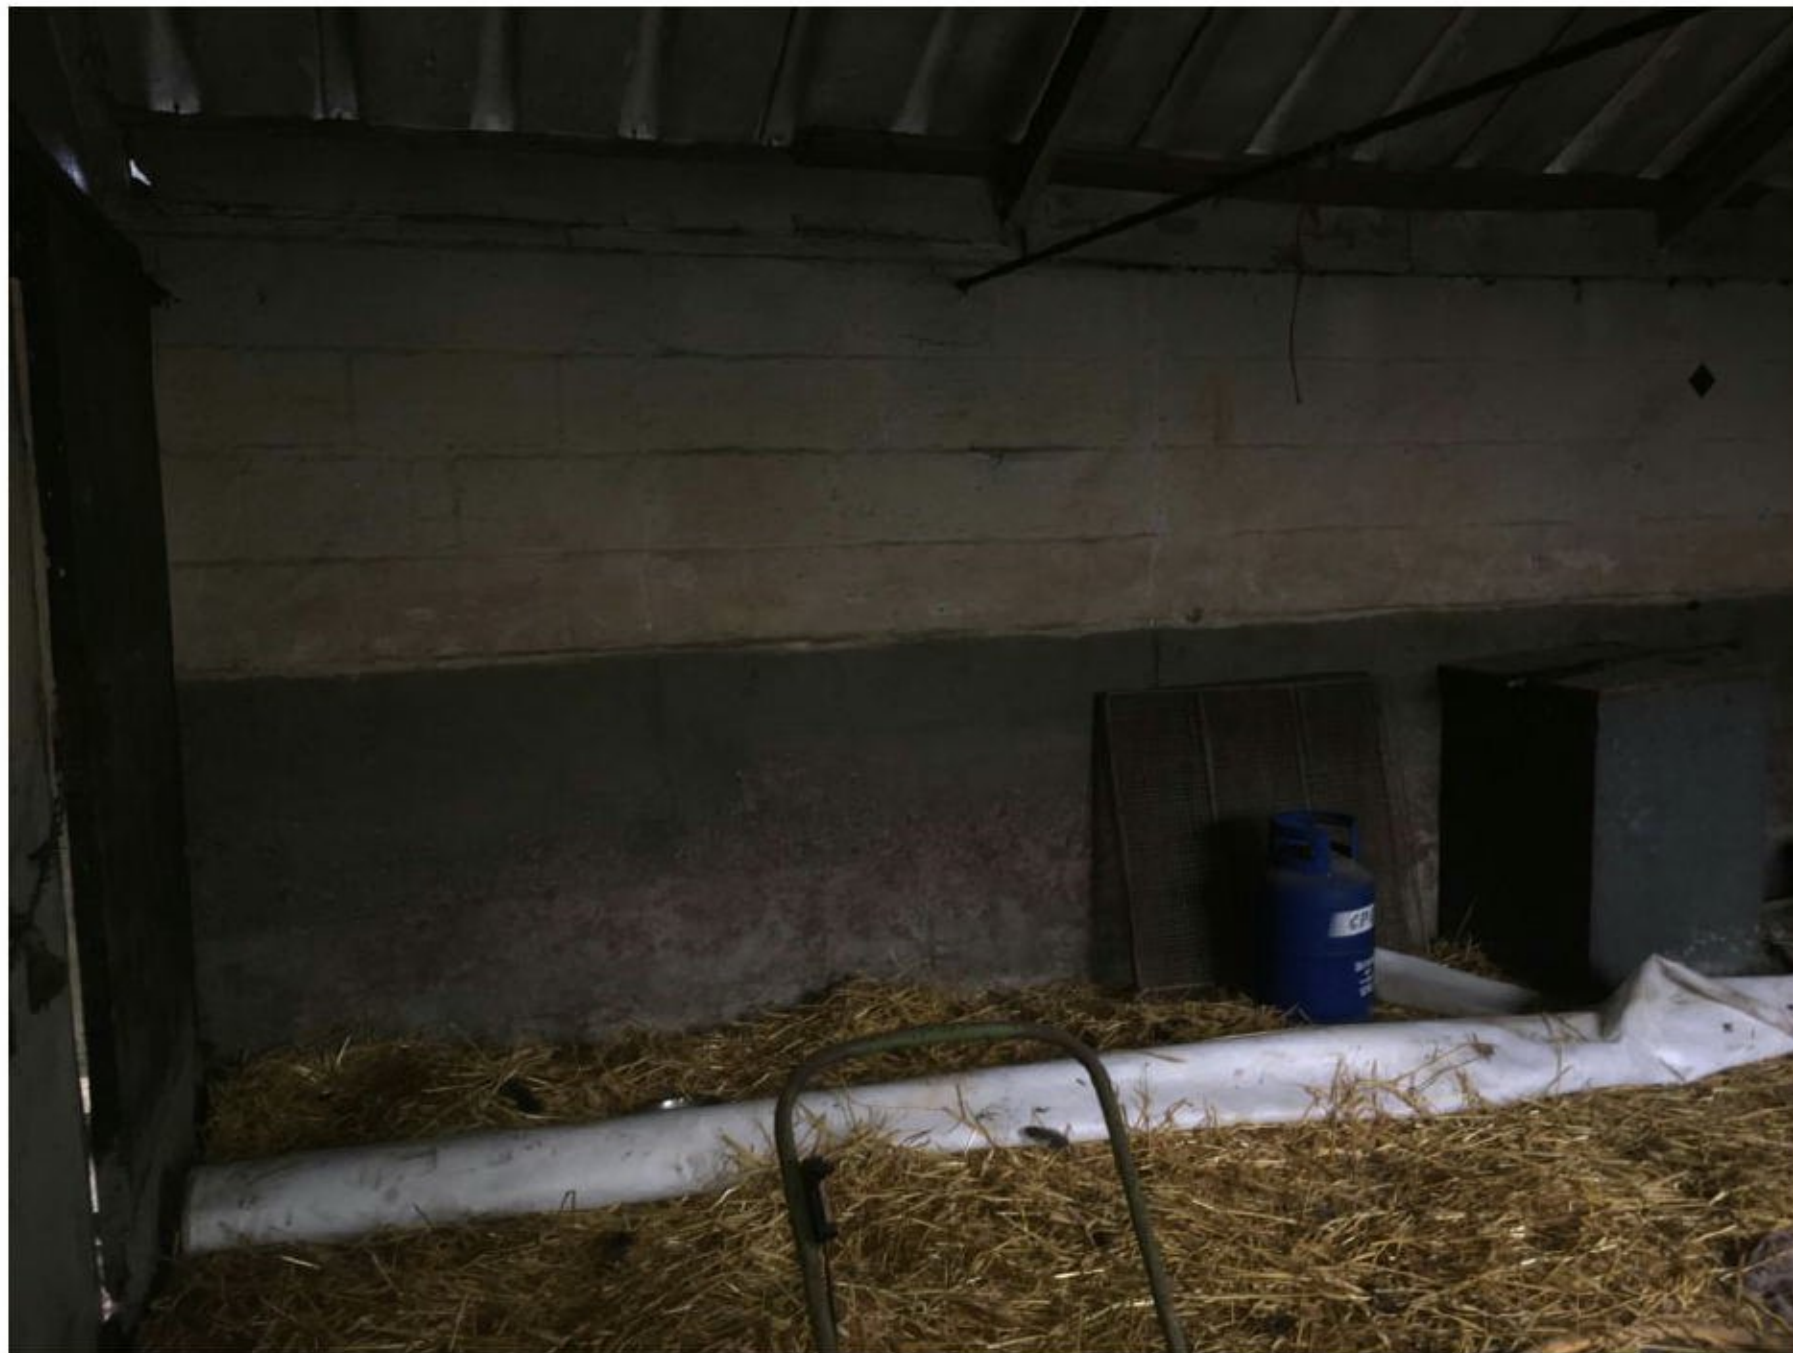
Front Section Internal

Internally there is no evidence of water ingress in all sections of the barn. The main duo pitch roof remains in good order with only minor evidence of beetle attack and no wet or dry rot evident. The timbers generally appeared in good condition and performing as required. The rear mono pitch roof has been more recently replaced and is also performing as required with no noticeable defects.

There are concrete slabs in both areas of the barn with these also in good condition, no noticeable cracks or deviations in level. The slab to the main section of the barn is constructed over various levels.
