# **Barn at Ashfield Lodge, Ashfield cum Thorpe, Suffolk**

## **Heritage Asset Assessment**

# **Barn at Ashfield Lodge, Clowe's Corner, Ashfield cum Thorpe, Suffolk**

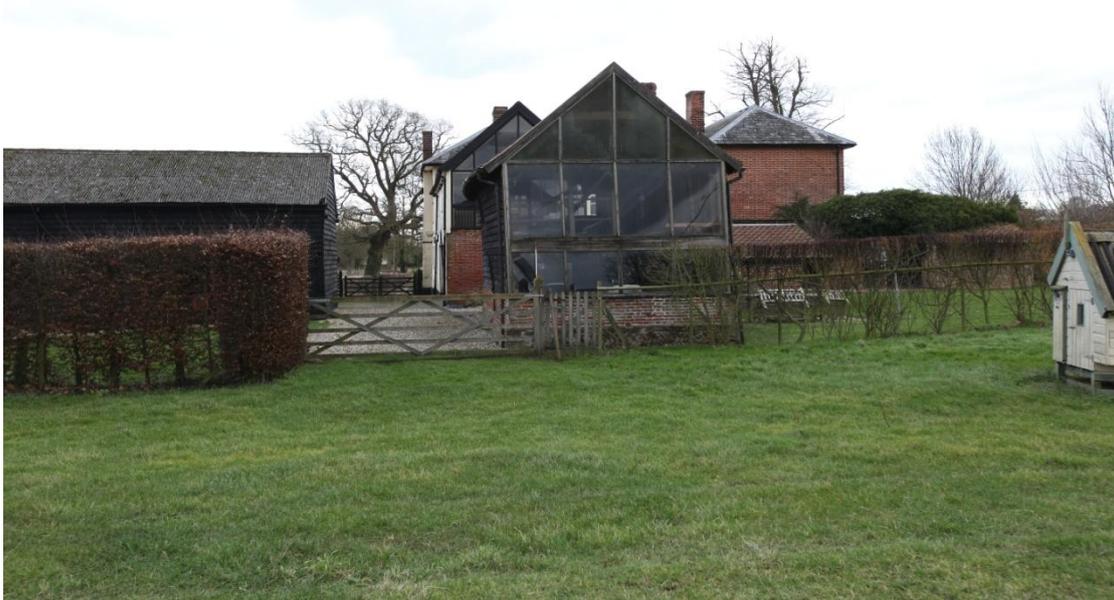
**Illus. 3. The site from the west showing the rear barn's bowed northern wall with the threshing barn on the left. The former's western gable was completely rebuilt and glazed in the late-20<sup>th</sup> century retaining only its brick plinth. The northern wing of the house was glazed in the same manner on its upper storey.**

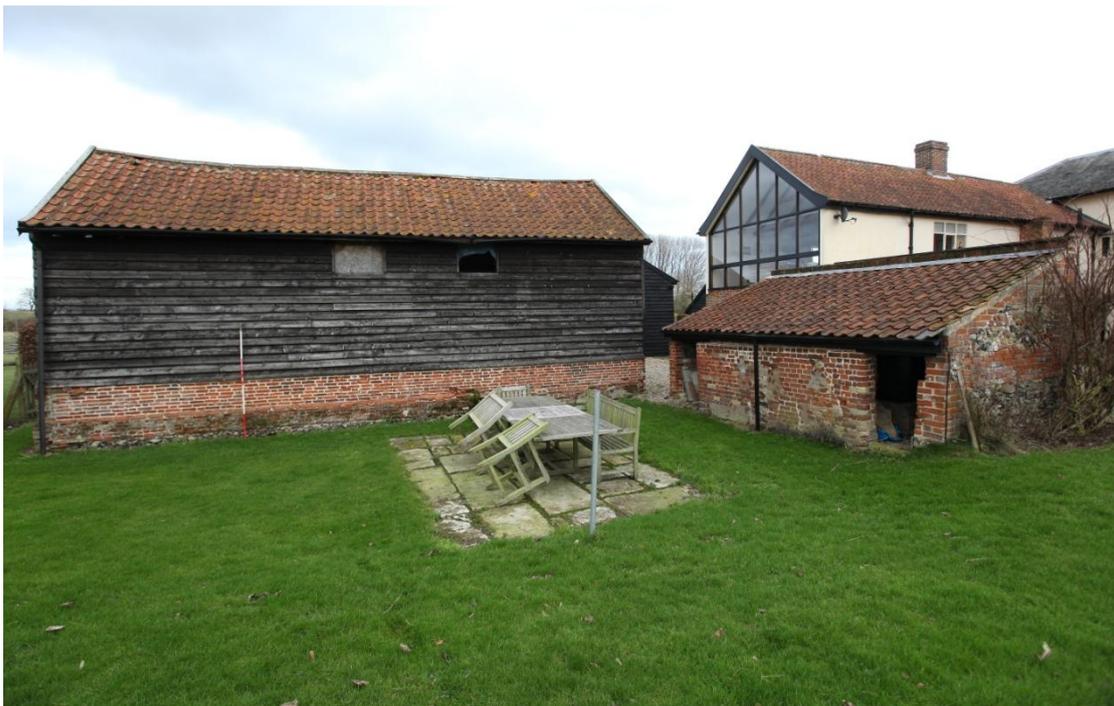
**Illus. 4. The rear barn's southern elevation showing its close proximity to the much altered 19<sup>th</sup> century range of pig sties on the right, which preserves the outlines of two earlier arched apertures between its existing entrances. The two buildings almost adjoin corner-to-corner as on the Ordnance Survey of 1883 but in marked contrast to the situation shown in 1837 when a building on the site of the rear barn extended much further to the right.**

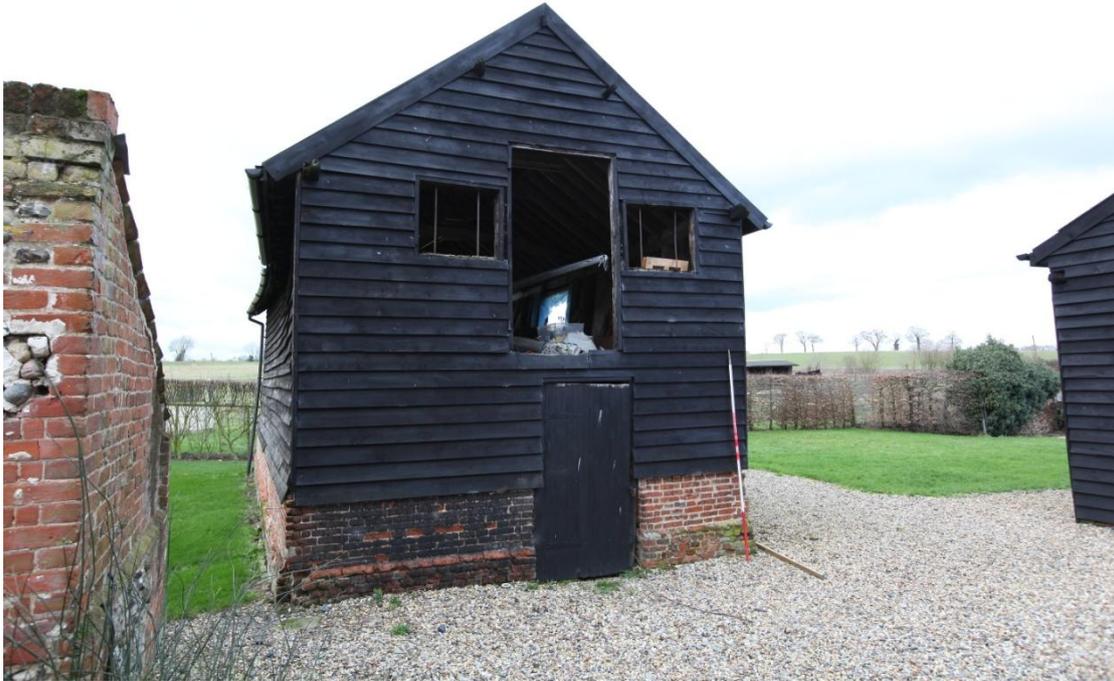
**Illus. 5. The eastern external gable showing the loading door to the loft which is offset on the right suggesting an external stair once rose from the left. The ground-floor entrance is respected by closers (quarter-bricks) in the brick plinth and is therefore an original feature.**

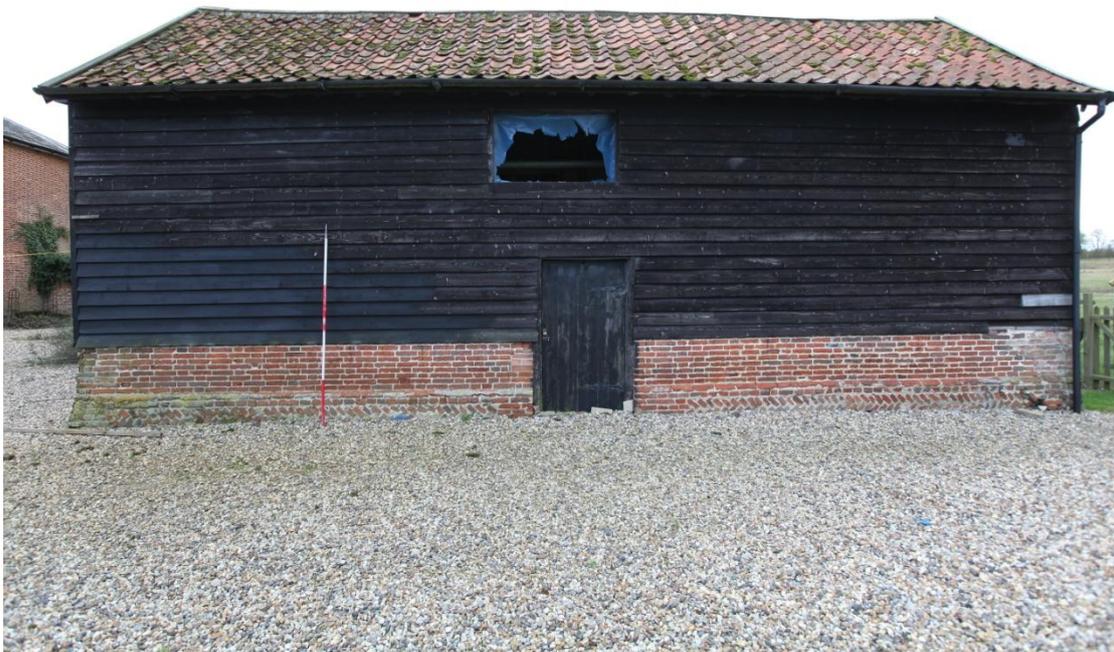
**Illus. 6. The northern elevation showing its renewed 20th century cladding of stained pine boards and the original central door respected by the brick plinth which is laid in Monk Bond. The first-floor windows in both this and the southern elevations appear to be later insertions.**

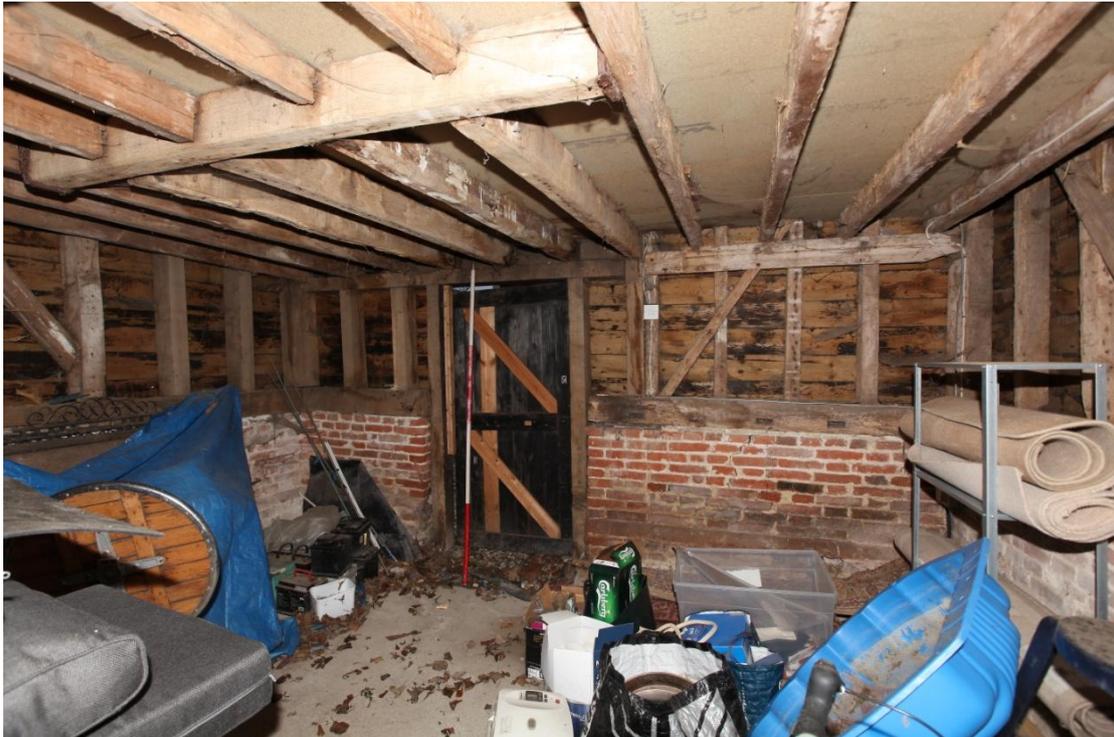
**Illus. 7. The internal eastern gable showing the original studwork to the right of the door with a narrow diagonal primary brace and evidence of re-used timber (as some studs bear the scars of lath-and-plaster while others do not). The studs and sill to the left of the door were renewed in the late-20<sup>th</sup> century.**

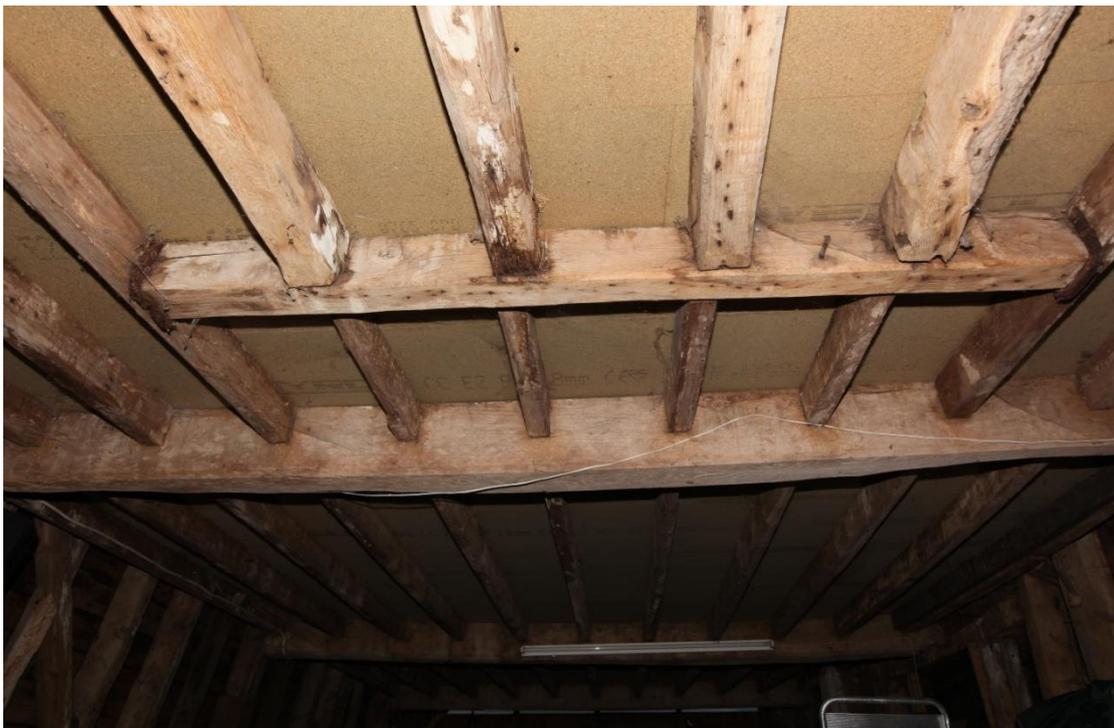
**Illus. 8. The ground-floor ceiling of bay A from the eastern gable showing the blocked trap that may have accommodated an internal stair or milling equipment. The trimmer and the joists in the foreground differ from the plain pine joists elsewhere in the ceiling and bear evidence of lath-and-plaster having been re-used from elsewhere.**

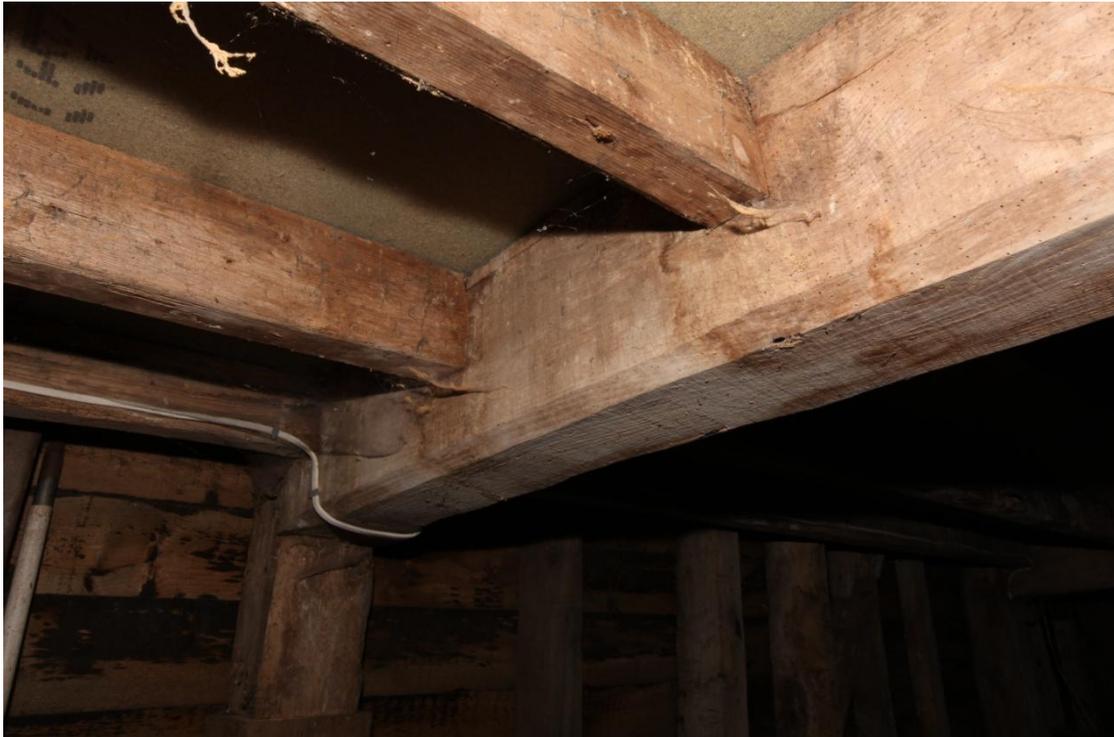
**Illus. 9.** A detail from the north-east of the neatly chamfered principal joist between bays B & C showing the tall-sectioned common joists which are of plain pine and typical of those elsewhere in the ceiling.

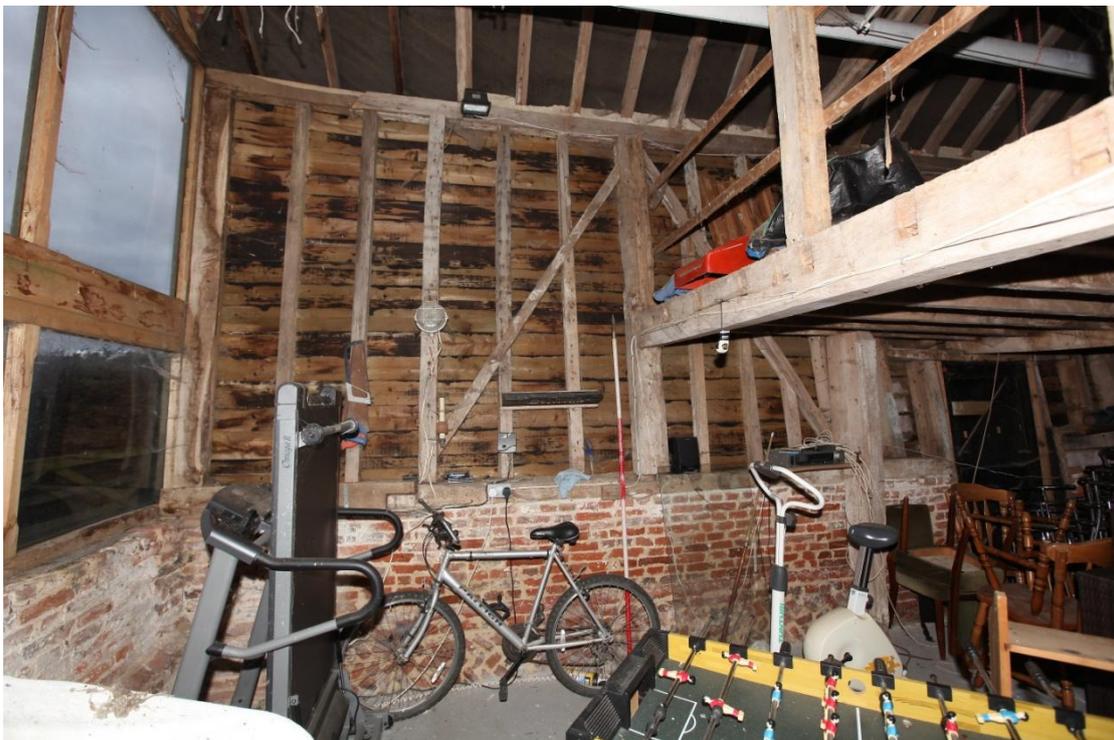
**Illus. 10.** The northern internal wall of bay D from which the original ceiling joists have been removed showing the rebuilt western gable on the left. The left-hand stud and sections of the roof-plate and sill have also been renewed but the brick plinth is original to the building. The diagonal braces are nailed to the principal posts, which lack jowls in the typical manner of the mid-19<sup>th</sup> century, and many studs show evidence of re-use from an 18<sup>th</sup> or early-19<sup>th</sup> century structure.

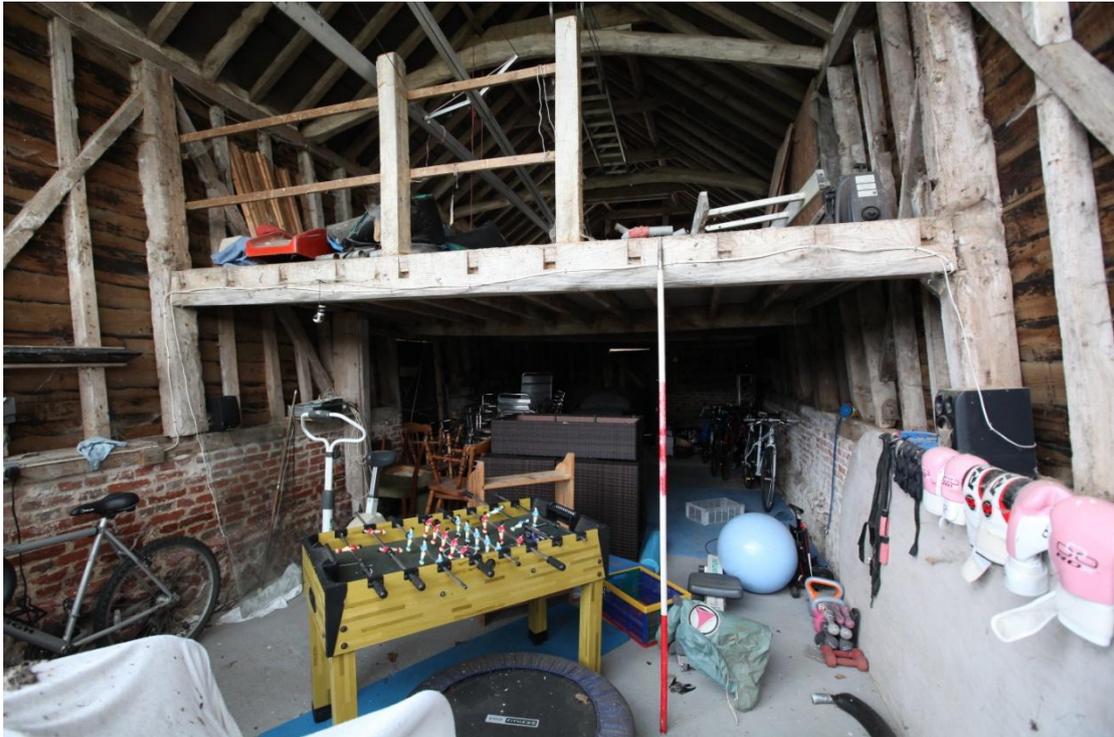
**Illus. 11. The interior looking east from the western gable showing the missing ceiling in bay D with empty joist mortises in the binding joist. The two posts above may have secured a piece of milling machinery.**

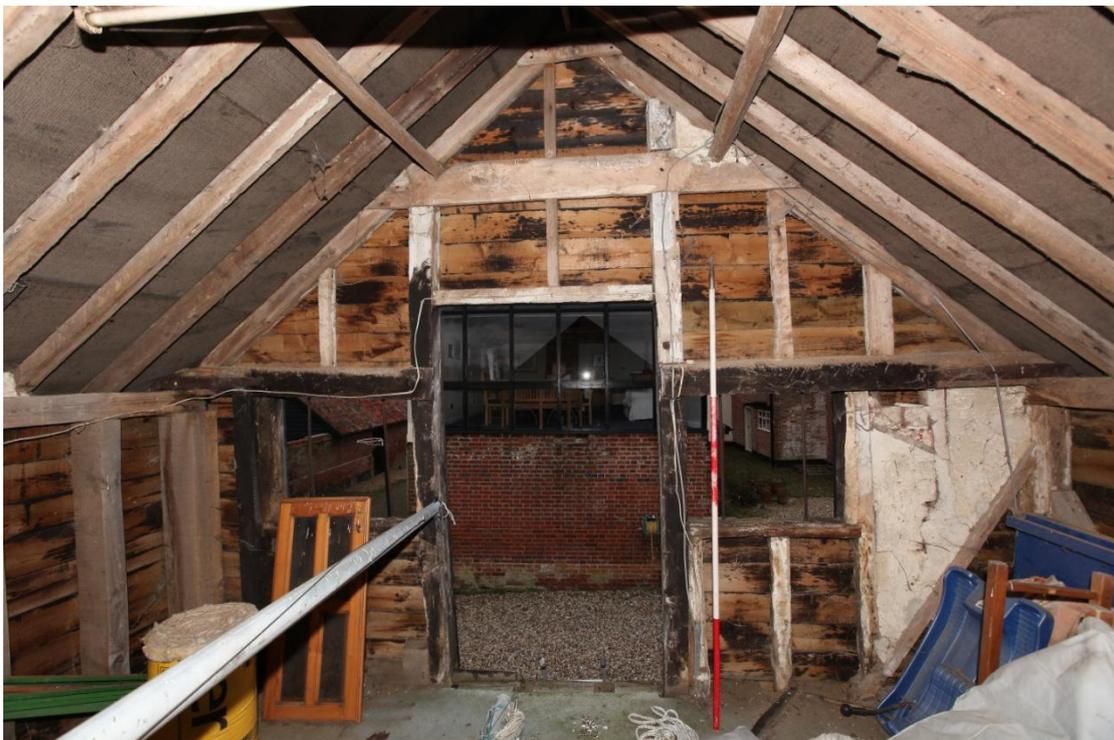
**Illus. 12. The eastern internal gable of the loft showing the loading door slightly to the left of centre with an intact section of original rendered brick infill on the right. The post and stud of the northern elevation on the left are modern replacements.**

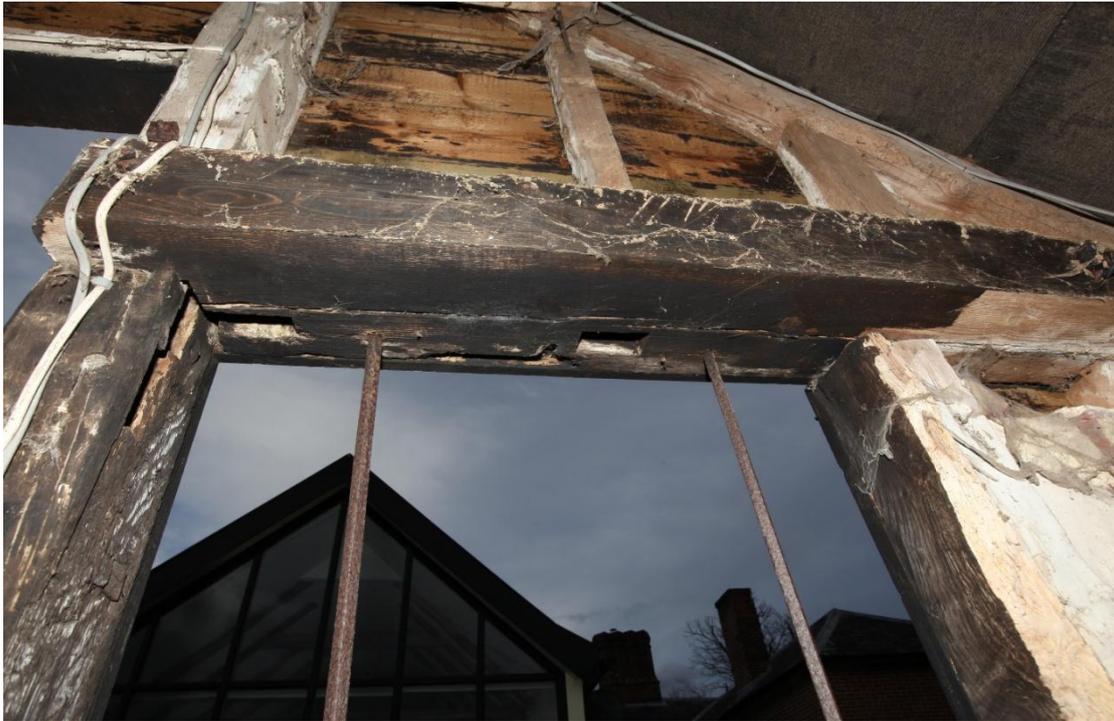
**Illus. 13. A detail of the underside of the pine tie-beam in the eastern gable showing empty stud mortises that suggest both the window and door are later insertions – or that the timber has been re-used. A small circular mortise in the centre housed a wooden mullion between the surviving iron bars.**

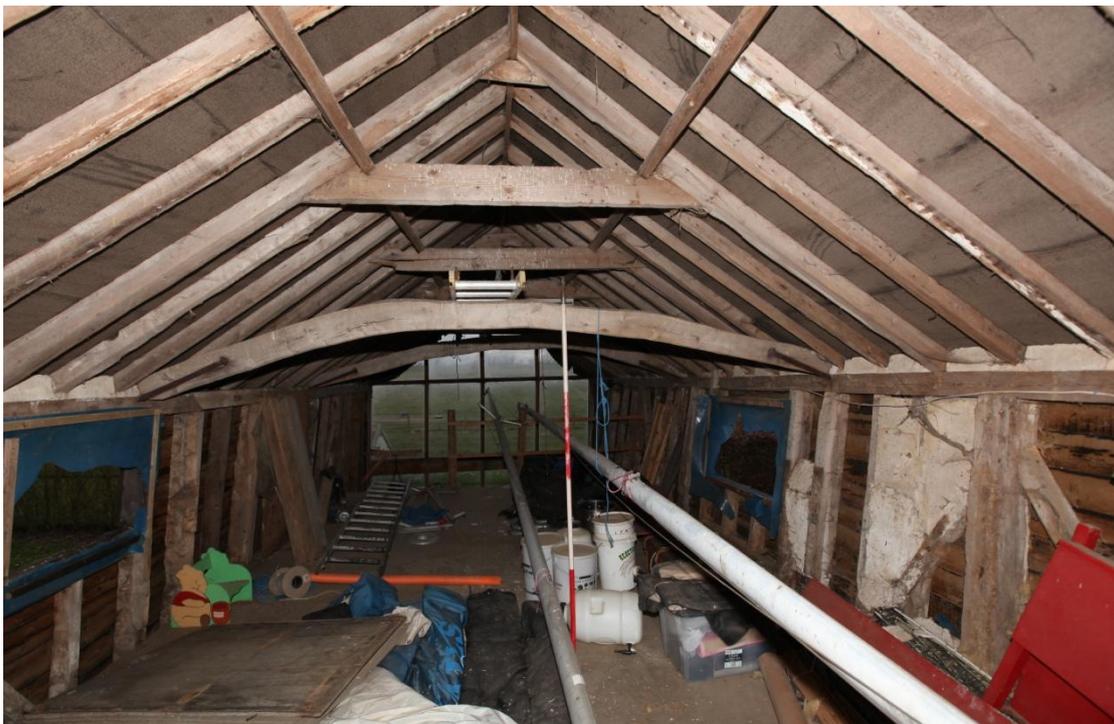
**Illus. 14. The loft from the eastern gable showing its ostensibly original clasped-purlin roof with a ridge board, purlins and nailed collars of pine. The two tie-beams, which are cambered to increase headroom, are also of pine and are secured to the roof-plates with original iron straps. A section of original infill of rendered brick is visible on the right and many rafters show signs of re-use with the remains of lath-and-plaster that are not relevant to the existing building.**
