ST CATHERINE'S COLLEGE, OXFORD
REPAIRS TO THE GARDEN WALLS
HERITAGE STATEMENT
DESIGN & ACCESS STATEMENT
DECEMBER 2020

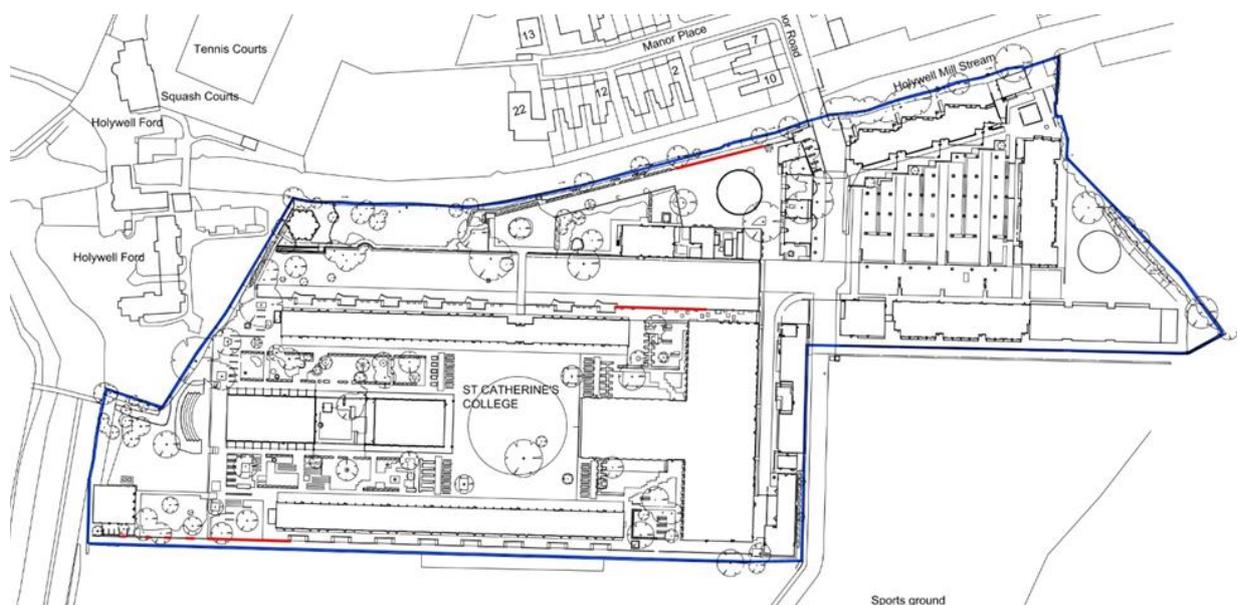
St Catherine's College site plan- damaged garden walls in red (north to right, not to scale)

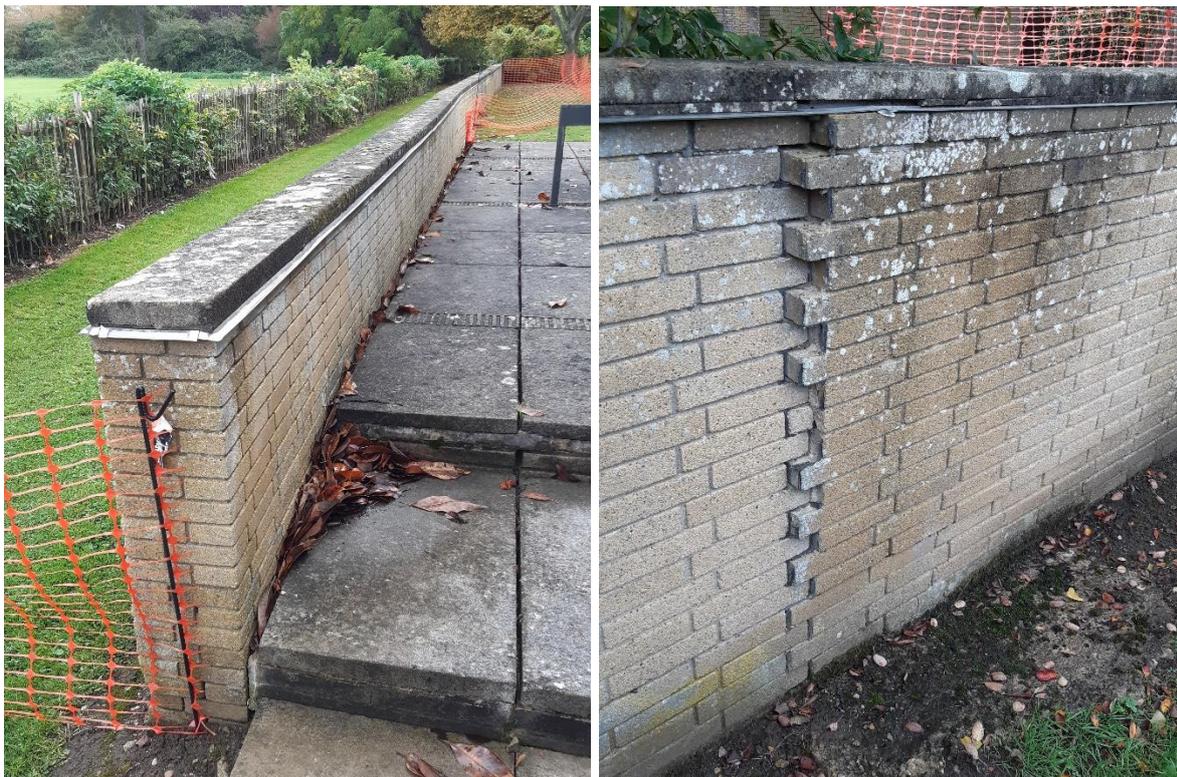
Podium eastern wall, southern half, northern end

Left- note wall leaning towards sports field and buckle near to middle, at far end of paving

Right- original movement joint of open brickwork joints, sealed with mastic

For the southern half of the podium eastern wall, north of the central movement joint, the wall has been badly affected by movement as shown above and noted in the structural engineer's report, such that the wall is leaning towards sports field side by 125mm. Since this wall is adjacent to a paved and grassed area where students might gather, the garden has been temporarily cordoned off to prevent students leaning against the wall and it collapsing with them or students sitting under it and it collapsing onto them.

For the east podium wall, the northern half of the southern length has such a lean and several areas of dislodged and cracked bricks, that it needs to be rebuilt from its northern end, to the existing movement joint at the midpoint of the wall. It is proposed that the concrete coping stones and zinc flashings are set aside on the adjacent lawn in the same order as their current locations on the wall. The brickwork would then be carefully taken down to foundation level, with the mortar being cleaned off the bricks as the work progresses. On the podium side, there would be a new leaf of two courses of standard dense concrete blocks, which would then match the existing coursing of the wall up to the level of the existing paving slabs. The concrete blockwork will provide improved retaining strength against the higher ground level adjacent and should release sufficient bricks to replace the worst of the damaged bricks on the visible side. The original bricks would then be reused in rebuilding the wall, following which the zinc flashings and concrete coping stone would then be re-laid in the same order as originally. When the brickwork is rebuilt, movement joints would be incorporated at approximately every 6 metres, to the same detail as the existing movement joint at the midpoint of the wall and pointed with a mid-grey mastic.

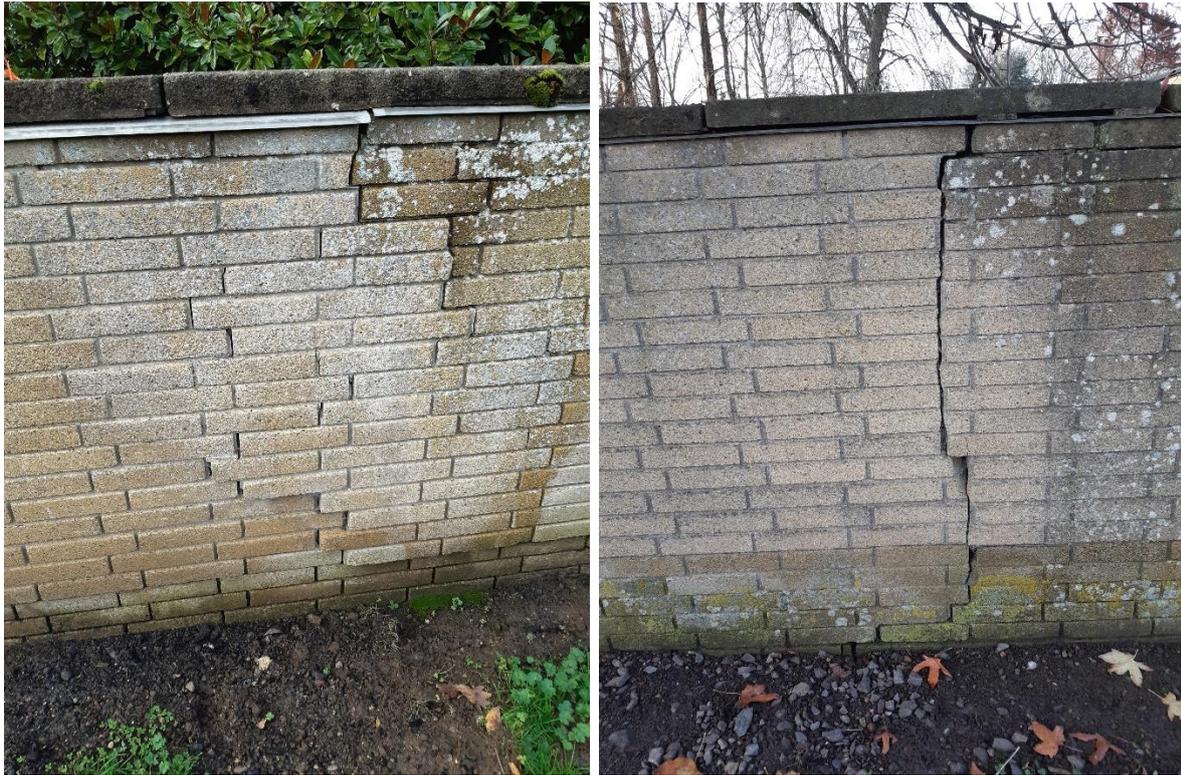
Further areas of buckling and cracking to the podium eastern wall, southern half

There is also some cracking to the southern half of the southern length of the east podium wall. To reduce the likelihood of future buckling and cracking, it is proposed to insert new movement joints into the existing brickwork at approximately 6 metre intervals. These movement joints would be formed by using a 5mm drill to drill a series of holes in the 8mm wide mortar of perp joints and adjacent bed joints to both leaves. Once holes have been drilled, the remaining mortar will be carefully cut with a chisel and then a file used to link the holes and remove the remaining mortar. The mortar joint in the coping stones closest to the new brickwork movement joint would also have the mortar removed, to allow for movement. Once the joints have been cleared of mortar, they would be repointed with a mid-grey mastic.

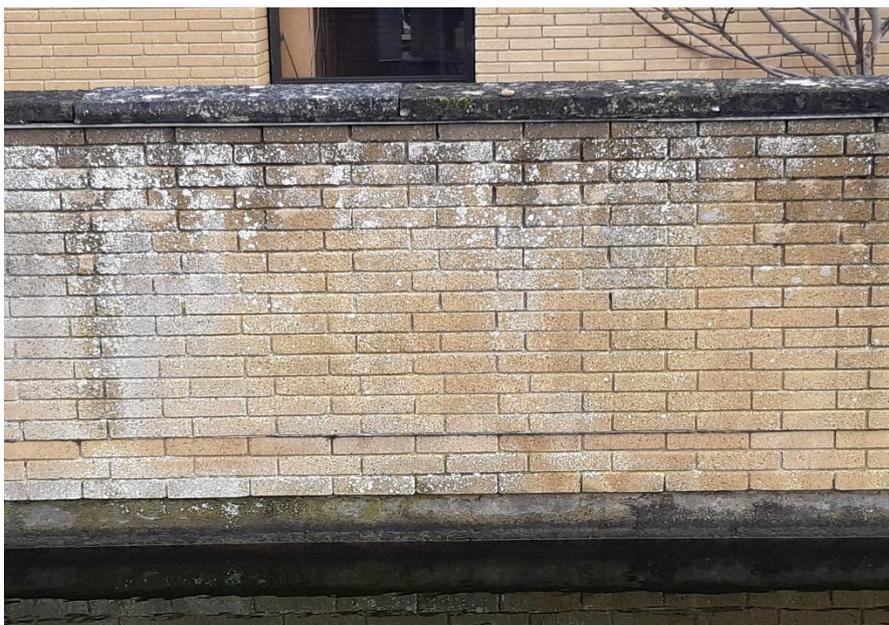
For the northern part of the wall to the east side of the central pond, the wall has remained nearly upright but has buckled towards the pond. However, since the walls have an unfilled cavity, the movement has not been consistent, with the leaf of brickwork on the paving side exhibiting more damage than the leaf facing the pond. Since this area is not frequently used by students, the problem is less of a safety concern but nevertheless needs to be repaired.

Wall to east side of the central pond, showing outward movement over damp-proof course

For the damaged areas of the central wall adjacent to the pond and the northern part of the podium western wall, these would be carefully taken down only in the affected areas and rebuilt, as described for the east podium wall, with movement joints incorporated as described. It is also proposed to create several other movement joints in the long lengths of the central wall adjacent to the pond and the podium west wall, to allow for movement and prevent any buckling and cracking in the future.

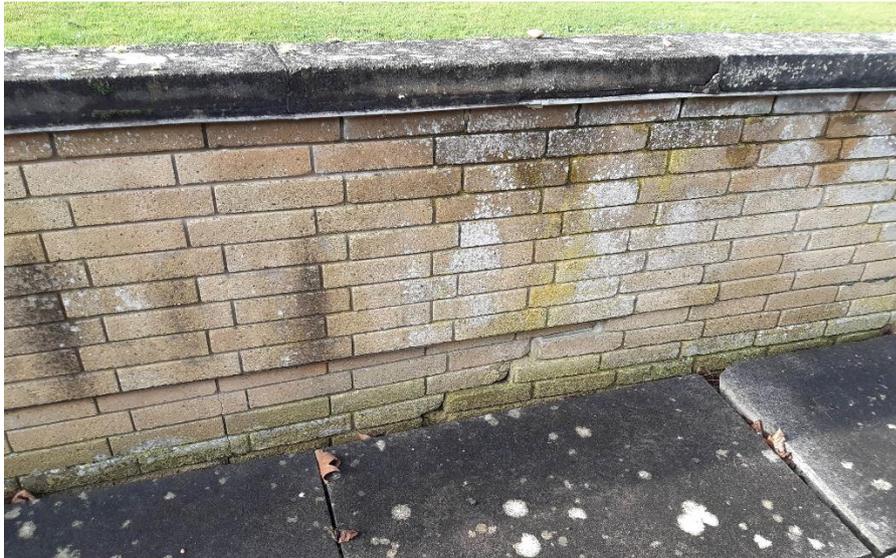
Wall to east side of the central pond, showing inward buckling between damp-proof courses, more pronounced than buckling to outer leaf

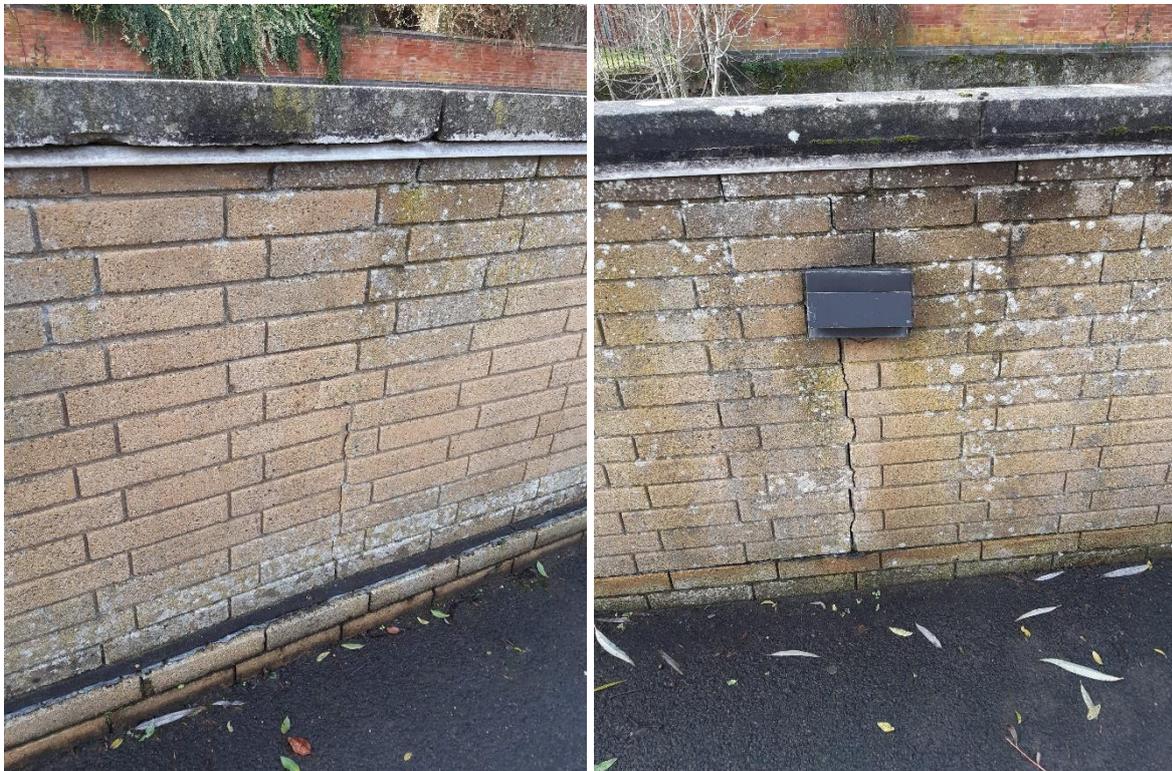
For the northern part of the wall to the podium western wall, this has buckled in a similar way to the central wall, with the western wall buckling towards the Holywell Mill Stream. This area is also less of a safety concern, since it is more of a transition area for pedestrians, cyclists and the occasional motorist. Nevertheless, this wall also needs to be repaired.

Northern part of the wall to the podium western wall, showing inward and outward buckling with cracking, above damp-proof course
