ST CATHERINE'S COLLEGE, OXFORD

REPAIRS TO THE GARDEN WALLS

HERITAGE STATEMENT

DESIGN & ACCESS STATEMENT

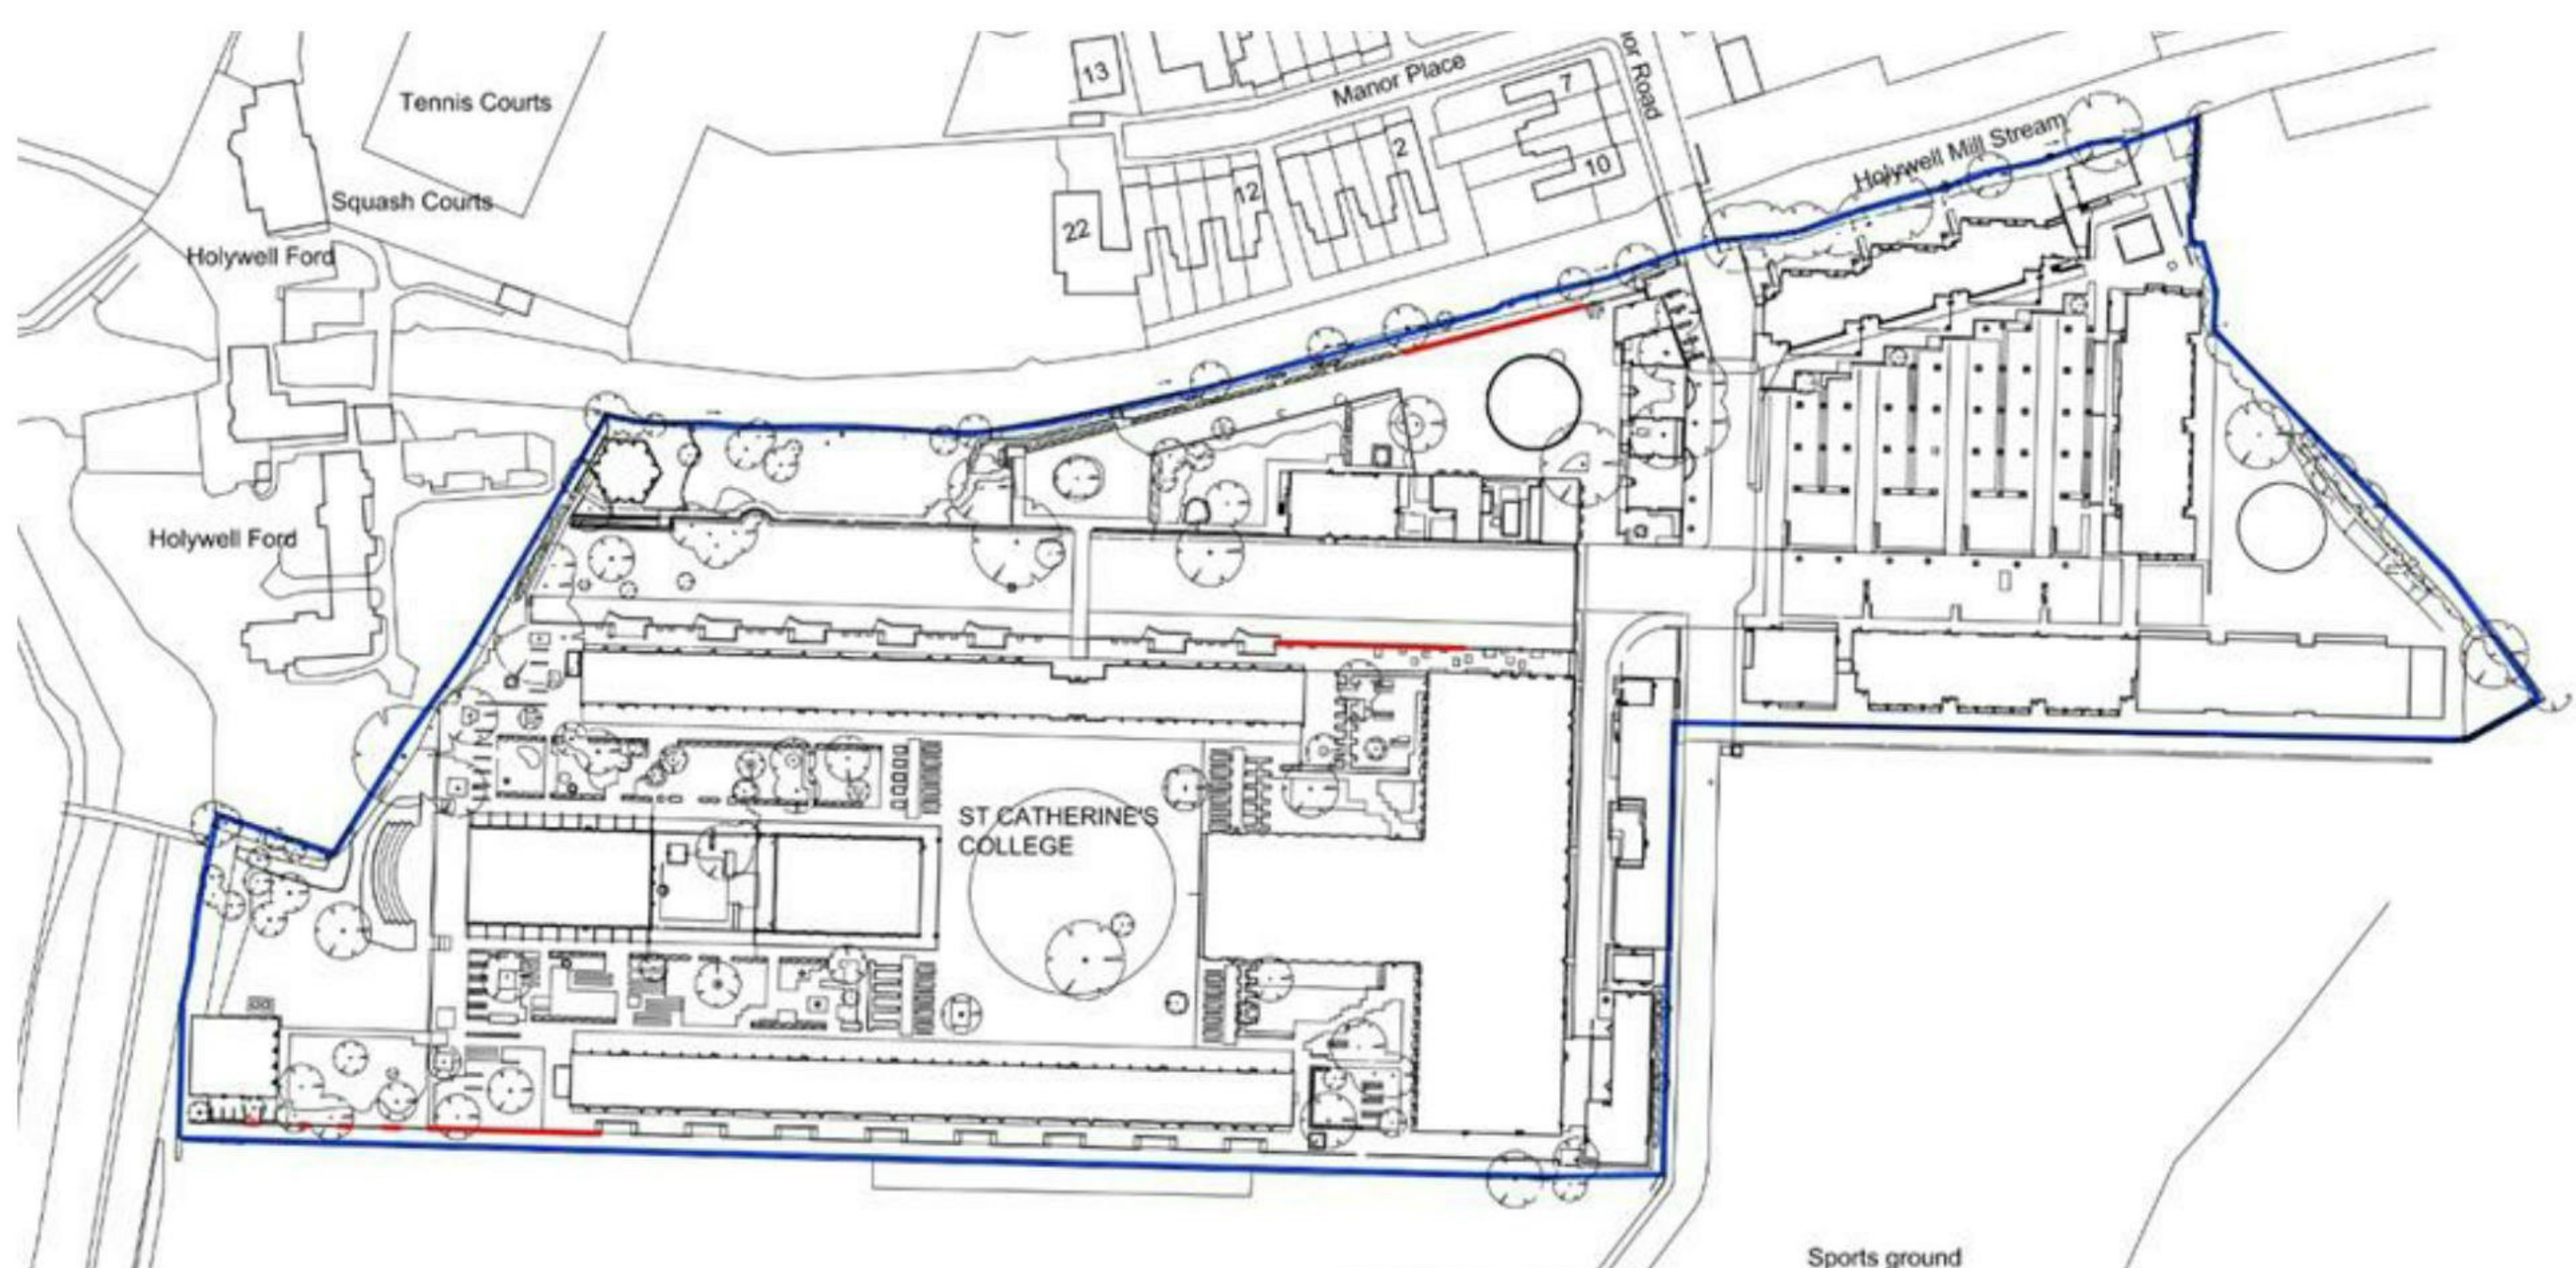
St Catherine's College site plan- damaged garden walls in red (north to right, not to scale)

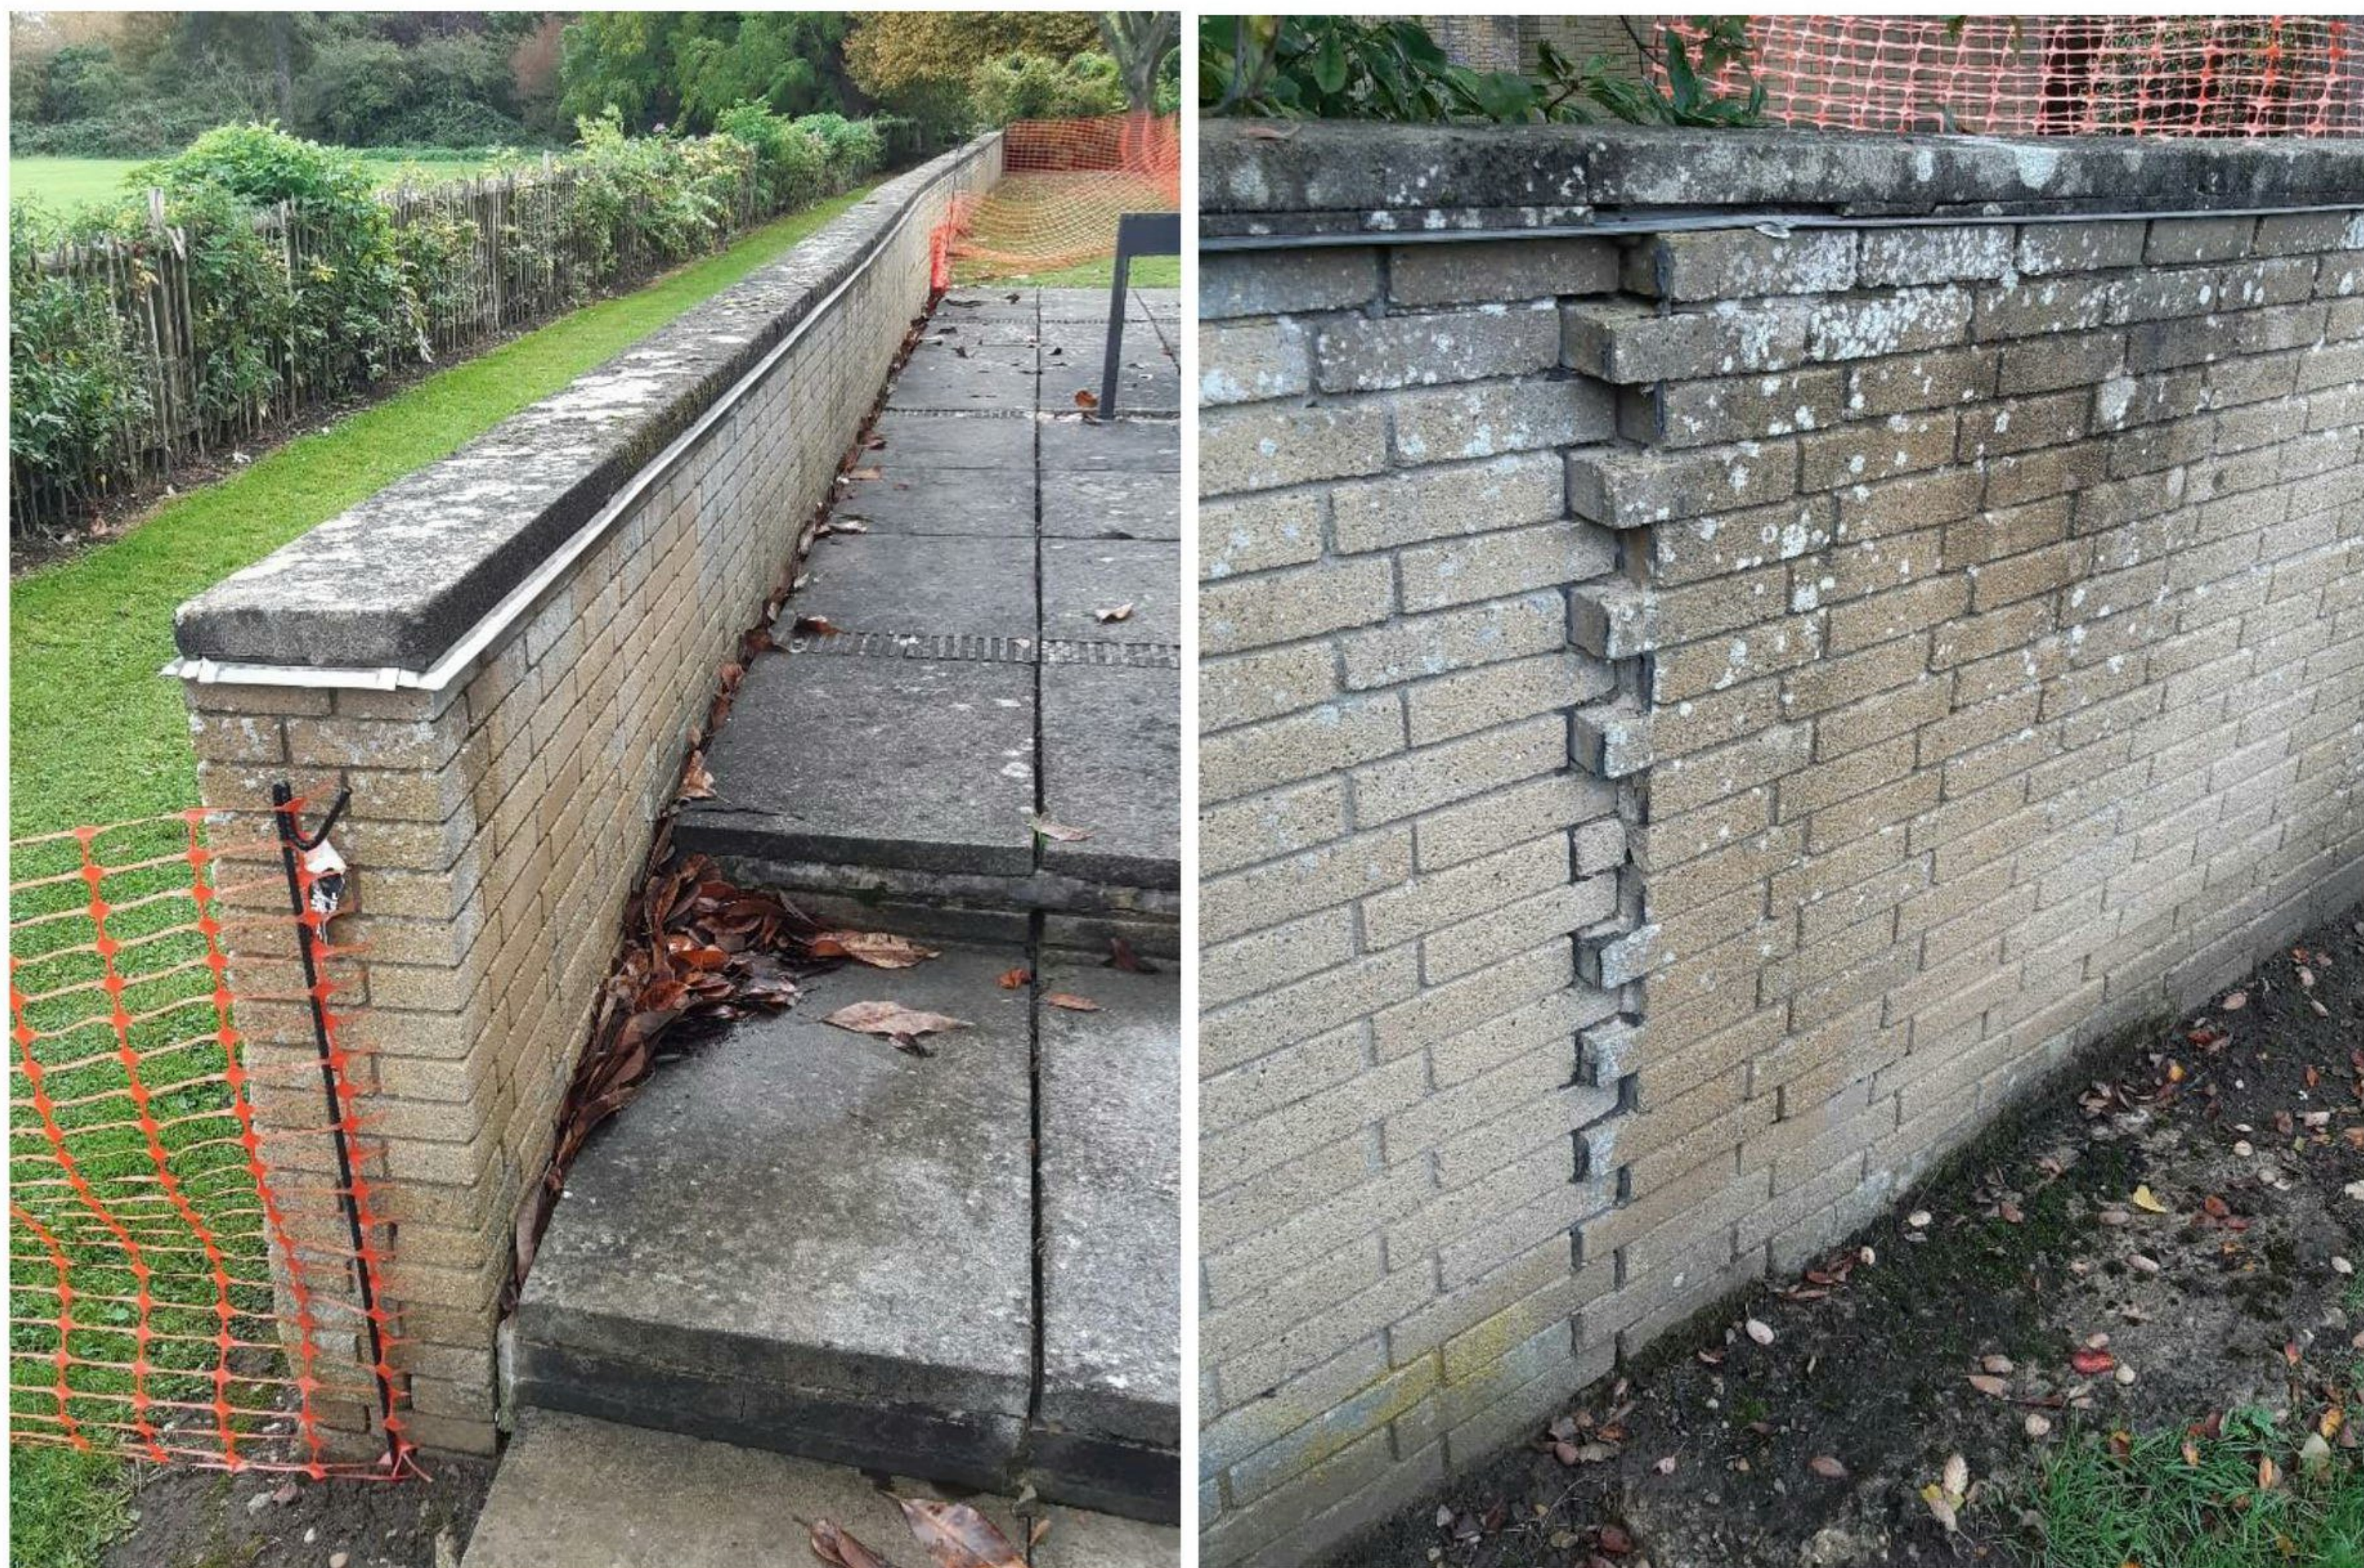
Podium eastern wall, southern half, northern end

Left- note wall leaning towards sports field and buckle near to middle, at far end of paving

Right- original movement joint of open brickwork joints, sealed with mastic

For the southern half of the podium eastern wall, north of the central movement joint, the wall has been badly affected by movement as shown above and noted in the structural engineer's report, such that the wall is leaning towards sports field side by 125mm. Since this wall is adjacent to a paved and grassed area where students might gather, the garden has been temporarily cordoned off to prevent students leaning against the wall and it collapsing with them or students sitting under it and it collapsing onto them.

For the east podium wall, the northern half of the southern length has such a lean and several areas of dislodged and cracked bricks, that it needs to be rebuilt from its northern end, to the existing movement joint at the midpoint of the wall. It is proposed that the concrete coping stones and zinc flashings are set aside on the adjacent lawn in the same order as their current locations on the wall. The brickwork would then be carefully taken down to foundation level, with the mortar being cleaned off the bricks as the work progresses. On the podium side, there would be a new leaf of two courses of standard dense concrete blocks, which would then match the existing coursing of the wall up to the level of the existing paving slabs. The concrete blockwork will provide improved retaining strength against the higher ground level adjacent and should release sufficient bricks to replace the worst of the damaged bricks on the visible side. The original bricks would then be reused in rebuilding the wall, following which the zinc flashings and concrete coping stone would then be re-laid in the same order as originally. When the brickwork is rebuilt, movement joints would be incorporated at approximately every 6 metres, to the same detail as the existing movement joint at the midpoint of the wall and pointed with a mid-grey mastic.

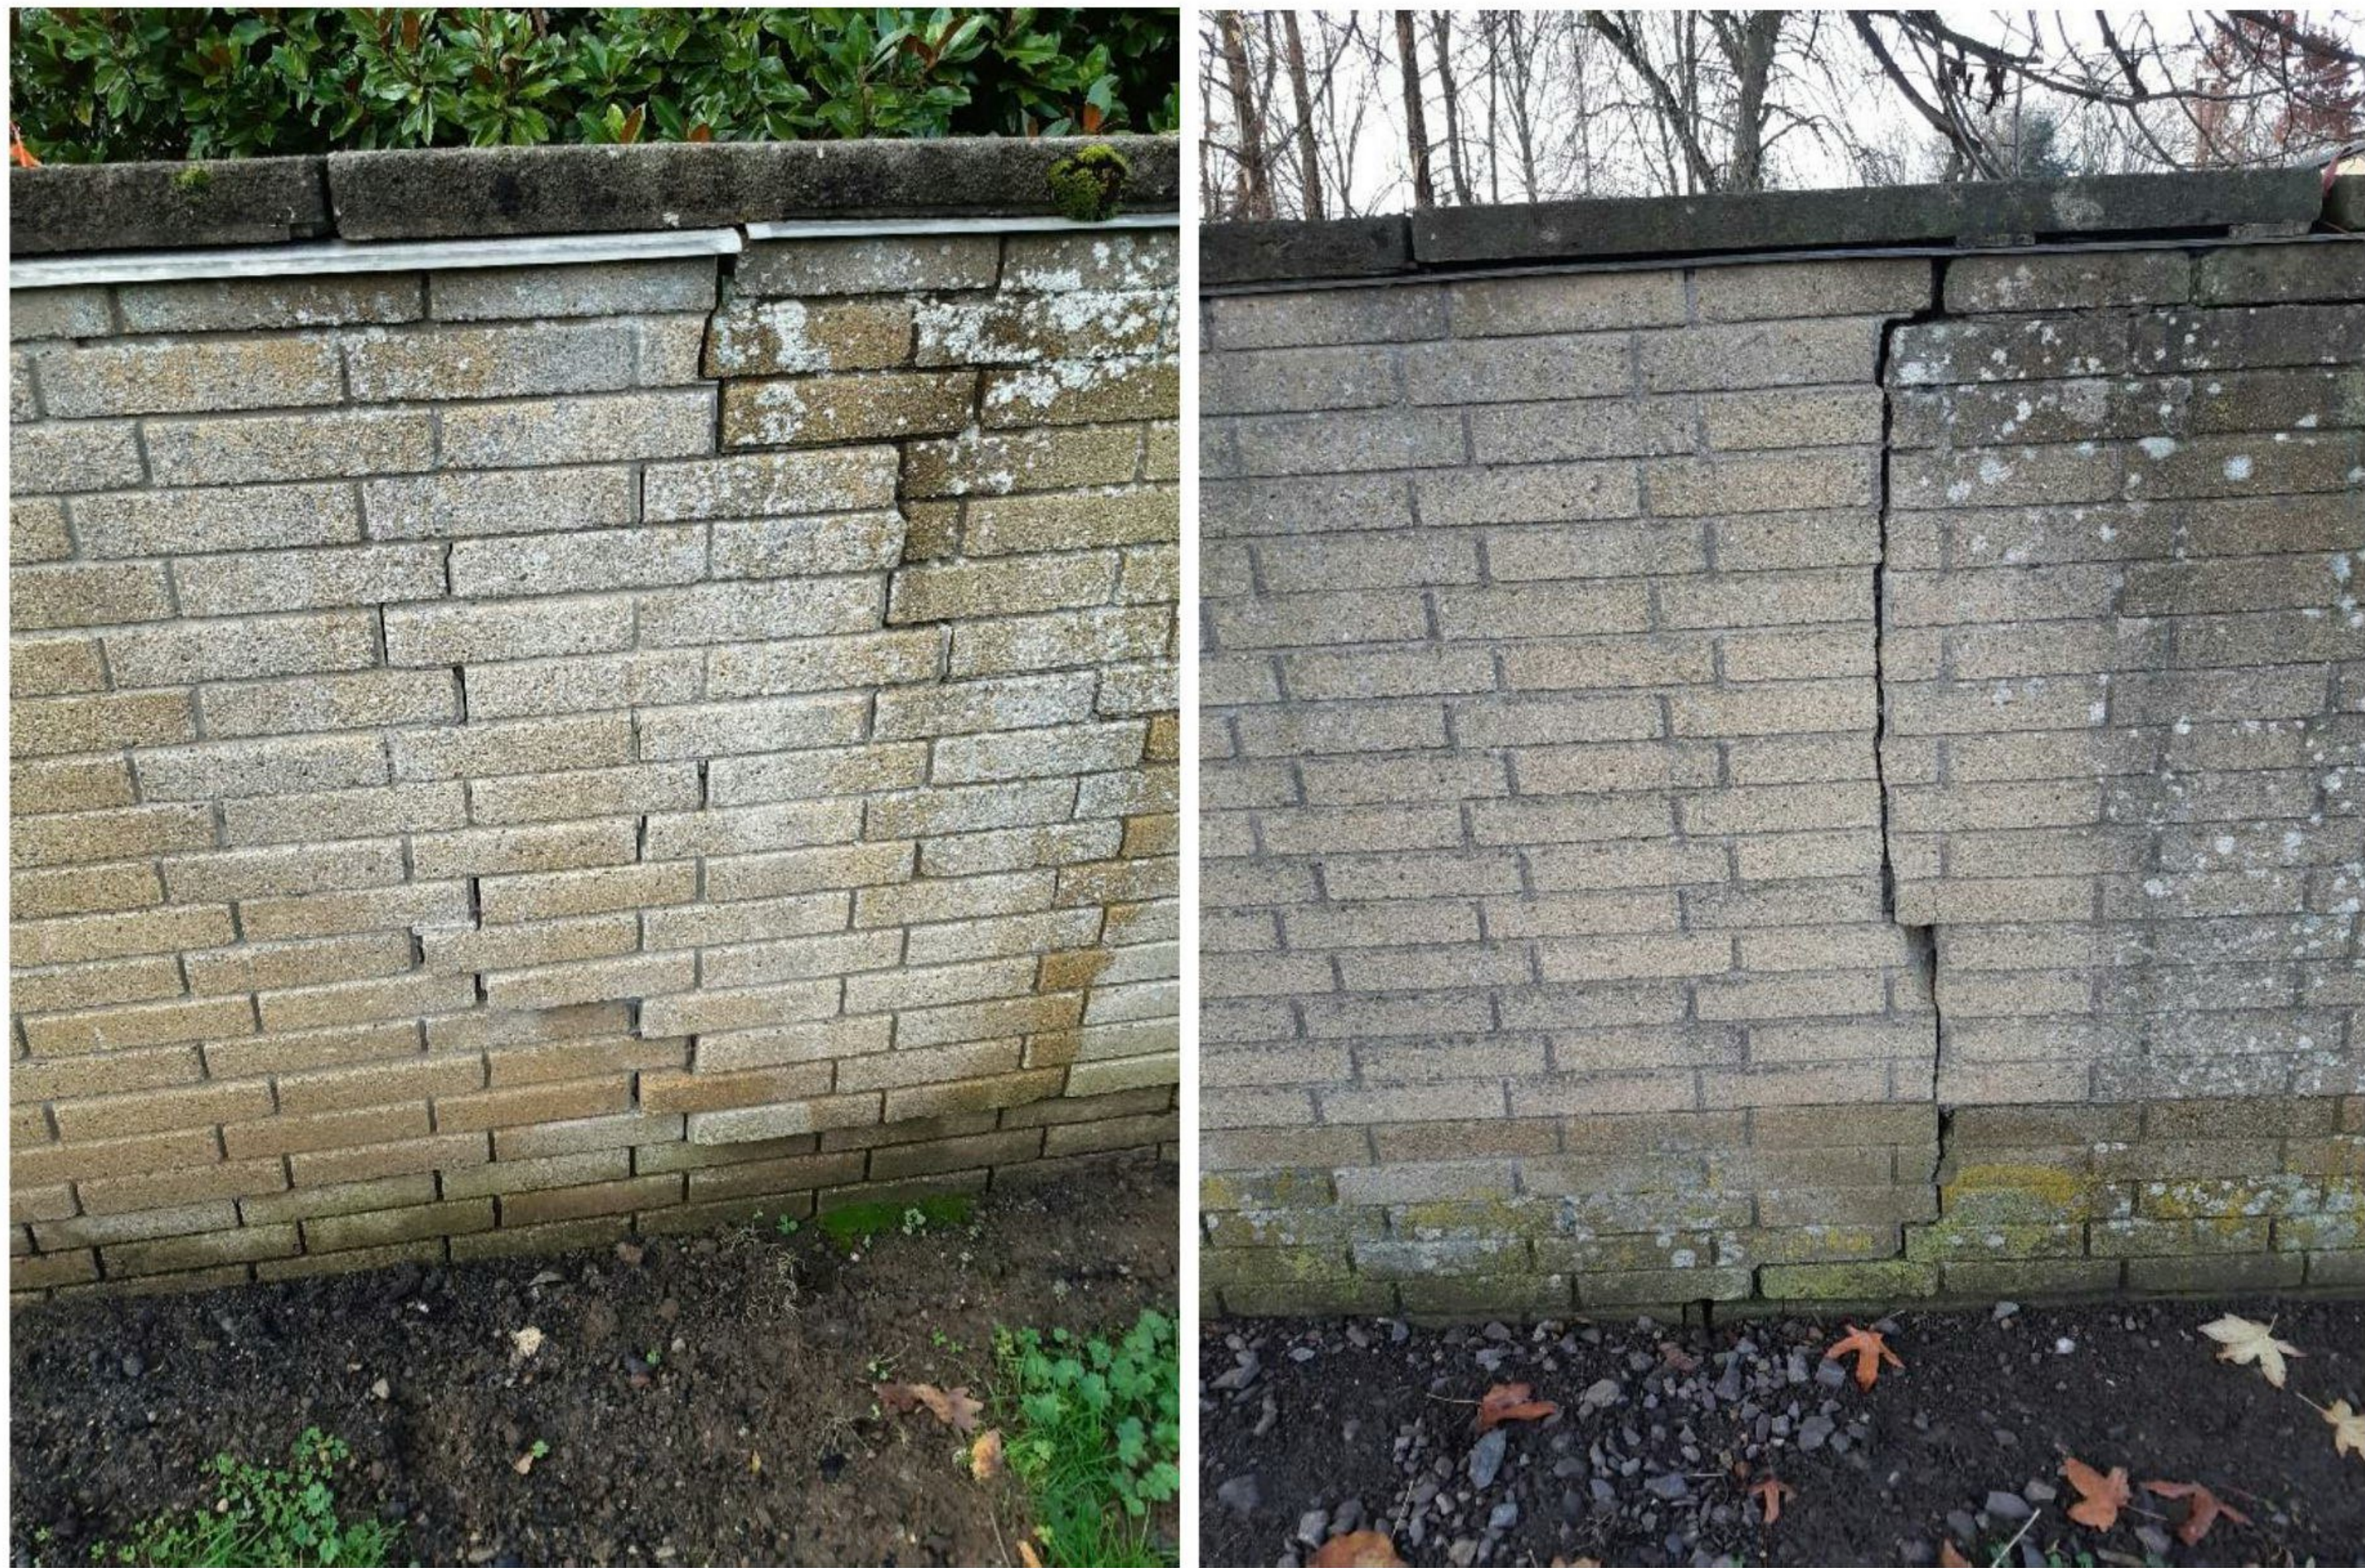
Further areas of buckling and cracking to the podium eastern wall, southern half

There is also some cracking to the southern half of the southern length of the east podium wall. To reduce the likelihood of future buckling and cracking, it is proposed to insert new movement joints into the existing brickwork at approximately 6 metre intervals. These movement joints would be formed by using a 5mm drill to drill a series of holes in the 8mm wide mortar of perp joints and adjacent bed joints to both leaves. Once holes have been drilled, the remaining mortar will be carefully cut with a chisel and then a file used to link the holes and remove the remaining mortar. The mortar joint in the coping stones closest to the new brickwork movement joint would also have the mortar removed, to allow for movement. Once the joints have been cleared of mortar, they would be repointed with a mid-grey mastic.

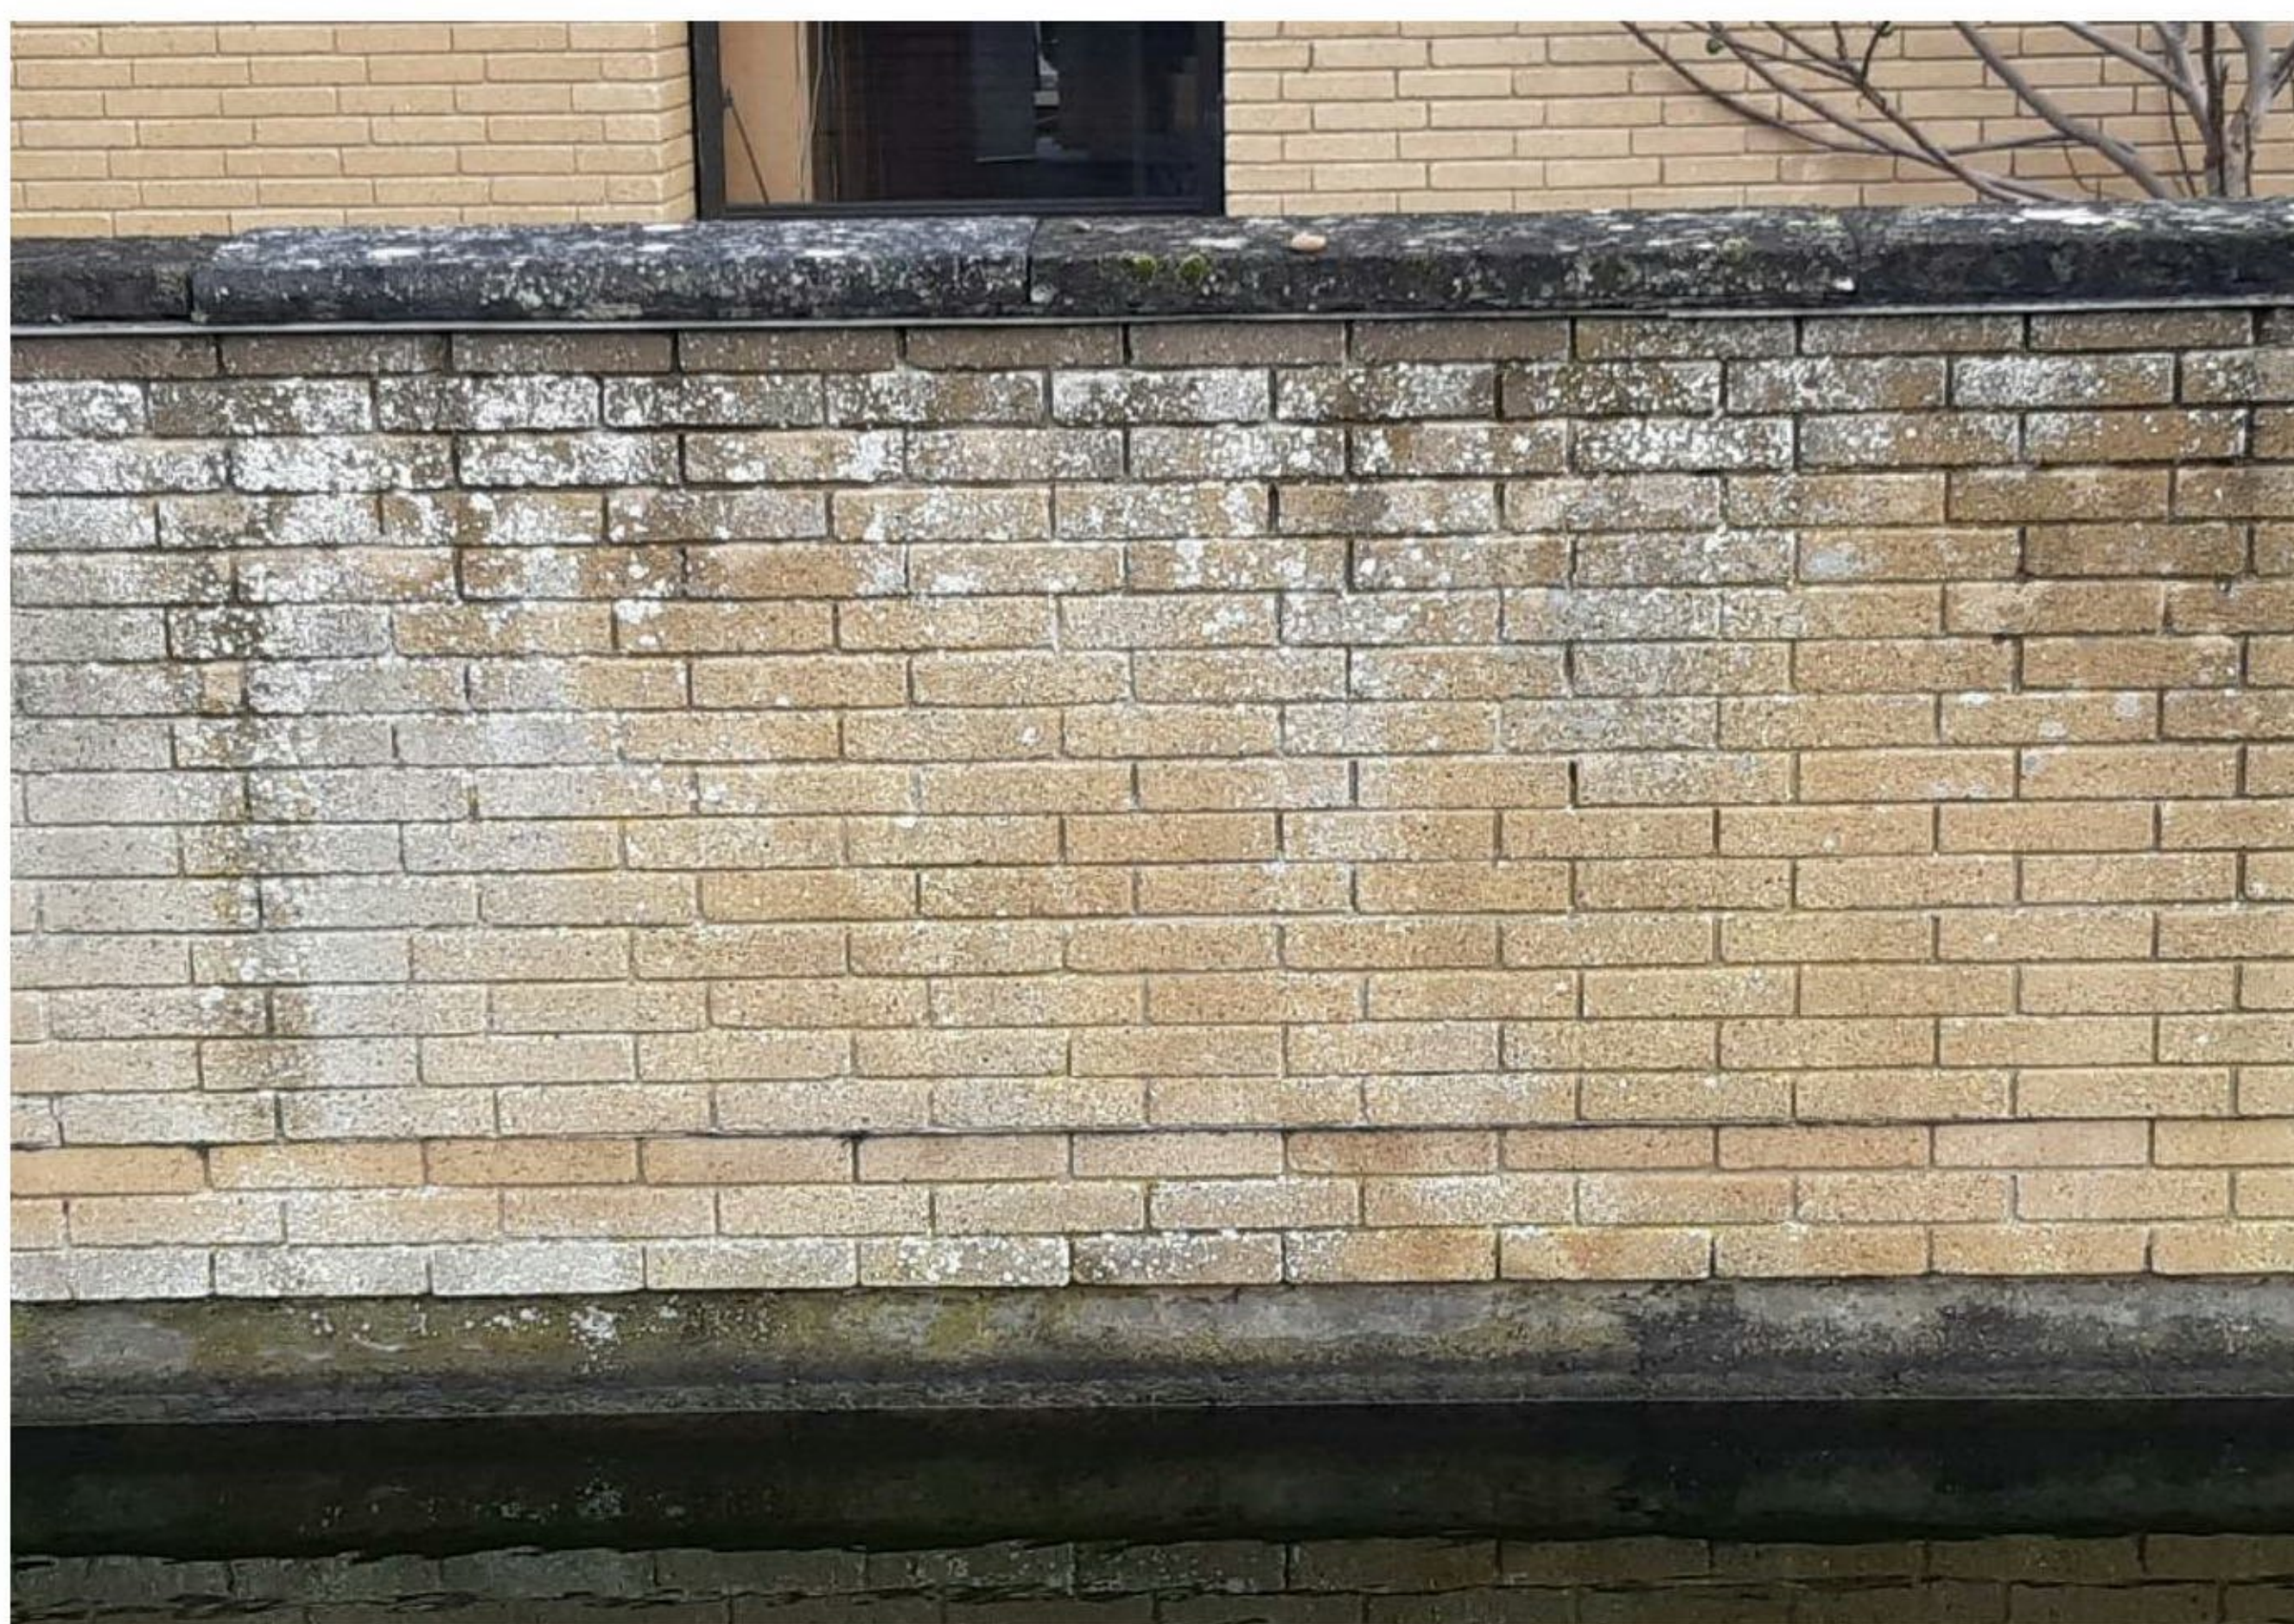
For the northern part of the wall to the east side of the central pond, the wall has remained nearly upright but has buckled towards the pond. However, since the walls have an unfilled cavity, the movement has not been consistent, with the leaf of brickwork on the paving side exhibiting more damage than the leaf facing the pond. Since this area is not frequently used by students, the problem is less of a safety concern but nevertheless needs to be repaired.

Wall to east side of the central pond, showing outward movement over damp-proof course

For the damaged areas of the central wall adjacent to the pond and the northern part of the podium western wall, these would be carefully taken down only in the affected areas and rebuilt, as described for the east podium wall, with movement joints incorporated as described. It is also proposed to create several other movement joints in the long lengths of the central wall adjacent to the pond and the podium west wall, to allow for movement and prevent any buckling and cracking in the future.

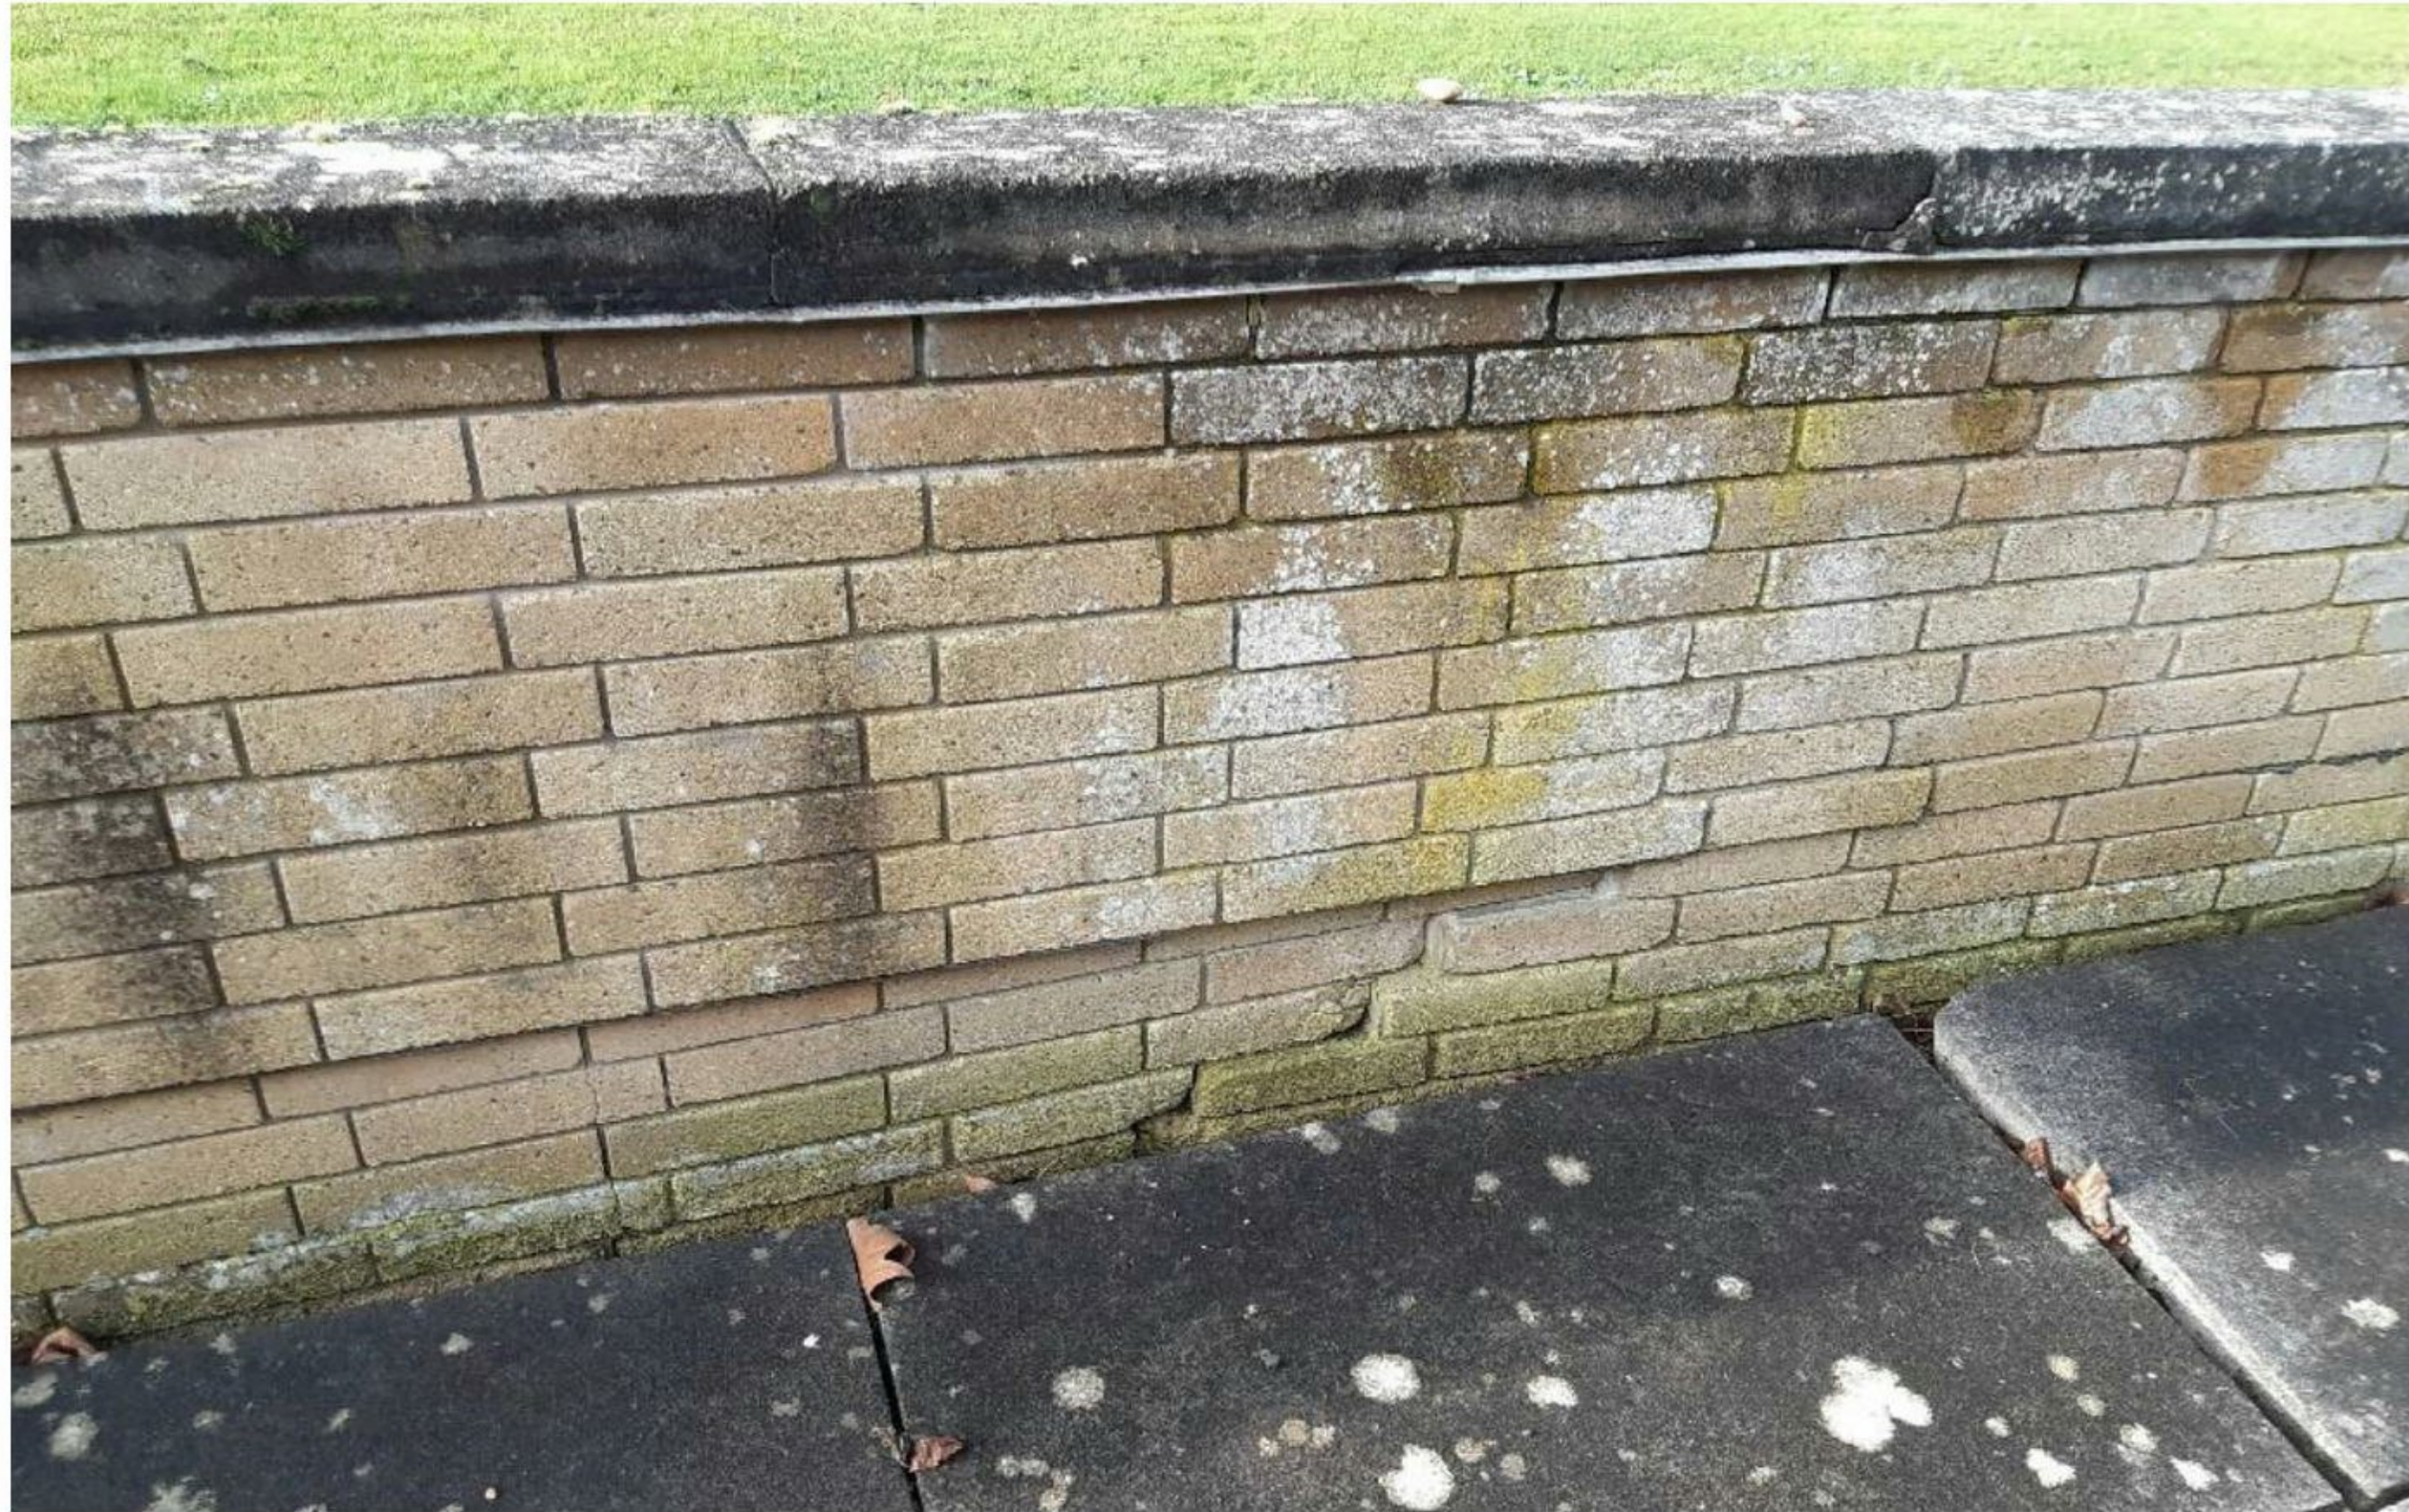
Wall to east side of the central pond, showing inward buckling between damp-proof courses, more pronounced than buckling to outer leaf
