ST CATHERINE'S COLLEGE, OXFORD

REPAIRS TO THE GARDEN WALLS

HERITAGE STATEMENT

DESIGN & ACCESS STATEMENT

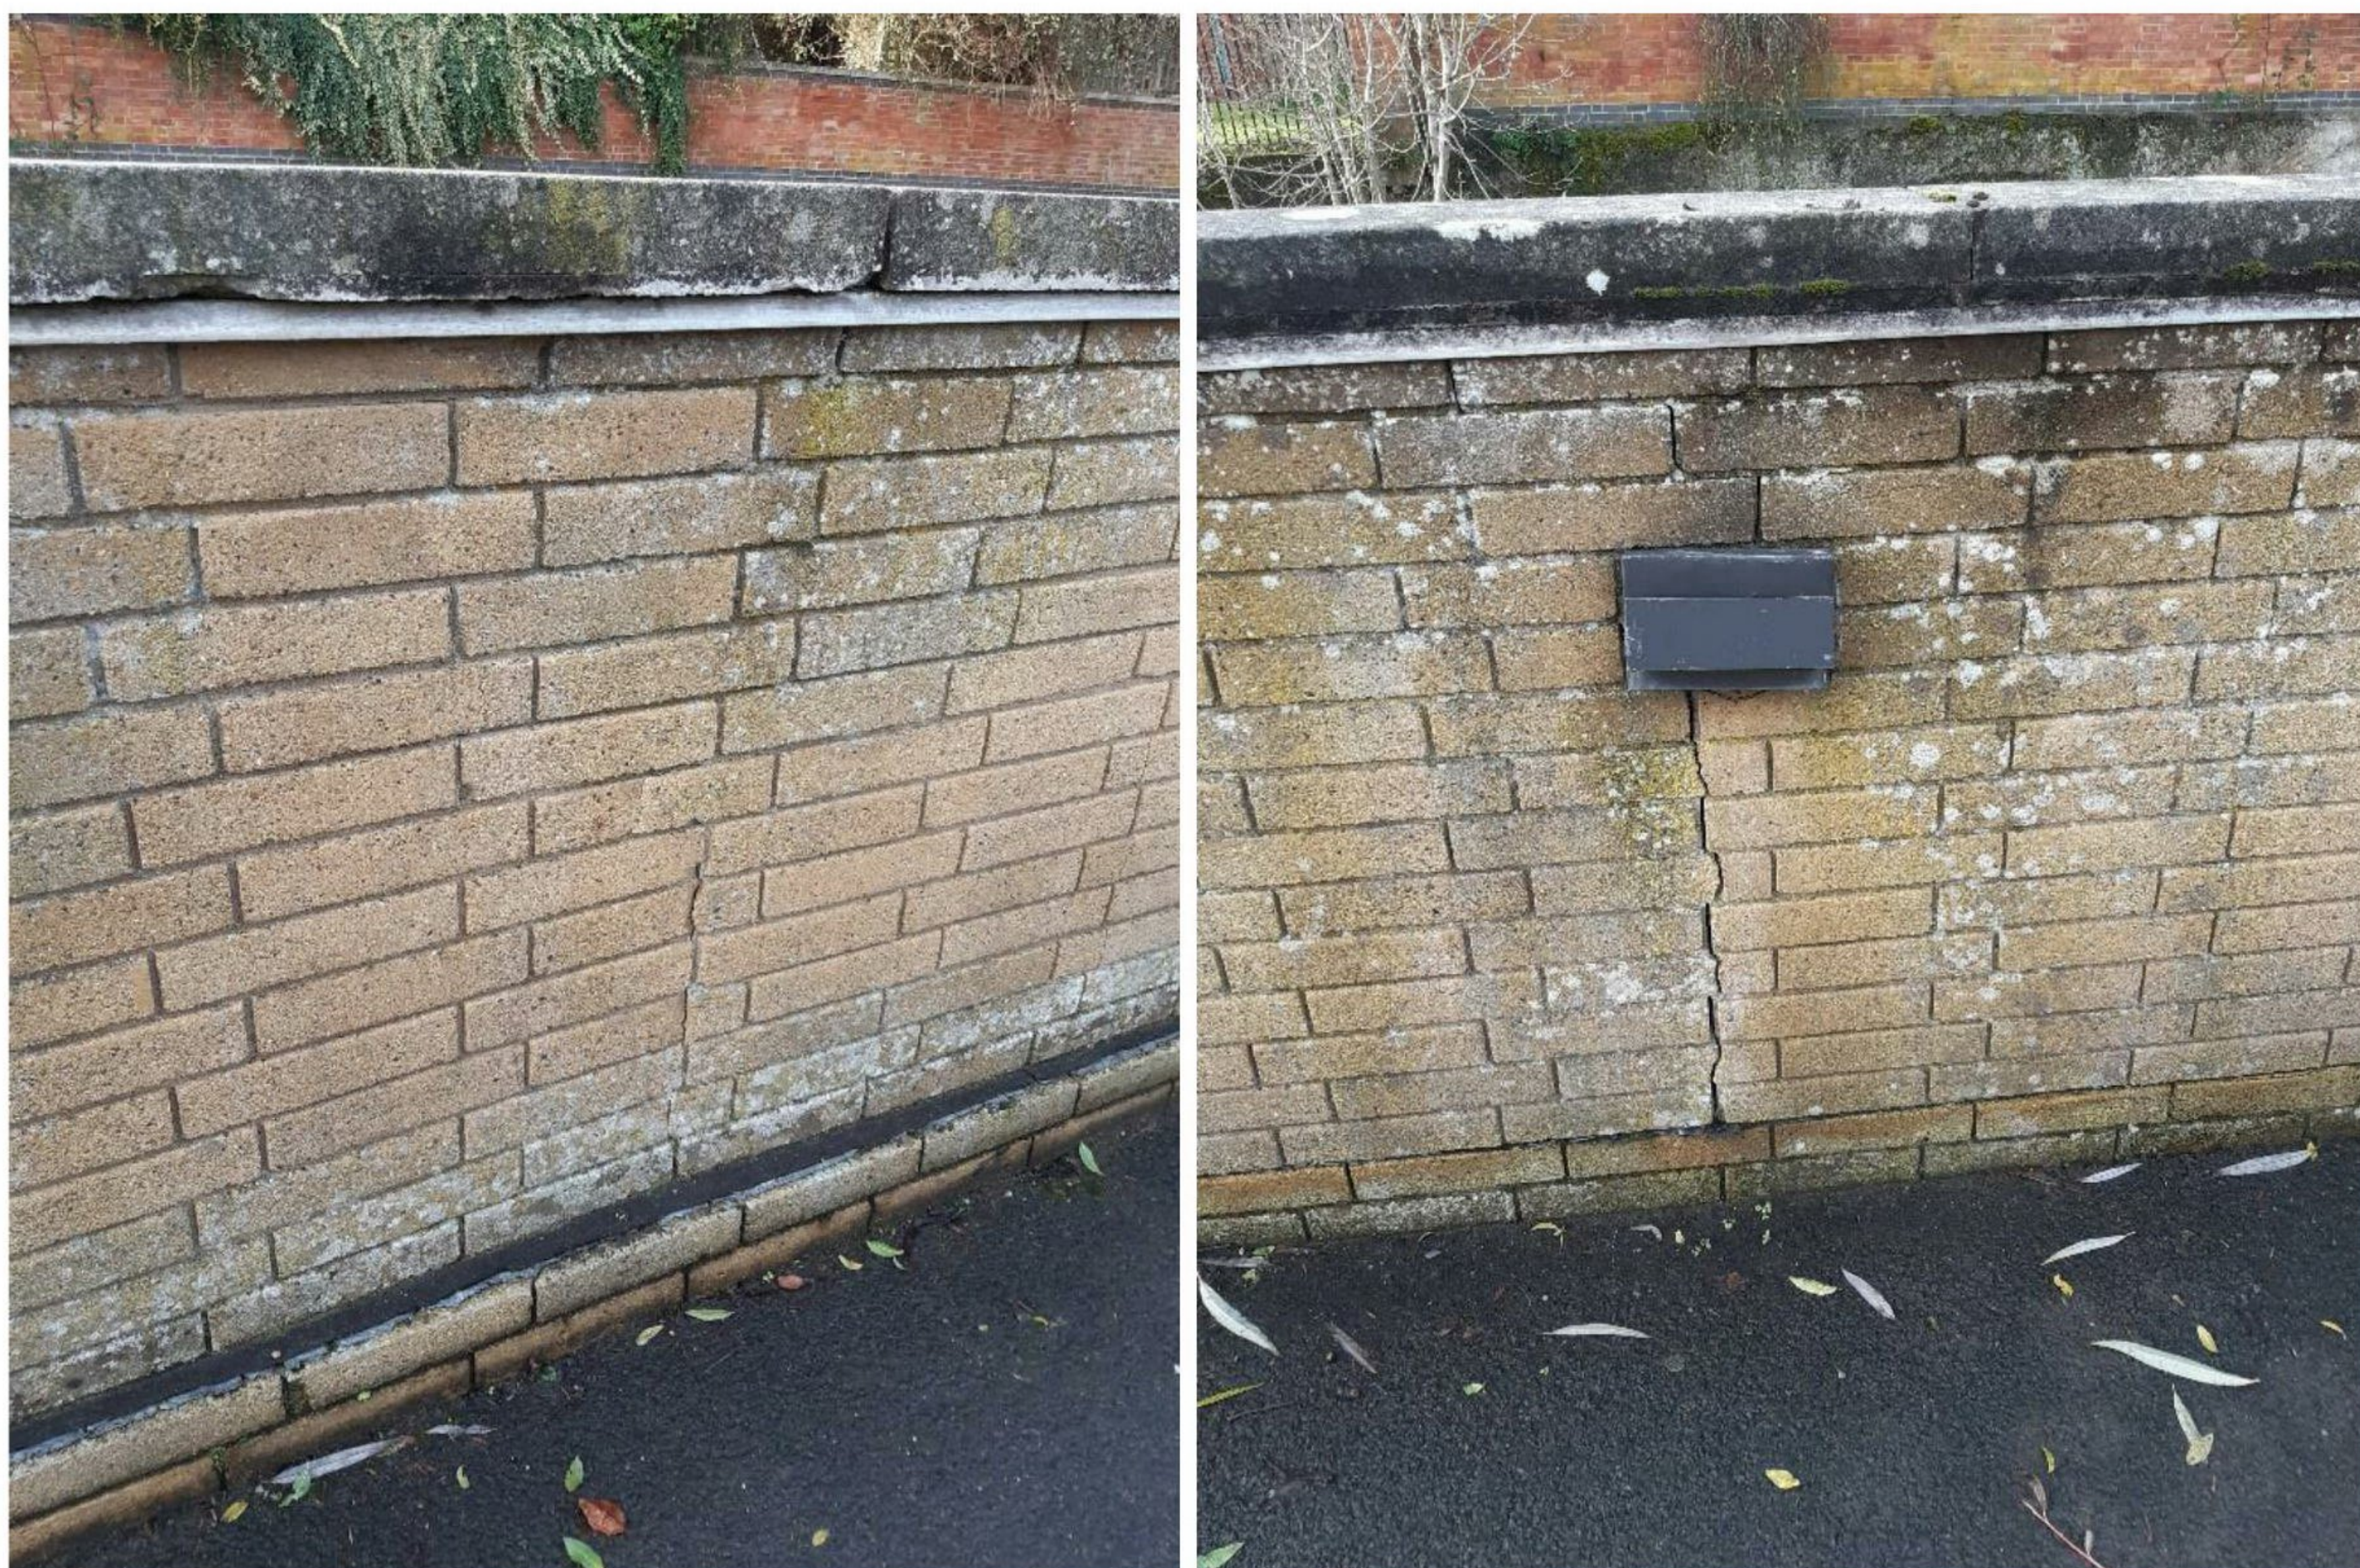
For the northern part of the wall to the podium western wall, this has buckled in a similar way to the central wall, with the western wall buckling towards the Holywell Mill Stream. This area is also less of a safety concern, since it is more of a transition area for pedestrians, cyclists and the occasional motorist. Nevertheless, this wall also needs to be repaired.

Northern part of the wall to the podium western wall, showing inward and outward buckling with cracking, above damp-proof course

For the damaged areas of the central wall adjacent to the pond and the northern part of the podium western wall, these would be carefully taken down only in the affected areas and rebuilt, as described for the east podium wall, with movement joints incorporated as described. It is also proposed to create several other movement joints in the long lengths of the central wall adjacent to the pond and the podium west wall, to allow for movement and prevent any buckling and cracking in the future.

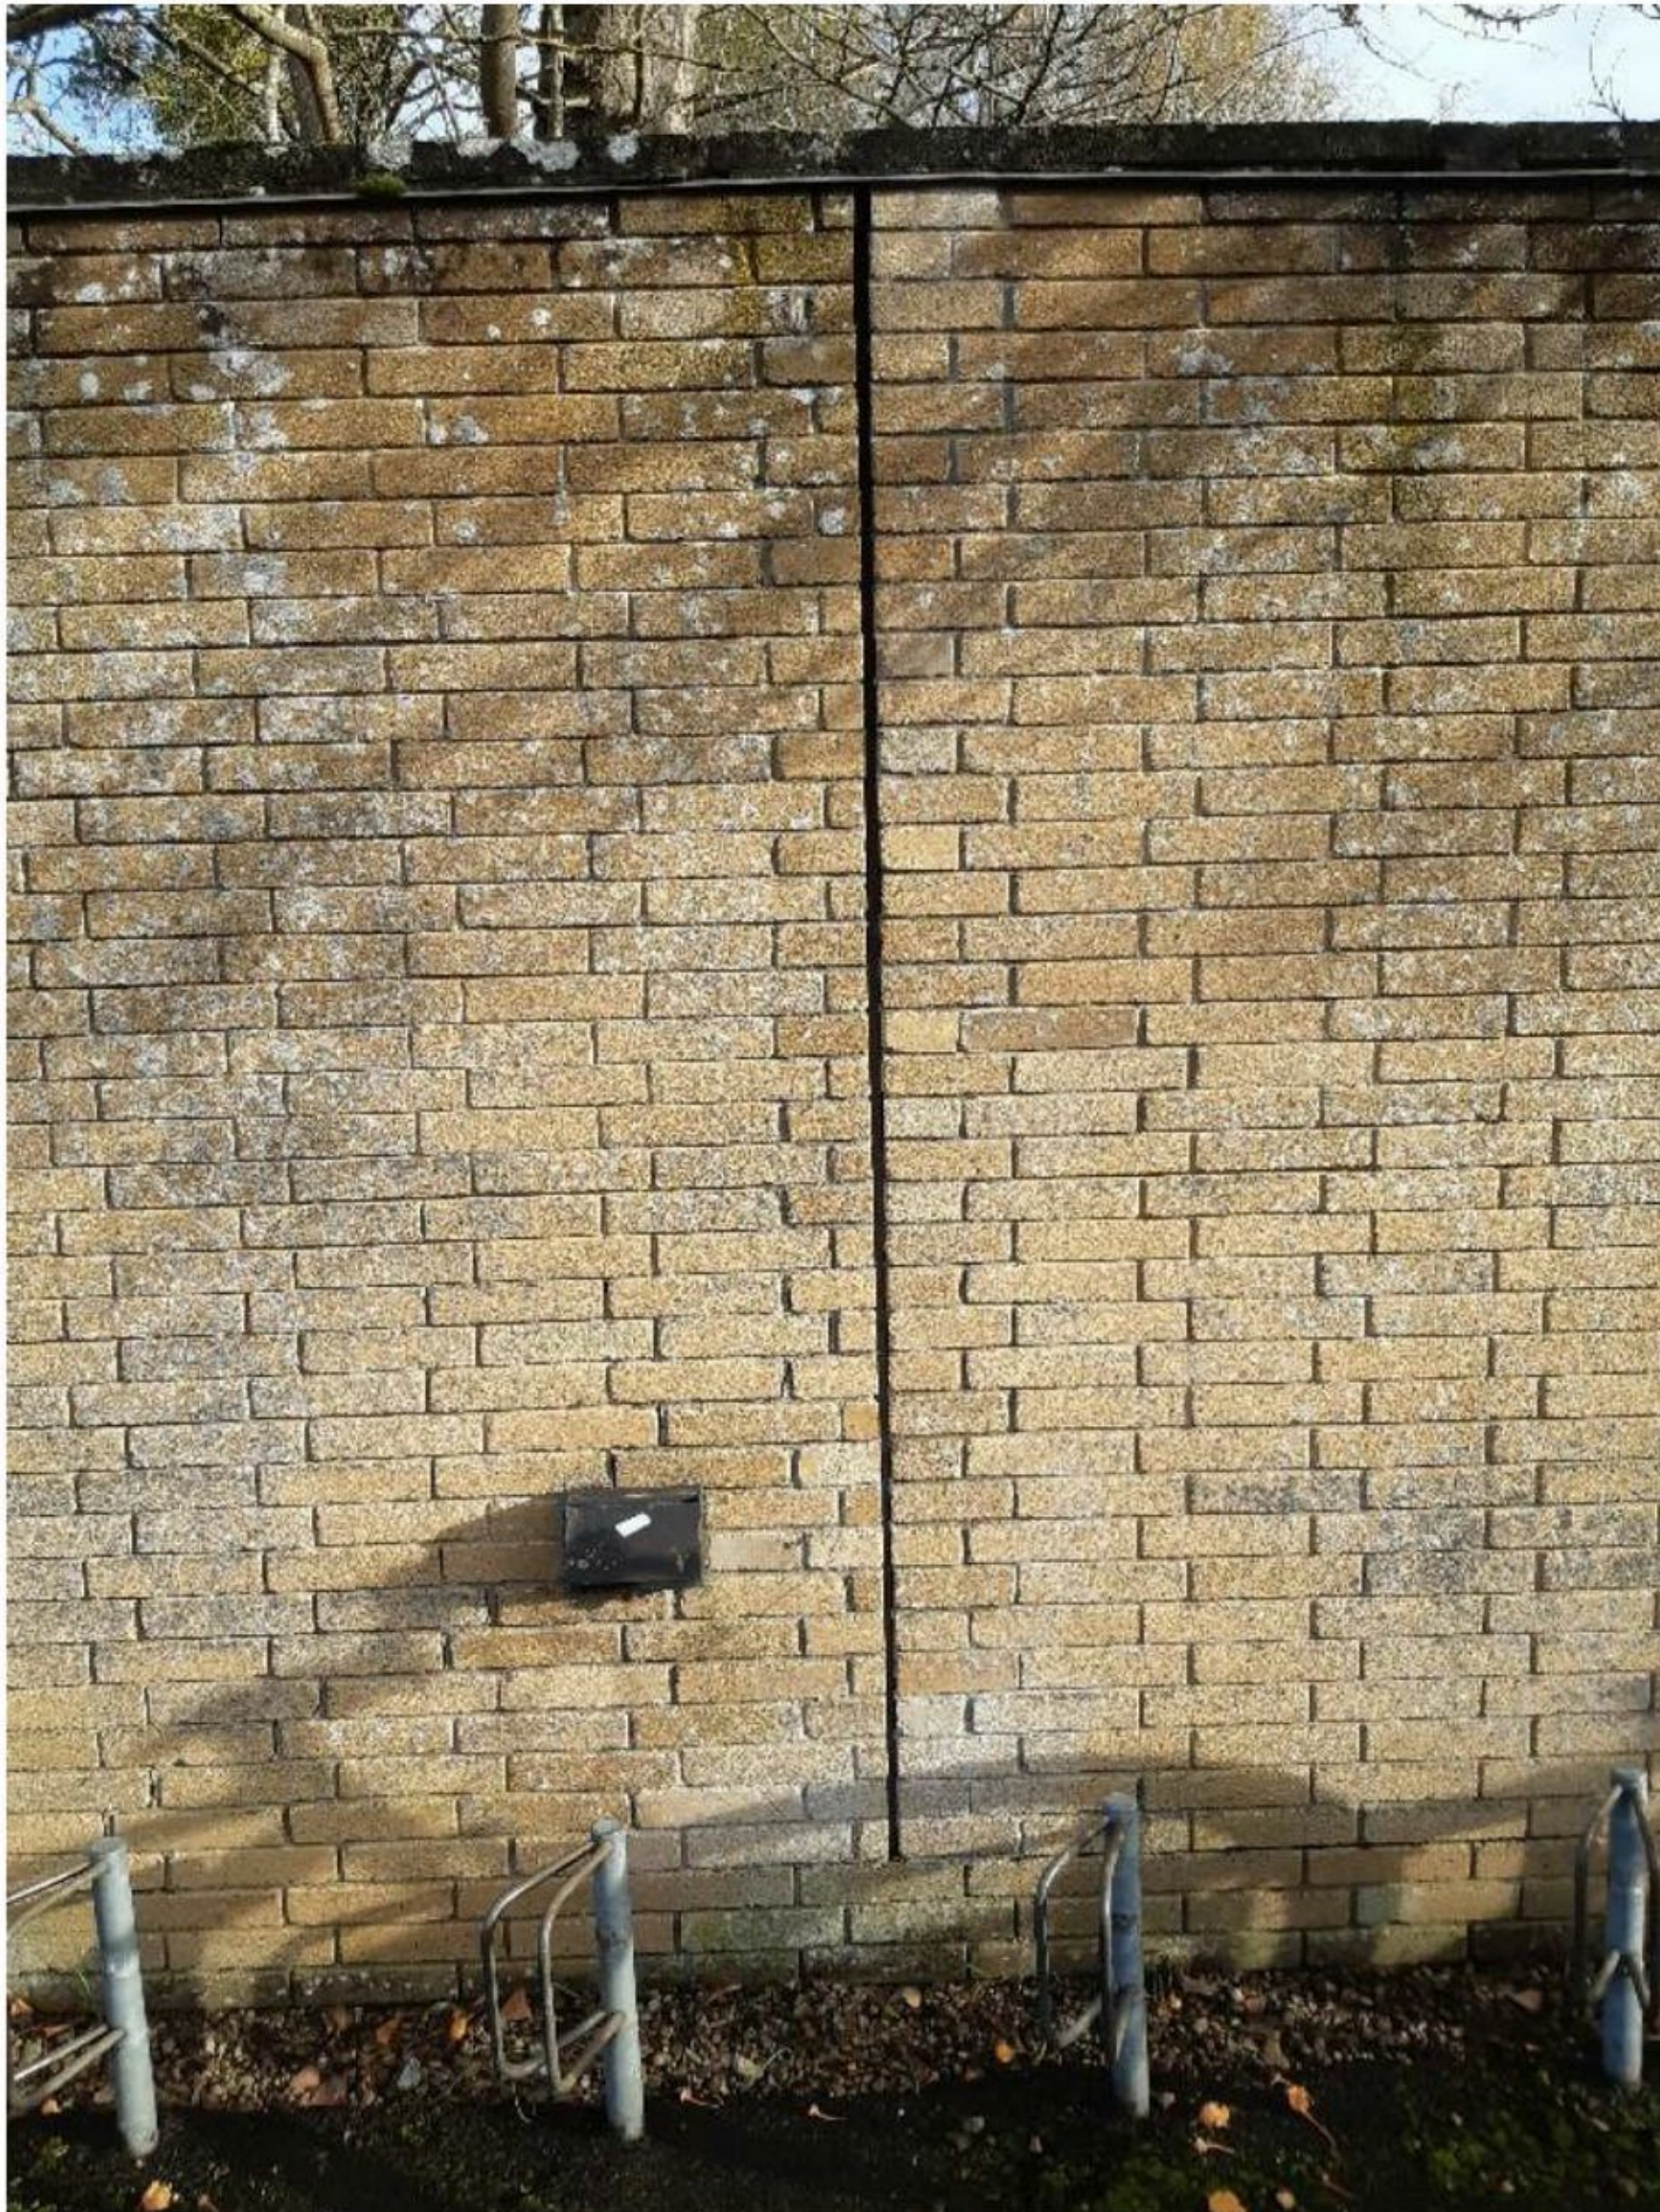
It is also interesting to note the condition of the freestanding walls elsewhere in the original College buildings. The circular cycle store walls were also built without any movement joints, as two semicircles with gaps in the walls for the gates. The two semi-circular walls have both moved outwards towards the top and there are some vertical cracks. Nearby, the Master's Lodgings garden walls were built towards the end of the original construction period. Those walls do incorporate some original vertical movement joints, at approximately 6 metre intervals and there has been no cracking of the brickwork.

Original movement joint in west garden wall to Master's Lodgings
