TREE / Picus REPORT on 1 Beech Tree
Landwades Stud, Kentford Road, Moulton
Carried on the 2nd of February 2021

Prepared for
Anglia Tree Contractors

**Beech Tree ~ Tree inspection and Picus testing carried out on the 2nd of February
Landwades Stud, Kentford Road, Moulton**

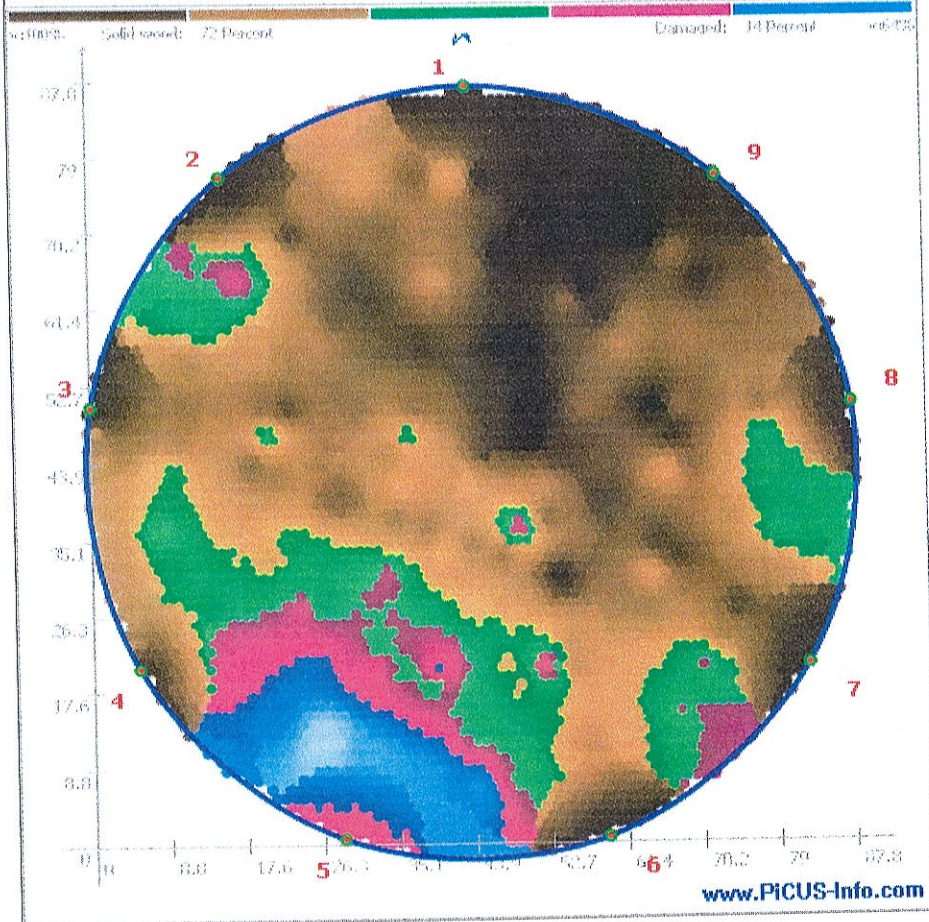
Picus: KENTFORD MOULTON ROAD

The Picus test was taken at approximately 4 metres from ground level, the Tomograph shows minor pockets of decay between sensors 2 and 3 and sensors 6 and 7. There is a larger area of decay between sensors 4 and 6, this is the area of the open cavity.

The damaged wood is shown on the Tomograph in blue and pink, this is wood with little to no structural integrity or an open cavity. The altered wood extending further outwards shown in green is regarded as the tree's defensive system, chemically altering the wood cell make-up to resist decay. There is 72% structurally sound wood remaining, the parameter of accepted remaining solid residual wall is 30% and there are no internal cracks evident, this would be shown on the Tomograph as yellow lines. The decay is of minimal significance at this time and is possibly as a result of a wound caused by the raising of the crown. The removal of adjacent trees has left this tree in a quite exposed position and it is also apparent that the woodland belt in this area is prone to waterlogged conditions.

With regards to the Picus test, the decay is well within the accepted parameters. My concern is the increased exposure due to removed trees, the very wet soil conditions and the close proximity to the neighbouring property.

Reduce and thin the crown to reduce wind forces or consider removal and replant.
