**LIMITED / PART / R & D SURVEY  
PRE-DEMOLITION OR MAJOR WORK ASBESTOS SURVEY AT  
86 THE BROADWAY  
MILL HILL  
LONDON  
NW7 3TD**

**SURVEY NUMBER: SUR 3038/03/03/21**

## ASBESTOS REPORT FOR ATHENE HOUSE, MILL HILL

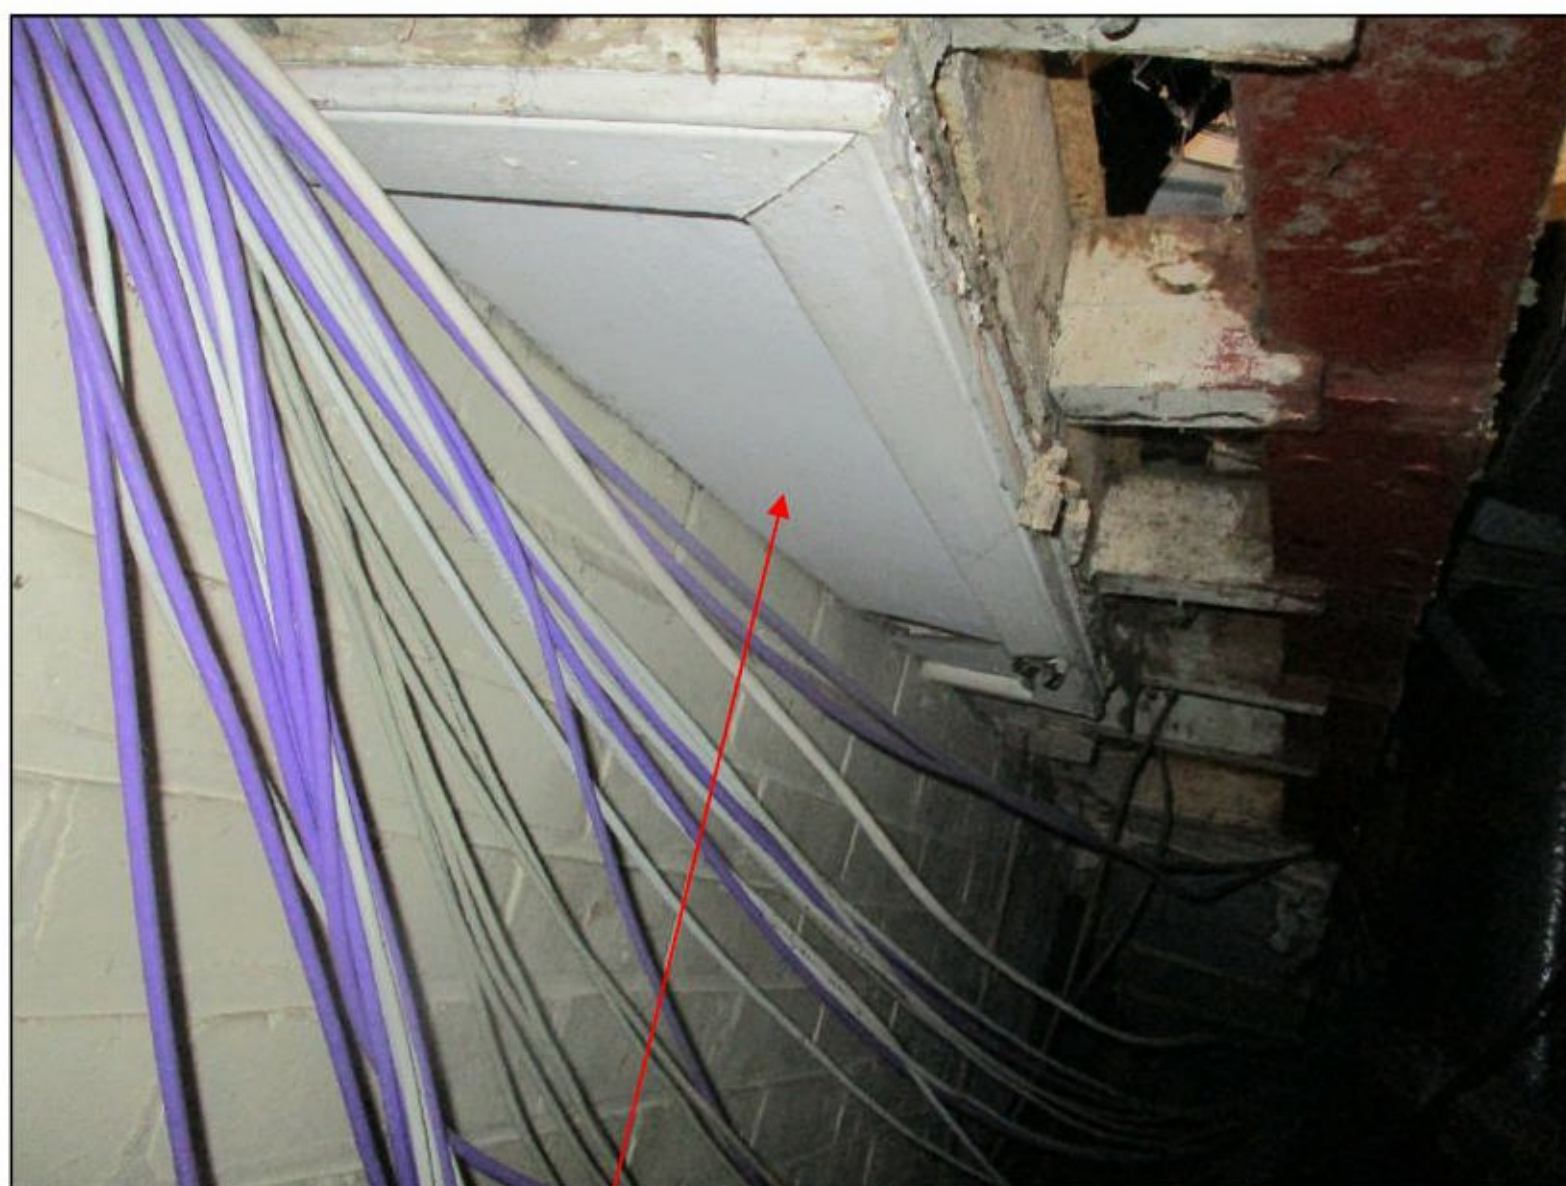
<b>SAMPLE REF.</b>	<b>S04</b>
<b>PHOTO NO.</b>	<b>One</b>
<b>DESCRIPTION</b>	<b>Board in void area of roof space/loft</b>
<b>LOCATION</b>	<b>Loft – void area – To front by sink</b>
<b>FLOOR</b>	<b>Roof space</b>
<b>COMMENTS</b>	<b>Chrysotile (white) asbestos.</b>
<b>EXTENT</b>	<b>2m2 as seen, no full safe access</b>
<b>RISK</b>	<b>Low risk. Dispose of as hazardous waste. Control of Asbestos 2012</b>
<b>REMOVE</b>	<b>REMOVE IF TO BE DISTURBED</b>
<b>REGULATION</b>	<b>Unlicensed works - CAR 2012</b>

**UNABLE TO ACCESS BEYOND WALL – 2m2 AS SEEN ONLY**

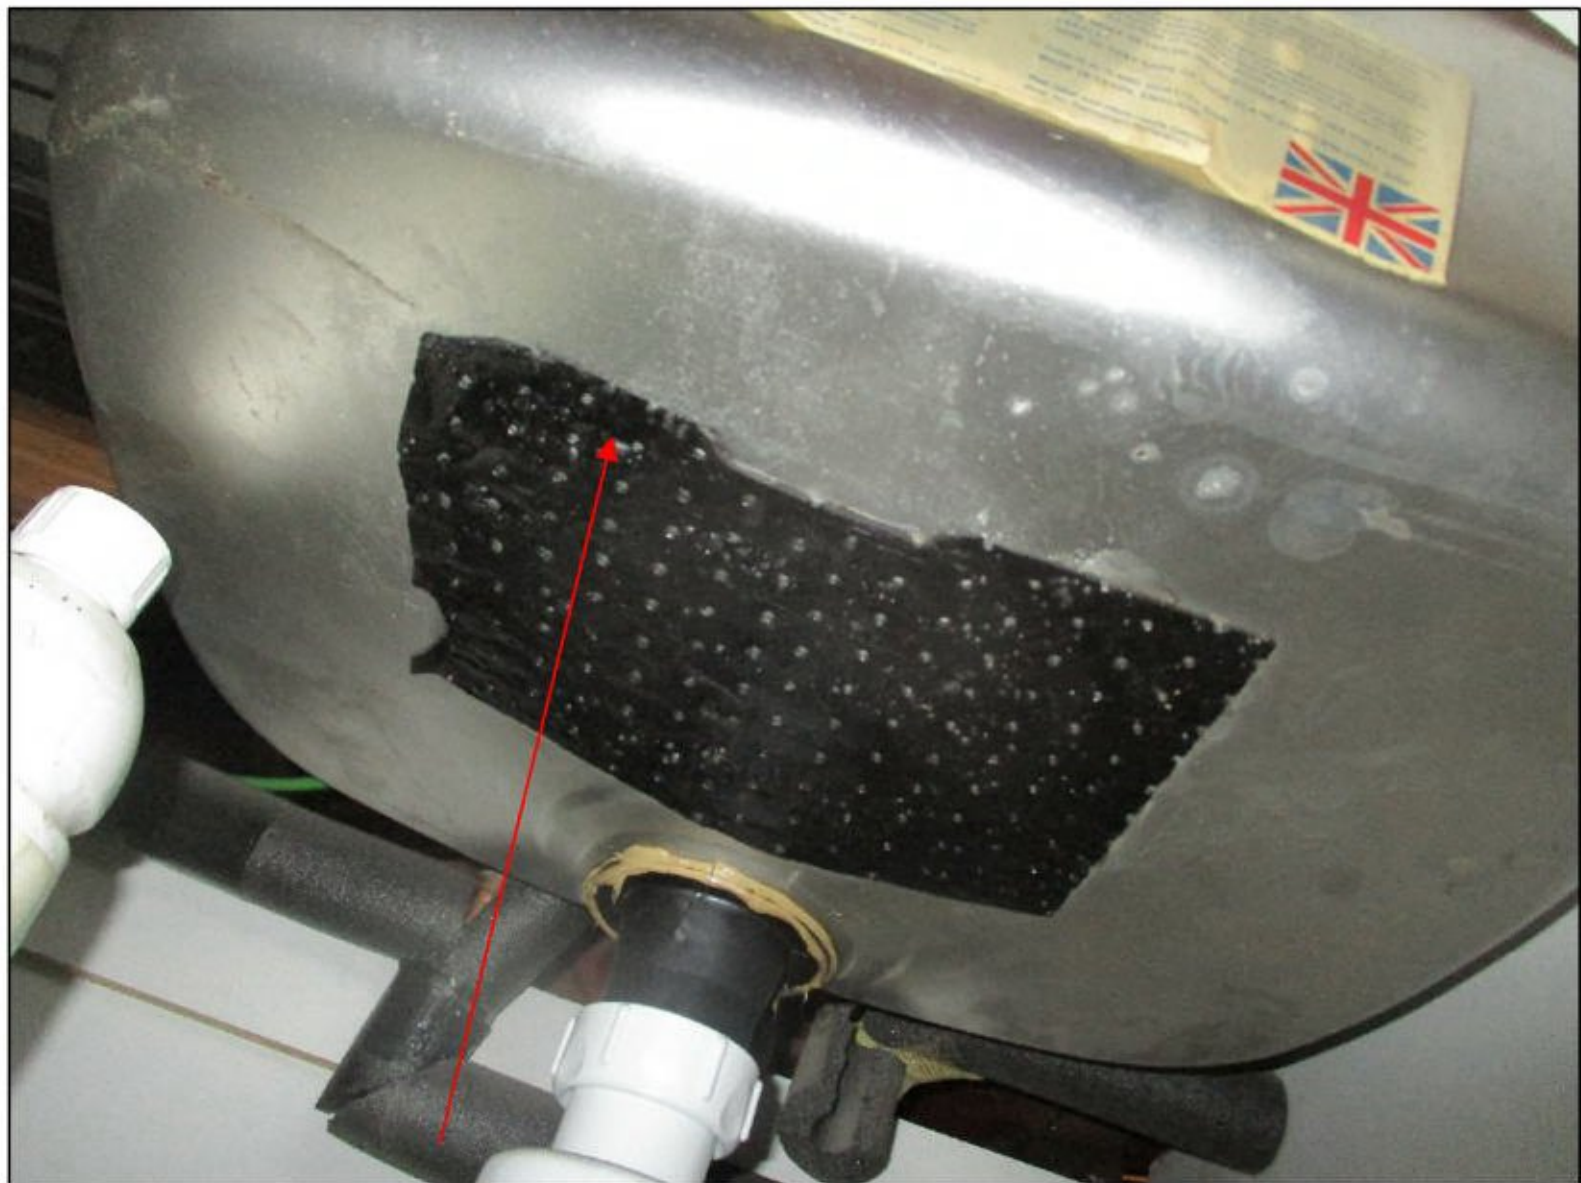
<b>SAMPLE REF.</b>	<b>S03</b>
<b>PHOTO NO.</b>	<b>Two</b>
<b>DESCRIPTION</b>	<b>Bitumen sink pad</b>
<b>LOCATION</b>	<b>Old sink in loft by front decorators area</b>
<b>FLOOR</b>	<b>Loft void – lower level</b>
<b>COMMENTS</b>	<b>Chrysotile (white) asbestos</b>
<b>EXTENT</b>	<b>&lt; 1m<sup>2</sup></b>
<b>RISK</b>	<b>Low Risk Dispose of as hazardous waste. Control of Asbestos 2012</b>
<b>REMOVE</b>	<b>REMOVE IF TO BE DISTURBED</b>
<b>REGULATION</b>	<b>Unlicensed works - CAR 2012</b>

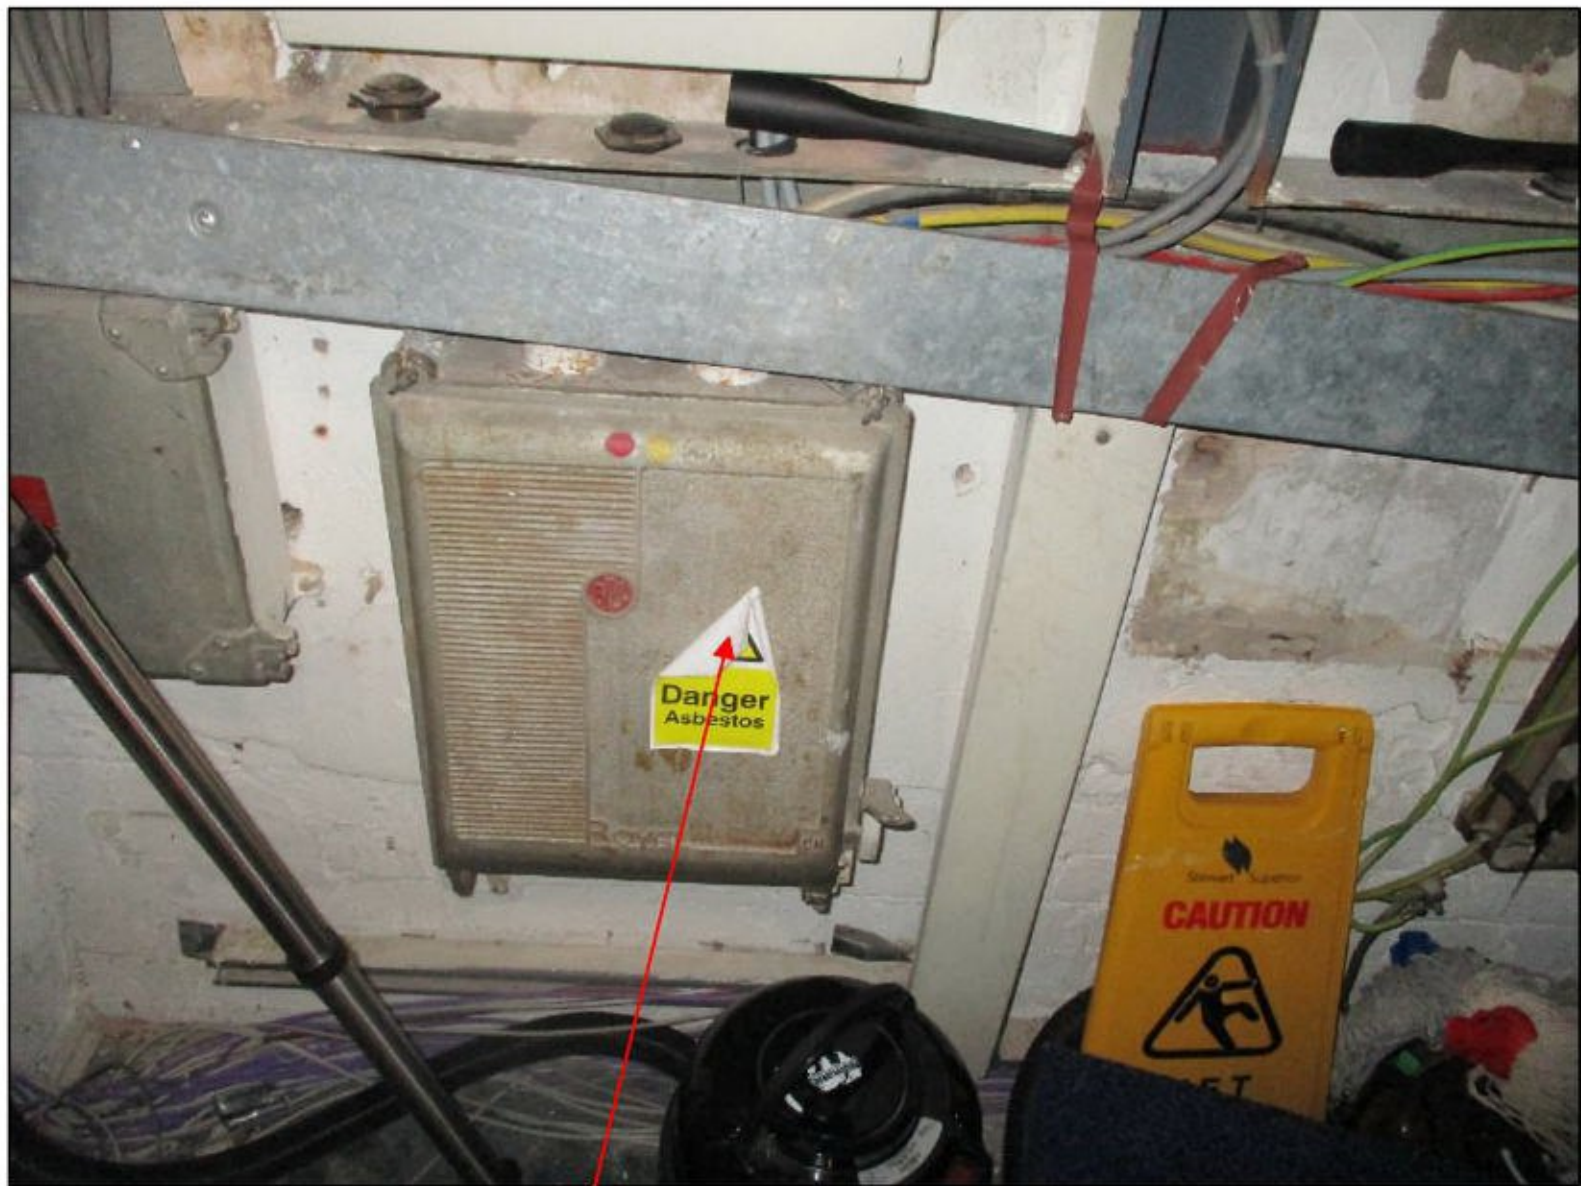
<b>SAMPLE REF.</b>	<b>No sample – Live electrics</b>
<b>PHOTO NO.</b>	<b>Three</b>
<b>DESCRIPTION</b>	<b>Presumed flash guards in electrical box</b>
<b>LOCATION</b>	<b>Kitchen – electrical room</b>
<b>FLOOR</b>	<b>First floor</b>
<b>COMMENTS</b>	<b>Chrysotile (white) asbestos.</b>
<b>EXTENT</b>	<b>1 box</b>
<b>RISK</b>	<b>Low risk. Dispose of as hazardous waste. Control of Asbestos 2012</b>
<b>REMOVE</b>	<b>REMOVE IF TO BE DISTURBED</b>
<b>REGULATION</b>	<b>Unlicensed works - CAR 2012</b>

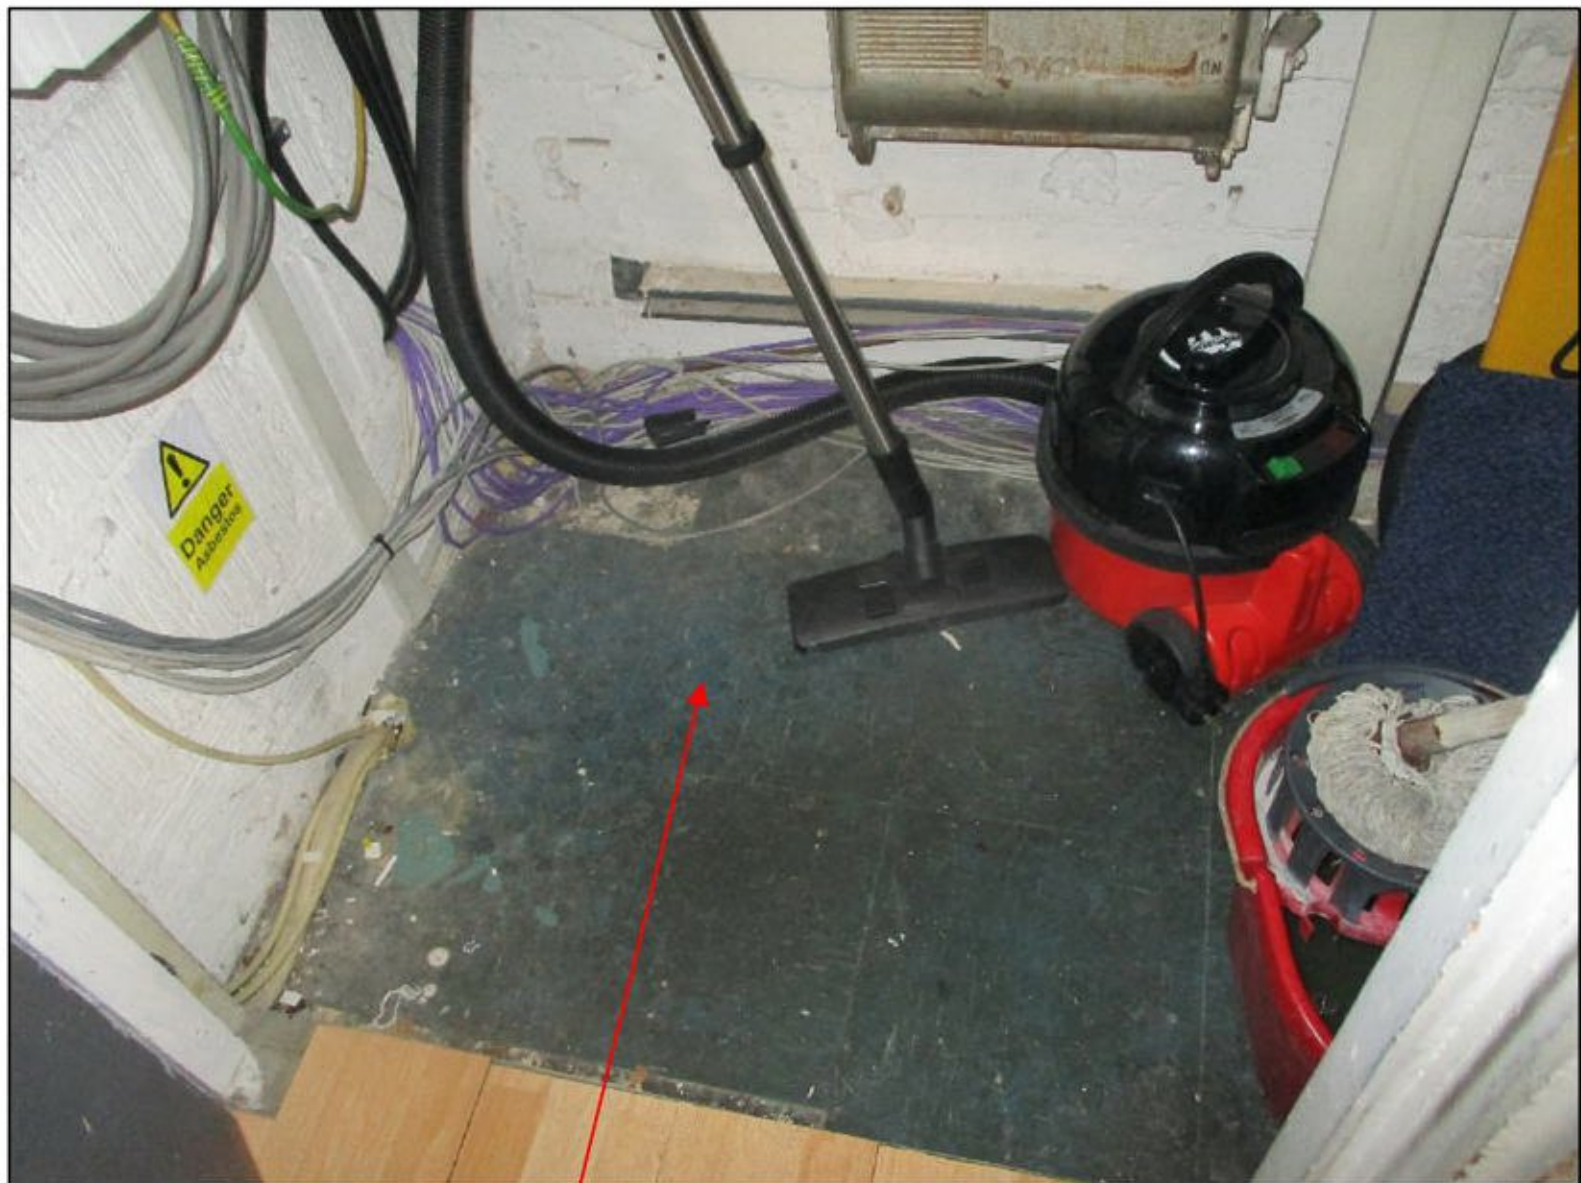
<b>SAMPLE REF.</b>	S07
<b>PHOTO NO.</b>	Four
<b>DESCRIPTION</b>	Floor tiles
<b>LOCATION</b>	Kitchen electrical cupboard
<b>FLOOR</b>	First floor
<b>COMMENTS</b>	Chrysotile (white) Asbestos
<b>EXTENT</b>	2m2 - As seen – No access under laminate
<b>RISK</b>	Low risk. Dispose of as hazardous waste. Control of Asbestos 2012
<b>REMOVE</b>	REMOVE IF TO BE DISTURBED
<b>REGULATION</b>	Unlicensed works - CAR 2012

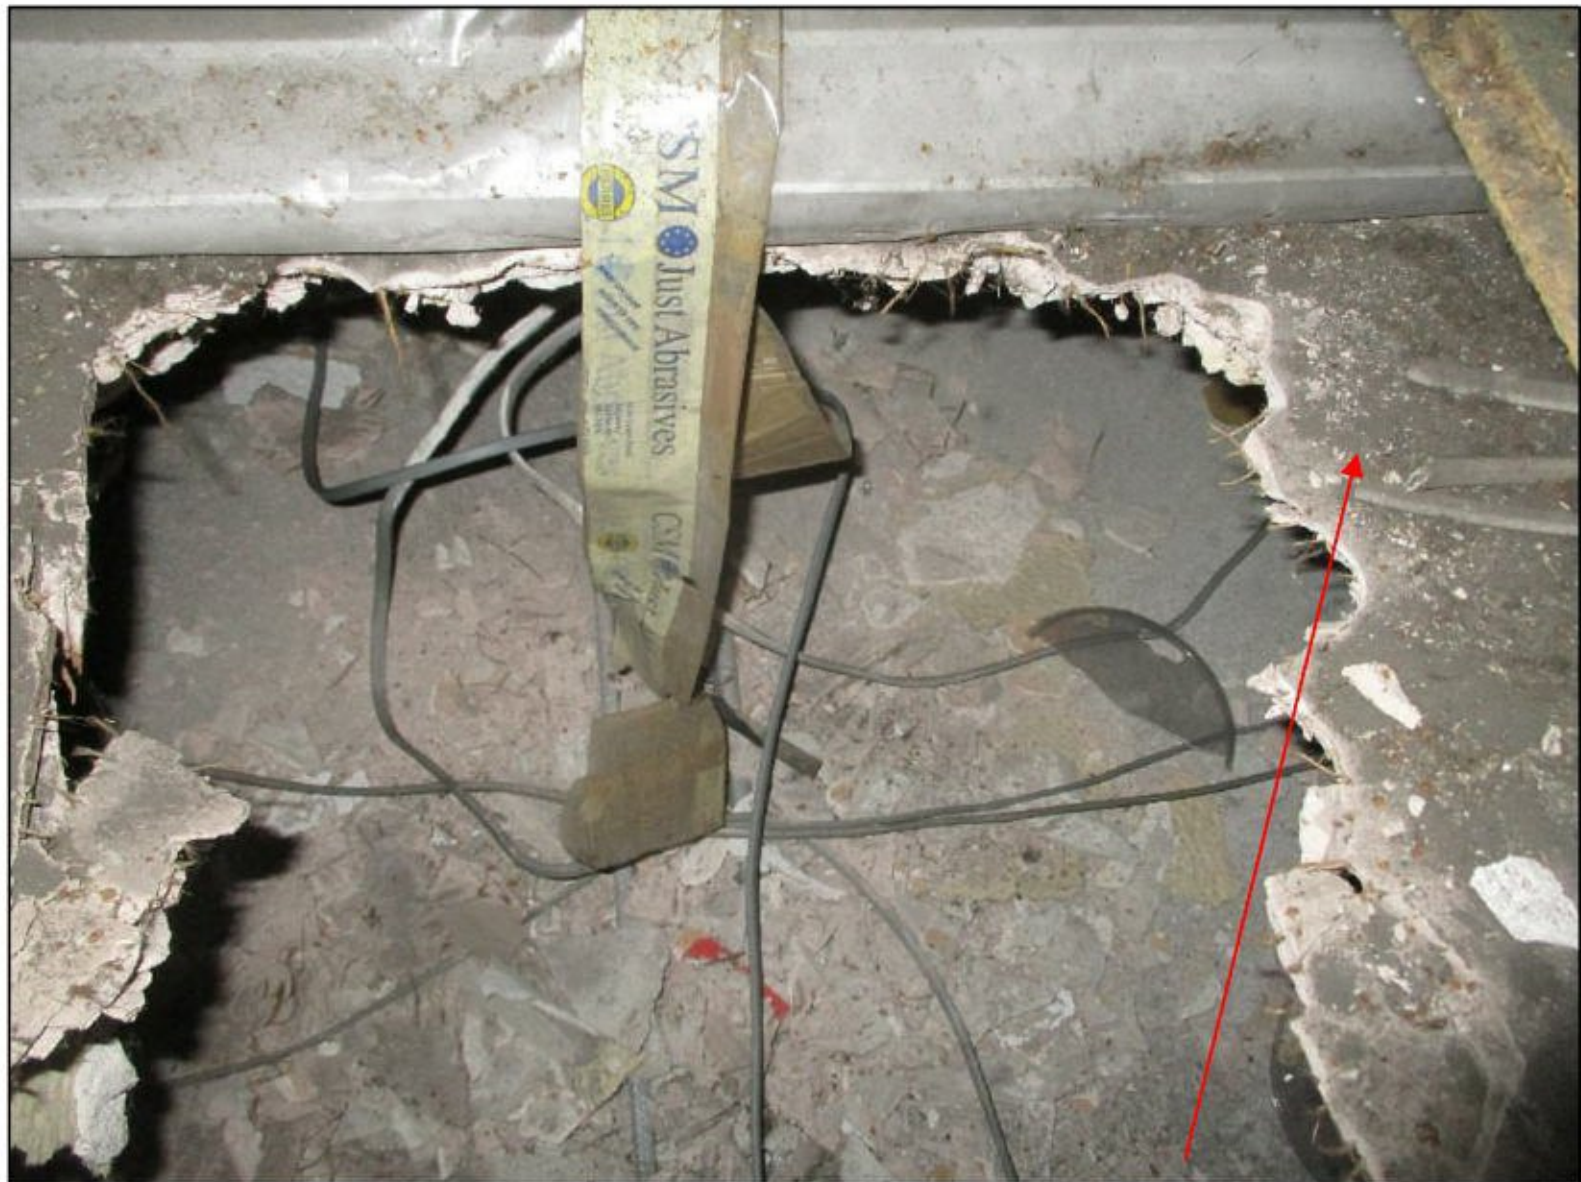
<b>SAMPLE REF.</b>	<b>S01</b>
<b>PHOTO NO.</b>	<b>Five</b>
<b>DESCRIPTION</b>	<b>Original first floor ceilings</b>
<b>LOCATION</b>	<b>In void between loft floor &amp; new first floor ceilings</b>
<b>FLOOR</b>	<b>Loft void – first</b>
<b>COMMENTS</b>	<b>No asbestos detected</b>
<b>EXTENT</b>	
<b>RISK</b>	
<b>REMOVE</b>	
<b>REGULATION</b>

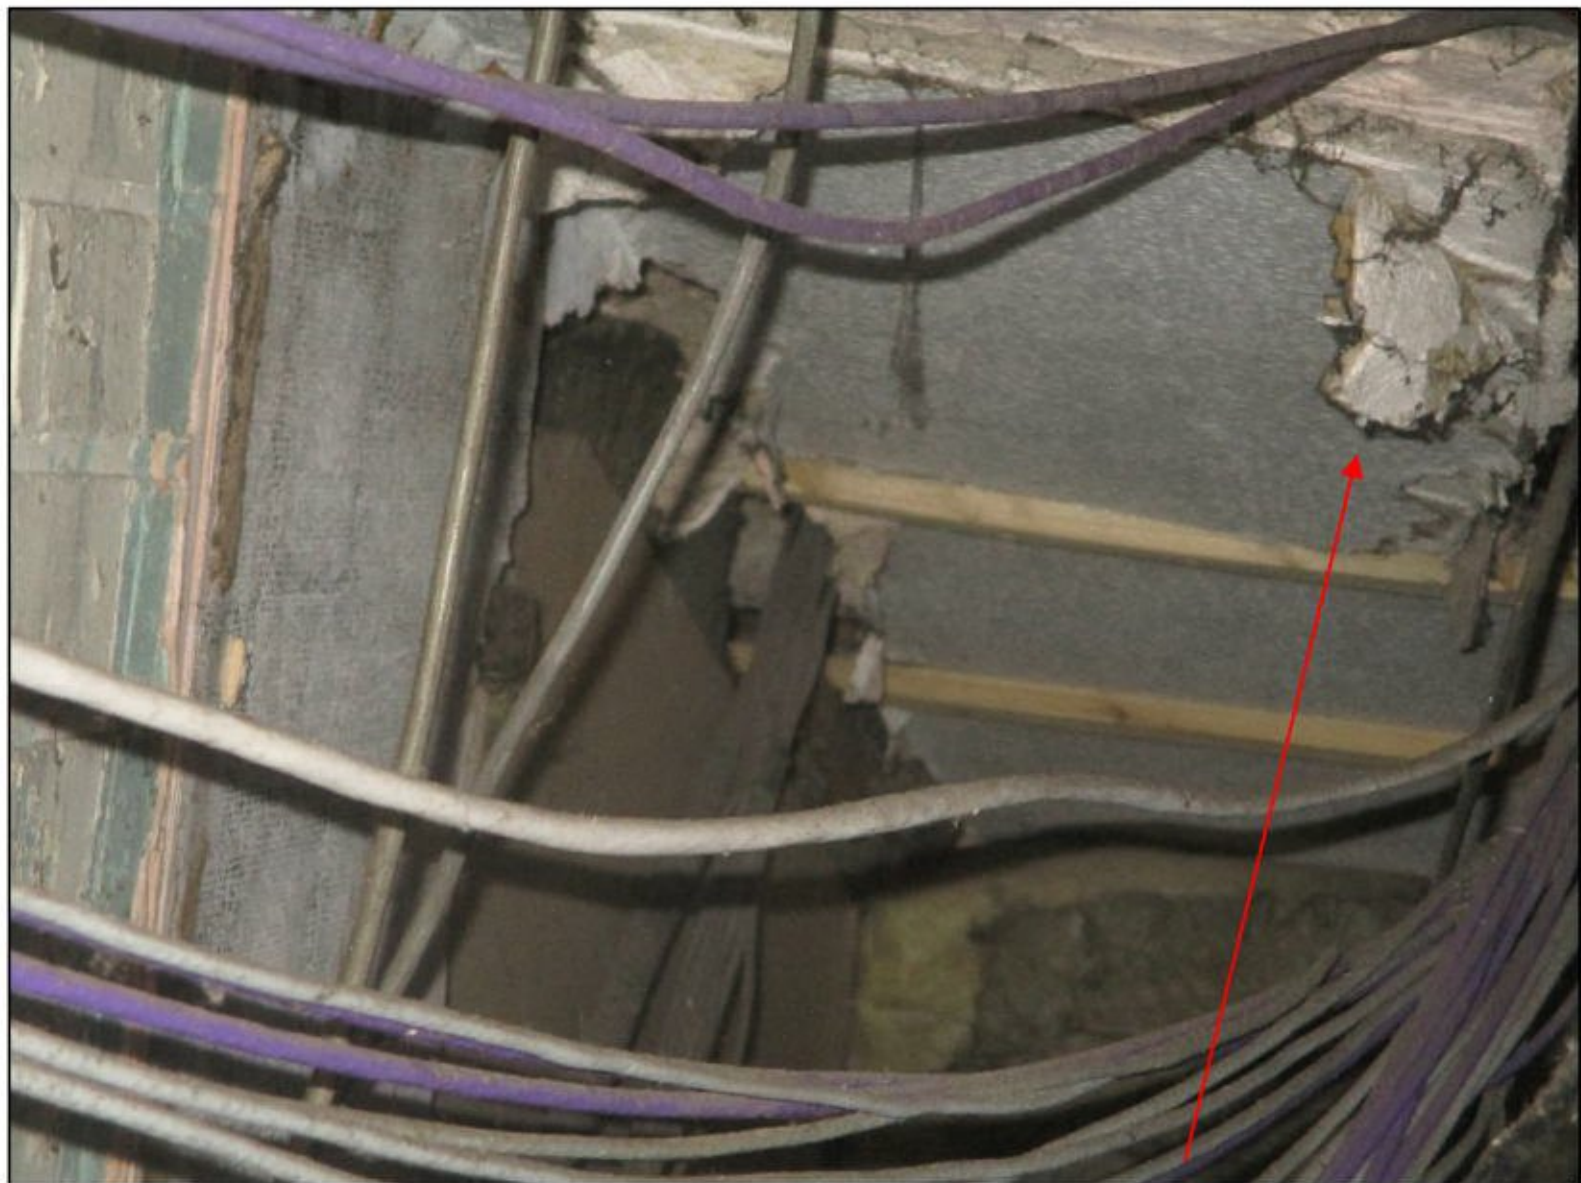
<b>SAMPLE REF.</b>	S02 & S05
<b>PHOTO NO.</b>	Six
<b>DESCRIPTION</b>	Textured coating/Artex to original first floor ceilings
<b>LOCATION</b>	In void between loft floor & new first floor ceilings
<b>FLOOR</b>	Loft void – first
<b>COMMENTS</b>	No asbestos detected
<b>EXTENT</b>	
<b>RISK</b>	
<b>REMOVE</b>	
<b>REGULATION</b>

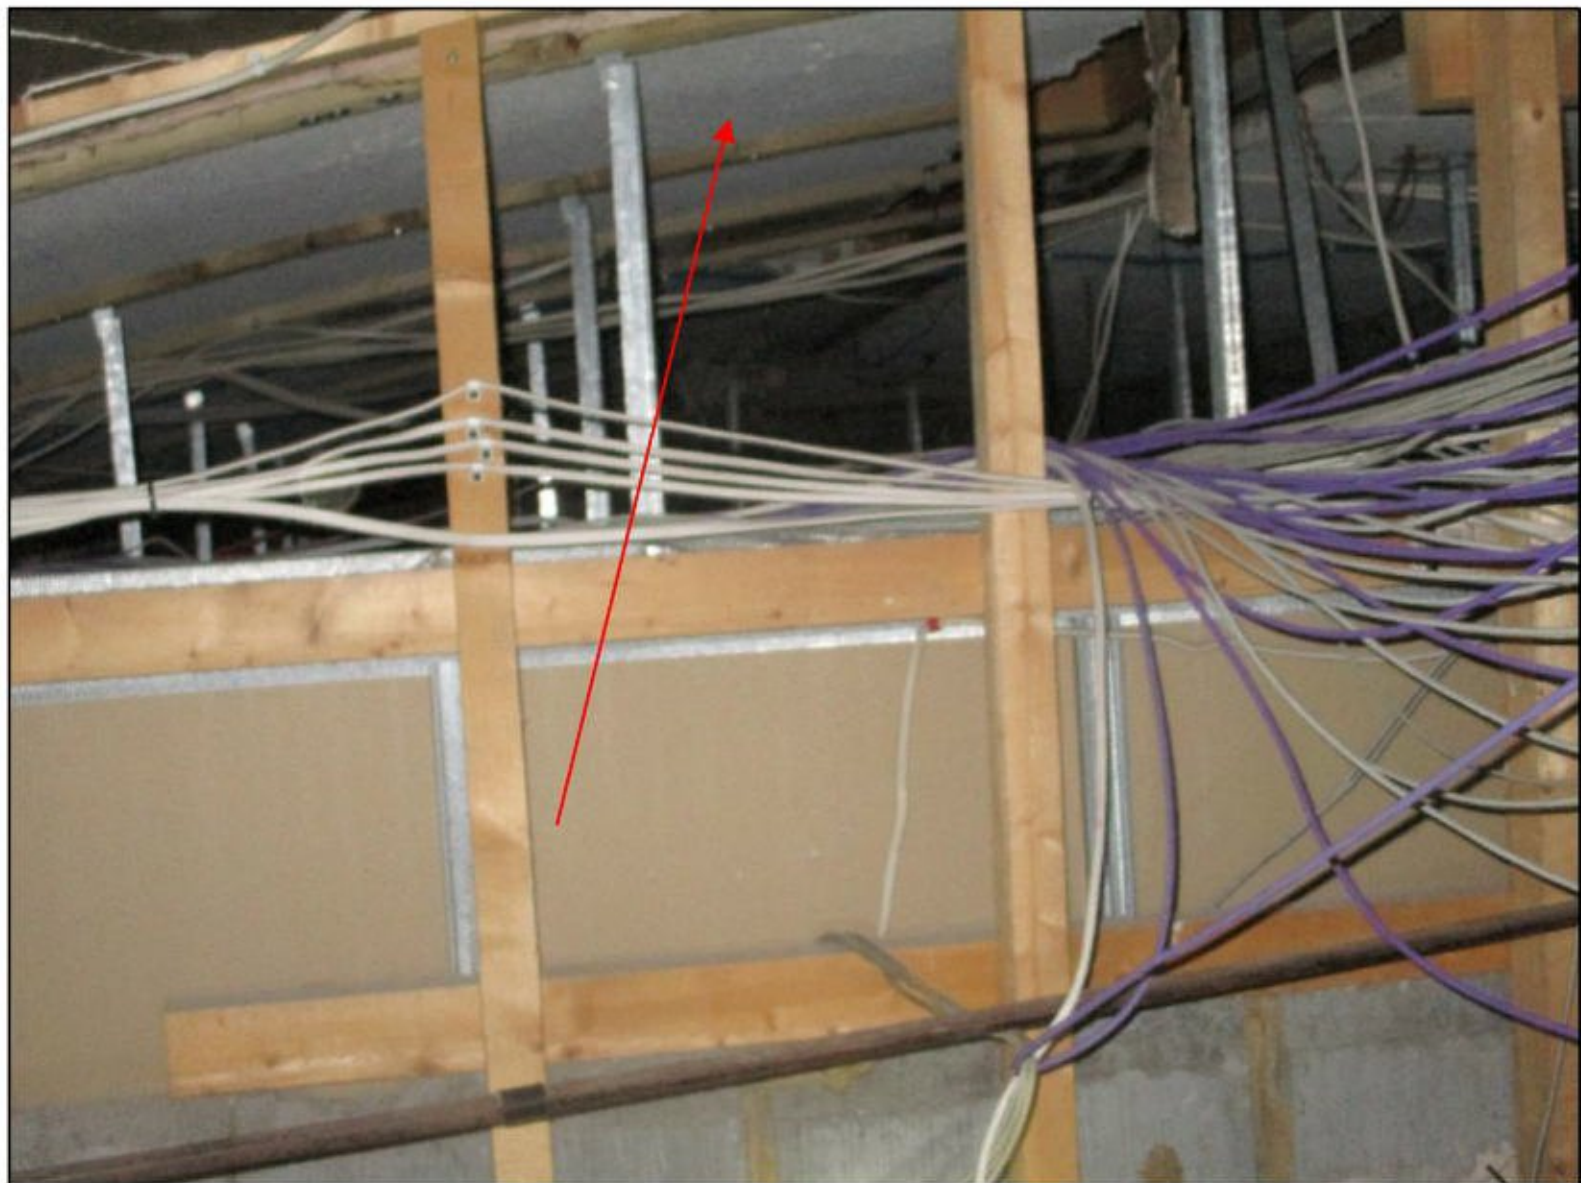
<b>SAMPLE REF.</b>	<b>S02 &amp; S05</b>
<b>PHOTO NO.</b>	<b>Seven</b>
<b>DESCRIPTION</b>	<b>Textured coating/Artex to original first floor ceilings</b>
<b>LOCATION</b>	<b>In void between loft floor &amp; new first floor ceilings</b>
<b>FLOOR</b>	<b>Loft void – first</b>
<b>COMMENTS</b>	<b>No asbestos detected</b>
<b>EXTENT</b>	
<b>RISK</b>	
<b>REMOVE</b>	
<b>REGULATION</b>

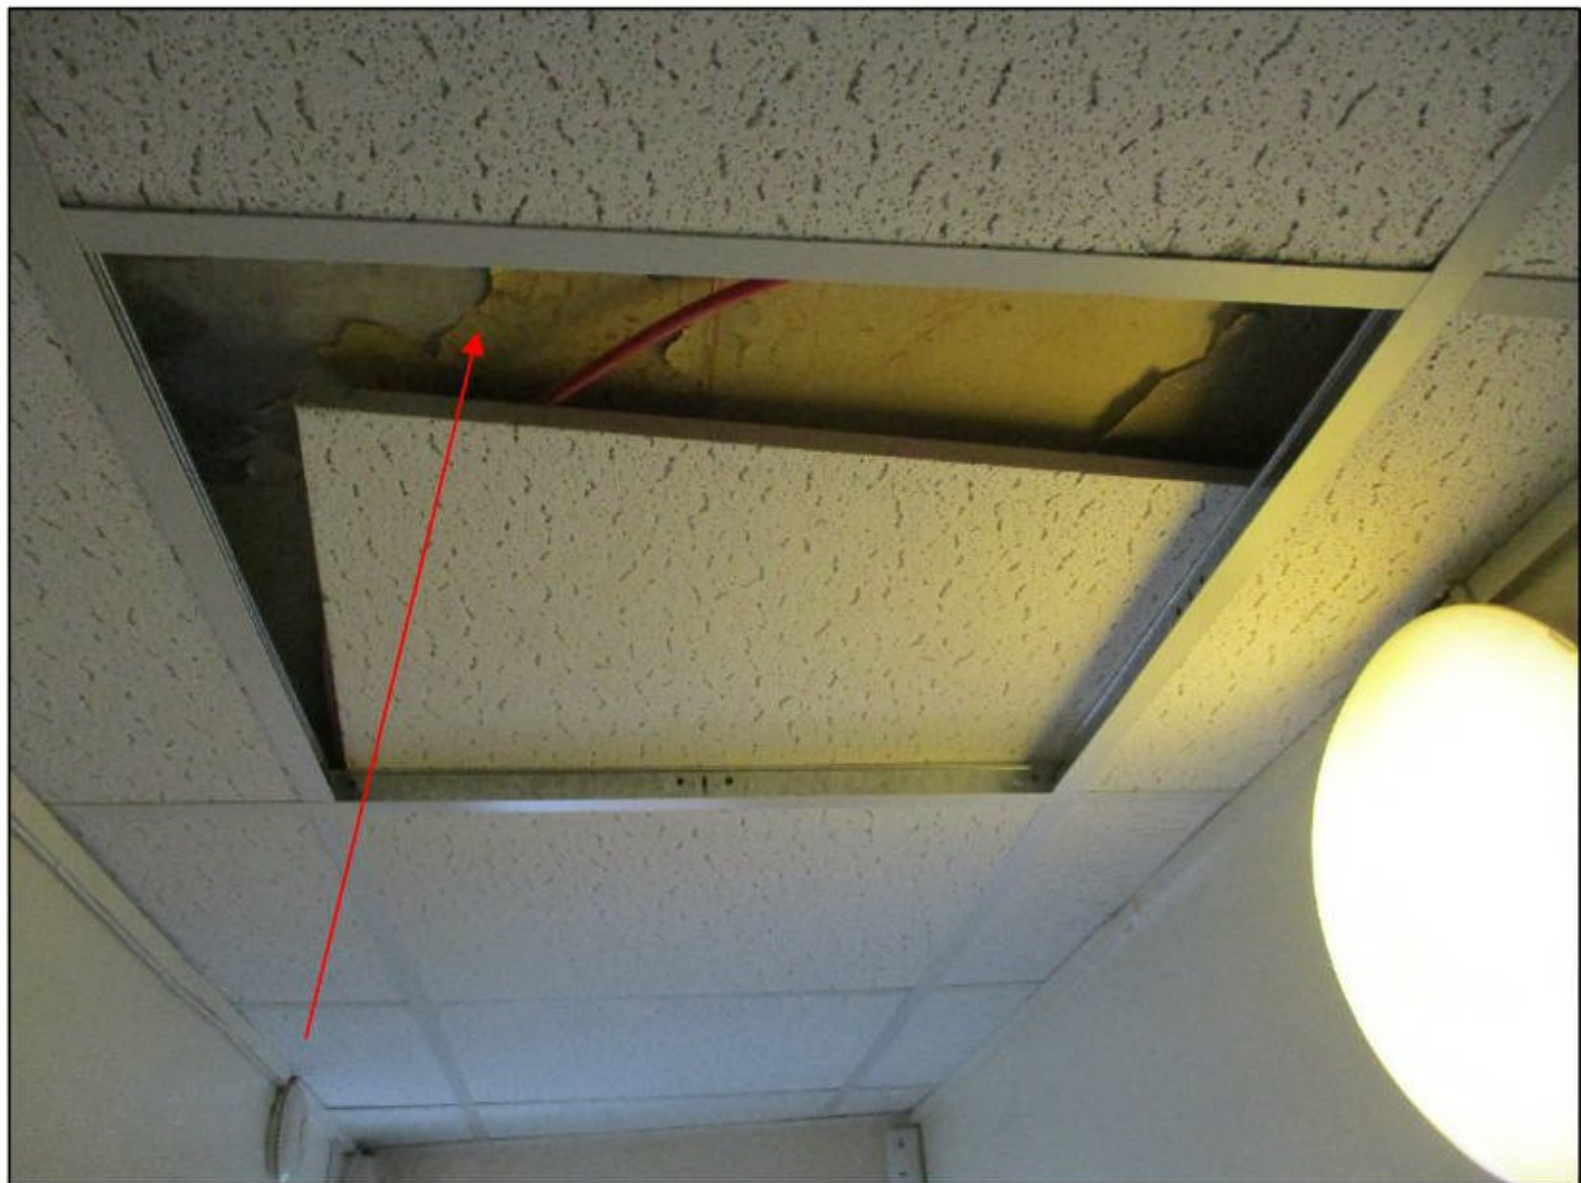
<b>SAMPLE REF.</b>	<b>S06</b>
<b>PHOTO NO.</b>	<b>Eight</b>
<b>DESCRIPTION</b>	<b>Textured coating/Artex to original first floor ceilings</b>
<b>LOCATION</b>	<b>Above suspended ceiling caretakers room</b>
<b>FLOOR</b>	<b>First</b>
<b>COMMENTS</b>	<b>No asbestos detected</b>
<b>EXTENT</b>	
<b>RISK</b>	
<b>REMOVE</b>	
<b>REGULATION</b>

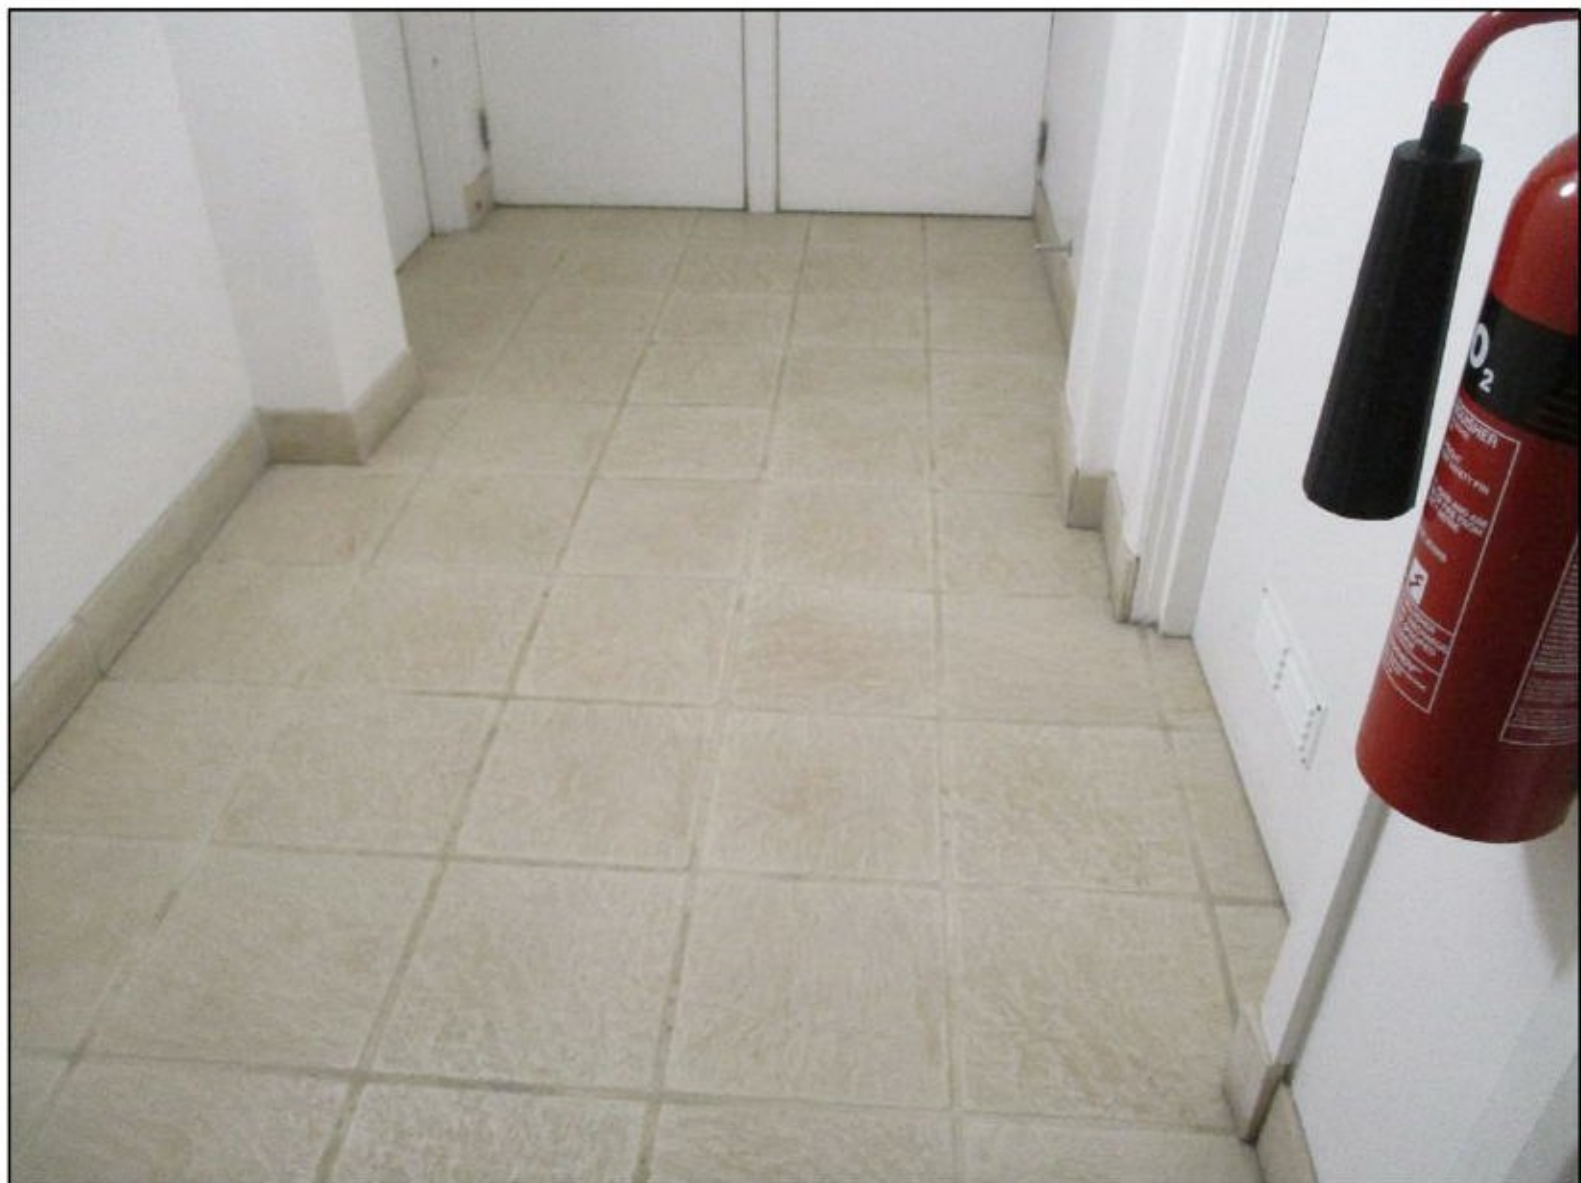
<b>SAMPLE REF.</b>	N/A
<b>PHOTO NO.</b>	Nine
<b>DESCRIPTION</b>	Basement area
<b>LOCATION</b>	General picture
<b>FLOOR</b>	Basement
<b>COMMENTS</b>	No asbestos detected
<b>EXTENT</b>	
<b>RISK</b>	
<b>REMOVE</b>	
<b>REGULATION</b>

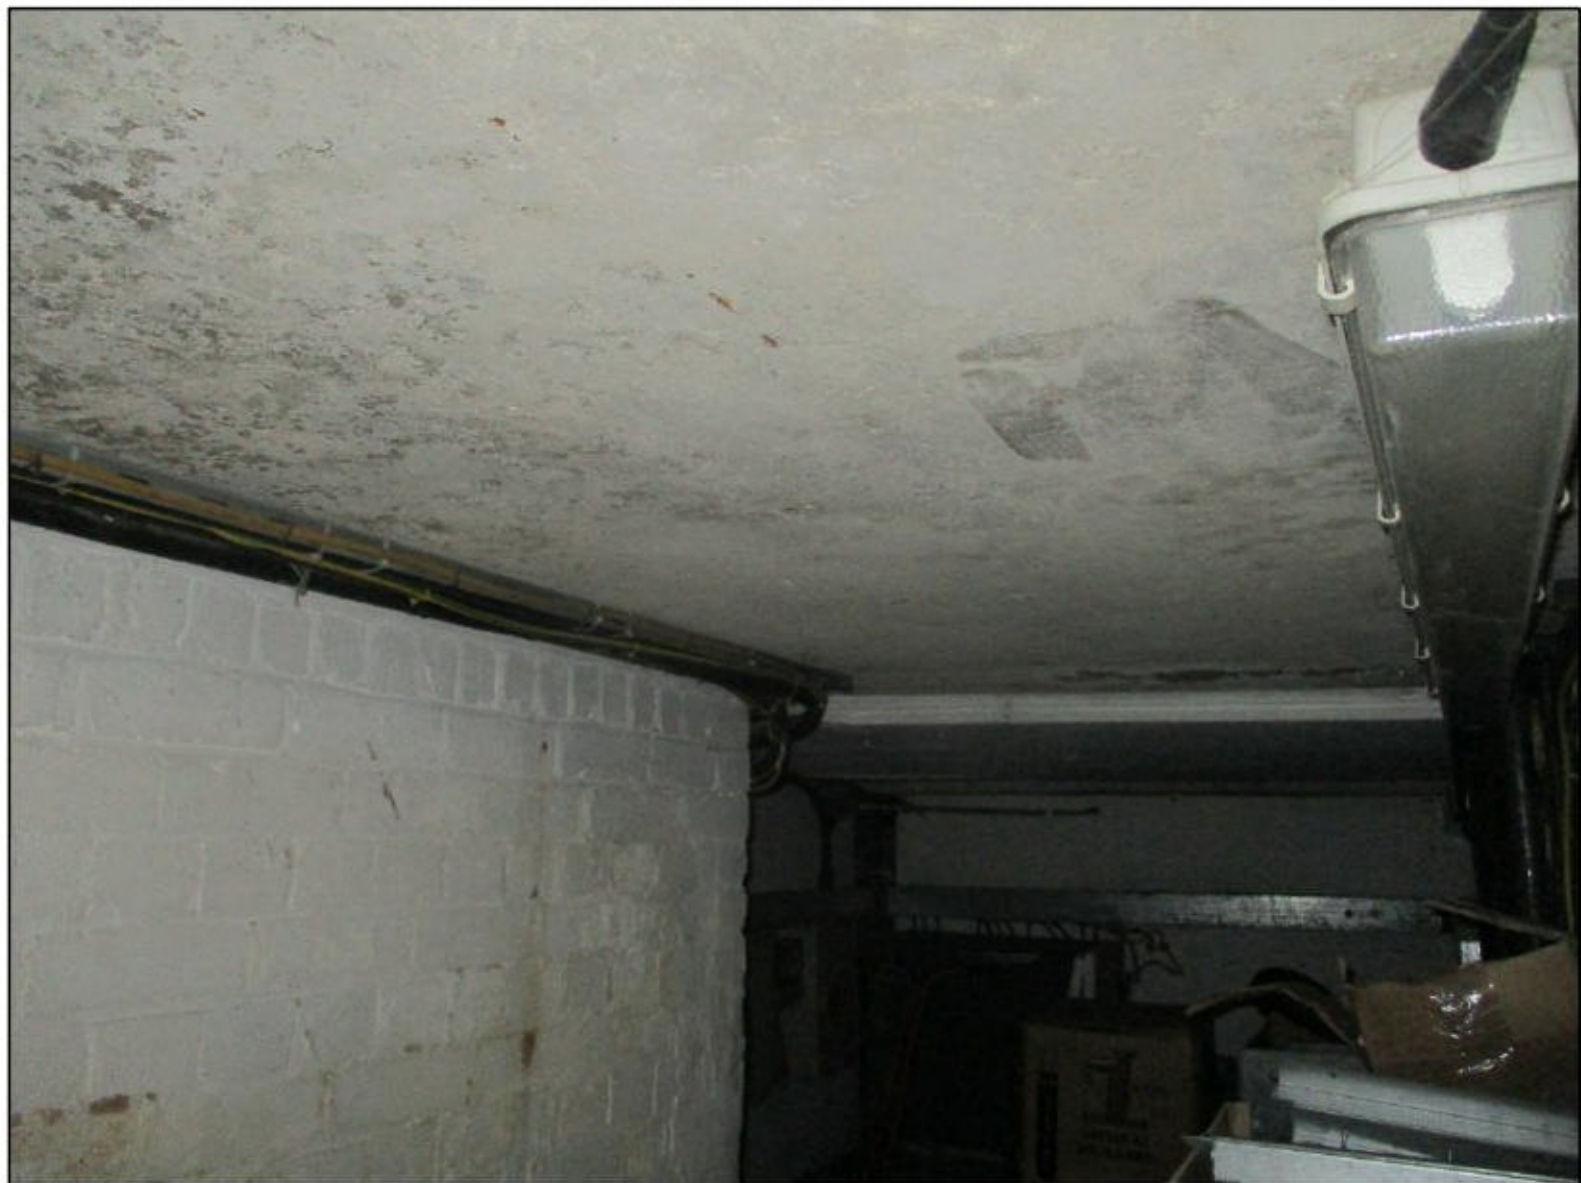
<b>SAMPLE REF.</b>	<b>N/A</b>
<b>PHOTO NO.</b>	<b>Ten</b>
<b>DESCRIPTION</b>	<b>Basement area</b>
<b>LOCATION</b>	<b>General picture</b>
<b>FLOOR</b>	<b>Basement</b>
<b>COMMENTS</b>	<b>No asbestos detected</b>
<b>EXTENT</b>	
<b>RISK</b>	
<b>REMOVE</b>	
<b>REGULATION</b>

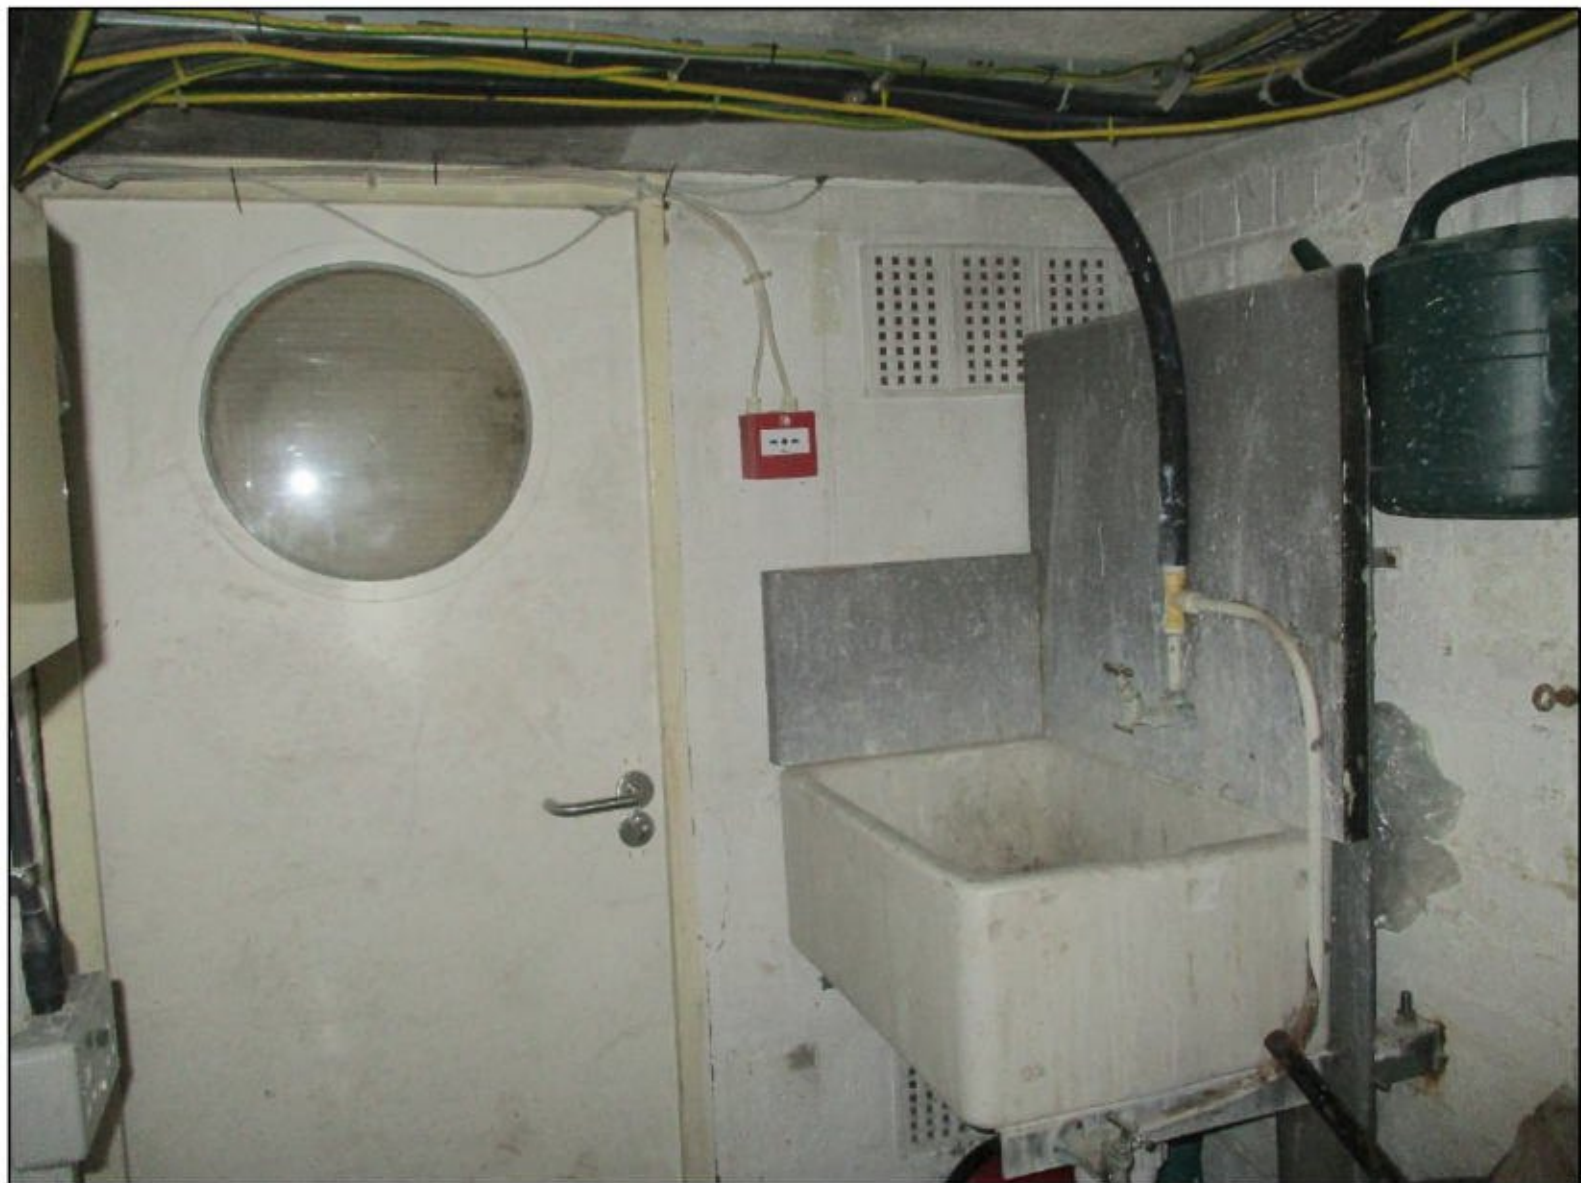
<b>SAMPLE REF.</b>	<b>N/A</b>
<b>PHOTO NO.</b>	<b>Eleven</b>
<b>DESCRIPTION</b>	<b>Basement area</b>
<b>LOCATION</b>	<b>General picture</b>
<b>FLOOR</b>	<b>Basement</b>
<b>COMMENTS</b>	<b>No asbestos detected</b>
<b>EXTENT</b>	
<b>RISK</b>	
<b>REMOVE</b>	
<b>REGULATION</b>
