**LIMITED / PART / R & D SURVEY  
PRE-DEMOLITION OR MAJOR WORK ASBESTOS SURVEY AT  
86 THE BROADWAY  
MILL HILL  
LONDON  
NW7 3TD**

**SURVEY NUMBER: SUR 3038/03/03/21**

## ASBESTOS REPORT FOR ATHENE HOUSE, MILL HILL

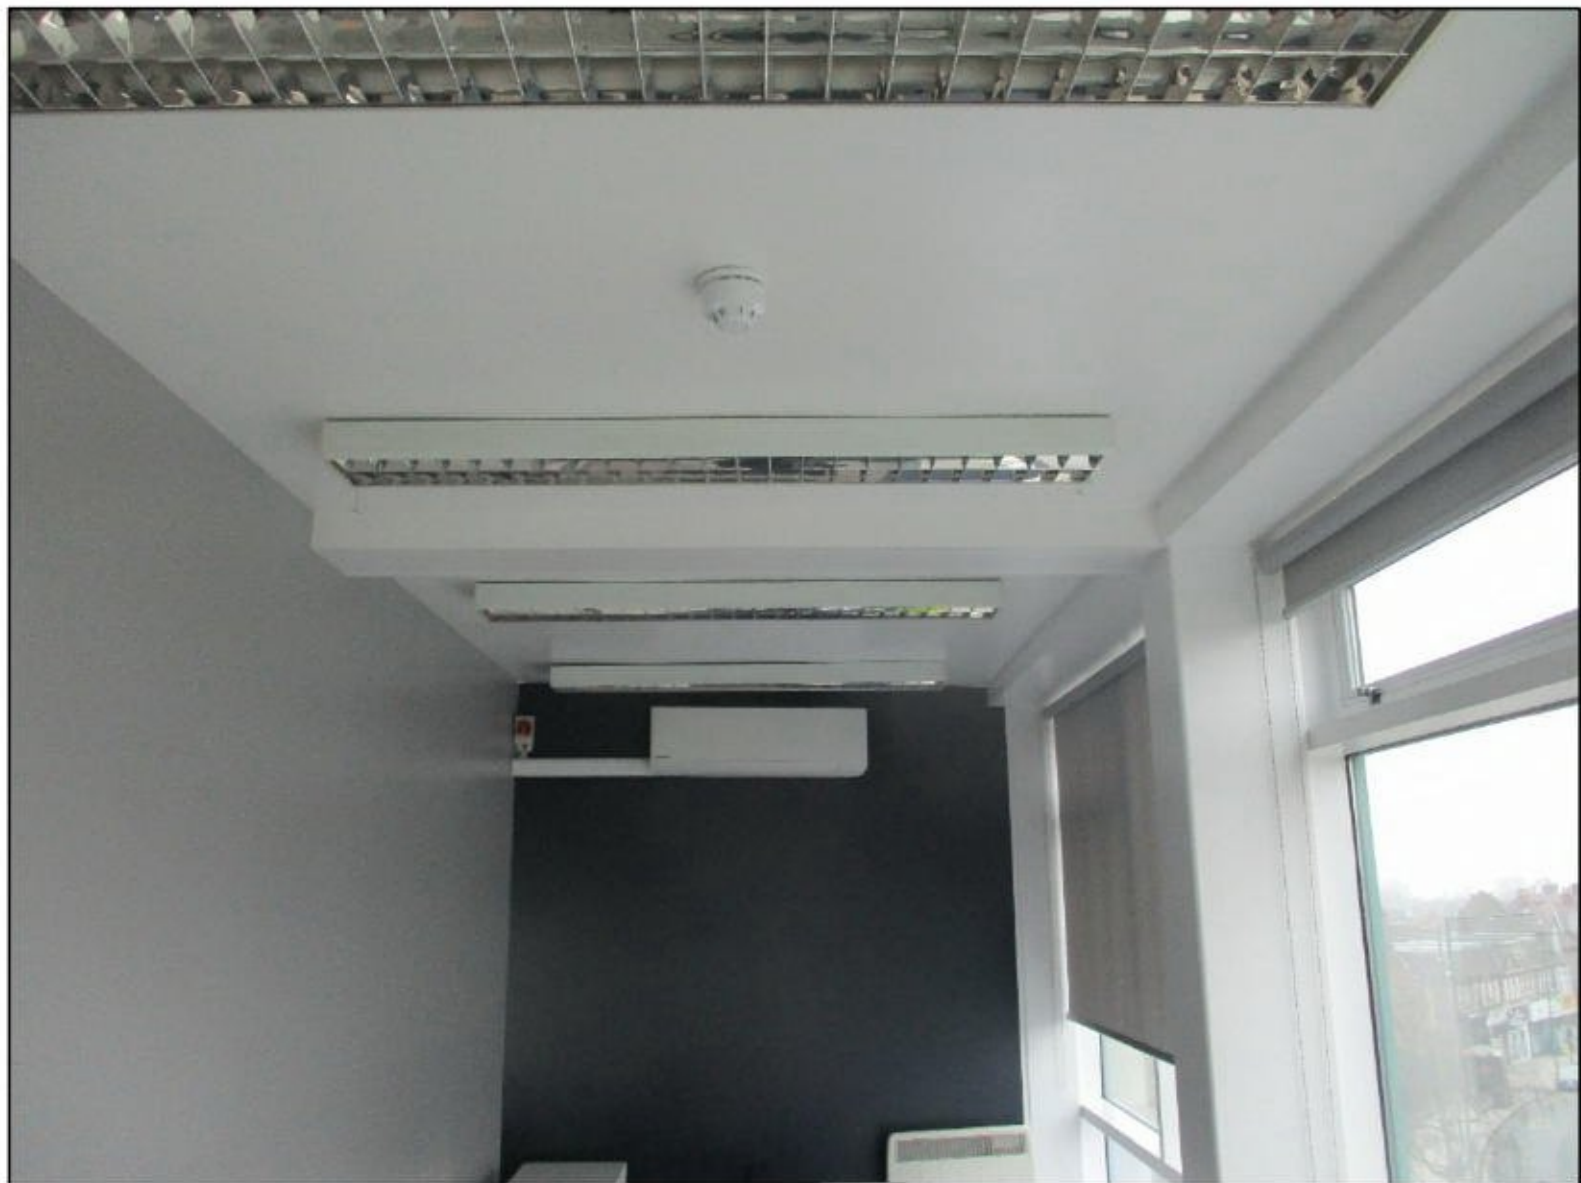
<b>SAMPLE REF.</b>	N/A
<b>PHOTO NO.</b>	Twelve
<b>DESCRIPTION</b>	Offices
<b>LOCATION</b>	General picture
<b>FLOOR</b>	Ground & first
<b>COMMENTS</b>	No asbestos detected within general office areas
<b>EXTENT</b>	
<b>RISK</b>	
<b>REMOVE</b>	
<b>REGULATION</b>

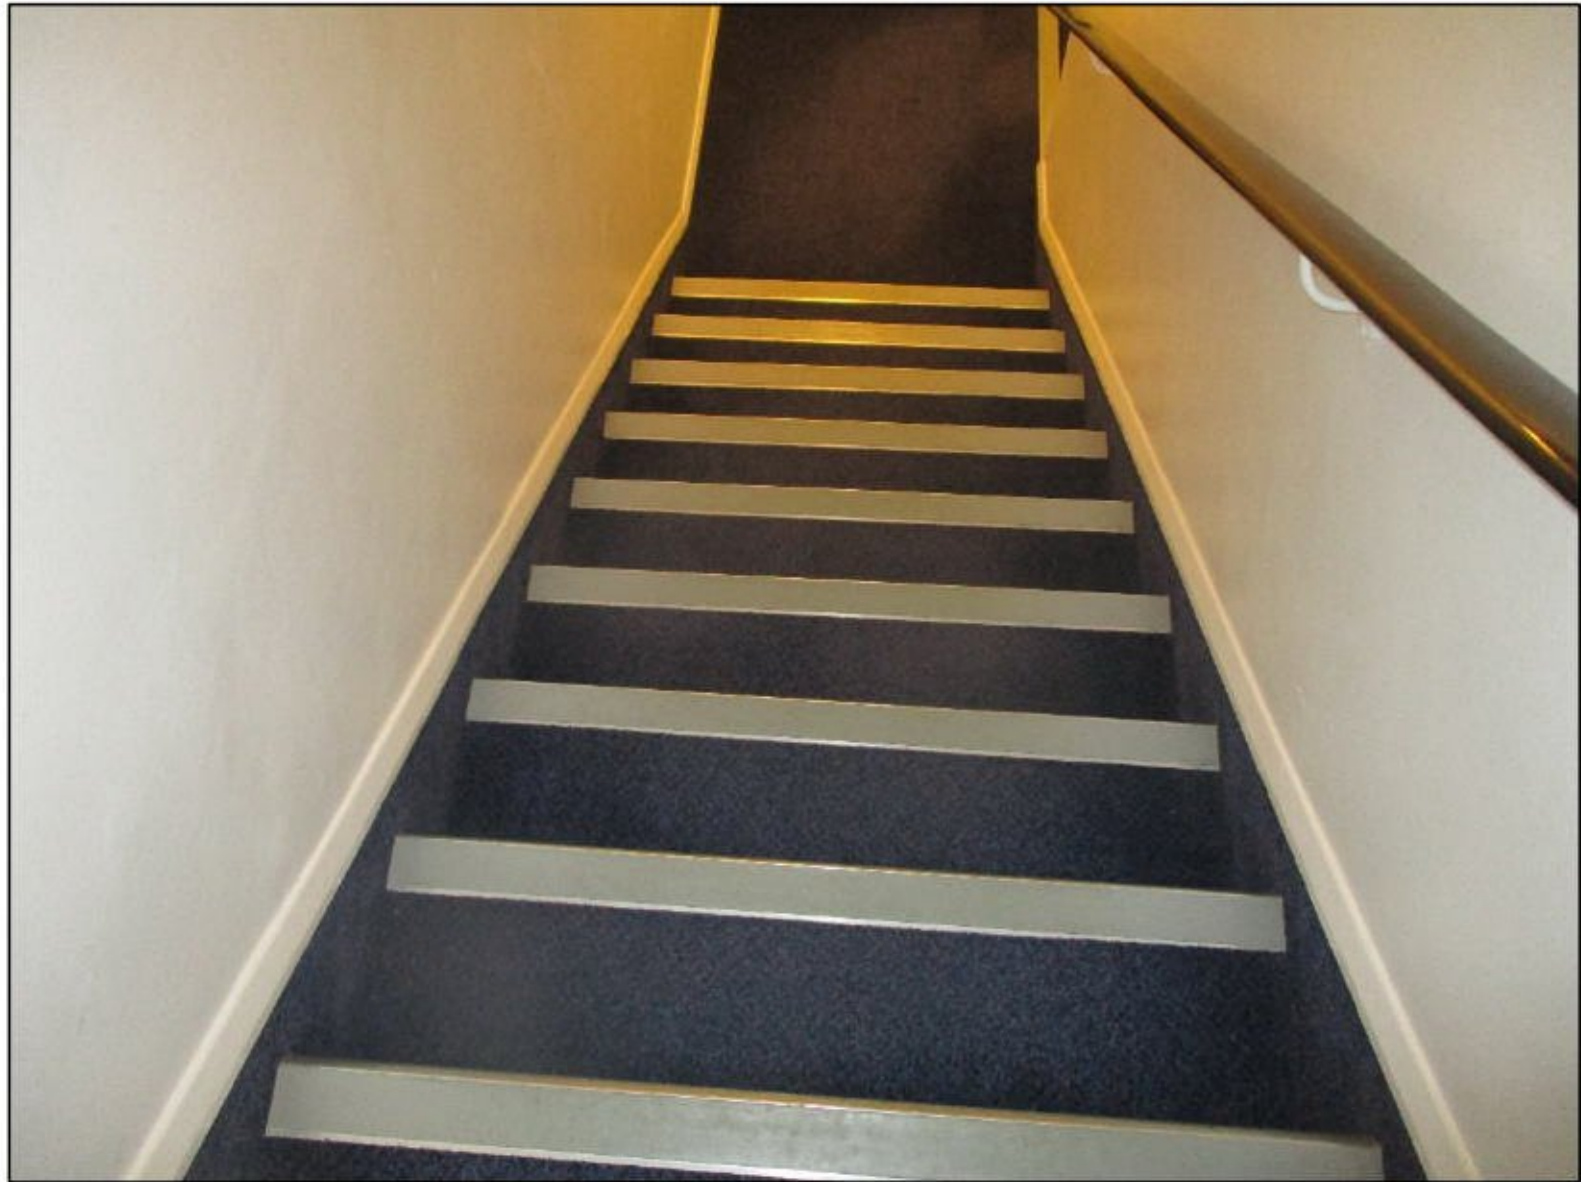
<b>SAMPLE REF.</b>	N/A
<b>PHOTO NO.</b>	Thirteen
<b>DESCRIPTION</b>	Offices
<b>LOCATION</b>	General picture
<b>FLOOR</b>	Ground & first
<b>COMMENTS</b>	No asbestos detected within general office areas
<b>EXTENT</b>	
<b>RISK</b>	
<b>REMOVE</b>	
<b>REGULATION</b>

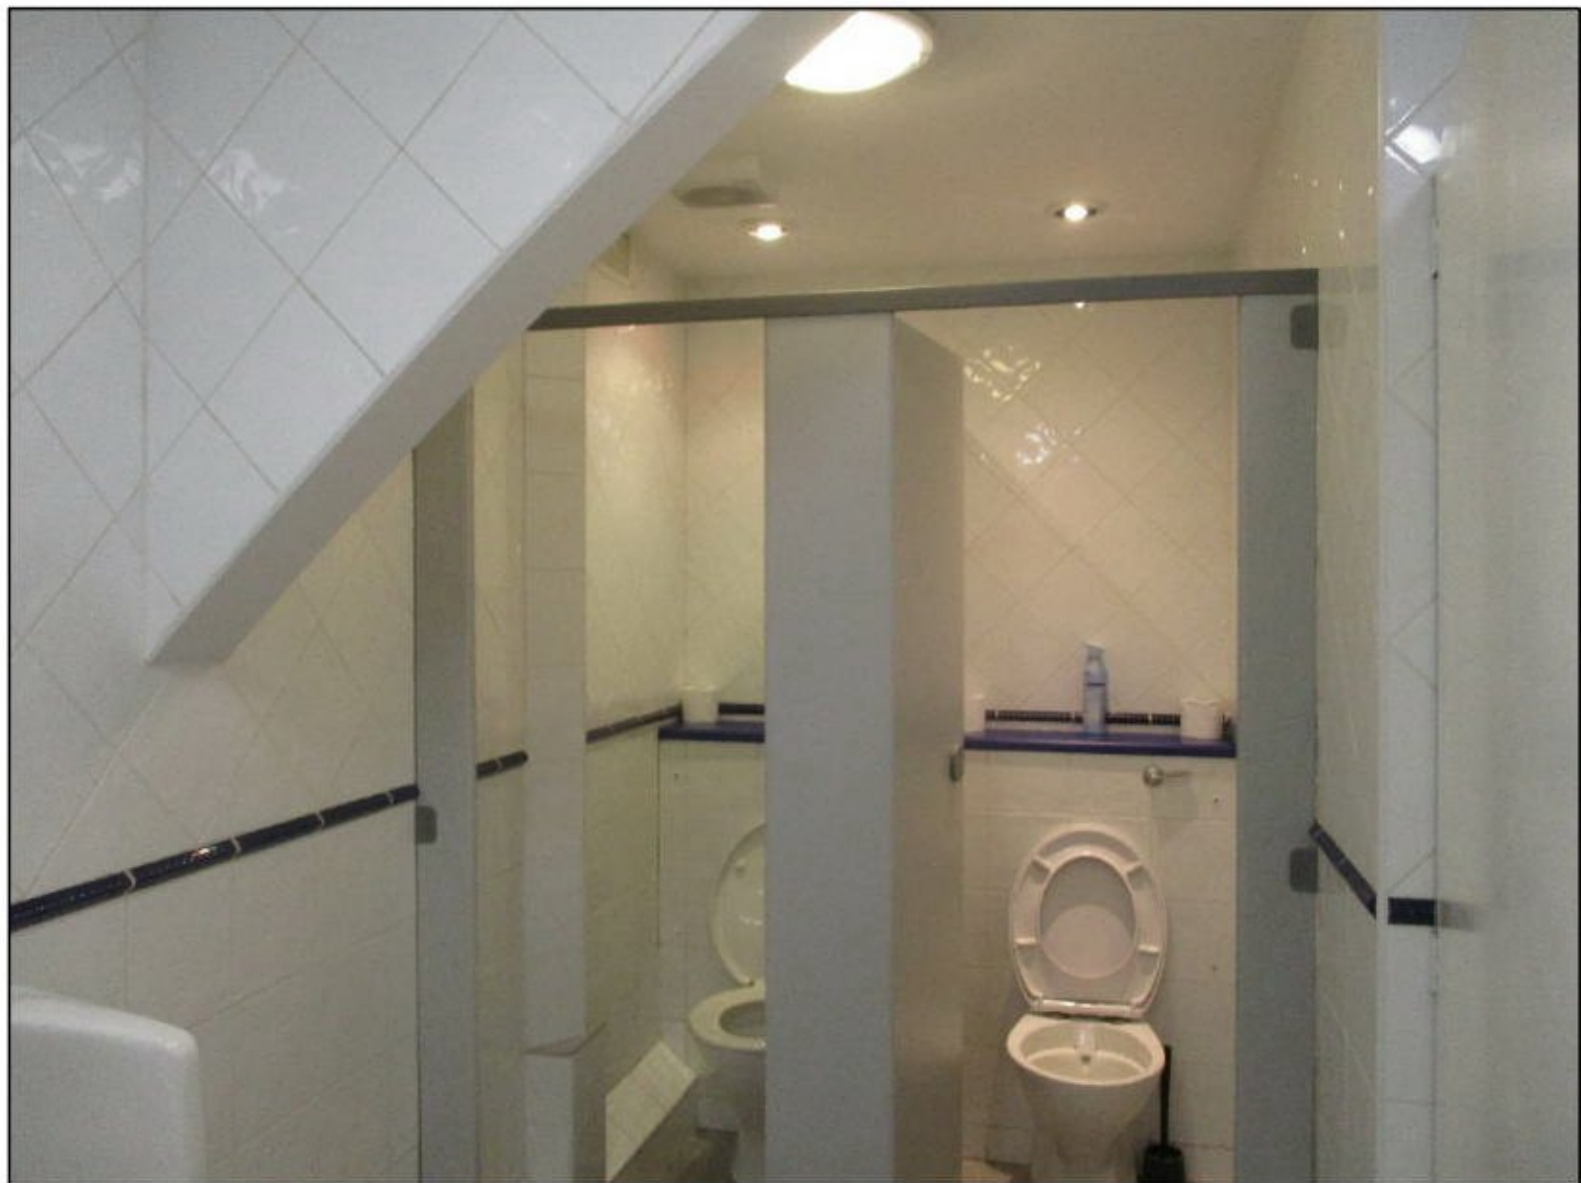
<b>SAMPLE REF.</b>	<b>N/A</b>
<b>PHOTO NO.</b>	<b>Fourteen</b>
<b>DESCRIPTION</b>	<b>Offices</b>
<b>LOCATION</b>	<b>General picture</b>
<b>FLOOR</b>	<b>Ground &amp; first</b>
<b>COMMENTS</b>	<b>No asbestos detected within general office areas</b>
<b>EXTENT</b>	
<b>RISK</b>	
<b>REMOVE</b>	
<b>REGULATION</b>

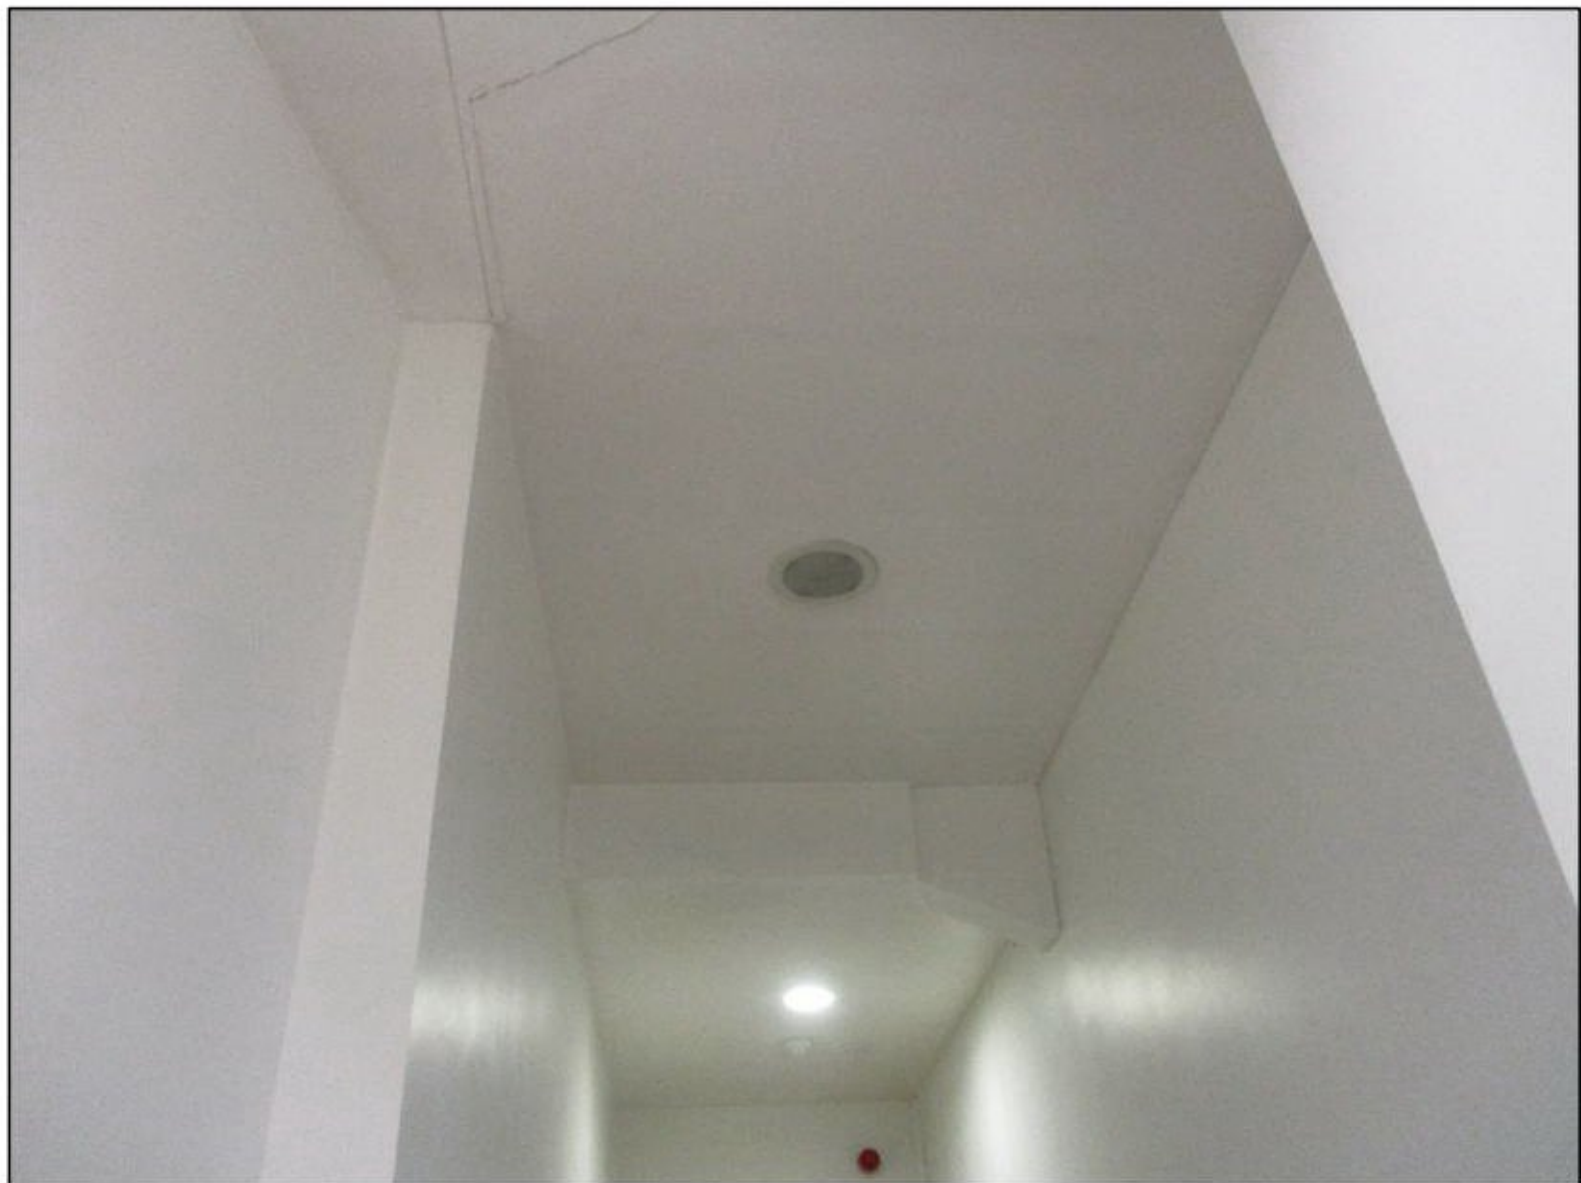
<b>SAMPLE REF.</b>	<b>N/A</b>
<b>PHOTO NO.</b>	<b>Fifteen</b>
<b>DESCRIPTION</b>	<b>Offices</b>
<b>LOCATION</b>	<b>General picture</b>
<b>FLOOR</b>	<b>Ground &amp; first</b>
<b>COMMENTS</b>	<b>No asbestos detected within general office areas</b>
<b>EXTENT</b>	
<b>RISK</b>	
<b>REMOVE</b>	
<b>REGULATION</b>

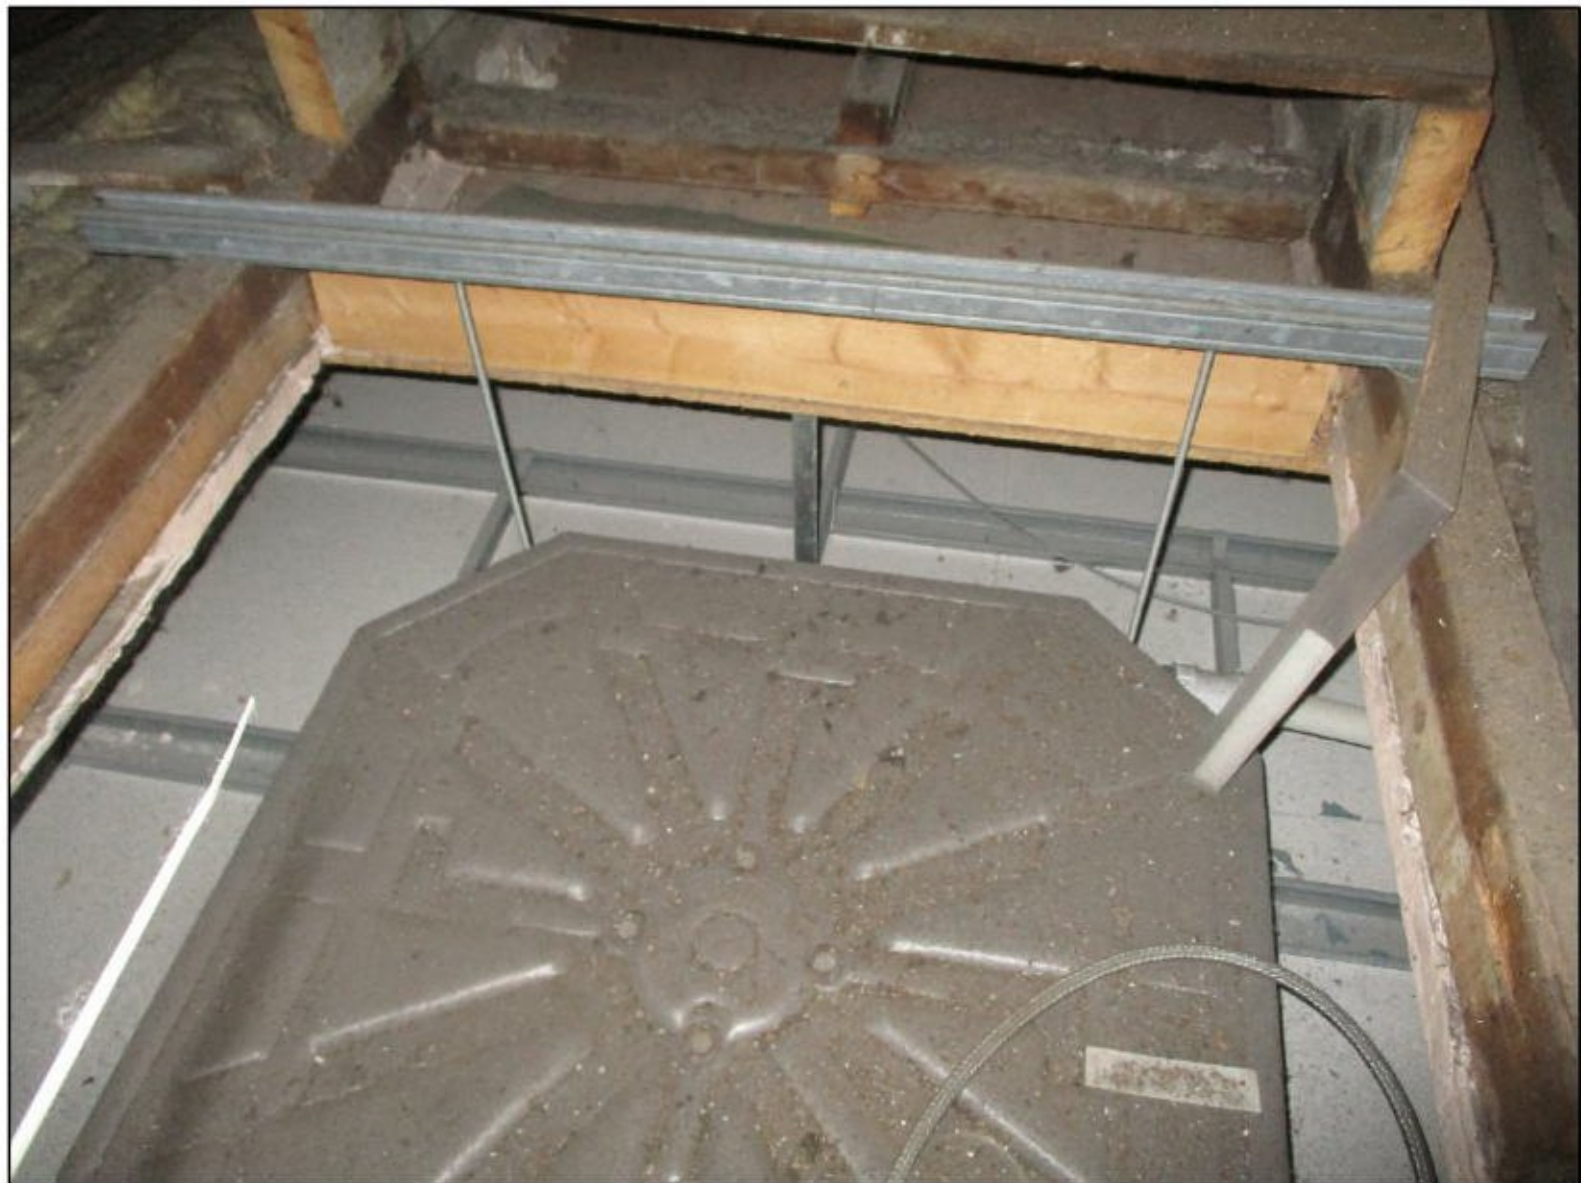
<b>SAMPLE REF.</b>	N/A
<b>PHOTO NO.</b>	Sixteen
<b>DESCRIPTION</b>	Roof space
<b>LOCATION</b>	General picture – ceiling ventilation and first floor ceilings from grid in void – no asbestos
<b>FLOOR</b>	Loft
<b>COMMENTS</b>	Asbestos has been detected within the void between the roof/loft space and first floor ceilings
<b>EXTENT</b>	
<b>RISK</b>	
<b>REMOVE</b>	
<b>REGULATION</b>

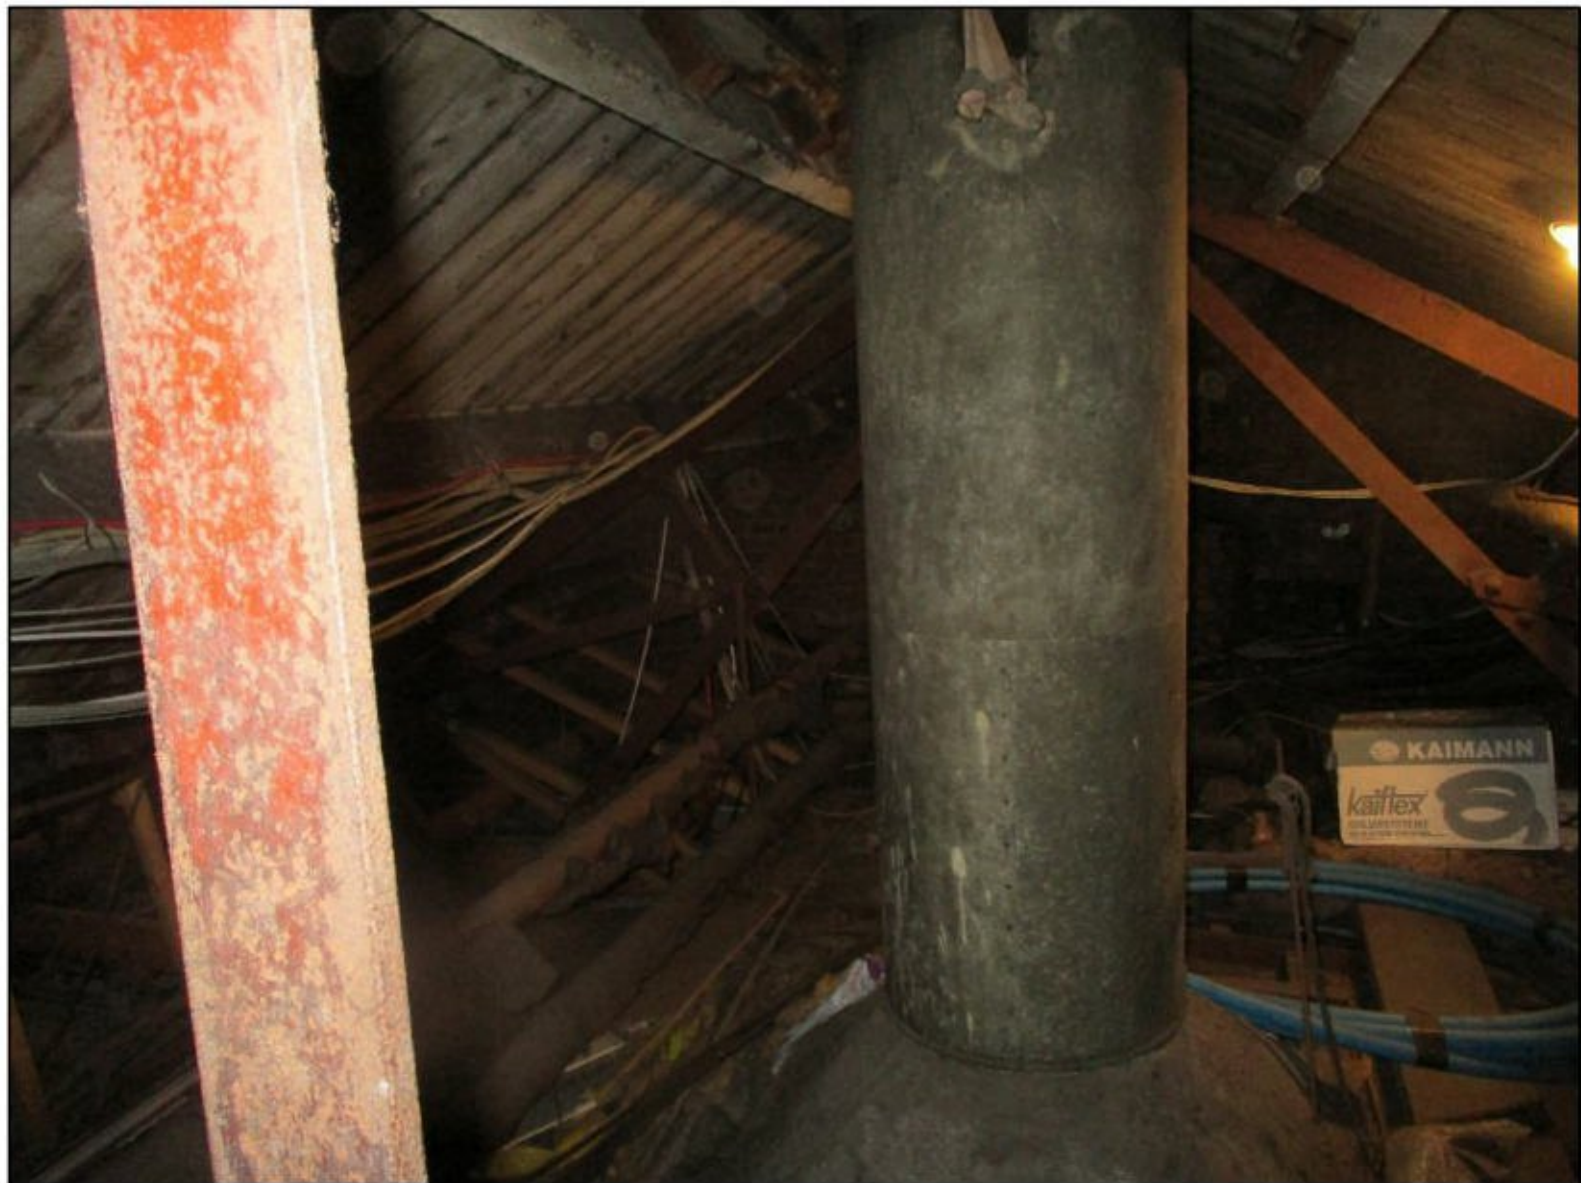
<b>SAMPLE REF.</b>	N/A
<b>PHOTO NO.</b>	Seventeen
<b>DESCRIPTION</b>	Roof space
<b>LOCATION</b>	General picture – ceiling ventilation from first floor in void – no asbestos
<b>FLOOR</b>	Loft
<b>COMMENTS</b>	Asbestos has been detected within the void between the roof/loft space and first floor ceilings
<b>EXTENT</b>	
<b>RISK</b>	
<b>REMOVE</b>	
<b>REGULATION</b>

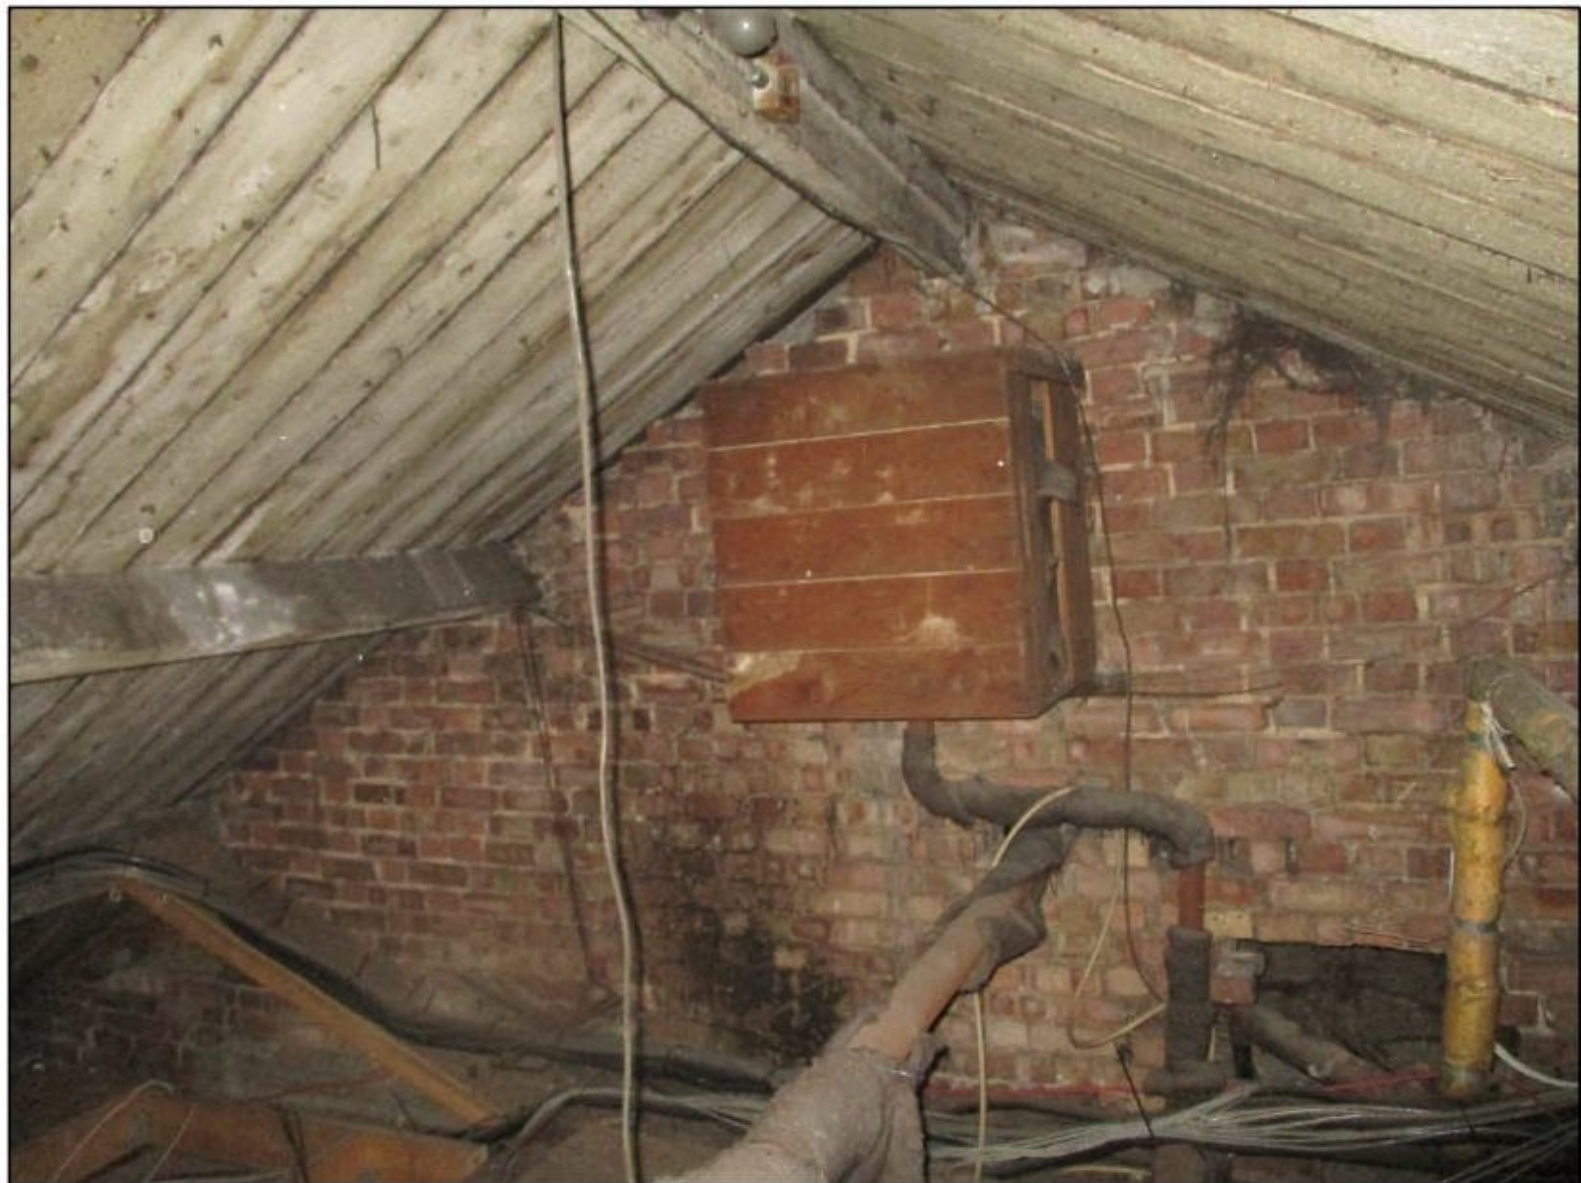
<b>SAMPLE REF.</b>	N/A
<b>PHOTO NO.</b>	Eighteen
<b>DESCRIPTION</b>	Roof space
<b>LOCATION</b>	General picture – No access beyond wall, boarded roof and pipe insulation – non asbestos
<b>FLOOR</b>	Loft
<b>COMMENTS</b>	Asbestos has been detected within the void between the roof/loft space and first floor ceilings
<b>EXTENT</b>	
<b>RISK</b>	
<b>REMOVE</b>	
<b>REGULATION</b>

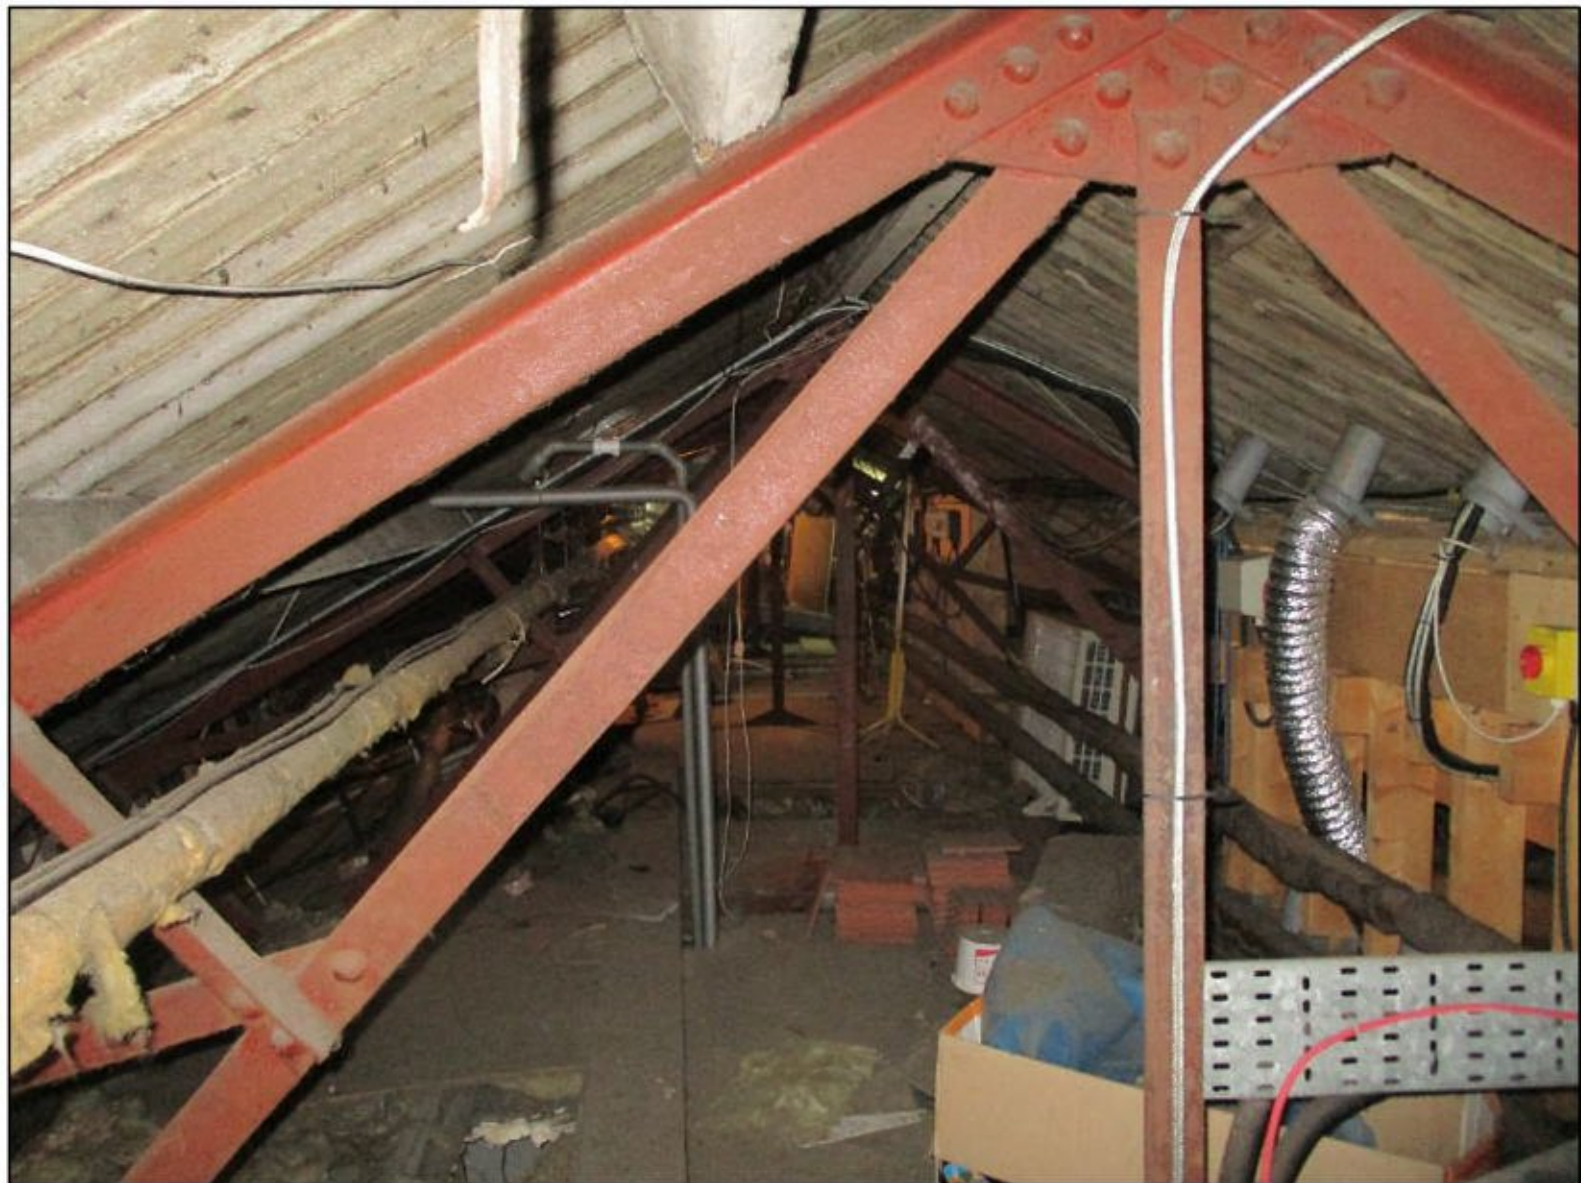
<b>SAMPLE REF.</b>	N/A
<b>PHOTO NO.</b>	Nineteen
<b>DESCRIPTION</b>	Roof space
<b>LOCATION</b>	General picture
<b>FLOOR</b>	Loft
<b>COMMENTS</b>	Asbestos has been detected within the void between the roof/loft space and first floor ceilings
<b>EXTENT</b>	
<b>RISK</b>	
<b>REMOVE</b>	
<b>REGULATION</b>

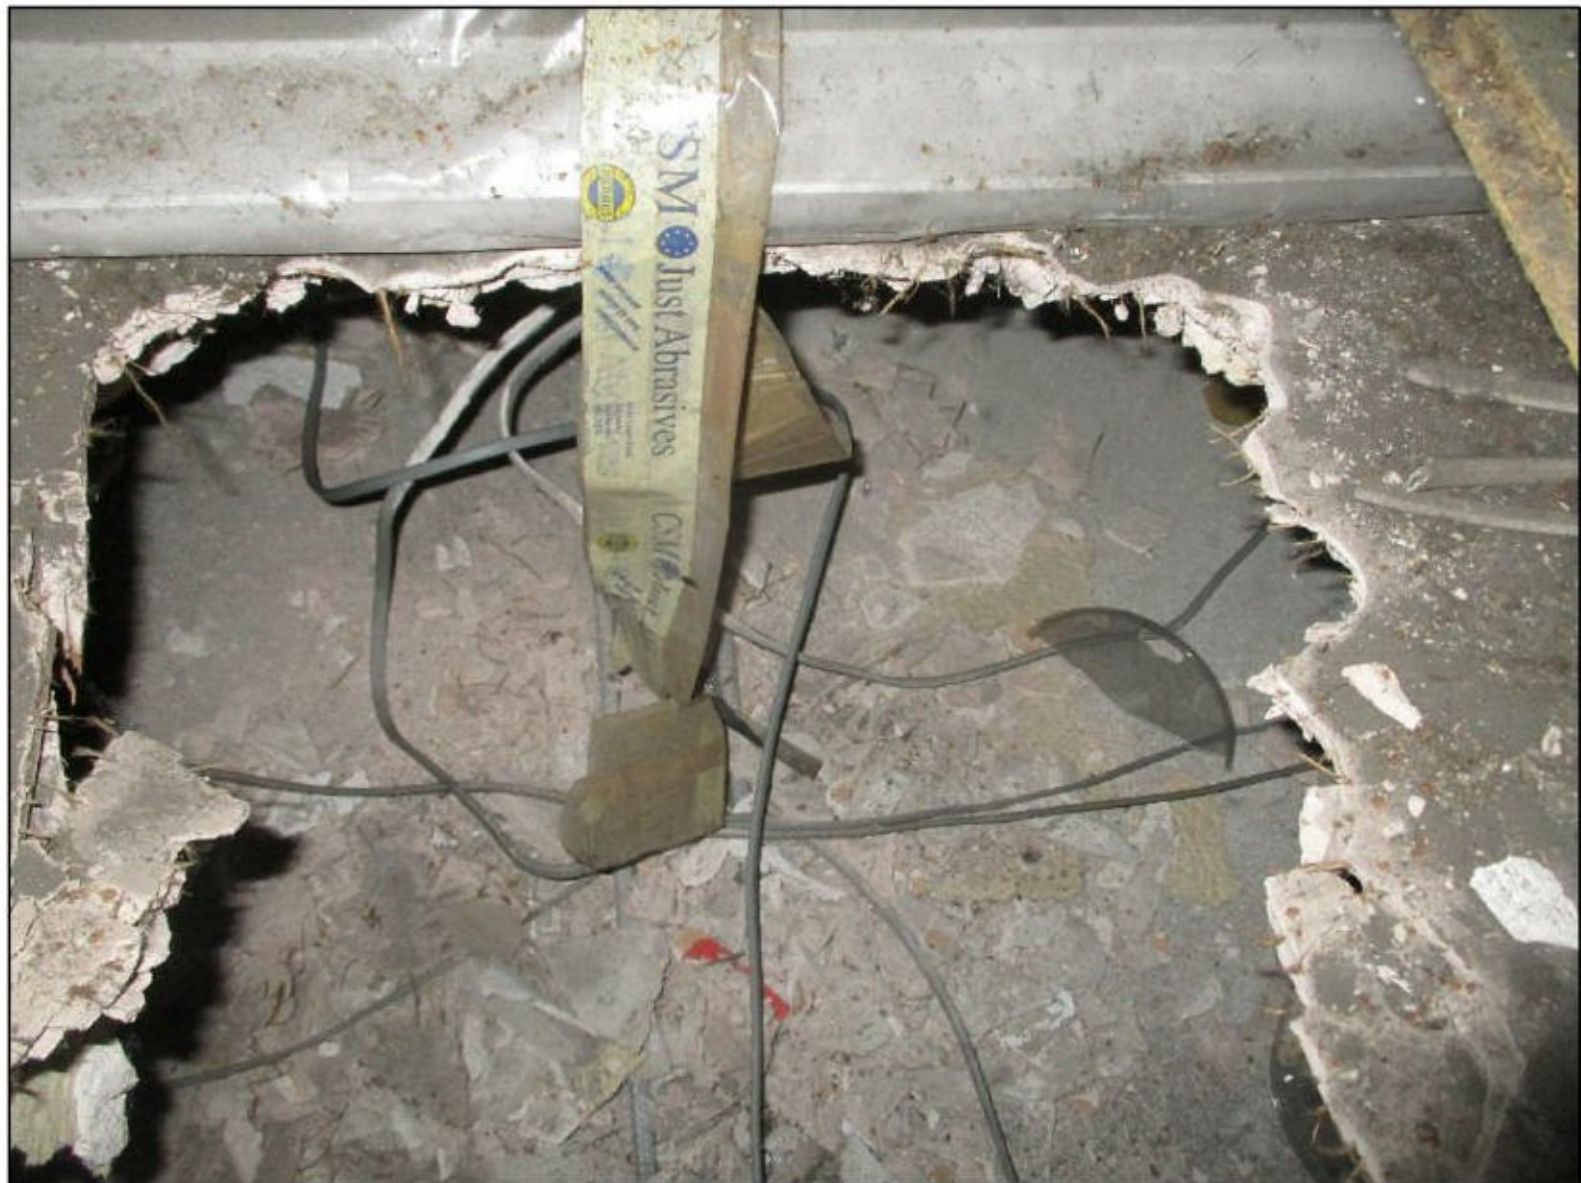
<b>SAMPLE REF.</b>	N/A
<b>PHOTO NO.</b>	Twenty
<b>DESCRIPTION</b>	Roof space
<b>LOCATION</b>	General picture, holes cut into ceilings at different levels to support first floor grid and new ceiling
<b>FLOOR</b>	Loft
<b>COMMENTS</b>	Asbestos has been detected within the void between the roof/loft space and first floor ceilings
<b>EXTENT</b>	
<b>RISK</b>	
<b>REMOVE</b>	
<b>REGULATION</b>

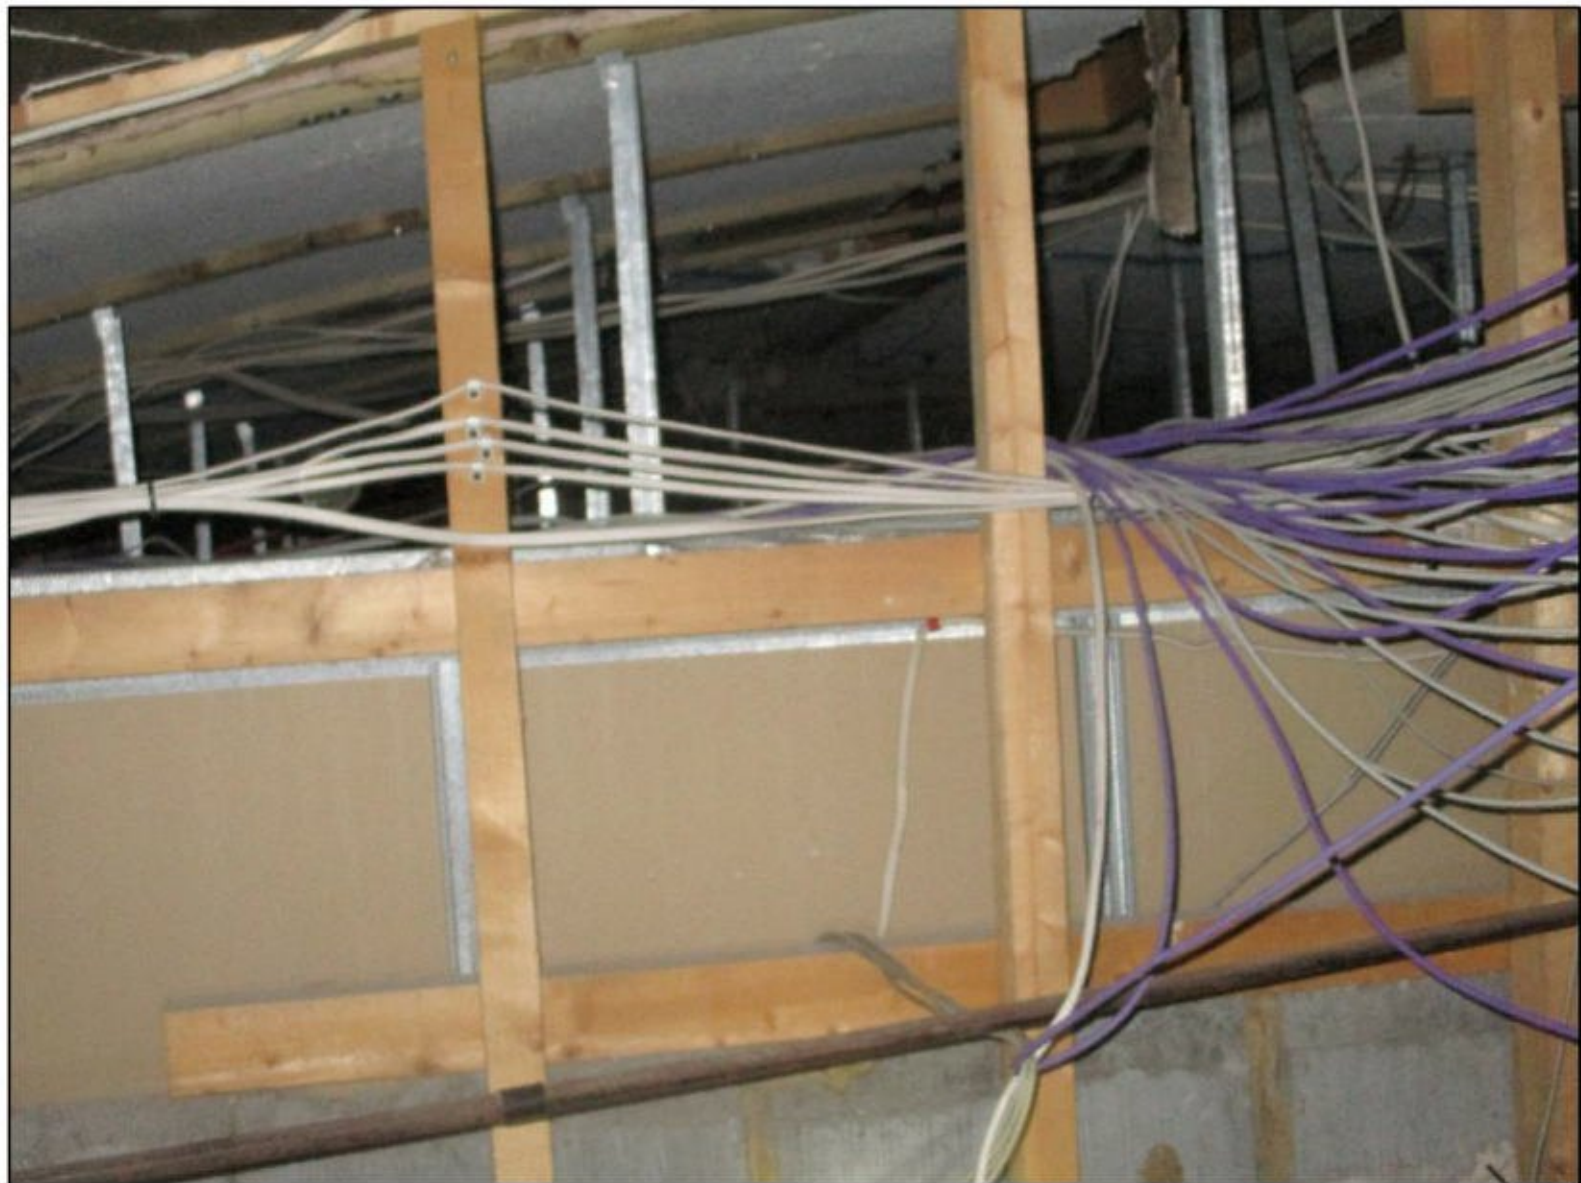
<b>SAMPLE REF.</b>	N/A
<b>PHOTO NO.</b>	Twenty one
<b>DESCRIPTION</b>	Roof space
<b>LOCATION</b>	General picture, Ceiling void of different levels. New ceilings fitted into original ceiling on hanging grid.
<b>FLOOR</b>	Loft
<b>COMMENTS</b>	Asbestos has been detected within the void between the roof/loft space and first floor ceilings
<b>EXTENT</b>	
<b>RISK</b>	
<b>REMOVE</b>	
<b>REGULATION</b>

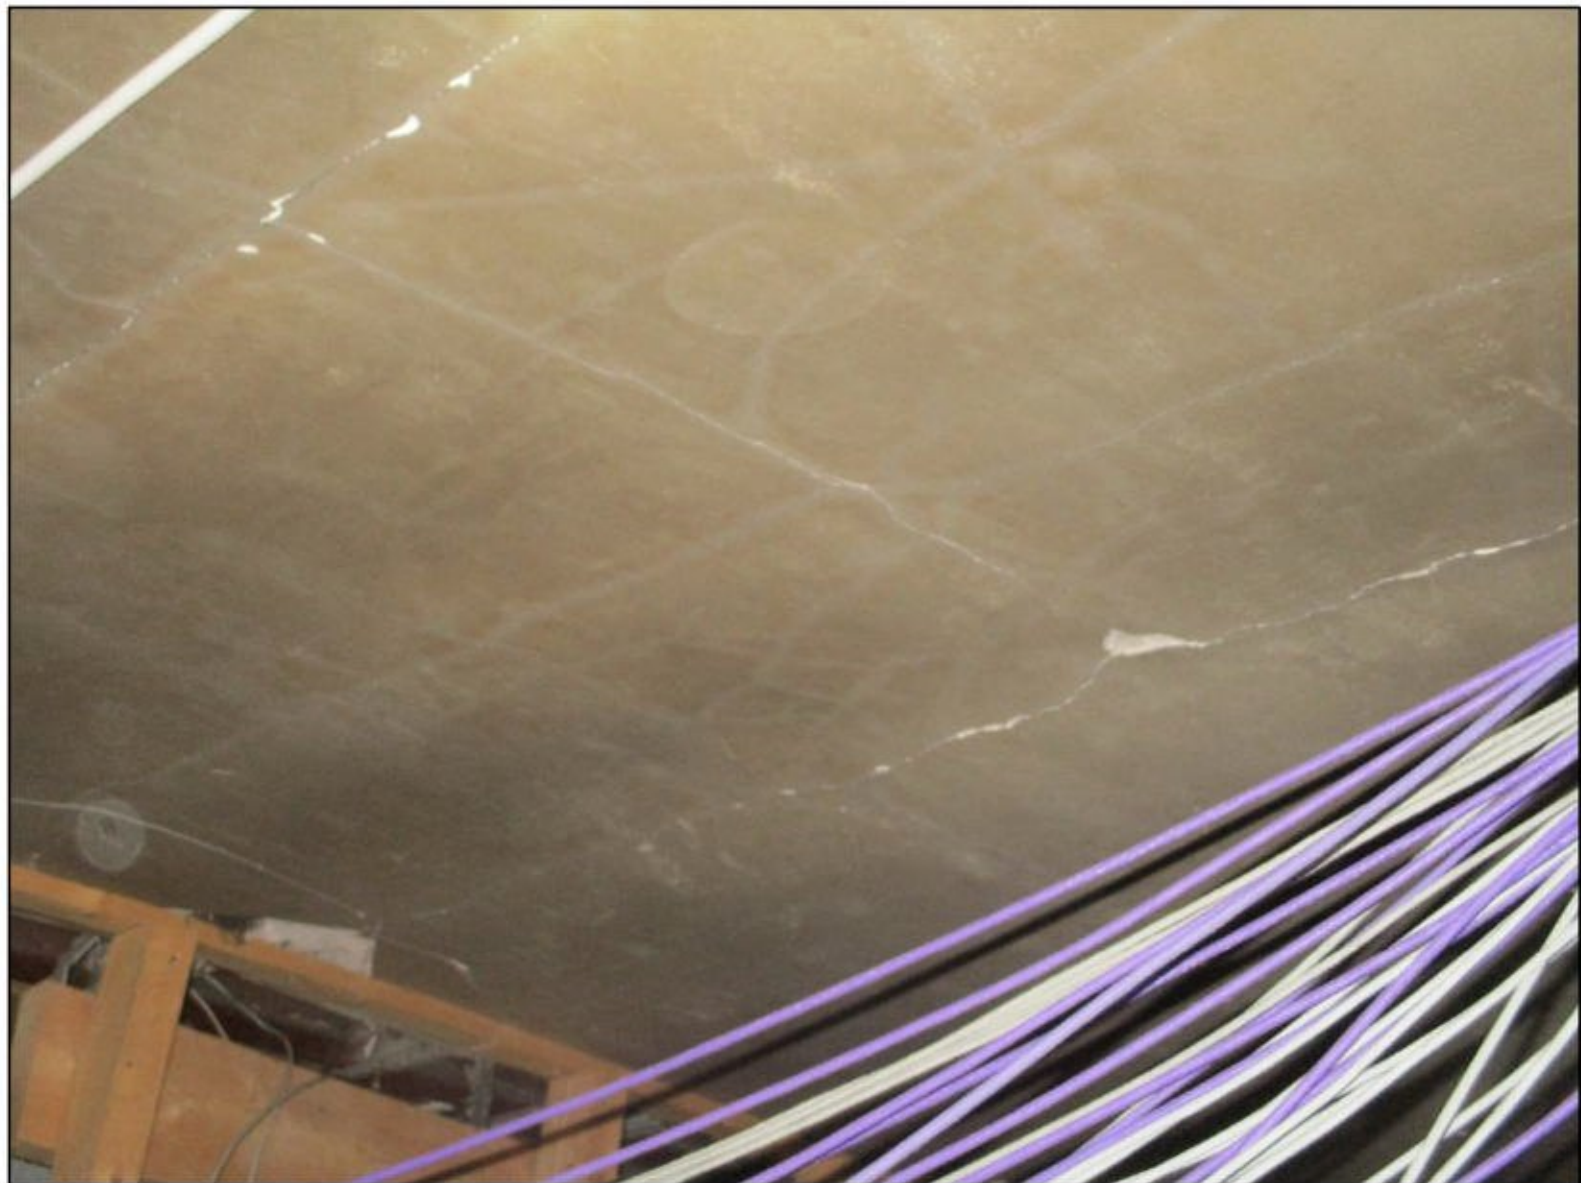
<b>SAMPLE REF.</b>	N/A
<b>PHOTO NO.</b>	Twenty two
<b>DESCRIPTION</b>	Roof space
<b>LOCATION</b>	General picture, Ceiling void of different levels. Camera view, no safe access to inspect.
<b>FLOOR</b>	Loft
<b>COMMENTS</b>	Asbestos has been detected within the void between the roof/loft space and first floor ceilings
<b>EXTENT</b>	
<b>RISK</b>	
<b>REMOVE</b>	
<b>REGULATION</b>
