**LIMITED / PART / R & D SURVEY  
PRE-DEMOLITION OR MAJOR WORK ASBESTOS SURVEY AT  
86 THE BROADWAY  
MILL HILL  
LONDON  
NW7 3TD**

**SURVEY NUMBER: SUR 3038/03/03/21**

## ASBESTOS REPORT FOR ATHENE HOUSE, MILL HILL

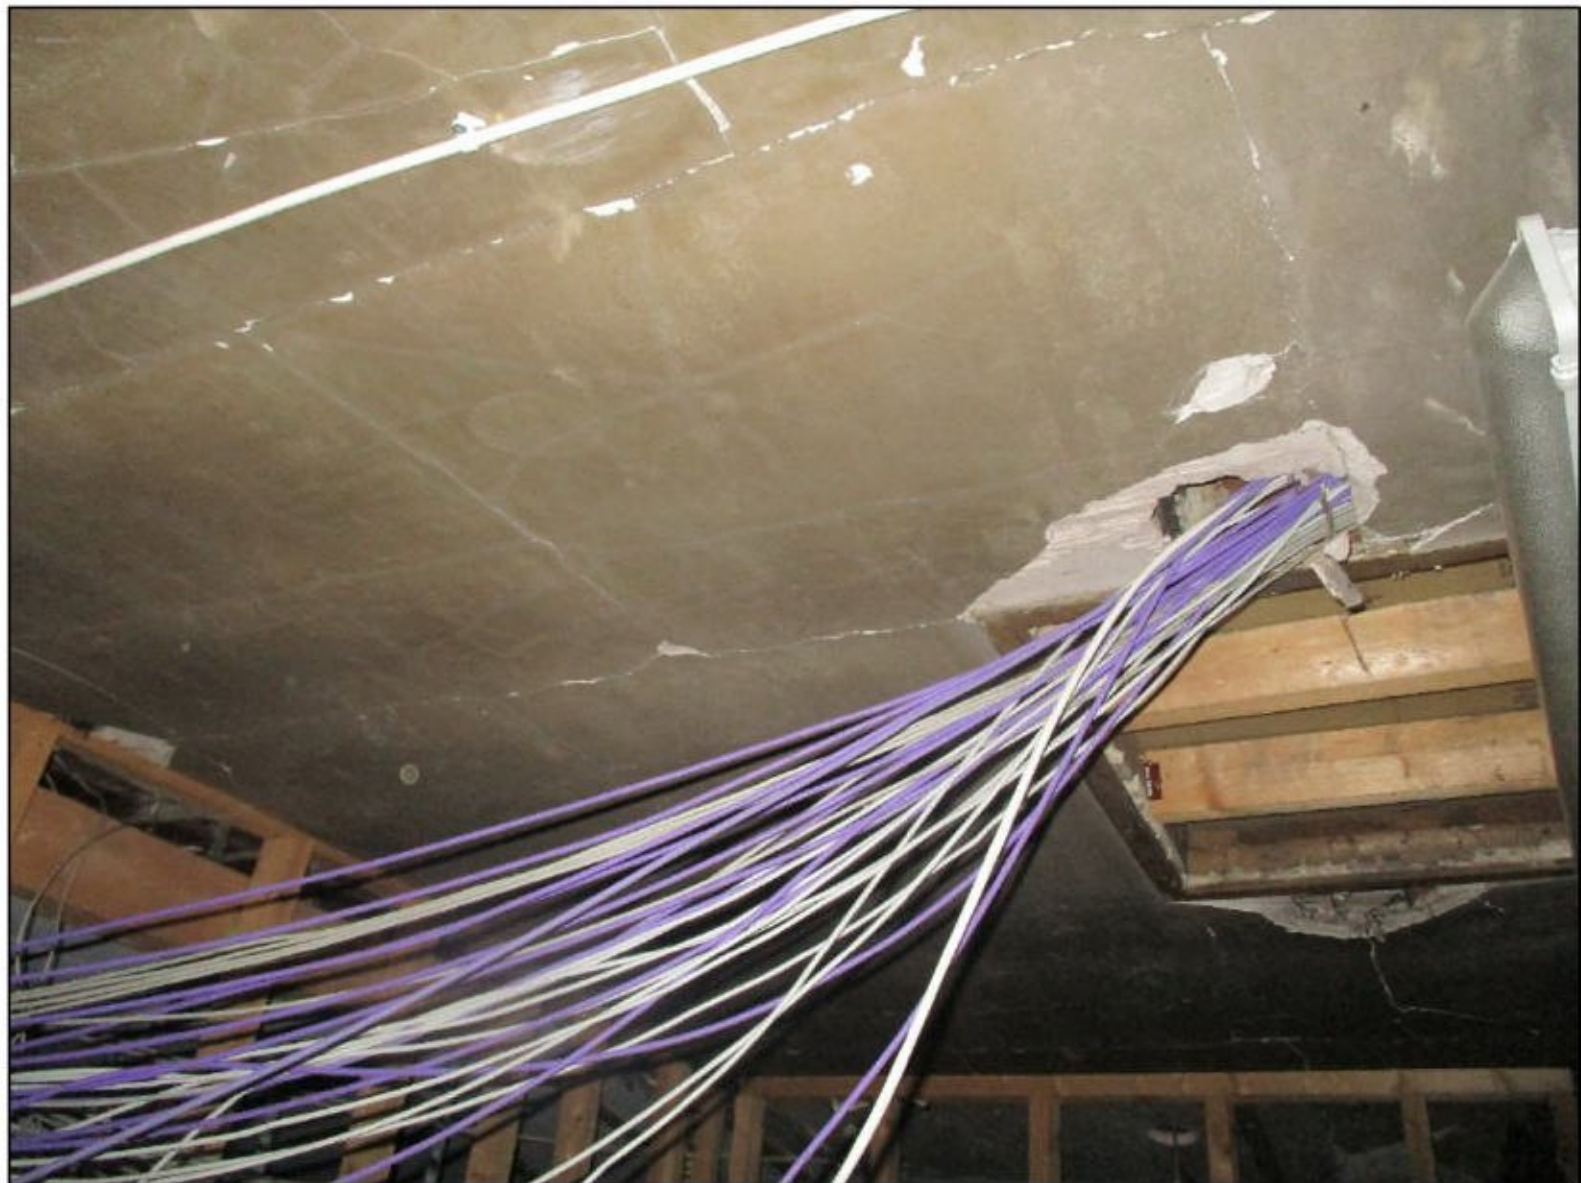
<b>SAMPLE REF.</b>	N/A
<b>PHOTO NO.</b>	Twenty three
<b>DESCRIPTION</b>	Roof space
<b>LOCATION</b>	General picture, Ceiling void of different levels. Camera view, no safe access to inspect.
<b>FLOOR</b>	Loft
<b>COMMENTS</b>	Asbestos has been detected within the void between the roof/loft space and first floor ceilings
<b>EXTENT</b>	
<b>RISK</b>	
<b>REMOVE</b>	
<b>REGULATION</b>

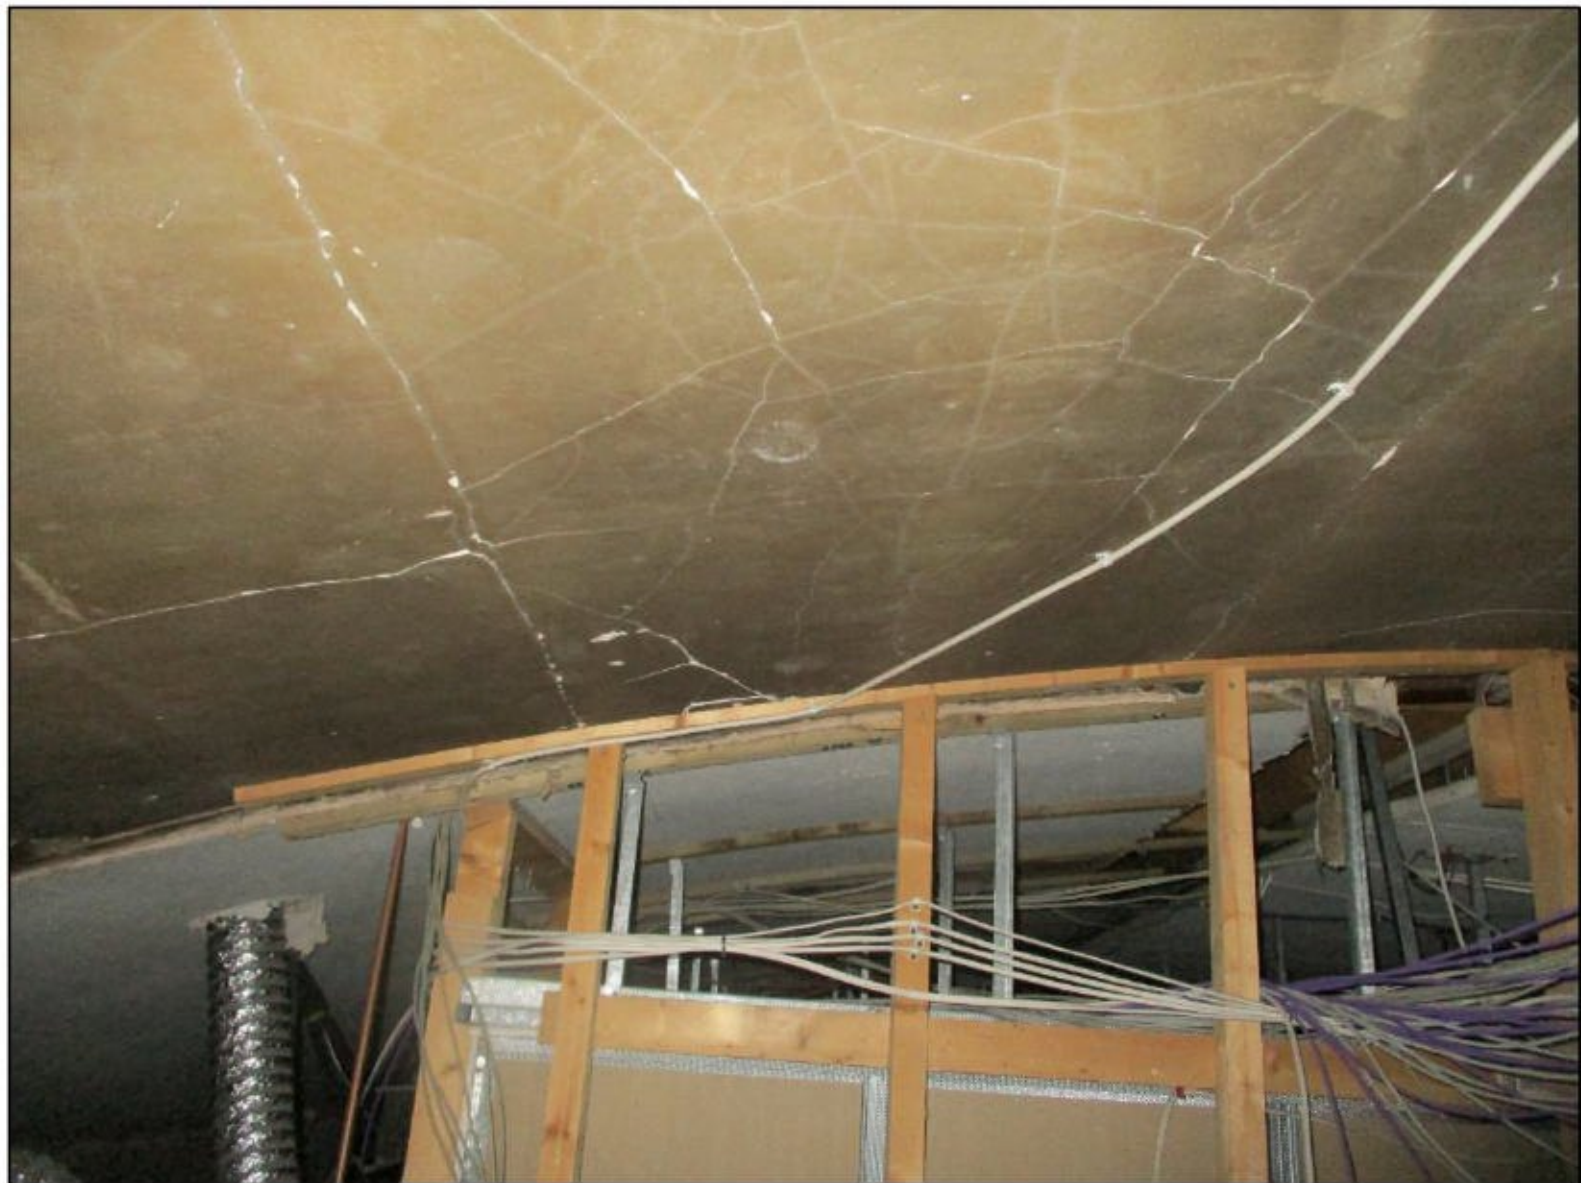
<b>SAMPLE REF.</b>	N/A
<b>PHOTO NO.</b>	Twenty four
<b>DESCRIPTION</b>	Roof space
<b>LOCATION</b>	General picture, Ceiling void of different levels. Camera view, no safe access to inspect.
<b>FLOOR</b>	Loft
<b>COMMENTS</b>	Asbestos has been detected within the void between the roof/loft space and first floor ceilings
<b>EXTENT</b>	
<b>RISK</b>	
<b>REMOVE</b>	
<b>REGULATION</b>

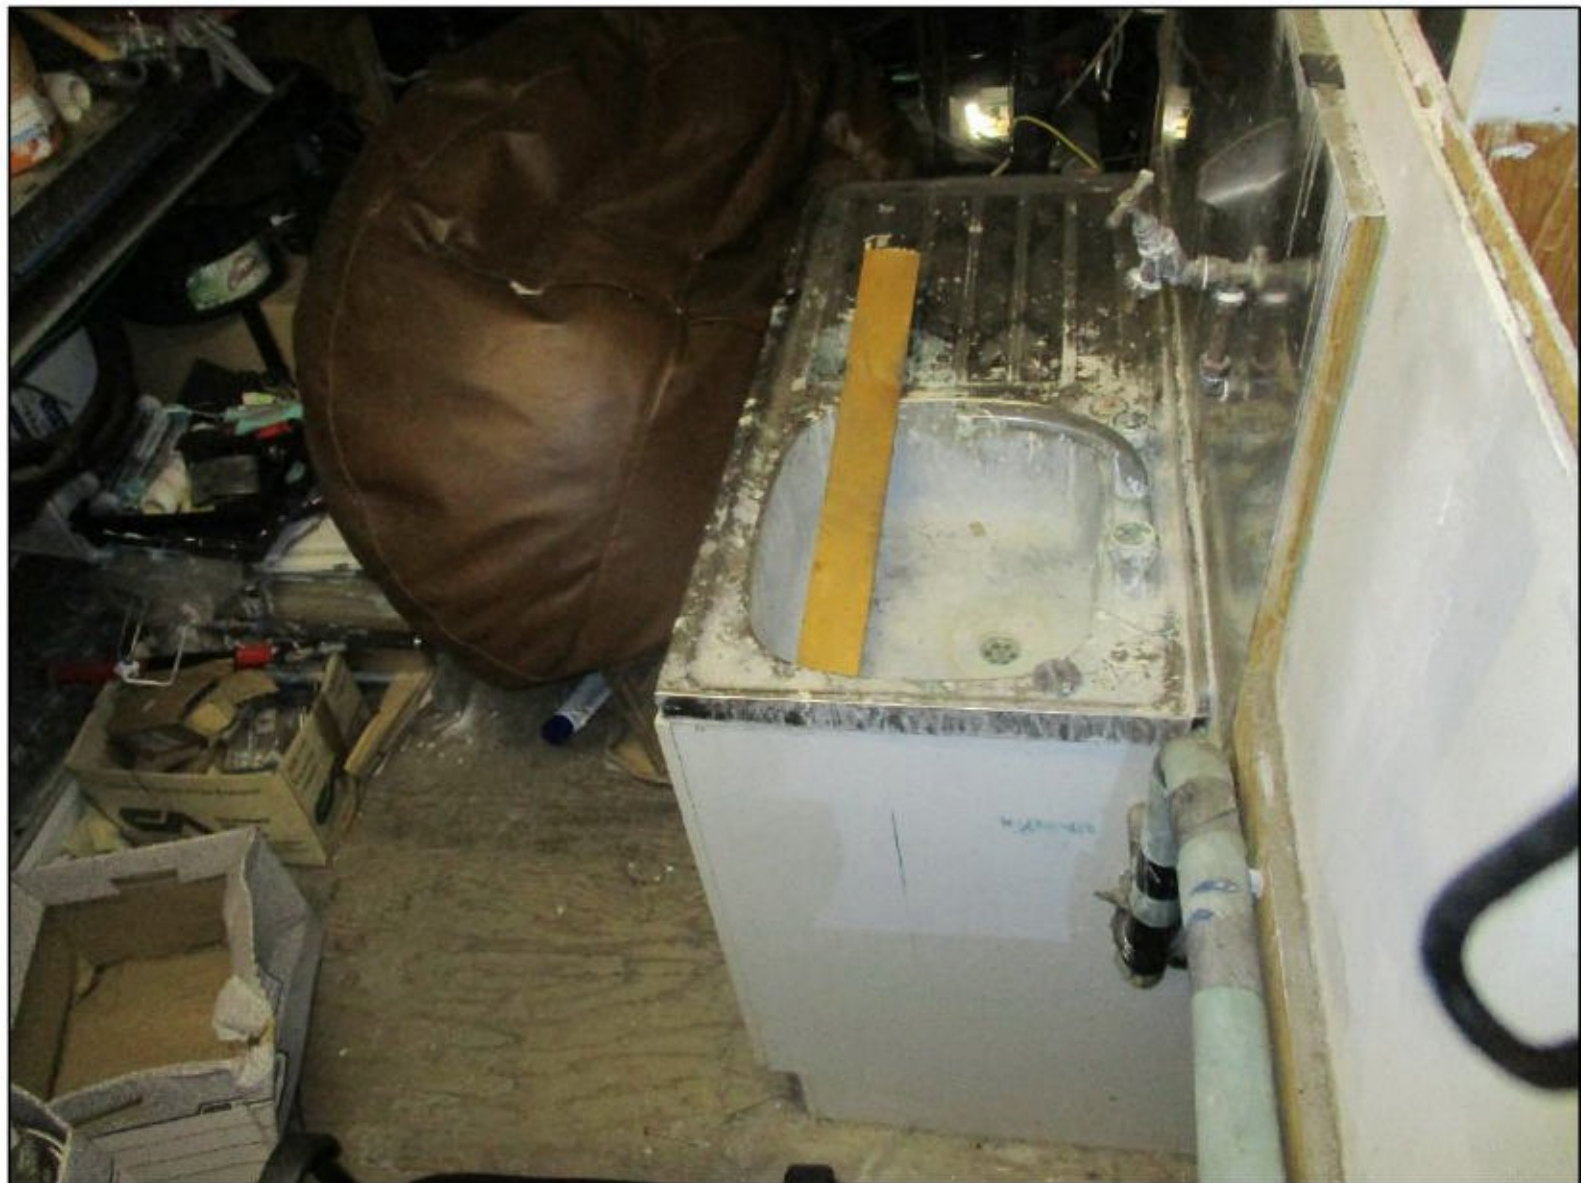
<b>SAMPLE REF.</b>	N/A
<b>PHOTO NO.</b>	Twenty five
<b>DESCRIPTION</b>	Roof space
<b>LOCATION</b>	General picture, decorators sink, lower level for camera view, no safe access to inspect.
<b>FLOOR</b>	Loft
<b>COMMENTS</b>	Asbestos has been detected within the void between the roof/loft space and first floor ceilings
<b>EXTENT</b>	
<b>RISK</b>	
<b>REMOVE</b>	
<b>REGULATION</b>

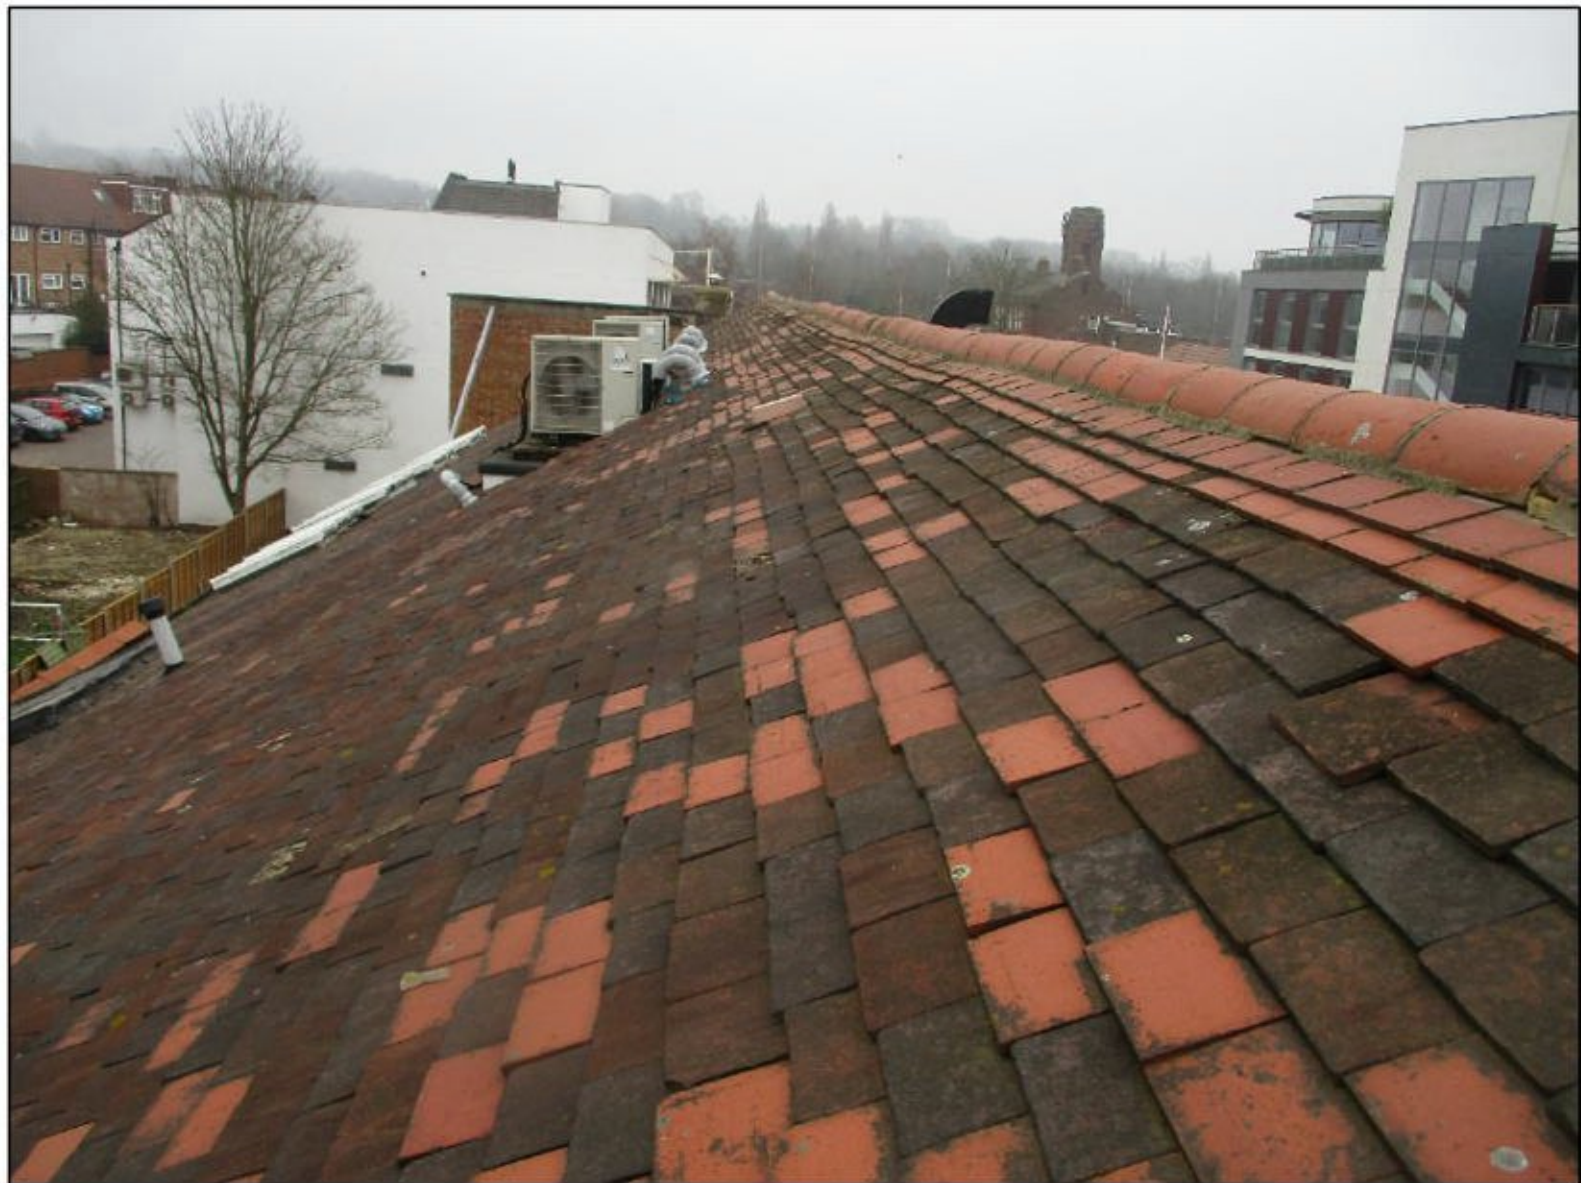
<b>SAMPLE REF.</b>	N/A
<b>PHOTO NO.</b>	Twenty six
<b>DESCRIPTION</b>	Roof
<b>LOCATION</b>	General picture – no external asbestos detected.
<b>FLOOR</b>	Roof
<b>COMMENTS</b>	
<b>EXTENT</b>	
<b>RISK</b>	
<b>REMOVE</b>	
<b>REGULATION</b>

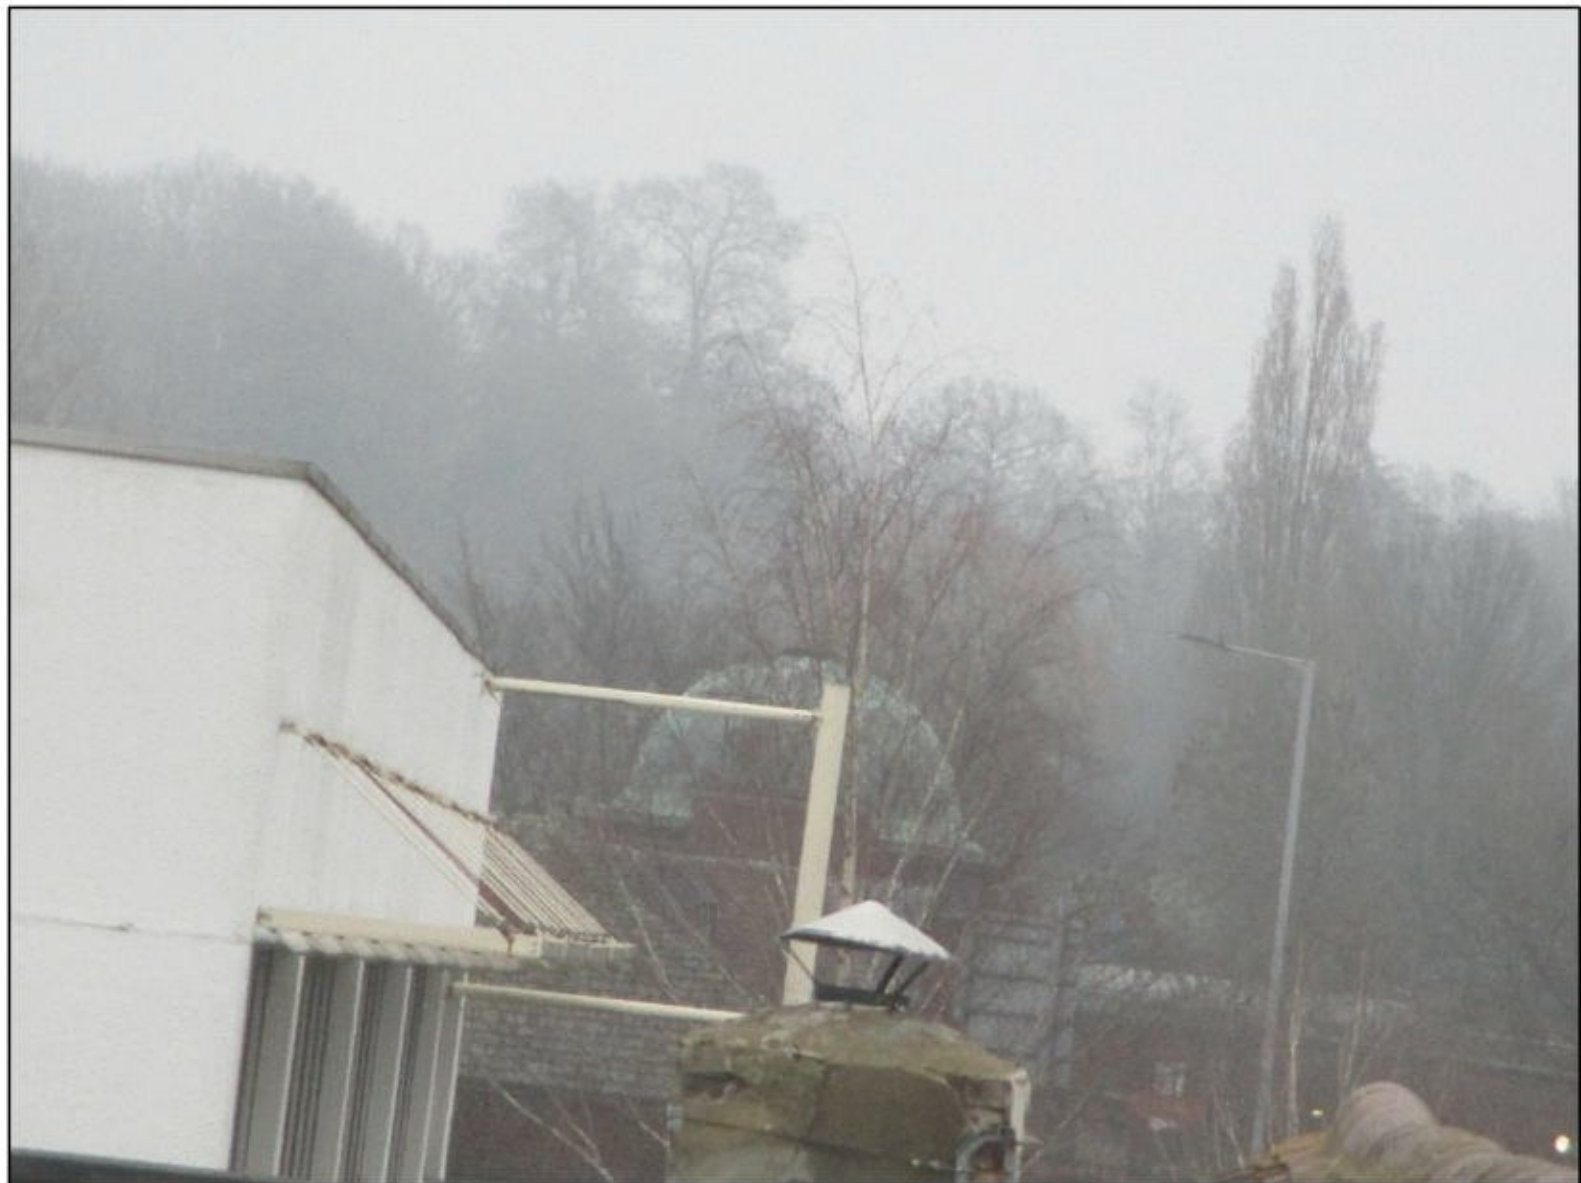
<b>SAMPLE REF.</b>	N/A
<b>PHOTO NO.</b>	Twenty seven
<b>DESCRIPTION</b>	Roof
<b>LOCATION</b>	General picture – stack and metal cowl, no external asbestos detected.
<b>FLOOR</b>	Roof
<b>COMMENTS</b>	
<b>EXTENT</b>	
<b>RISK</b>	
<b>REMOVE</b>	
<b>REGULATION</b>

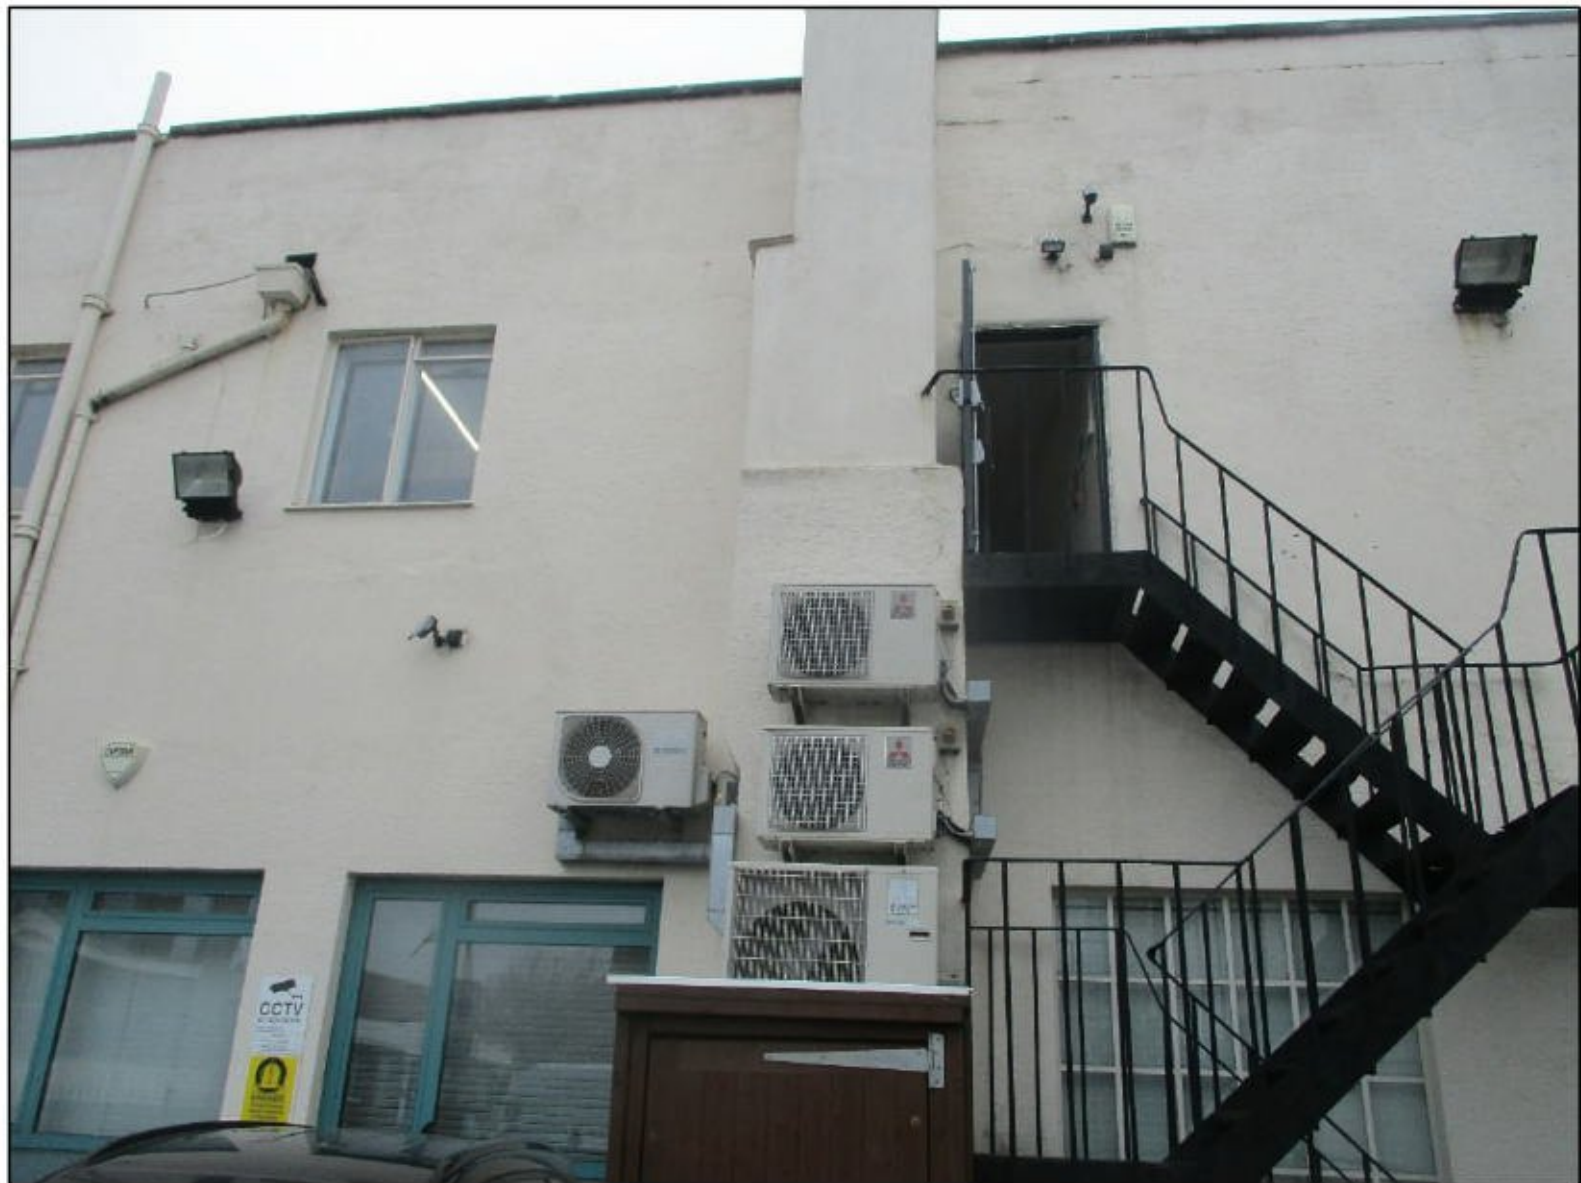
<b>SAMPLE REF.</b>	N/A
<b>PHOTO NO.</b>	Twenty eight
<b>DESCRIPTION</b>	External
<b>LOCATION</b>	General picture – no external asbestos detected.
<b>FLOOR</b>	All
<b>COMMENTS</b>	
<b>EXTENT</b>	
<b>RISK</b>	
<b>REMOVE</b>	
<b>REGULATION</b>

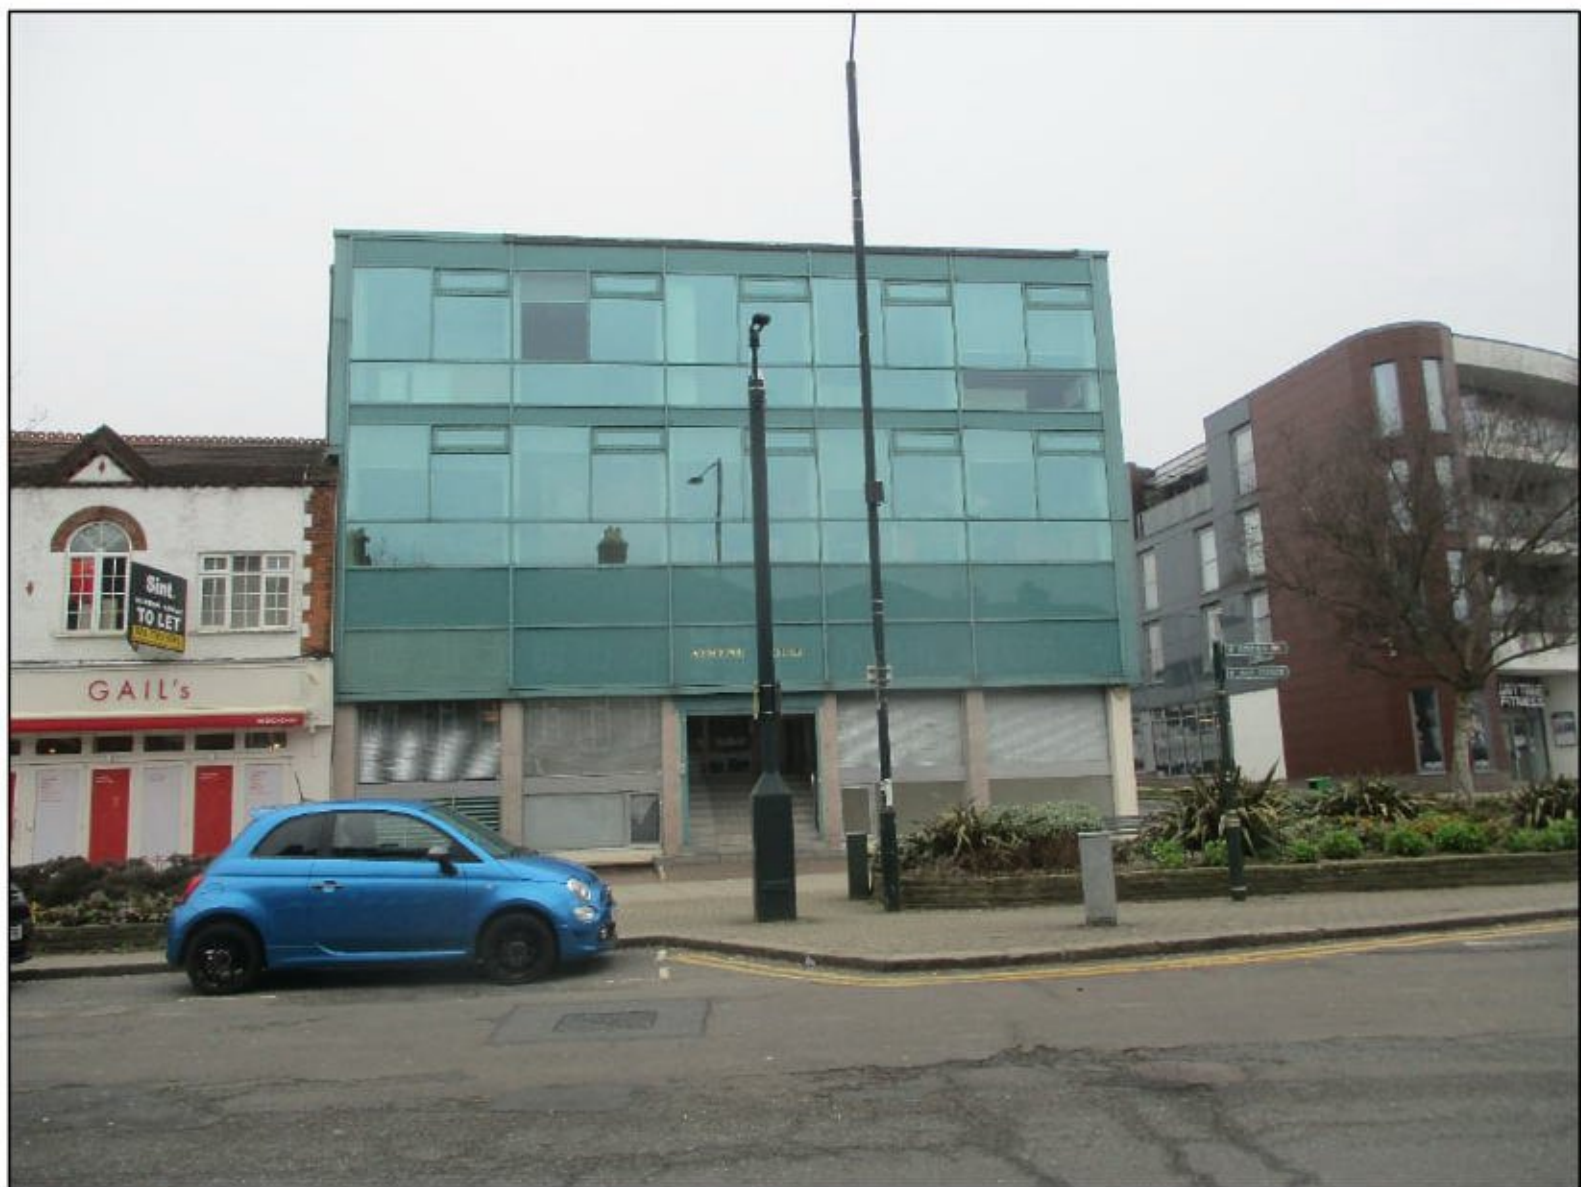
<b>SAMPLE REF.</b>	N/A
<b>PHOTO NO.</b>	Twenty nine
<b>DESCRIPTION</b>	External
<b>LOCATION</b>	General picture – no external asbestos detected.
<b>FLOOR</b>	All
<b>COMMENTS</b>	
<b>EXTENT</b>	
<b>RISK</b>	
<b>REMOVE</b>	
<b>REGULATION</b>
