**Structural Appraisal Report**  
**on**  
**Proposed Renovation**  
**of**  
**The Royal Oak,**  
**Monk Soham IP13 7EX**

Project No : **G050**

Date : **20th February 2021**

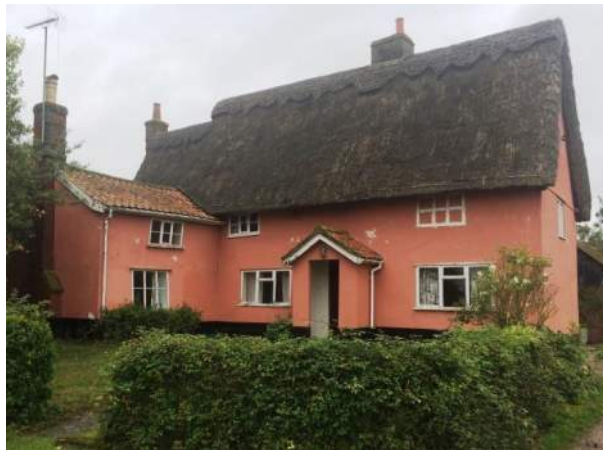
**Fig 1 – The Royal Oak, viewed from front garden area.  
Also showing small one and a half storey wing off left-hand end**

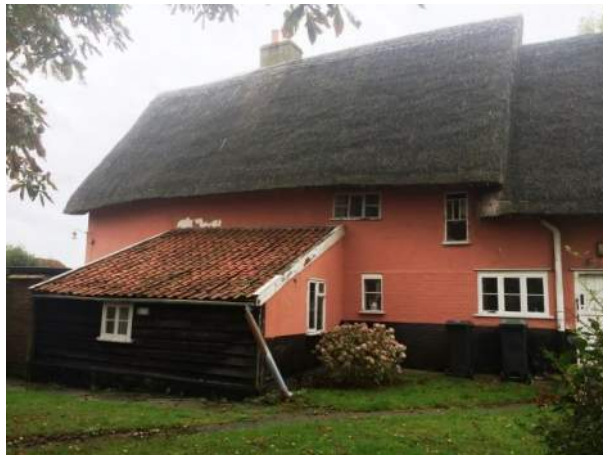
**Fig 2 – The Royal Oak, viewed from rear garden.  
Showing single storey lean-to rear store**

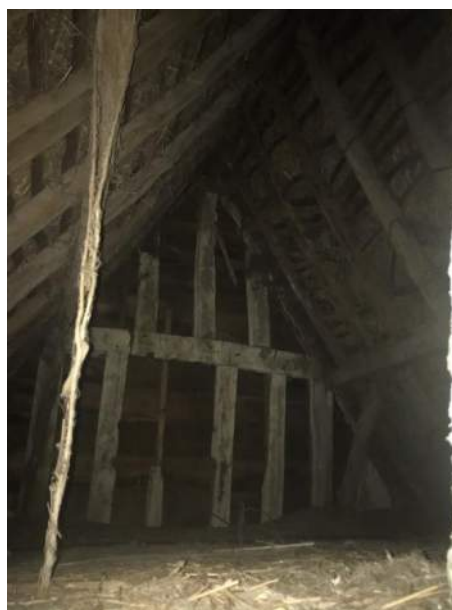
The main roof structure has not been fully inspected as safe access is not yet available, however a visual inspection through the loft hatch revealed one of the knee braces to the main roof purlin at the gable end wall to be broken/displaced.

**Fig 3 – View of timber roof structure**

- ii) The timber roof structure should be inspected when safe access is available and again should also be inspected by a timber preservation specialist to determine the scope of any treatments against insect attack. The broken/displaced knee brace to the longitudinal rear mid-height roof purlin will need to be reinstated.

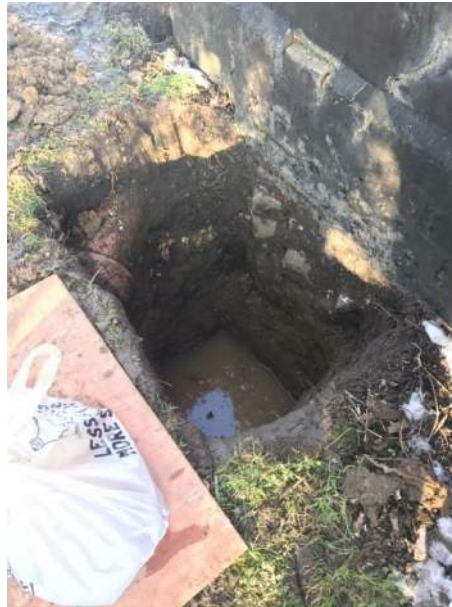
**Fig 4 – Trial Pit No1**

noted that the sub-soil in trial pit No3 contained a much higher sand content, compared with the sub-soil in trial pits Nos 1 and 2. The foundations in all cases were found to be relatively shallow by modern standards, but of a traditional brick and lime bound cobble from, typical for buildings of the period when constructed.

The 3No trial pits excavated revealed the existing foundations to be relatively shallow, founded in Lowestoft Formation (Glacial Till) in all cases. Whilst this material is generally considered to be suitable material to support foundations, it is by its nature a cohesive material which can be subject to volume change with variations in moisture content. Trees and shrubs will draw water from the ground and their water demand is dependent on their species. Trees/shrubs fall into HIGH, MEDIUM or LOW water demand categories. The volume change potential will vary depending on the physical makeup of the Glacial Till and Geotechnical laboratory testing is used to determine whether the volume change potential is classed as HIGH, MEDIUM or LOW. Samples of the ground are currently undergoing Geotechnical testing to determine the shrinkage potential.

- vi) All new foundations and substructures must acknowledge the underlying ground conditions in conjunction with the presence of the existing trees in close proximity to the property. The depths of the new foundations should be designed acknowledging the volume change potential of the Glacial Till subsoil.

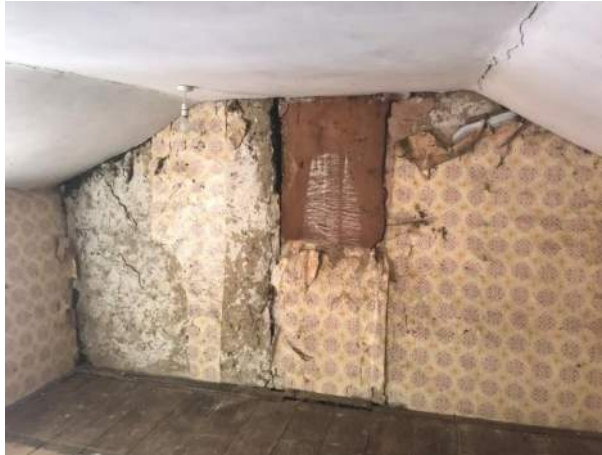
The walls are constructed as clay lump walls and the tops of the side walls have been allowed to lean outwards, which in turn has allowed the raised collar roof to spread at eaves wall plate level. The magnitude of the lean is beyond that which can be considered as safe or repairable. A brickwork chimney structure is present within the centre of the gable end clay lump wall. The chimney is possibly a later addition within the clay lump wall. The clay lump wall has become fully detached from the chimney brickwork, where clear separation can be seen and this loss of integrity has in turn led to the promotion of a significant full height vertical crack at the junction between the gable end wall and the side walls. The structural integrity of the clay lump walls has therefore been significantly compromised. The first floor to this section of the building also exhibits a 'springy' feel when walking across the floor. This is very likely due to the bearing of the floor joist having been compromised by the wall movements previously described. This part of the building will need a significant structural intervention if it is to be part of the overall renovation of the property. Consideration should be given to the full demolition and re-building of this part of the building.

**Fig 7 – Internal view of clay lump gable end wall with central brick chimney, also showing cracking due to spreading of roof structure and outwards leaning side walls**

- v) It is the opinion of this report that the structural condition of the one and a half storey front wing is beyond that which can be repaired and consideration must be given to its demolition and rebuilding.

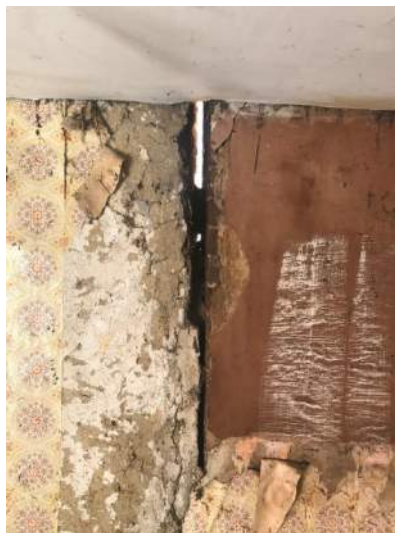
**Fig 8 – Internal view of separation of clay lump gable end wall away from central brick chimney, with daylight clearly visible through significant cracking**

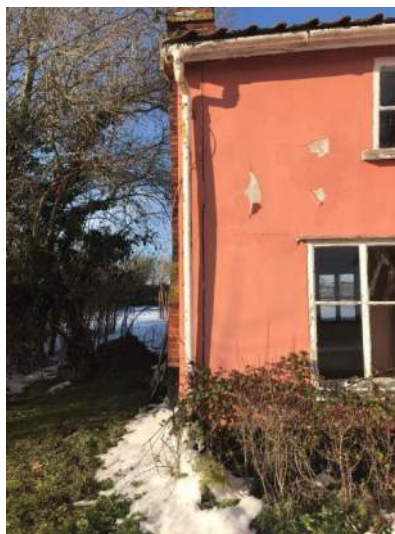
**Fig 9 – External view of full height crack separation of clay lump gable end and side wall**

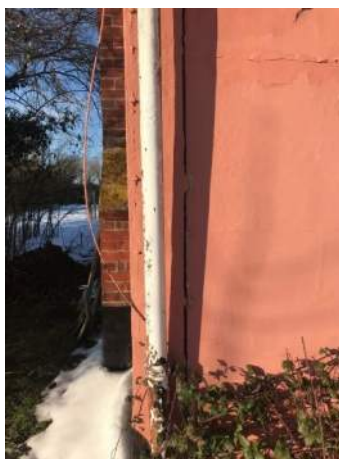
**Fig 10 – Close-up of full height crack separation of clay lump gable end and side wall**
