## WORKS TO THE ROYAL OAK, MONK SOHAM

### WINDOW SCHEDULE

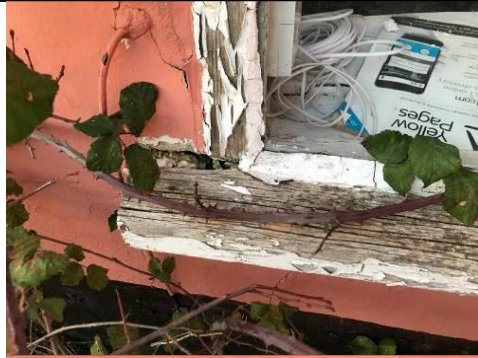
Ground Floor	
Kitchen east  	Overall in good condition, C19, well detailed with monkey tail ironmongery. Small amount of local repair to leftmost casement and cill. Repair and redecorate.
Bathroom north  	C20, Modern window with deterioration to cill and casements, replace with sympathetic detailed casement with slimlite glazing
Study north  	Overall in good condition, well detailed C19, with monkey tail ironmongery. Small amount of local repair required. Repair and redecorate.
Study south

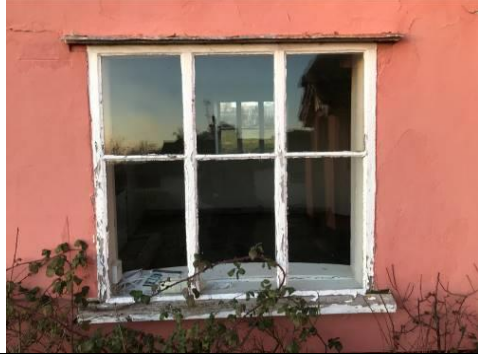
Overall in good condition, uniquely proportioned window. C19. Cill in poor condition. Replace cill, repair and redecorate.

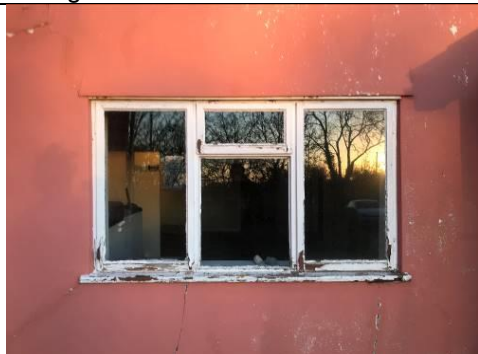
Dining room west

Modern window midC20 with deterioration to cill and casements, replace with sympathetic detailed casement with slimlite glazing

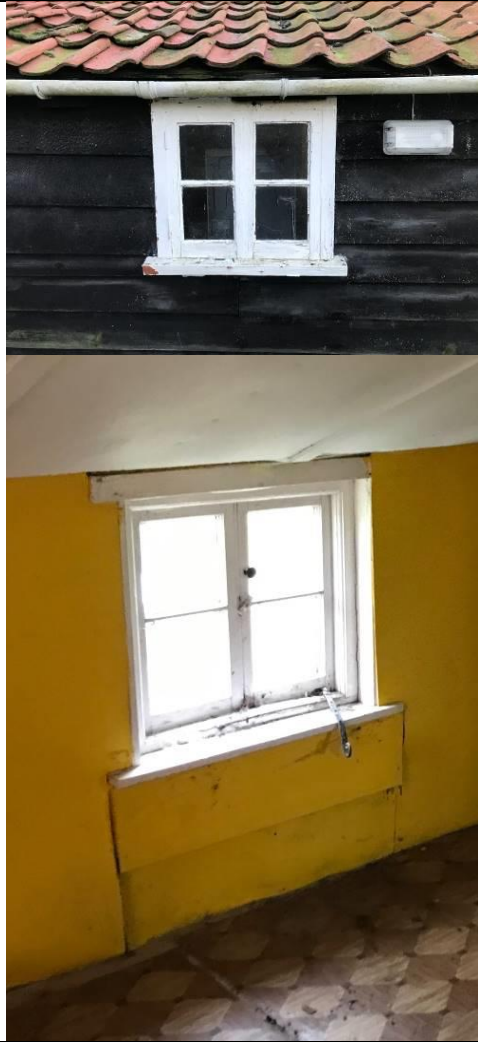
<p>Lean-to store east</p>

Smaller traditional C19 casement at low level, deterioration to frame, monkey tail stay, other ironmongery replaced with C20 knob and latch. Window to be removed, retain monkey tail stay for use elsewhere.

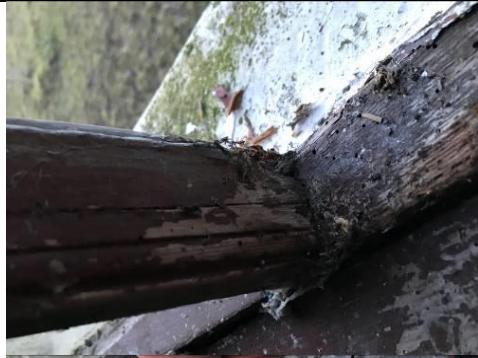
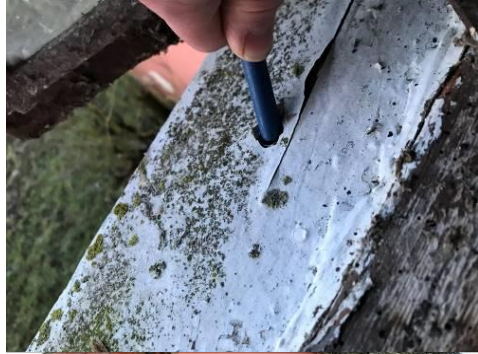
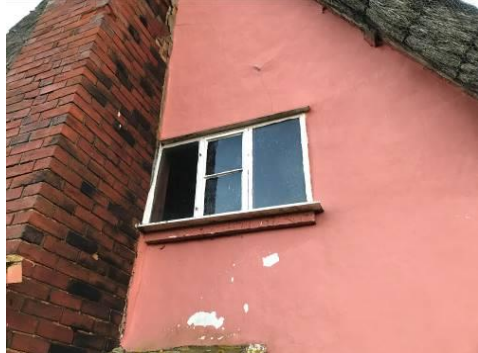
<b>First Floor</b>	
Bed 1 north

C19 3 light casement, in very poor condition to cill, frame, mullions and base of casement. Replace with sympathetically detailed slimlite 3 light casement.

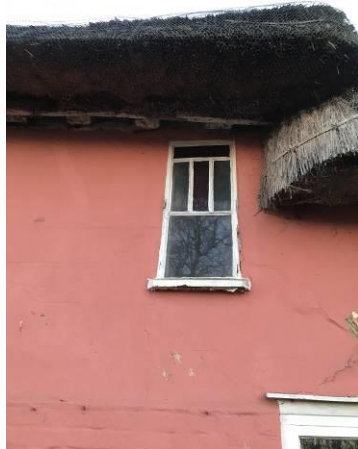
Stairwell east

Coloured glass fixed window to stair, to be repaired and redecorated.

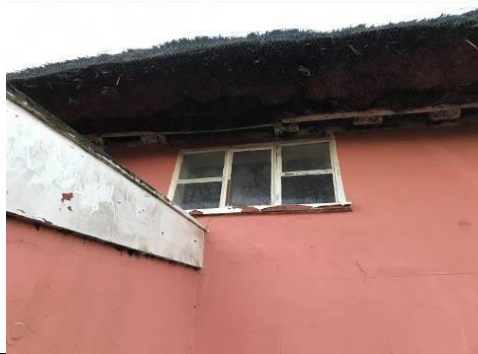
Upstairs lounge east

C19 3 light casement window. In Ok condition, to be repaired and redecorated.

Exploration of internal cill and head to see if original diamond mullion mortise holes are present.

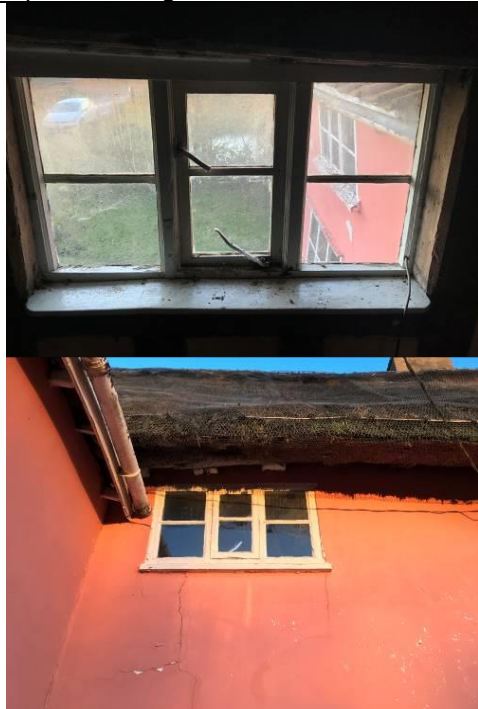
Upstairs lounge west

C19 3 light casement window. In Ok condition, to be repaired and redecorated.

Diamond mullion mortice holes present to head to be left on show.

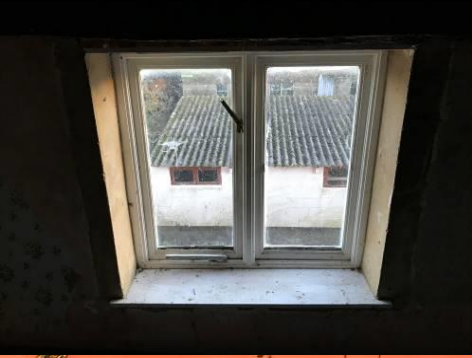
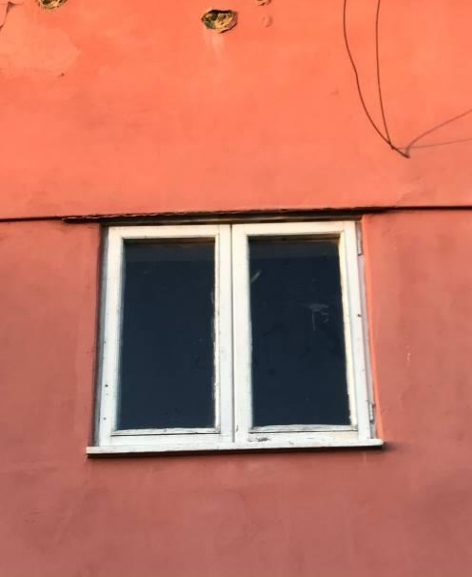
Bed 2 south

Modern window, midC20 replace with sympathetic detailed casement with slimlite glazing

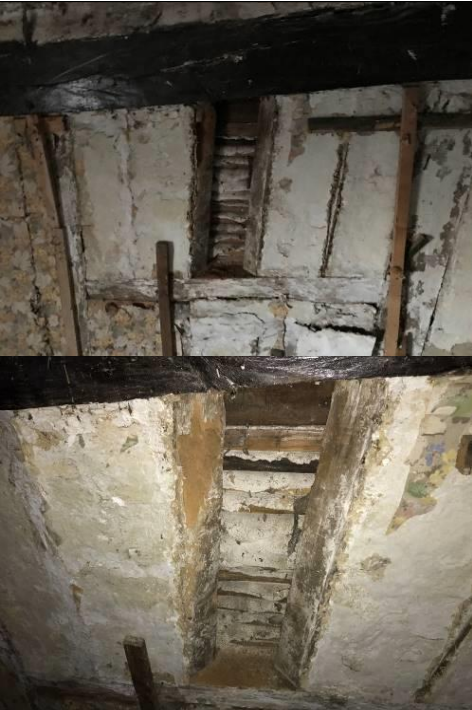
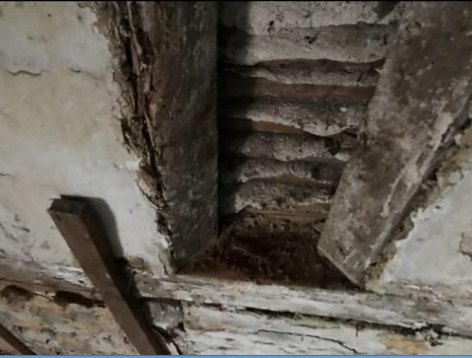
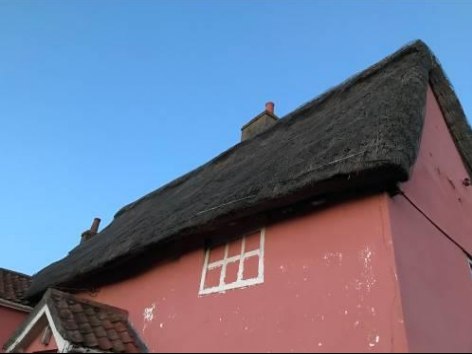
Bed 2 west

Original C16 diamond mullion window present within frame, previously infilled with a lime mortar and lime render externally. Later rendered over with cement based render and covered internally with hardboard. High historic value to the dwelling and area. The mullions have suffered wood worm damage potentially due to the cement render and linings.

Infill sections to be removed and condition of mullions assessed and conserved through sympathetic repair. Window to be exposed and new slimlite glazed casement installed externally. 3no casements to line up with mullions.

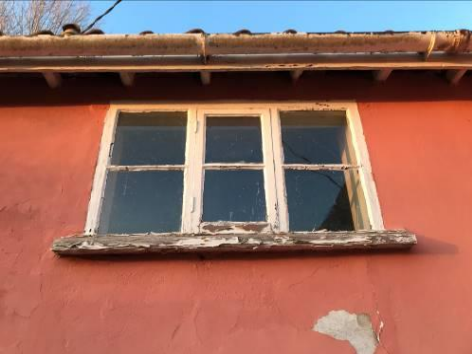
Bed 3 south

Cill and base of casements in poor condition, window to be replaced with sympathetic detailed slimlite casement.
