4 Bladon Close - Bat Roost Assessment

I write to you in regard to the bat roost assessment conducted at 4 Bladon Close, Oxford OX2 8AD in September 2020. A preliminary roost assessment (PRA) was conducted to inform demolition of the building and construction of a replacement dwelling.

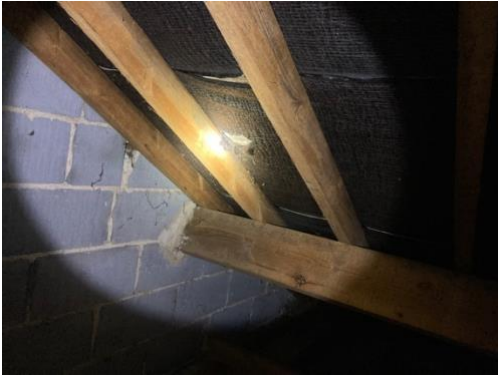
Internally there is one loft space which is c. 2.3m height to ridge and open with no loft insulation. The internal surface of the roof was felt lined with exposed structural timbers. The loft void was very clean, with no dust or detritus one would normally expect in an old building such as this. Ten fresh (< 1 month old) pipistrelle (*Pipistrellus* sp.) droppings were scattered within the loft space and three accumulations each with around 100 pipistrelle droppings were found in a dusty and tricky to access location at the south-western eaves. There are stains on the floor which could be indicative of urine staining caused by a significant colony of bats. Around ten fresh individual urine stains were noted on the small water tank. Light ingress into the loft space was observed at some areas at the eaves on the western and eastern aspect and through some areas of torn felt on the western aspect.

Photograph 1: Internal of main house

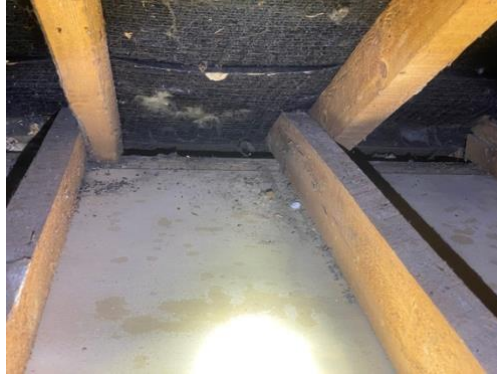
The bat roost assessment of 4 Bladon Close has concluded the loft space is a likely roost of pipistrelle bats. It is recommended that a sample of the droppings is sent off for DNA analysis to confirm the species present. Characterisation of the roost will need to be confirmed following a combination of three emergence or re-entry surveys to be conducted using three surveyors during the bat activity season: May-September.

Photograph 2: Droppings in south-west corner

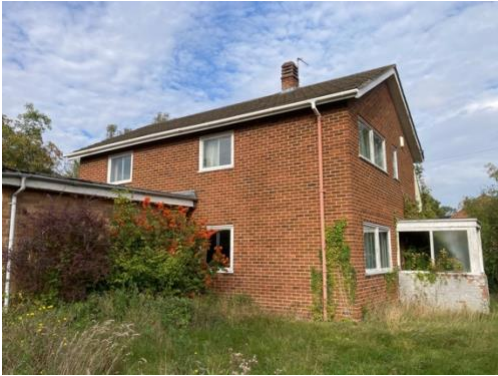
The pitched tiled roof appeared to be in good condition with no gaps of a suitable size for roosting bats noted. There were gaps beneath the eaves on the western and eastern aspect (between the wooden soffit and wall) which correlated with the light ingress observed internally. The north-western corner of the soffit also had an area of rot providing potential access.

Photograph 3: South-west of main house

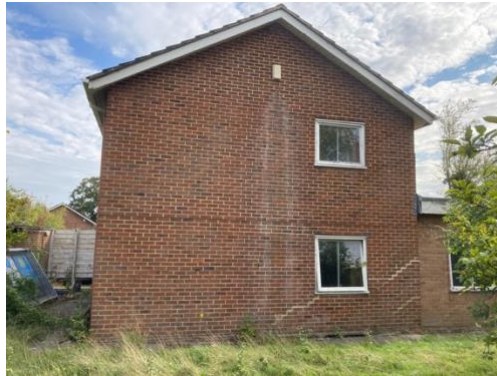
There was structural damage to the wall in the north-western corner with the bricks having shifted on the first floor such that five 7cm x 5cm gaps were present, providing direct access to the cavity wall.

Photograph 4: North of main house

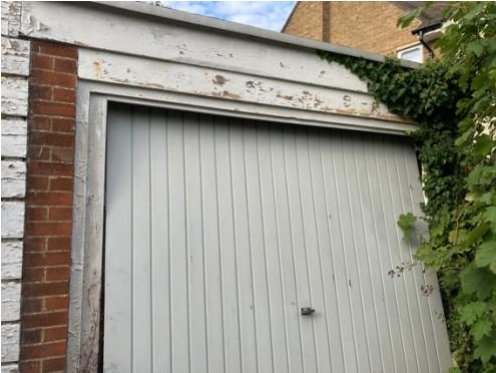
The brick garage had a felt roof in good condition. Several hibernating butterflies were present as well as high numbers of cobwebs. There was a door in the north-west which is permanently open. There was no evidence of bats internally. The building is considered to be of negligible suitability for roosting bats.

Photograph 5: External of garage

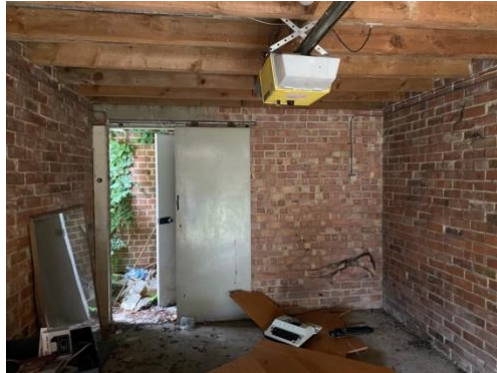
Photograph 6: Internal of garage
