**BUILDING FABRIC ANALYSIS TO ACCOMPANY
STRUCTURAL SURVEY OF OUTBUILDING**

**AT CHURCH HILL FARM, CRAGG LANE,
BLACKWELL, ALFRETON, DERBYSHIRE DE55 5HZ**

ROSAMUND NICHOLSON

MARCH 2021

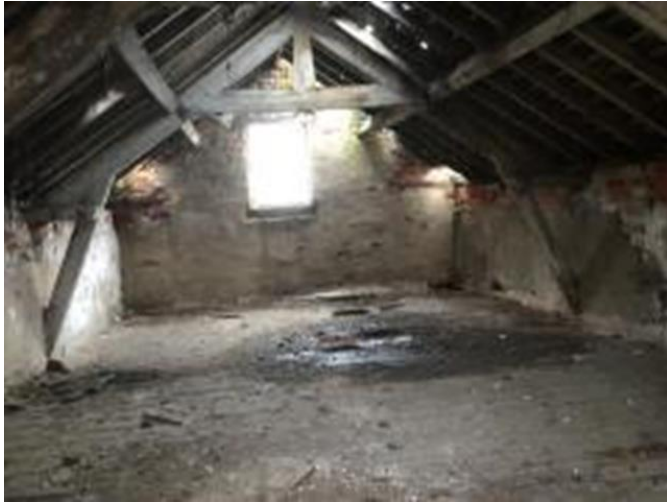
View into the first floor
'attic' room from the
entrance door

The building would need an entirely new first floor structure due to the extensive rot in the timbers.

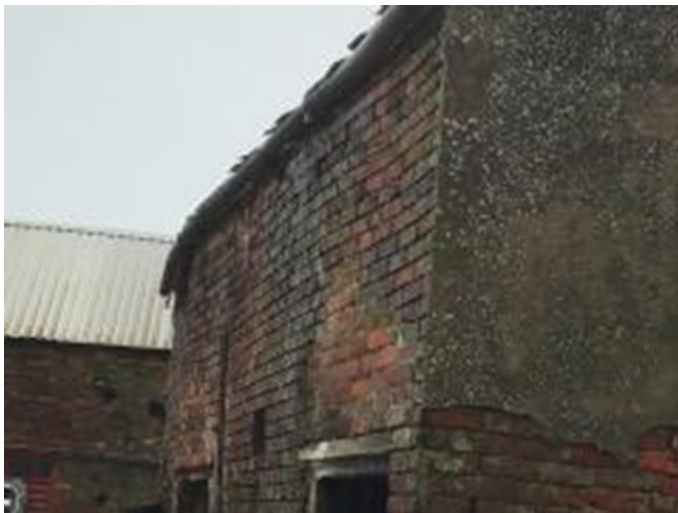
External Wall The northern wall has extensive bulging, mainly at first floor level as confirmed in the structural report. This is due to the lack of ties between the floor and wall in combination with the lack of bonding and buttressing from internal cross walls and the weakening effect of the three door openings.

View from the North-West
showing bulges and waves
in the wall

In addition, the structural engineer confirms that roof spread has contributed to the serious bowing of the wall. The type of roof trusses is those which exert pressure on what has become an unrestrained wall. The extent of this movement is best indicated by showing the large gap (140mm) which has opened up between floor and wall.

The bulging along the wall is in the form of a wave, not a single bulge.

The failure of the attic truss and the lack of tie between North-East wall and floor have caused the most significant failure of the building which is the bulging and waves of the North-East wall. This has now gone so far out of plumb that it would require the whole wall to be demolished and rebuilt.

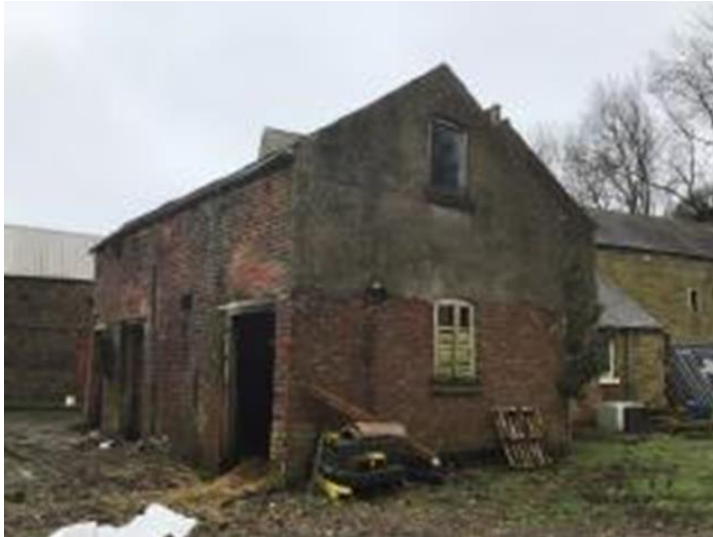
A large steel tie on the north elevation with a long vertical has been inserted to try and tie the northern and southern walls in an attempt to prevent further movement.

Photo on the left - View of the building from the North

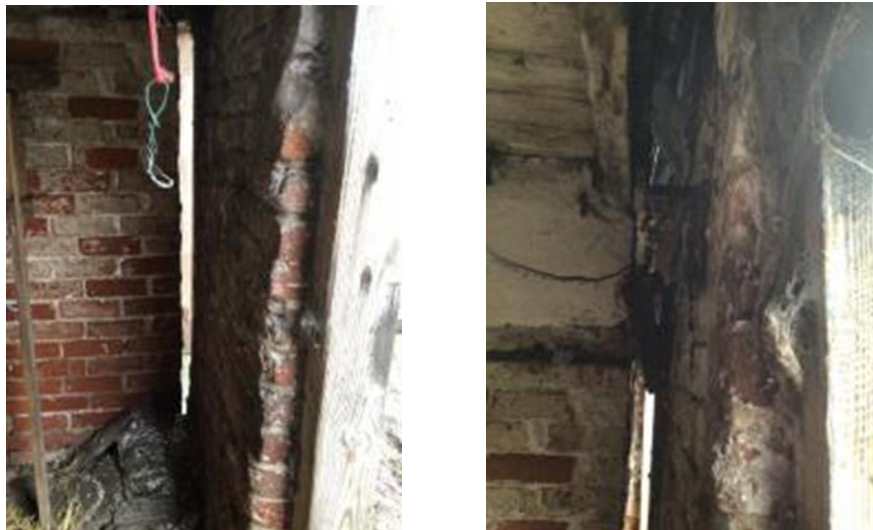
Photos below – gap between wall and internal wall showing the extent of the movement

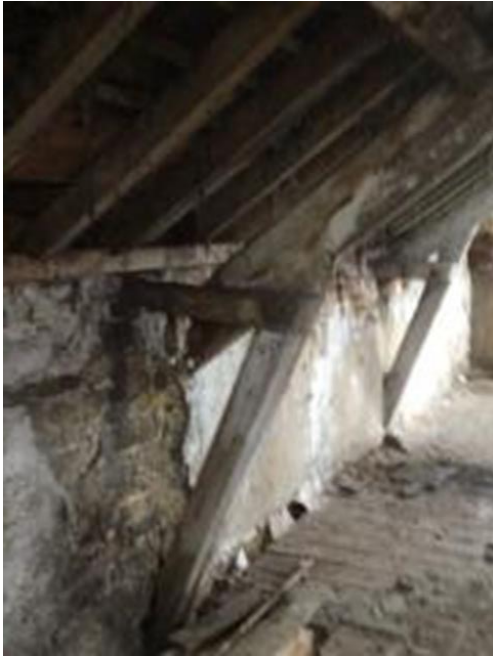
There are many slipped and missing slates to the roof which has allowed water ingress into the interior which has caused extensive rot to the roof structure and to the floor structure below. This deterioration is likely to have occurred decades ago in order to result in the failure that is present today.

The section of the truss where it meets the external wall showing damage from water ingress which has destroyed the end of the truss where it should bear onto the wall

There are two trusses. The southern truss has a significant failure to the Principal rafter. This will have contributed to the failure of the North-East wall. There is a valley gutter at the junction of roof and the adjacent wall of the two-storey previous extension to the farmhouse. This appears to have failed (a shrub can be seen growing out of the end and there is extensive damp on the adjacent wall).

The failure of the raised tie truss could be locally repaired but the roof has lost its profile and would have to be completely replaced to suit a new line of wallplate and external wall.

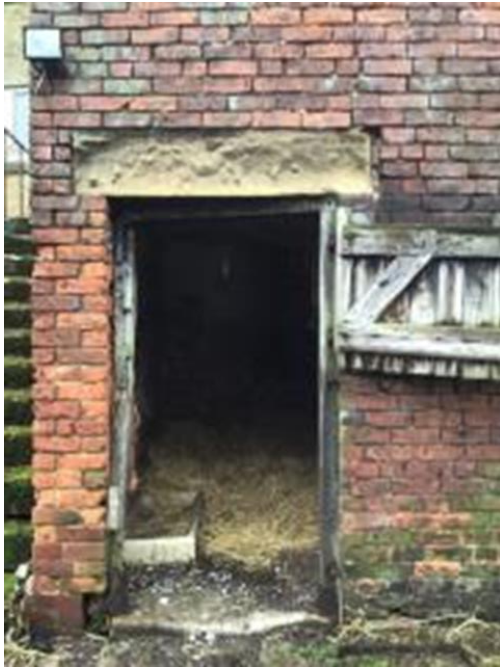
The soldier course lintels where the bricks have been laid flat to the window and door to the eastern elevation the lintels have failed and are now only partially supported by the window and door frames.

The stone lintel to the one door has severely eroded and is in poor condition. The photograph above also indicates an anomaly in the brickwork at the bottom left-hand corner of the door opening. The brickwork over the door opening at the western end of the northern elevation has sunk; presumably when the original lintel failed.

All lintels to the South-East and North-East elevations require replacing/rebuilding and additional building work to provide support by inserting some proprietary steel lintels.

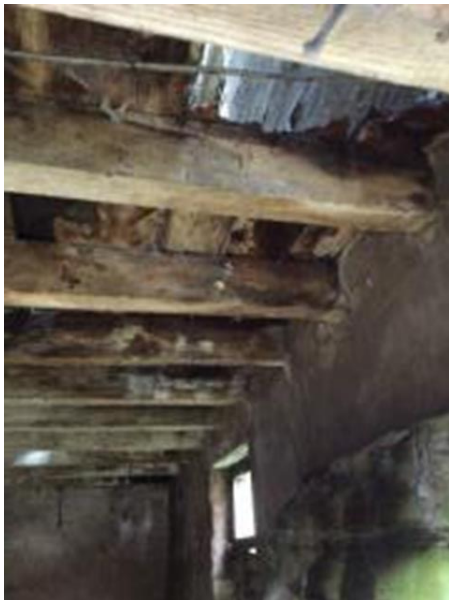
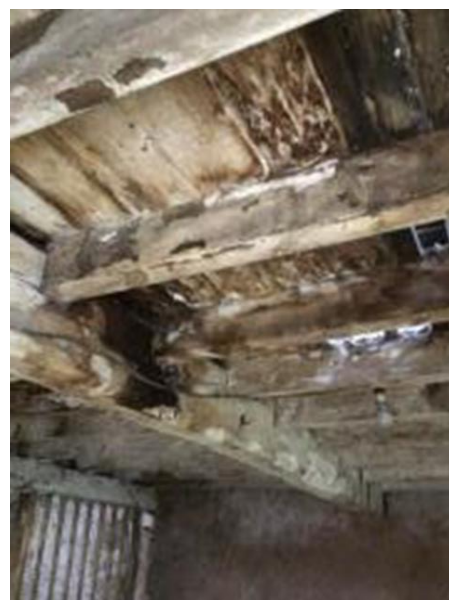
The boards and rafters have suffered from extensive rot due to water ingress, particularly at the northern end of the building.

Photographs showing holes in the floor due to rot and mould and rot to the timber joists and main beam

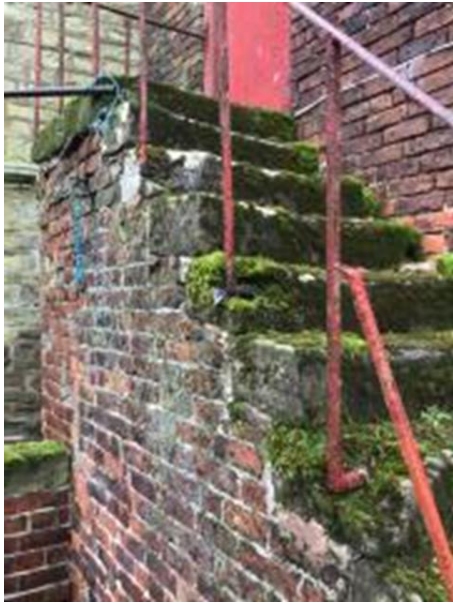
External Steps The brick wall supporting the flight of steps has tipped away from the gable and there is now a gap between gable and steps which widens to around 100mm at its maximum near the top of the steps.

The photo on the left shows the unevenness of the steps and how most of the balusters have lost their connection to the stone steps

The steps would have to be completely rebuilt due to the tipping away from the gable. The loss of 'seating' to the stone steps, the failure of the support to the landing slab and the poor brickwork would require extensive work even if the steps were not rebuilt.

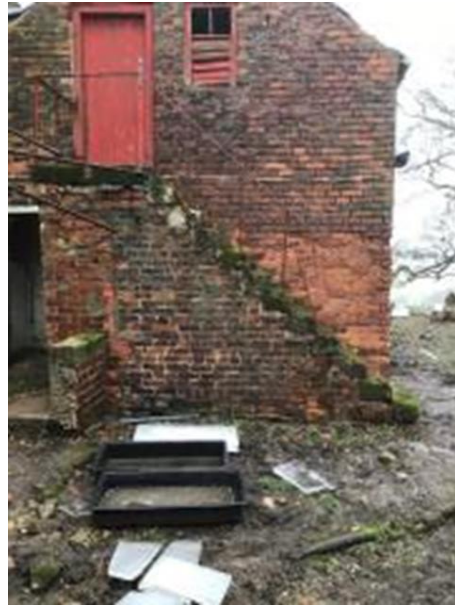
The photo on the right is a general picture of the steps

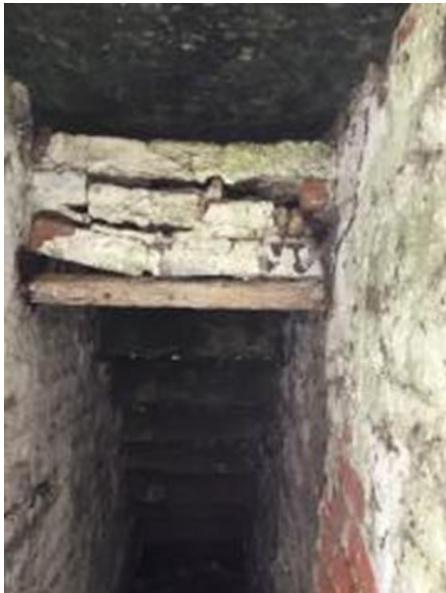
Failure of the internal support to the stone slab which forms the top landing

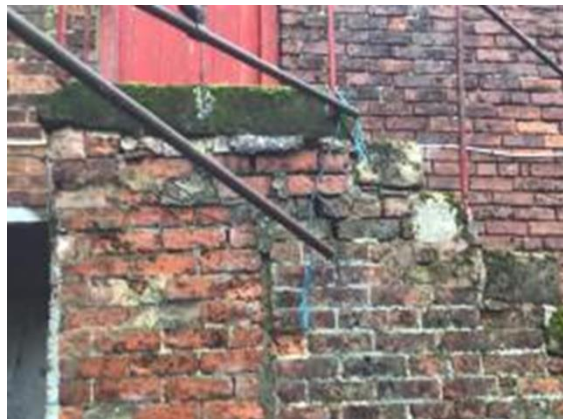
Poor quality brickwork

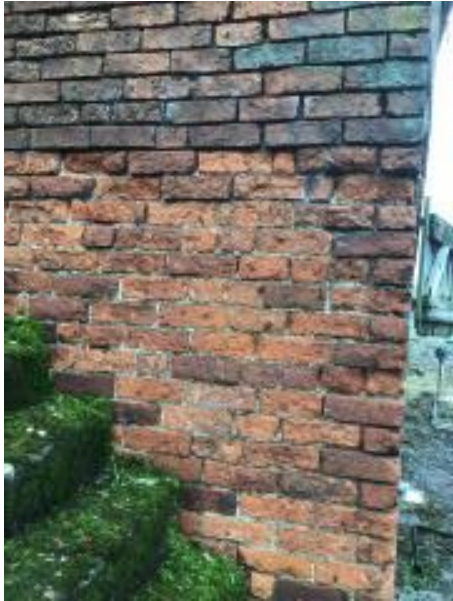
External wall Large proportion of the bricks are extensively eroded. Particularly on the eastern elevation from ground level to just below door head height; the wall supporting the stone flight of steps and occasional sections and individual bricks on the northern elevation.

The mortar holding the brickwork together has eroded; in many cases it has eroded too far back into the wall (at least 50mm). As such the brickwork is beyond being in a position where repair by repointing could be feasible.

Badly eroded brickwork on the South East wall. This also shows them deeply eroded mortar

The overall poor condition of the entire fabric; including the failure of the mortar and the erosion of large areas of brickwork would also lead to extensive areas of the other elevations that would require complete rebuilding.

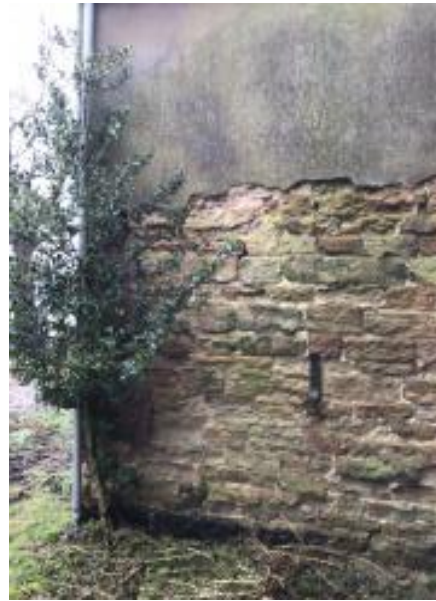
Stonework on the South West wall. Poor section to the top left behind the holly

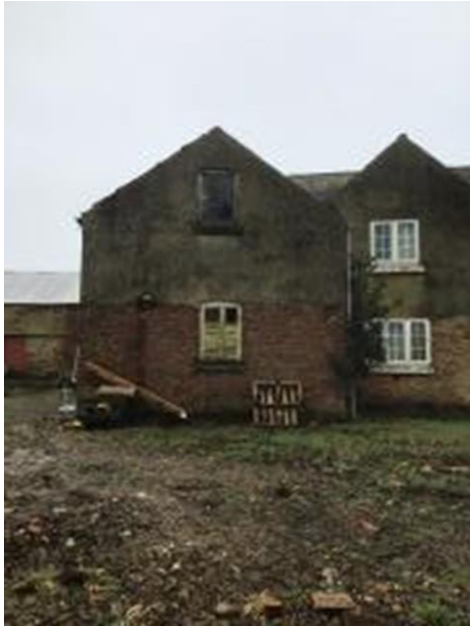
The North-West wall

It appears the entire northern wall was originally rendered. Where the render has been hacked off some of the bricks have lost some or all of their face and many are chipped. The render is a very hard cement-based render which is an inappropriate older style of render used. It would not be possible to remove this type of render without resulting in further extensive and irreparable damage to brick and stonework.
