**Hampden House, Hampden Road, Great Hampden, Great Missenden HP16 9RD**

Further to your recent instructions we confirm having made a visual structural inspection at Hampden House on 26 November 2020.

Our brief was to provide structural engineers advice on apparent vertical movement of ground and first floors to the small dining room and a landing outside a first bedroom along the east elevation.

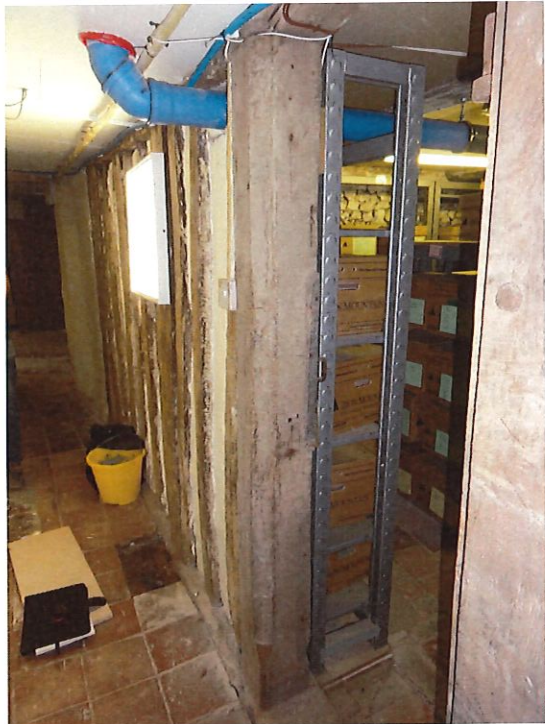
This beam is supported at approximately 765 mm c/c by 175 x 175 mm principal posts or studs. Smaller studs approximately 75 – 100 mm x 75 mm spaced at approximately 250 to 275 mm c/c infill between the principal posts to form a partition between a 1.3 m wide corridor and 4.7 m wide archive room in the basement.

Photo 1 – Timber partition in basement

In order to preserve the historic fabric of the building above basement level sympathetic repairs and augmentation should be carried out to the loadbearing timber framed partition.

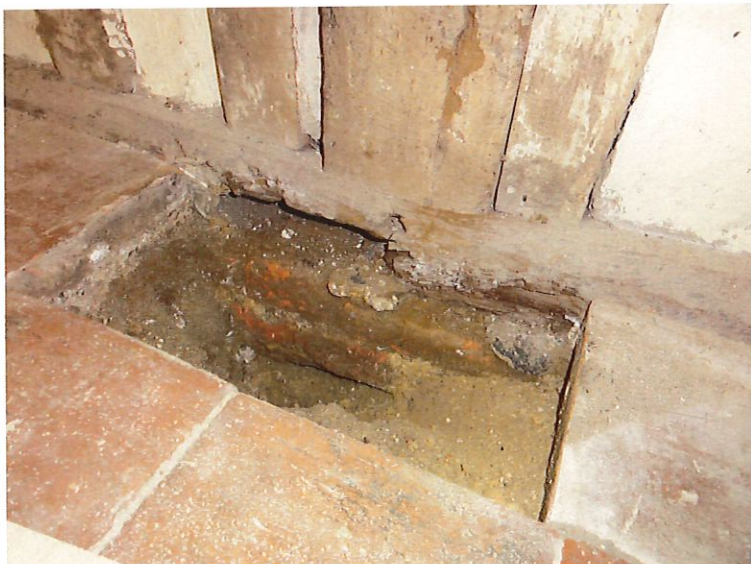
The floor to the corridor comprises approximately 40 mm thick tiles laid on a brown silty soil. On close inspection it is clear that a 225 mm wide x 100 mm deep hardwood sill plate at the base of the stud wall has decayed and compressed in a number of areas. Additionally, a shallow brick plinth used as a footing below the sill plate has settled. The plinth is founded approximately 270 mm below paving level and comprises just 2 courses of brick approximately 150 mm high. This detail has resulted in the timber sill plate being partially buried in the ground floor construction.

Where the sill plate is partially in contact with the basement floor, this has resulted in decay and loss of section of the timber. A narrow brick plinth or footing below the partition has settled compounding matters.

Photo 2 – Decay of sill plate

This work will involve carefully replacing the defective sill plate with a similar sized piece of well-seasoned hardwood or oak. In doing so the existing brick plinth or footing should be rebuilt on a suitable mass concrete footing onto competent subsoil below the existing basement floor. When reinstating the basement floor finishes, ideally levels should be augmented to ensure the replacement sill plate is not in contact with the floor construction and can breathe to avoid future decay.

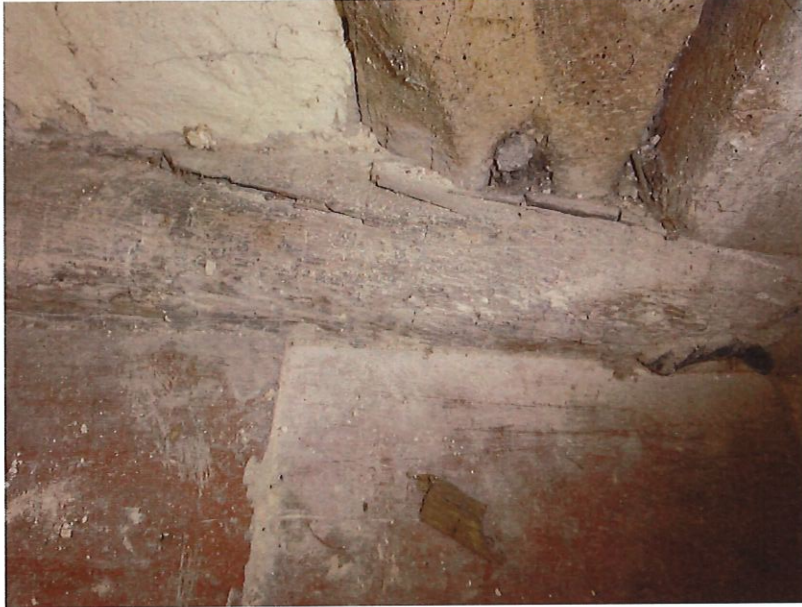
Photo 3 – Compression of decayed timber

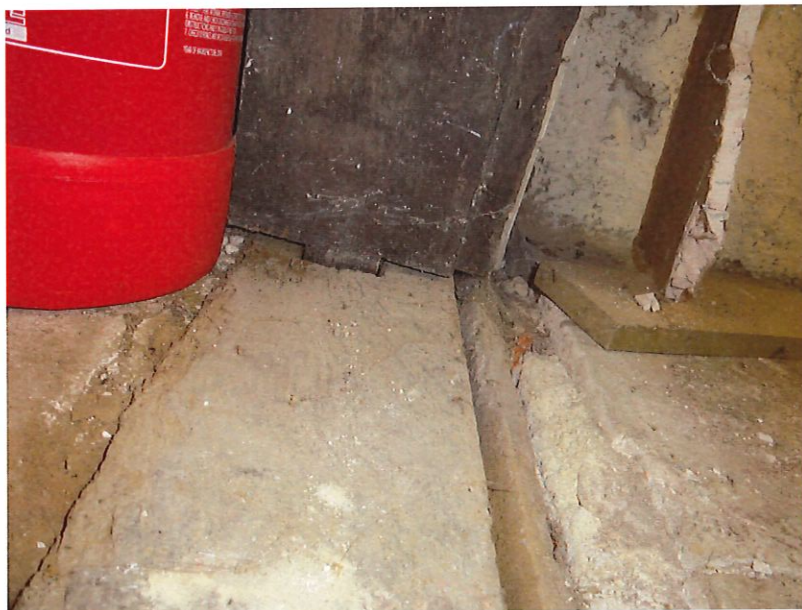
A few smaller vertical wall studs close to the end of the partition have dropped with the sill plate resulting in tenons pulling out of mortices in the underside of the header beam by approximately 40 mm. The studs are now loose causing movement and gapping to the edges of infill plaster panels.

Photo 4 – Threshold dropped exposing tenon

Existing principal timber studs can be adjusted locally to accommodate the new sill plate and incorporate a suitable anchorage plate or slip tenon if possible, to locate the stud. Where smaller studs have dropped out of existing tenons in the header beam they should be reinstated and spliced at the bottom, if required, to ensure they are the correct length.

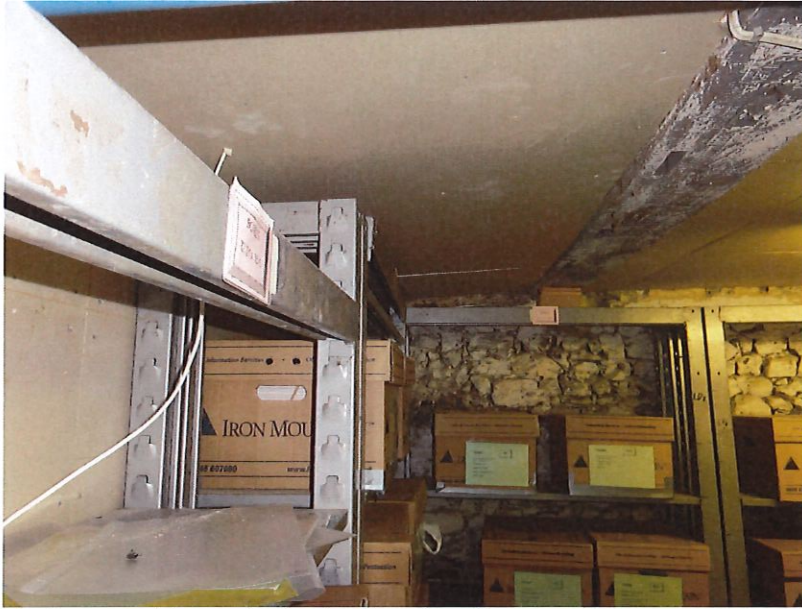
A downstand floor beam over the archive/store approximately 175 mm to 280 mm wide with stop chamfers, extends parallel to the loadbearing partition approximately 1.6 m away. The underside of the ground floor slopes noticeably from this beam downwards towards the partition.

Photo 5 – Archive, note sloping floor (over)

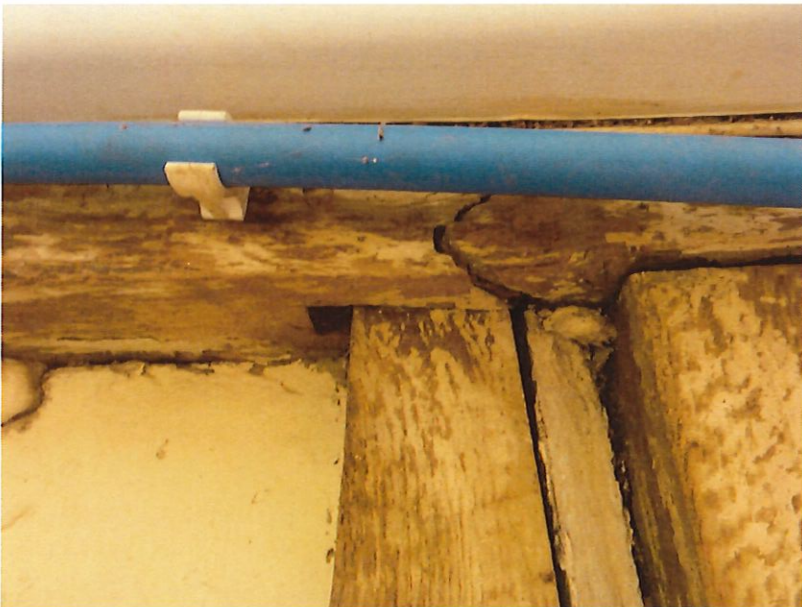
Two fractures can be seen in the ground floor header beam when viewed from the basement. Fractures are approximately 3 to 5 mm wide and have been caused by gradual deflection of the beam as the support stud partition and footing below have settled.

Photo 6 – Fractured header beam

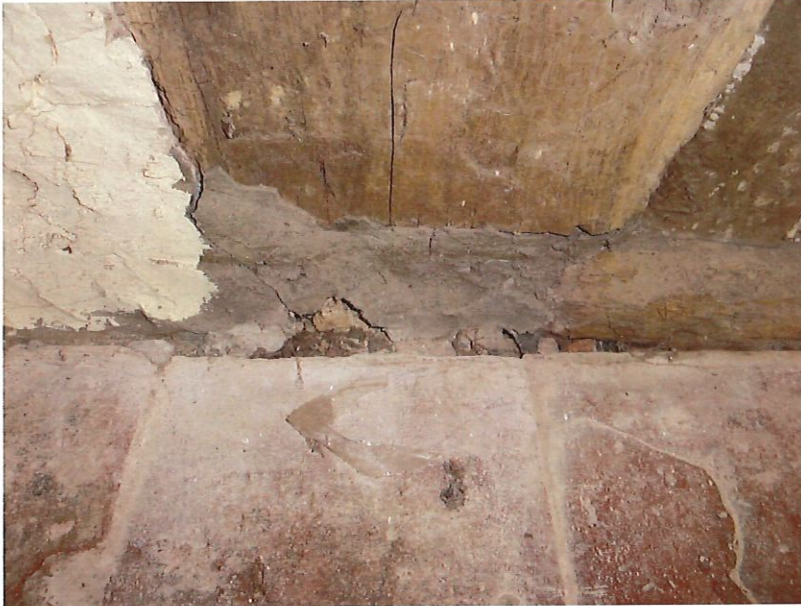
A later plastic repair can be seen to part of the sill plate where a gap has been filled below a primary vertical stud at the end of the partition.

Photo 7 – Historic repair to sill

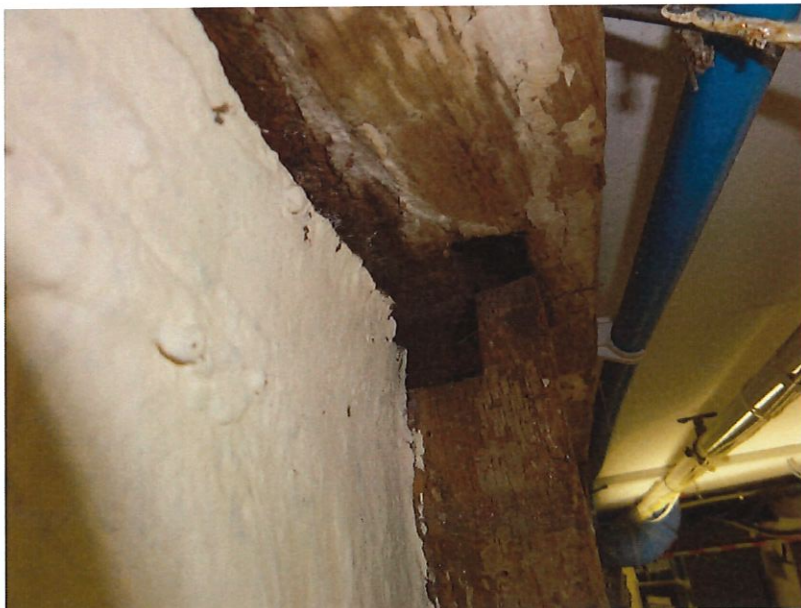
Photo 8 – Vertical stud dropped

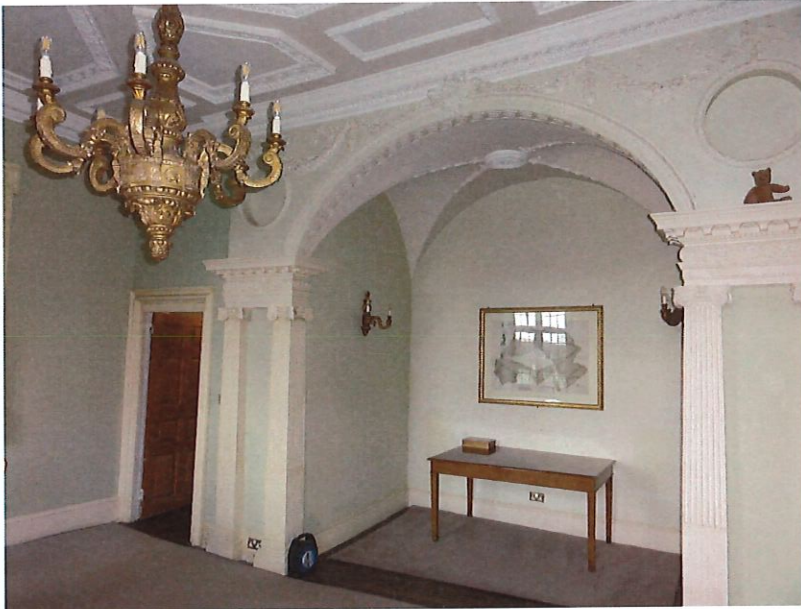
At ground floor level the most significant movement is close to an internal entrance to the small dining room from the servery.

Photo 9 – Small dining room (ground floor)

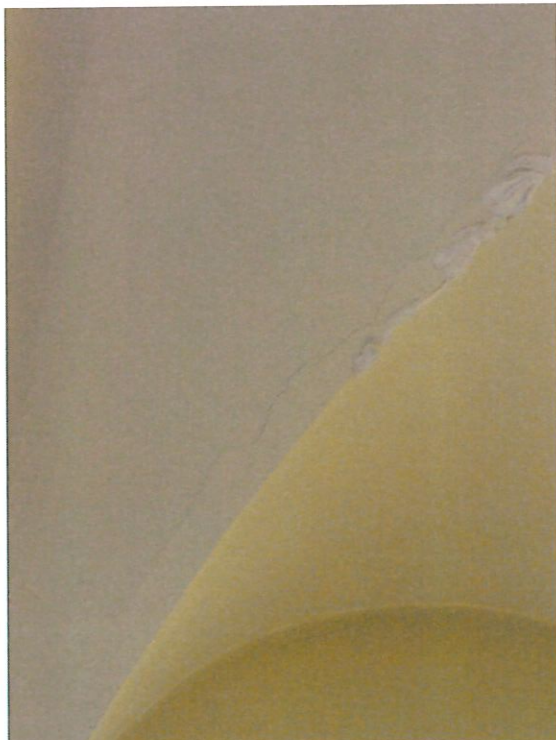
Hairline and 1 mm wide cracks can be seen in the wall over the doorway and in a vaulted ribbed ceiling over a recess to the dining room. This room has an ornate plastered ceiling with a decorative cornice. The overall height of the room is approximately 3.74 m. 0.5 to 1.0 mm wide vertical cracking was noted in the side face of a decorative column or pier between the entrance door and vaulted recess.

Photo 10 – Arch rib, plaster cracked

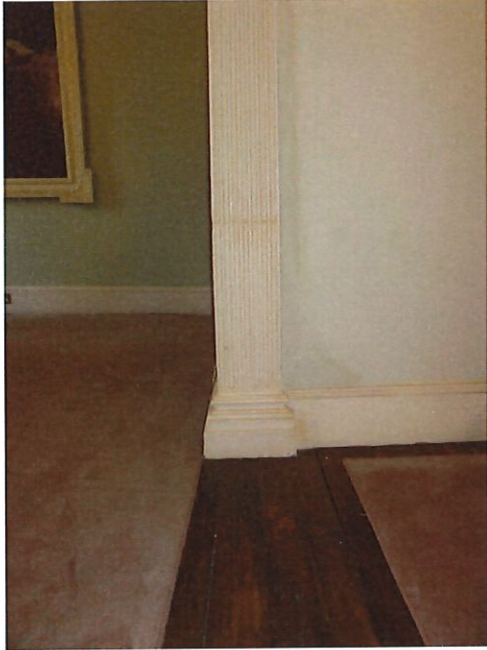
Photo 11 – Floor dropped and slight rotation of wall/pier

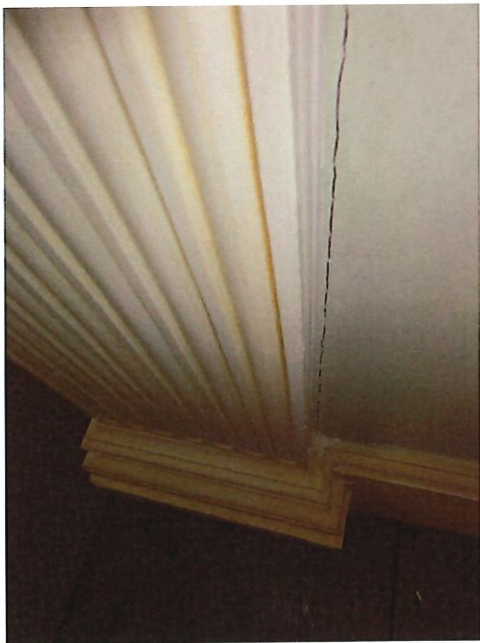
Photo 12 – Crack (vertical) adjacent decorative pier

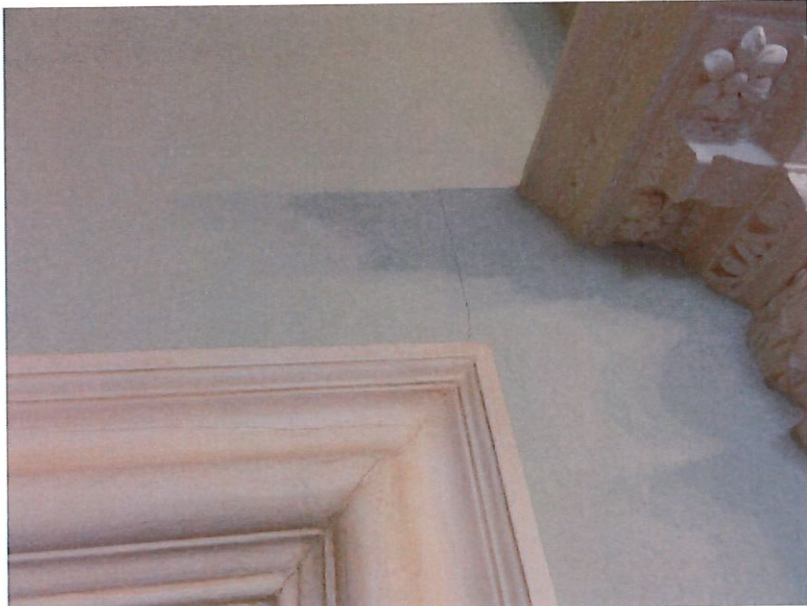
Photo 13 – Crack adjacent door head

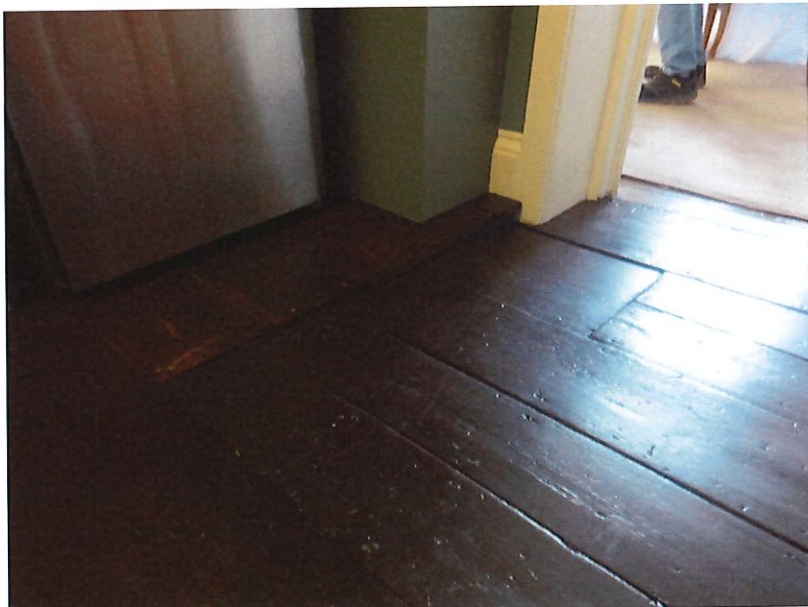
The ground floor typically slopes downward to this area and coincides with the position of the timber framed partition in the basement.

Photo 14 – Ramped floor to servery

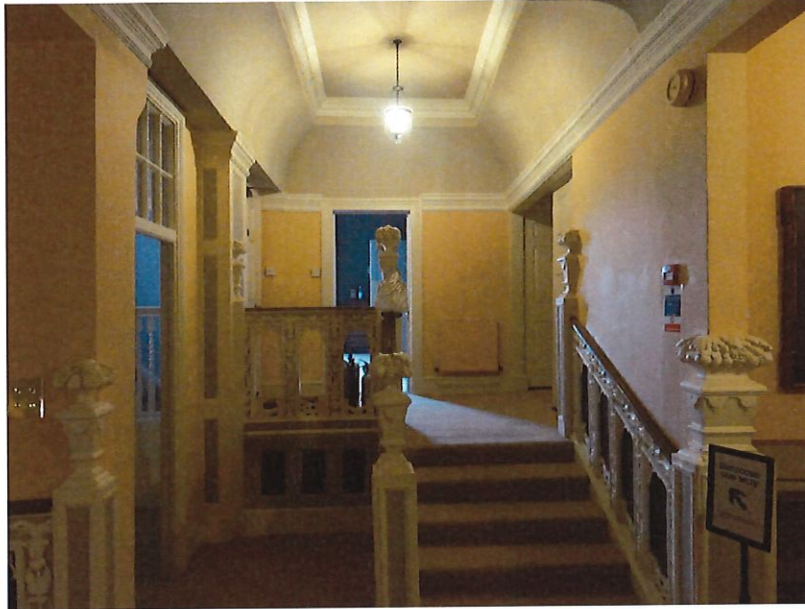
Movement is reflected in the landing floor and entrance to a bedroom at first floor level above this point. Hairline cracking was noted in the door architrave and in the wall and ceiling on the right hand side of the door when viewed from the landing.

Photo 15 – First floor landing

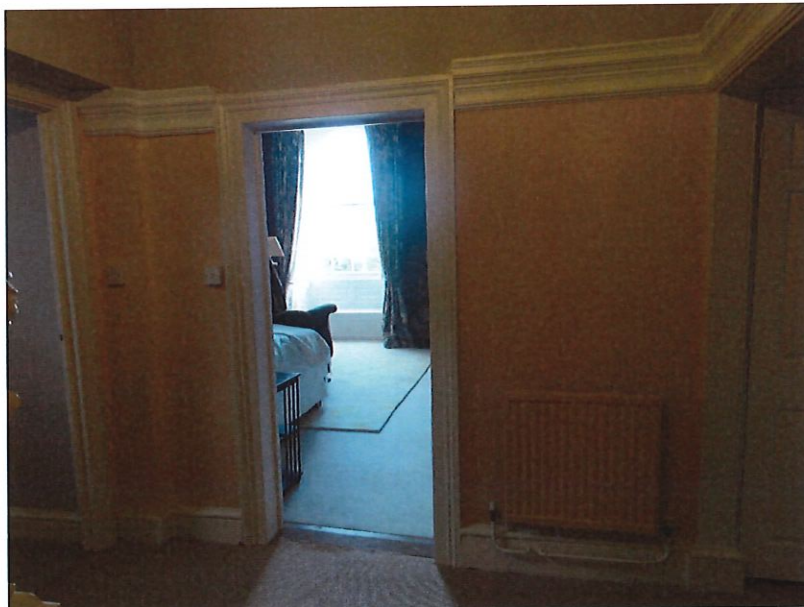
Photo 16 – View on entrance to first floor bedroom from landing

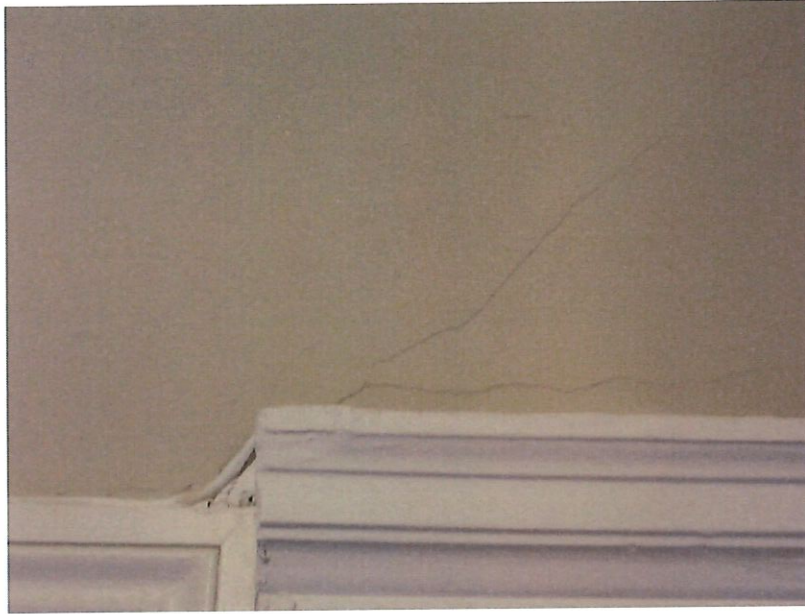
Photo 17 – Diagonal crack over architrave

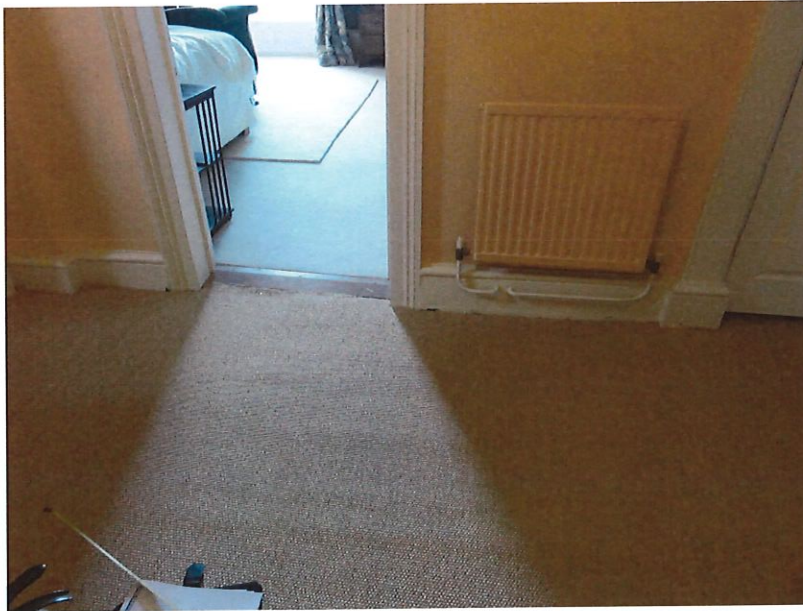
Photo 18 – Sloping floor at threshold (down from left to right)

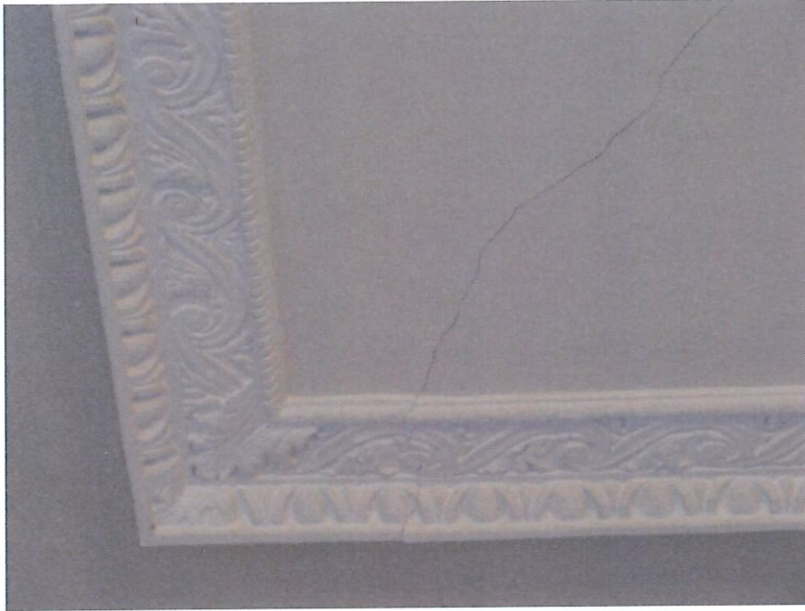
Photo 19 – Ceiling cracks over small dining room.
