# HAMPDEN HOUSE

*Heritage, Design and Access Statement*

Proposals concerning timber replacement to the lower ground floor

March 2021

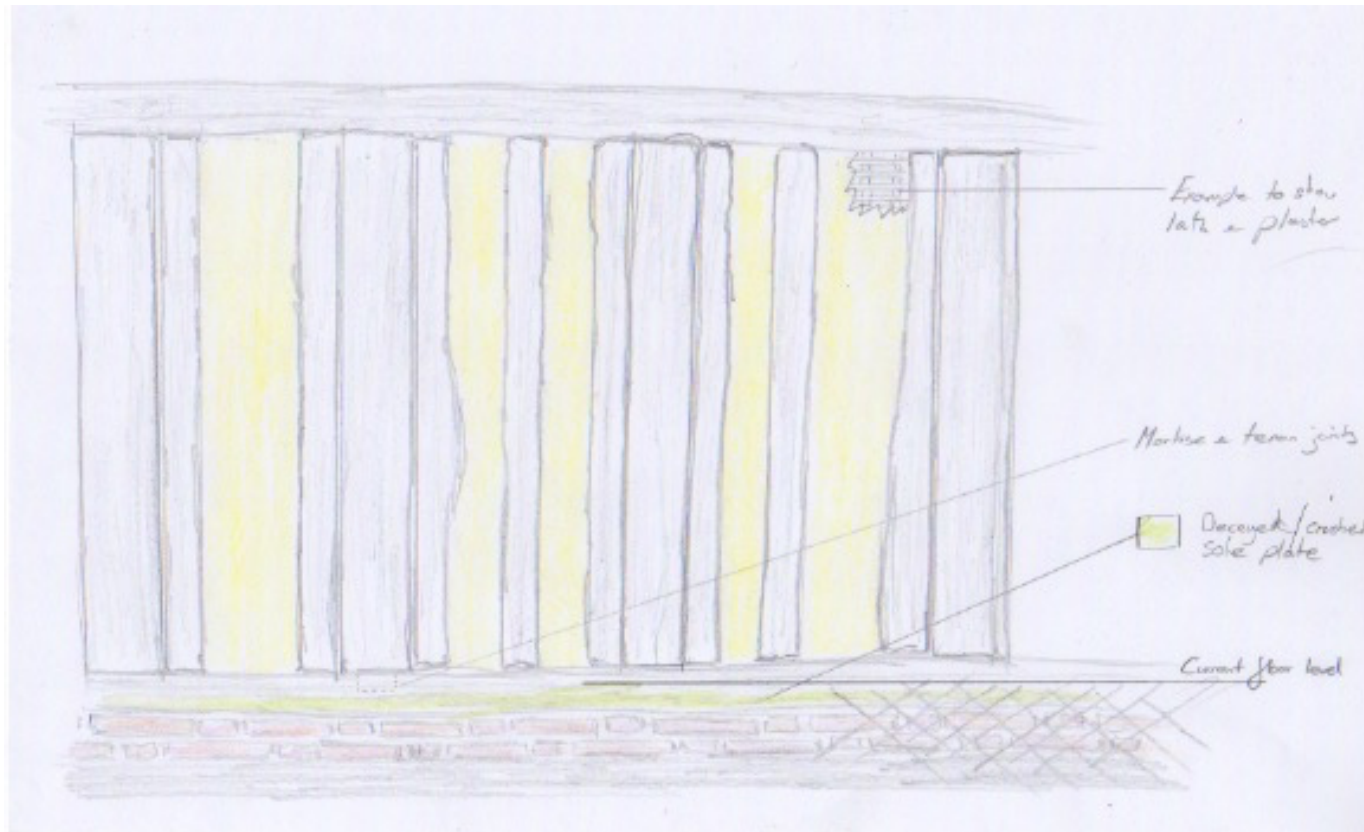
This application proposes localised works to a small section of timber stud wall found in the lower ground floor (see below sketch, fig. 6 and fig. 7), identified on the enclosed plan drawings as dividing 'Area 8' from the passage 'Area 5'. The consequence of the proposals would have a stabilising impact upon different layers of fabric above, however these are not directly to be worked upon. As such, the focus shall be on the subject timber framing localised in the lower ground floor. In the abstract it is very unusual to have a load bearing timber framed wall in the lower ground floor/basement of a building. Indeed, all of the other walls on this level are of brick, or flint/stone. Most of these walls can be architecturally dated to later re-building of Hampden, for example with the 18th century brickwork with integrated wine stores, however the timber wall in question is from an earlier period.

Fig. 6 - Sketch showing timber wall, with decay/crushing of the sole plate highlighted in green (not to scale, for advisory purposes only)

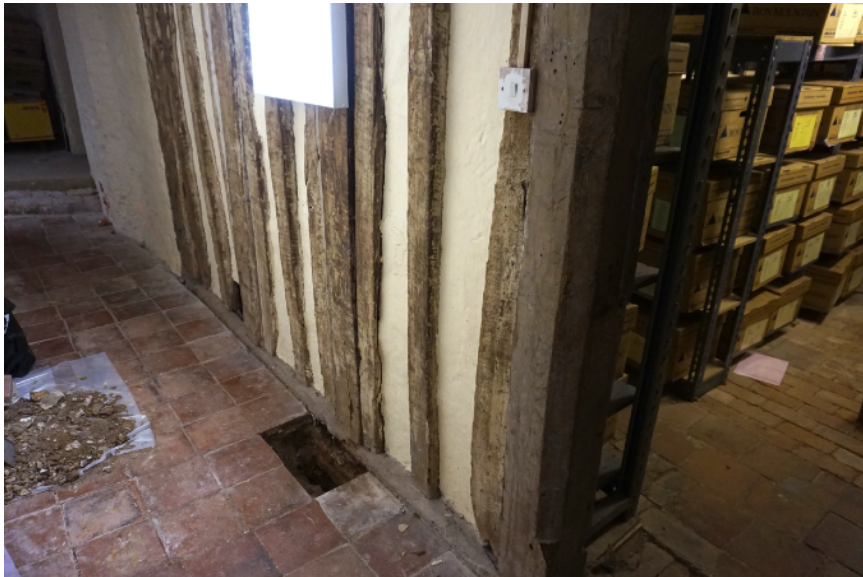
The form is unusual, with the studding irregular and suggestive of alteration. It is possible there were doors in this part of the framing, and/or that timbers may have been re-used. Close to this wall is a second bressumer or cross beam which has evidence of removed vertical studding (again see Fig. 8) with the mortises clear to see. This beam is supported by the walls within Area 8 and it is uncertain whether these timbers have been re-used or once formed an earlier structure. A third bressumer is located within Area 8, however this timber shows no sign of once having vertical studs. Due the proximity and form of the timbers, the area between may have been a cross passage, or it may simply be that these timbers have been reused in a different position in a later re-building.

Fig. 7 - Timber framed wall, showing sole plate predominately below floor level.

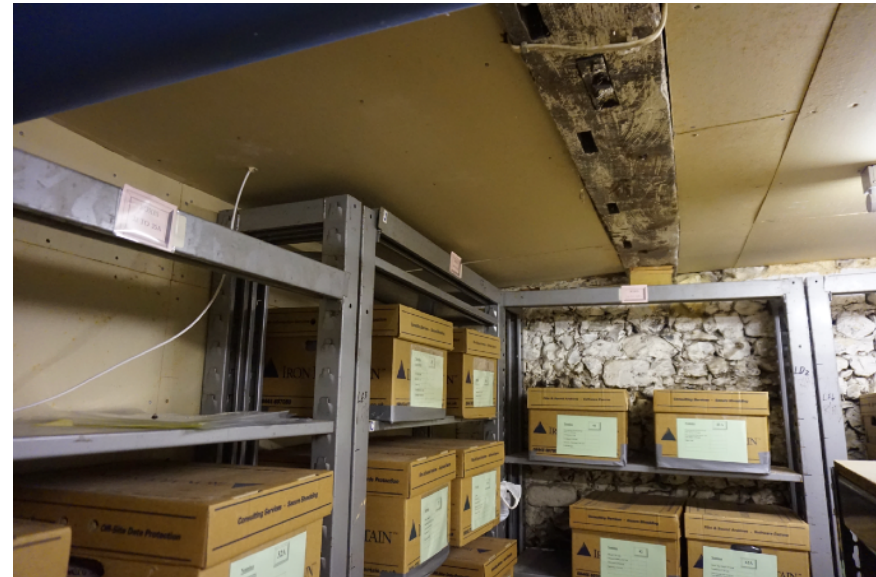
Fig. 8 - Store room showing bressumer with empty mortises

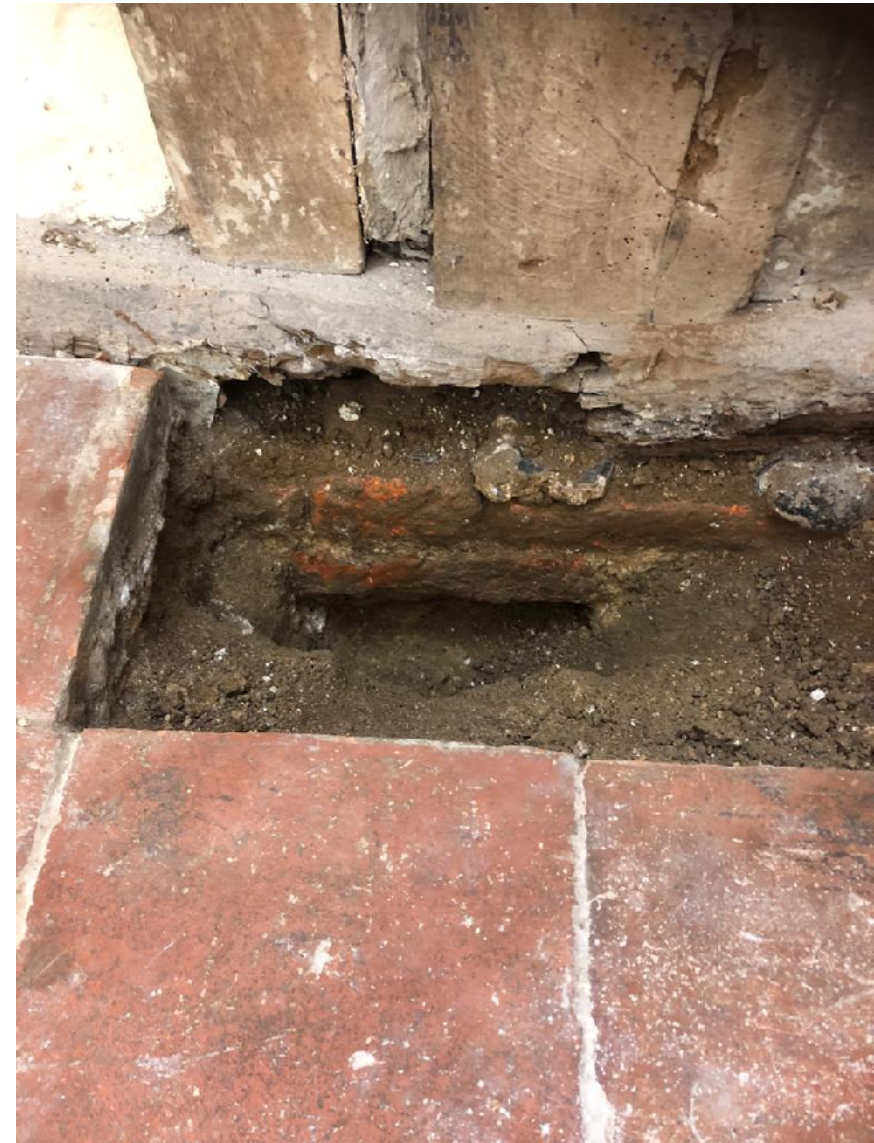
Without a full archaeological examination, and developmental study of building, it is not possible to say with absolute certainty the age, original position and function of the wall. However it is clear that it is from an early phase of the house, likely 16th century, given the form and style of the timbering and size and make-up of the bricks that form the plinth (see Fig 9).

*Fig. 9 - Detailed view of failed sole plate and brick plinth*

Judging from the physical evidence of the fabric, this structural failing has occurred slowly over many years and is not the result of a sudden break or failure. However upon localised examination of the lower ground stud wall, it has become clear that the timber sole plate, upon which a considerable load is focused, has weakened and failed, in part from the high load, but also from degradation caused by immediate contact with damp earth. Due to the evolution of the building, the sole plate of the wall was partially built up against (see fig. 9) with a raised floor finished with quarry tiles. Instead of the sole plate being exposed and sitting freely on its brick plinth, the plinth and approximately half of the timber are now below ground level. As a result moisture has been absorbed from the earth and caused significant timber decay to the timber, as such the timber is unfortunately no longer structurally viable.

- It is assumed, judging from the localised examination, (see fig. 9) that the brick plinth exists the full length of the sole plate. It is proposed to carefully remove the bricks which form the plinth, examine them as to their structural integrity (being heavily moisture laden they may be in a poor condition), any brick which are judged to be in an acceptable condition will be re-used, with any required replacements sourced to match from nearby brickworks H.G. Matthews.

- Following the plinth removal, it is proposed to rebuild the brick plinth in a like for like manner, using a strong lime mortar mix (NHL 5), and to dry pack with slate, once the mortar has cured the new sole plate will be carefully inserted into position and the frame joined with mortises and tenons.

- As discussed above, part of the failure is due to the sole plate now being below floor level due to the raised, or building up of the quarry tied floor. It is not proposed to alter the height of the floor as this impacts upon other parts of the fabric, but instead to introduce a small separation from the floor to the new sole plate, a de facto channel, as to allow for air to circulate to the new timber and ultimately prevent a similar occurrence.

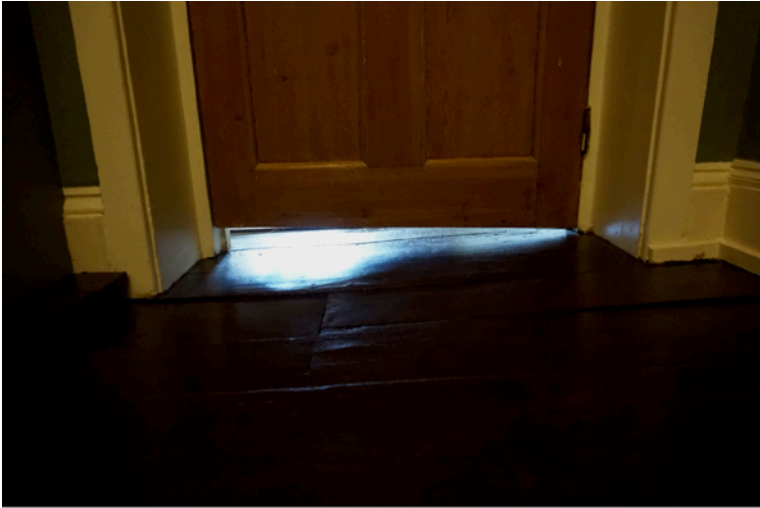
Within the lower-ground floor an oak frame stud wall section has dropped by approx. 70mm as a result of the crushing of the wall's sole plate. The 70mm movement has deflected in a downwards vertical direction, resulting in the localised dropping to the floors above. This movement has further transferred through the structure of the ground floor (see fig. 10) to the ceiling of the first floor (see fig 11). Further up, on the second floor level there does not appear to be any movement, as this area has a different plan layout with the load spread to other parts of the structure. As can be seen in the annotated photograph fig. 12, there is a considerable localised dropping - a 'pooling effect' to the timber floor. Minor repairs and redecoration have occurred over the years in an attempt to mask the aesthetic issue, but as this has not addressed the root cause, the cracks and breaks occur again. A specialist structural engineer has prepared a report which is included as part of this application.

*Fig. 10 - Detail showing deflection under ground floor door*

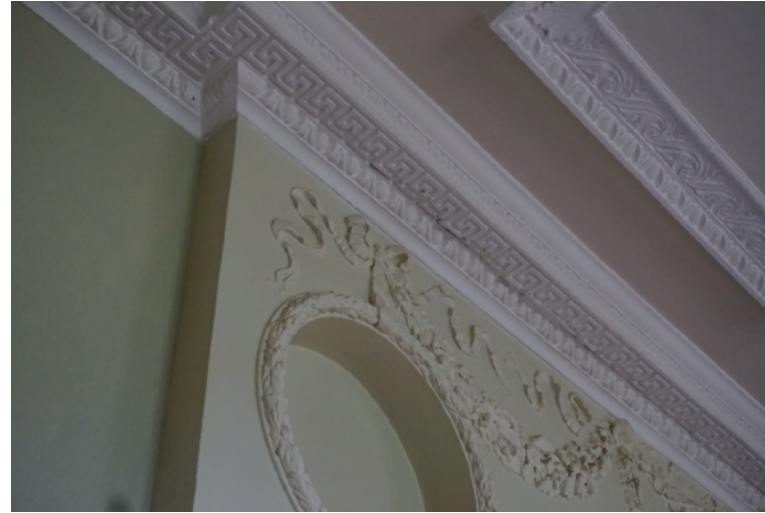
*Fig. 11 - Cracking to 18th century plasterwork*

- There are small areas of damage to the extant lath and plaster panels, these will be made good with matching materials (oak laths, three coat horse haired lime plaster (NHL 3.5) in a 3:1 mix). Similarly any unavoidable further damage that occurs or is discovered will be repaired in the same manner.

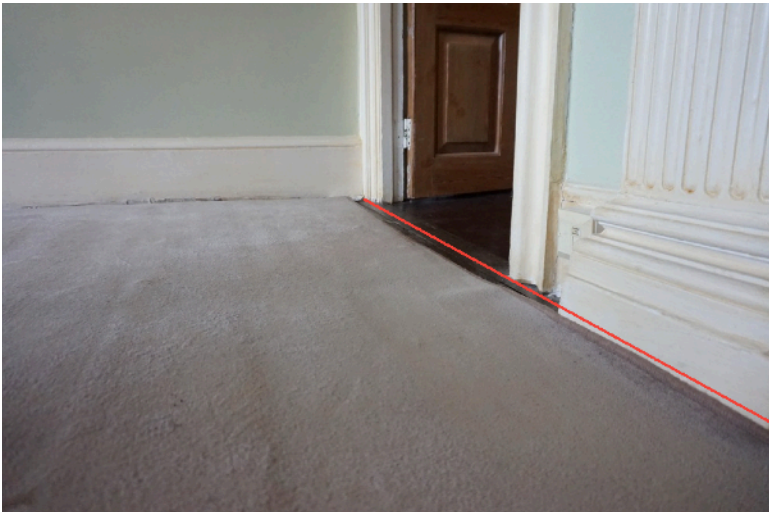
*Fig. 12 - Red line taken as plum showing approx. 70mm deflection*

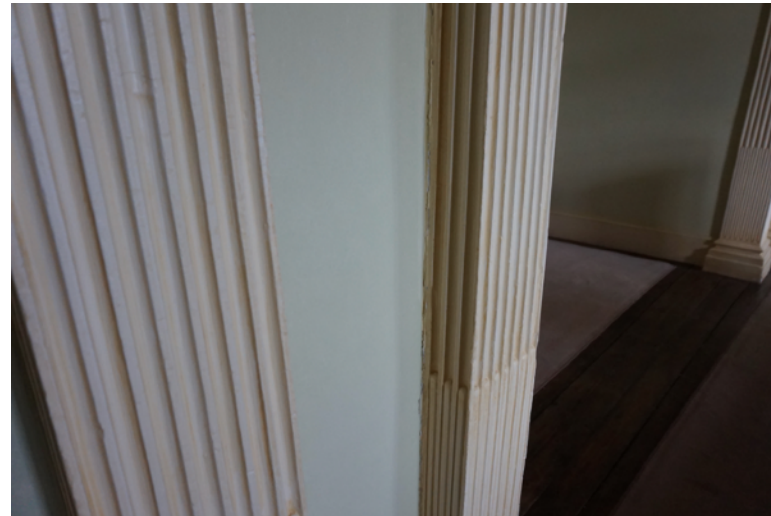
*Fig. 12 - Detail of cracking to pilaster*
