Appendix 3: Photographs

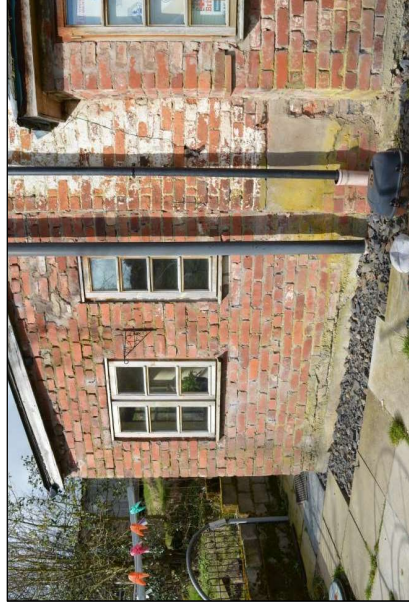
Fig. 18: The join between the southern extension and the 19th century house (CPAT 4900-0012)

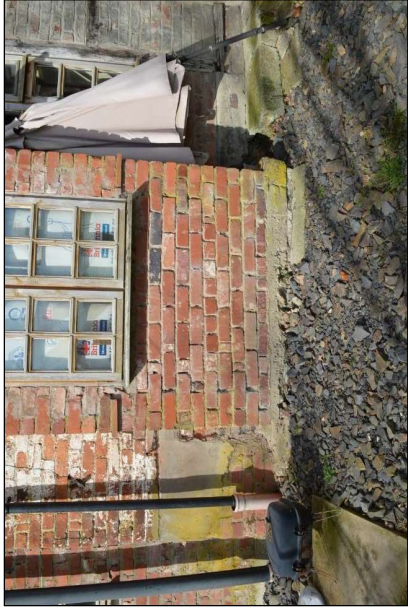
Fig. 19: Modern foundations of the bay window (CPAT 4900-0013)

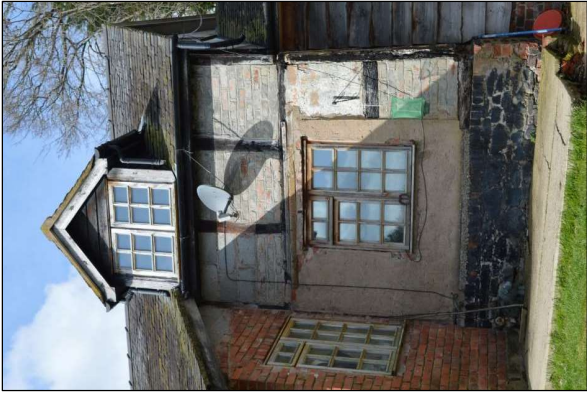
Fig. 25: Timber frame, note the upper panels are later (CPAT 4900-0019)

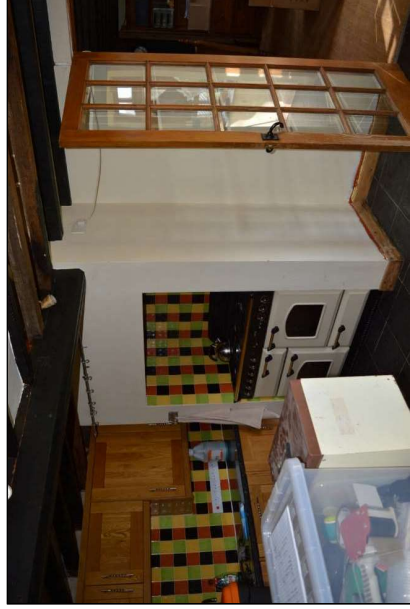
Fig. 29: False fireplace in the centre of the house (CPAT 4900-0023)

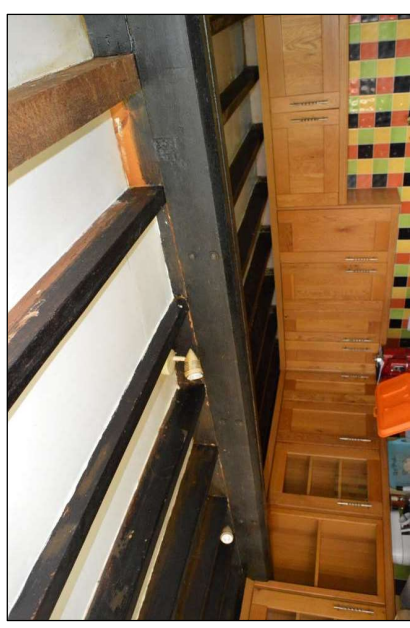
Fig. 30: Bolted together beam in the kitchen (CPAT 4900-0024)

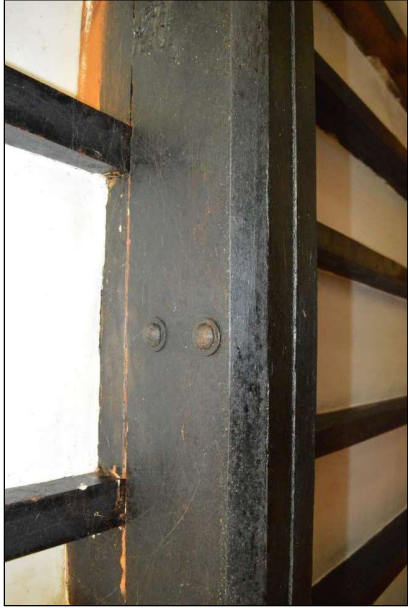
Fig. 31: The bolts in the main kitchen beam (CPAT 4900-0025)

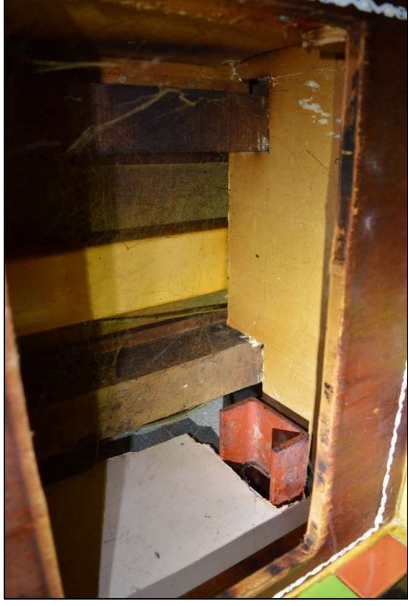
Fig. 32: Some of the structure hidden by the false fireplace (CPAT 4900-0026)

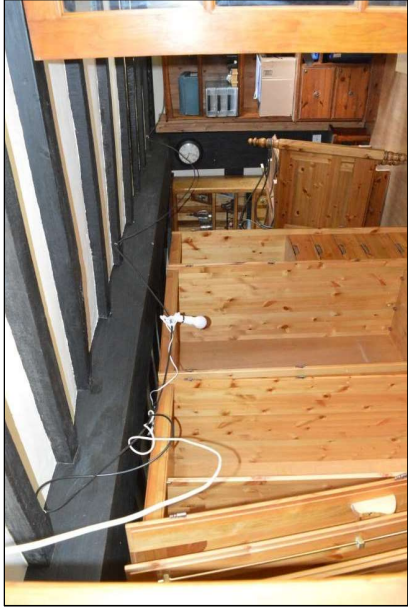
Fig. 33: False beam masking the steel girder in the living room (CPAT 4900-0027)

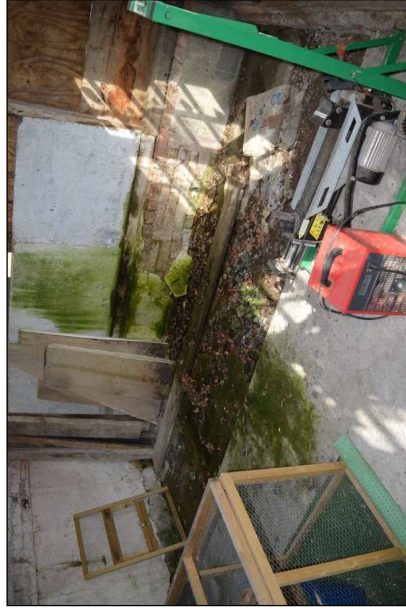
Fig. 46: Sleeper wall and possible drainage channel at north end of former byre (CPAT 4900-0040)

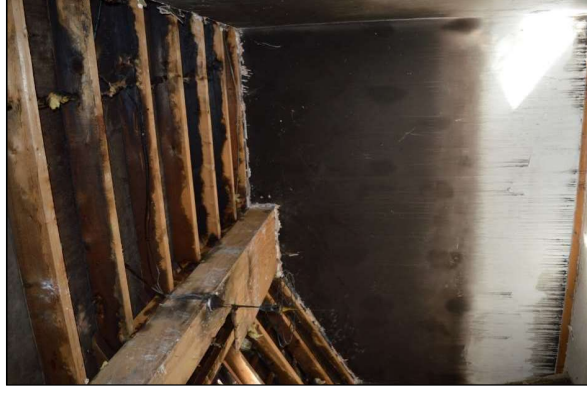
Fig. 48: Fire damaged bedroom 4 (CPAT 4900-0042)

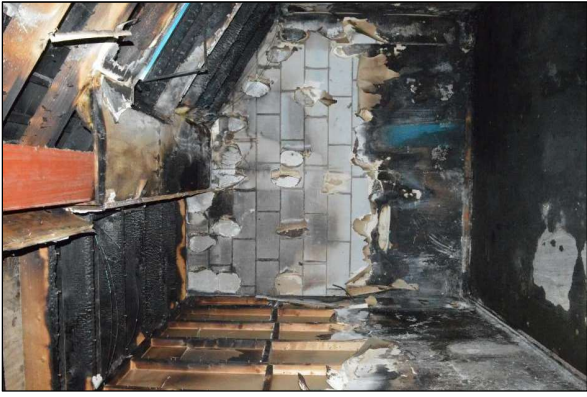
Fig. 49: Fire damaged bedroom 3 (CPAT 4900-0043)

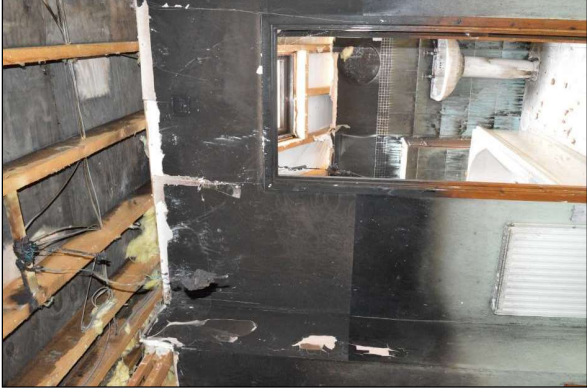
Fig. 50: Fire damaged landing and bathroom (CPAT 4900-0044)

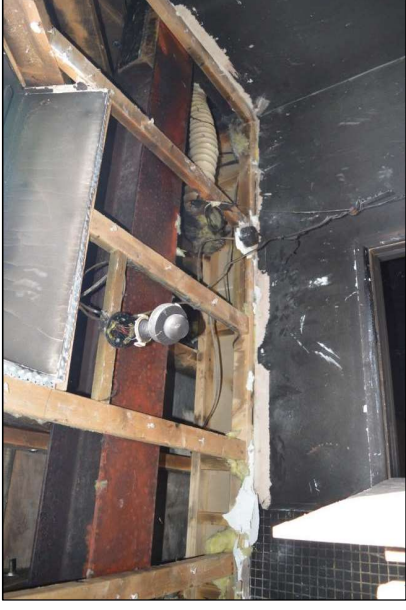
Fig. 51: Steel beam above the bathroom (CPAT 4900-0045)

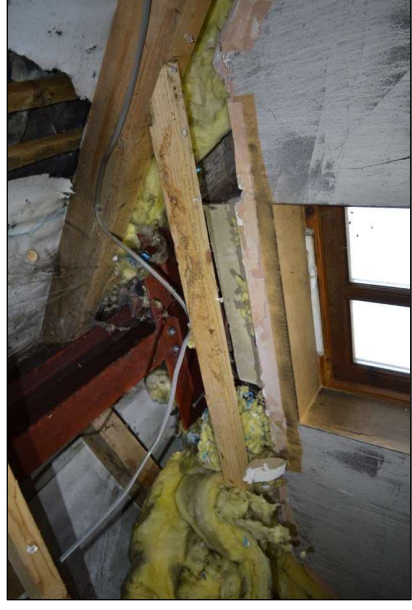
Fig. 54: Steel beam attached to apex of timber frame in bedroom 1 (CPAT 4900-0048)

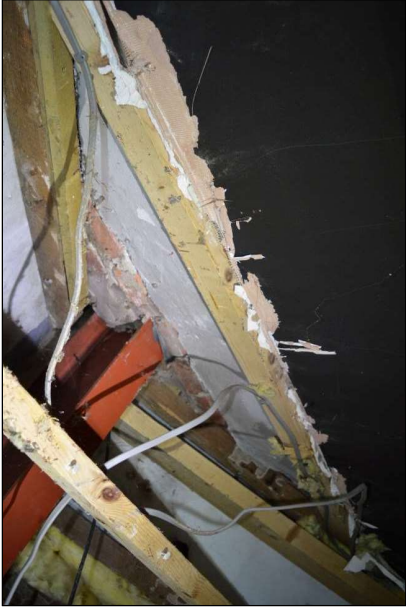
Fig. 61: Steel beam set into the south wall of the 19th century house (CPAT 4900-0055)
