A/15873 – MAINS OF PORTLETHEN, ABERDEENSHIRE

STRUCTURAL INSPECTION REPORT

24th October 2016

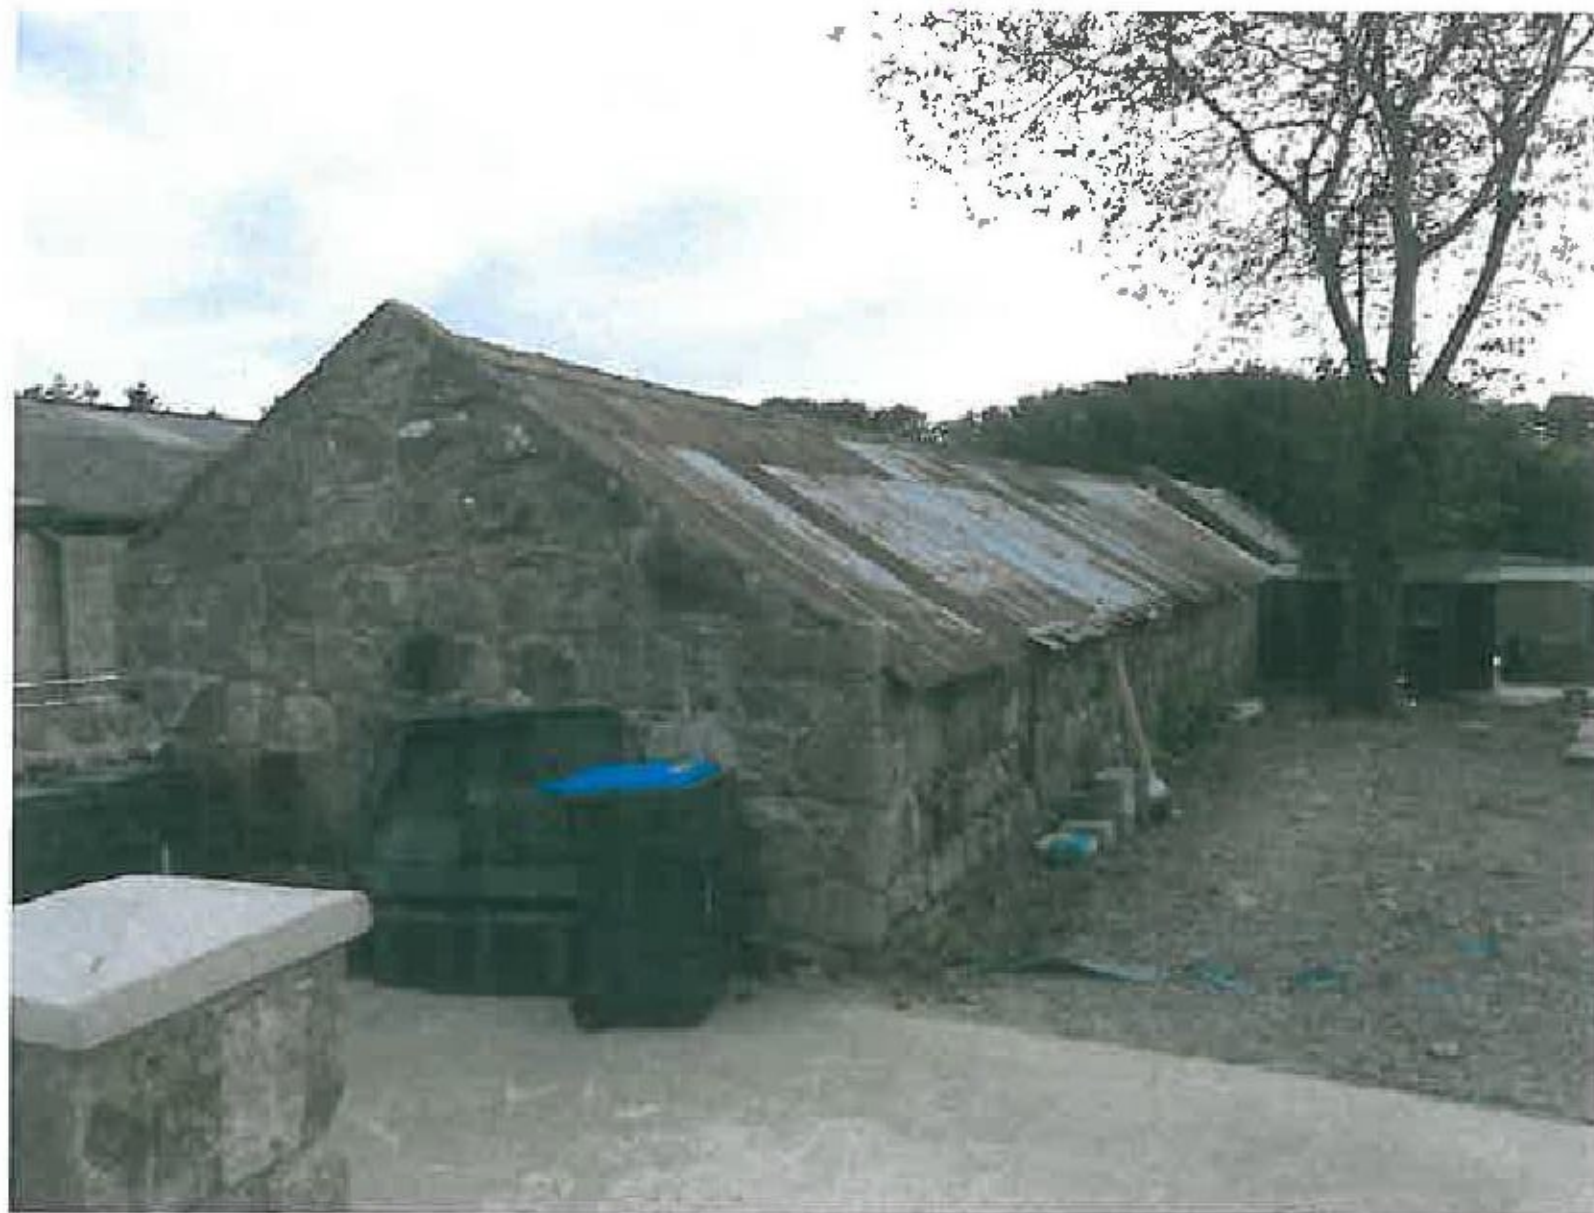
- 3.1 Building 1 is in a poor condition with deteriorating masonry, failing timber roof, sagging eaves beam and the support posts to the North elevation are out of plumb.

Rear wall in poor condition

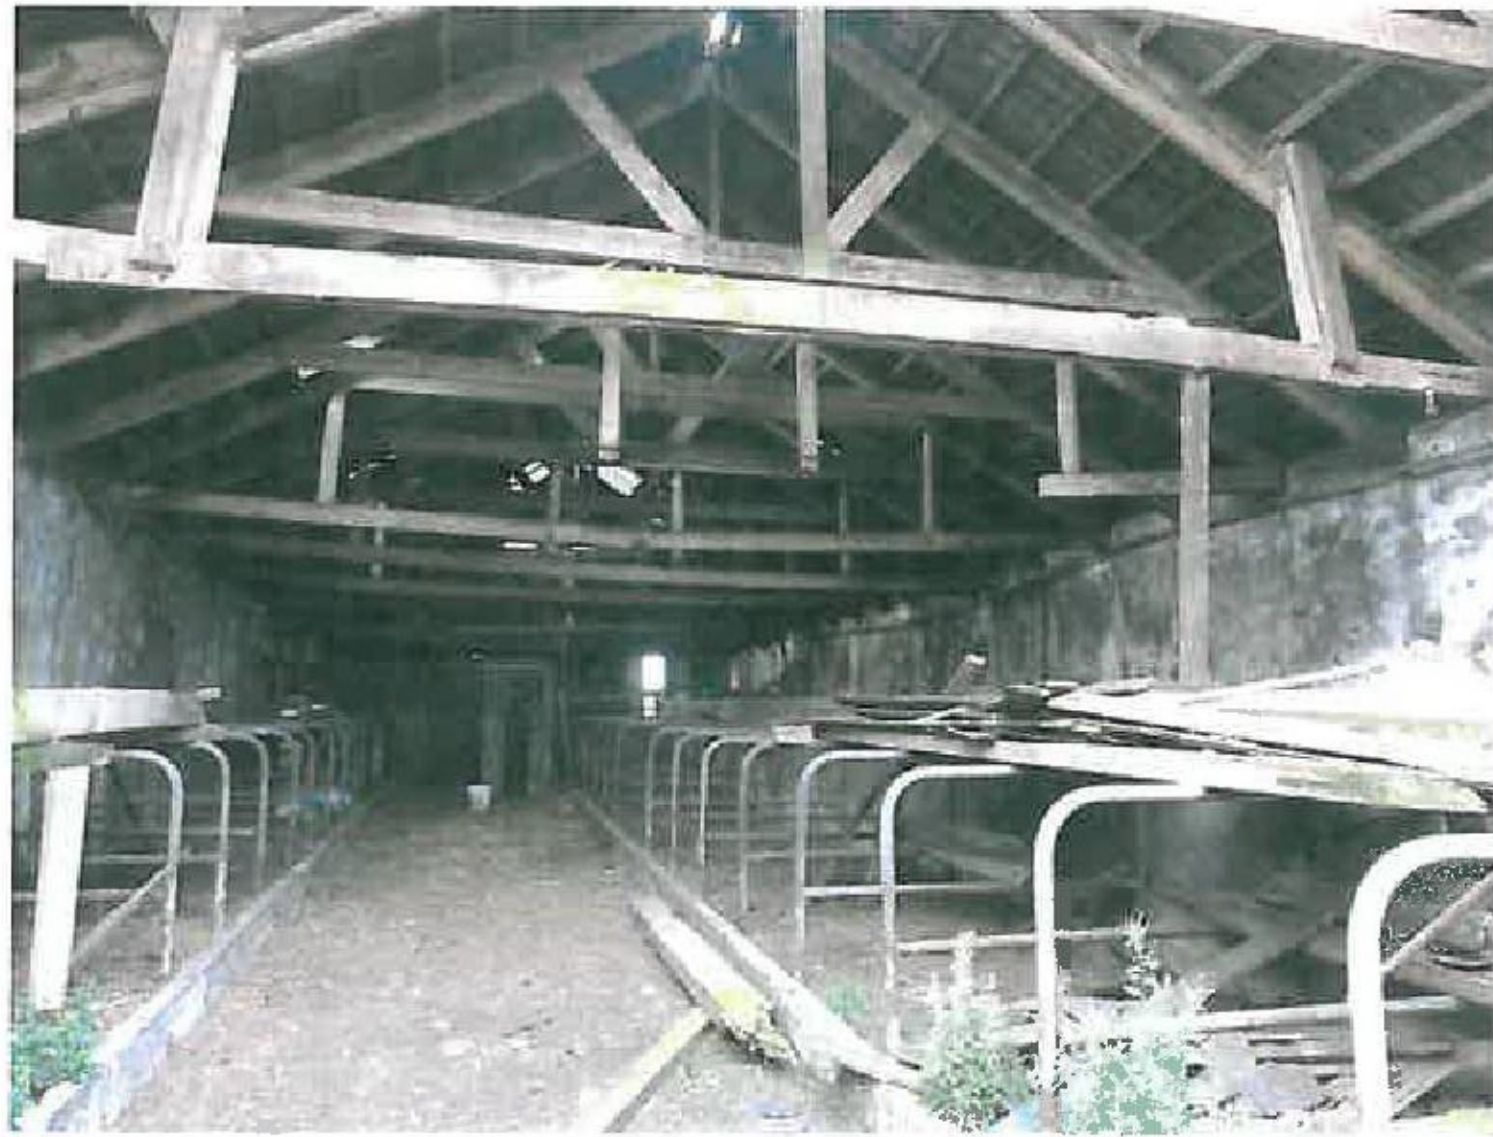
Roof timbers Building 3

- 3.2 As a general comment, it should be noted that all of the timber roofs are in a state of serious disrepair and there are significant areas where partial collapse of the roofs has already occurred.

Access to Buildings 2, 3, 7, 8 and 10 should be discouraged until such times as demolition can be carried out.

- 4.2 Given the condition of all of the roofs and with the majority of the walls also in poor condition it is our recommendation that these buildings should be demolished in the very near future.

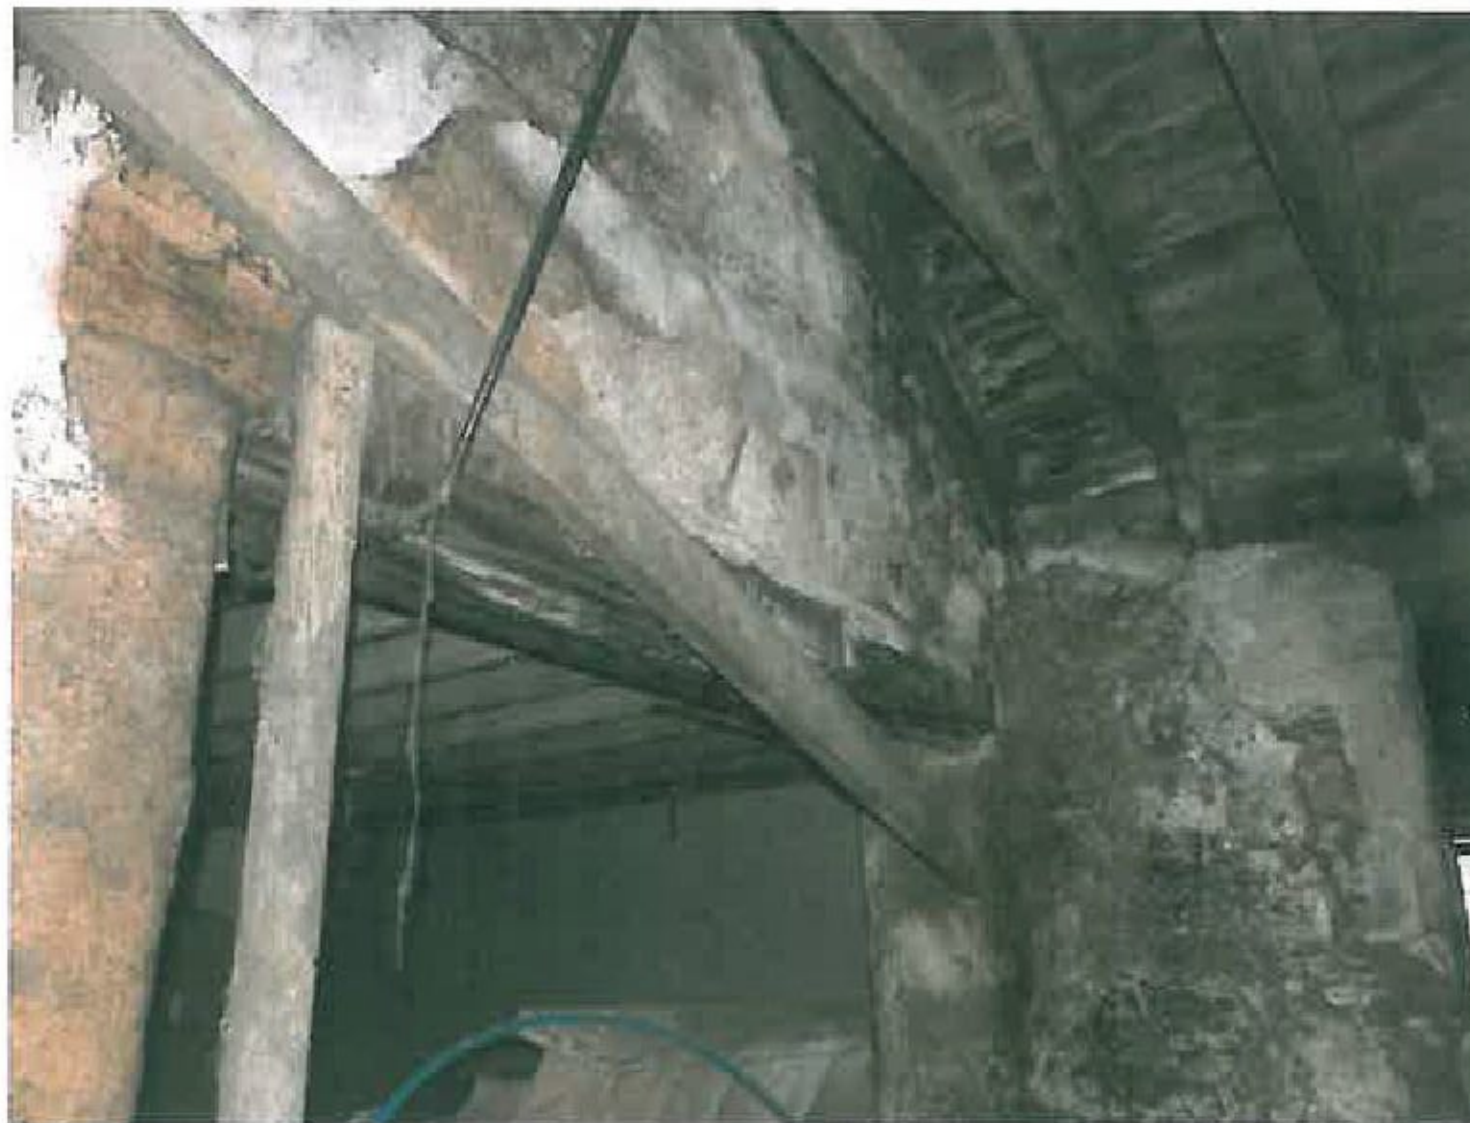
- 3.3 All timber lintels and beams built into masonry walls are affected by wet rot and/or wood boring insects.

Rotten timber lintel

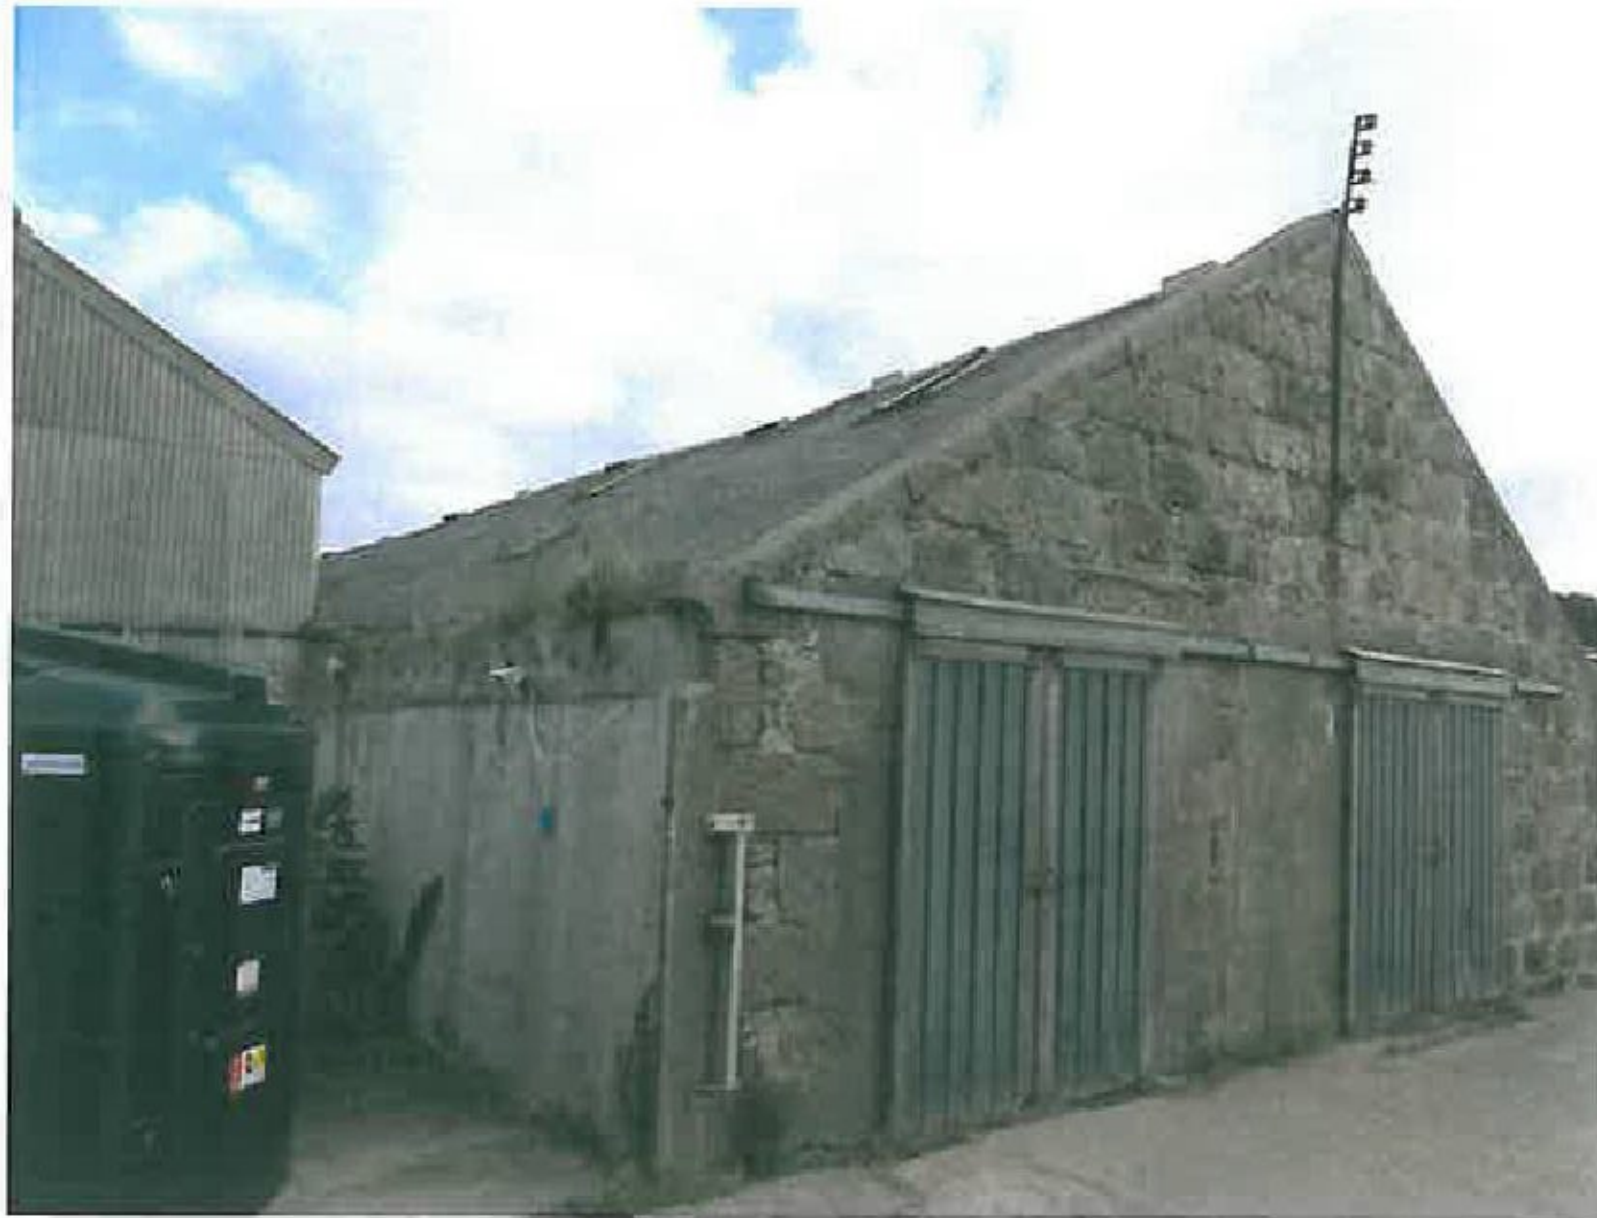
South gable of Building 3

- 3.4 Masonry walls have been modified over the years with new openings having been formed. Many of the original openings are infilled with concrete blockwork.

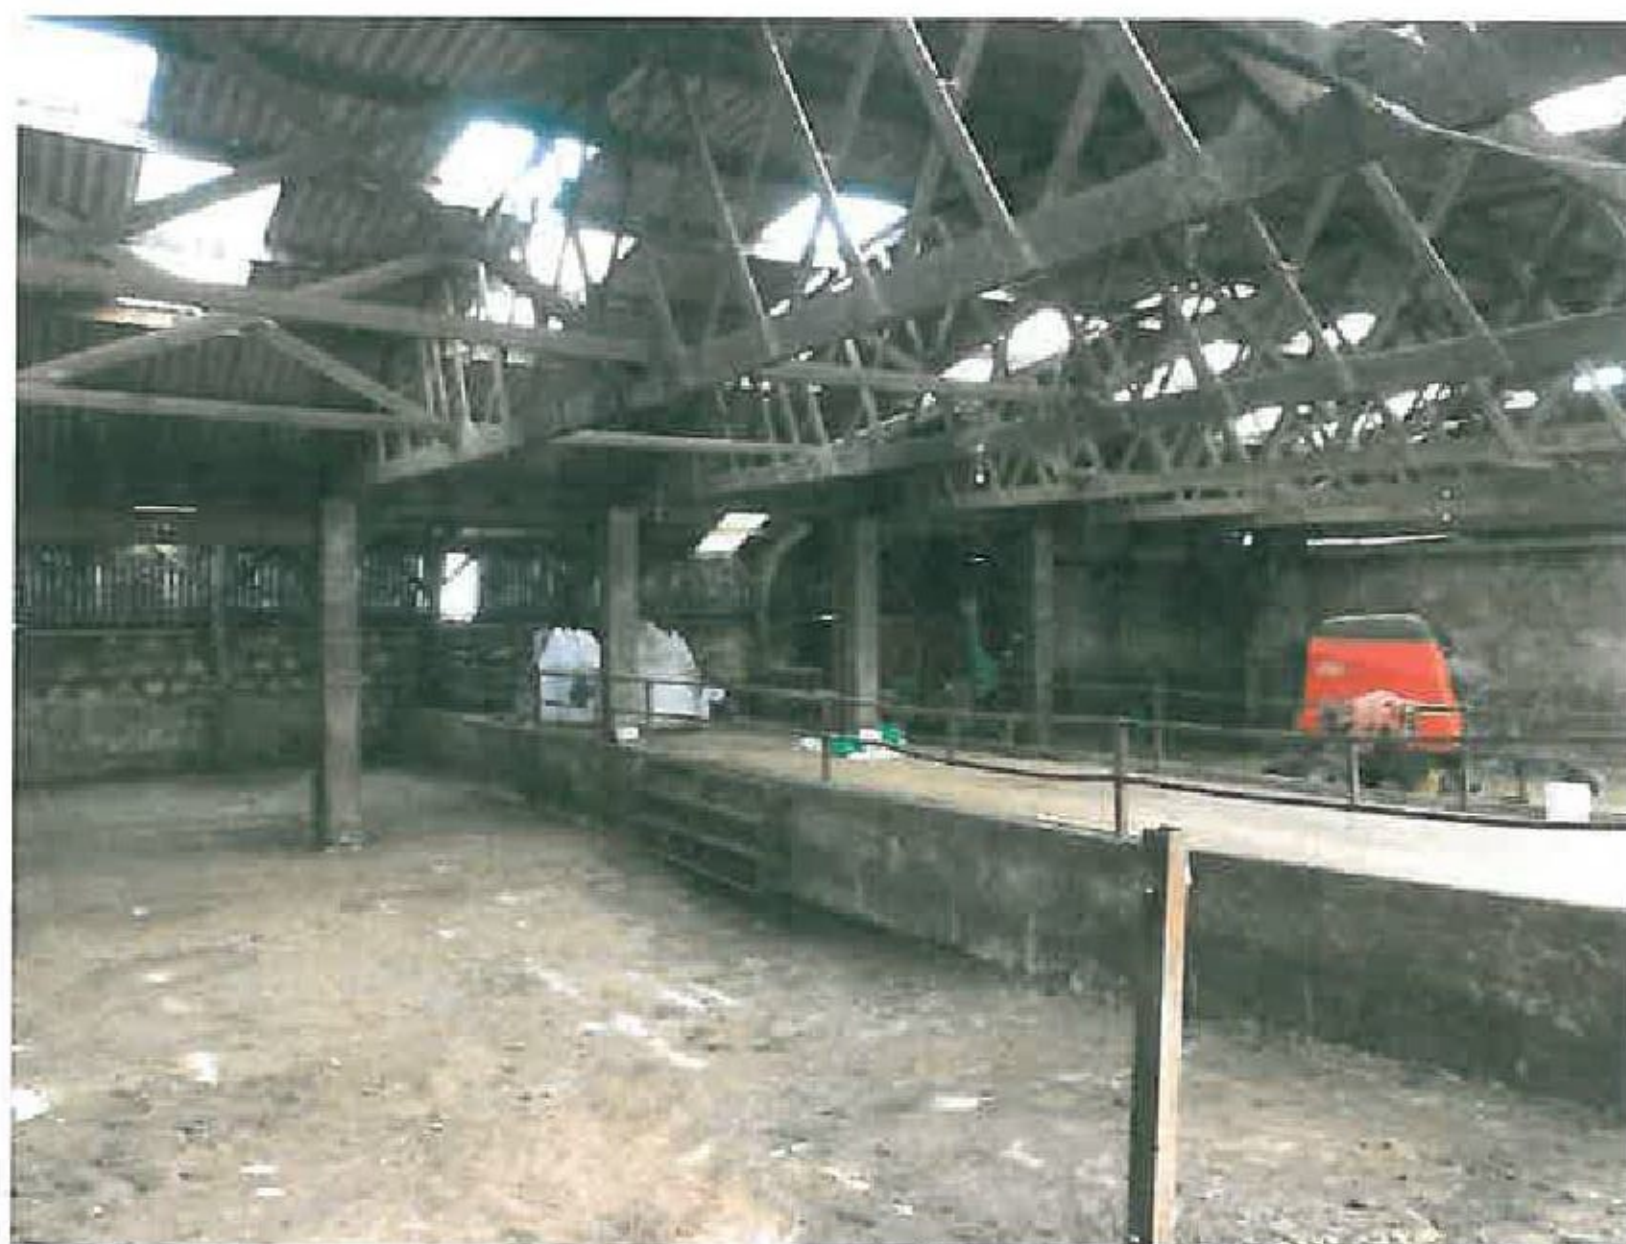
- 3.5 The main curved trusses forming the roof for Building 4 are sagging. The support of these trusses both to the North and South ends is not considered adequate.

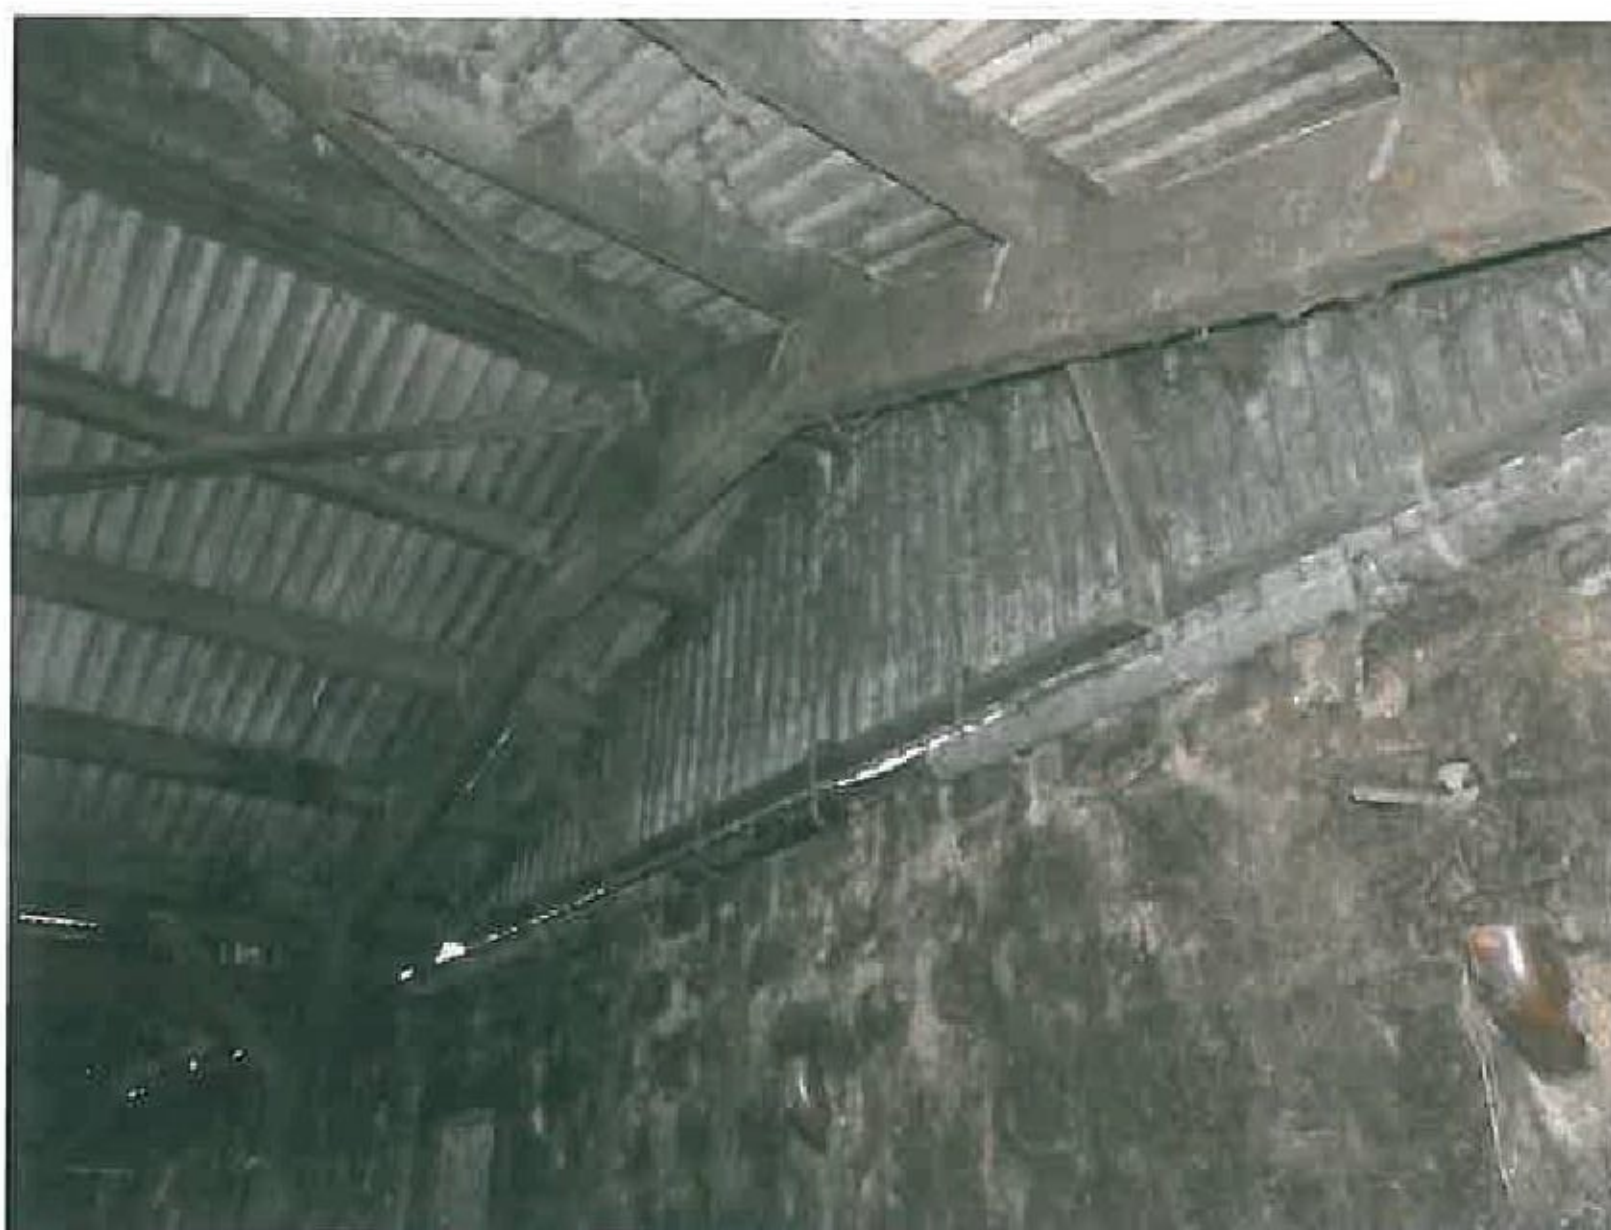
Timber portal Building 5

- 3.6 The timber portal frames forming the infill Building 5 have deteriorated in damp conditions and are affected by timber decay and wood boring insects.

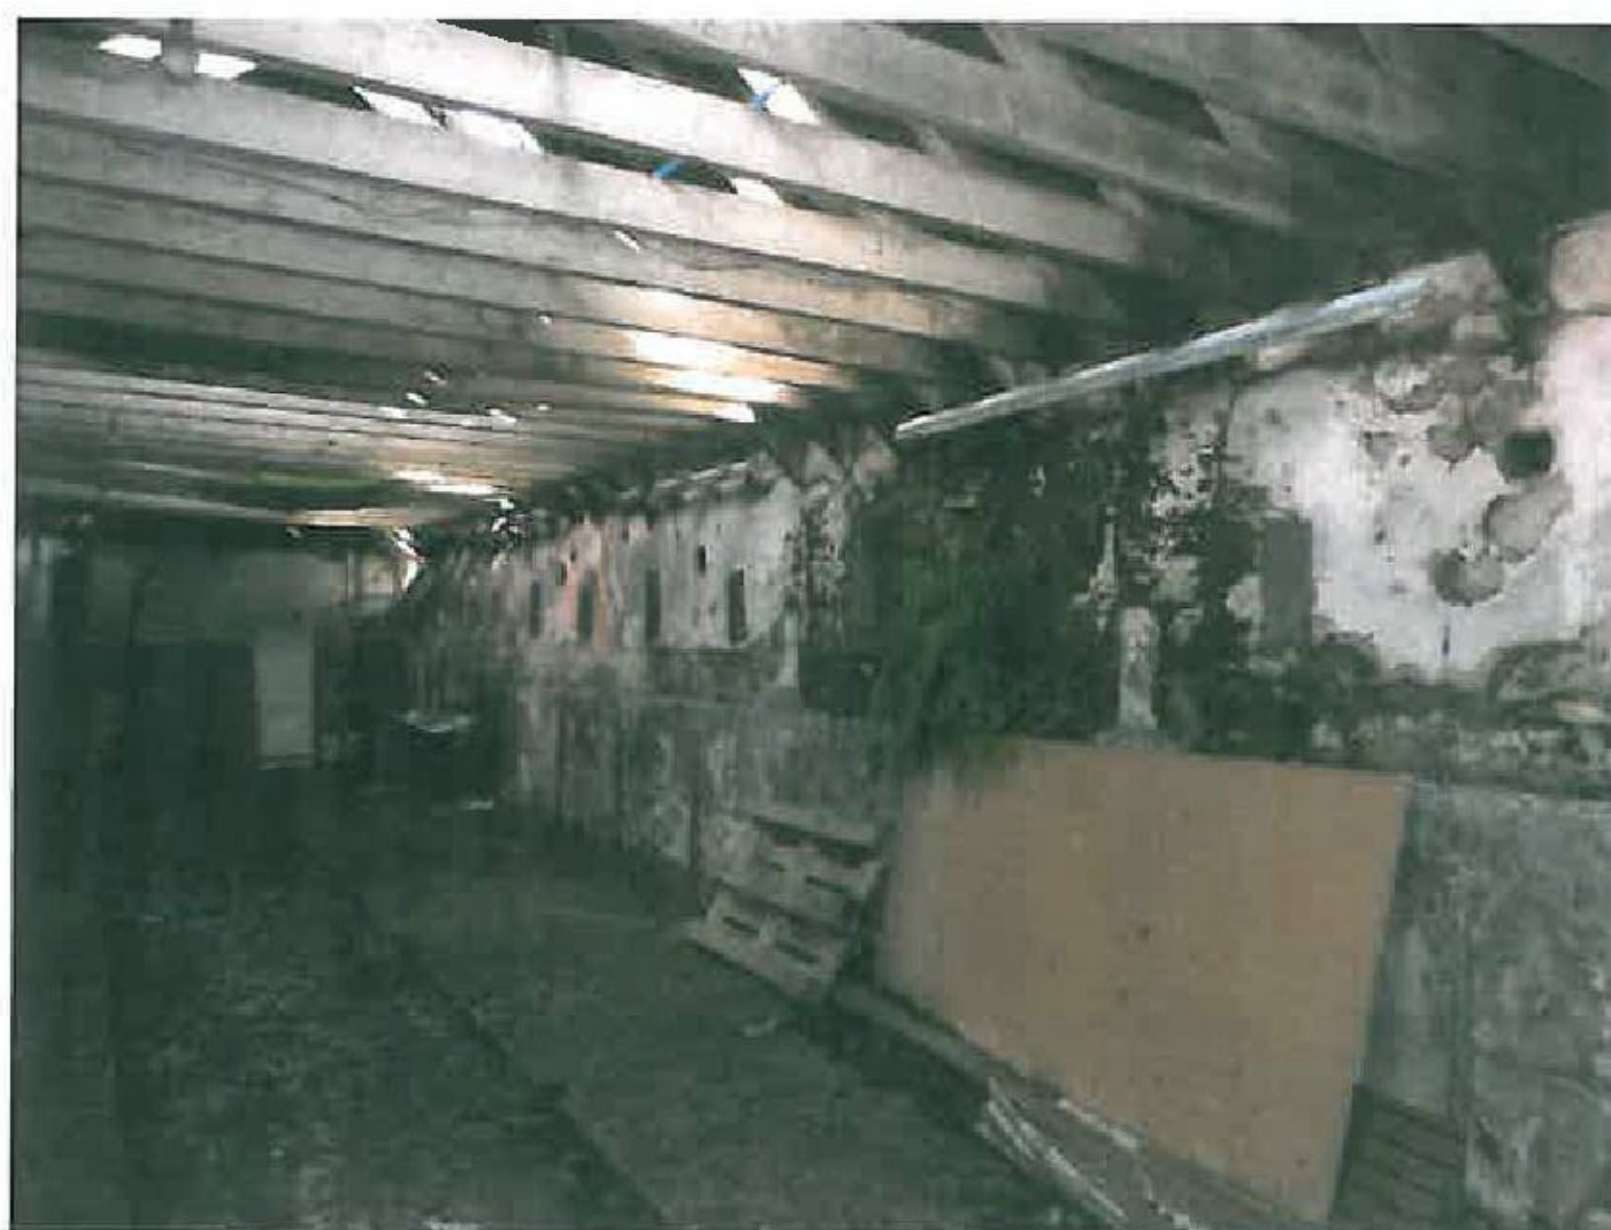
- 3.7 The timbers supporting the roof in Building 6 are affected by wet rot.

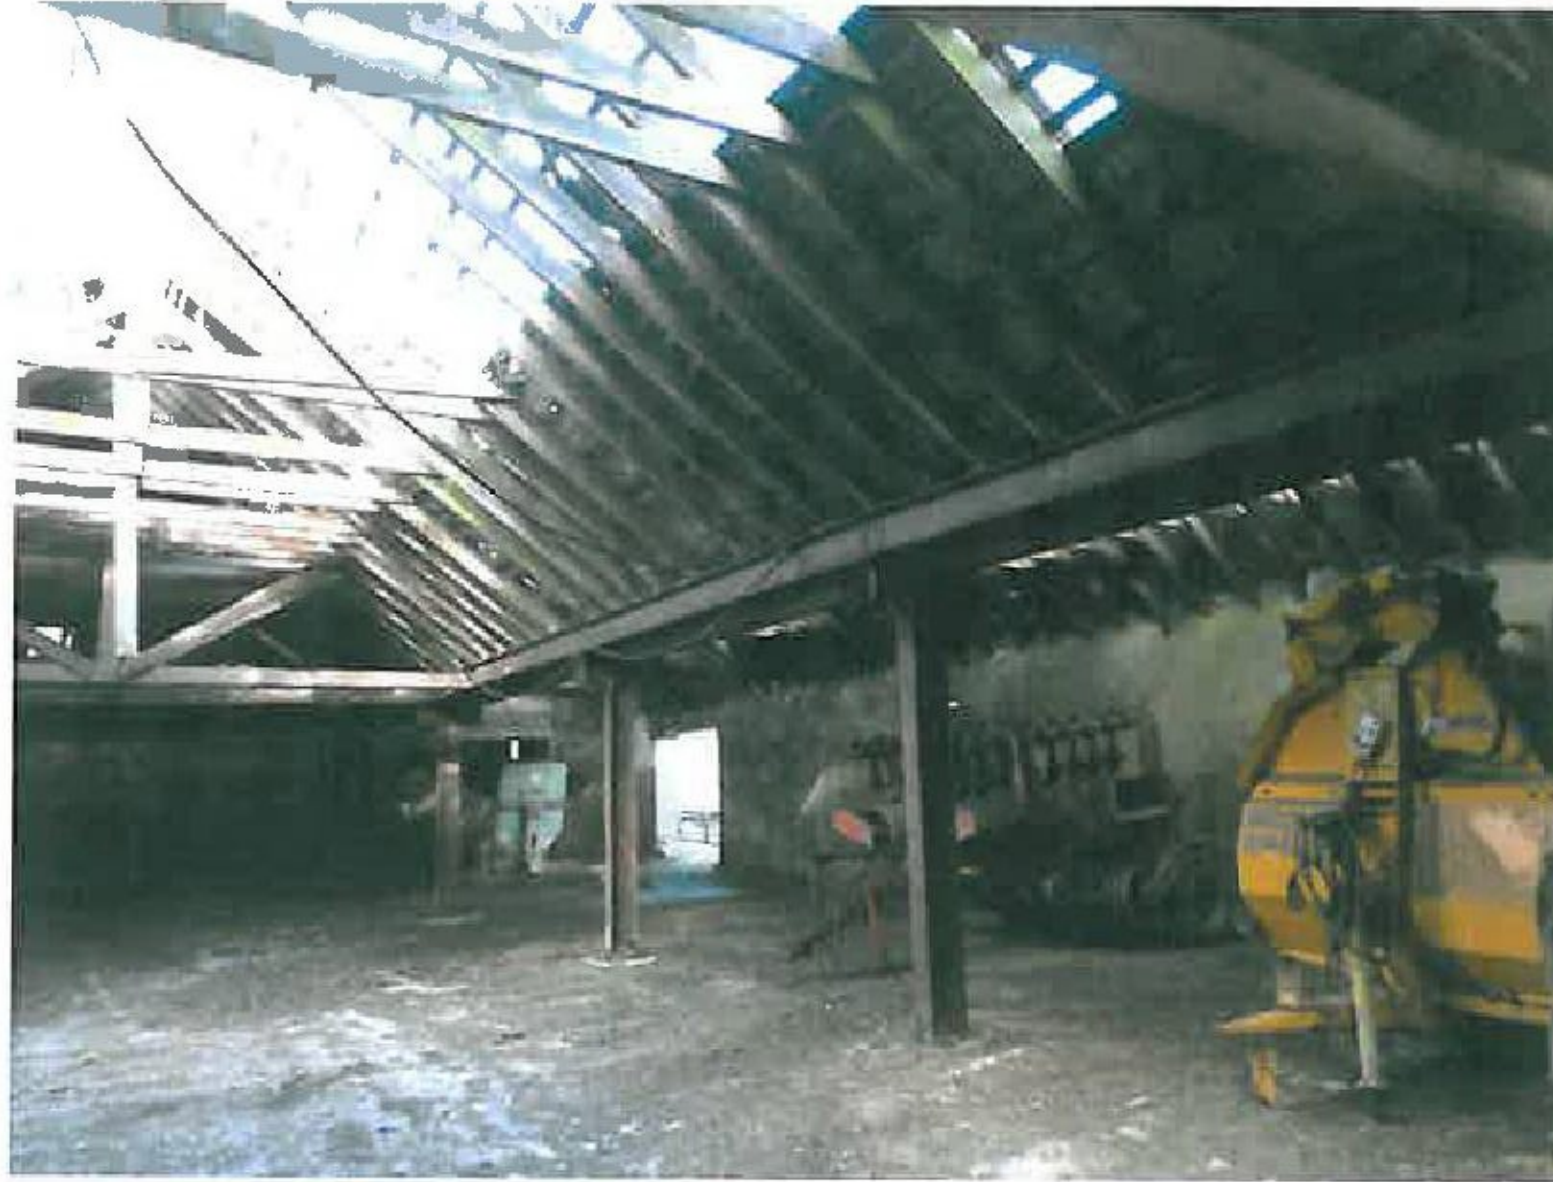
Steel supports between Buildings 7 and 8.

- 3.8 The roof structure to Building 7 has been modified with ceiling ties raised or removed, allowing the roof to sag. Significant areas of the roof have been stripped of slates and sarking and are also badly affected by wet rot.

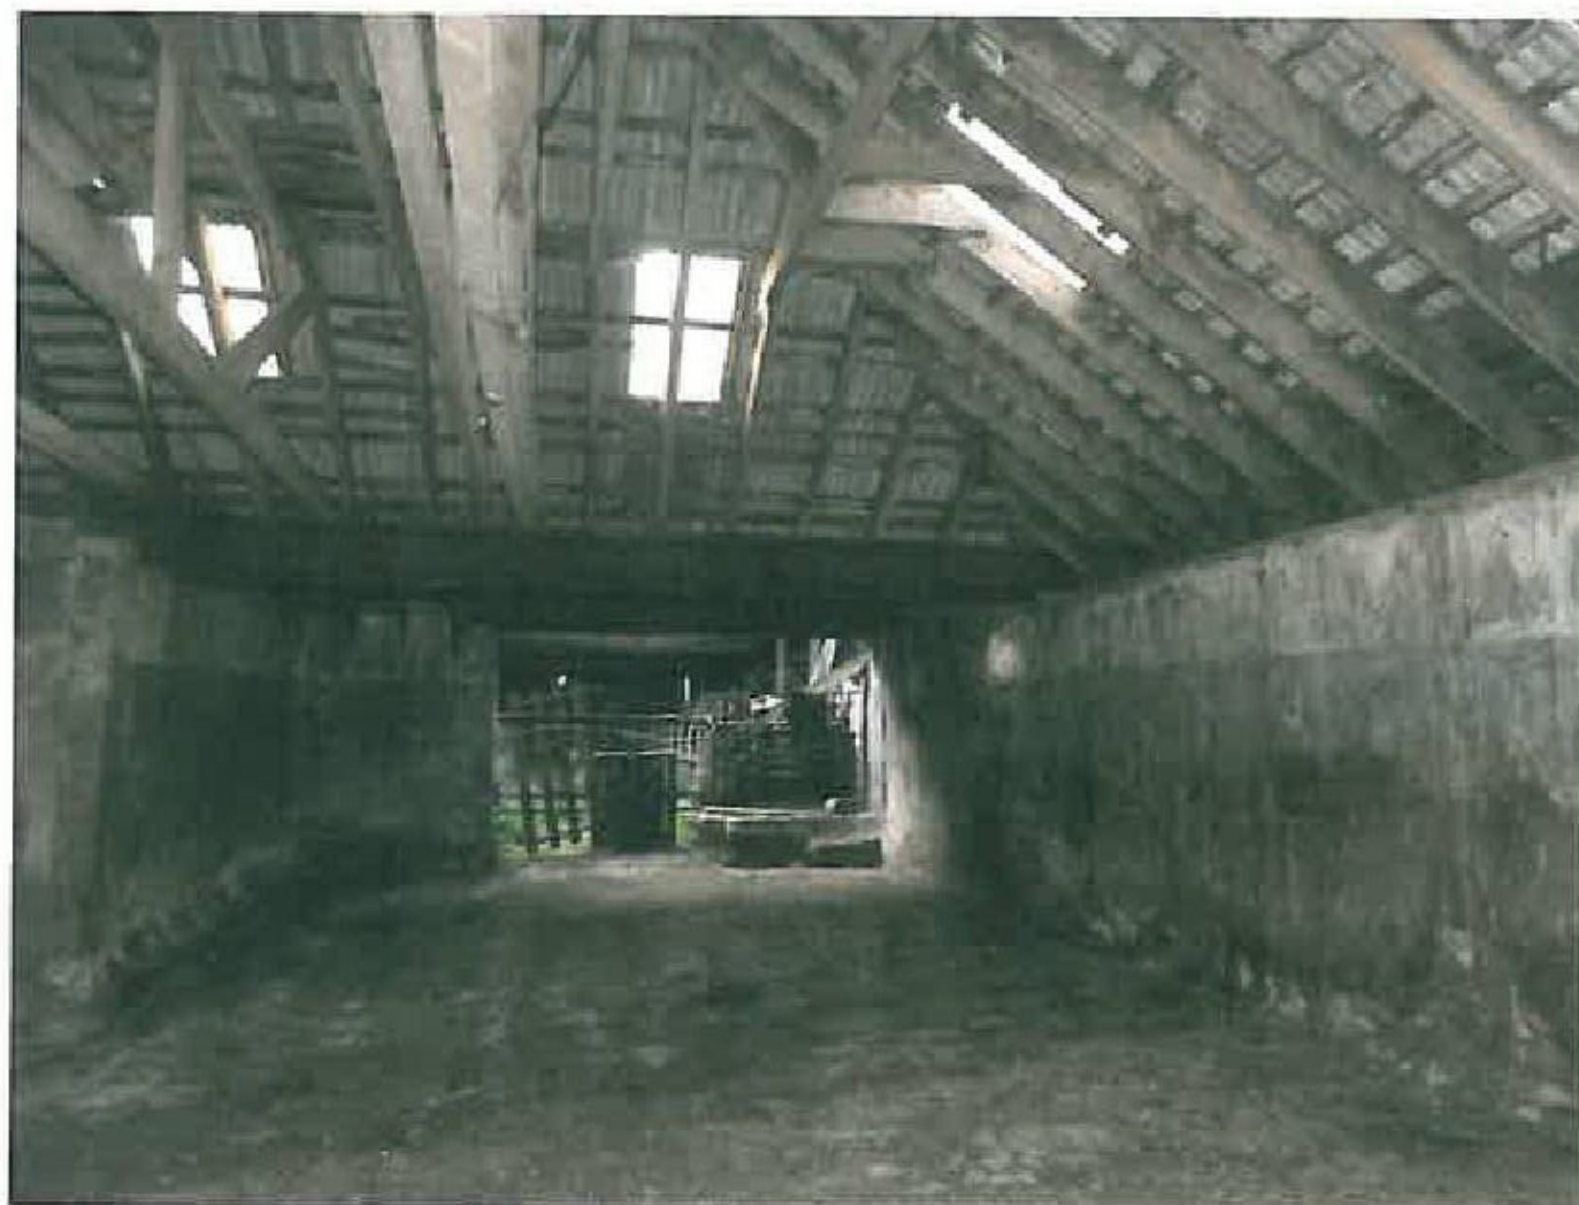
Inside Building 7 looking South into Building 3.
Note the collapsed section of roof at the end of Building 3.

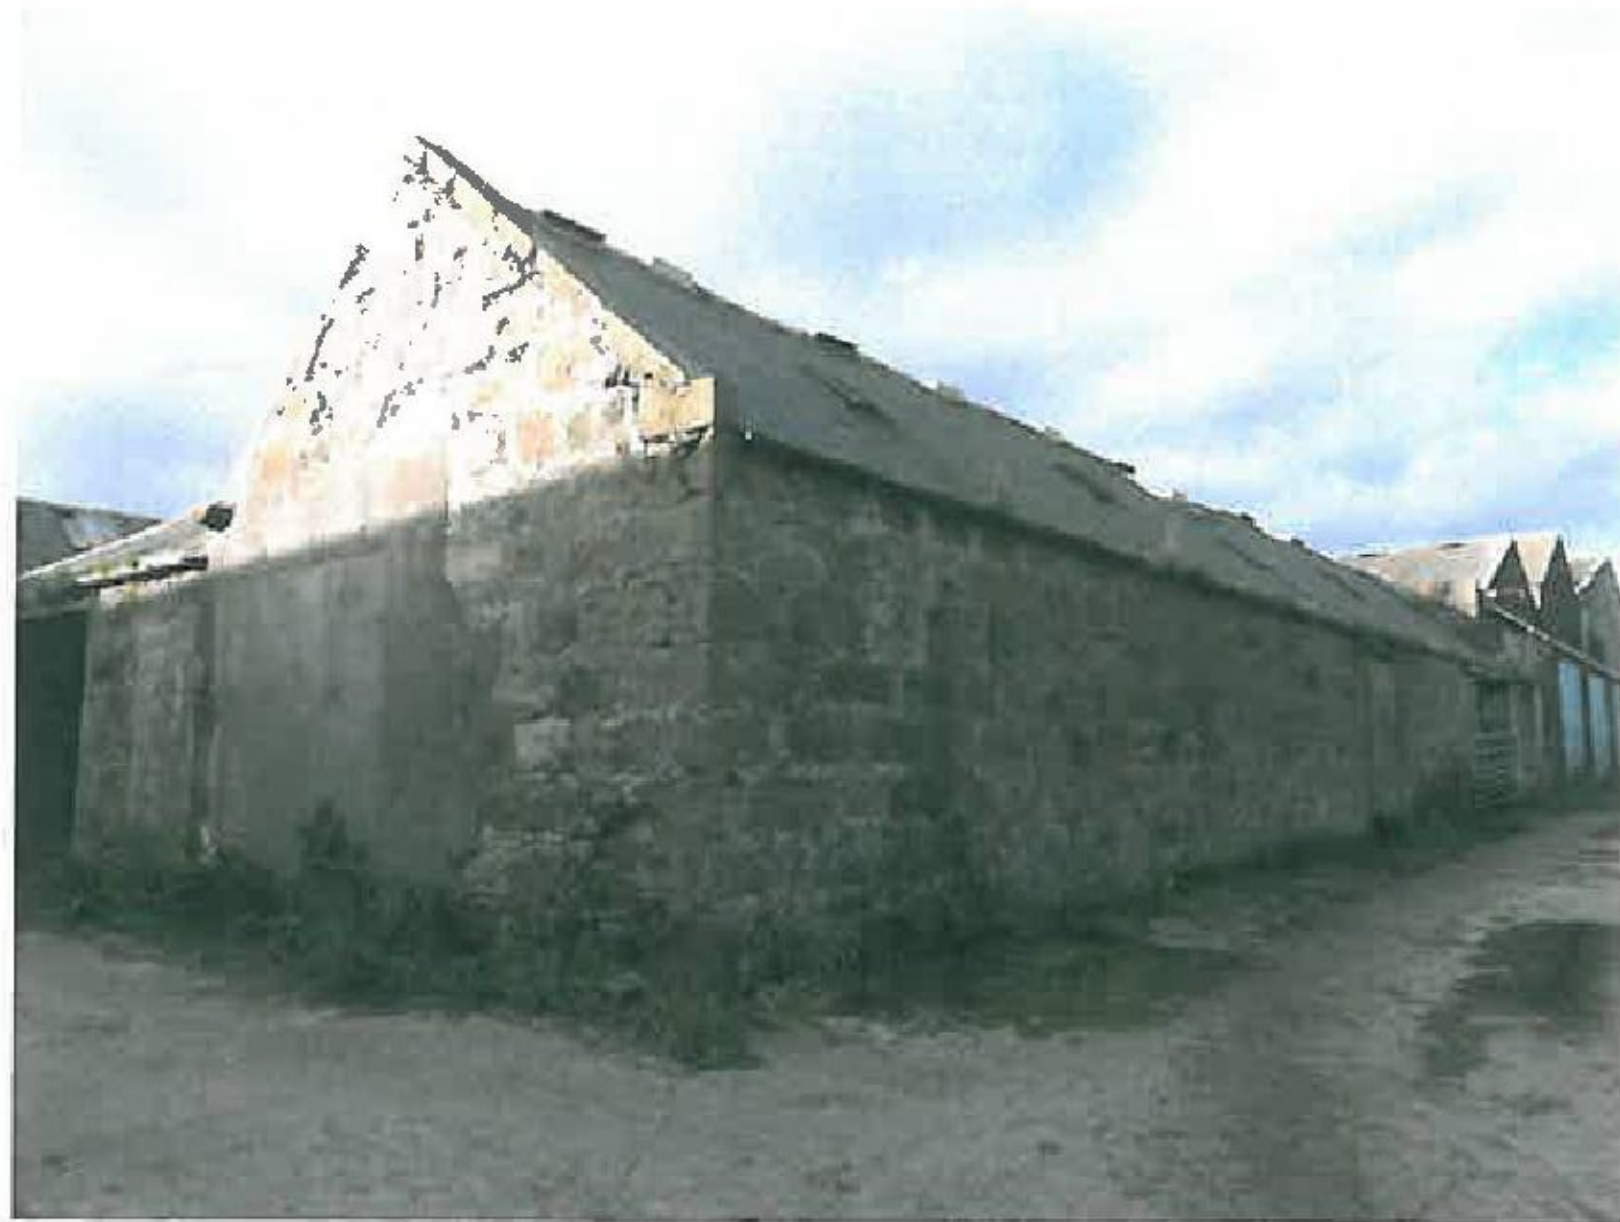
North East corner of Building 8

- 3.9 A large door opening in the East gable of Building 8 has been built up in blockwork. Foundation stones are exposed and the masonry is in poor condition.

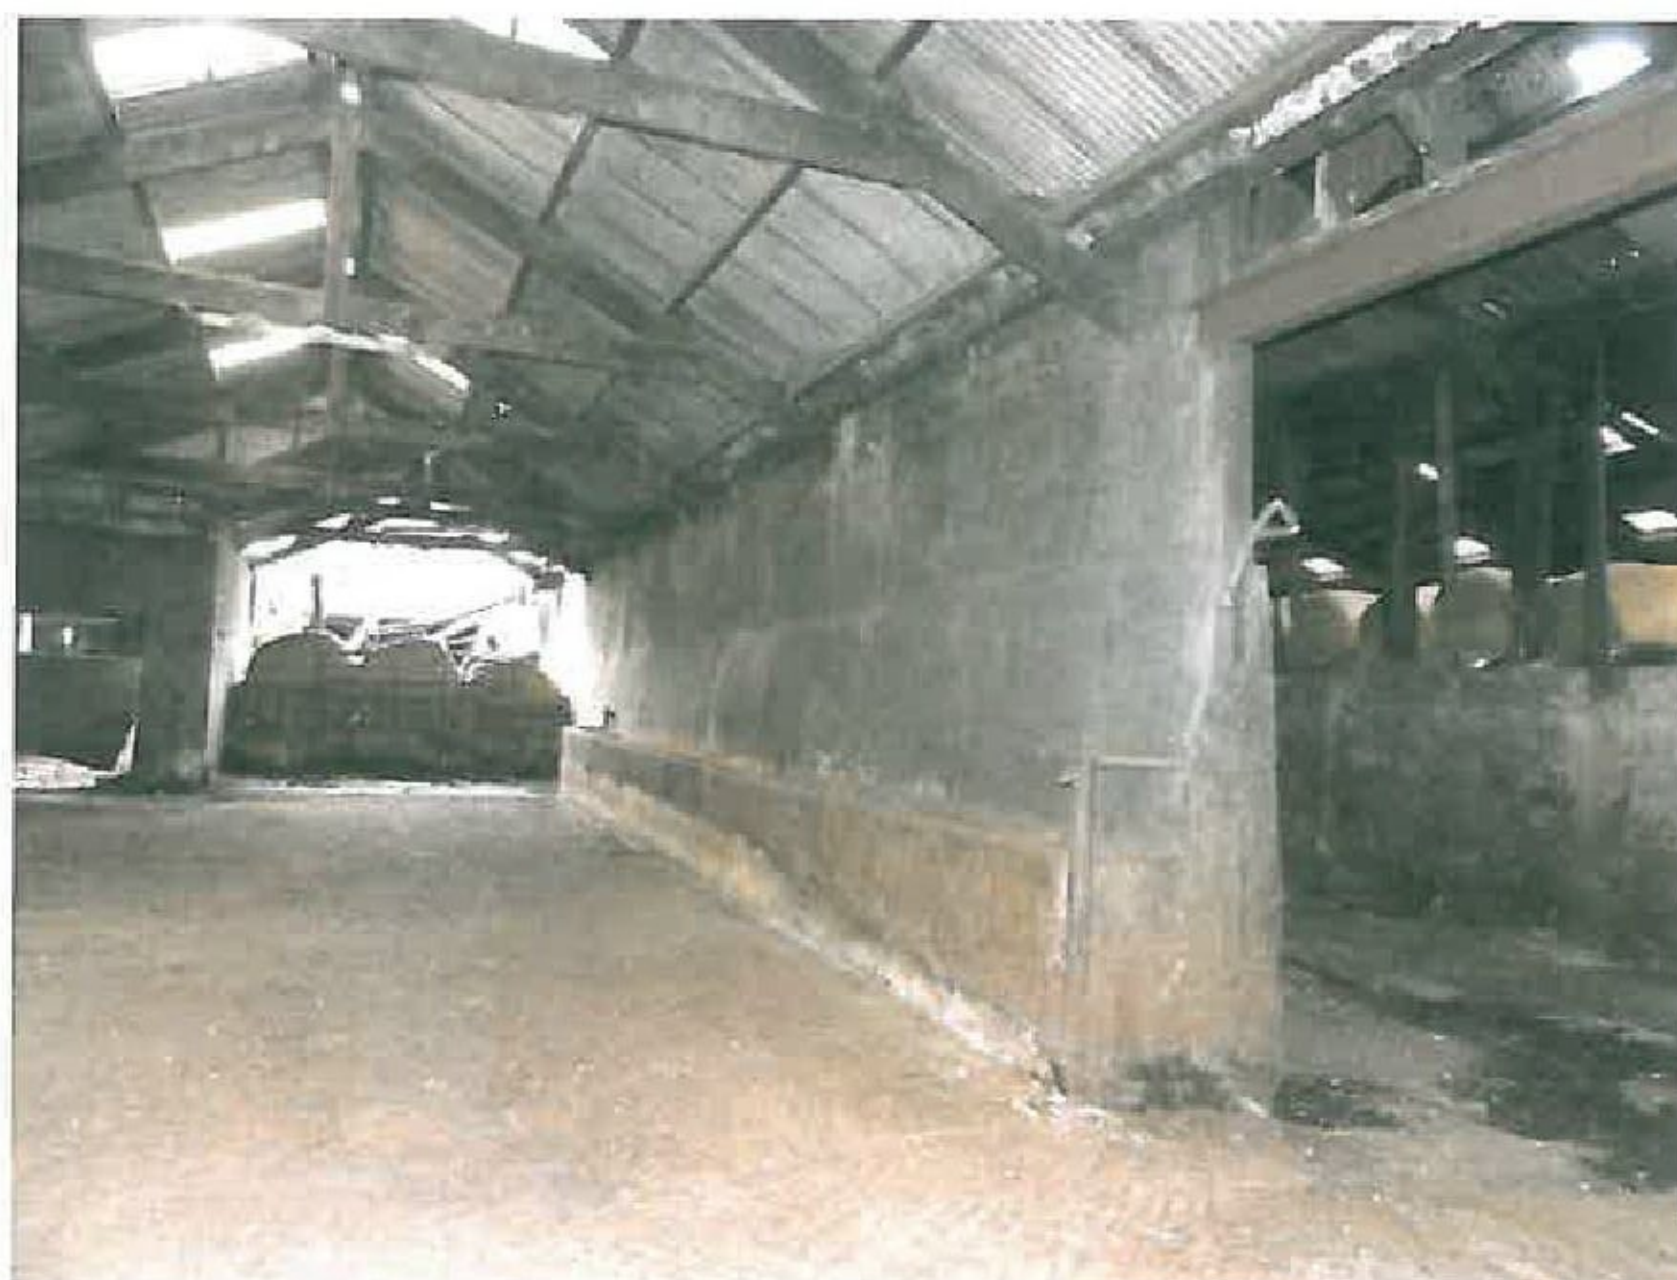
Building 9 looking South

- 3.10 Building 9 has timber trusses with purlins and an asbestos roof. A concrete wall forms the division between this building and the adjoining building to the West. Roof timbers are in poor condition allowing deformation.
