A/15873 – MAINS OF PORTLETHEN, ABERDEENSHIRE

STRUCTURAL INSPECTION REPORT

24th October 2016

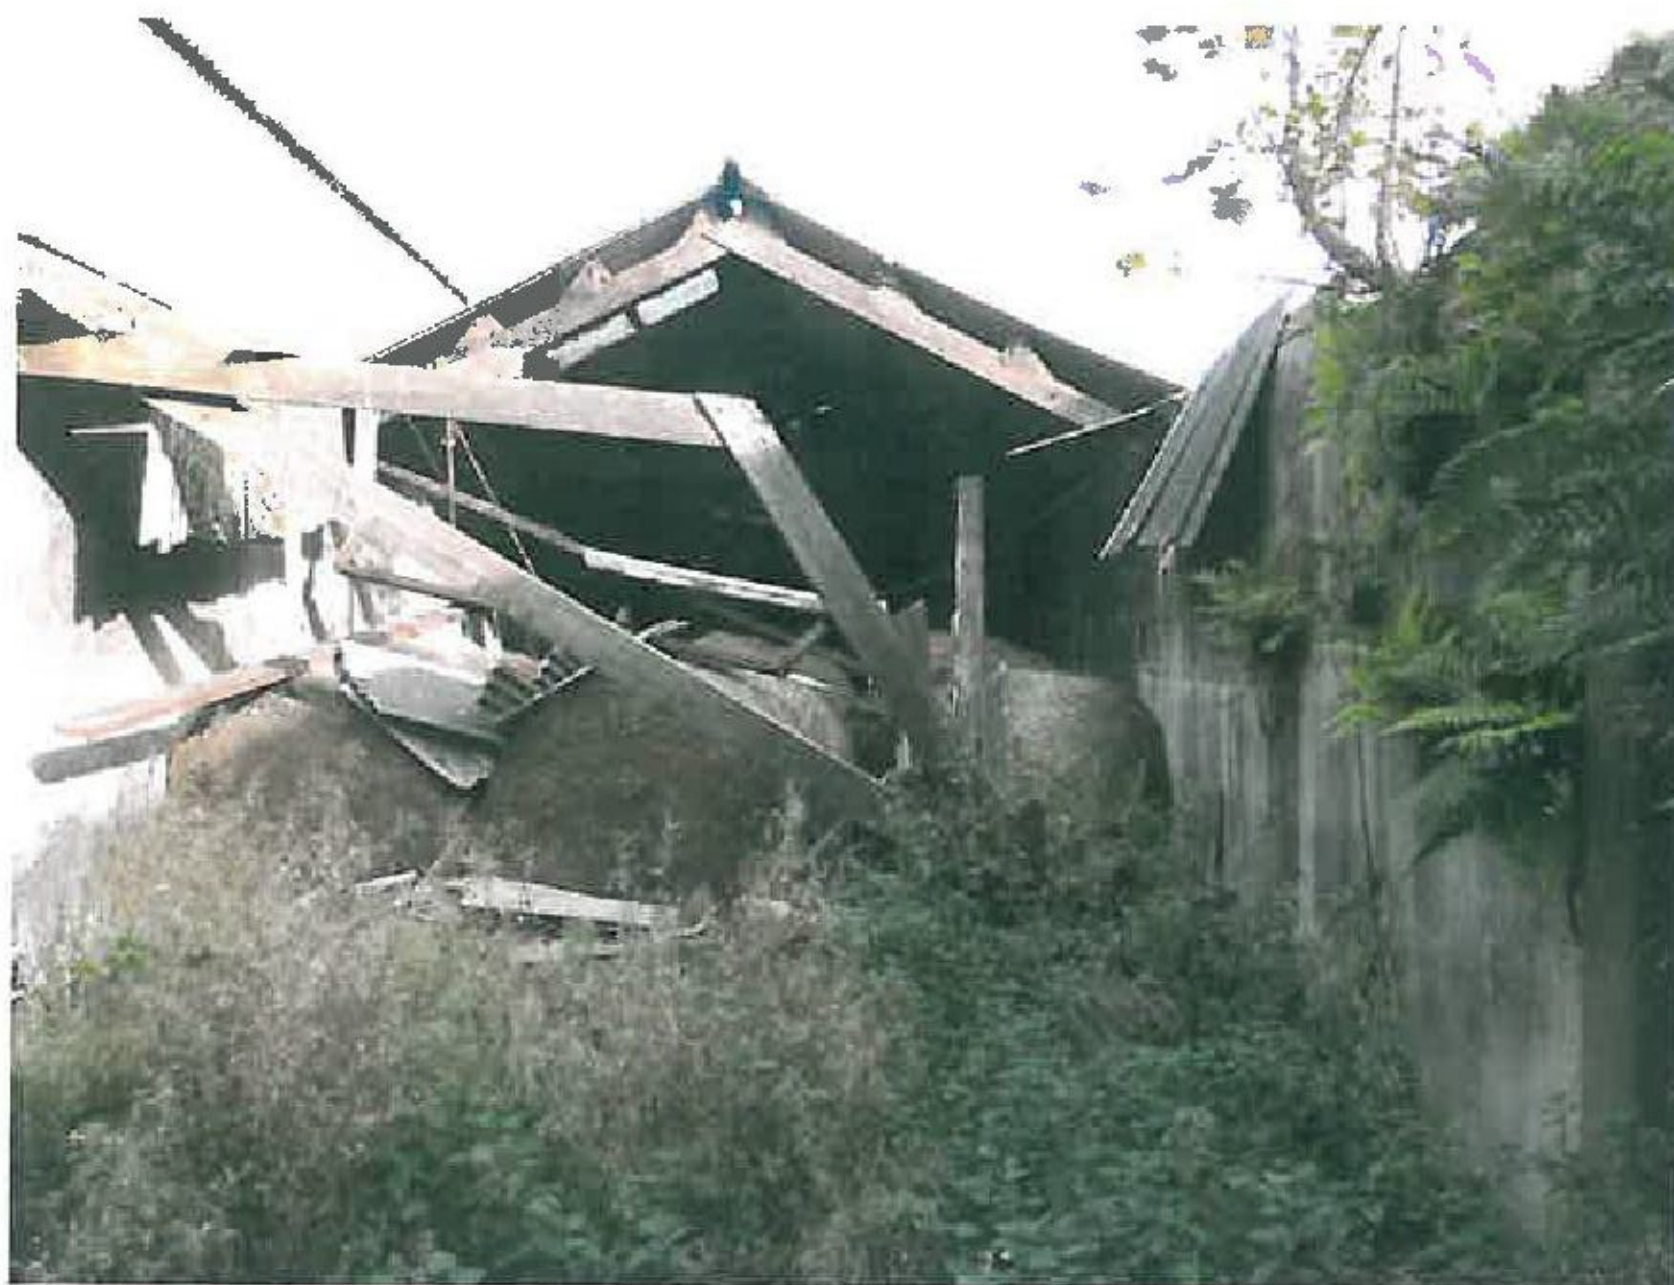
- 3.11 The roof of the infill Building 10 has already collapsed over a significant proportion of the building.

Collapsed Roof

Access to Buildings 2, 3, 7, 8 and 10 should be discouraged until such times as demolition can be carried out.
