**Phase I Site Investigation: Mains of Portlethen Farm, Portlethen,
Aberdeenshire, AB12 4QP**

Planning reference: Pre-planning enquiry for Planning Permission in Principle

Project no: ESL1664
Version no: 3
Status: Final
Date of Release: 26/09/16, 17/11/16(v2- rev site plan), 21/12/16 (v3)
Prepared on behalf of Mr & Mrs Graham Shand
Prepared by: H.McGregor
Released by: Dr Fiona Moore

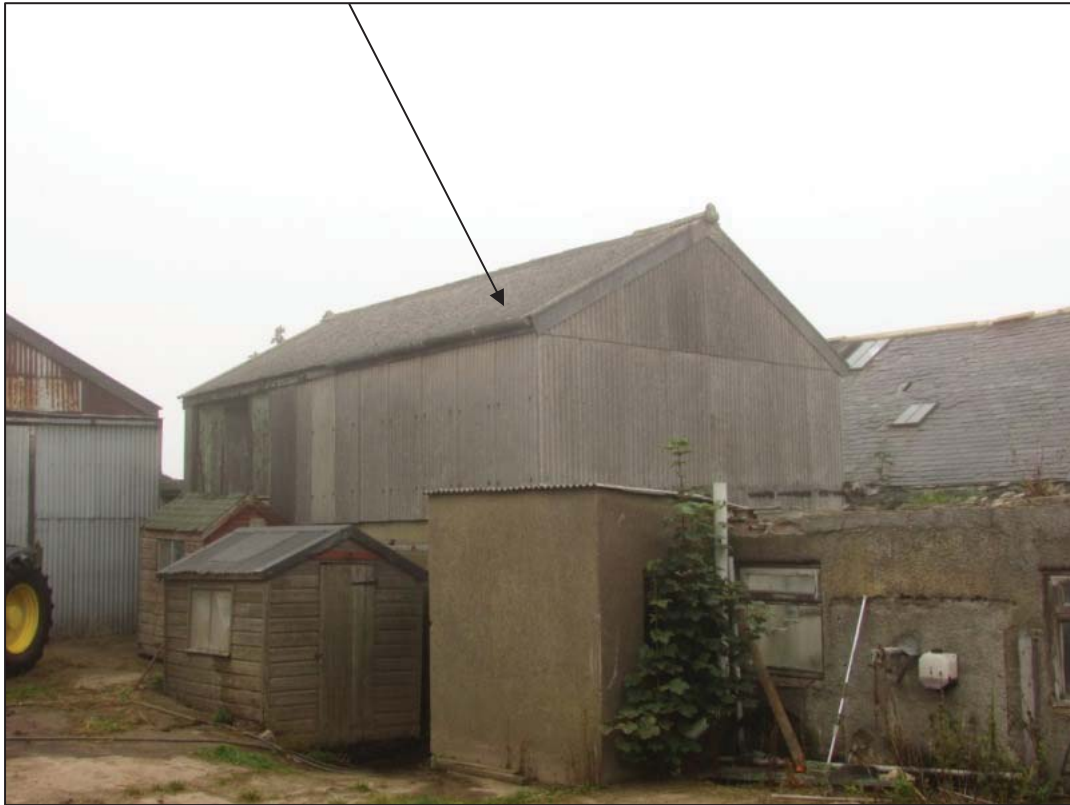
Building C was most noticeable as a tall building with probable asbestos containing sheeting forming the upper walls and roof. The lower halves of the walls are blockwork. Inside this building was the former small milking parlour. It was last used by the client's Uncle when he ran the farm some 20 years ago. The walls and ceiling of this building were lined with a fibrous sheeting which could contain asbestos, with some damage to this apparent. The building was intact however. To the south side of building C were the outer walls of a former building only. This provided a sheltered area for the storage of a modern green fuel station for red diesel. This had only recently been delivered to the farm. Adjacent to this was a small lean-to building (annotated D) which had block-work walls and an intact corrugated asbestos roof. It appeared to have been used as an outhouse.

3. Building C close up - asbestos upper walls and roof.

- Potentially asbestos containing roof and wall panels on the site should be removed carefully and double-wrapped prior to any other demolition works by a competent contractors. It should be noted that the corrugated roof sheeting and the wall panels inside the old dairy are likely to be of different types and may pose a different risk level. Handling and disposal of any asbestos containing material should be undertaken in accordance with current Health & Safety procedures, and disposal should at a licensed facility. Evidence of correct disposal should be retained. The ground around each building should be visually examined for the presence of small fragments.

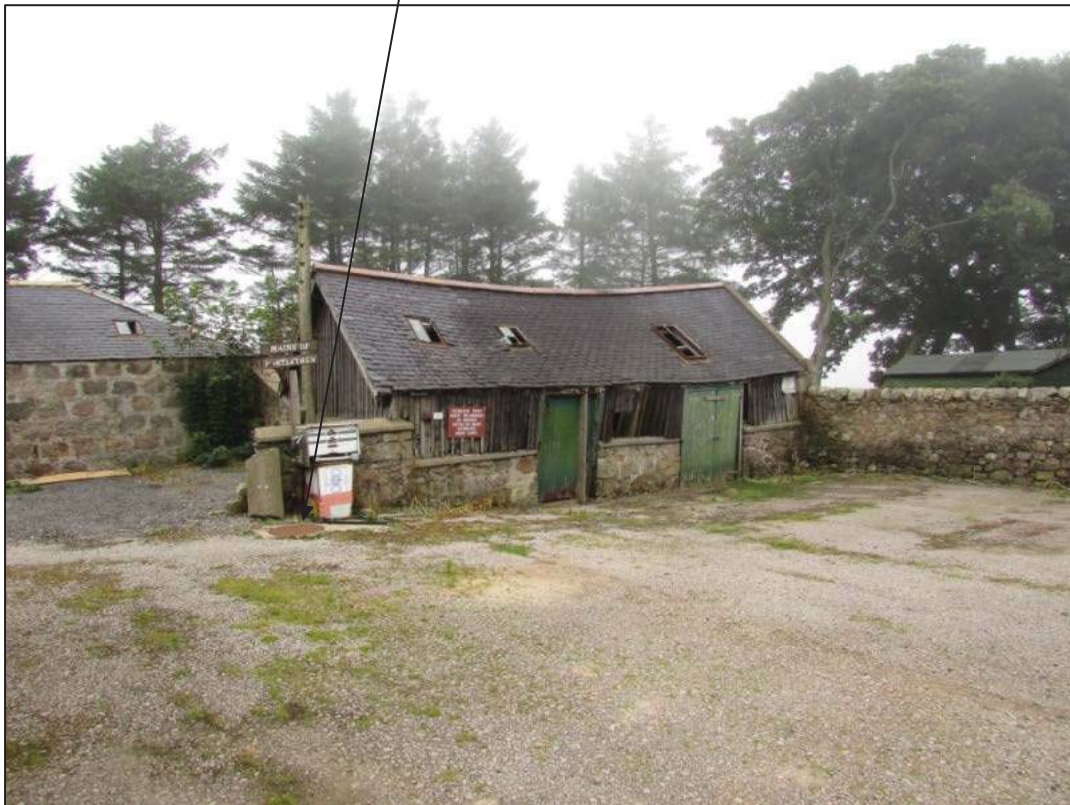
11. Building O with pump and tank cover.

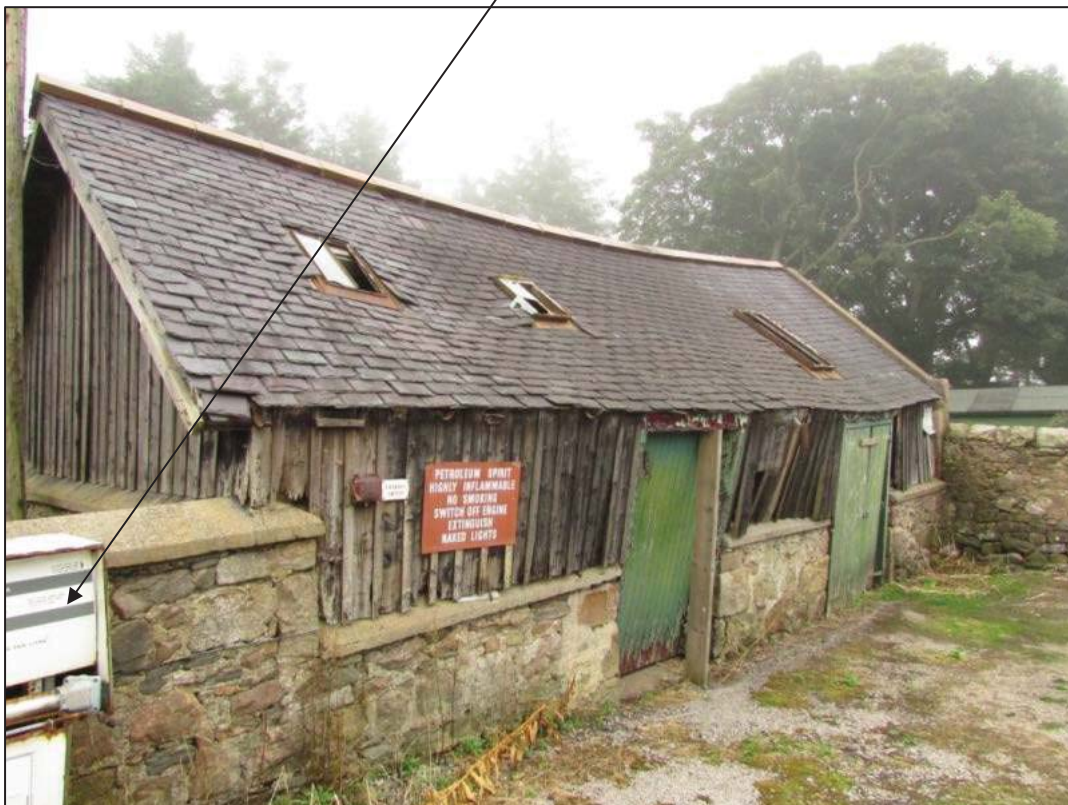
Building O was used for welding, and general workshop repairs, and so there is a potential for contamination. Given the poor state of the building this would merit a further visual inspection after demolition.

12. Building O in very poor state. Fuel pump located here and UG tank adjacent

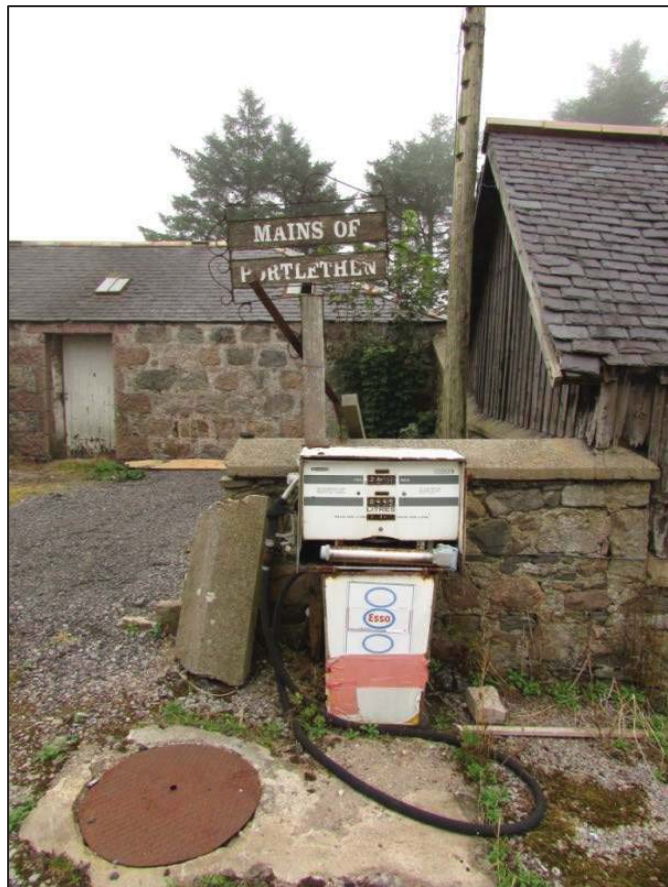
There is one underground fuel tank that is reported to be empty now, and its associated pump, but this tank has in the past held petroleum (1971 - 2005) and after that time, diesel. There is always an associated risk of fuel spillage or leakage from fuel tanks and pumps. This can lead to TPH and metals in the soils.

There is a single underground fuel tank with its associated pump in the north east corner of the site. This has not been used to store fuel for around 10 years and is currently believed to be empty. However it was used to store petrol from 1971-2005. This is just beside a small building in precarious condition and therefore tank removal at this stage could be problematic. It is therefore recommended that following removal of the adjacent buildings this tank is decommissioned and vapour checked, prior to being extracted. The ground below the tank and around the pump, and potentially under the workshop building could then be checked for indications of fuel impact. There are no visual signs of surface spillages from the dispensing pump and no records of spillages/leakages.

13. Fuel pump with manhole cover to UG tank seen at west end of Building O.

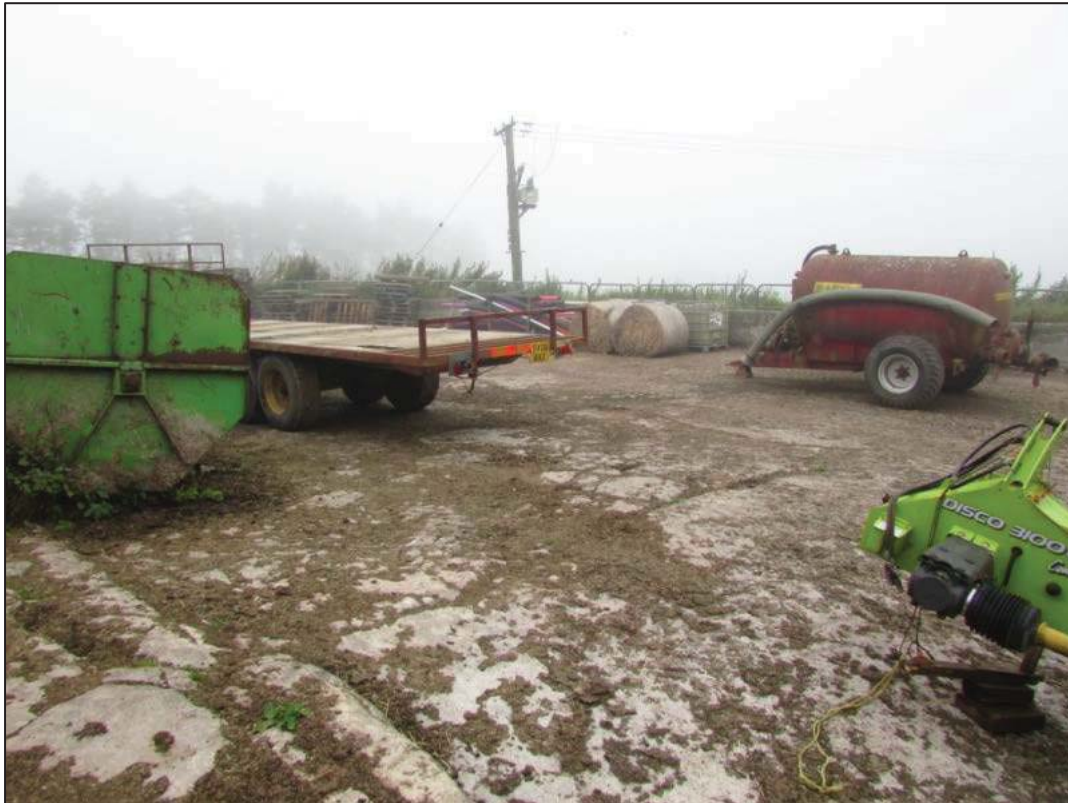
To the north side of the site, and within the planned site boundary, is an area known as the slurry yard. It is now used for storage but was originally where the slurry and soiled bedding was scraped and stored from the cattle sheds. This is concreted with a slight depression in the centre to prevent run off. The outside is penned with metal bars. The concrete appears to be in good condition but with a few cracks visible in some areas.

19. Storage yard at north end of site is all concreted

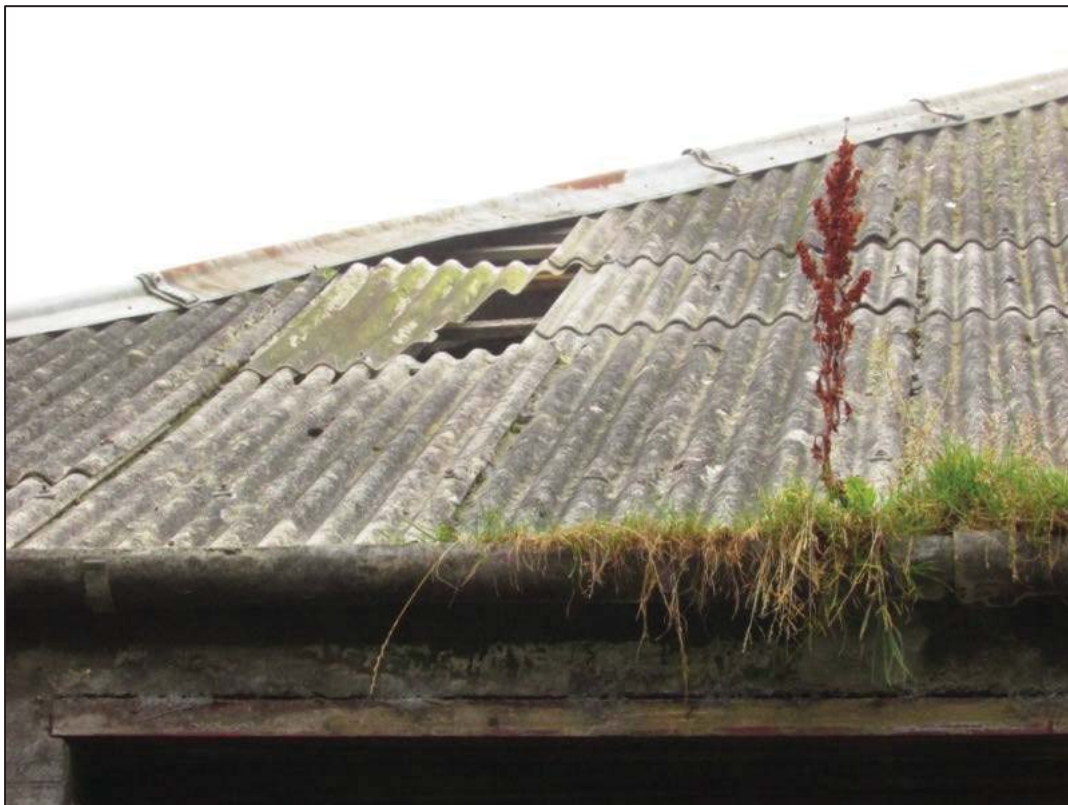
22. Building G - missing roof sections throughout.

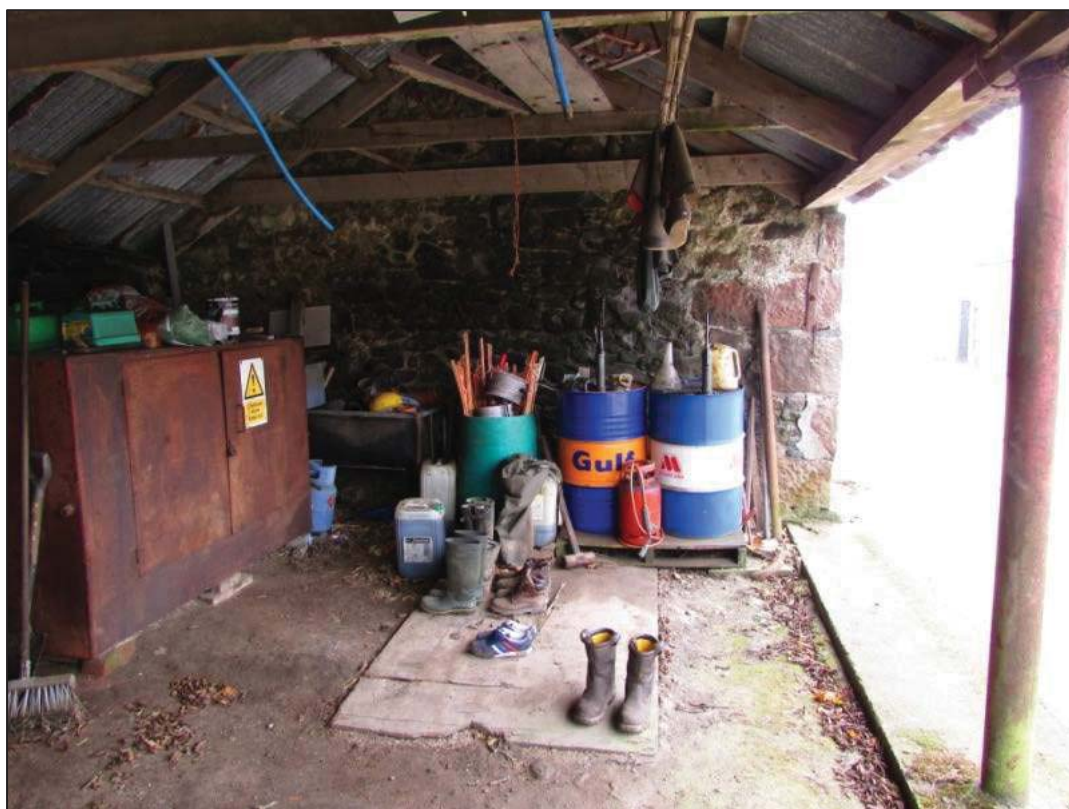
There are agricultural chemicals stored in the chemical cabinet in building A. However this is in good condition and has a spill proof design with inner capacity in the base. The client reports no accidental spillages.

27. Building A - chemical store at west end plus oil drums on pallets. No staining.

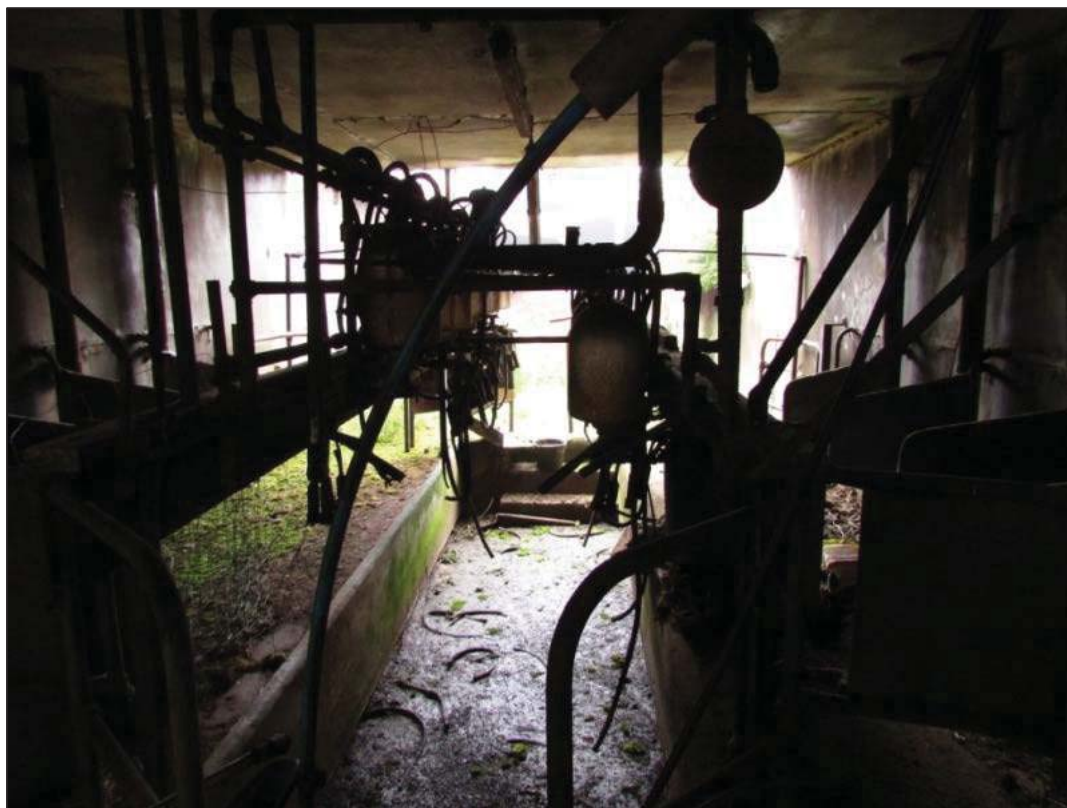
29. Building C - small milking parlour/dairy with asbestos roof, walls and possibly inside lining.

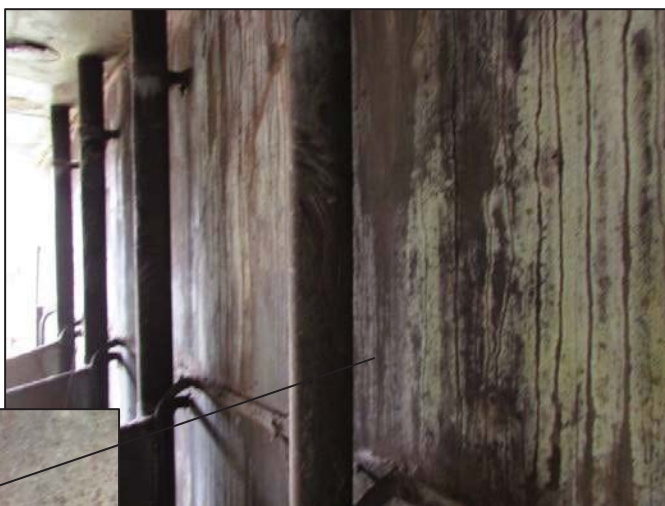
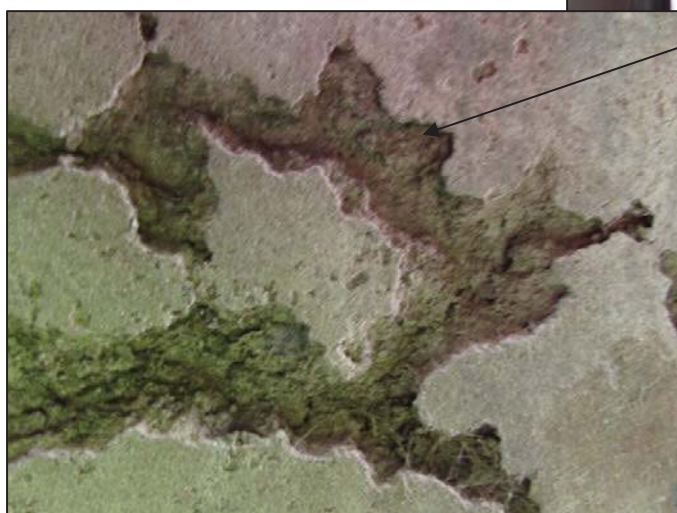
30a. Building C - internal dairy walls are clad in sheeting, which may contain asbestos.

30b. Building C- internal walls on former dairy may contain asbestos.

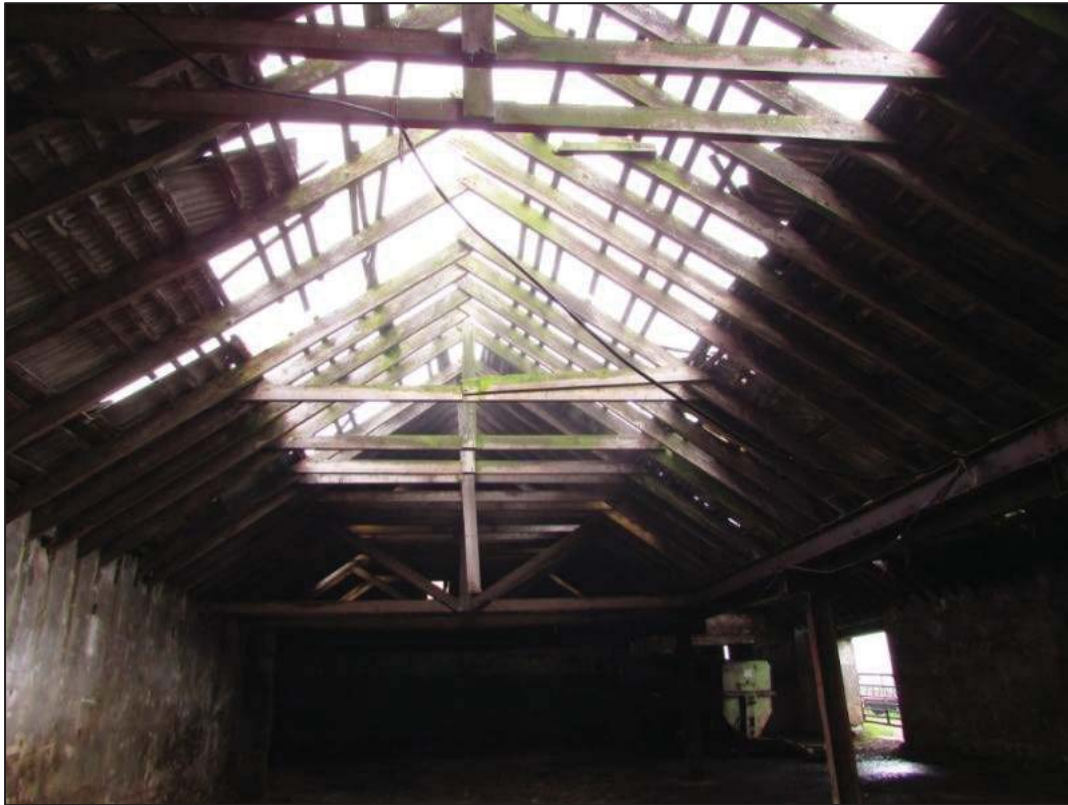
37. Building G - large sections of asbestos roof gone.

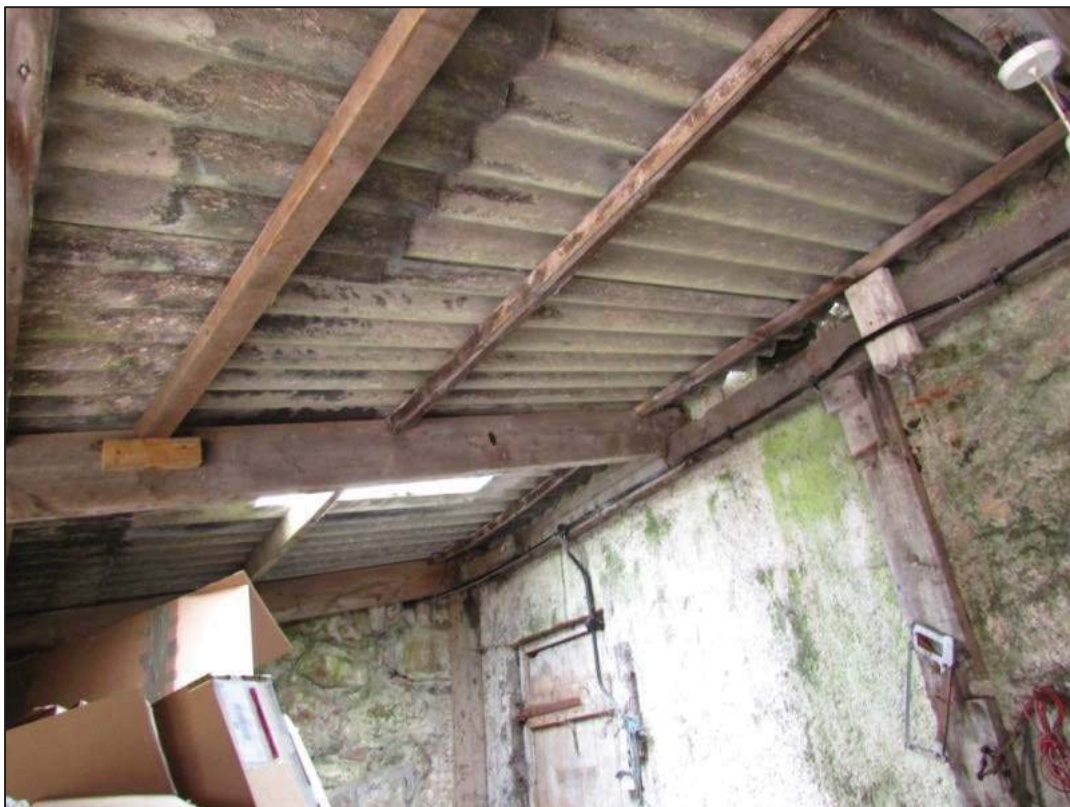
43. Building M - asbestos roof sheets seen from inside. Intact.
