K WING OUTER BOUNDARY WALL

PROJECT
K WING BOUNDARY WALL
OXFORD UNIVERSITY PRESS
GREAT CLARENDON STREET
OXFORD
OX2 6DP

DRAWING TITLE
PROPOSED REMEDIAL WORKS TO K WING BOUNDARY WALL
GREAT CLARENDON STREET

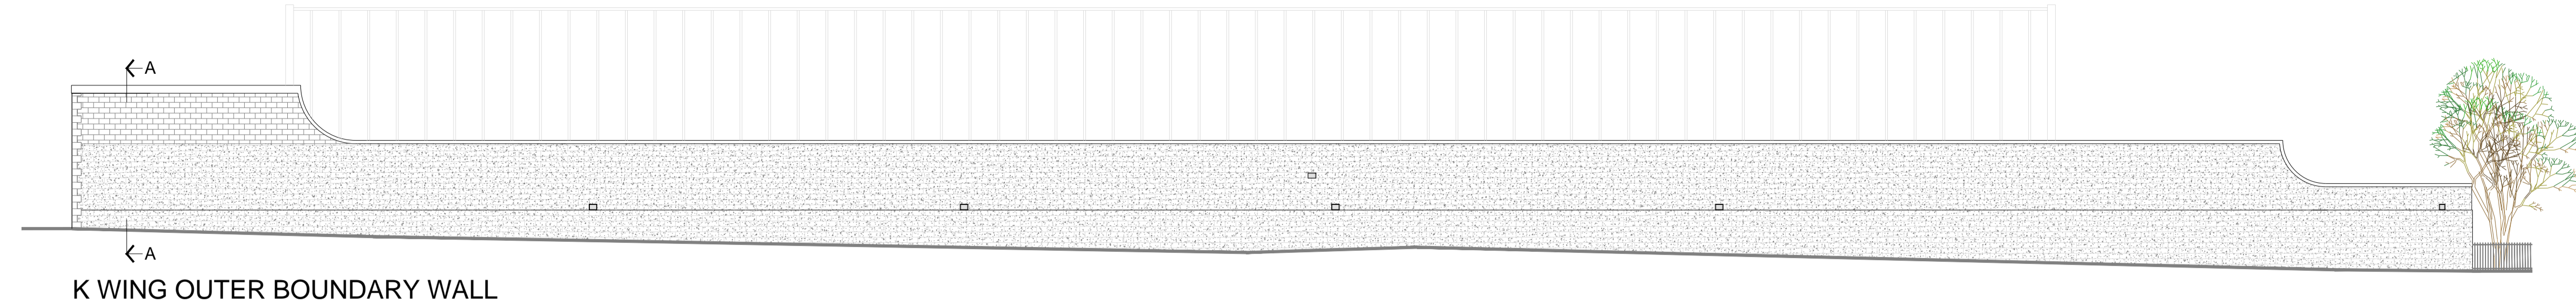
ELEVATIONS 1:150@A1

Copings
The central horizontal wall section copings have been replaced with in situ cast concrete, which is cracked and worn, with vegetation growth to it and the initial stone wall course below.
Carefully remove concrete copings and take off upper course of masonry.
Clean surfaces, remove vegetation and treat with suitable weedkiller.
Reinstate upper course of masonry.
Supply and install new once weathered Clipsham (or similar) stone copings, with drip throat to both wall faces, to match adjacent existing stone copings.

Repair methodology to be:
General
Tool back loose and friable stone surfaces due to Sulphates and rainwater action.
Tool back old cement/sand render patch repairs.
Indents
Generally caused by corrosion of fixings within the bed joints, resultant expansion of the metal and fracturing of the surrounding stone faces.
Broken stone to be removed; any corroded fixings to be removed and replaced with stainless steel.
Indent with new section of stone to match existing.
Replacement stone
Individual stone blocks beyond repair (estimated less than 5No to complete wall) to be carefully cut out and replaced with stone block to match existing.
It is envisaged that a suitable stone for indent/replacement work would be Clipsham; Conservation Officer to agree sample repair/indent.
Repointing
Remove any loose/cracked materials; rake out by hand and repoint in suitable lime mortar, to match existing colour and texture.

The stonework is to be Specialist cleaned and repaired by OG Stonemasonry Contractors Ltd.
A general visual Condition assessment of the stonework has been carried out by OG Stonemasonry.
Cleaning
The DOFF super heater steam system to be used to remove organic growth and kill spores.
The TORC system to be used to remove pollutants, sulphates etc.
Stone cleaning to:
a. Reveal the actual condition of the stonework where surface deposits are potentially concealing failed pointing, structural defects etc.
b. Slow down deterioration of the stonework caused by surface deposits,
c. Blend the existing stone with any localised repairs/indents,
d. Generally improve the appearance of the stonework.
Level of stone cleaning to be approved on site by Oxford City Council Conservation Officer.

The extent of stone repair/replacement and of mortar repair/replacement to be agreed on site by Oxford City Council Conservation Officer.
