## **04 MONTPELIER SQUARE - SW71JT**

LBMVarchitects - SITE INVESTIGATIONS PHOTOS - FLOORS AND ROOF STRUCTURE

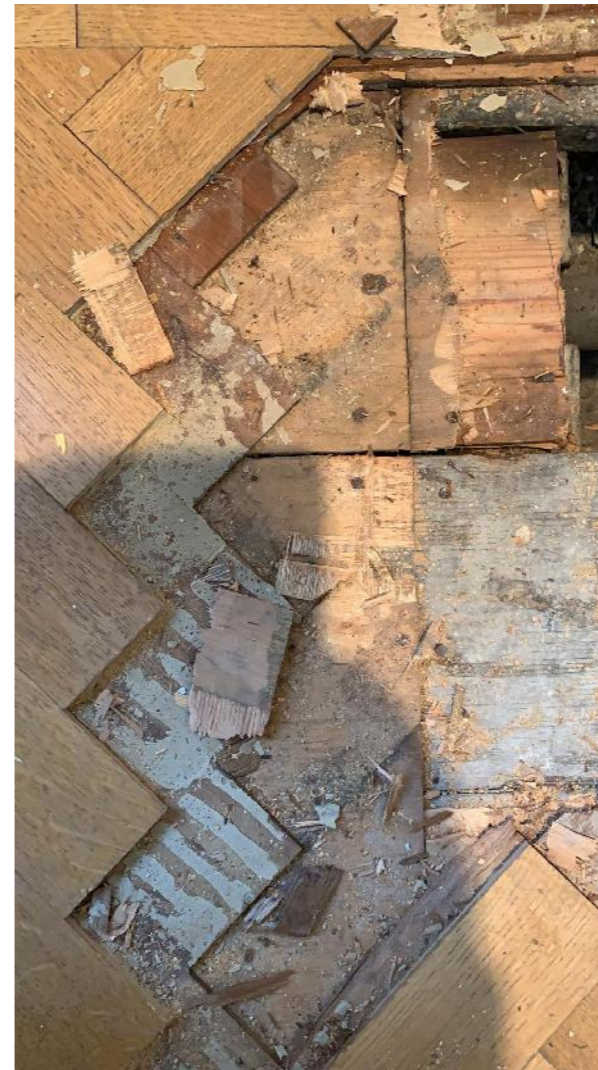
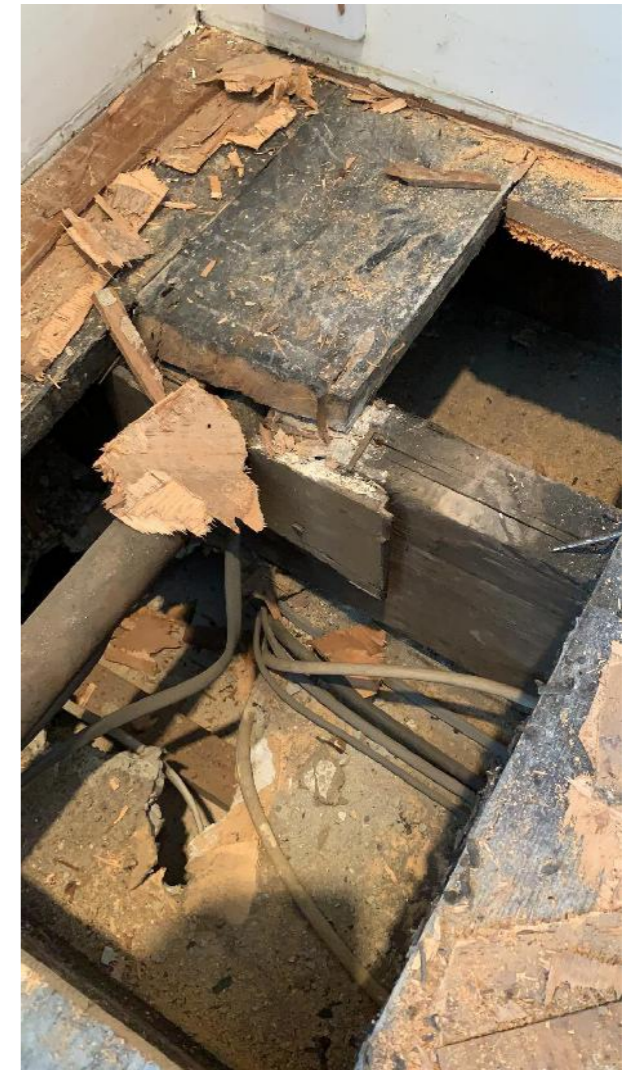
2 layers of Timber harring bone of recent manufacture  
1 Layer of Pine boards of recent manufacture mixed with some original boards on top of joists  
Joists 200X50  
Some damages to joists

Walls lined with plasterboard

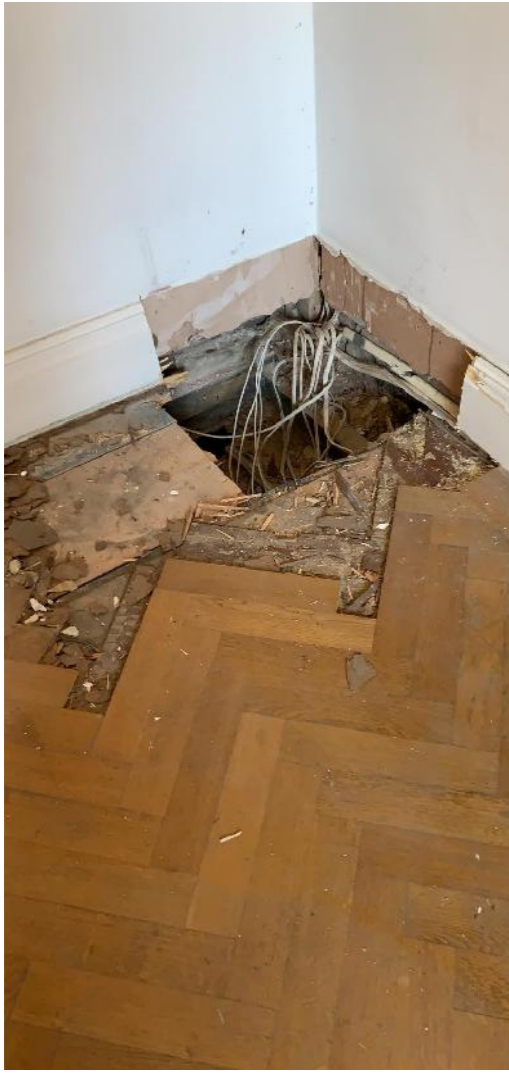
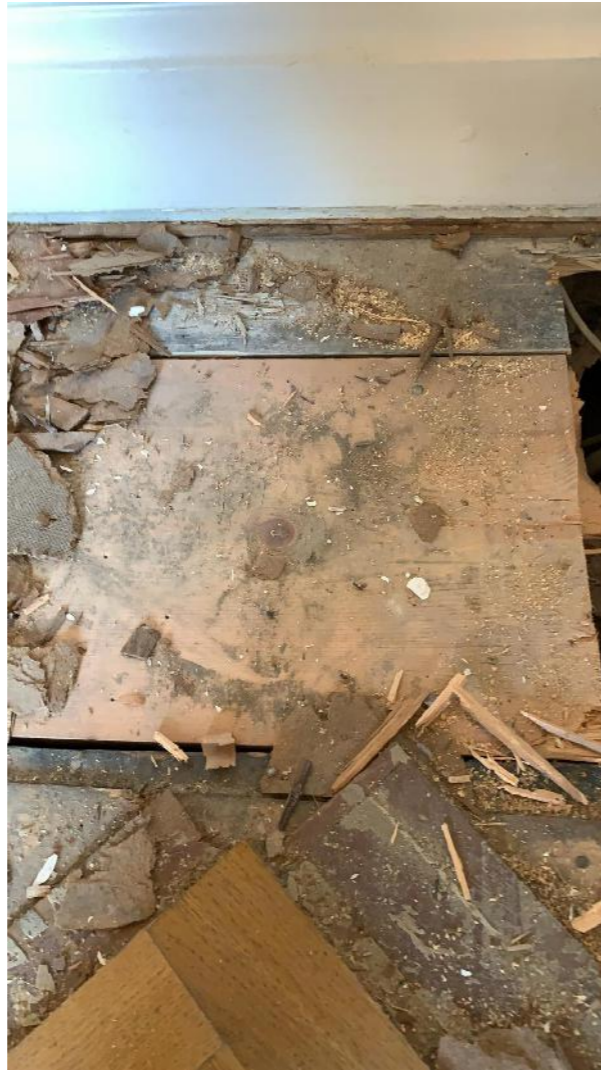
3

2 layers of Timber floor  
 1 Layer of pine boards of recent manufacture  
 Joists 200X50

Some Damages to joists

No Beam under middle wall

Walls lined with plasterboard

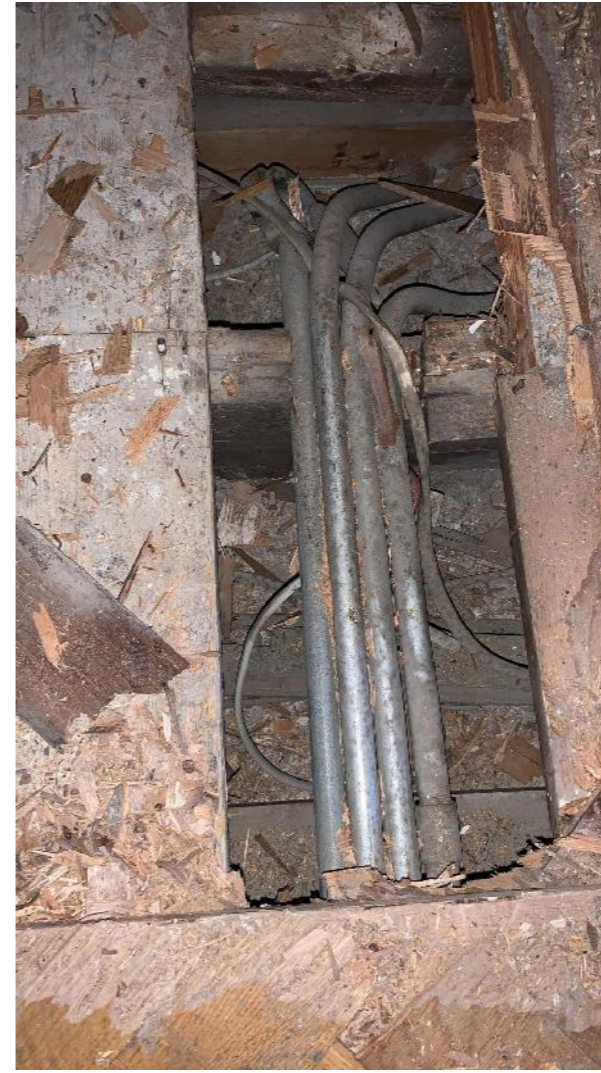
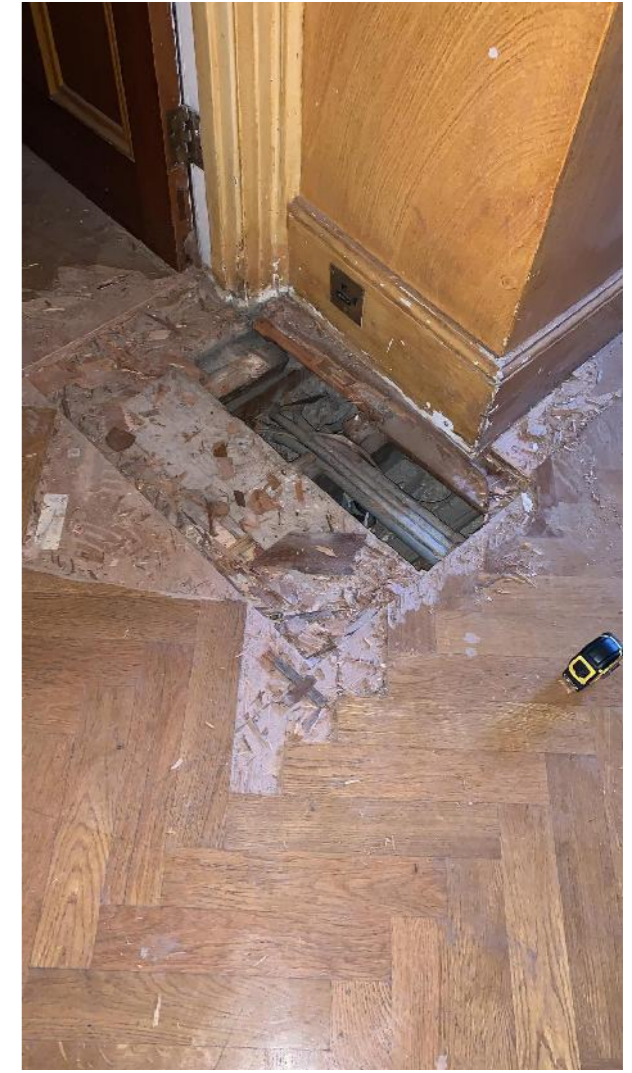
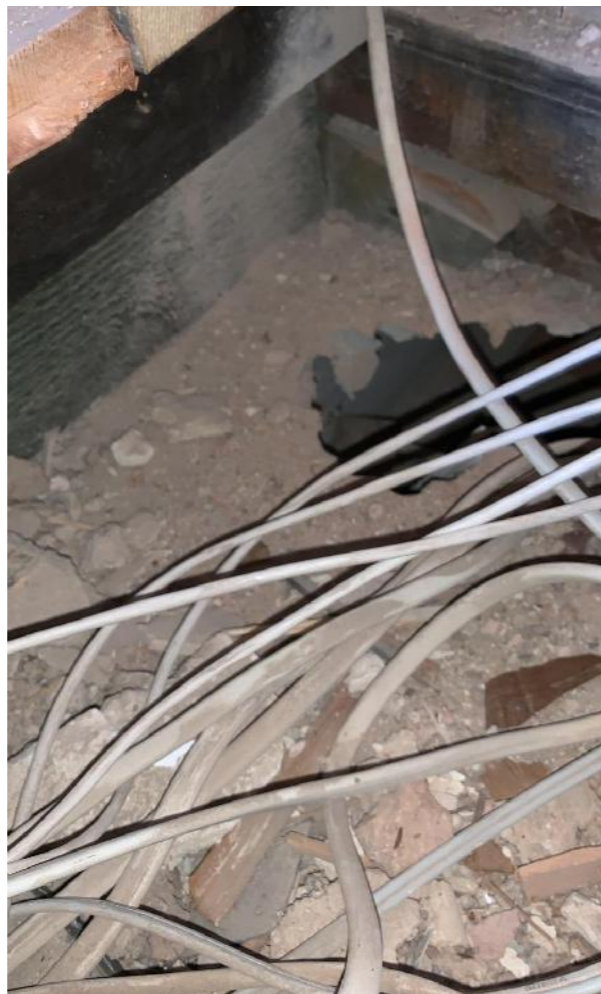
4

1 layer of Timber harring bone of recent manufacture  
 1 layer of Pine boards of recent manufacture on top of joists  
 Joists 200X50

Some damages to joists, possibly original

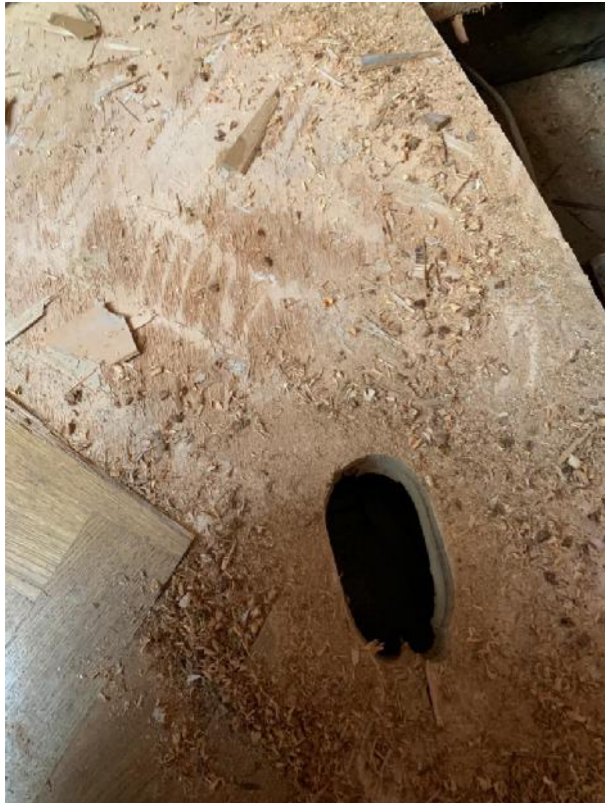
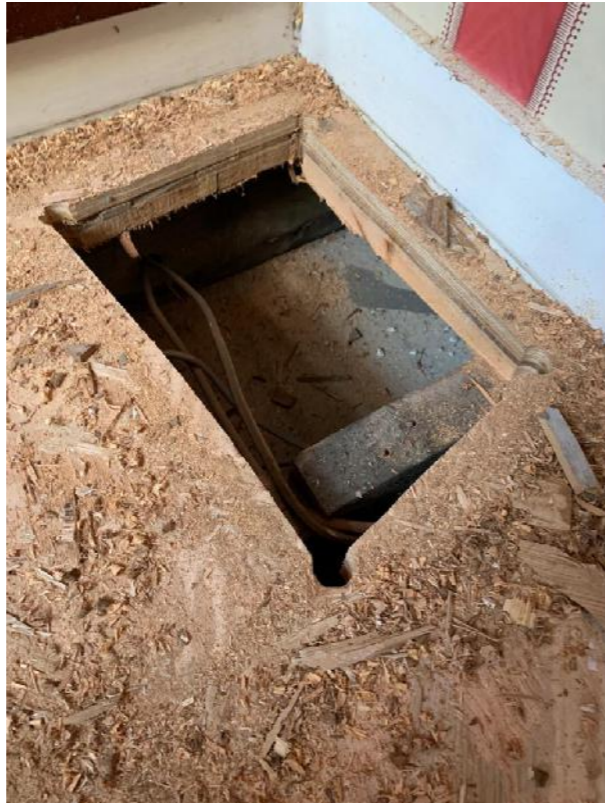
5

1 layer of Timber harring bone of recent manufacture  
 1 Layer of ply  
 1 layer of Pine boards of recent manufacture  
 Joists 200X50

Some damages to joists

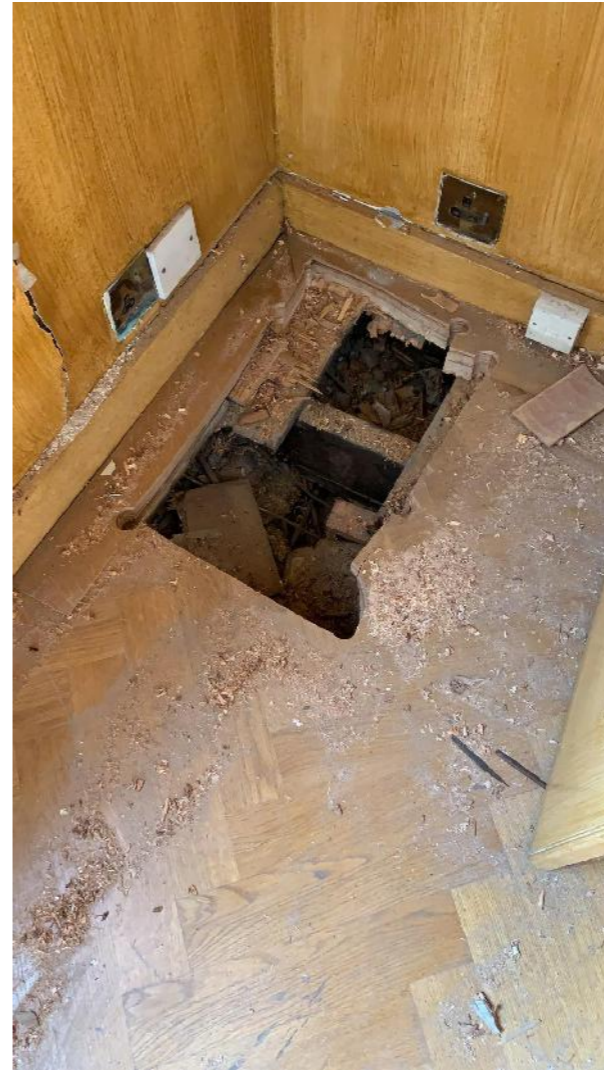
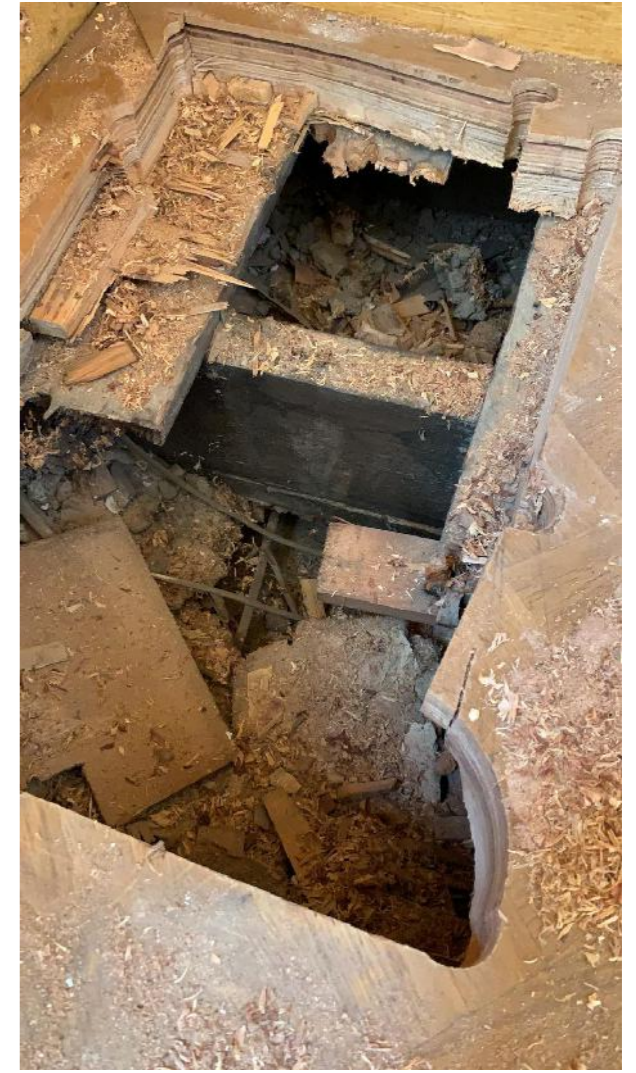
6

1 layers of Timber harring bone of recent manufacture  
 2 Layers of ply  
 1 Layer of Pine boards  
 Joists 180X40

Some damages to joists, possibly original

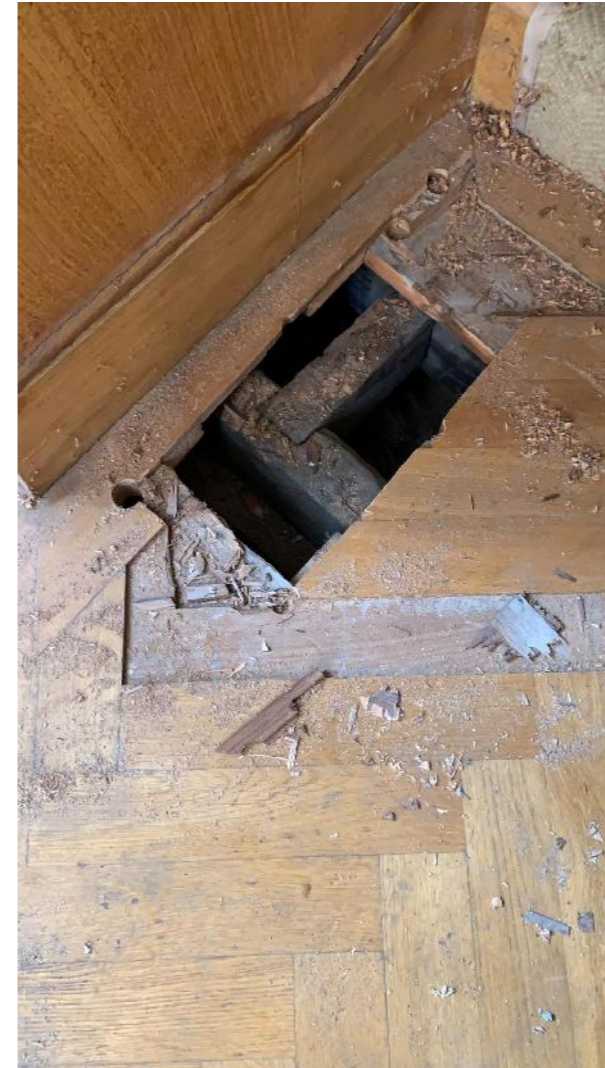
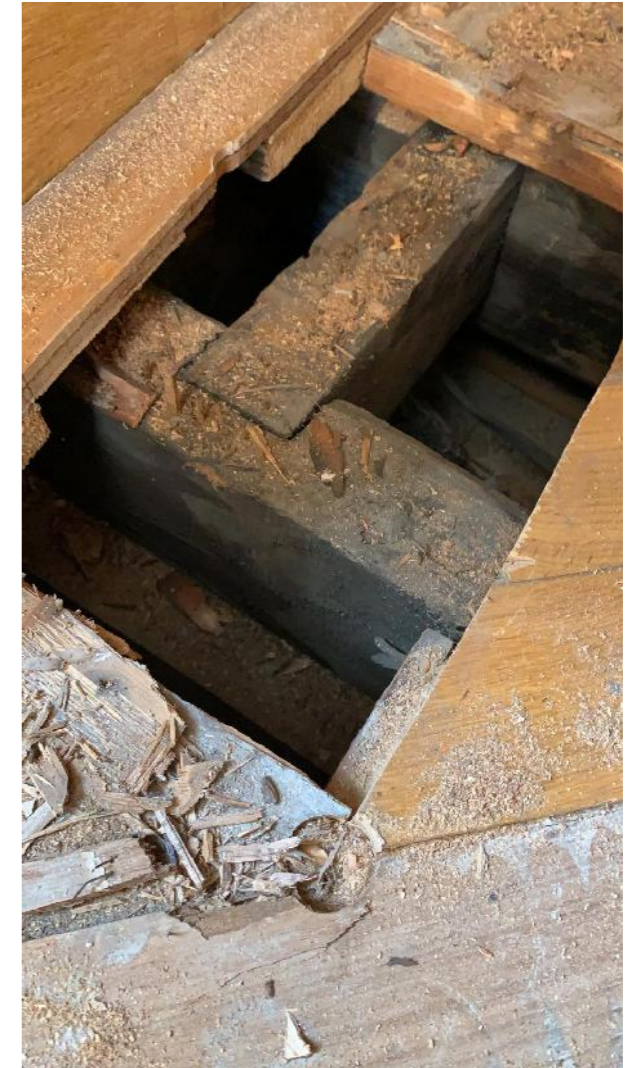
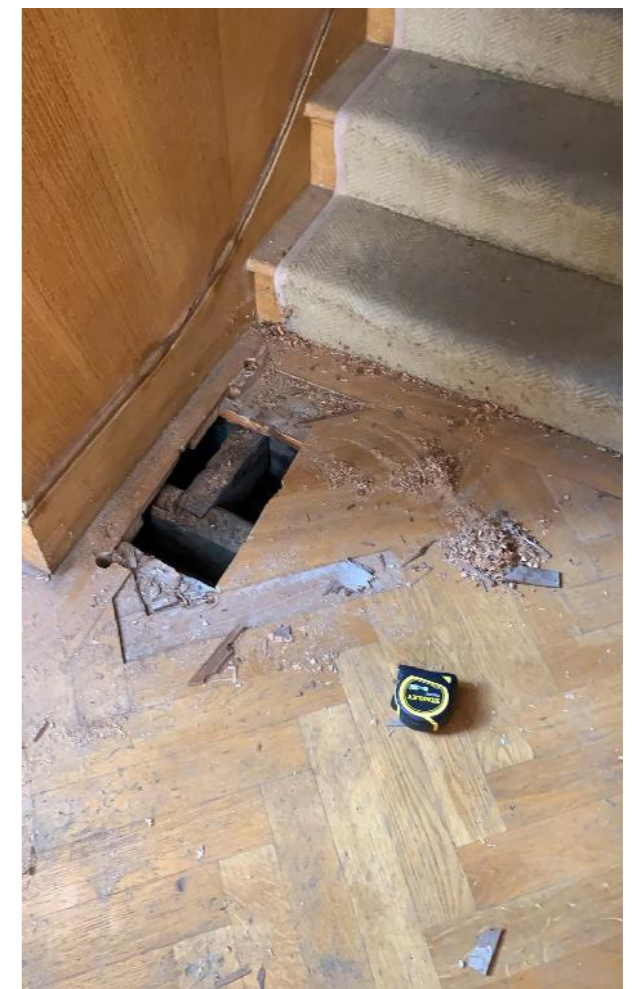
7

1 layer of Timber harring bone of recent manufacture  
1 layer of Pine boards  
Joists 140X70  
Some damages to joists

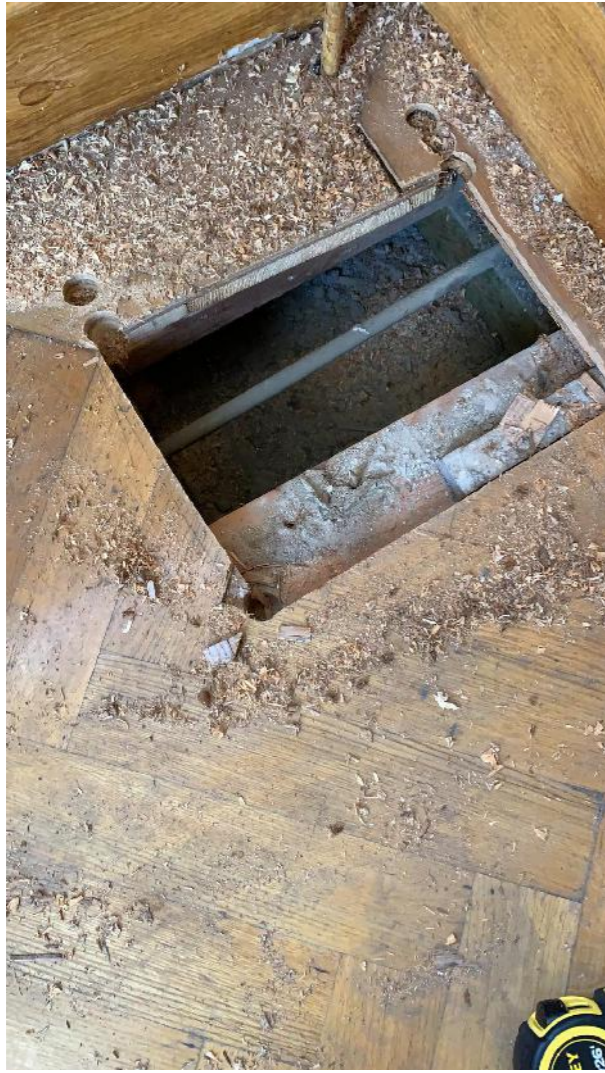
8

1 layer of Timber herring bone of recent manufacture  
1 layer of Pine boards  
Joists 140X40

Some damages to joists

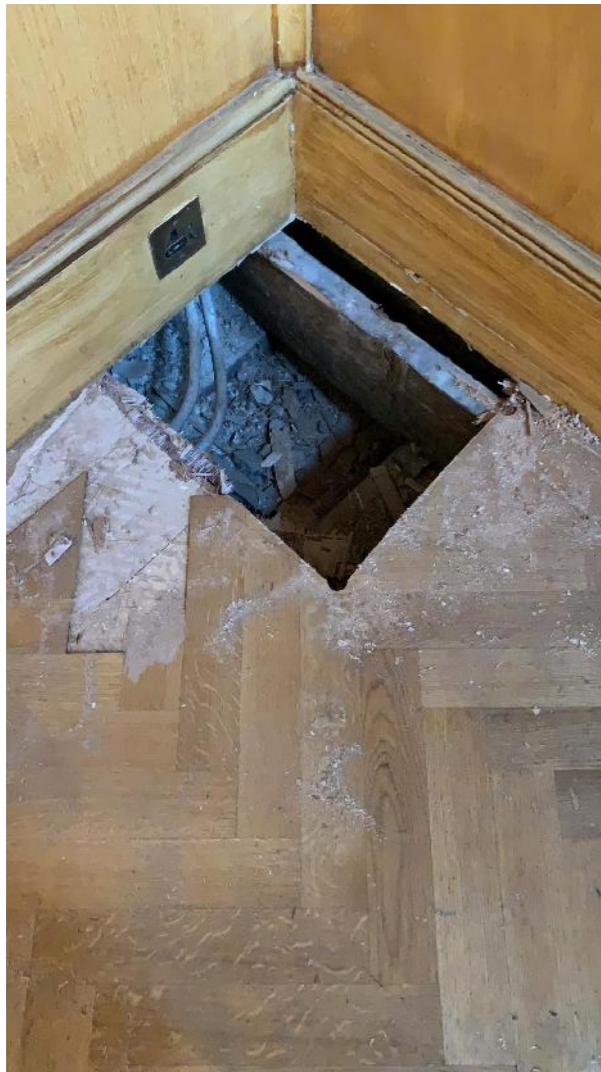
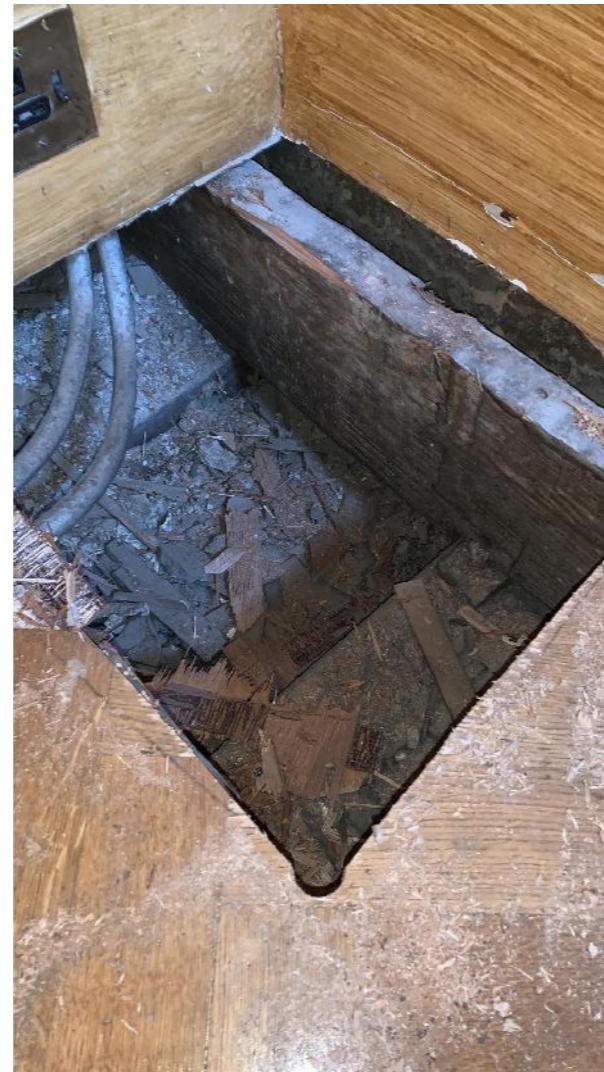
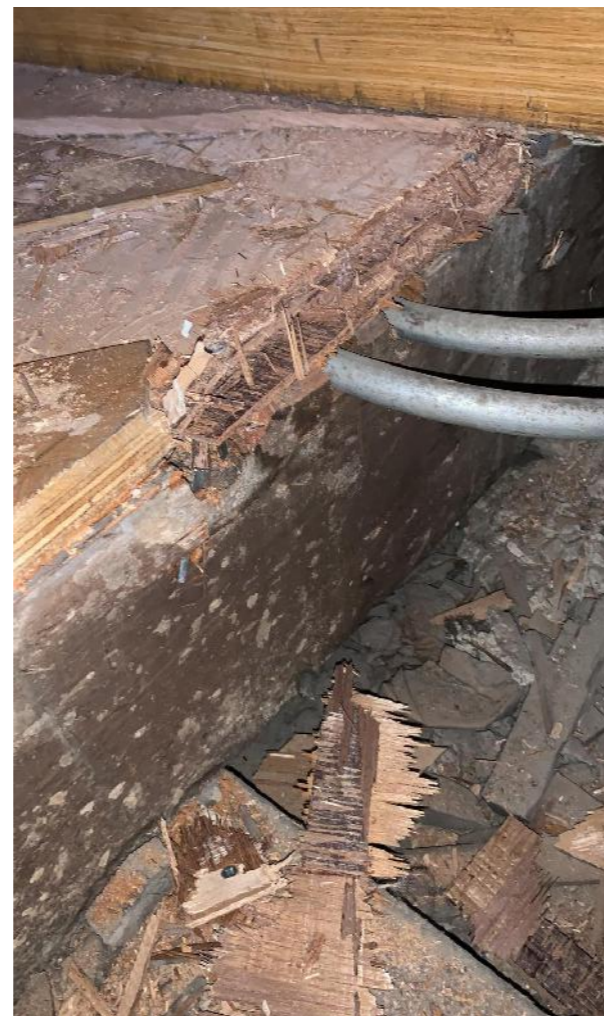
10

1 layer of Timber harring bone  
 1 layer of ply  
 Joists 240X50  
 Some damages to joists

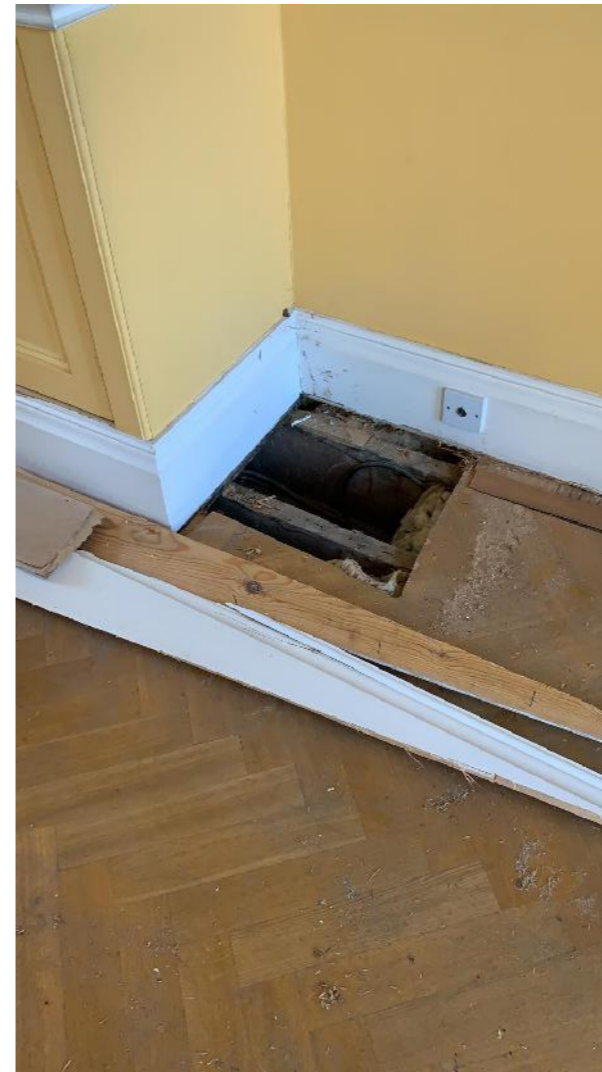
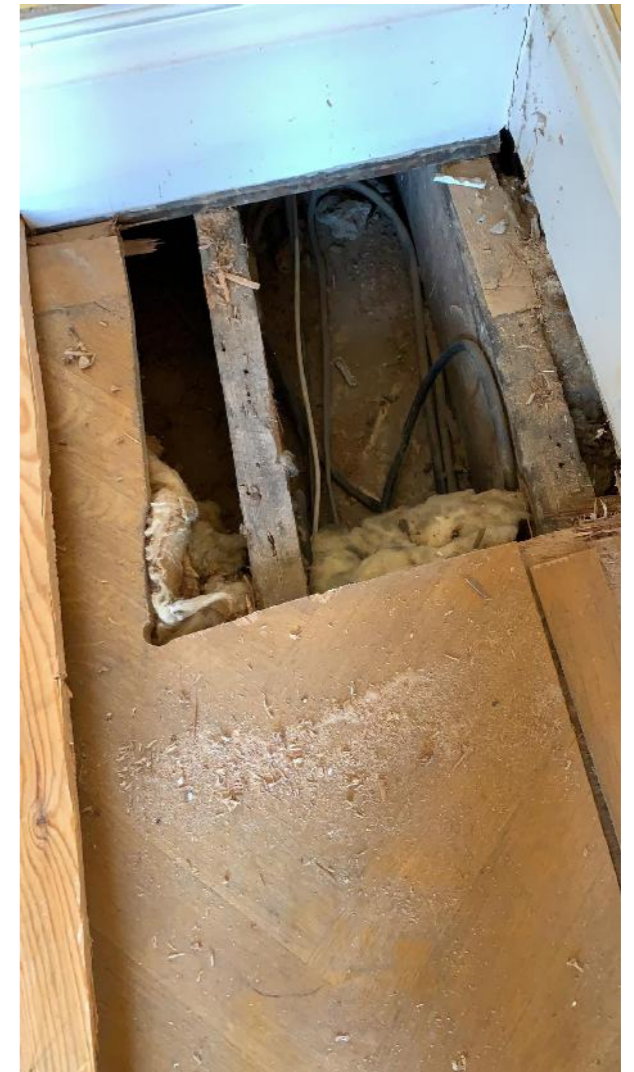
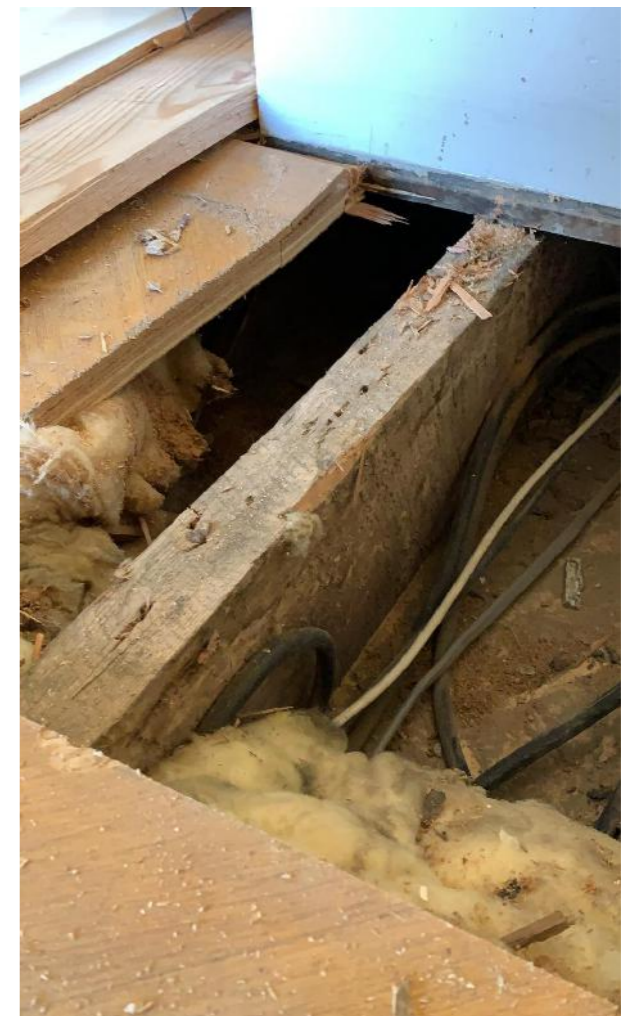
11

1 layer of Timber harring bone  
 1 layer of ply  
 Joists 140X70  
 Some damages to joists

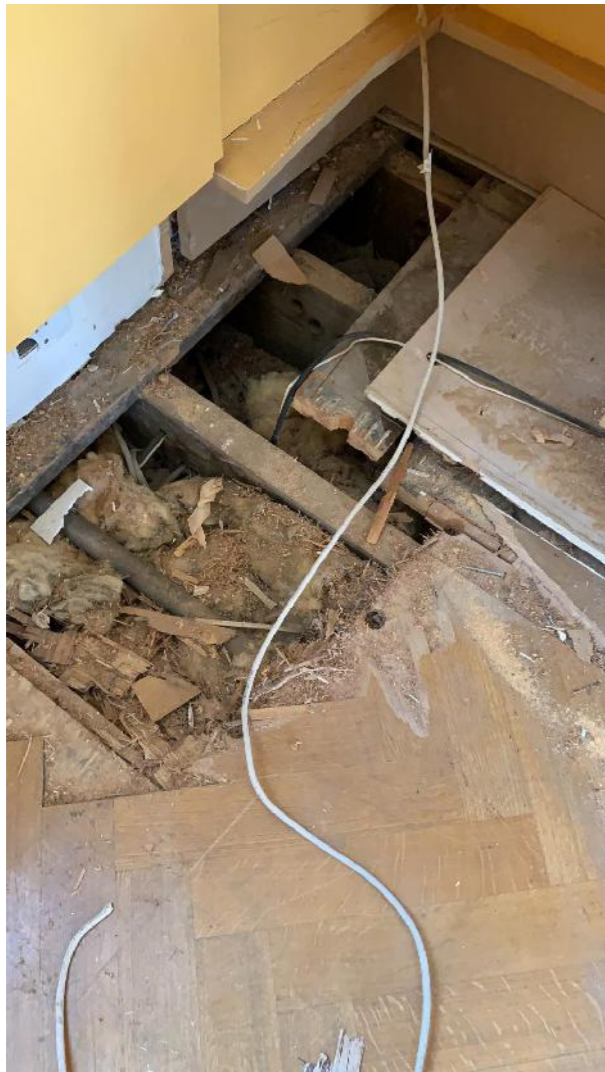
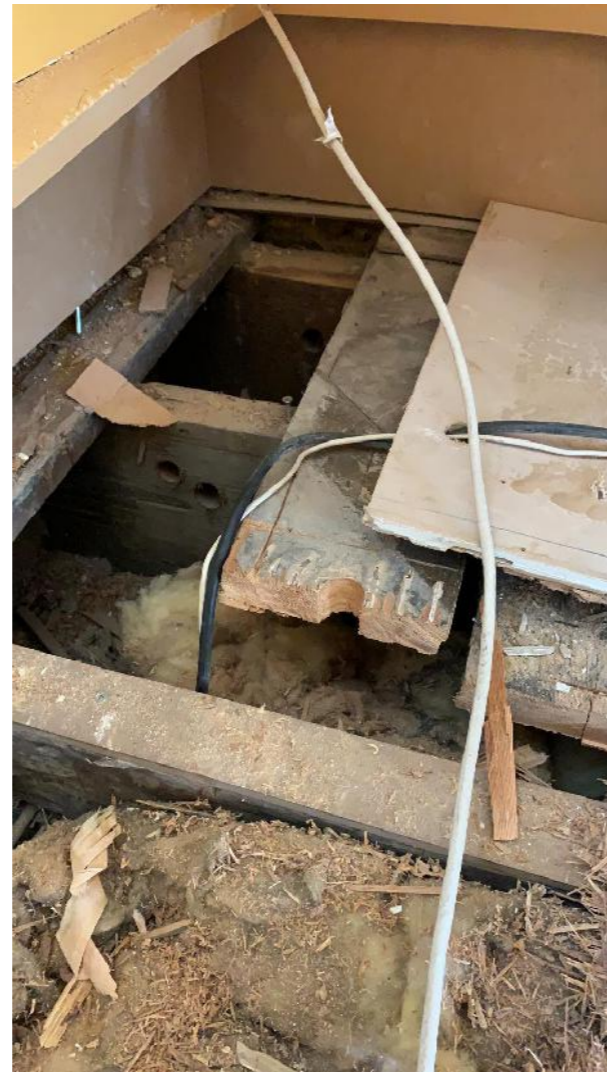
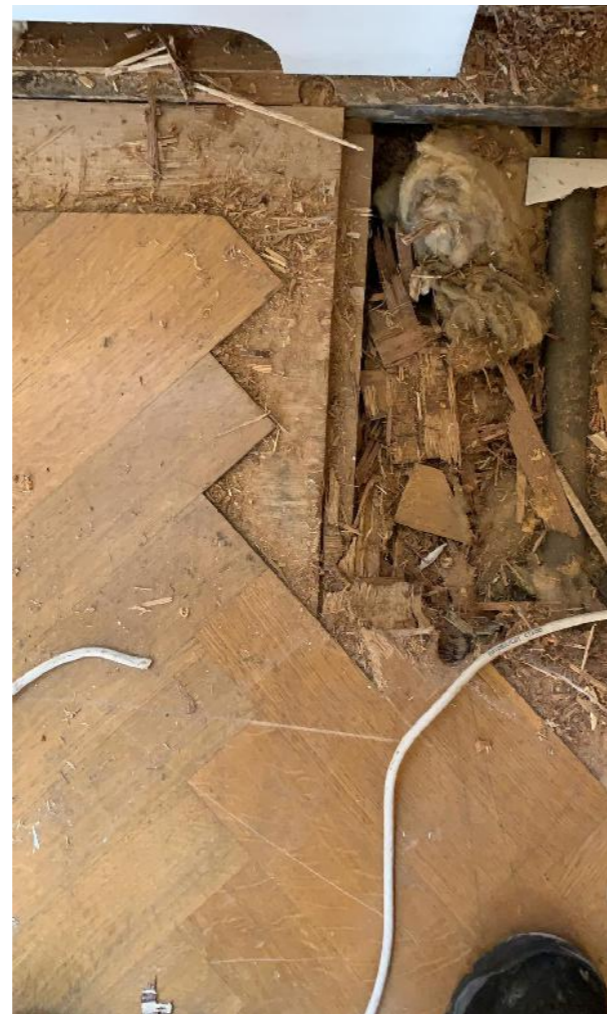
12

1 layer of Timber harring bone  
1 layer of ply mixed with pine planks  
Joists 220X50

Some damages to joists

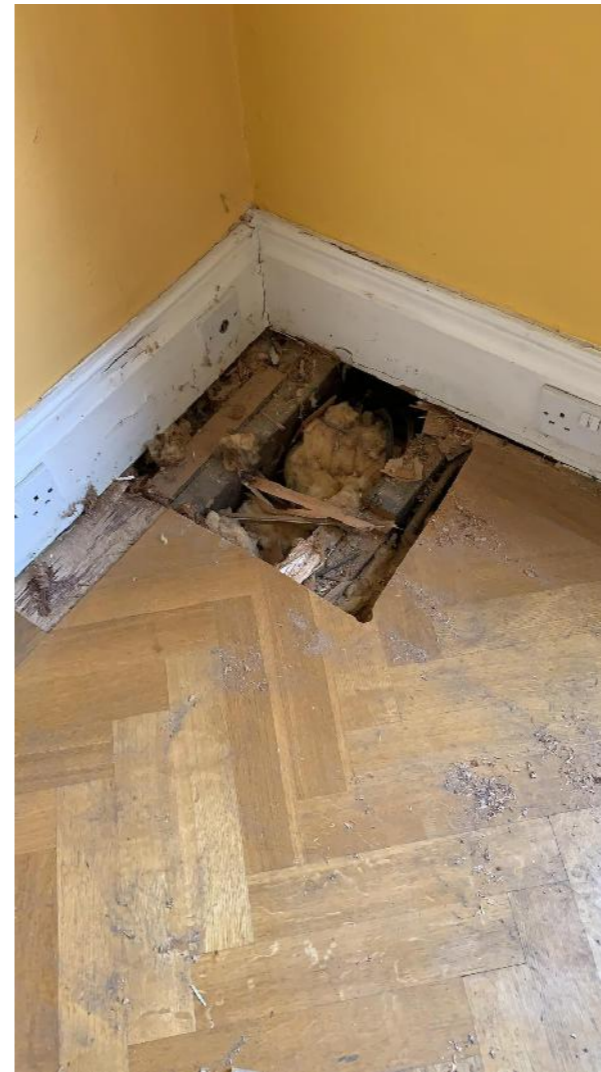
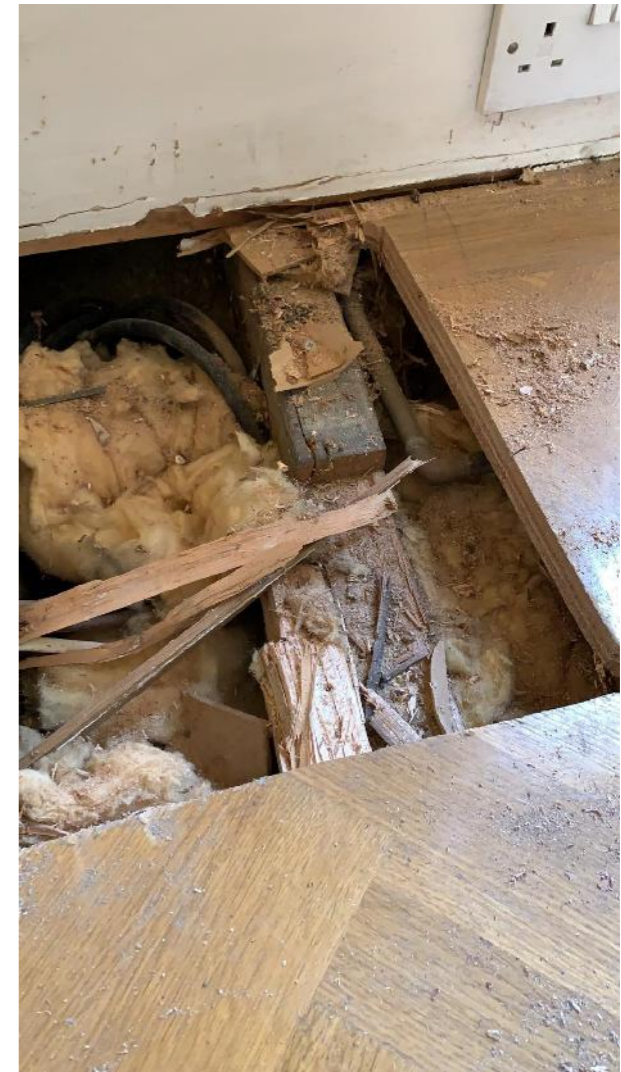
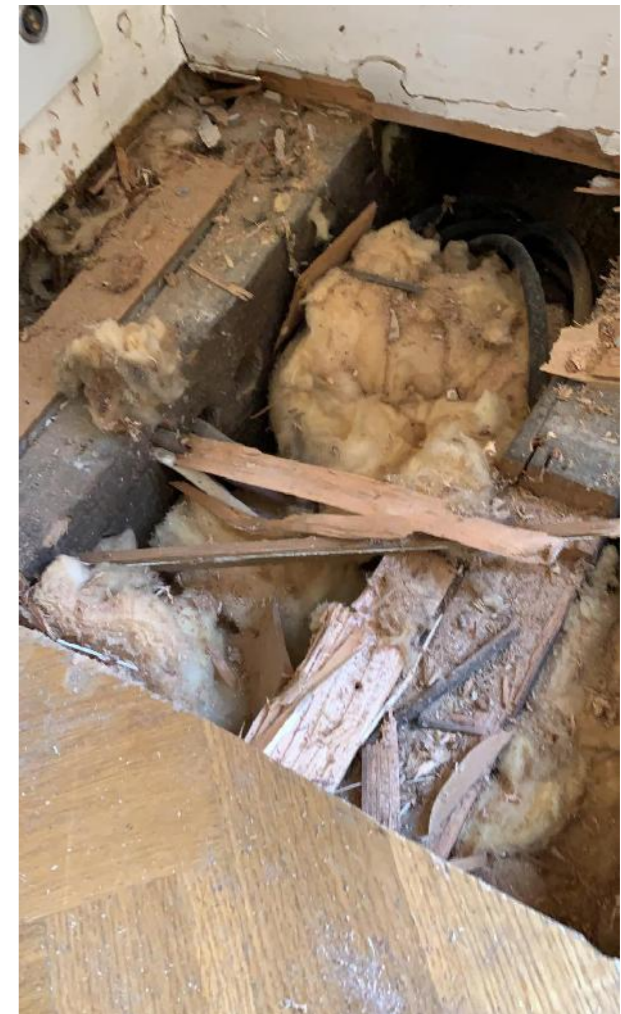
13

1 layer of Timber harring bone  
1 layer of ply + firrings to level the floor  
Joists 220X50

Some damages to joists

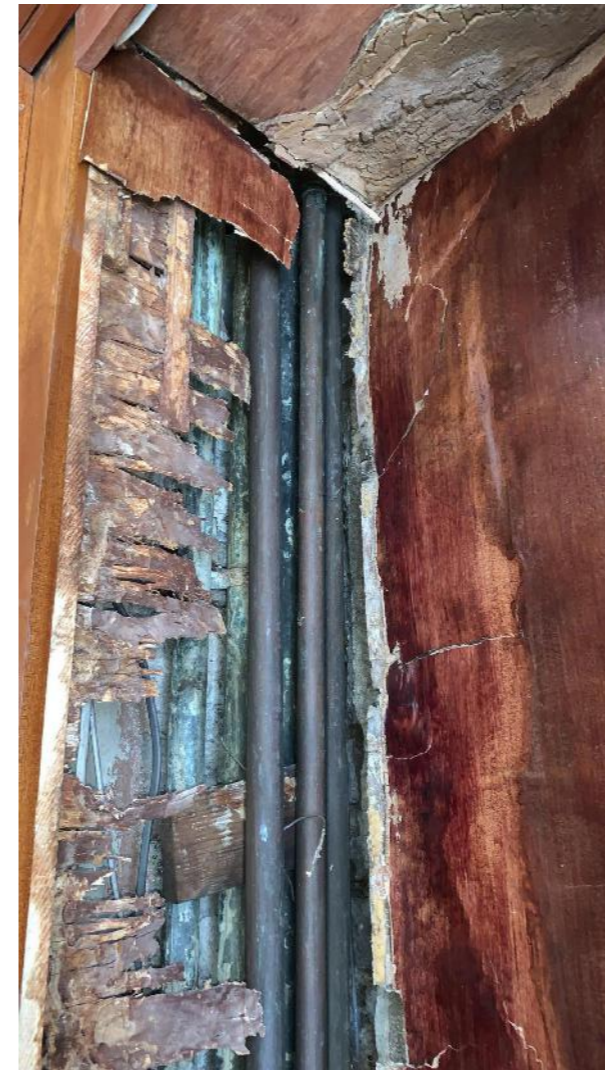
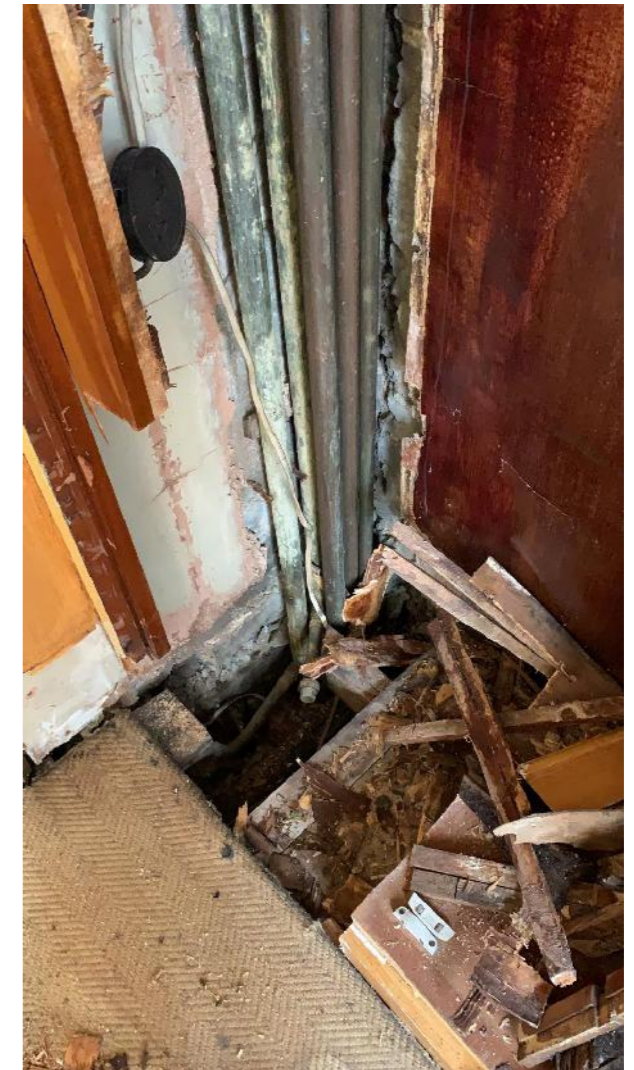
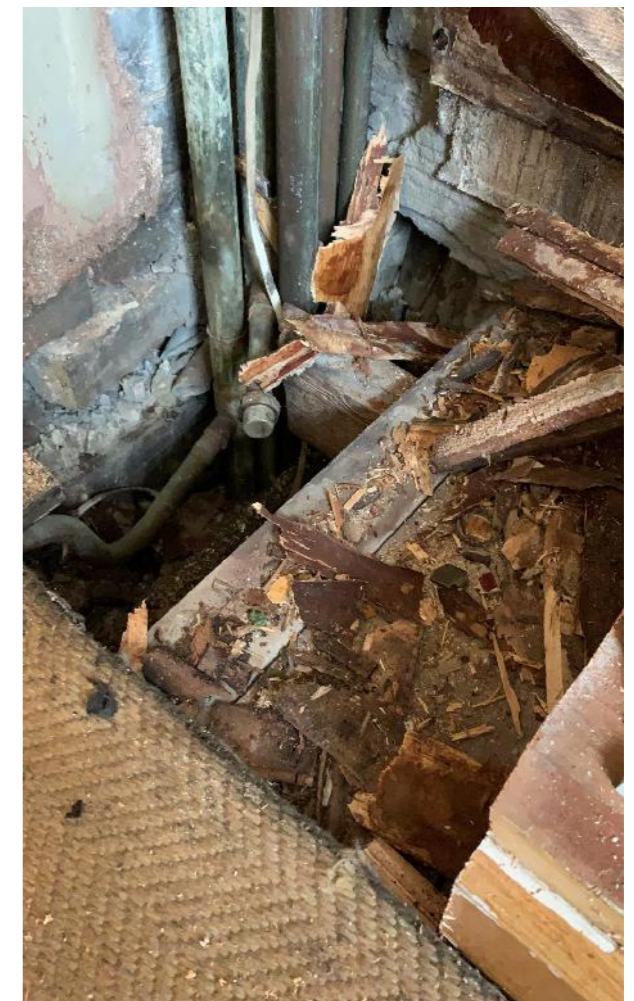
14

1 layer of Carpet + underlay  
1 layer of pine boards  
Joists 300X50 from side to side  
Joists 100X40 from front to back  
500 mm void in the floor in total

Heavy damages to joists

Damages to walls following haevy leak

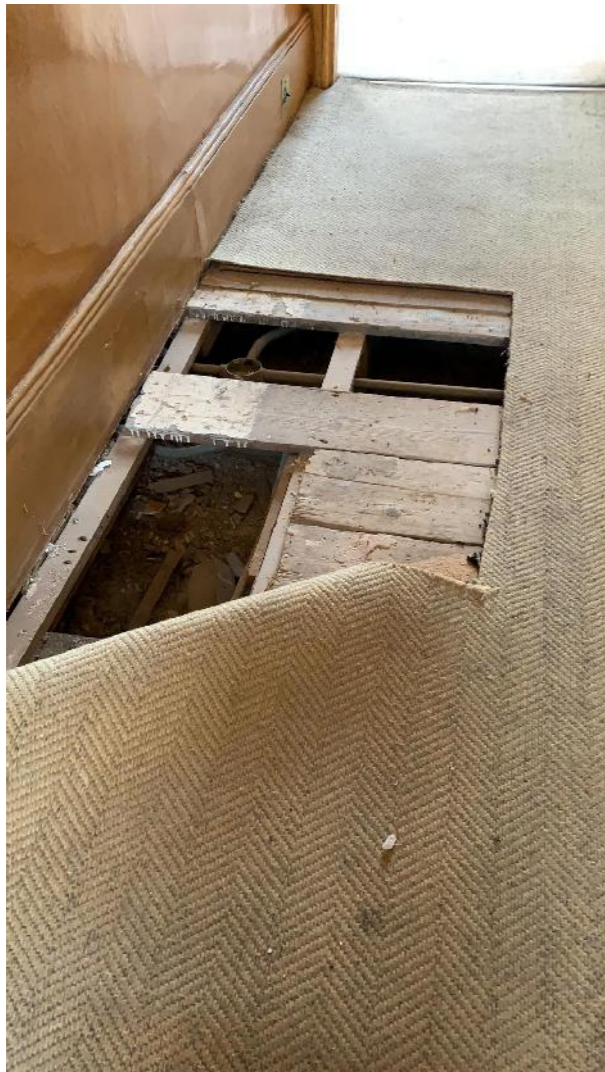
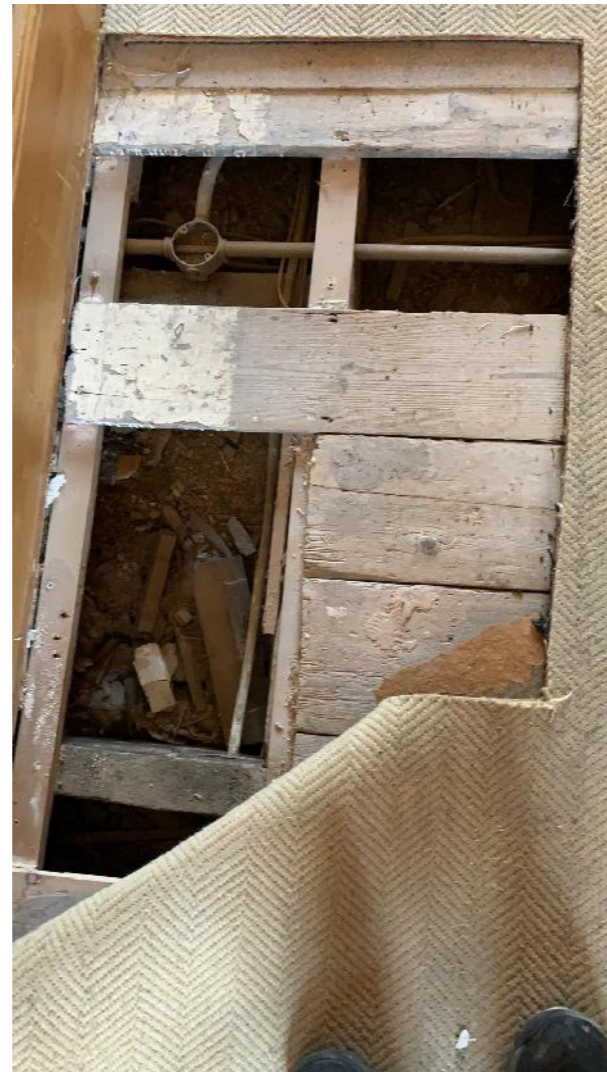
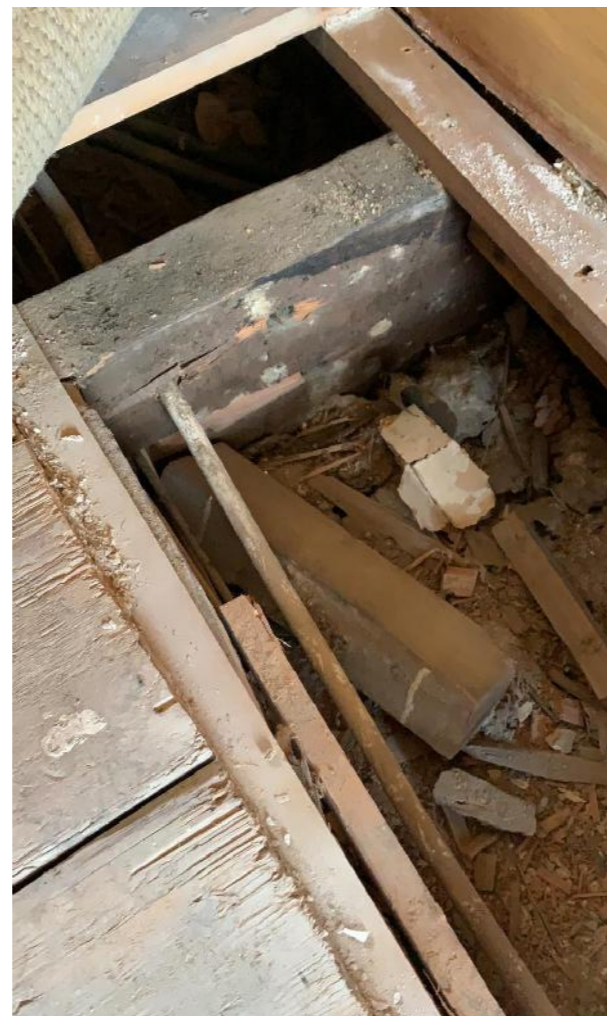
15

1 layer of Carpet  
 1 layer of ply pine boards of recent manufacture  
 Firrings  
 Joists 200X60  
 Some damages to joists
