## **04 MONTPELIER SQUARE - SW71JT**

LBMVarchitects - SITE INVESTIGATIONS PHOTOS - FLOORS AND ROOF STRUCTURE

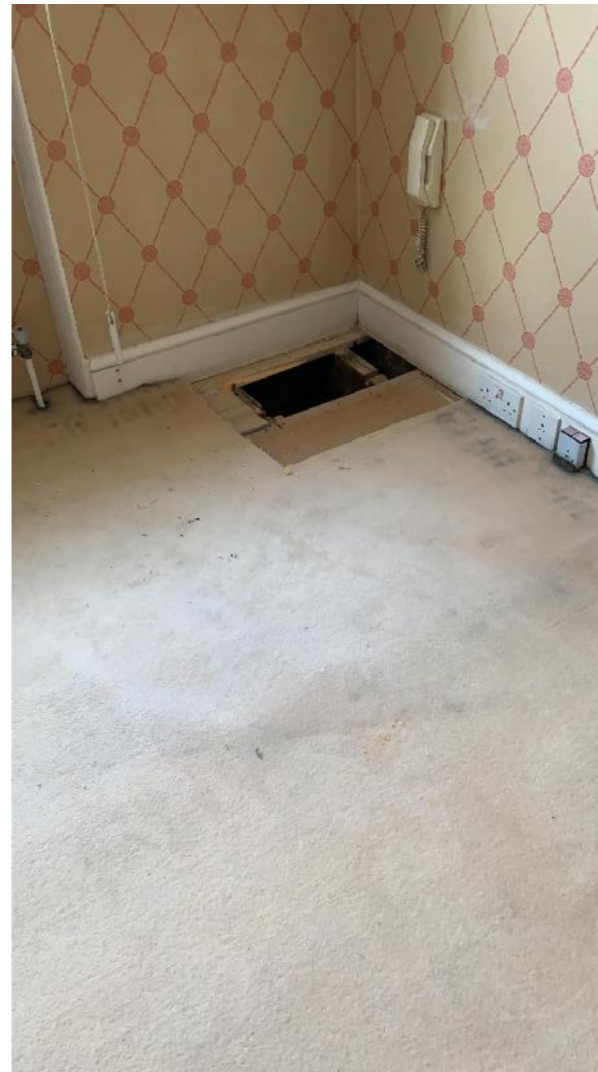
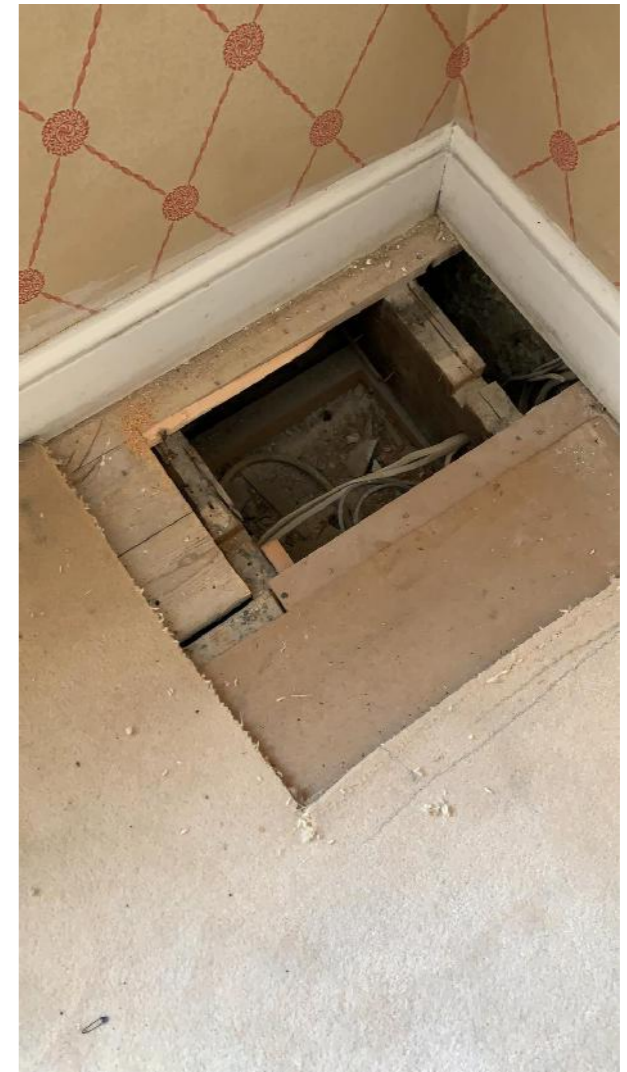
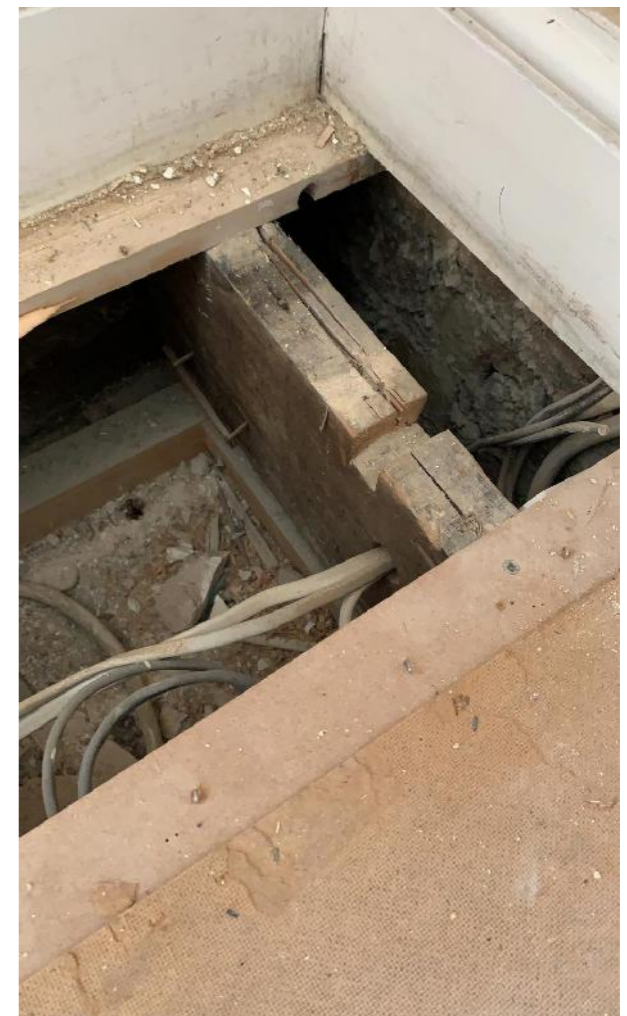
16

1 layer of Carpet  
 1 layer of pine boards of recent manufacture  
 Joists 200X60  
 Some damages to joists

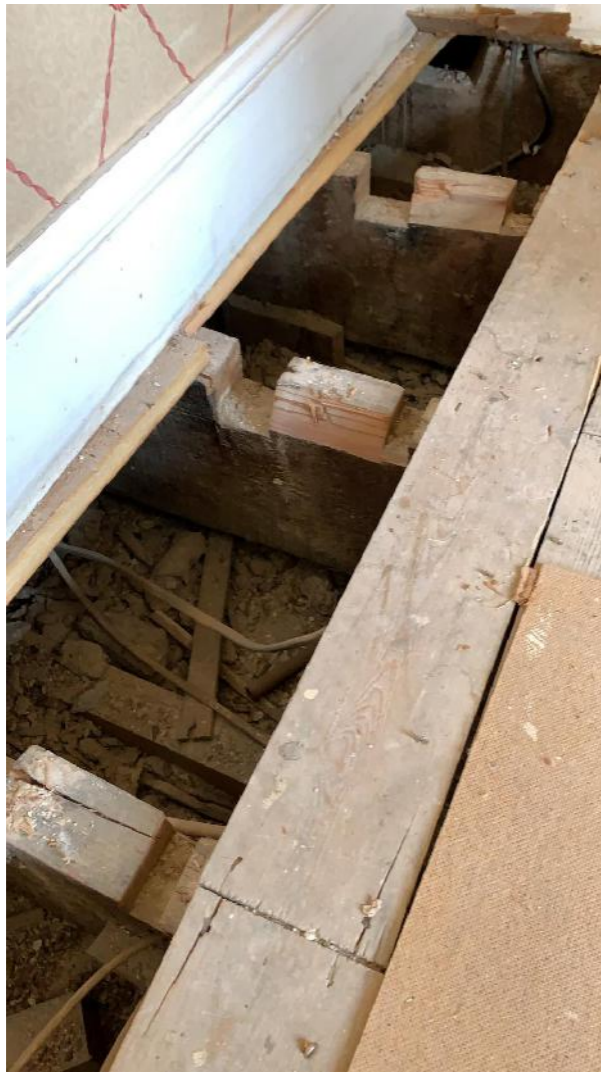
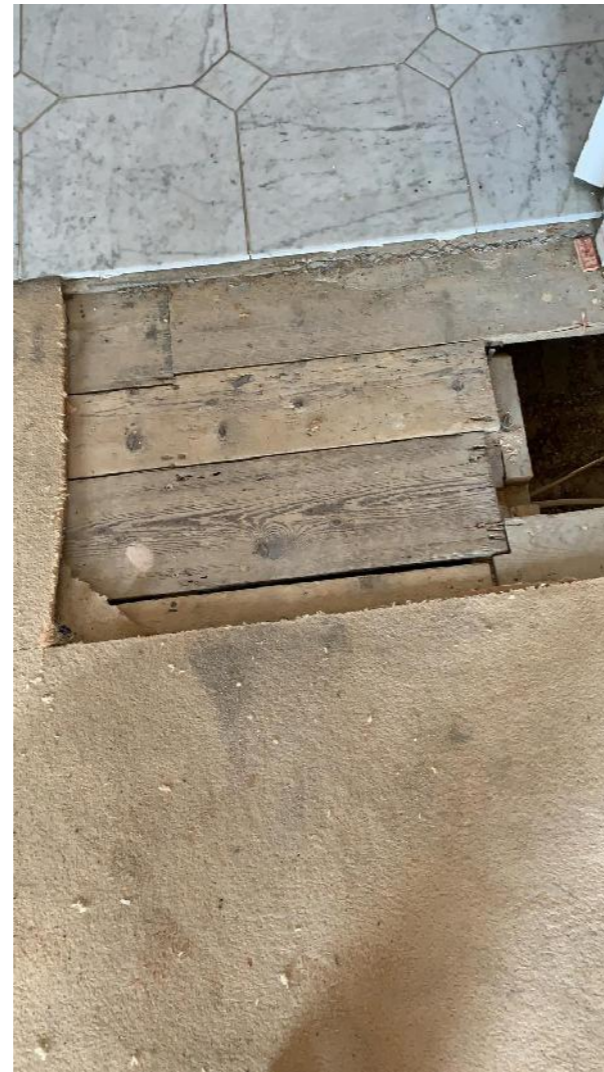
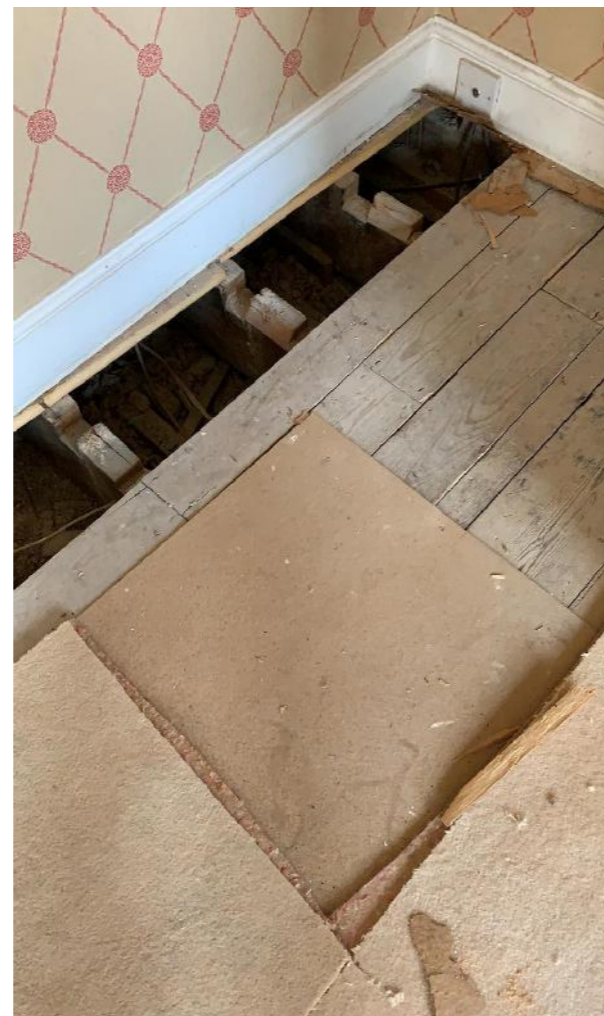
17

1 layer of Carpet + hardboard  
1 layer of pine boards of recent  
manufacture  
Joists 240X50

Some damages to joists

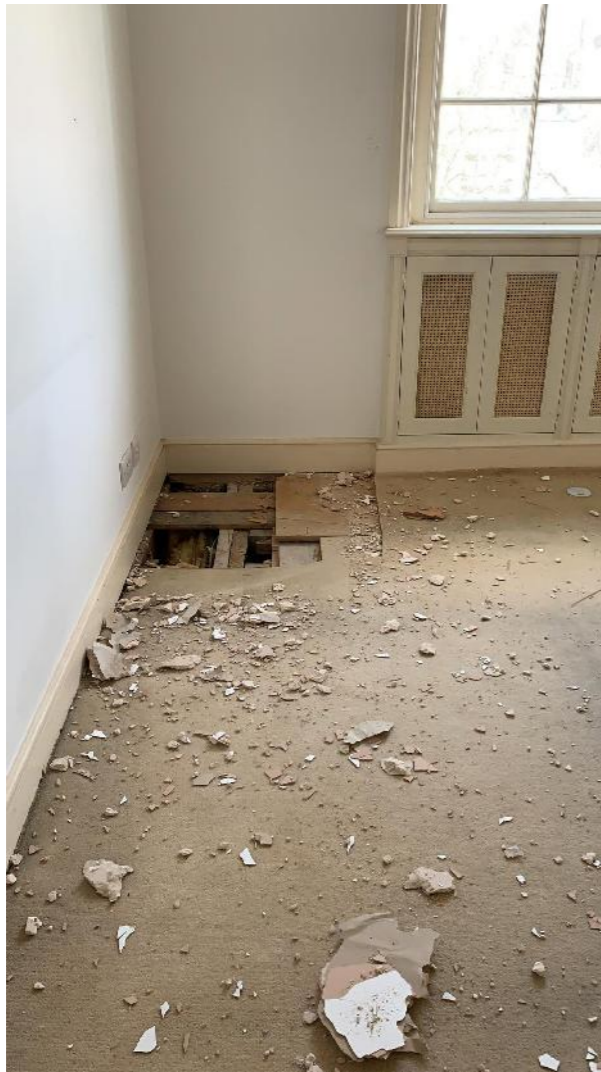
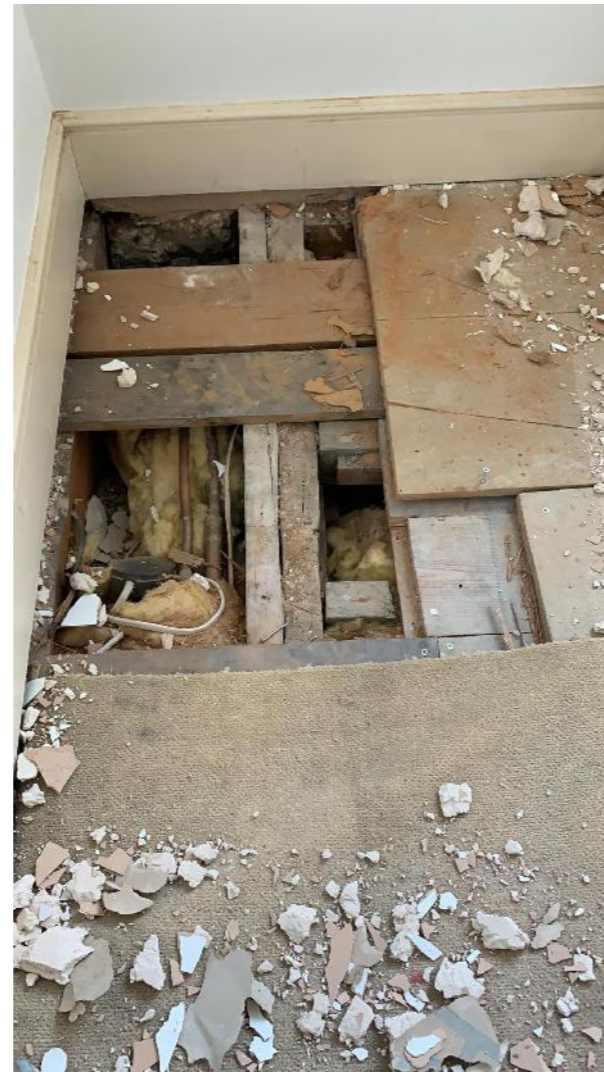
19

1 layer of Carpet with underlay  
1 layer of chipboard  
1 Layer of pine boards of recent manufacture  
Joists 200X40

A lot of alteration to joists

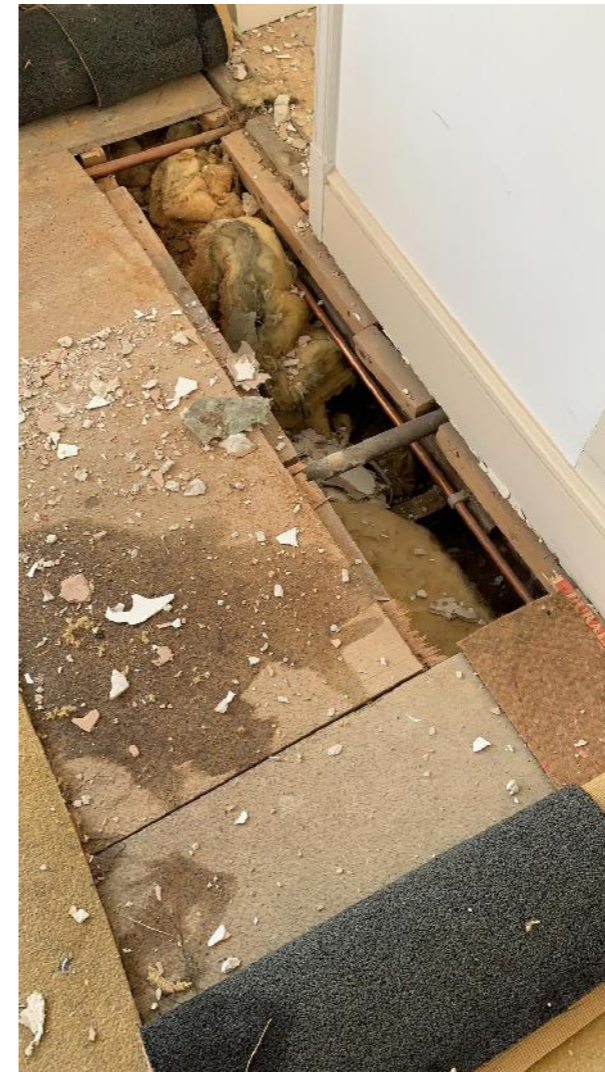
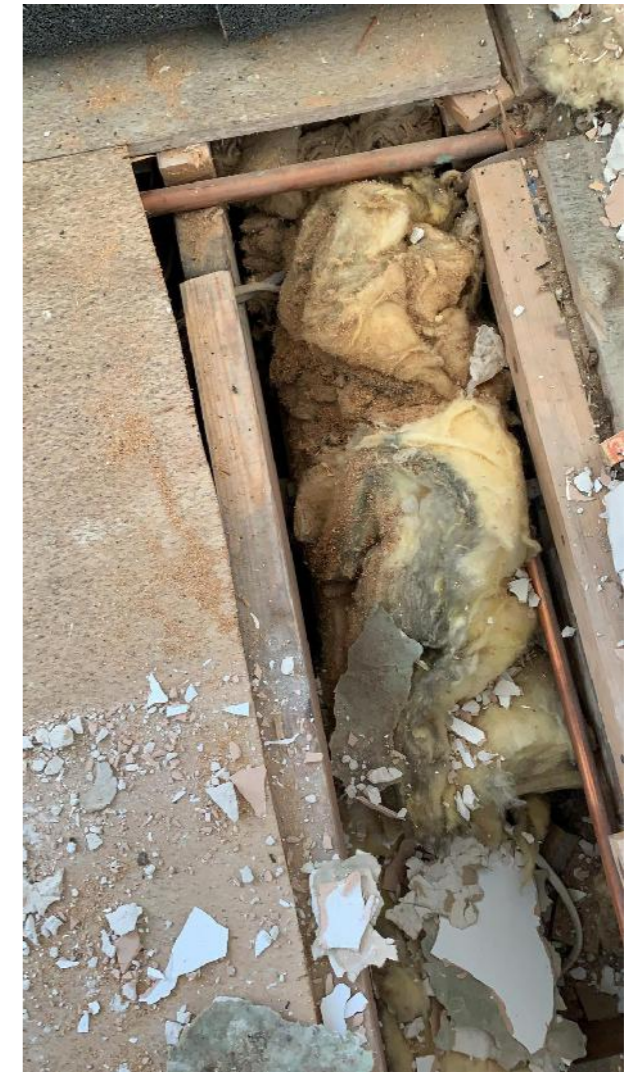
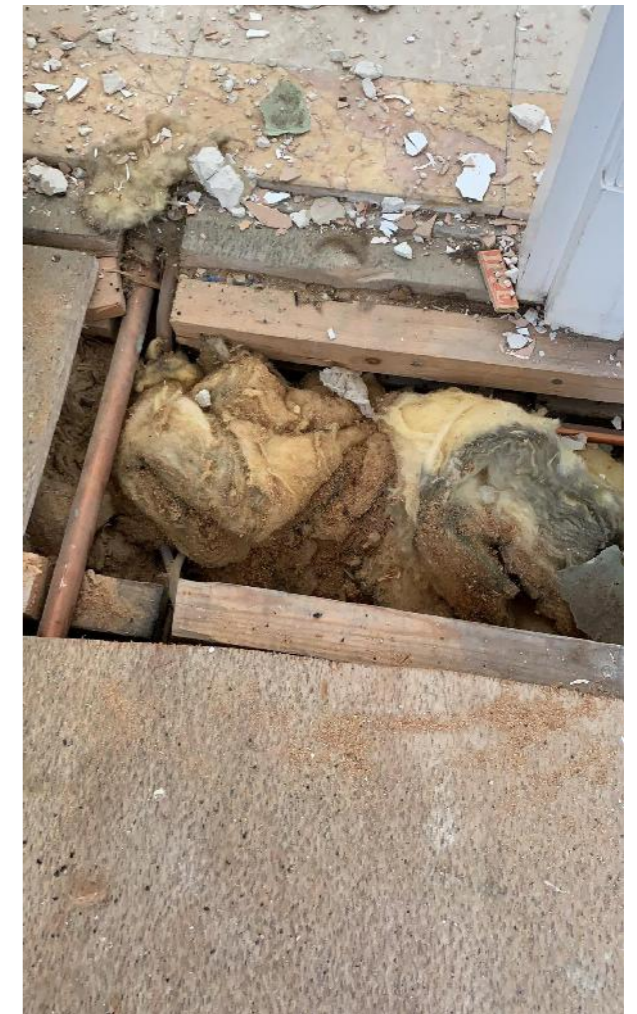
20

1 layer of Carpet with underlay  
1 layer of chipboard  
Joists 180X40

A lot of alteration to joists

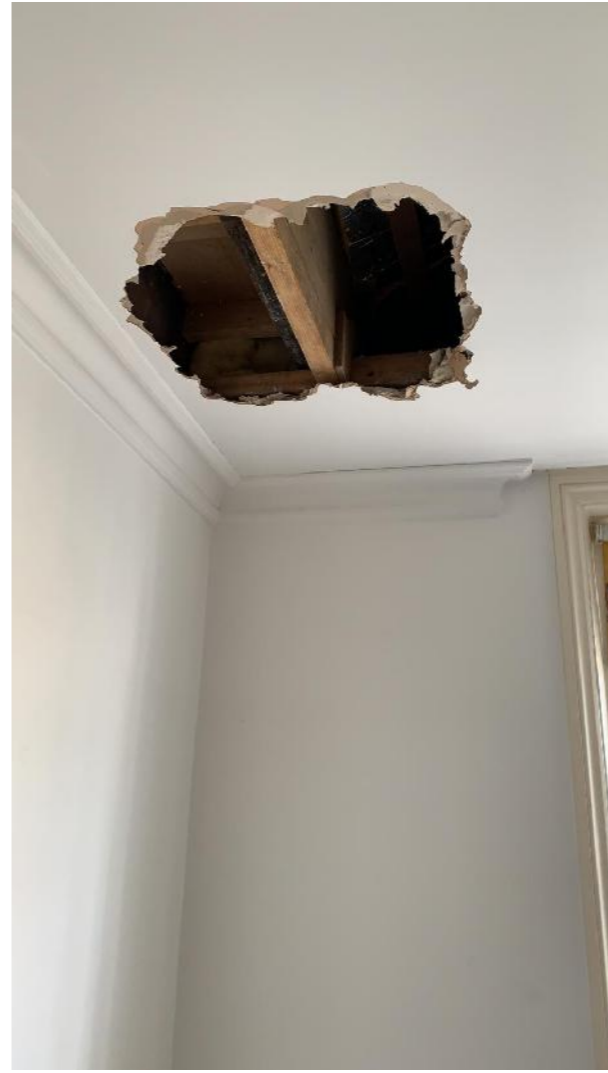
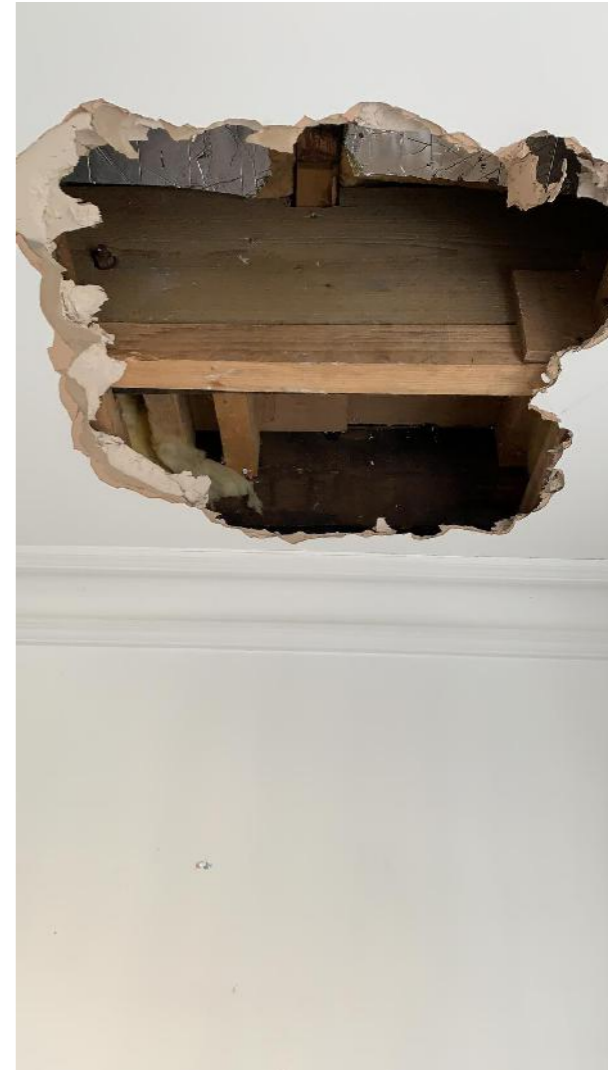
22

The roof was almost entirely rebuilt in the 90' following a partial collapse of the ceiling due of guttering blockage. New structural elements appear to be incorporated into the very fragemented original stucture It is also visible new insulation in between the rafters

New roof timber structure visible and new insulation

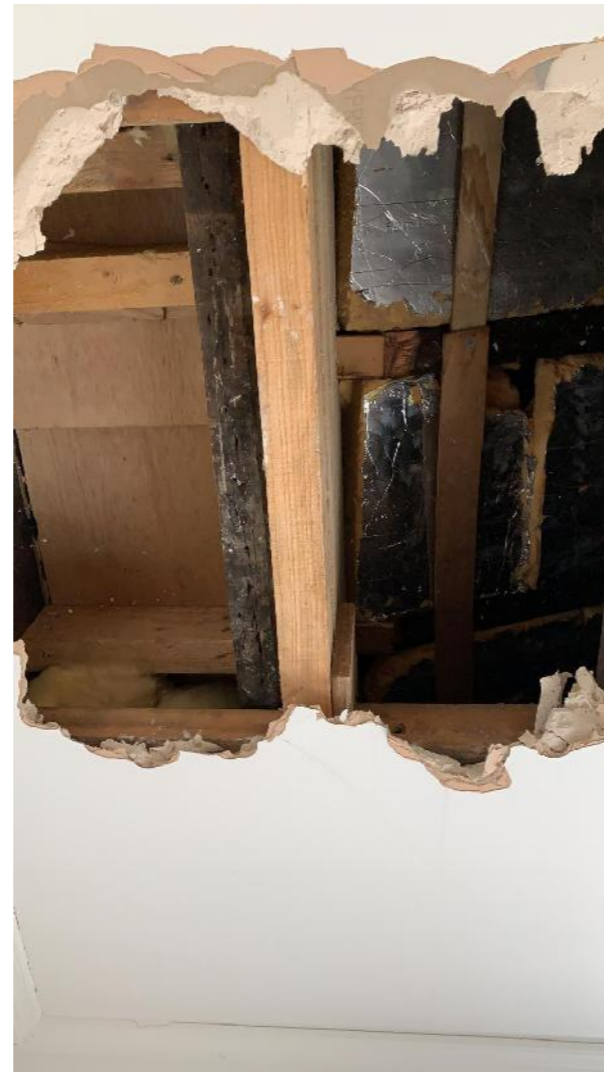
New roof structure visible  
New insulation  
Small fargments of the orginal roof structure , heavily altered

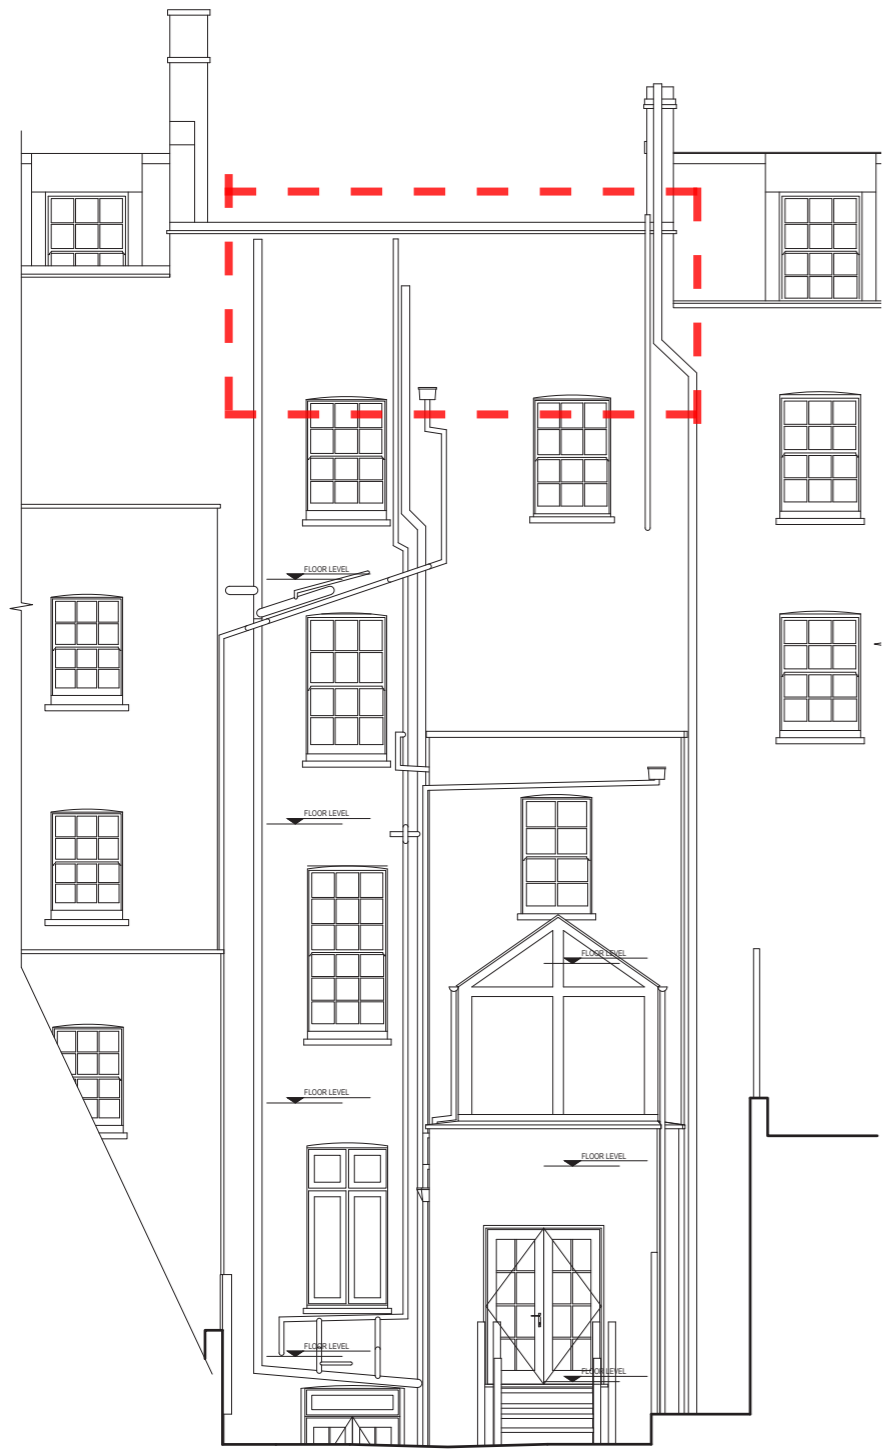
The top section of the rear wall of the building was entirely rebuilt following the collapse of the roof, as visible from the photo 25
