AO
CONSULTING ENGINEERS

0224w0001A -Structural Conversion Report, Barn at Trekennick

House

Mr Walker and Ms Templeton-Walker

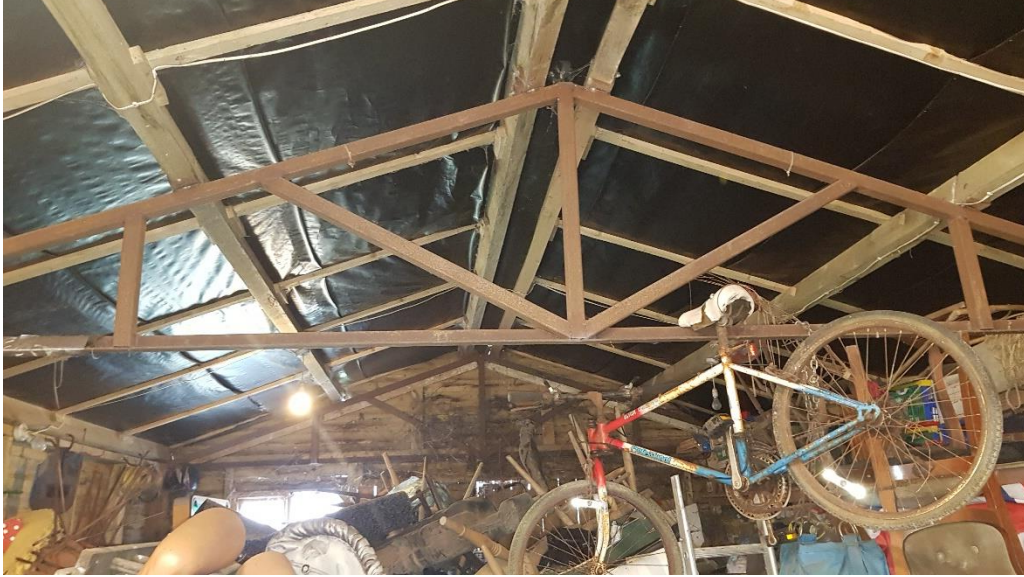
The purlins were in turn supported on three steel trusses (Photograph 1). The steel trusses had square hollow section top chords and internal struts with an equal angle bottom chord. The steel trusses were supported at their bearings by a 125x200dp timber post.

The steel trusses were in good condition but could benefit for wire brushing and painting to remove surface corrosion and to future proof. The sizes of the principal steel members forming the trusses are expected to be adequately sized to support the upgraded roof.

Photograph 1. Steel trusses to roof structure

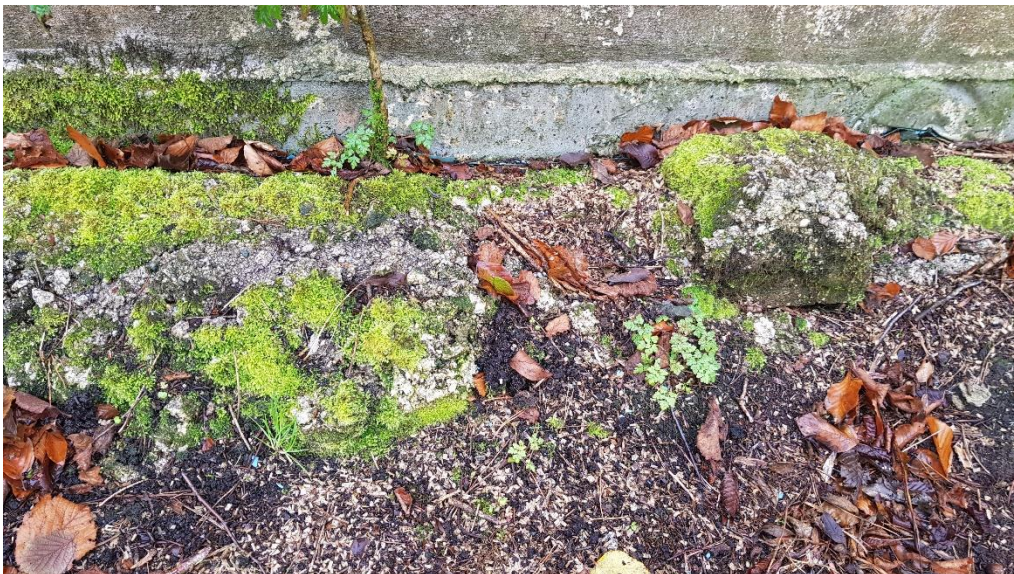
At ground floor level a concrete slab (minimum 125mm) supported the building including the perimeter walls. Concrete edge thickenings to the perimeter of the slab was noted (Photograph 2).

The ground floor slab was measured at 125mm thick (minimum). This will provide approximately spread onto the strata below even considering a conservative, unreinforced slab. The concrete edge thickenings will enhance load spread to the strata below. A replacement slab is not anticipated for conversion.

Photograph 2. Concrete slab and edge thickening

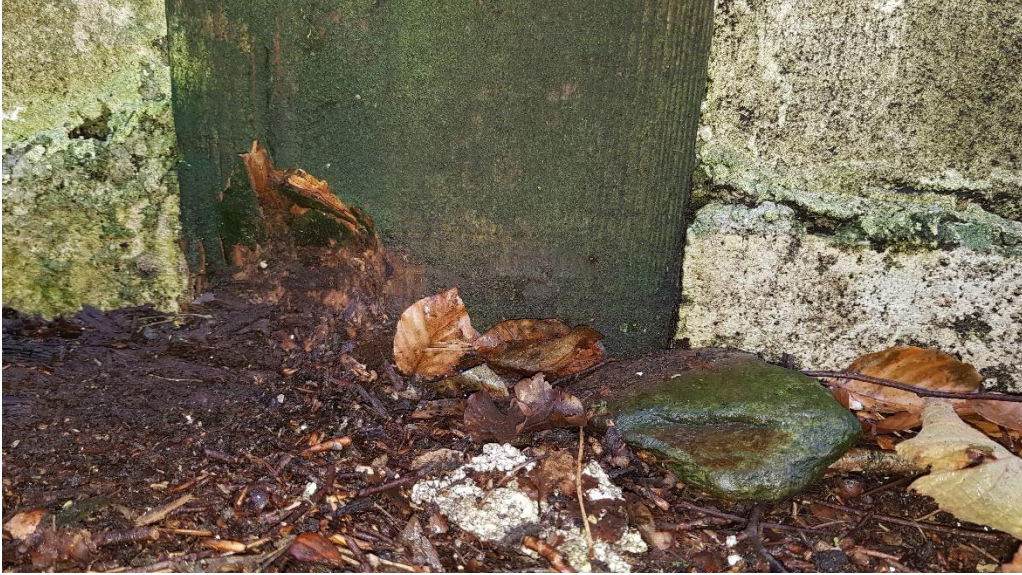
The six timber posts that supported the roof trusses are expected to have an adequate cross section to deal with the additional loadings from a modern roof system. One of the six timber posts was rotten at the base (Photograph 3). A simple replacement section to the bottom of post will be adequate to reinstate the original timber.

Photograph 3. Rotten timber at bottom of post

Apart from the replacement of the bottom section of a single post, no elements of the structure were found to be defective or in need of removal.
