Development tree report for Mr./Mrs. Bunch

Site Address:
16 Bedford Close,
Whitehill,
Bordon,
Surrey,
GU35 9PS

This report is an arboricultural assessment to cover the requirements under B.S.5837:2012 - Trees in relation to design, demolition, and construction.

FINAL REPORT

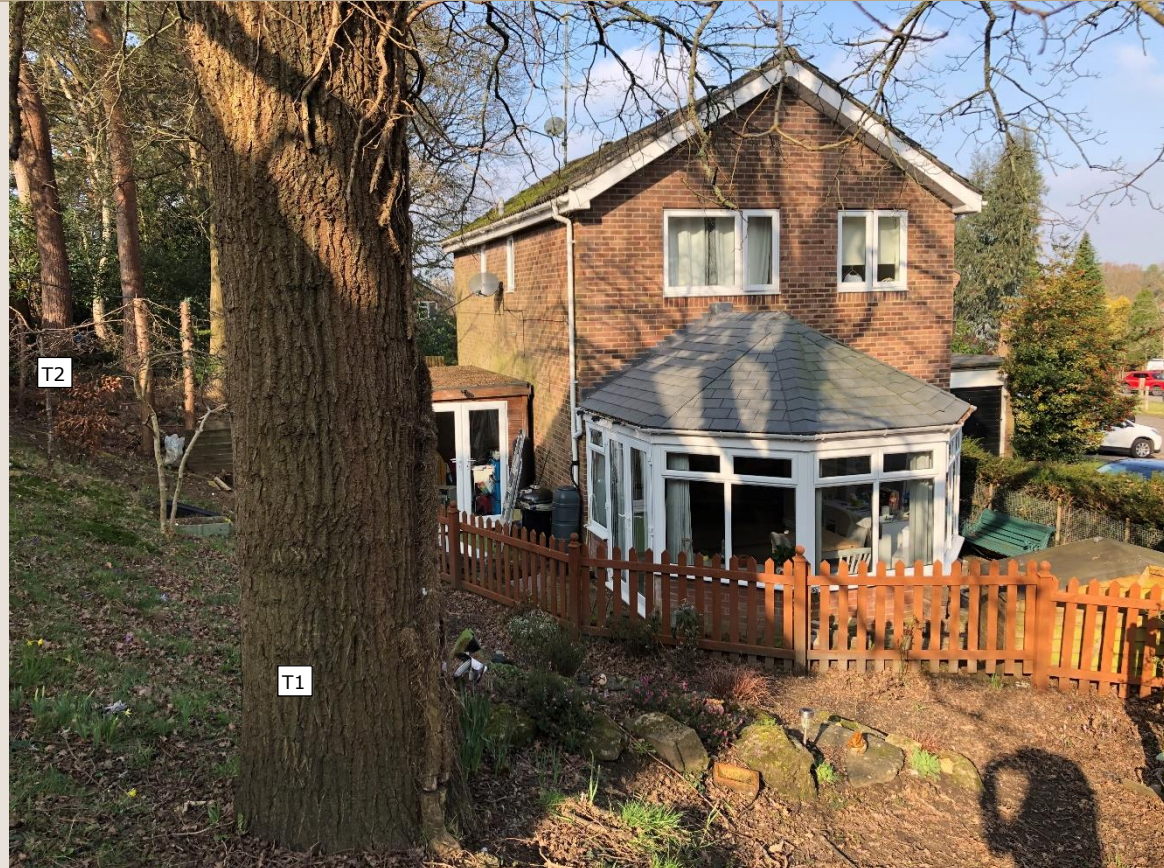
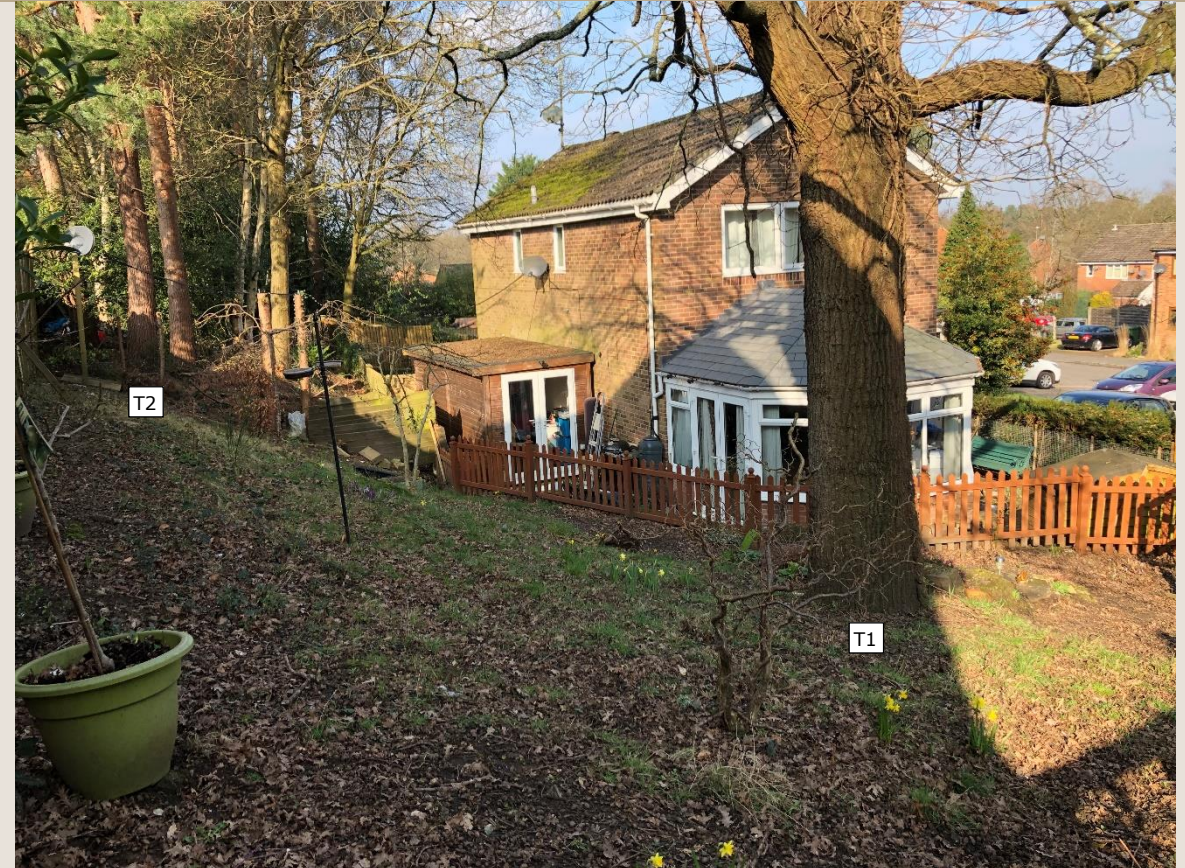
Surveyed trees in relation to existing property.

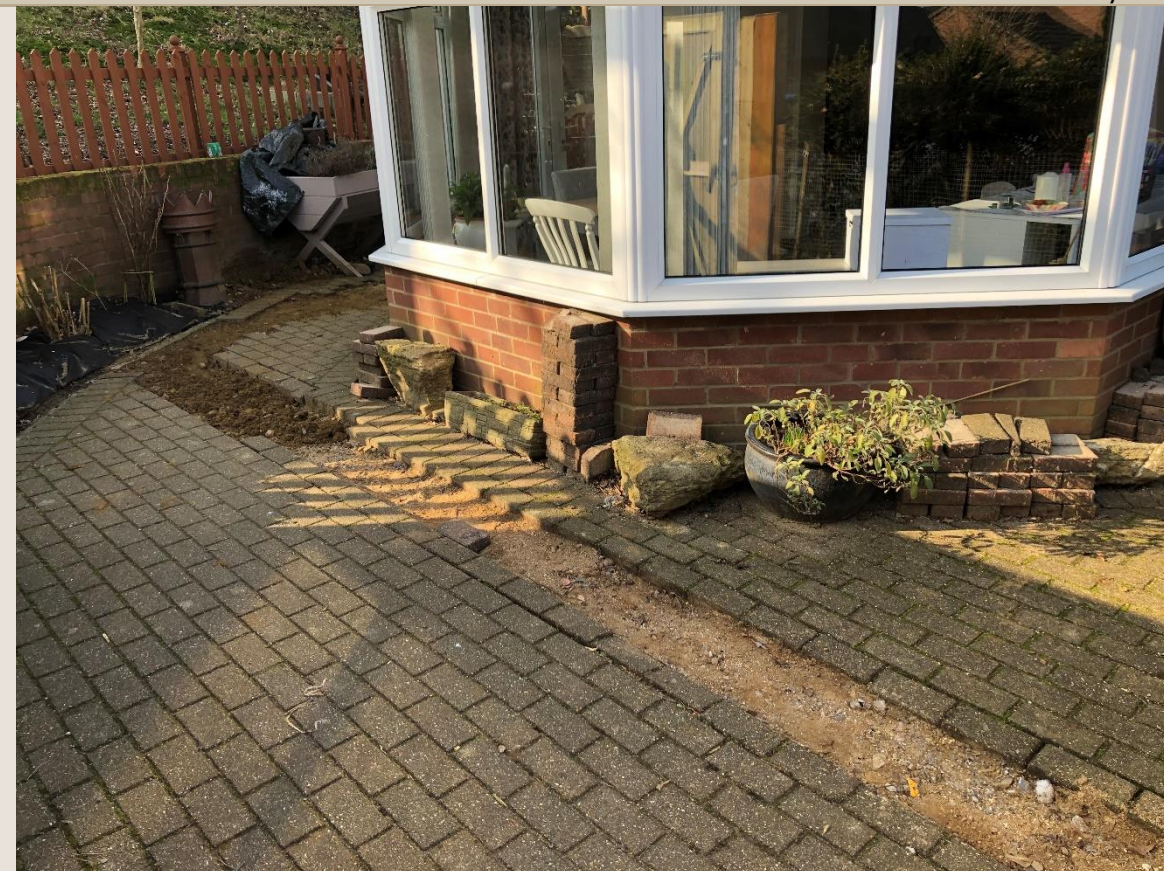
The only possible tree impact is from T1. However, prior to proceeding with the project on our advice air spade excavations were carried out and have revealed no major root structures within the 300mm wide, 600mm deep excavation. This is most likely due to the retaining wall which is located 4.5m from T1, to which, the ground level of the proposals is 850mm lower than the ground level of T1.

Air spade trench showed no major root activity.

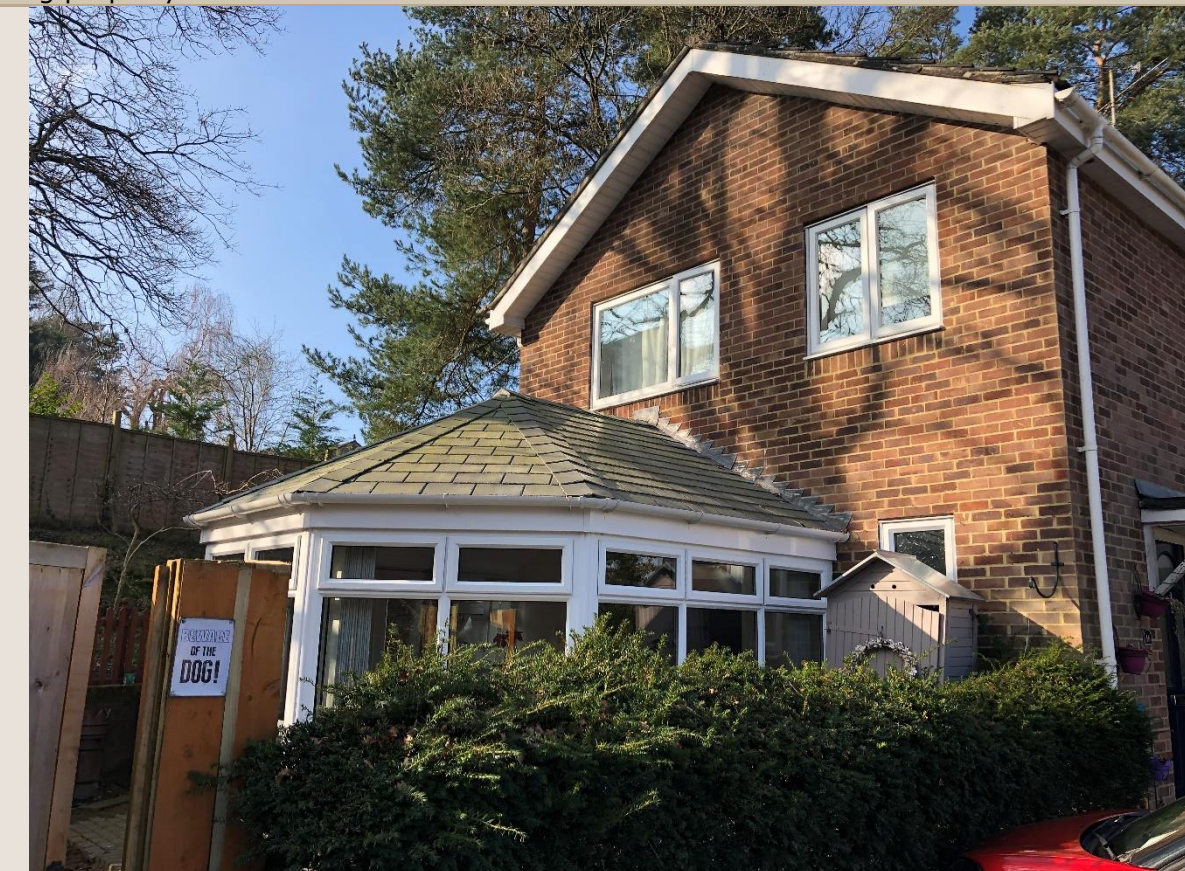
Area of proposed double storey extension.

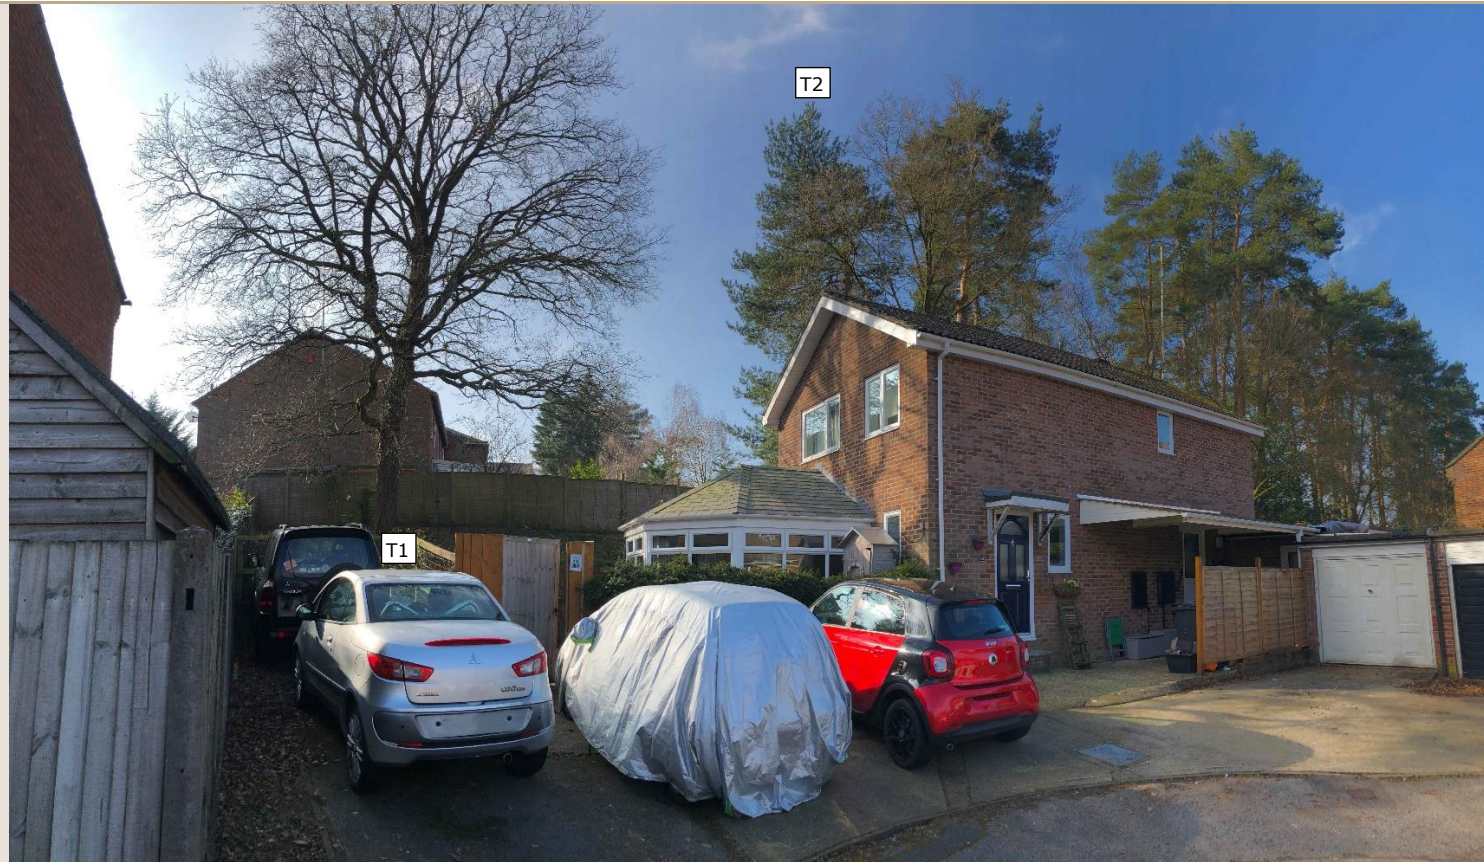
Overview of surveyed trees in relation to existing property.

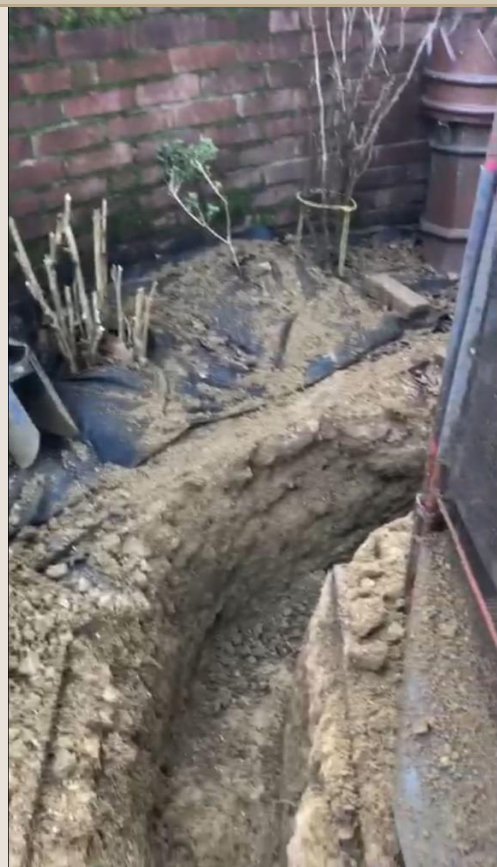
Air spade excavations on the corner closest to T1

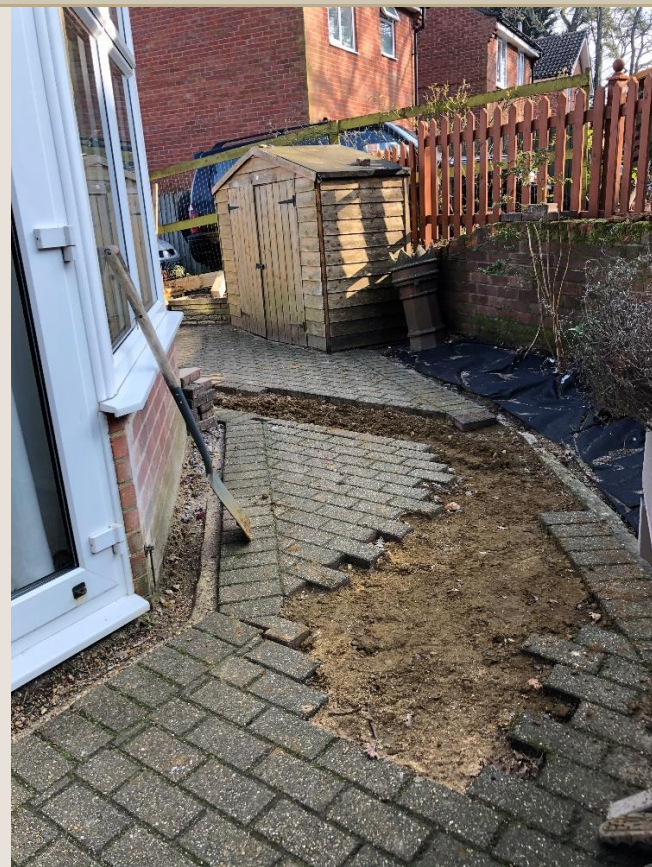
Air spade works in proximity to existing.

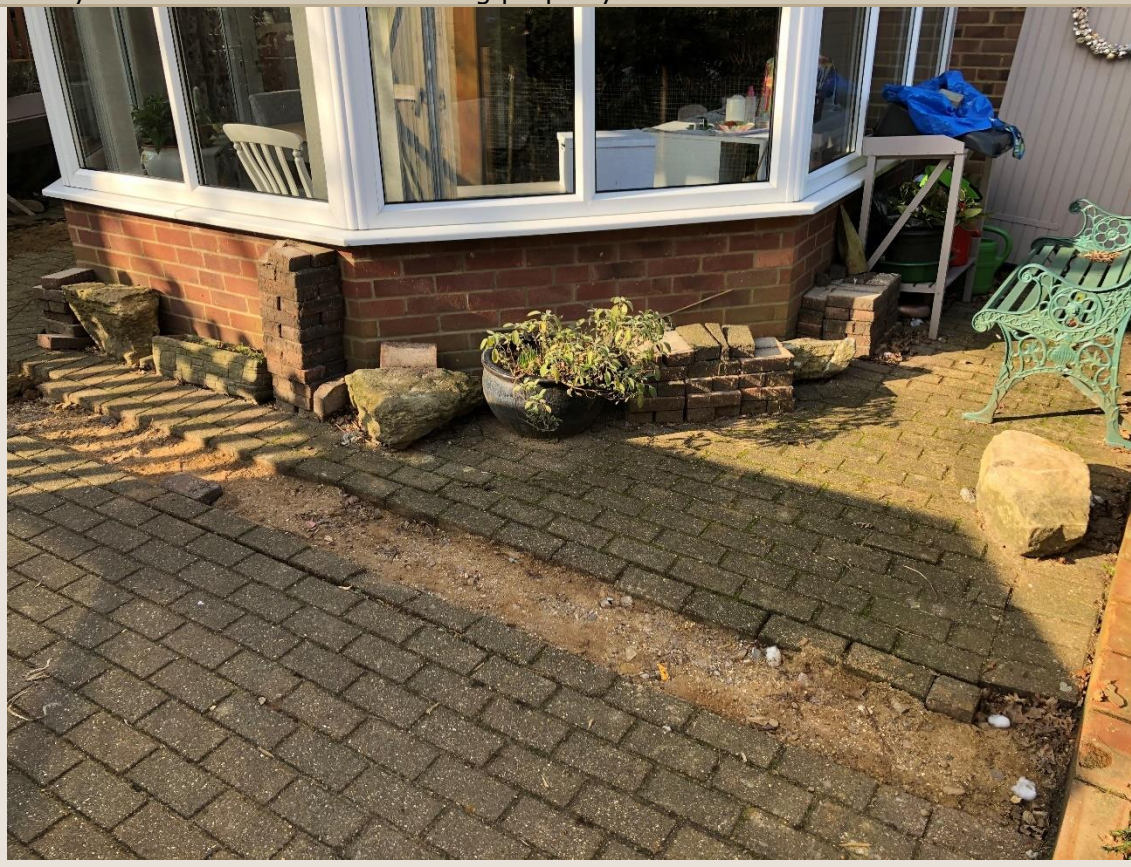
Air spade trench, property left of trench
